**REPORT NUMBER: SPNCAP-MGA-2012-008**

**NEW CAR ASSESSMENT PROGRAM (NCAP)  
Side Impact Pole Test**

**CHRYSLER GROUP LLC  
2012 Dodge Avenger SXT 4-Dr Sedan  
NHTSA No.: MC0312**

**FINAL REPORT**

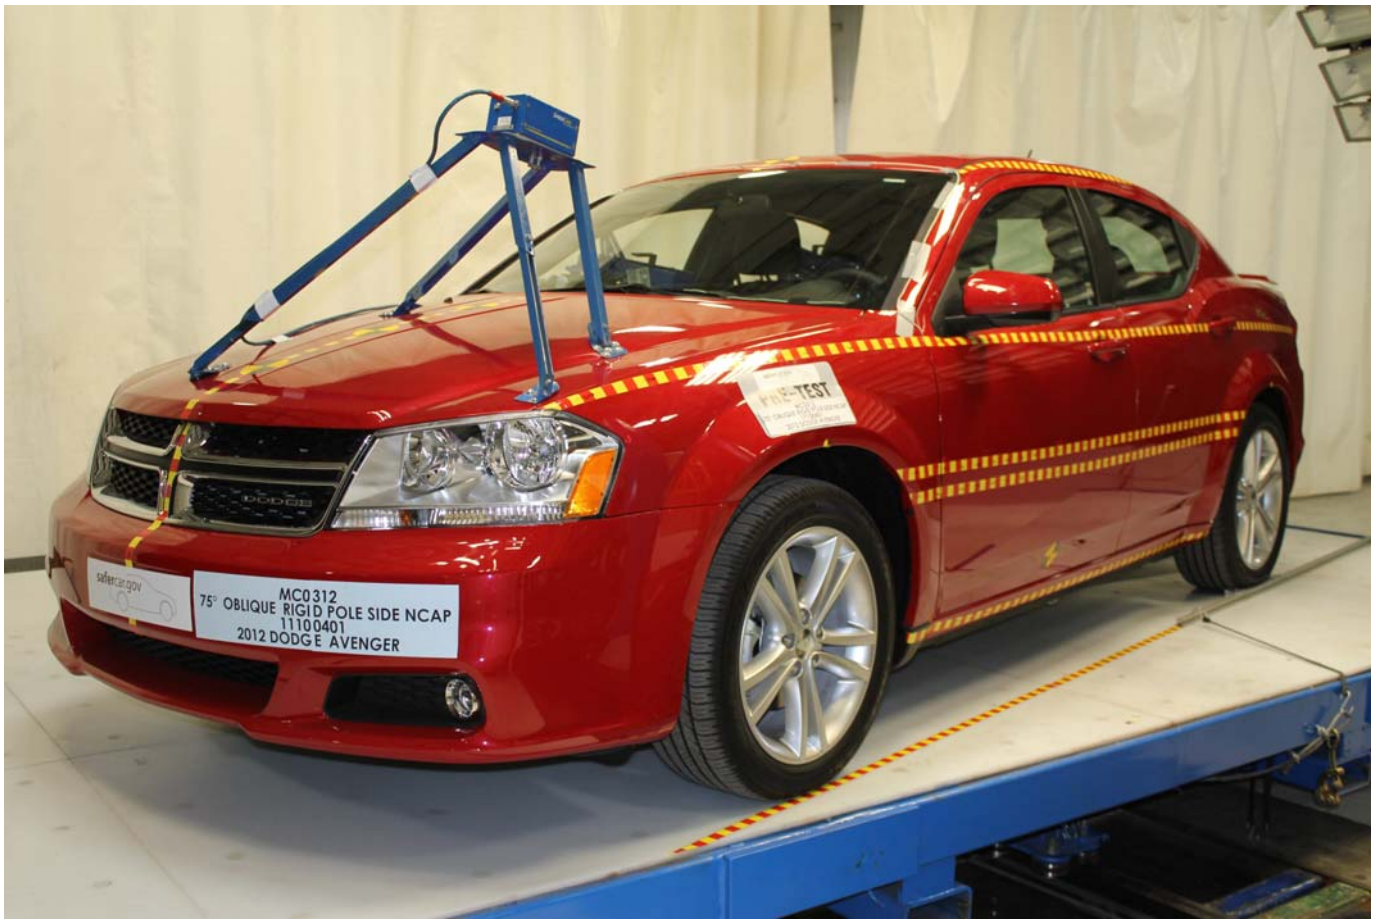
Post-Test Frontal View of Test Vehicle

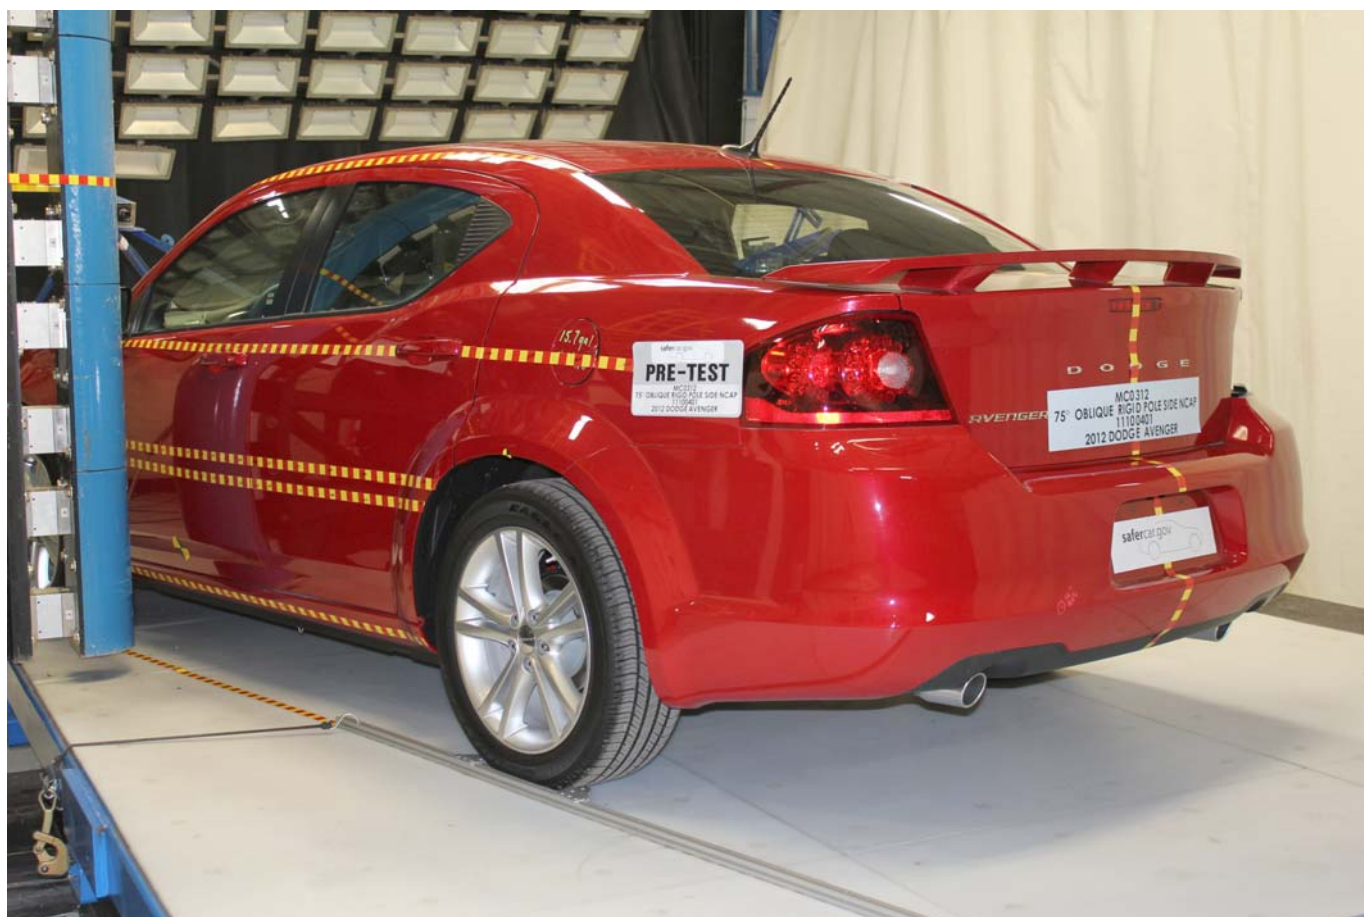
Pre-Test Left Side View of Pole Positioned Against Side of Vehicle

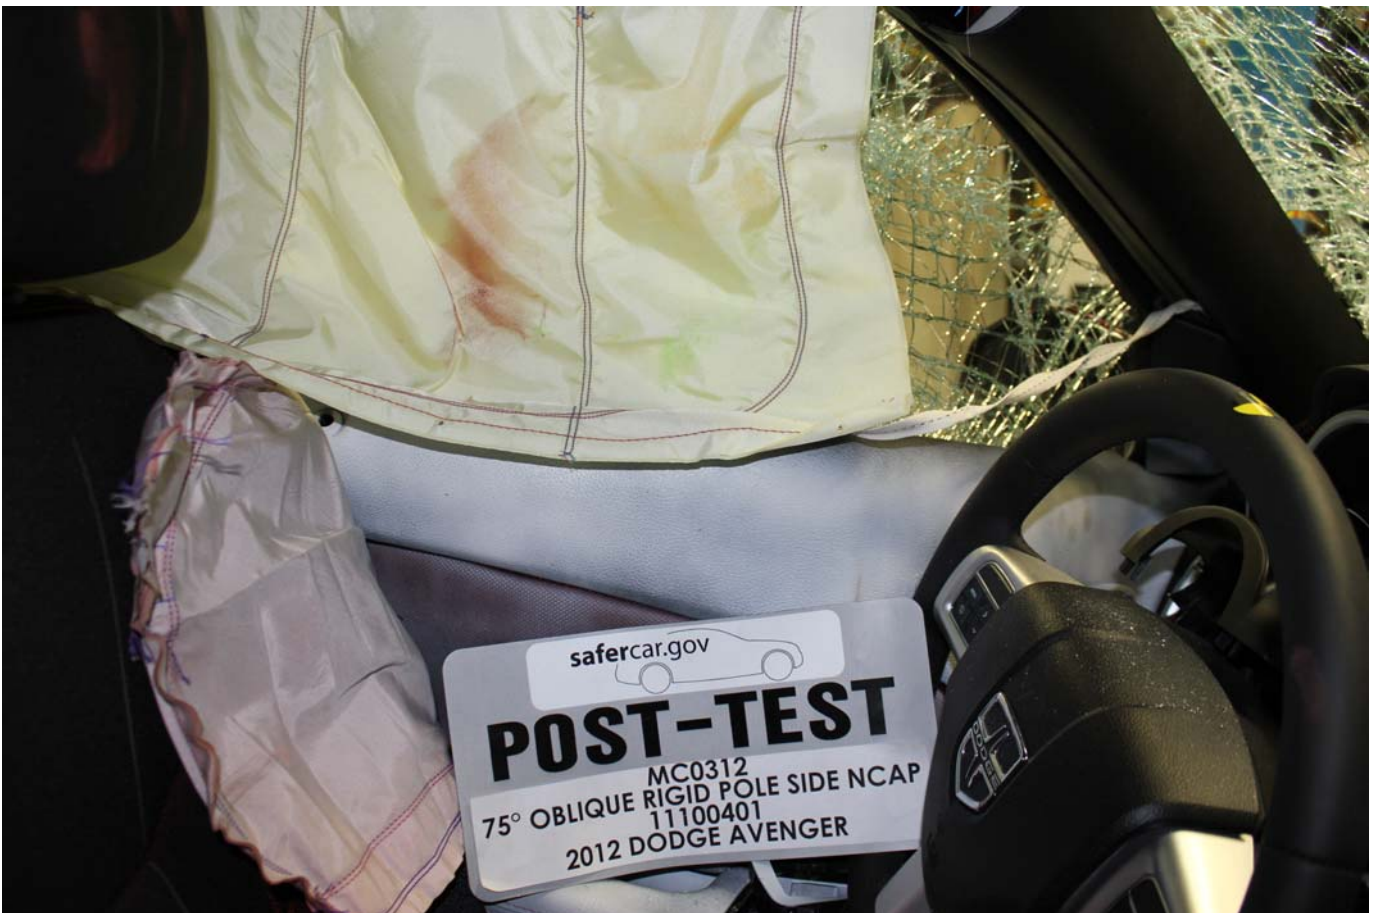
Post-Test Dummy Close-Up Head Contact with Vehicle Interior View

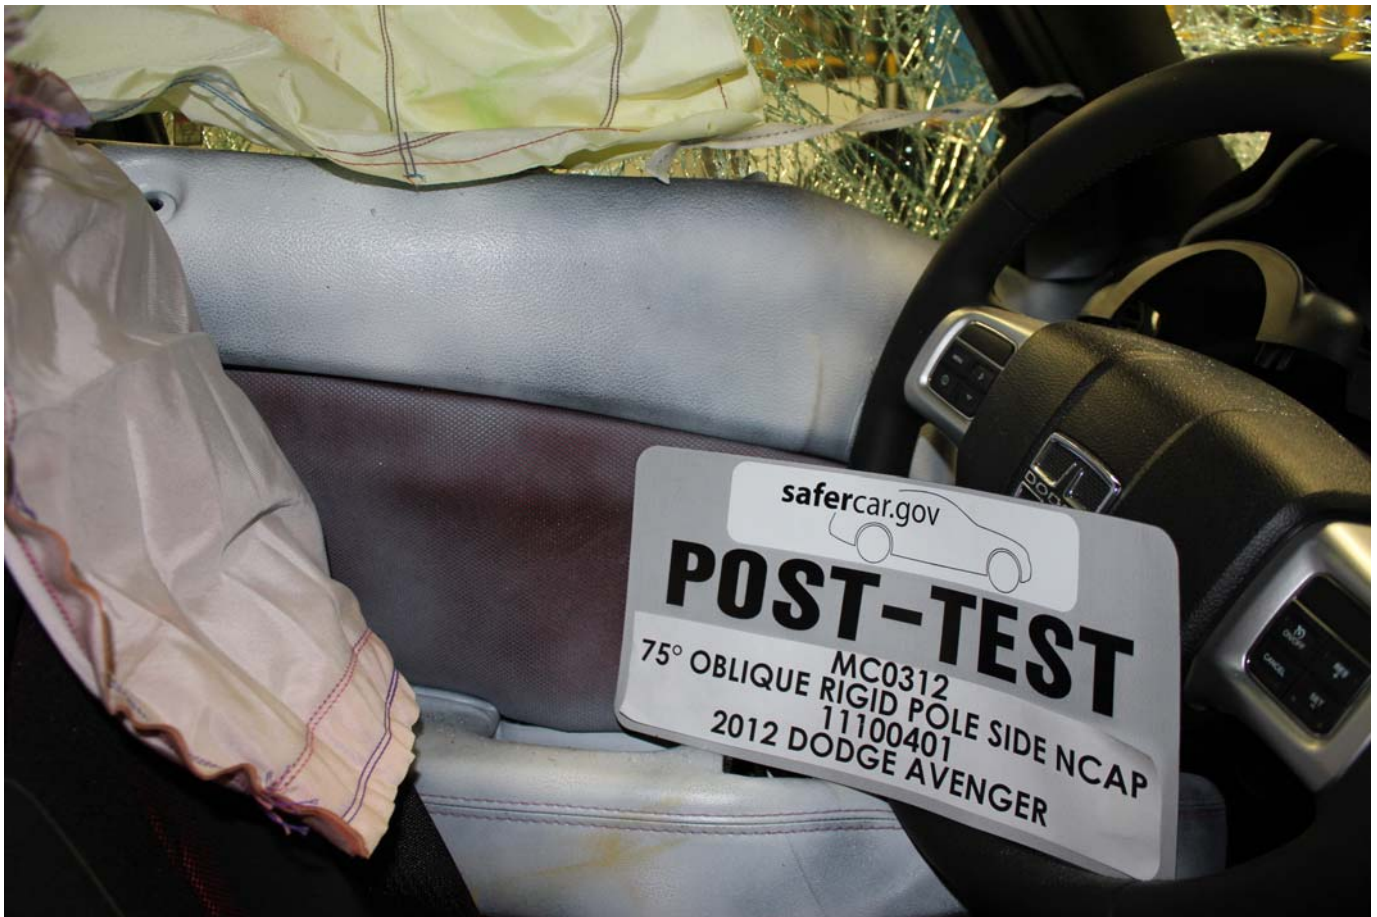
Post-Test Dummy Close-Up Head Contact with Side Air Bag View

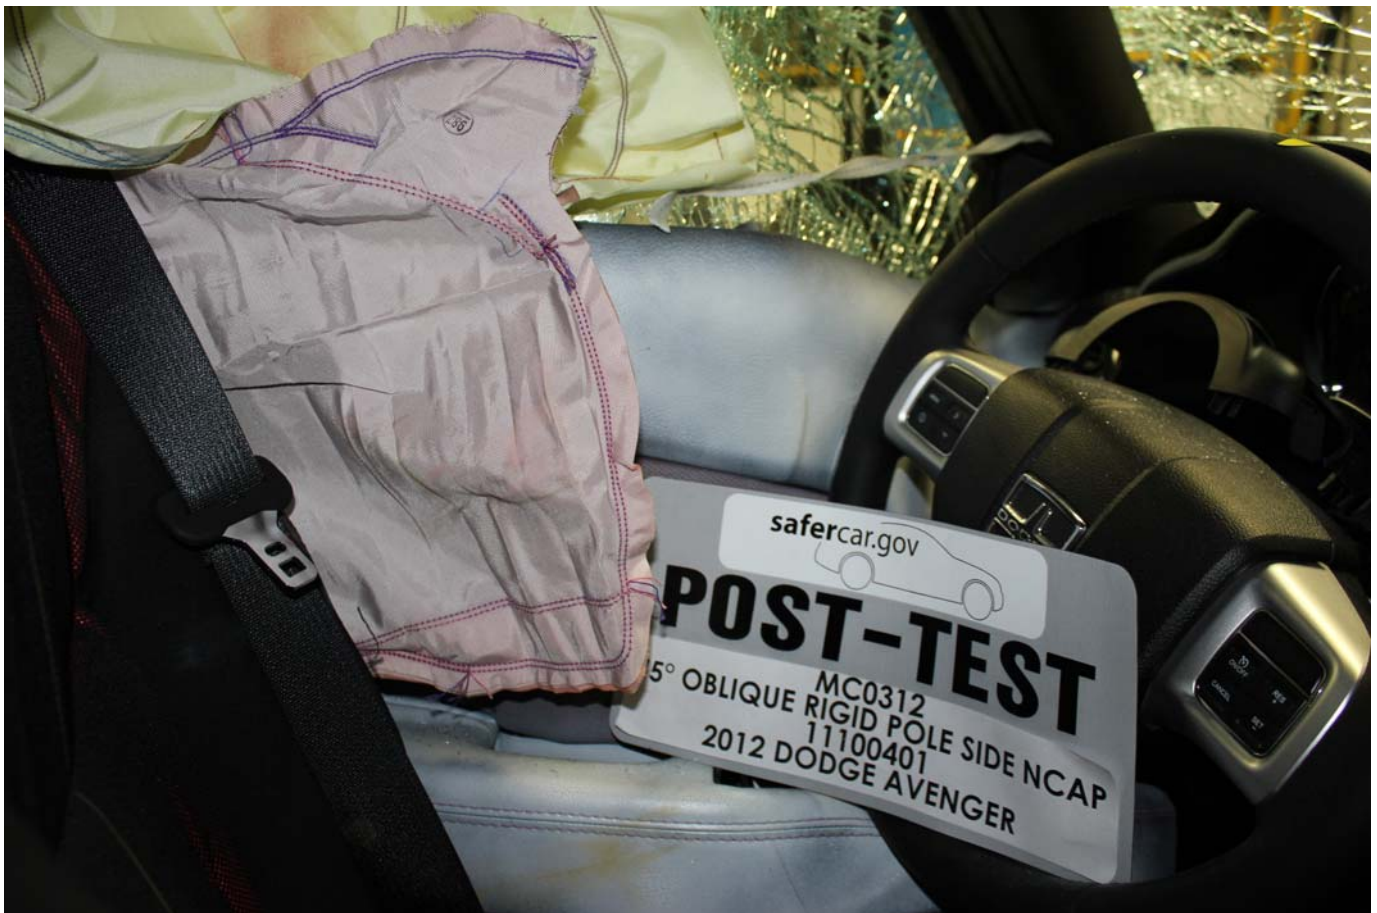
Post-Test Dummy Close-Up Torso Contact with Vehicle Interior View

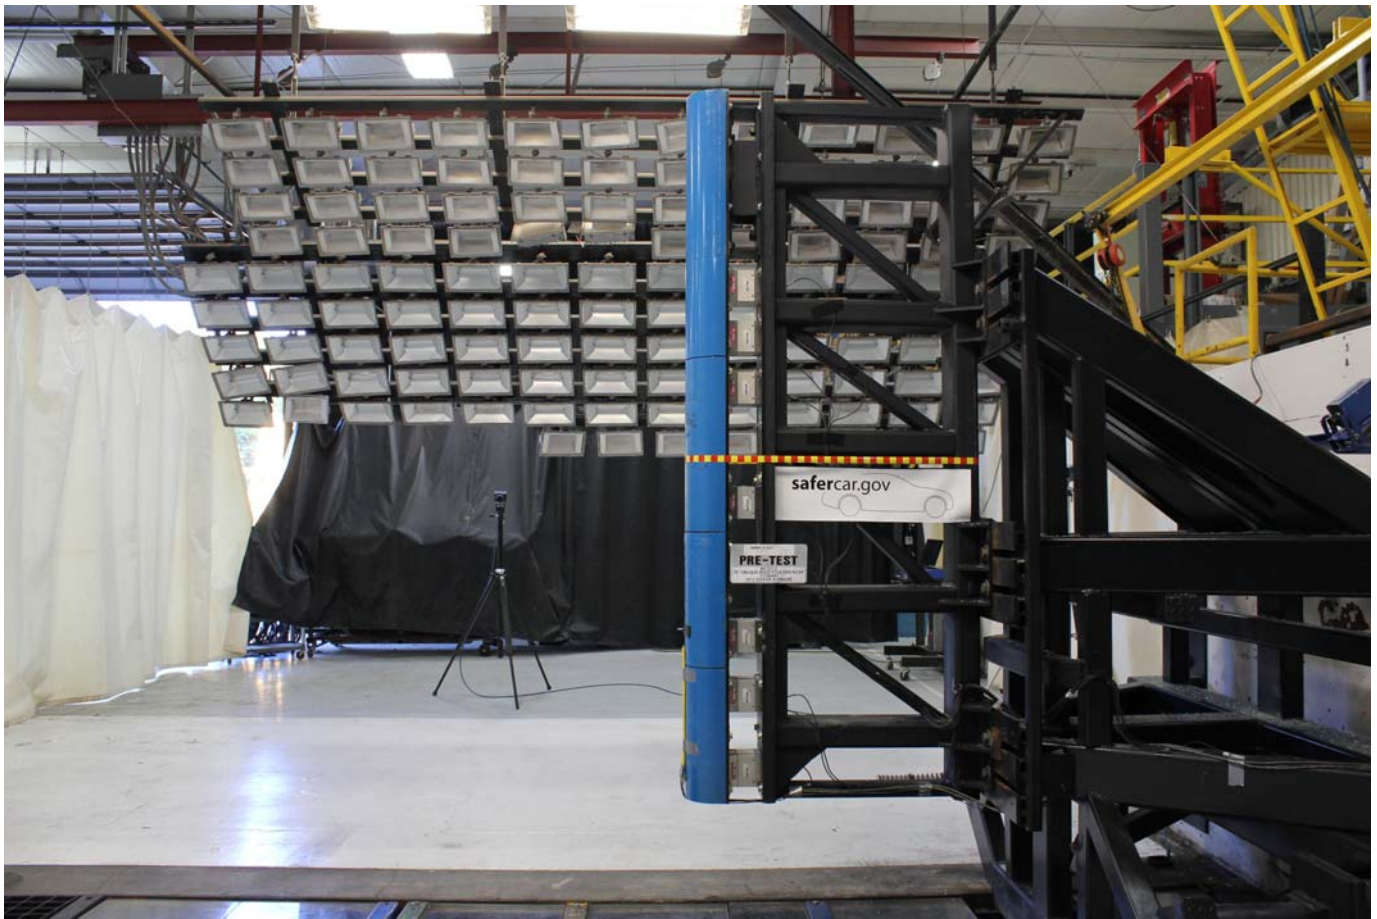
Pre-Test Pole Barrier Side View

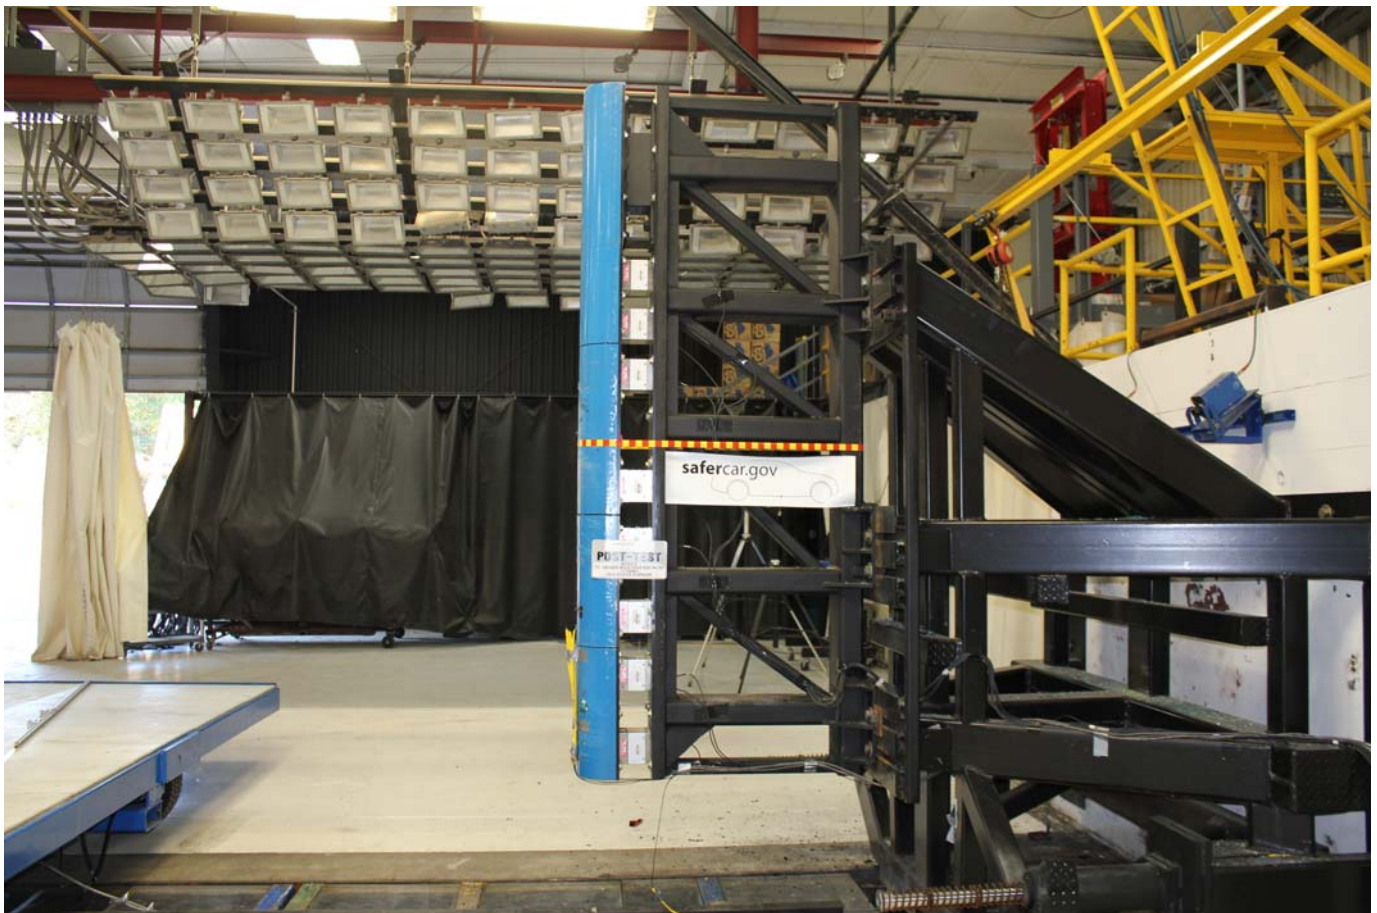
Post-Test Pole Barrier Side View
