REPORT NUMBER: R&D – CAL – 11 – 017

**MOVING BARRIER TO VEHICLE CRASH TEST IN SUPPORT OF NHTSA'S FRONTAL
OBLIQUE OFFSET PROGRAM
RESEARCH MOVING BARRIER INTO LEFT FRONT OF A**

**2011 BUICK LACROSSE
56 MPH, 15 DEGREE ANGLE, 35% OVERLAP**

**TEST DATE: SEPTEMBER 21st 2011
NHTSA NO: RB0179**

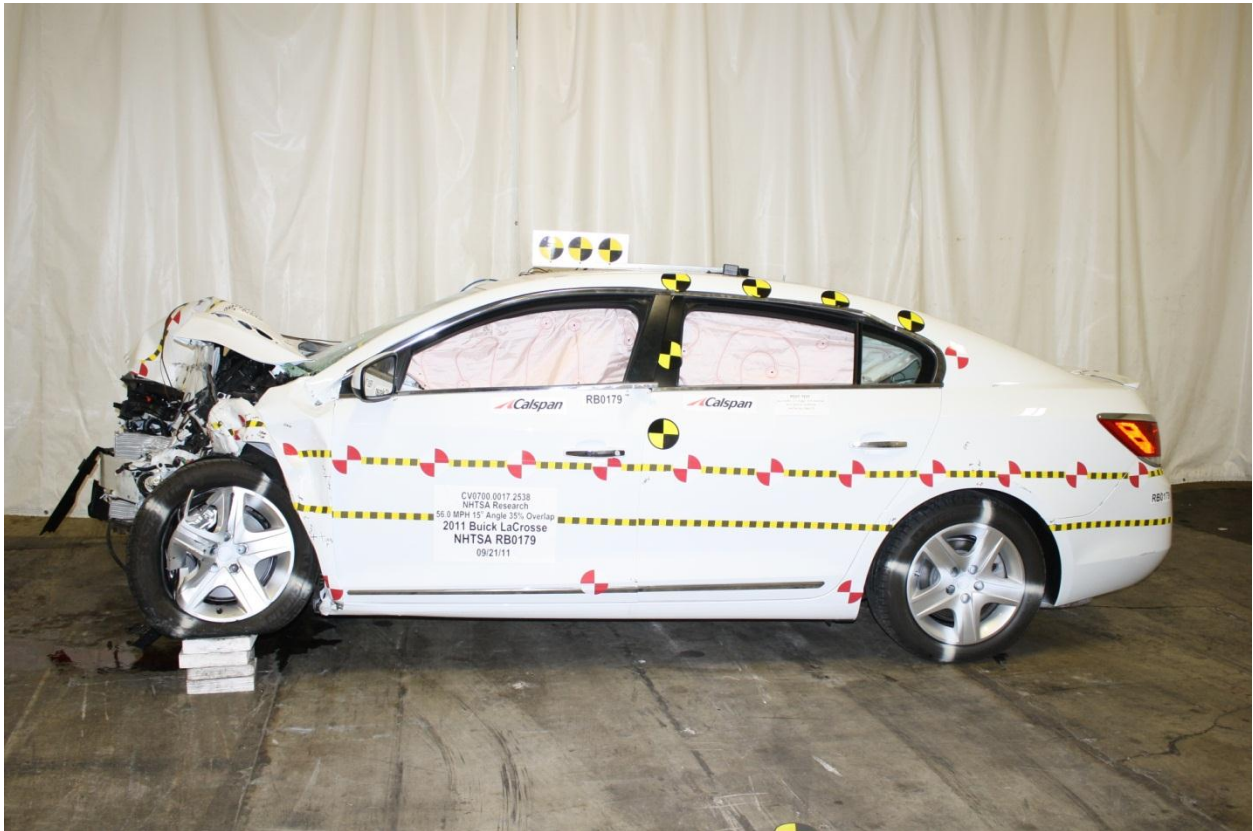
No. 010 Post-Test Left Side View of Test Vehicle

All four vehicle doors remained closed and latched during the test. The left front door was jammed shut, but was able to be opened. The left rear, right front, and right rear doors all remained operational after the test.

- The A-Pillar and the door sill buckled, causing some separation at the top of the door from the vehicle.

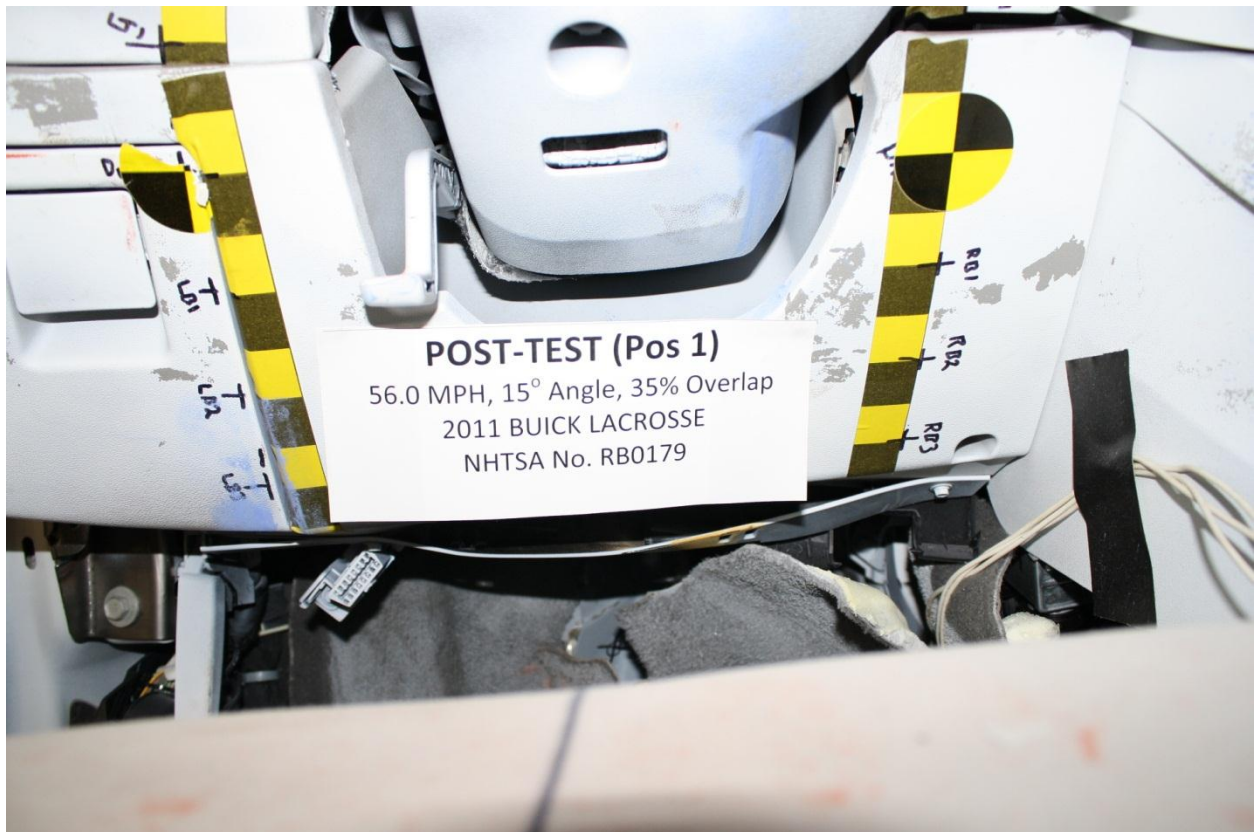
No. 039 Post-Test Overall View of Driver Knee Bolsters

- The knees contacted the knee bolster

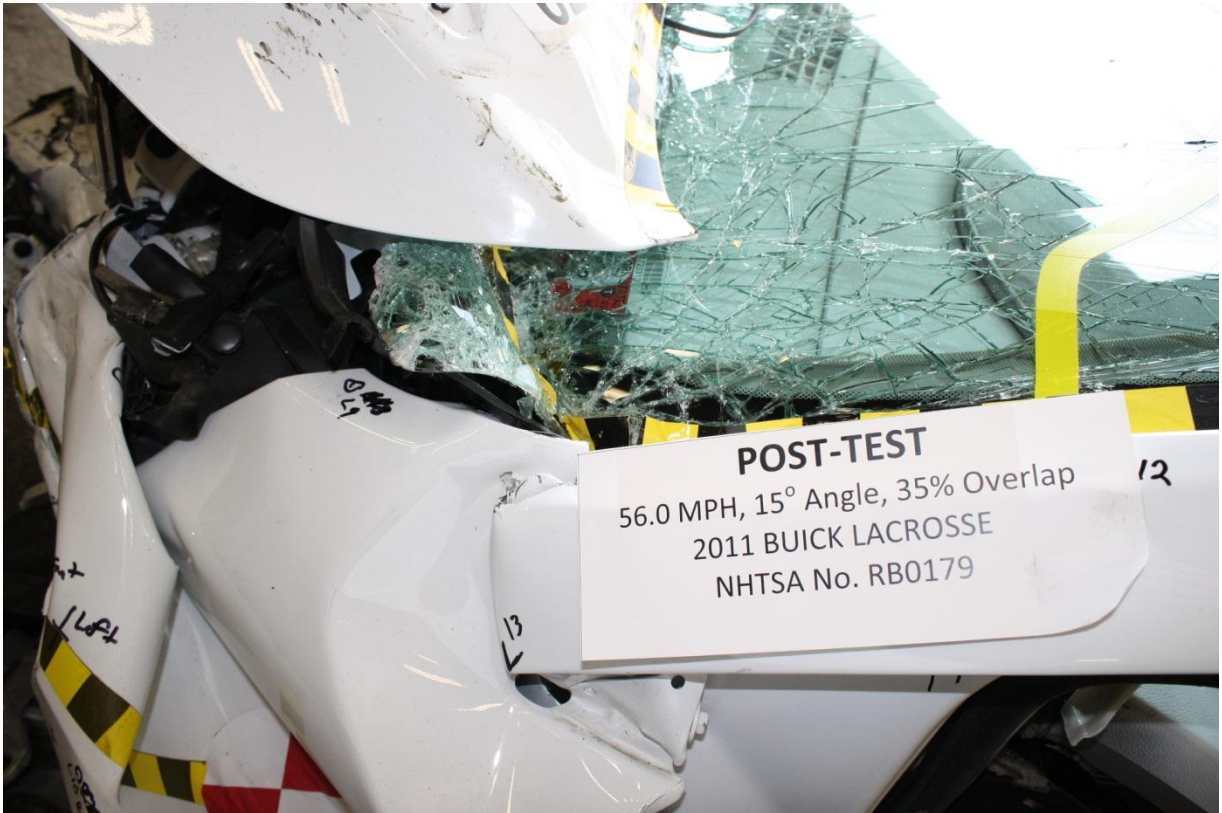
No. 127 Post-Test View of Windshield Separation

There was 86.8% total windshield retention, with 73.6% and 100% retention on the left and right sides respectively. There appeared to be no intrusion into the protected zone of the windshield during any portion of the impact test. The maximum static crush of the vehicle was 435 mm at C1 to the left of the vehicle's centerline. The maximum crush of the lower bumper beam was 483 mm at C2, to the left of vehicle's centerline. Full vehicle measurements are presented in Section 3 of this report.
