**REPORT NUMBER: SINCAP-MGA-2012-009**

**NEW CAR ASSESSMENT PROGRAM (NCAP)  
Moving Deformable Barrier Side Impact Test**

**CHRYSLER GROUP LLC  
2012 Dodge Avenger SXT 4-Dr Sedan  
NHTSA No.: MC0311**

**FINAL REPORT**

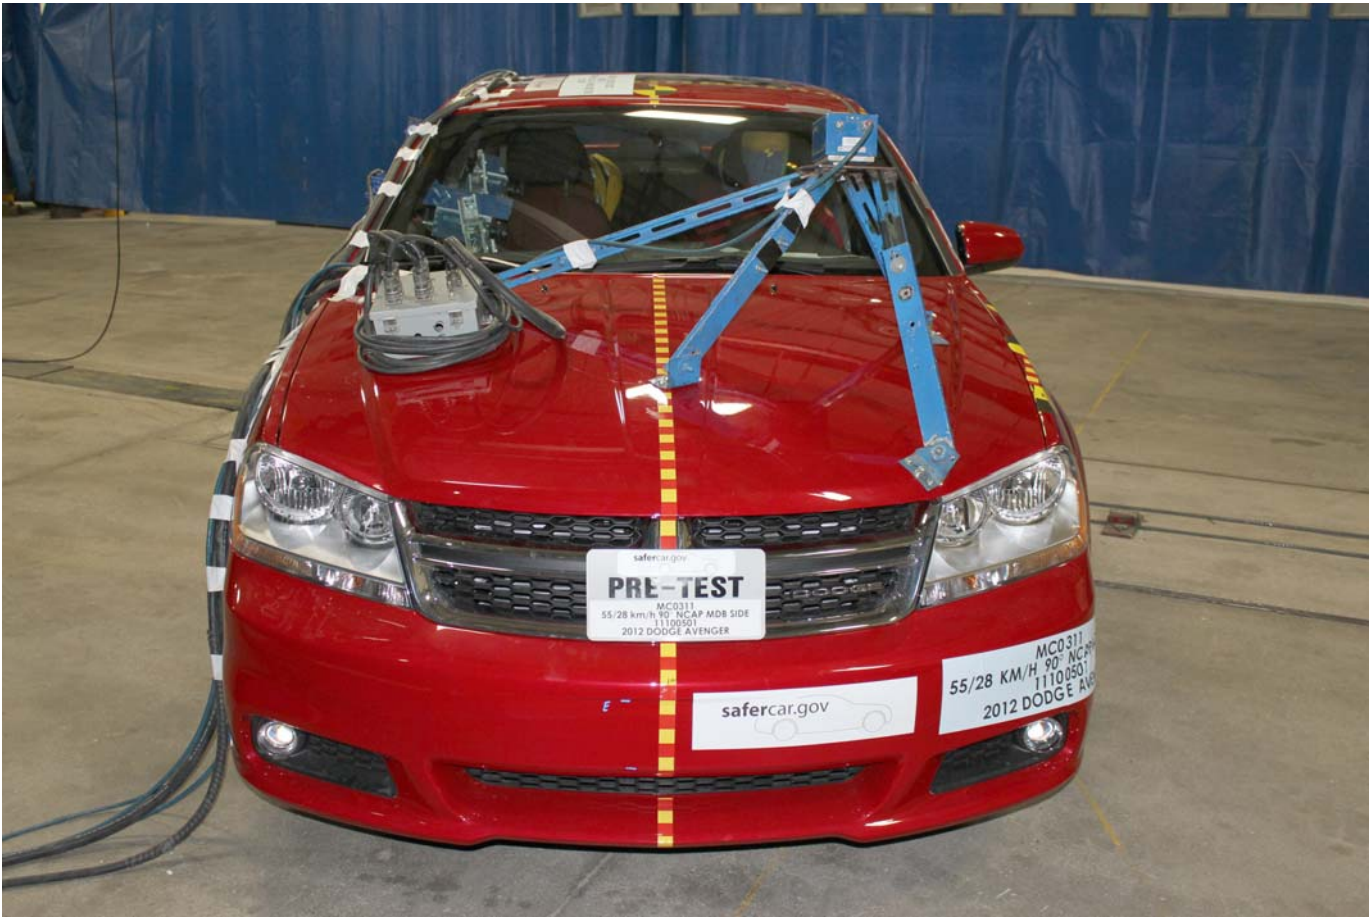
Pre-Test Frontal View of Test Vehicle

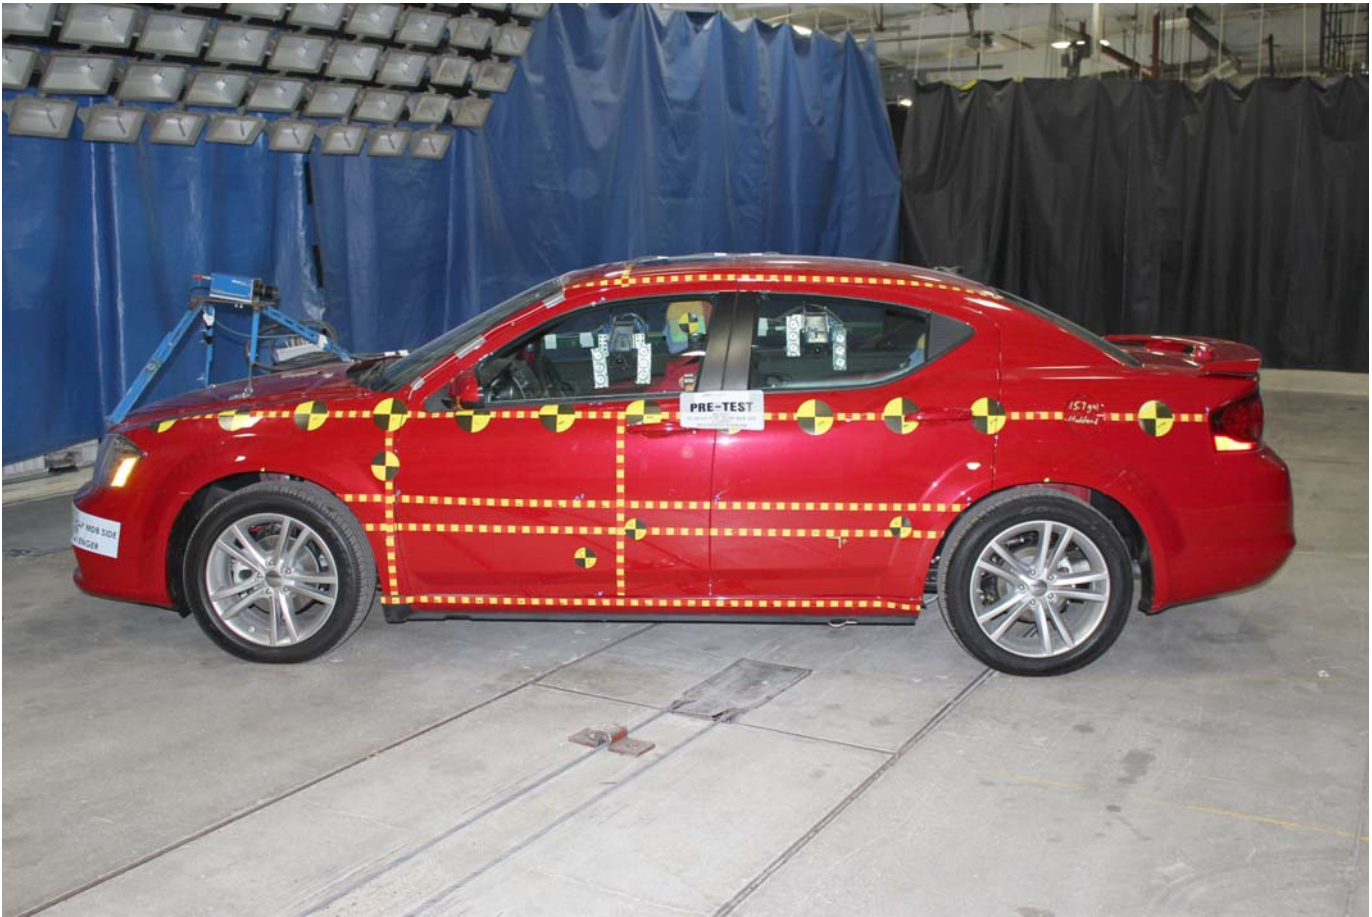
Pre-Test Left Side View of Test Vehicle

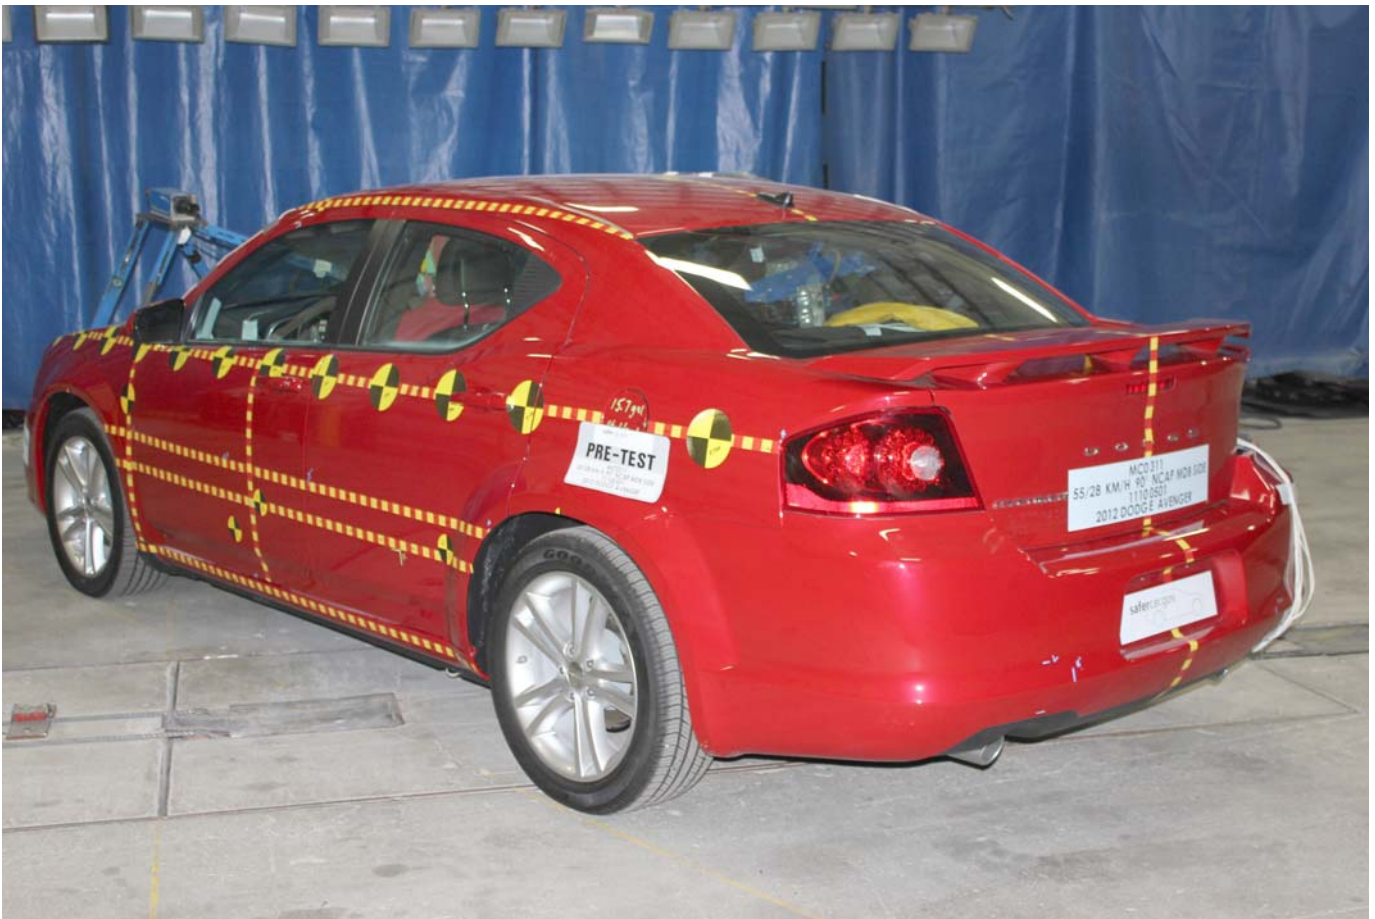
Pre-Test Left Three-Quarter Rear View of Test Vehicle

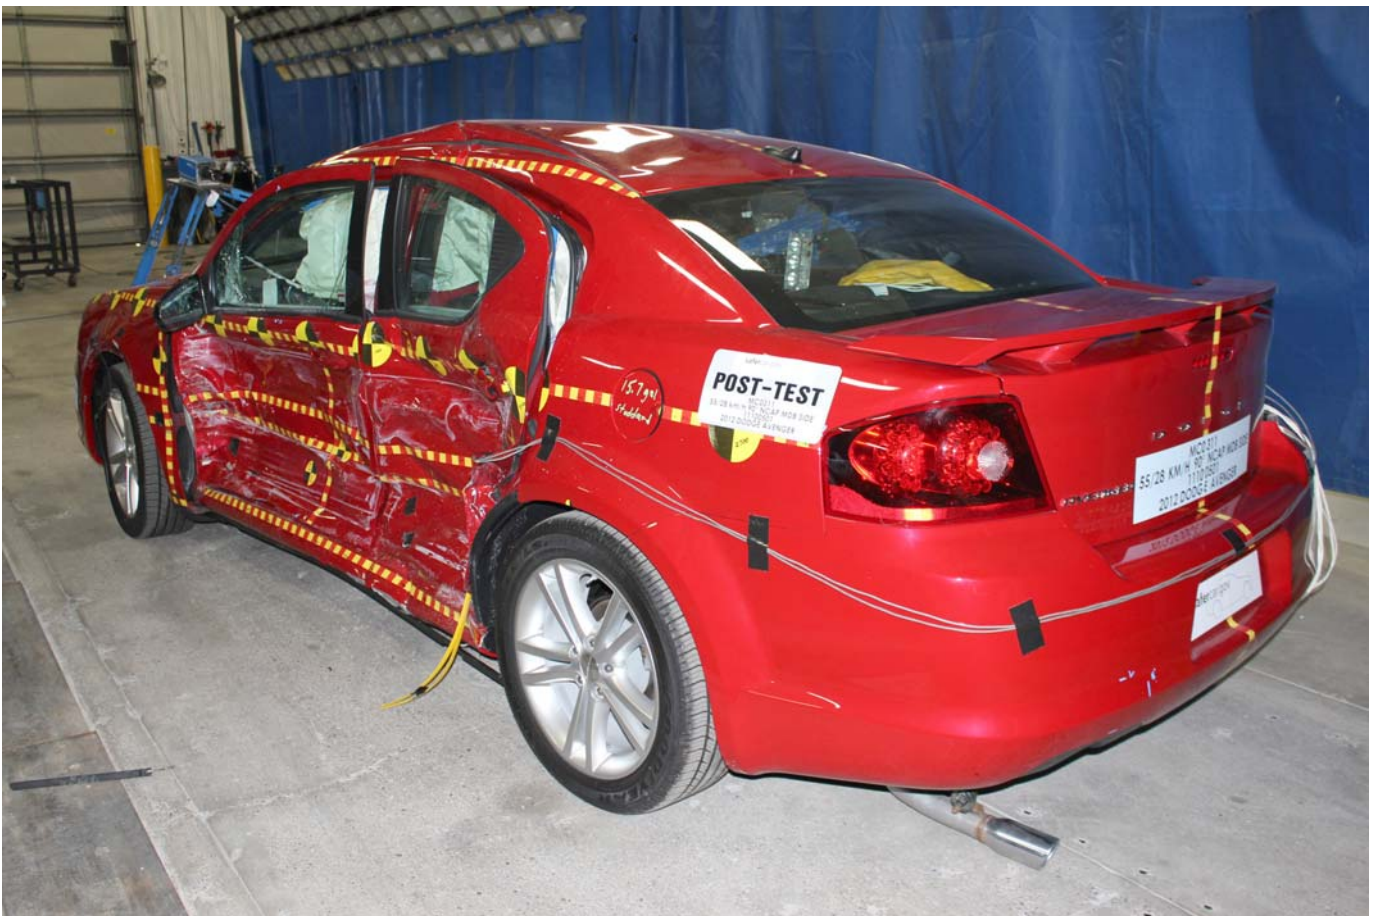
Post-Test Left Three-Quarter Rear View of Test Vehicle

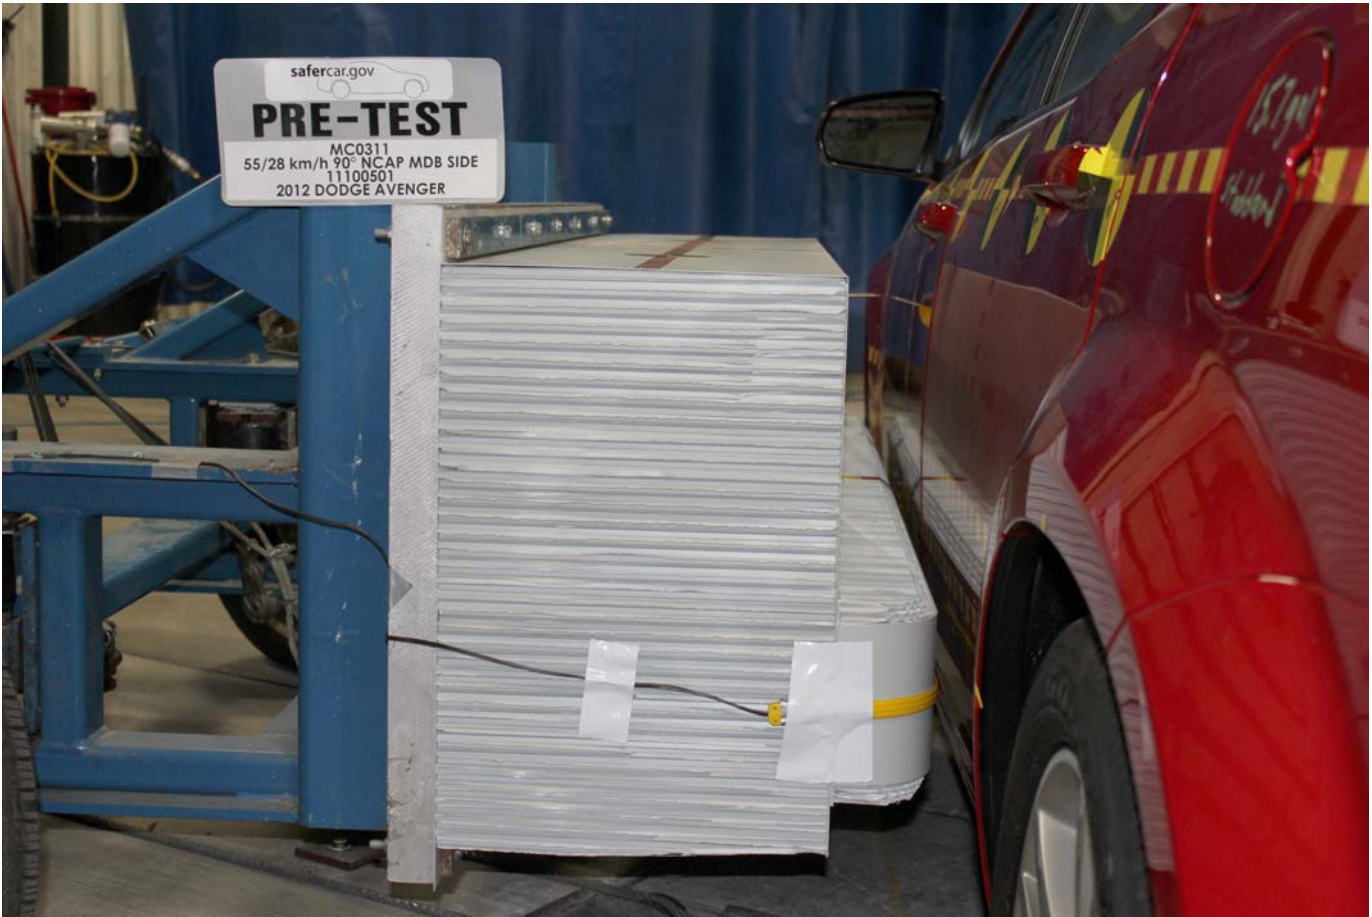
Pre-Test Right Side View of MDB Positioned Against Side of Test Vehicle

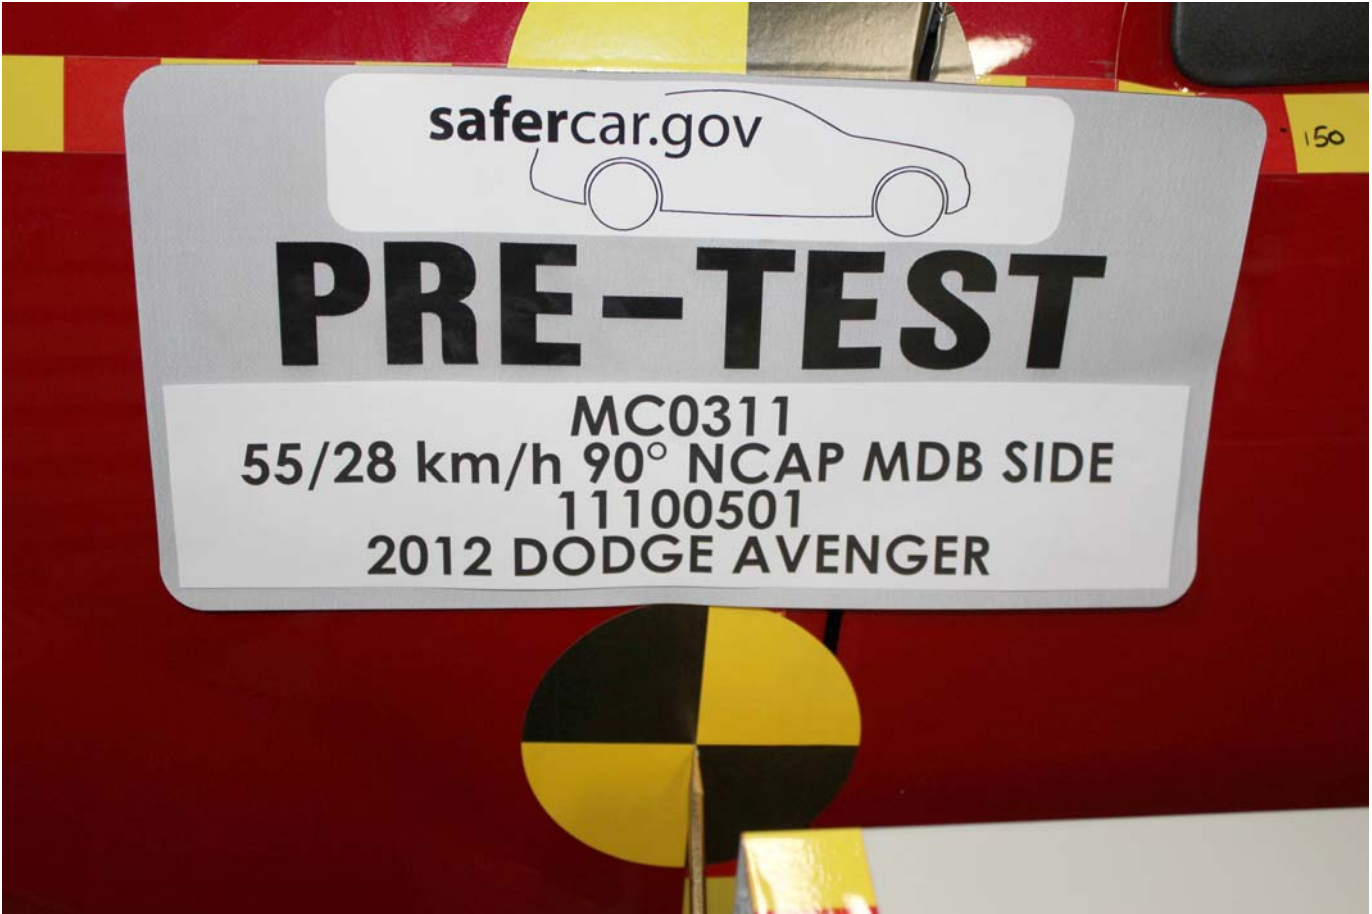
Pre-Test Close-Up View of Impact Point Target

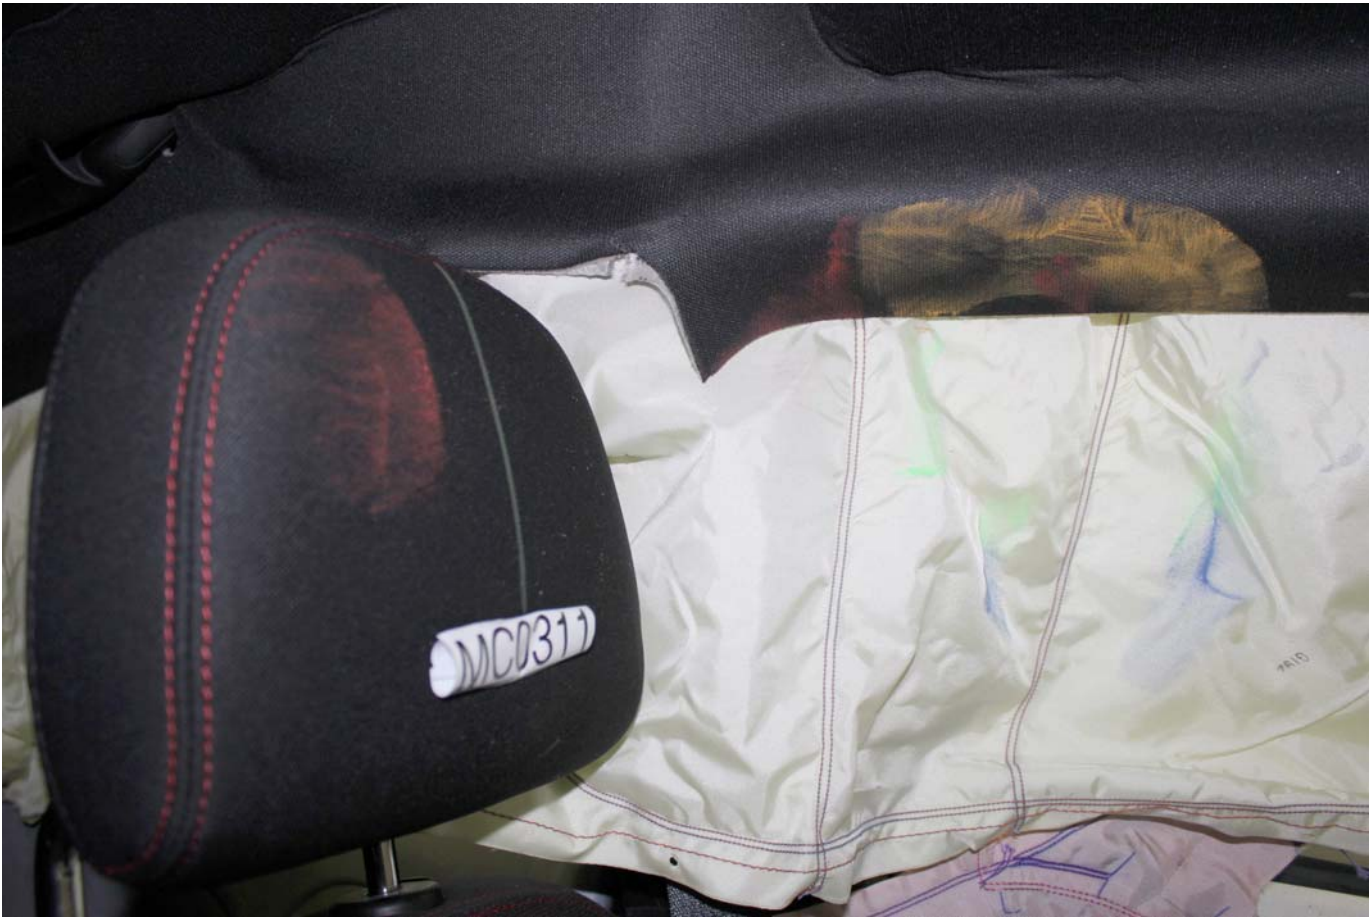
Post-Test Driver Dummy Close-up Head Contact with Vehicle Interior View

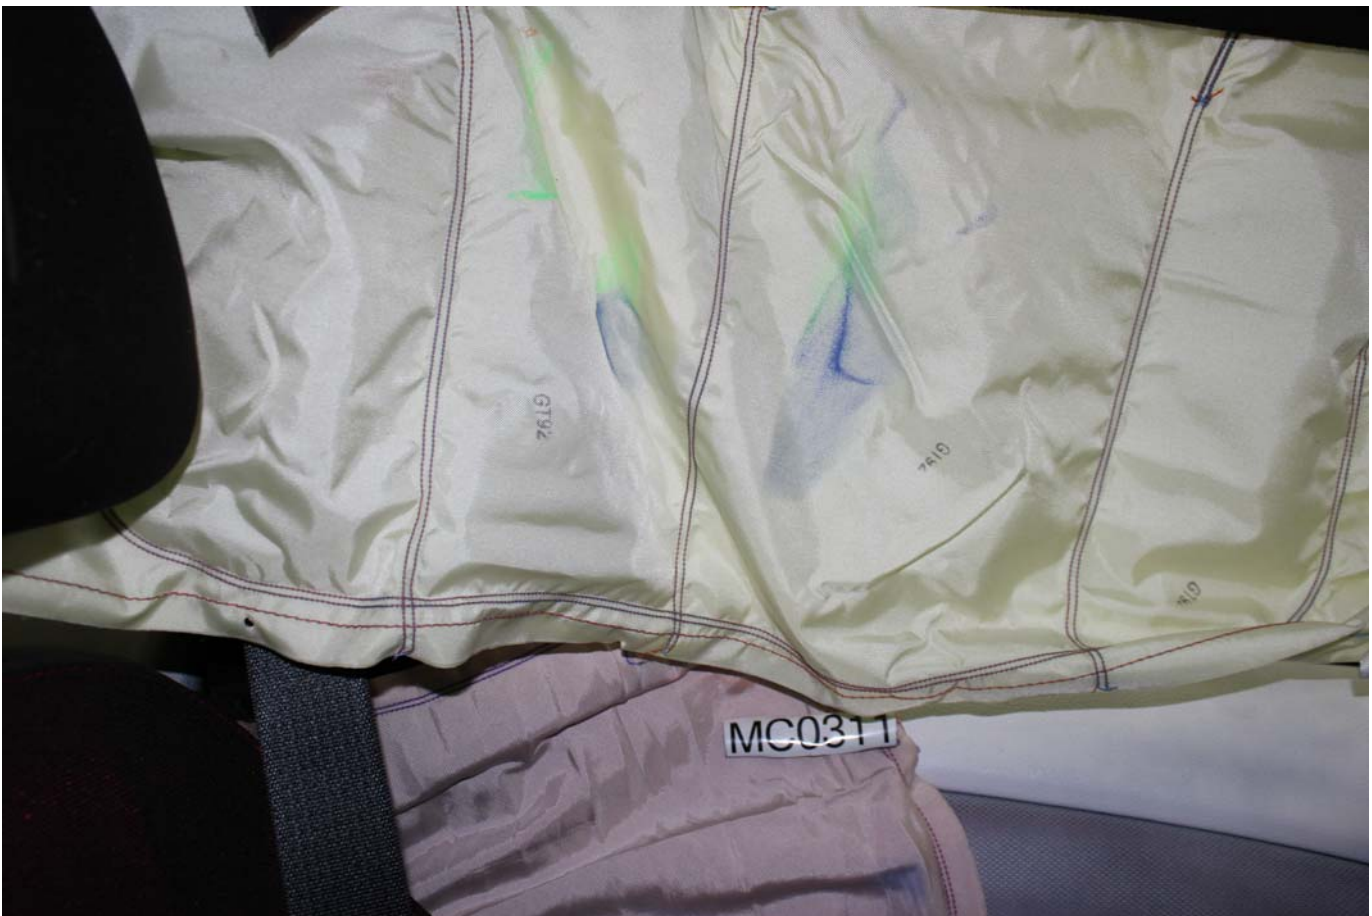
Post-Test Driver Dummy Close-up Head Contact with Side Airbag View

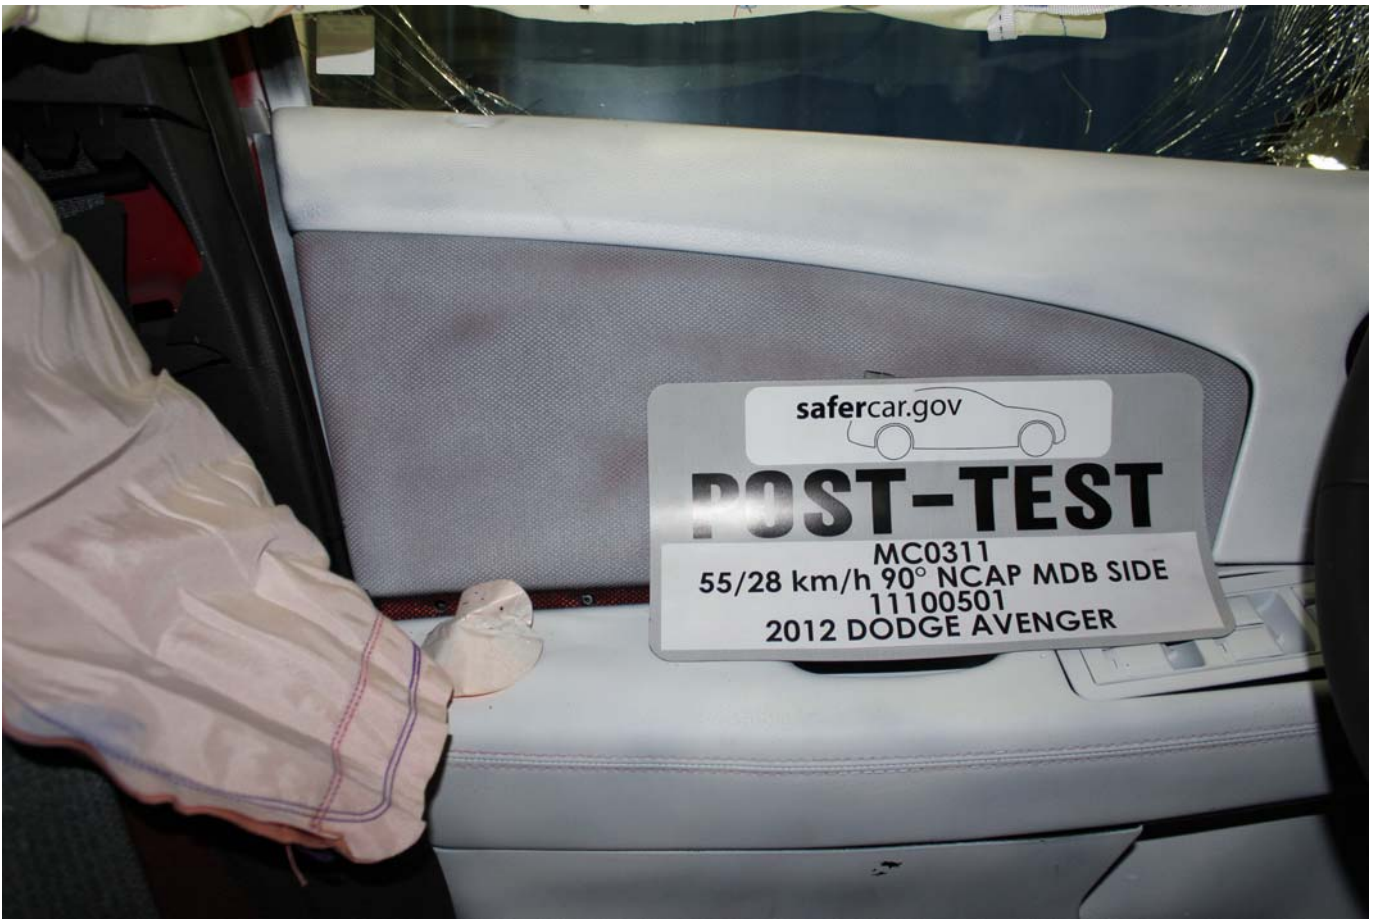
Post-Test Driver Dummy Close-up Torso Contact with Vehicle Interior View

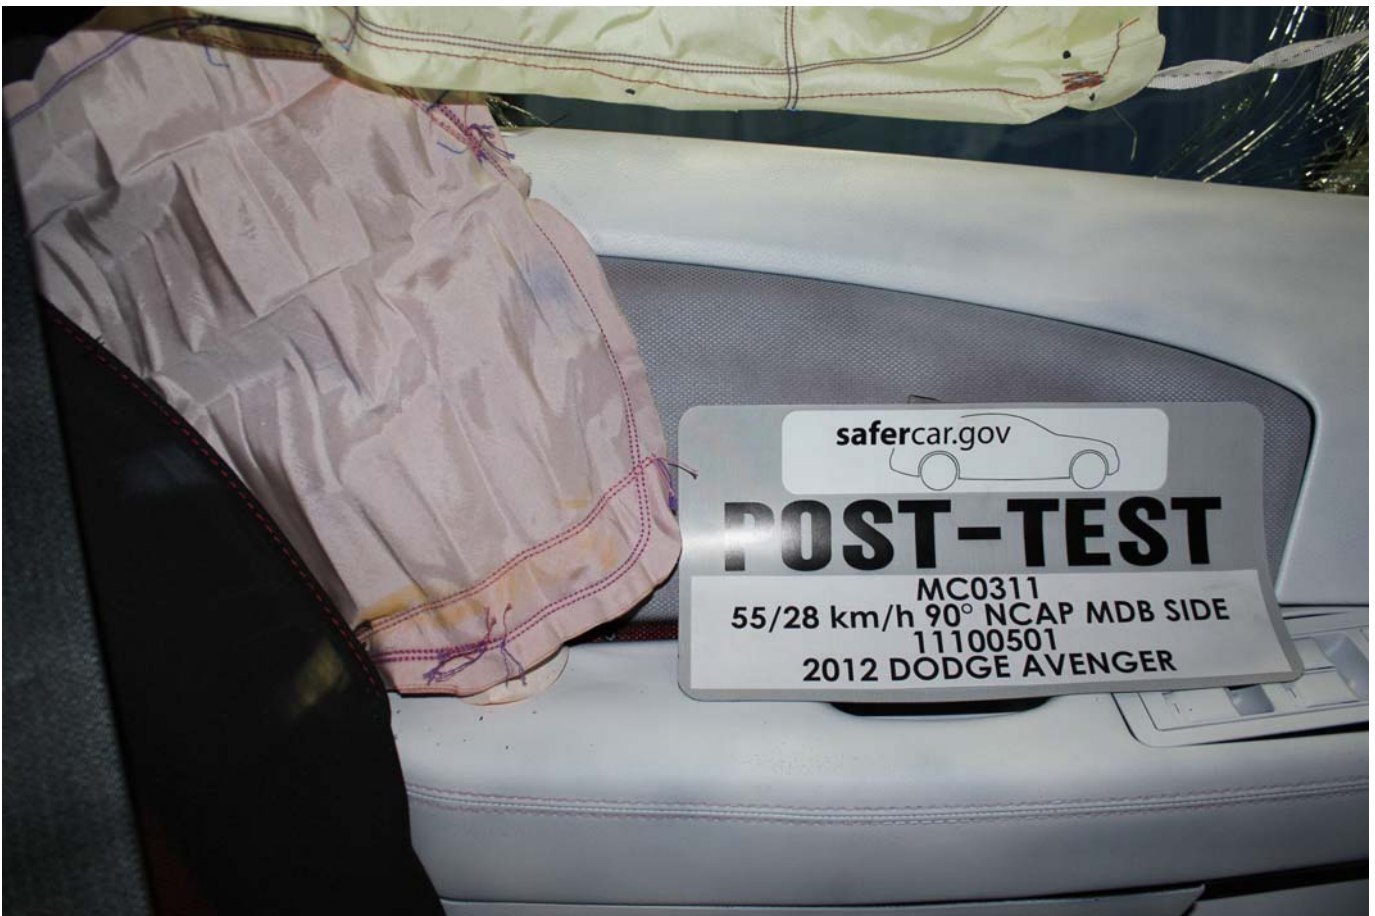
Post-Test Driver Dummy Close-up Torso Contact with Side Airbag View

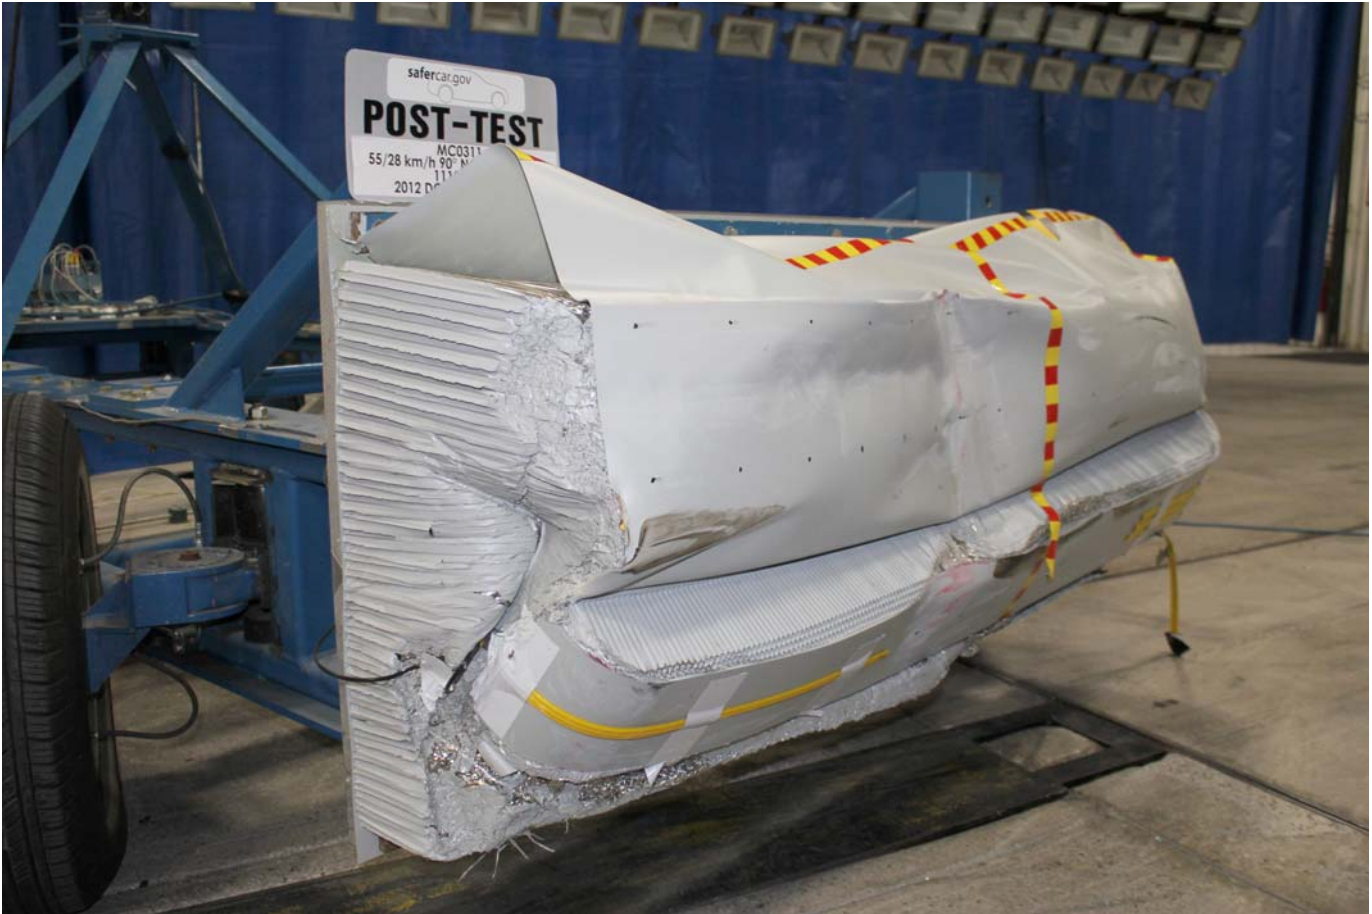
Post-Test Right Side View of MDB Impactor Face

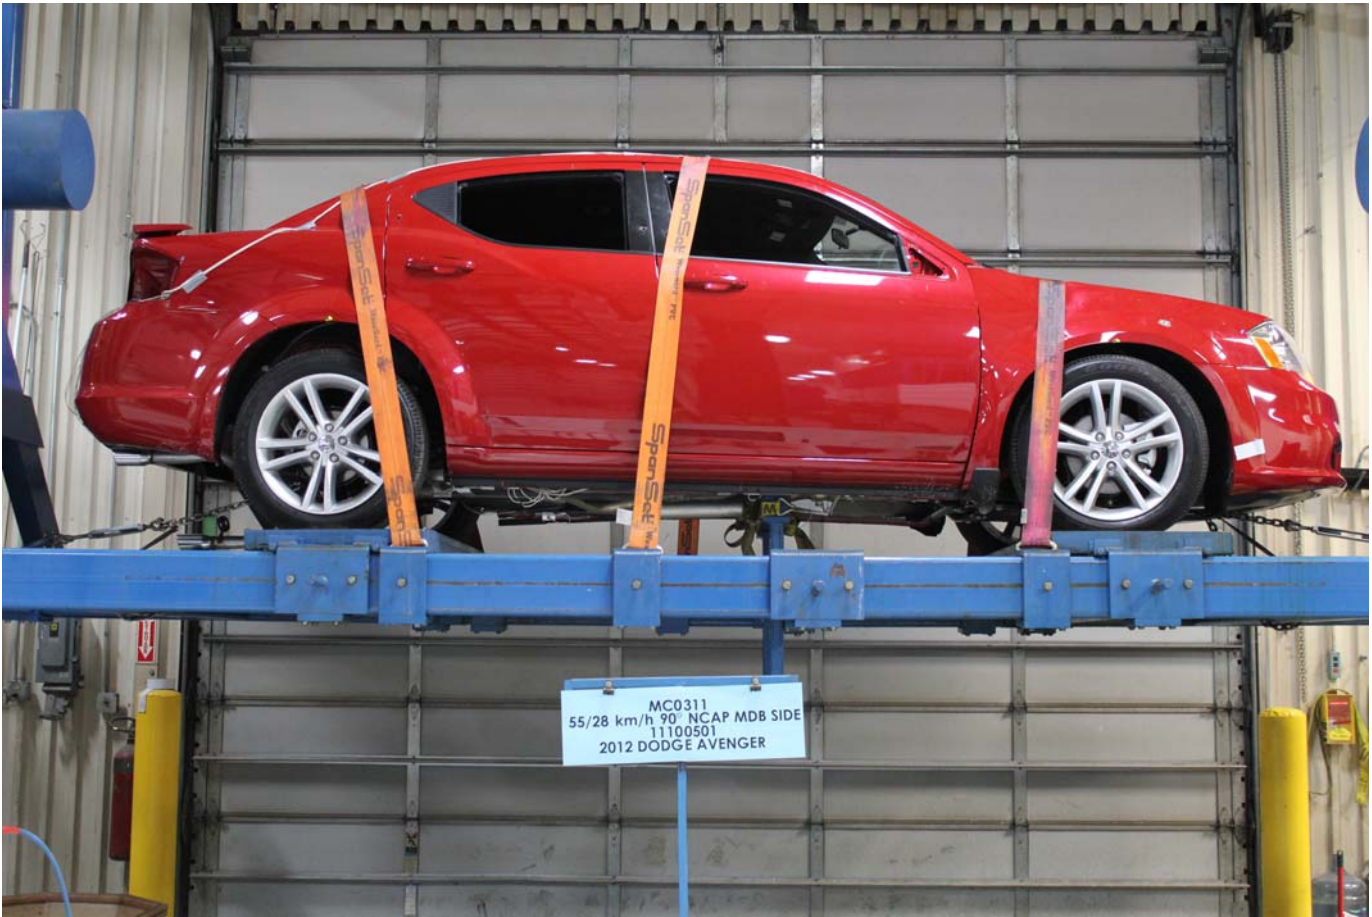
MC0311  
55/28 km/h 90° NCAP MDB SIDE  
11100501  
2012 DODGE AVENGER

FMVSS No. 301 Static Rollover 0 Degrees

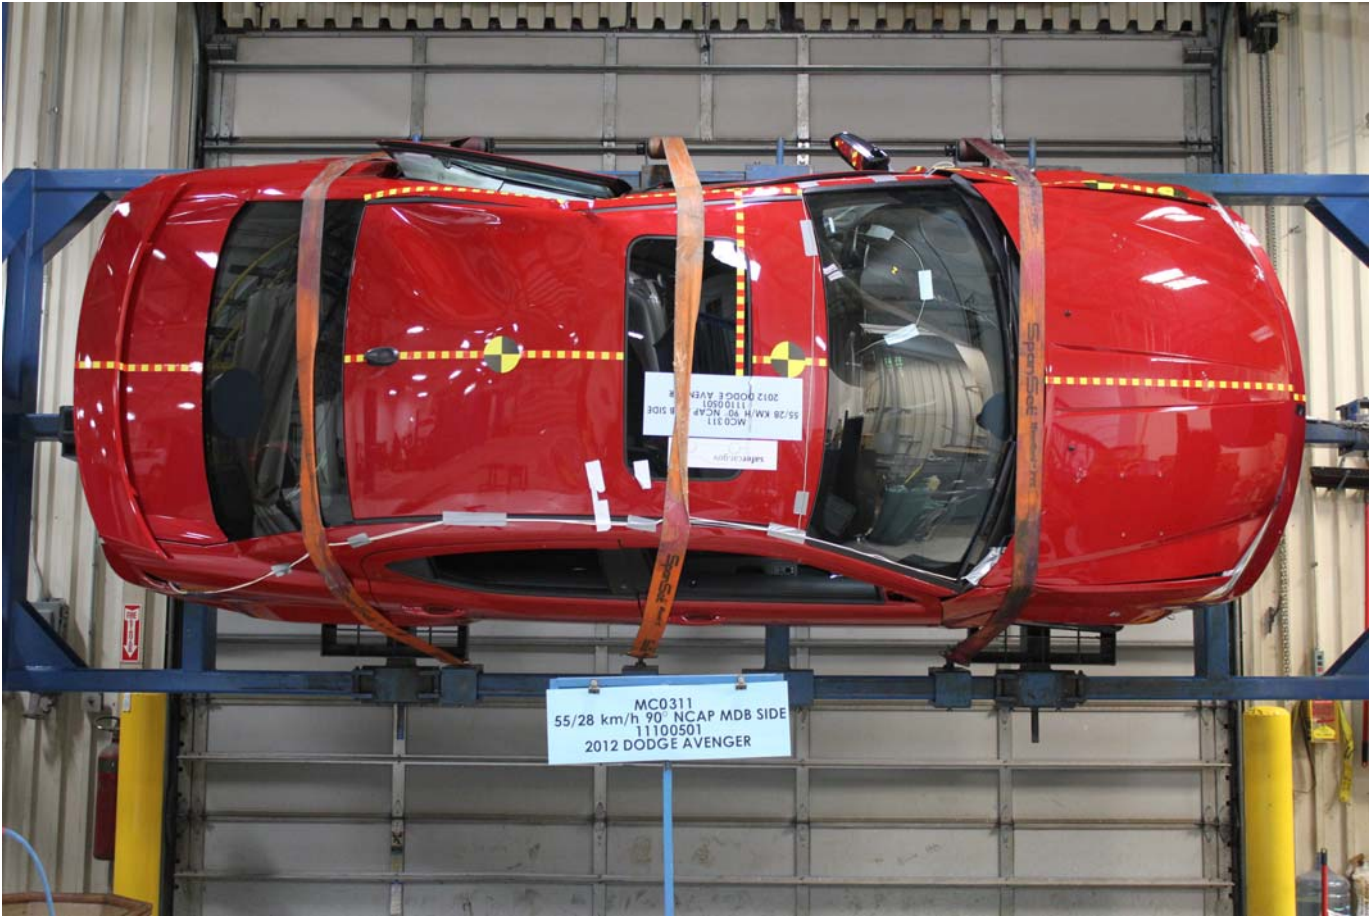
MC0311  
55/28 km/h 90° NCAP MDB SIDE  
11100501  
2012 DODGE AVENGER

FMVSS No. 301 Static Rollover 270 Degrees
