**REPORT NUMBER: NCAP-MGA-2012-010**

**NEW CAR ASSESSMENT PROGRAM (NCAP)  
Frontal Barrier Impact Test**

**CHRYSLER GROUP LLC  
2012 Dodge Journey SXT AWD SUV  
NHTSA No.: MC0319**

**FINAL REPORT**

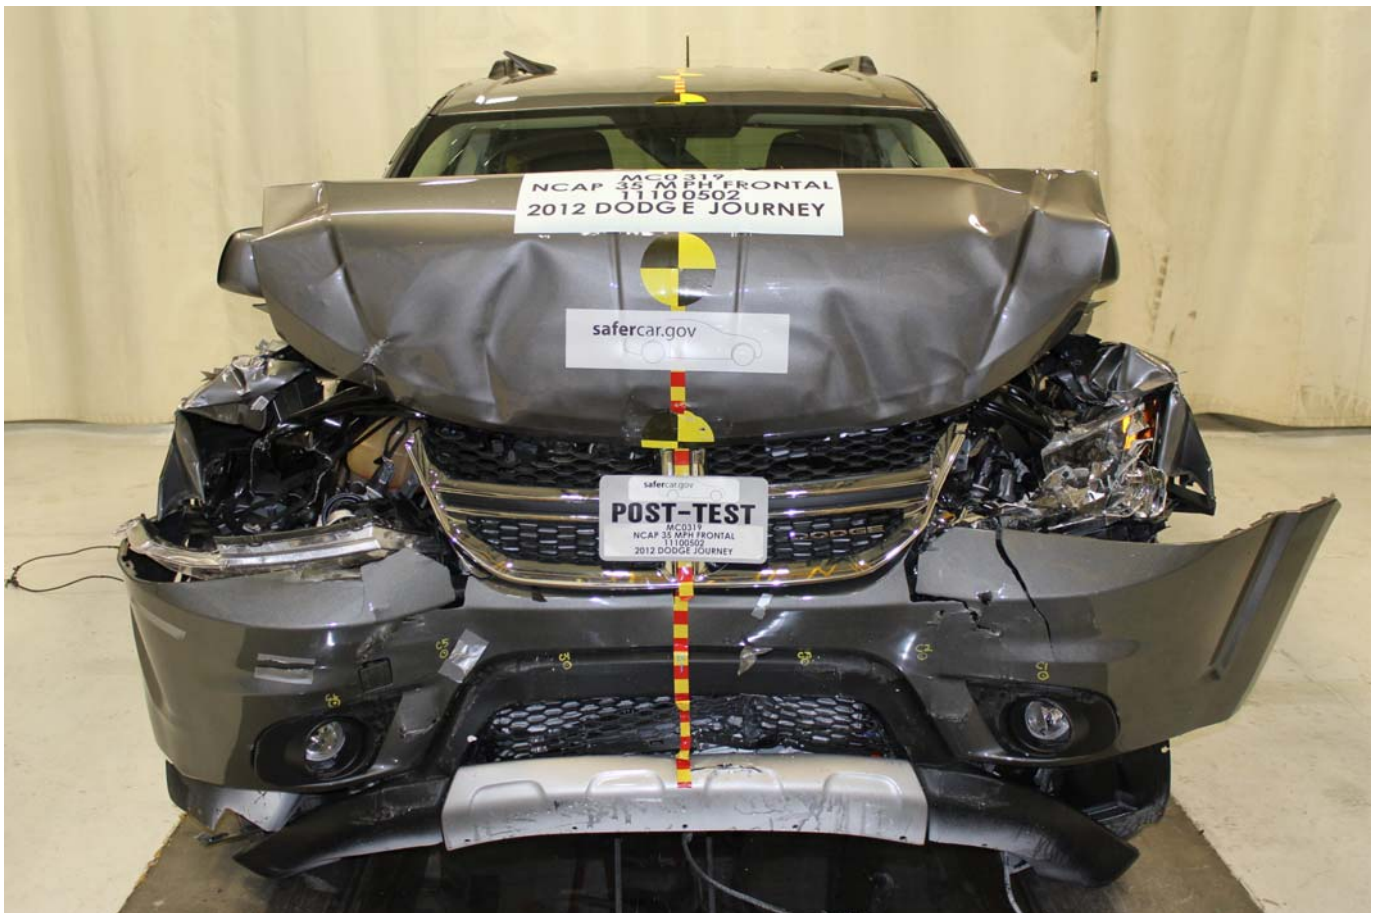
Post-Test Front View of Test Vehicle

The maximum static crush of the vehicle was 621 mm and both the driver and passenger side doors remained closed during the impact event and were operable after the impact.

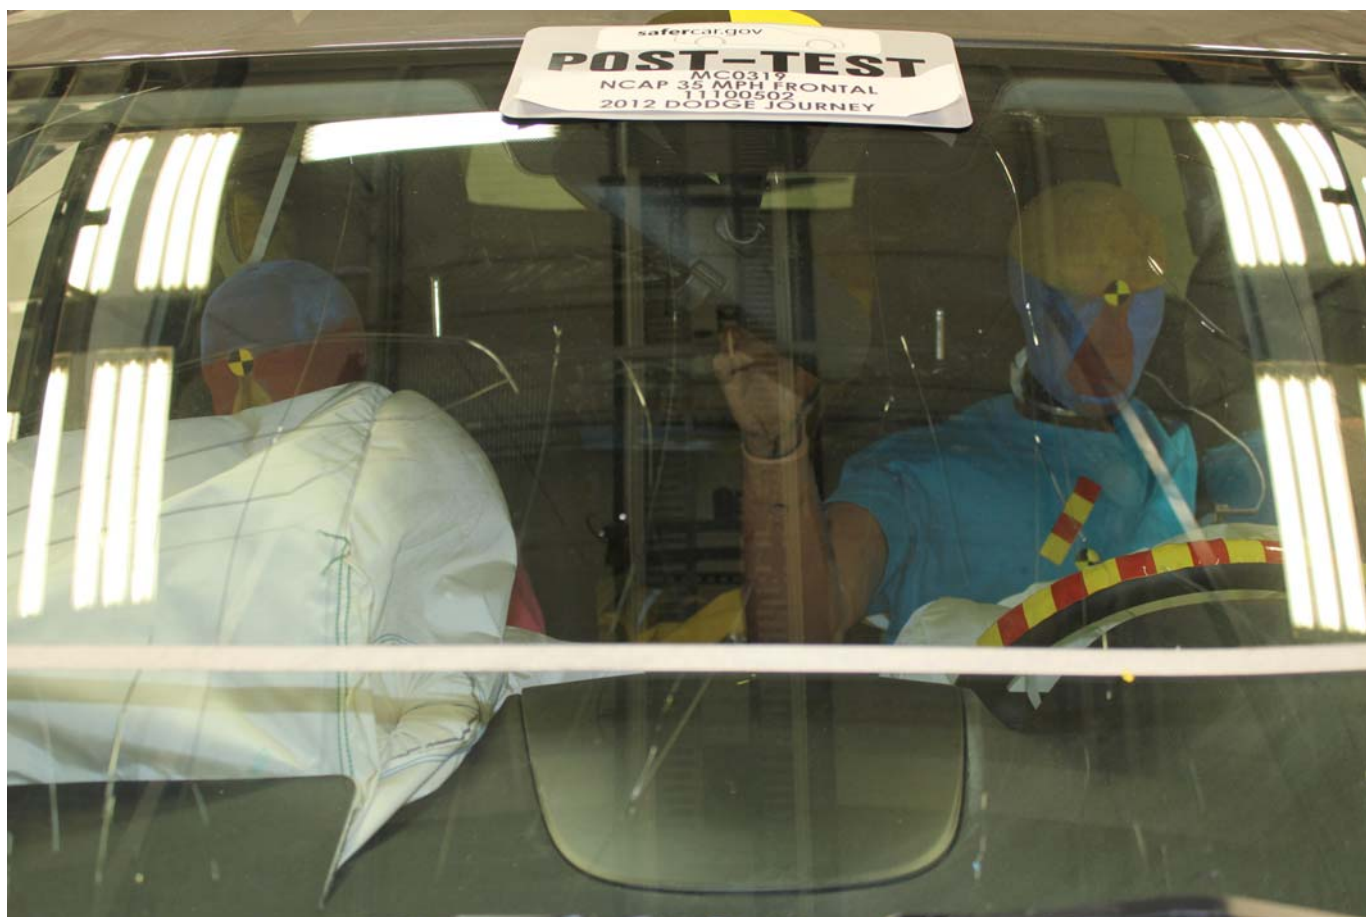
Post-Test Windshield View

There was 100 percent windshield retention and no intrusion into the protected zone of the windshield during the event. There was no Stoddard Solvent leakage after the event or during any phase of the static rollover.

| Critical Areas of Performance | Observations and Conclusions |
|---|---|
| Windshield Damage | Cracked |

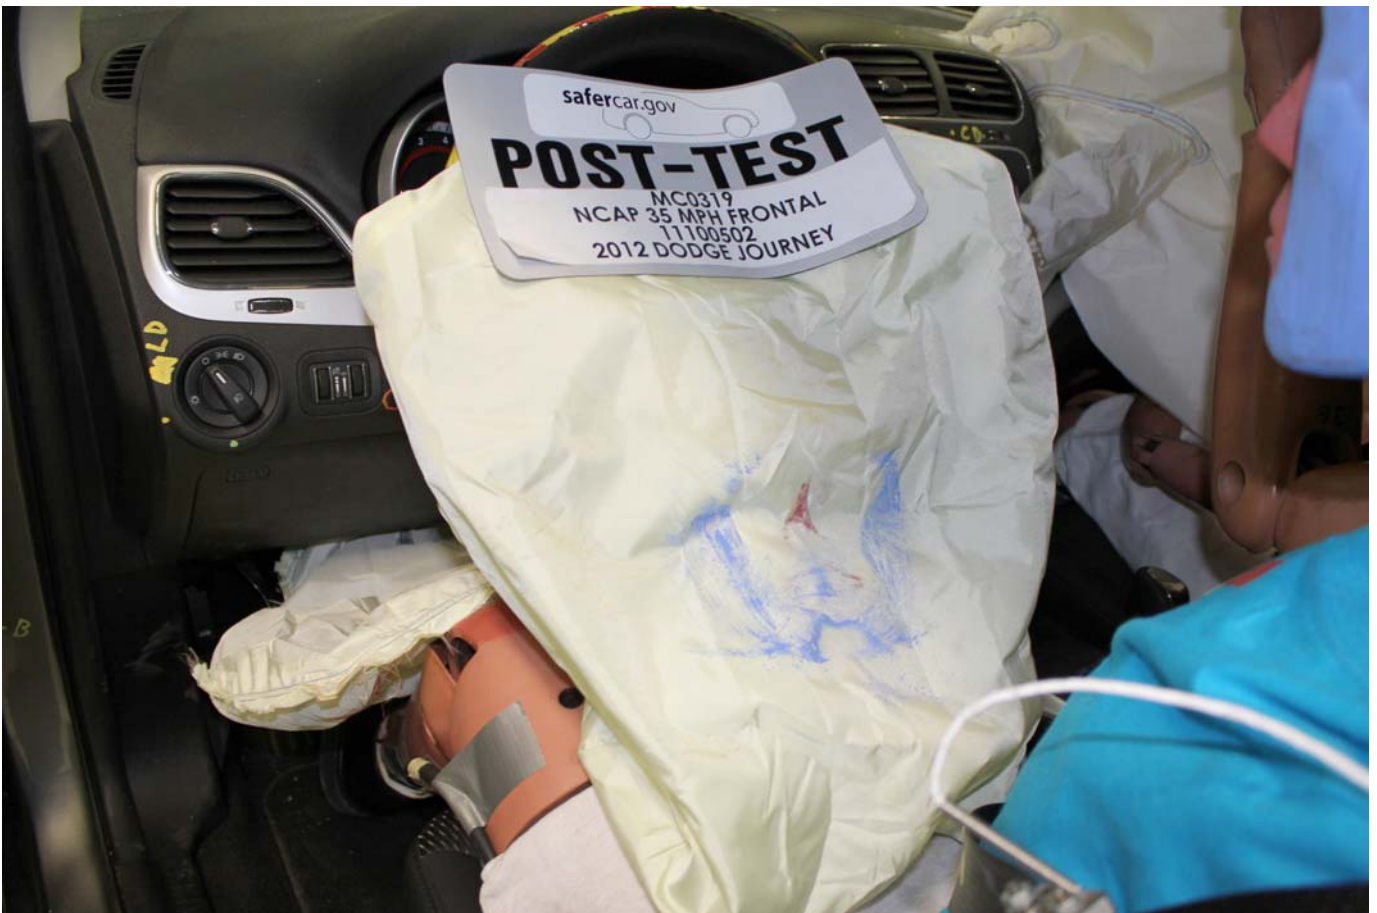
Post-Test Driver Dummy Contact with Airbag

The driver's visible contact points were as follows: The driver's head and chest contacted the airbag. The driver's head also contacted the headrest. The driver's knees contacted the knee bag. The passenger's visible contact points were as follows: The passenger's head and chest contacted the airbag. The passenger's head also contacted the headrest and seatback. The passenger's knees contacted the glovebox.

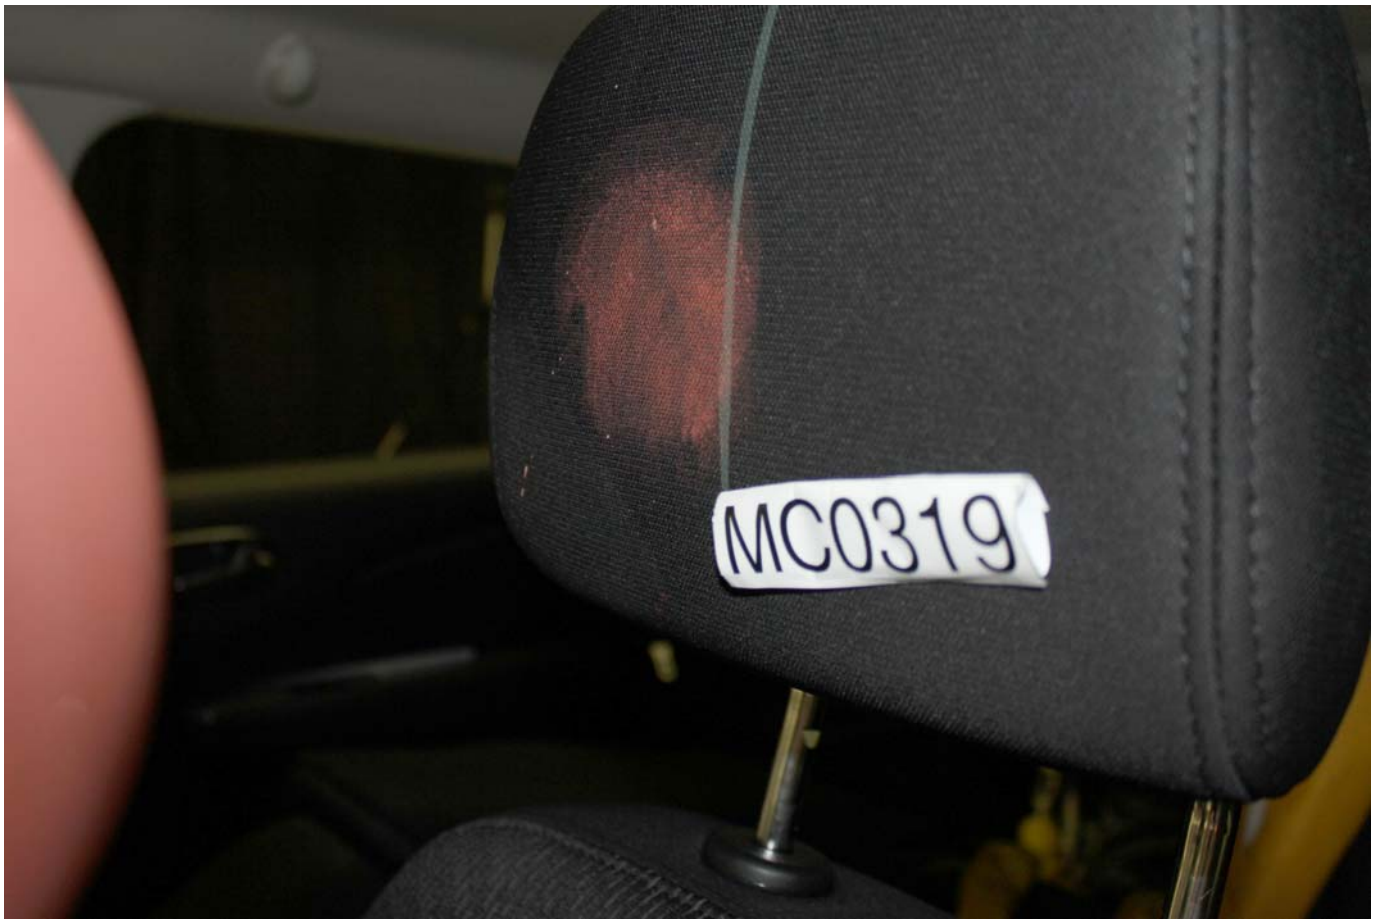
Post-Test Driver Dummy Contact with Headrest

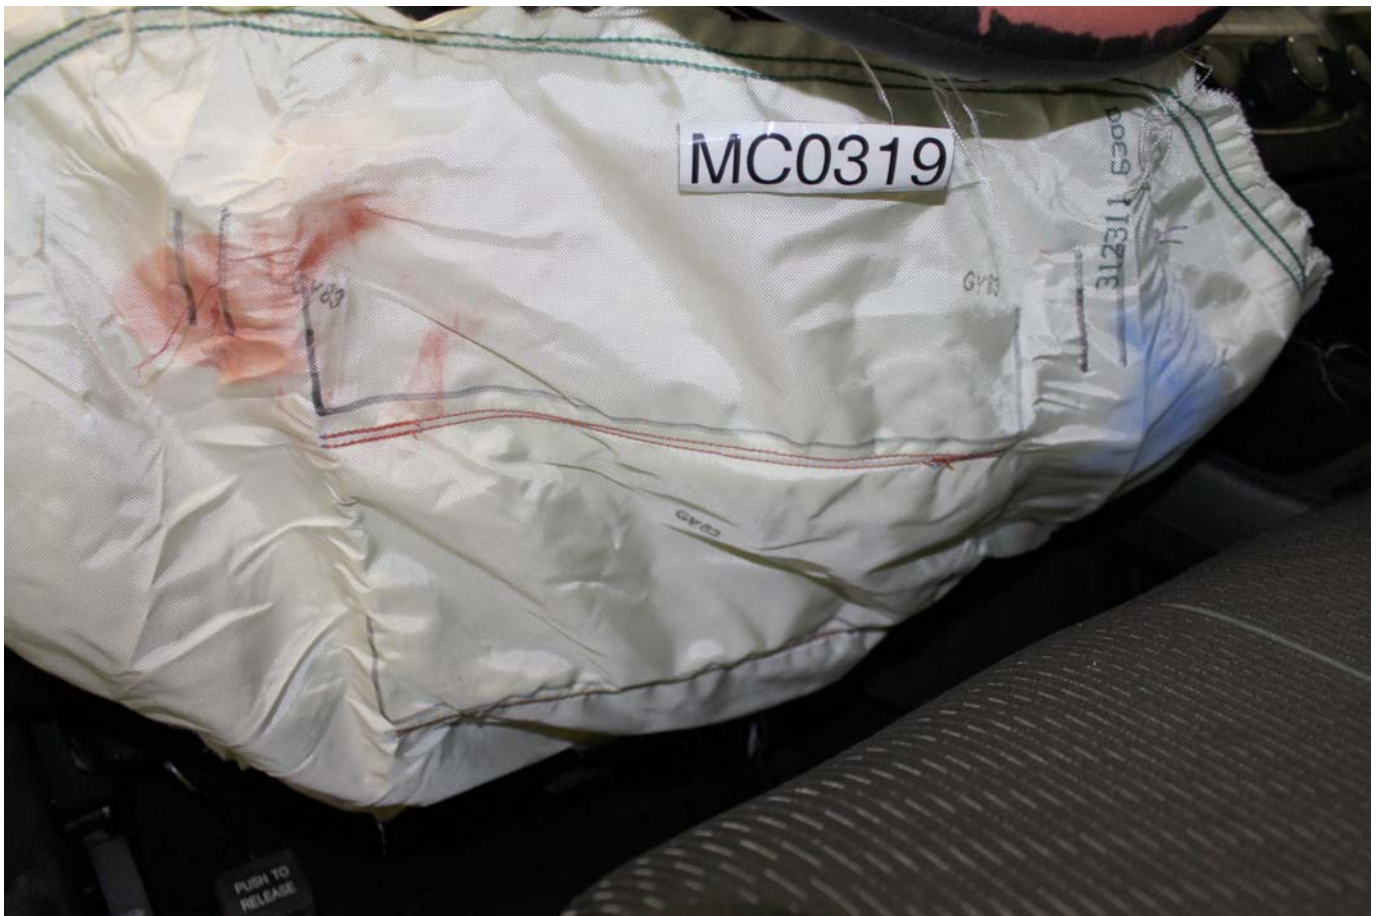
Post-Test Driver Dummy Contact with Knee Bag

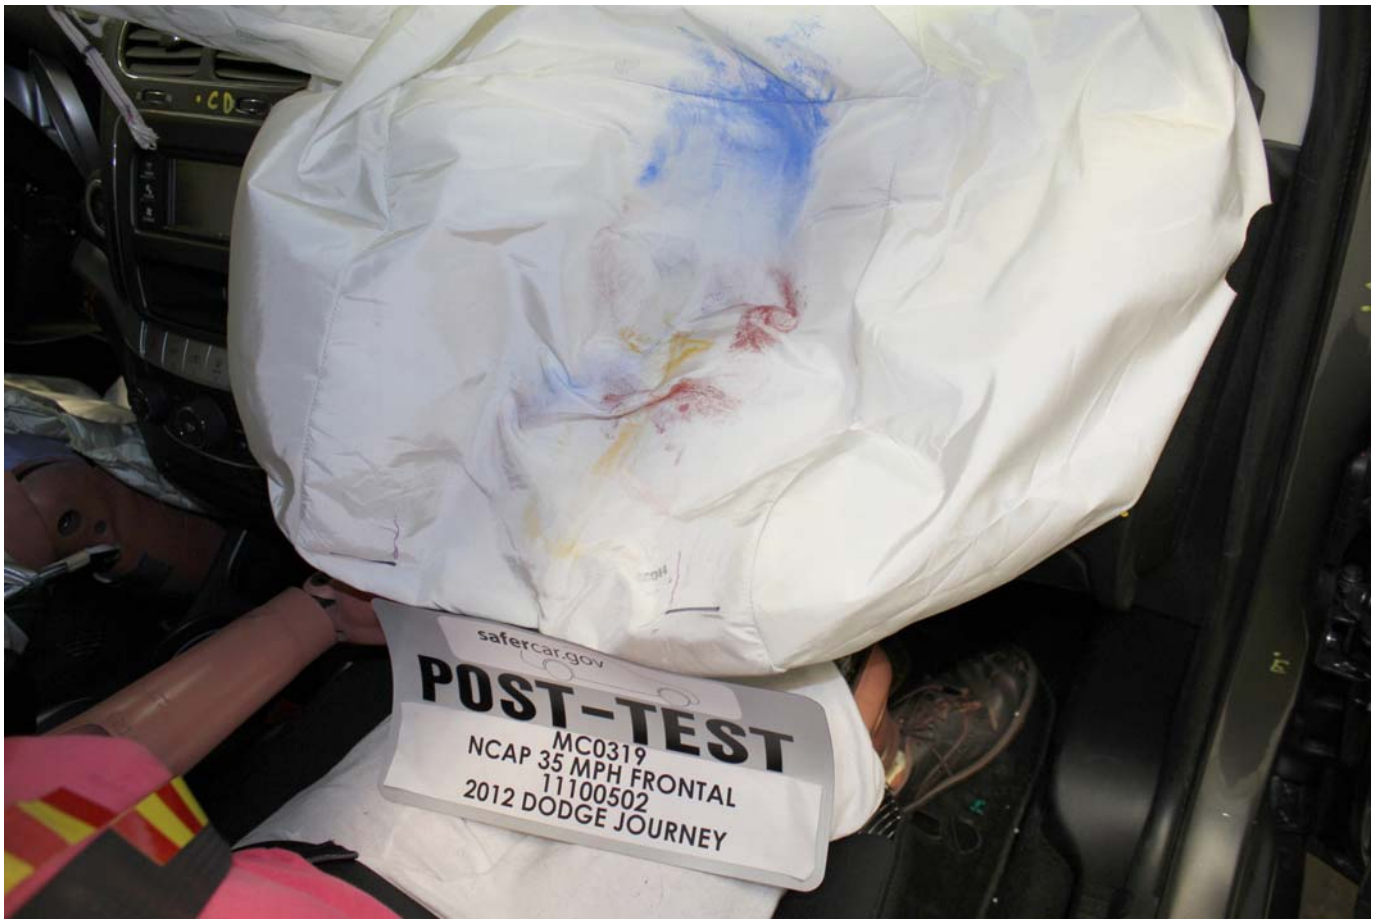
Post-Test Passenger Dummy Contact with Airbag

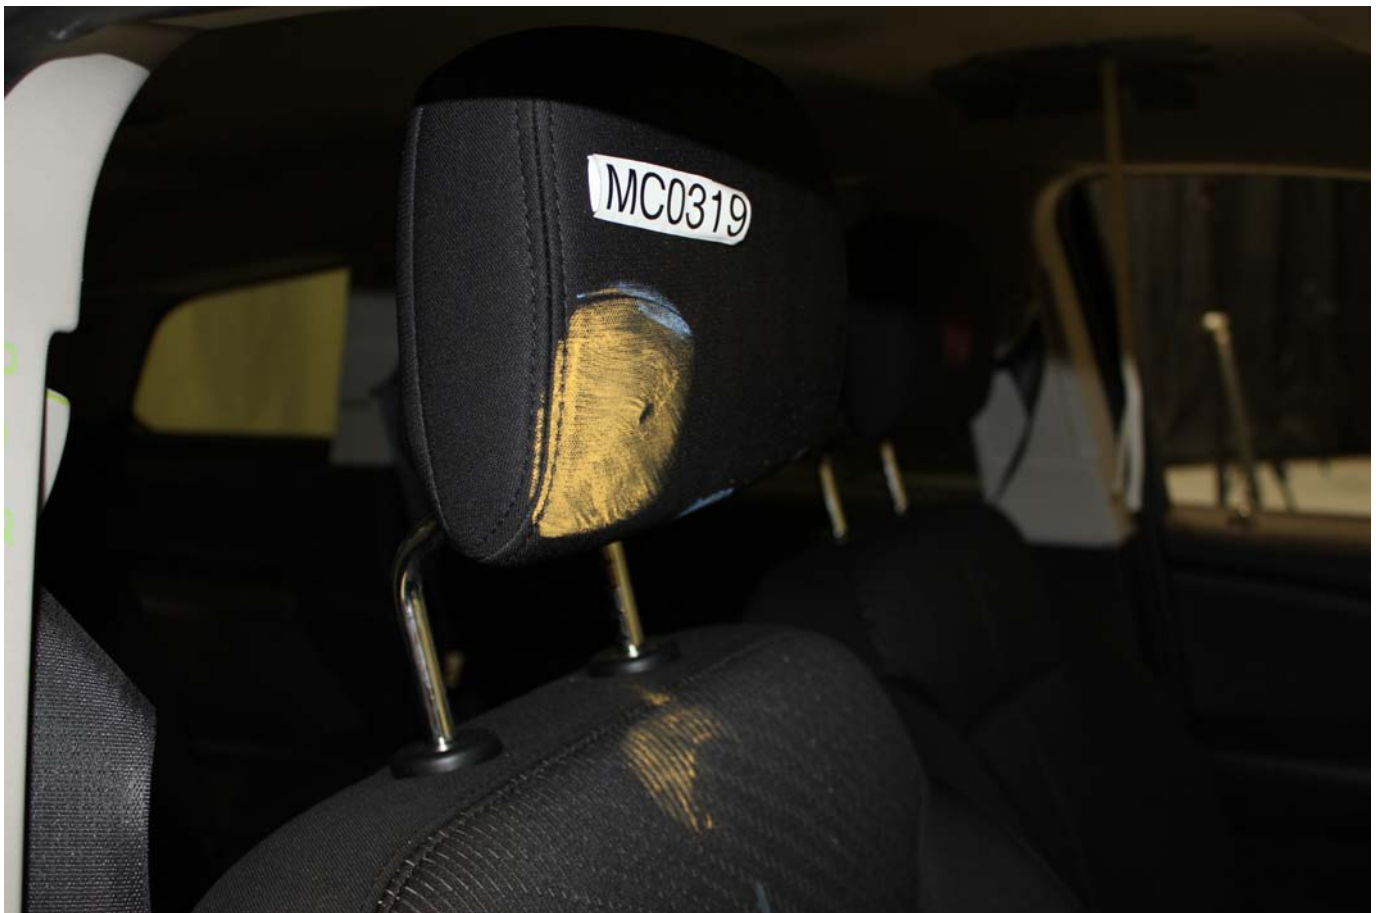
Post-Test Passenger Dummy Contact with Headrest

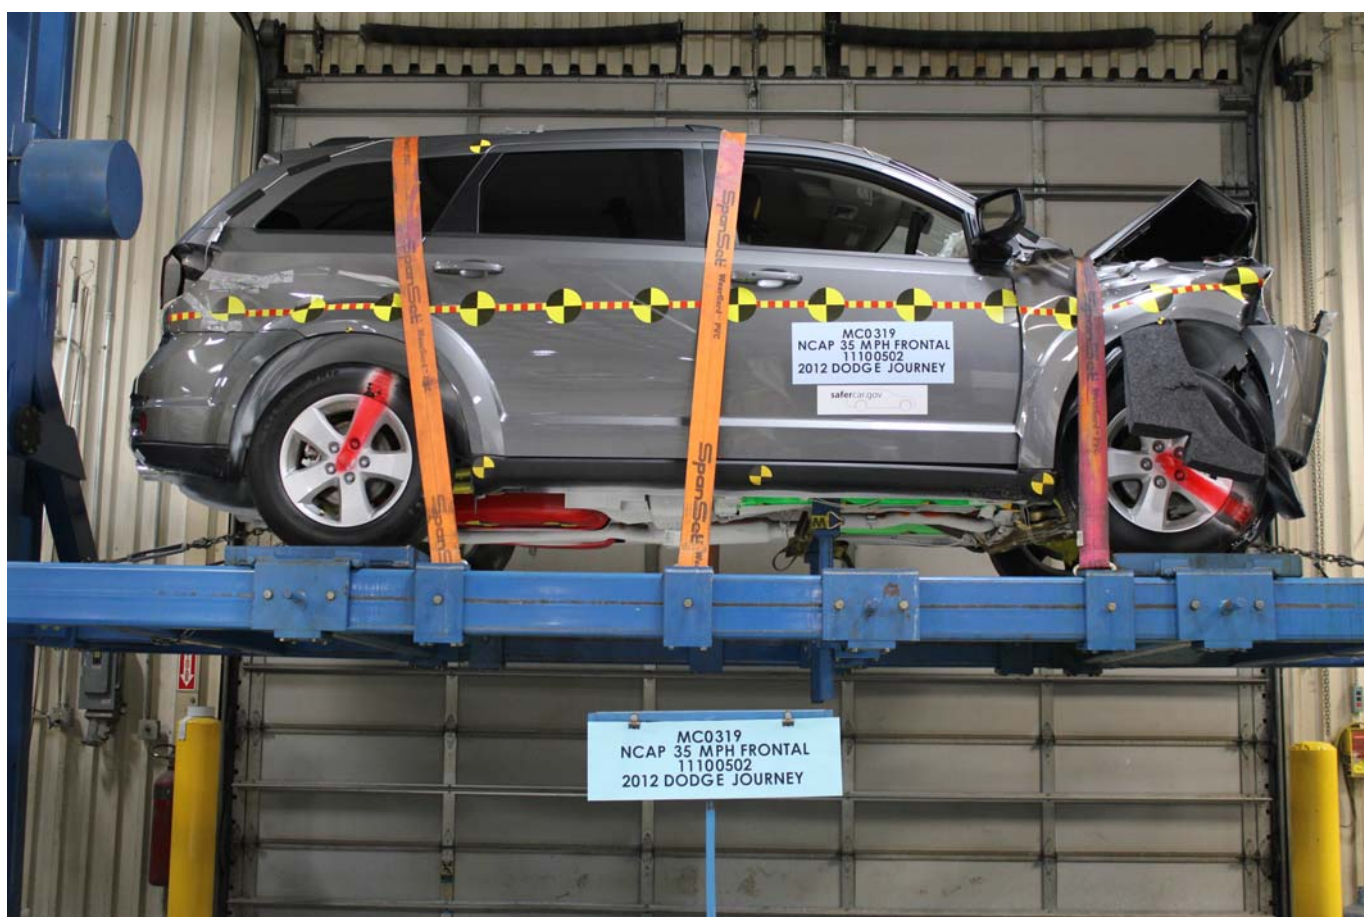
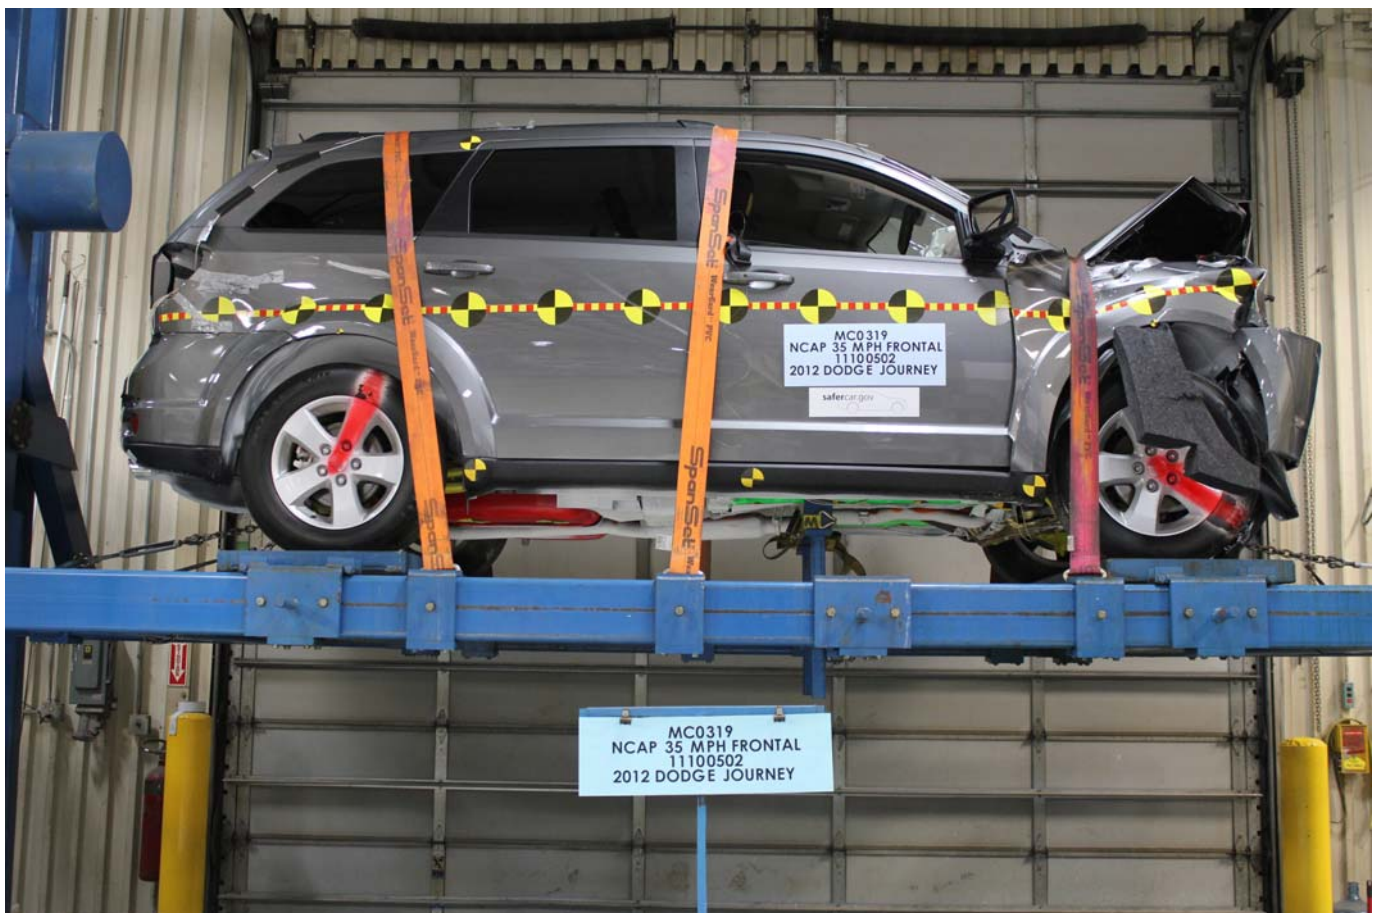
Vehicle at 0 Degrees on Static Rollover Device

Vehicle at 90 Degrees on Static Rollover Device

Vehicle at 180 Degrees on Static Rollover Device

Vehicle at 270 Degrees on Static Rollover Device

Vehicle at 360 Degrees on Static Rollover Device
