**REPORT NUMBER: SPNCAP-MGA-2012-011**

**NEW CAR ASSESSMENT PROGRAM (NCAP)  
Side Impact Pole Test**

**CHRYSLER GROUP LLC  
2012 Dodge Journey SE FWD SUV  
NHTSA No.: MC0321**

**MGA RESEARCH CORPORATION  
5000 Warren Road  
Burlington, WI 53105**

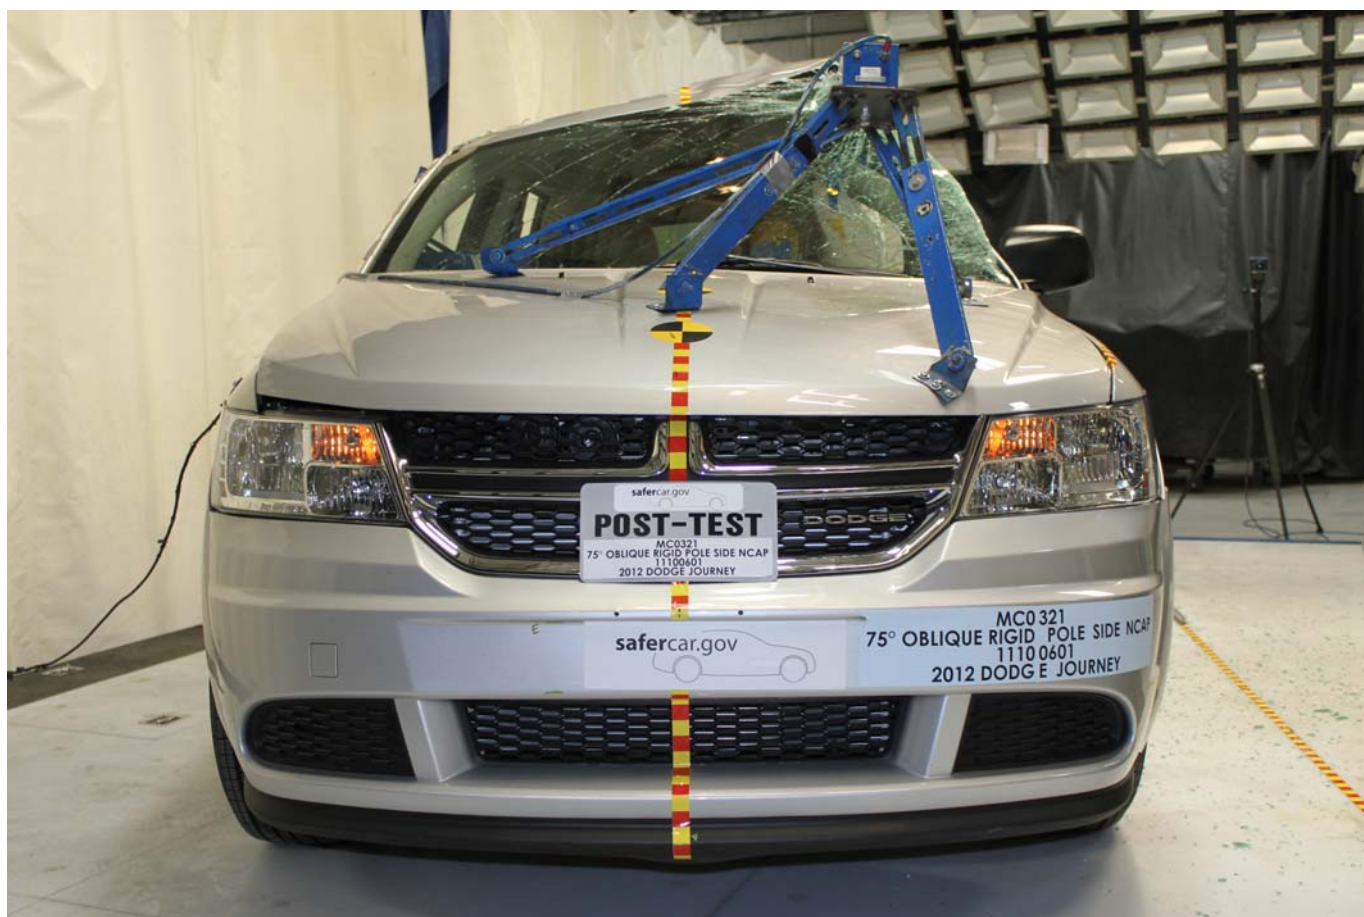
Post-Test Frontal View of Test Vehicle

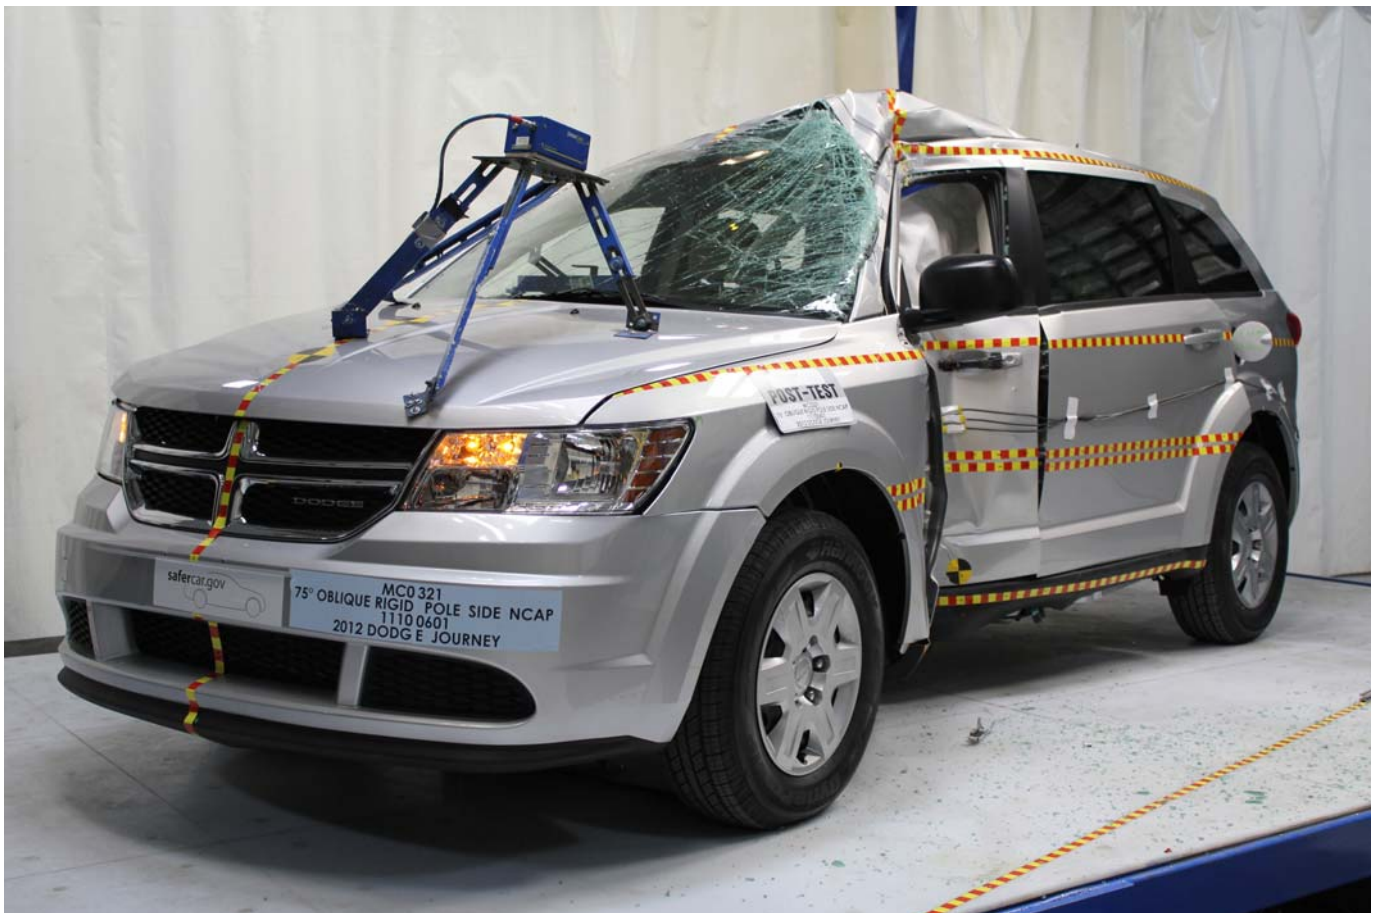
Post-Test Left Front  $\frac{3}{4}$  View of Test Vehicle

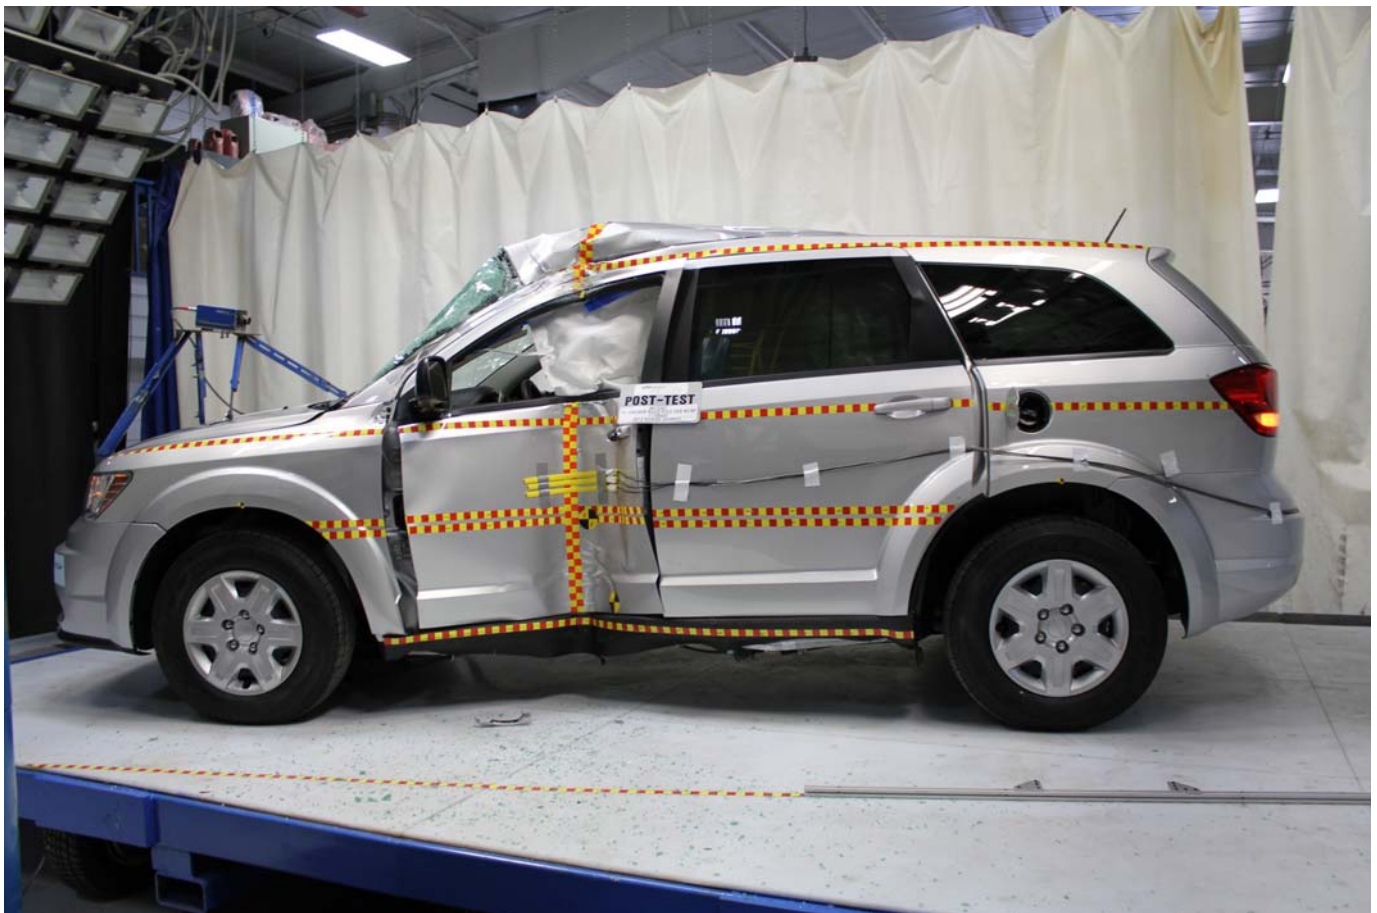
Post-Test Left Side View of Test Vehicle

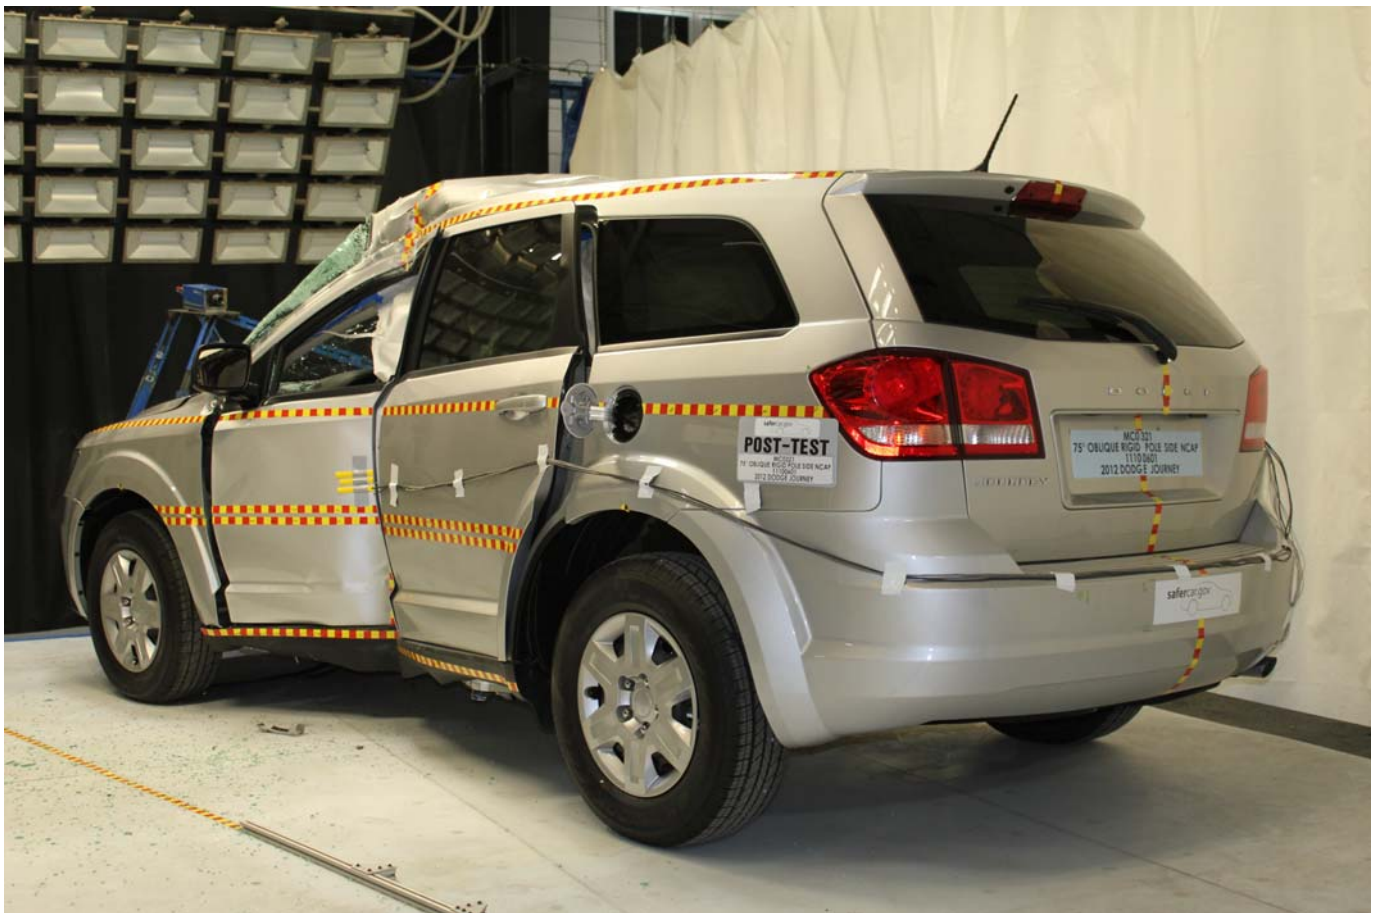
Post-Test Left Rear  $\frac{3}{4}$  View of Test Vehicle

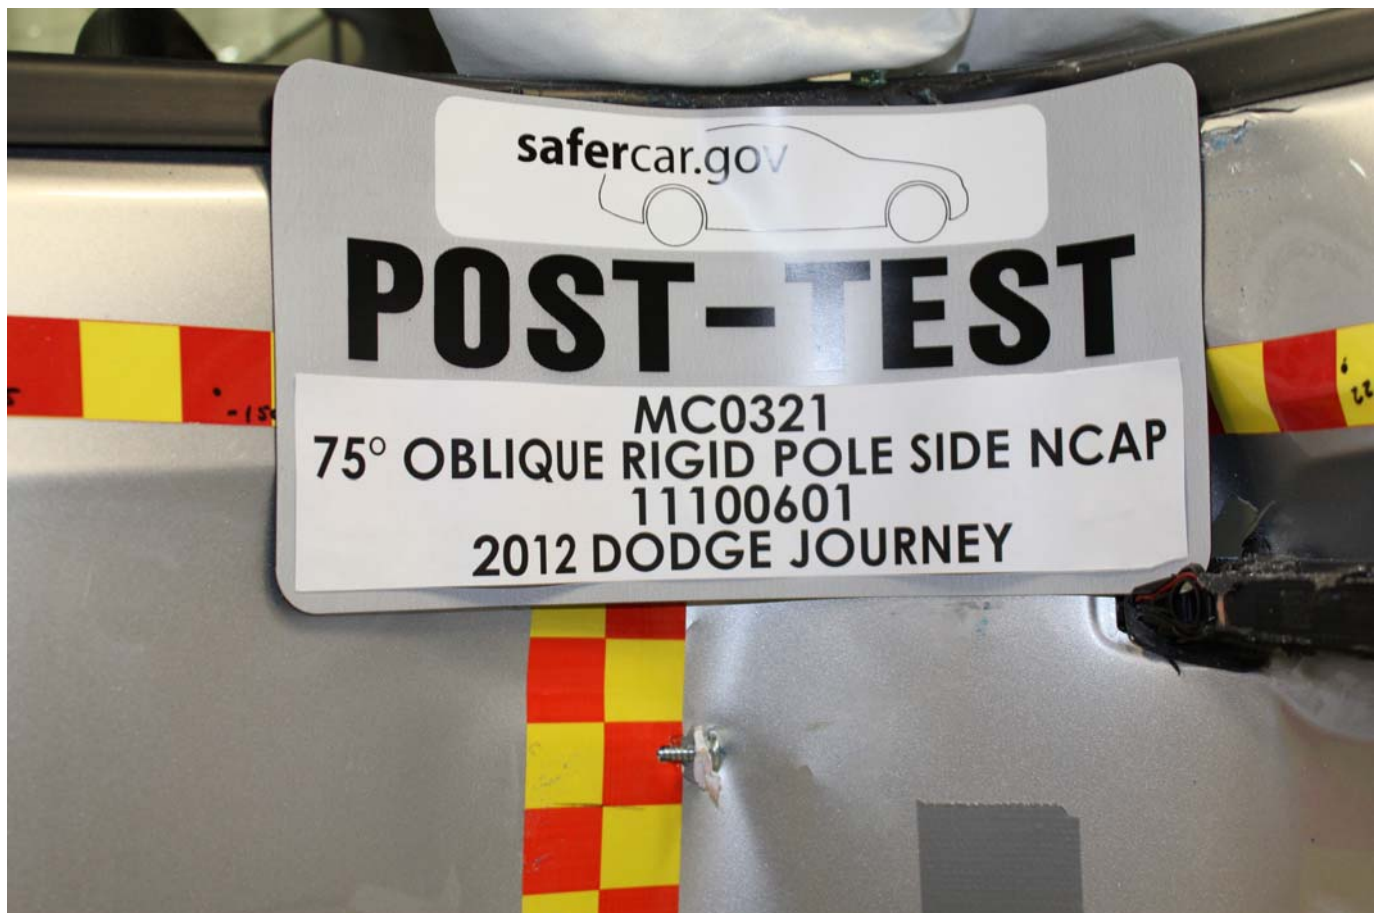
Post-Test Close-Up View of Impact Point Target Showing Impact Location

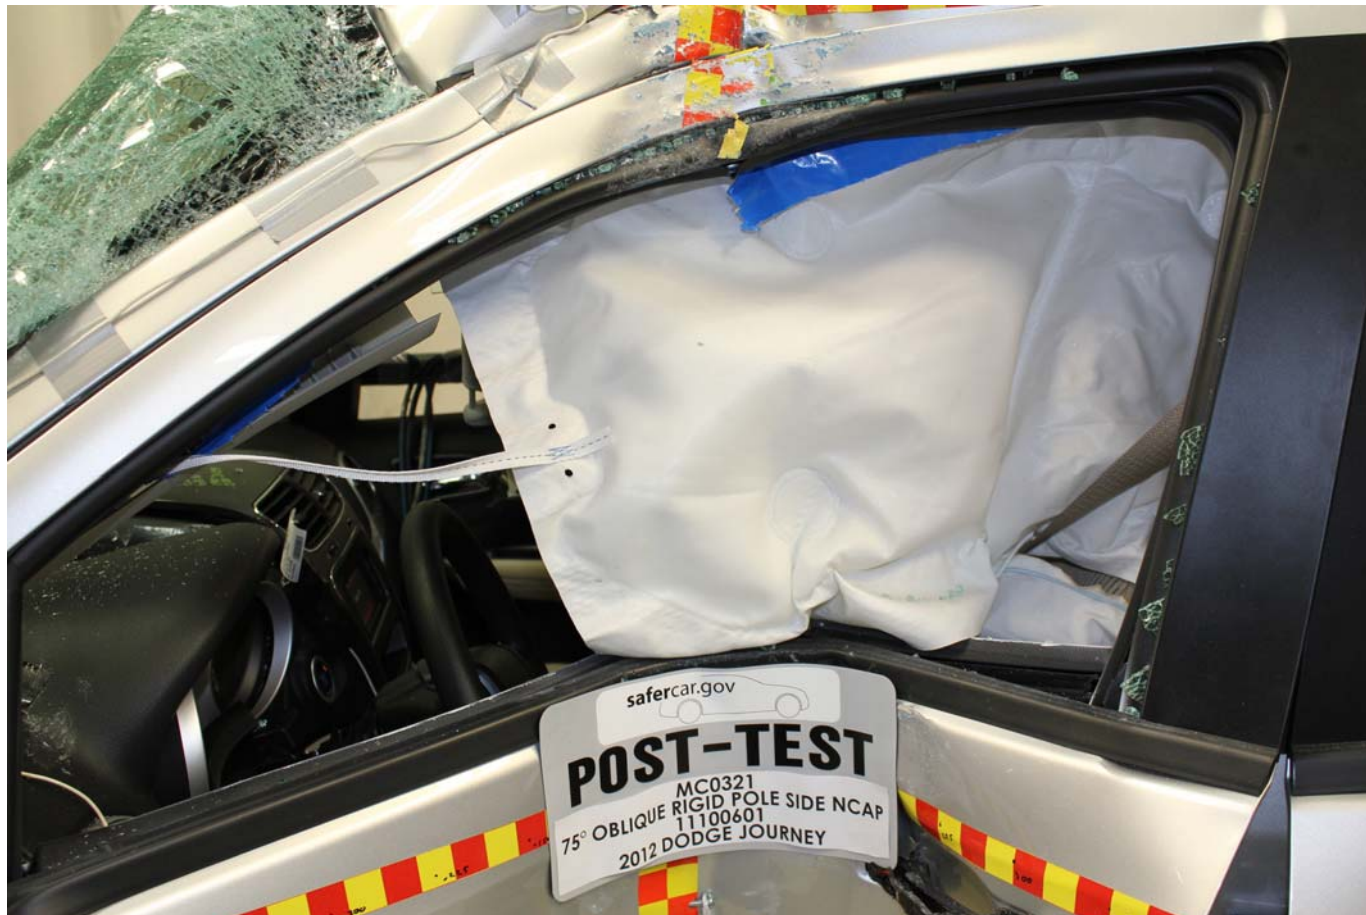
Post-Test Left Side View of Dummy Shoulder and Door Top View

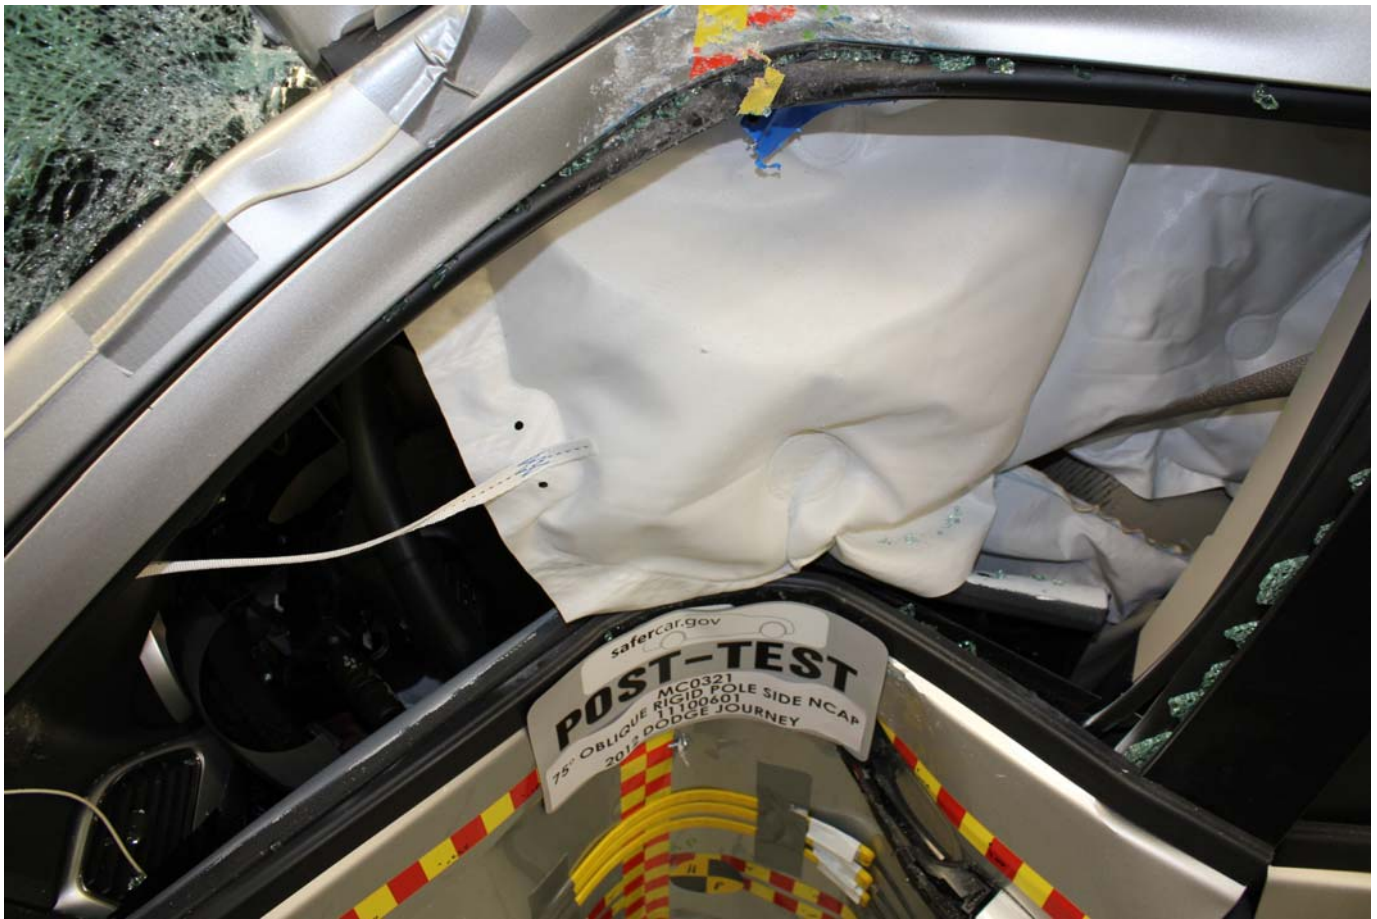
Post-Test Dummy and Door Clearance View

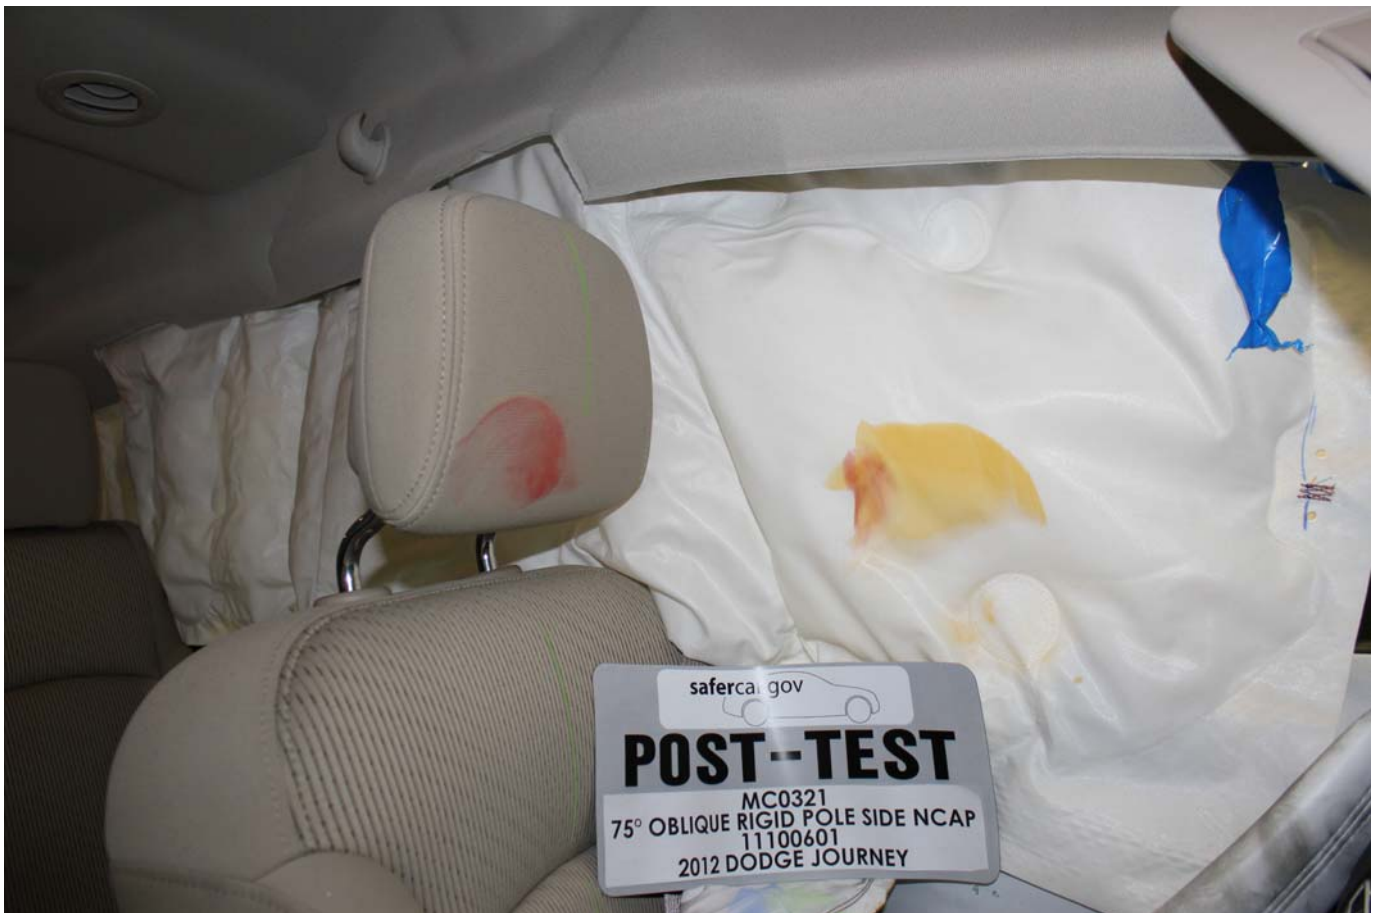
Post-Test Dummy Close-Up Head Contact with Vehicle Interior View

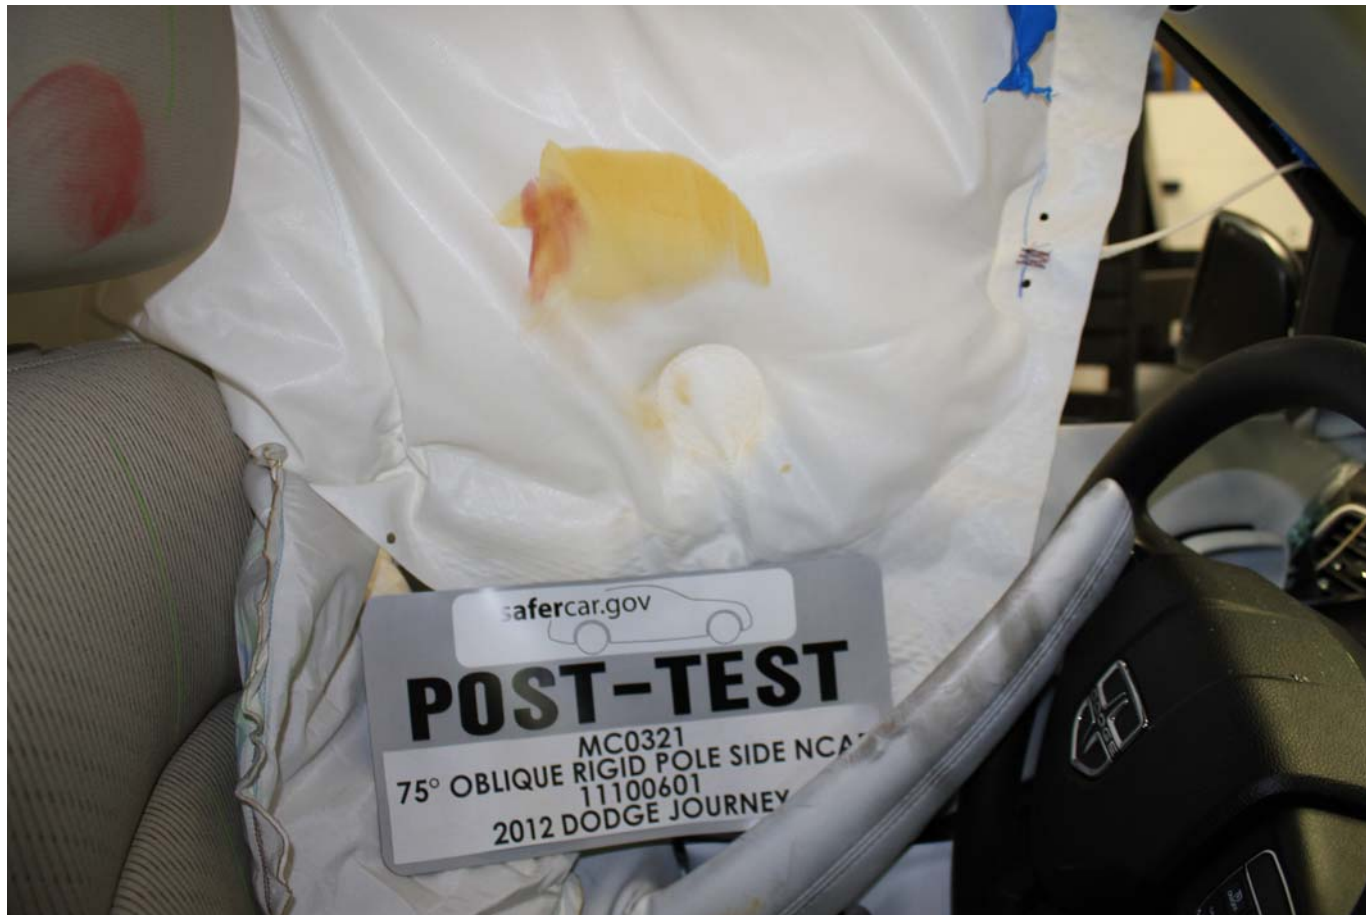
Post-Test Dummy Close-Up Head Contact with Side Air Bag View

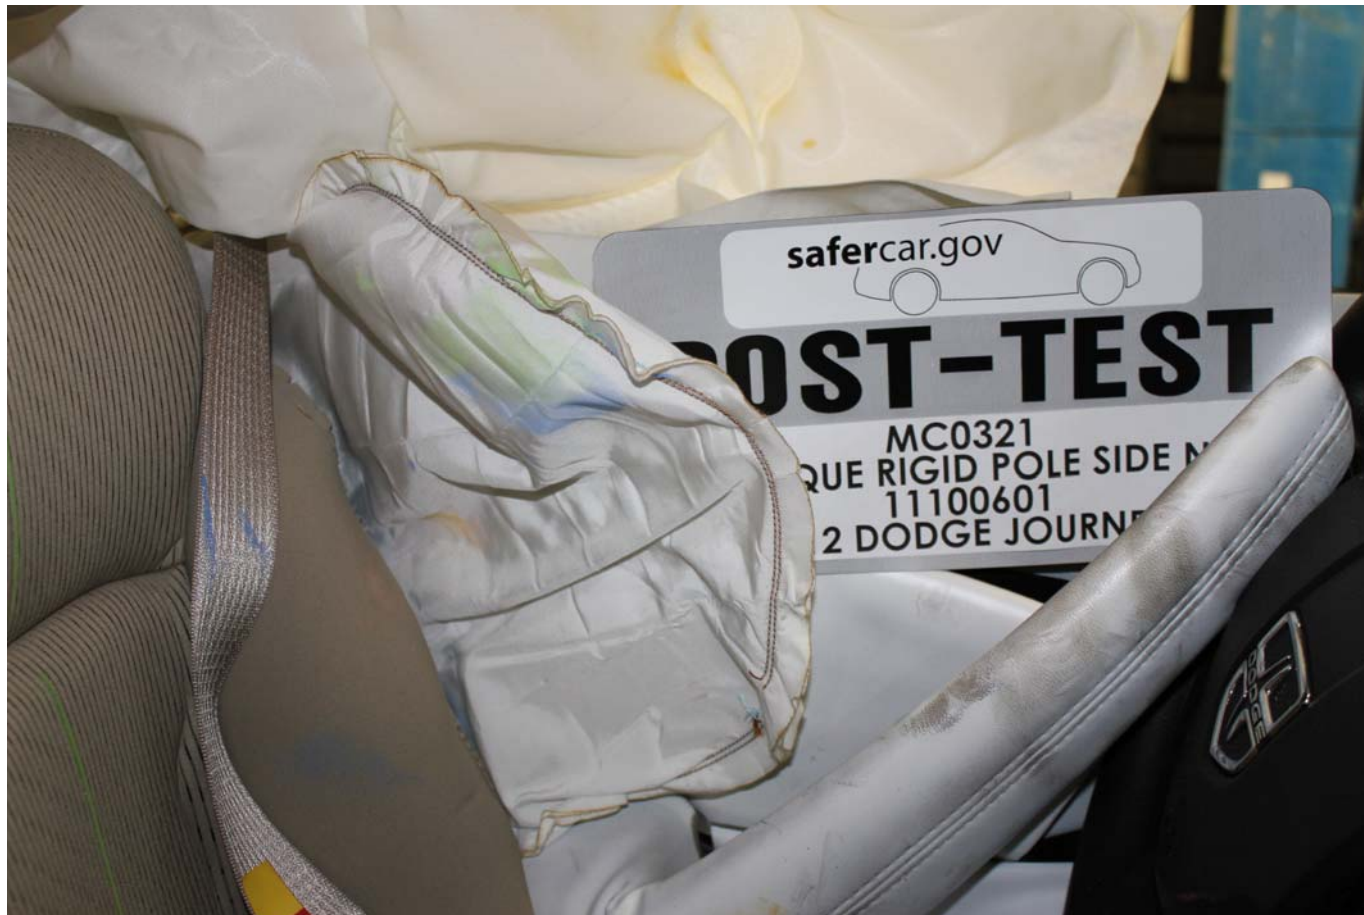
Post-Test Dummy Close-Up Torso Contact with Side Air Bag View

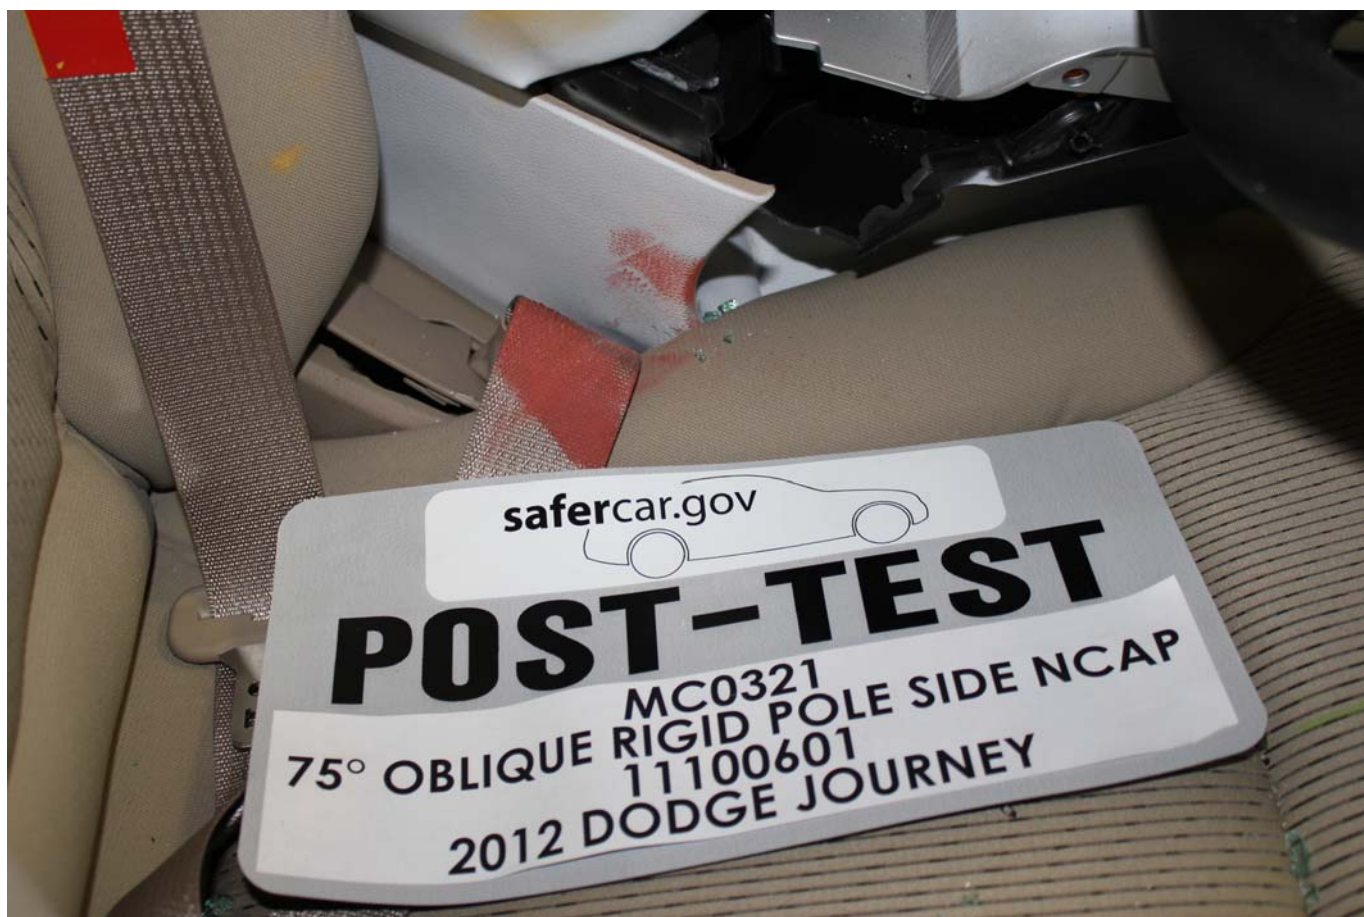
Post-Test Dummy Close-Up Pelvis Contact with Vehicle Interior View

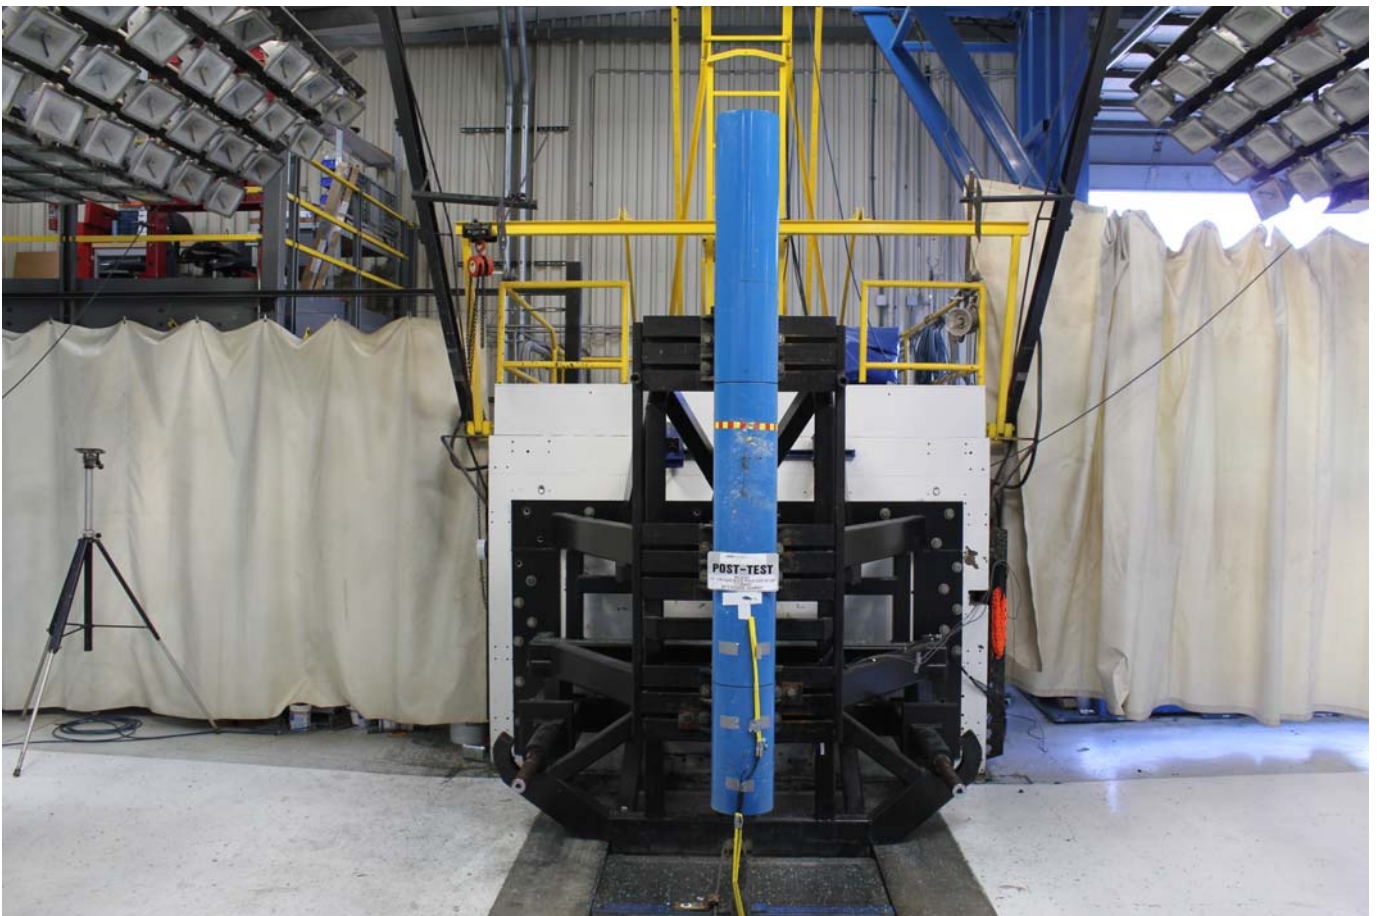
Post-Test Pole Barrier Front View

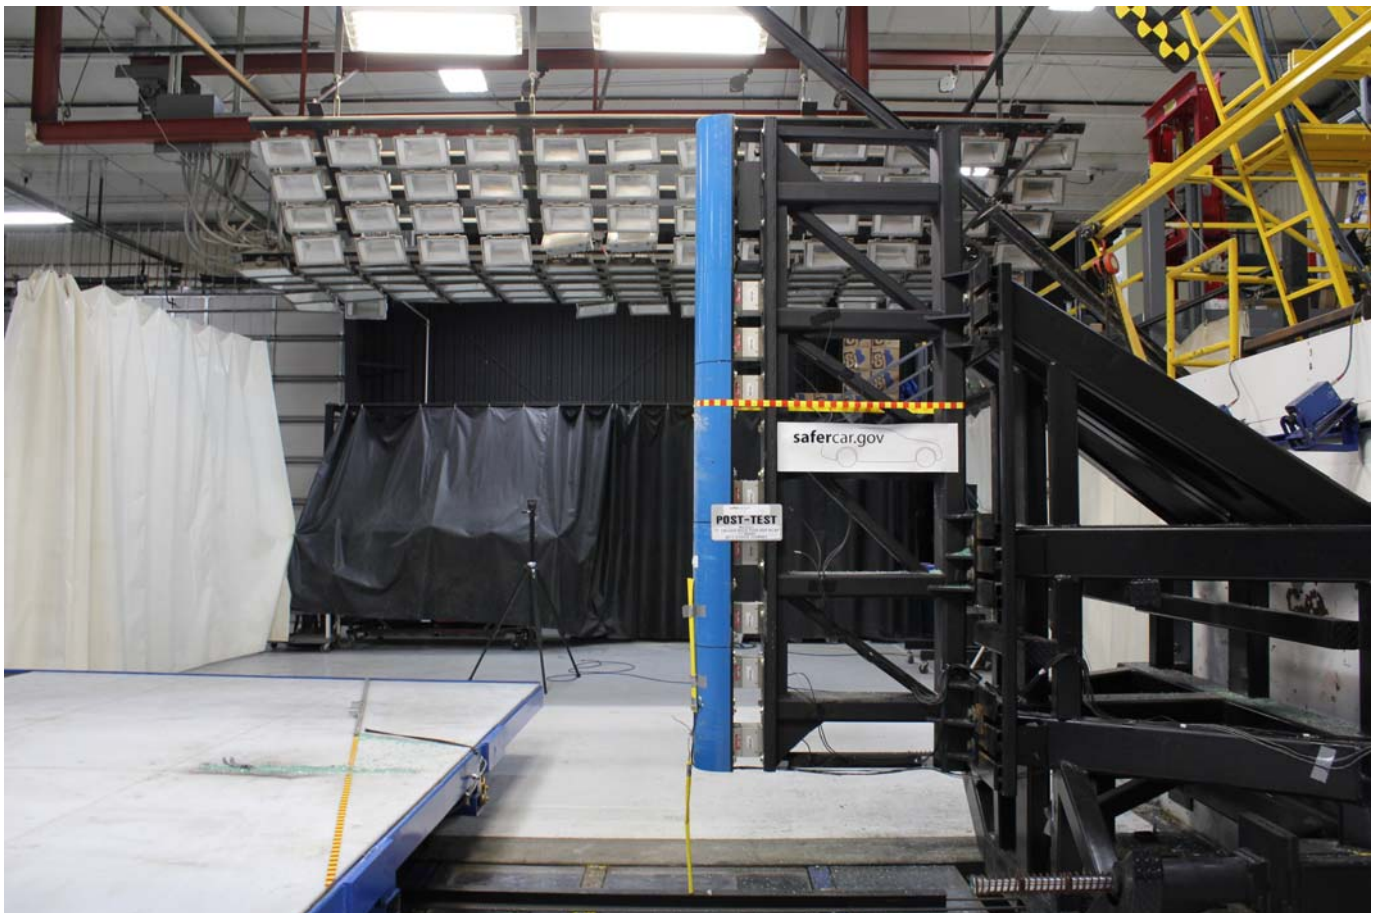
Post-Test Pole Barrier Side View

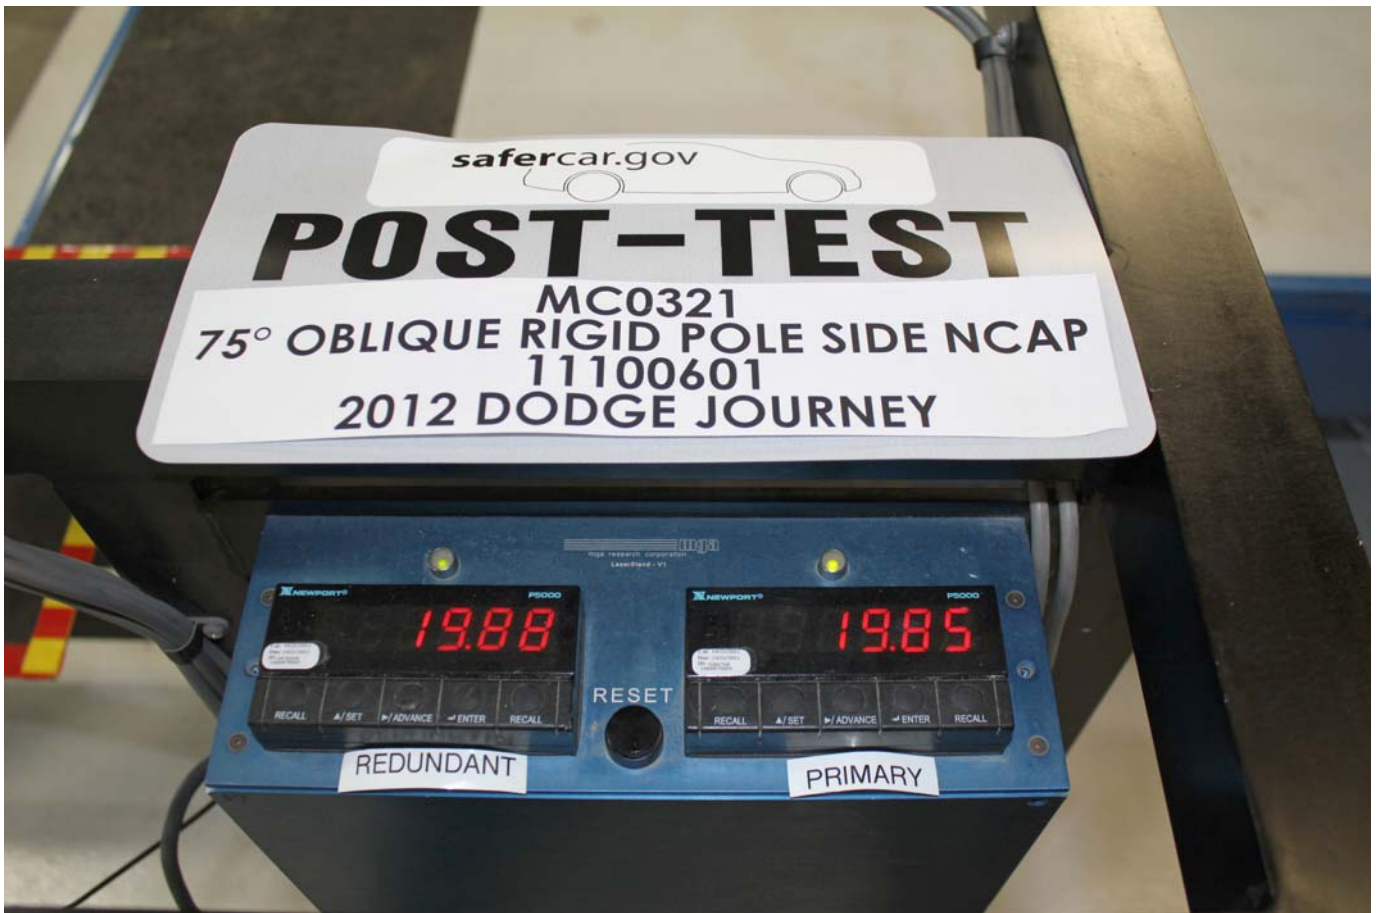
Post-Test Primary and Redundant Speed Trap Read-Out

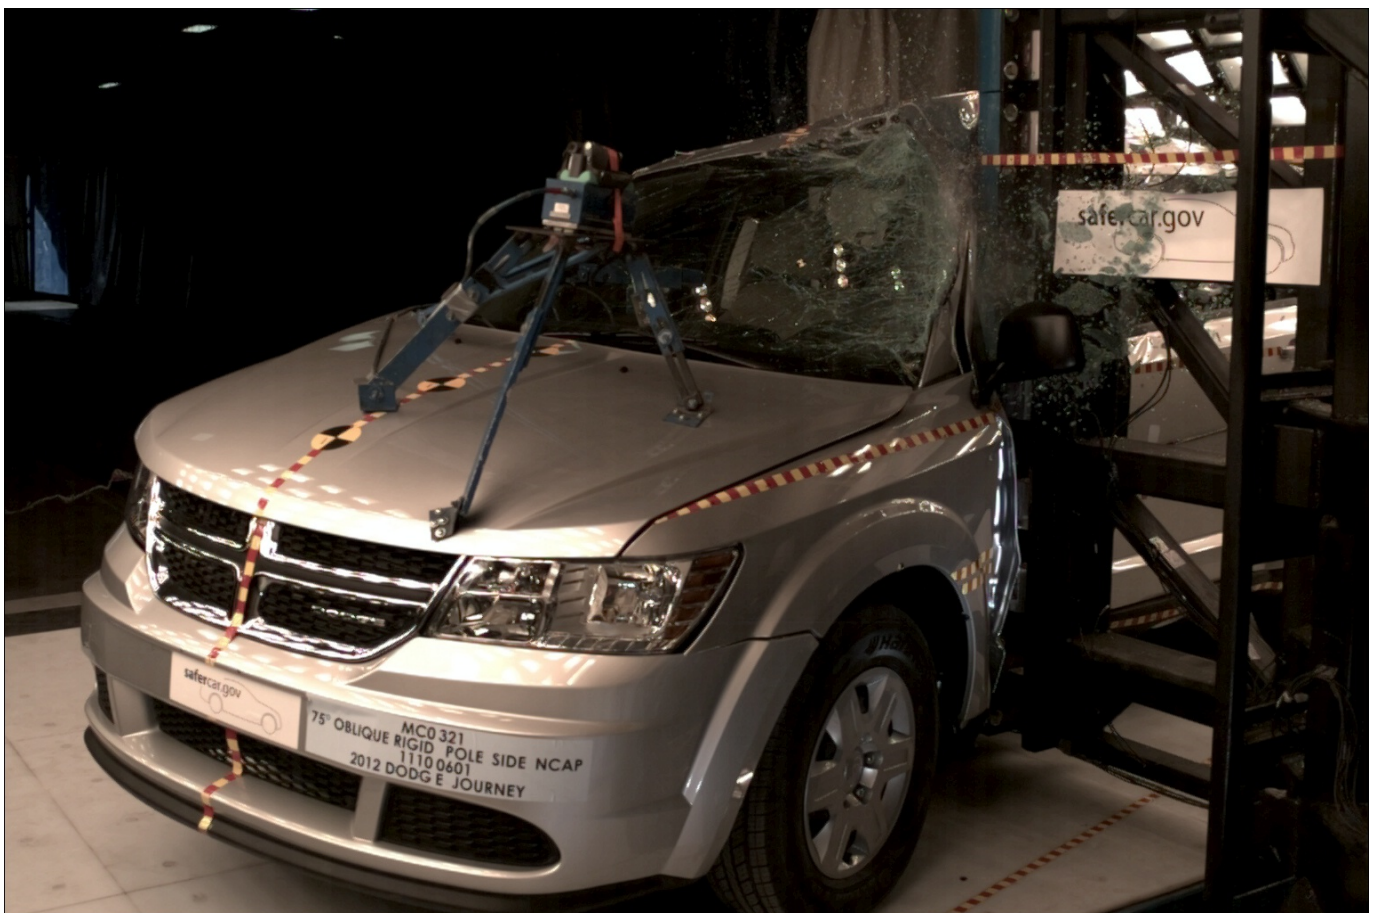
Impact Event

A rigid pole side impact test was conducted on a 2012 Dodge Journey SE FWD SUV. The subject vehicle was towed into the rigid pole at an angle of 75° and a velocity of 31.9 km/h. The test was conducted by MGA Research Corporation in Burlington, Wisconsin, on October 6, 2011. Pre-test and post-test photographs of the test vehicle and side impact dummy (SID-IIs) are included in Appendix A of this report.

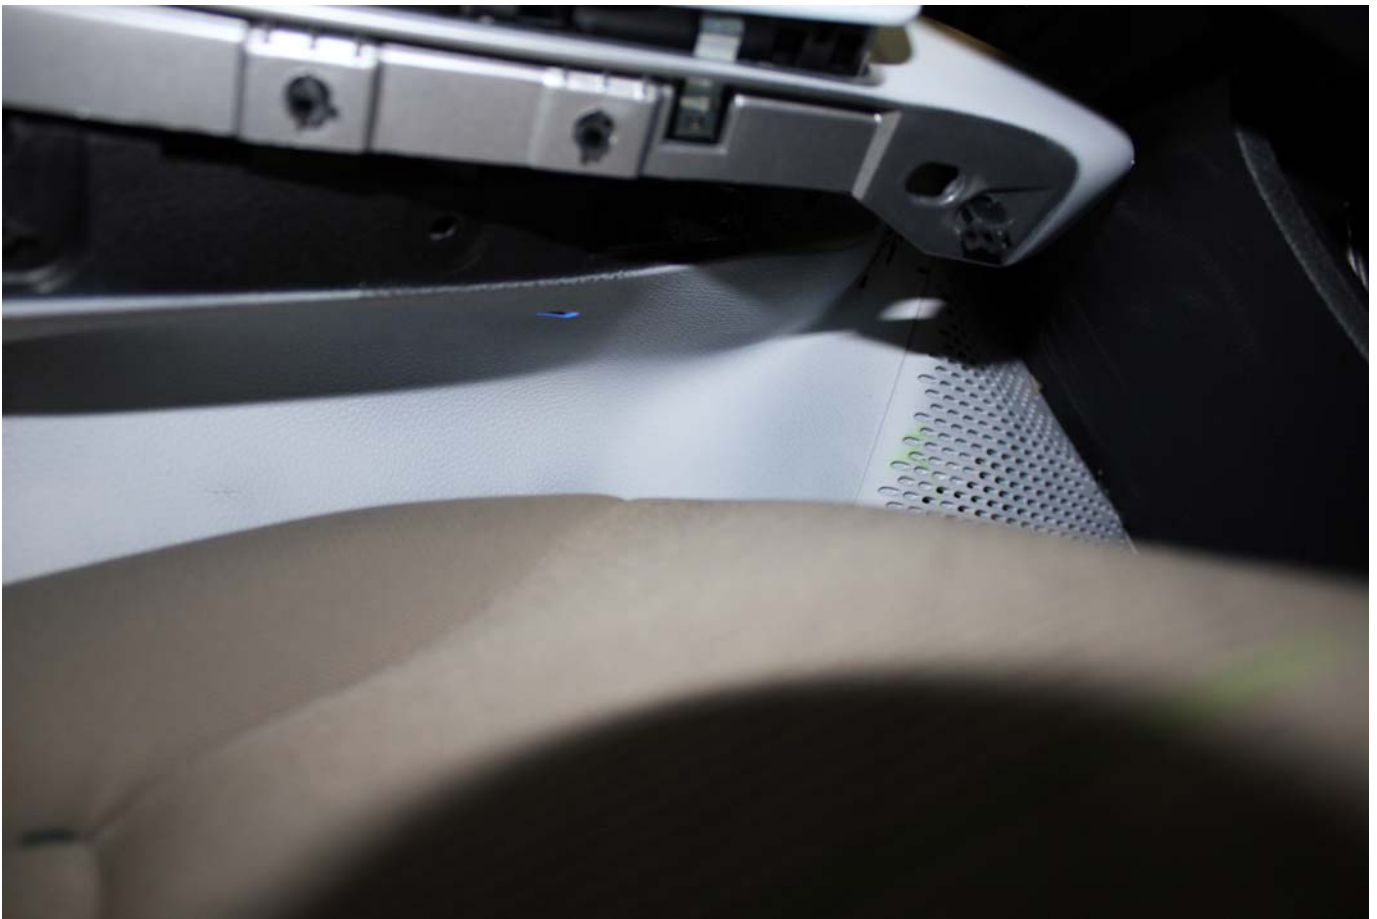
Post-Test Dummy Close-Up Knee Contact with Vehicle Interior View
