REPORT NUMBER: SINCAP-MGA-2012-012

**NEW CAR ASSESSMENT PROGRAM (NCAP)
Moving Deformable Barrier Side Impact Test**

**CHRYSLER GROUP LLC
2012 Dodge Journey SXT FWD SUV
NHTSA No.: MC0320**

FINAL REPORT

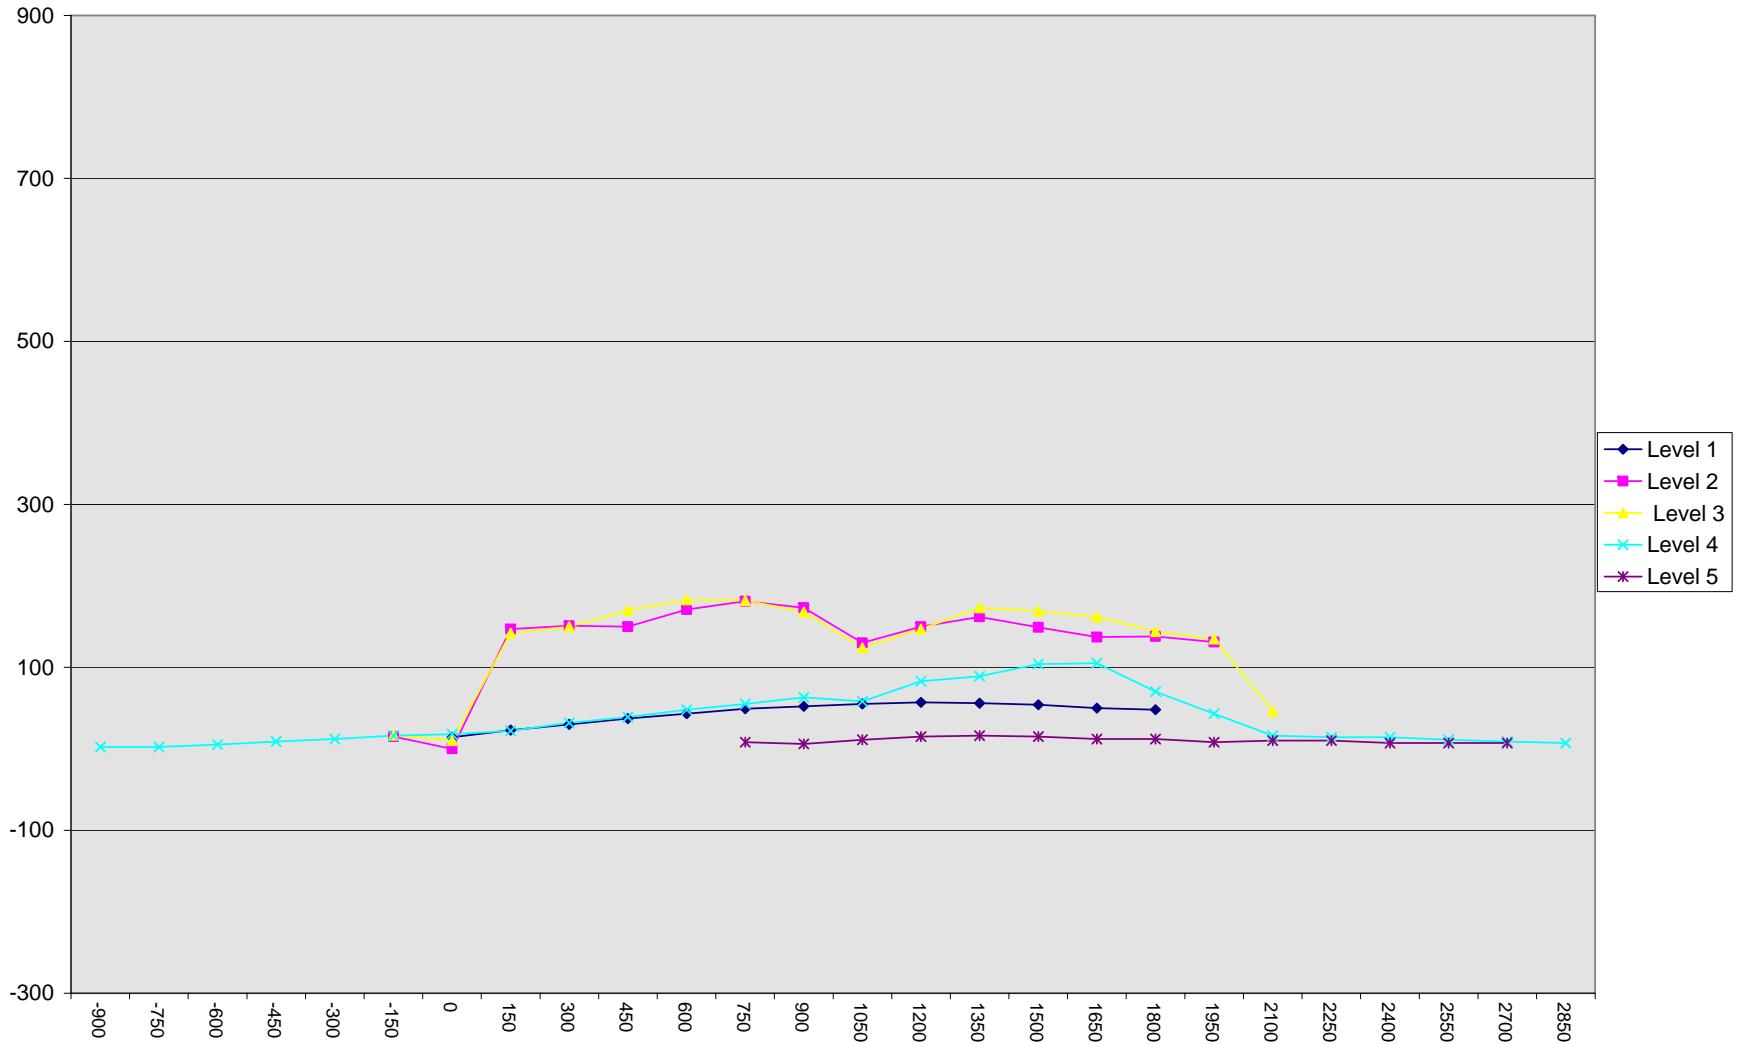
DATA SHEET NO. 12
MDB EXTERIOR STATIC CRUSH MEASUREMENTS

NOTE: Pre-test measurements are taken when the vehicle is in the "As Tested" weight condition. Vehicle measurements forward of the vertical impact reference line are negative. The crush profile grid is established prior to the test based on an estimated impact point.

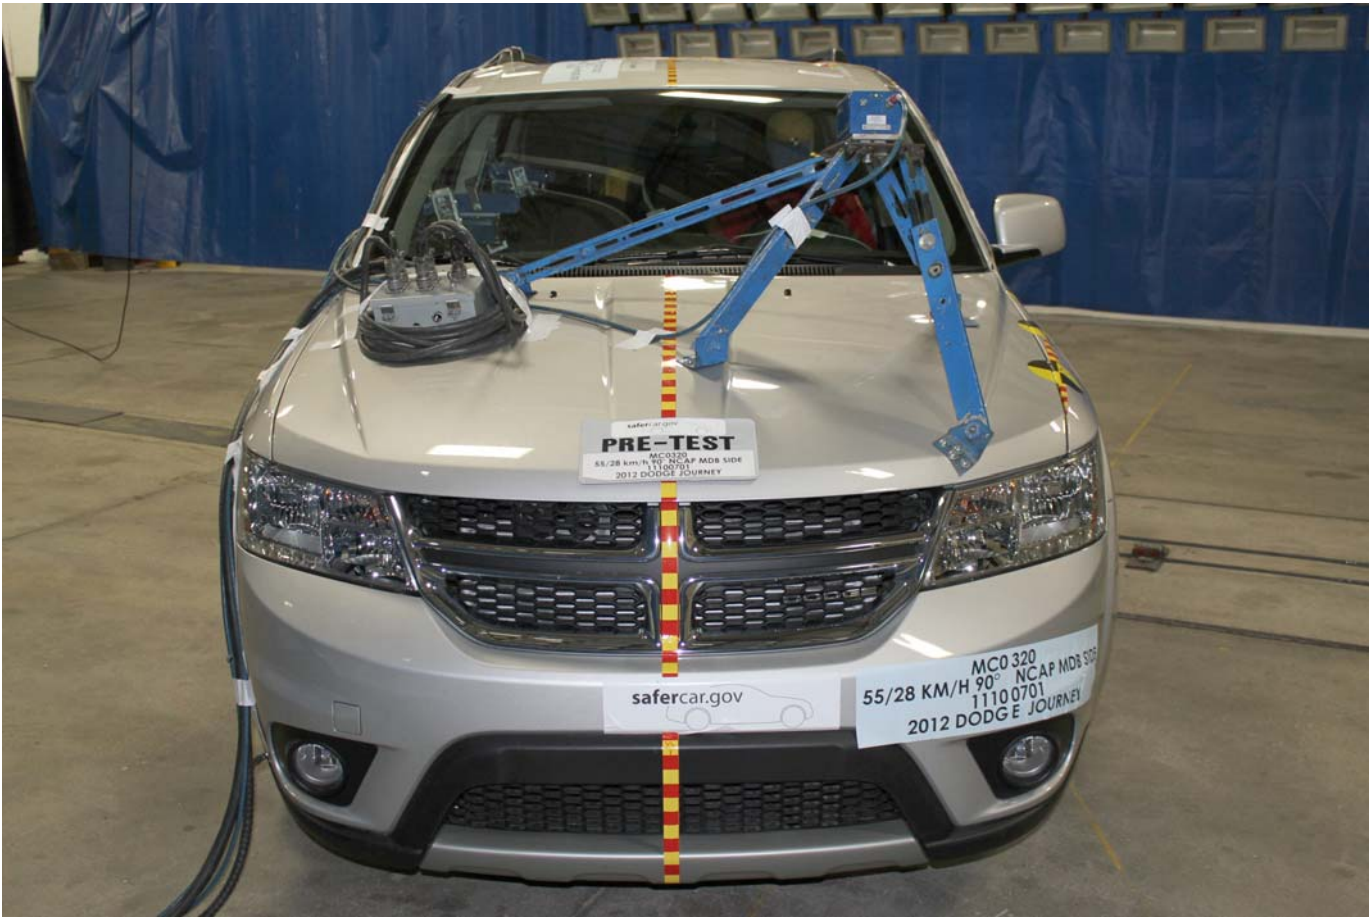
Pre-Test Frontal View of Test Vehicle

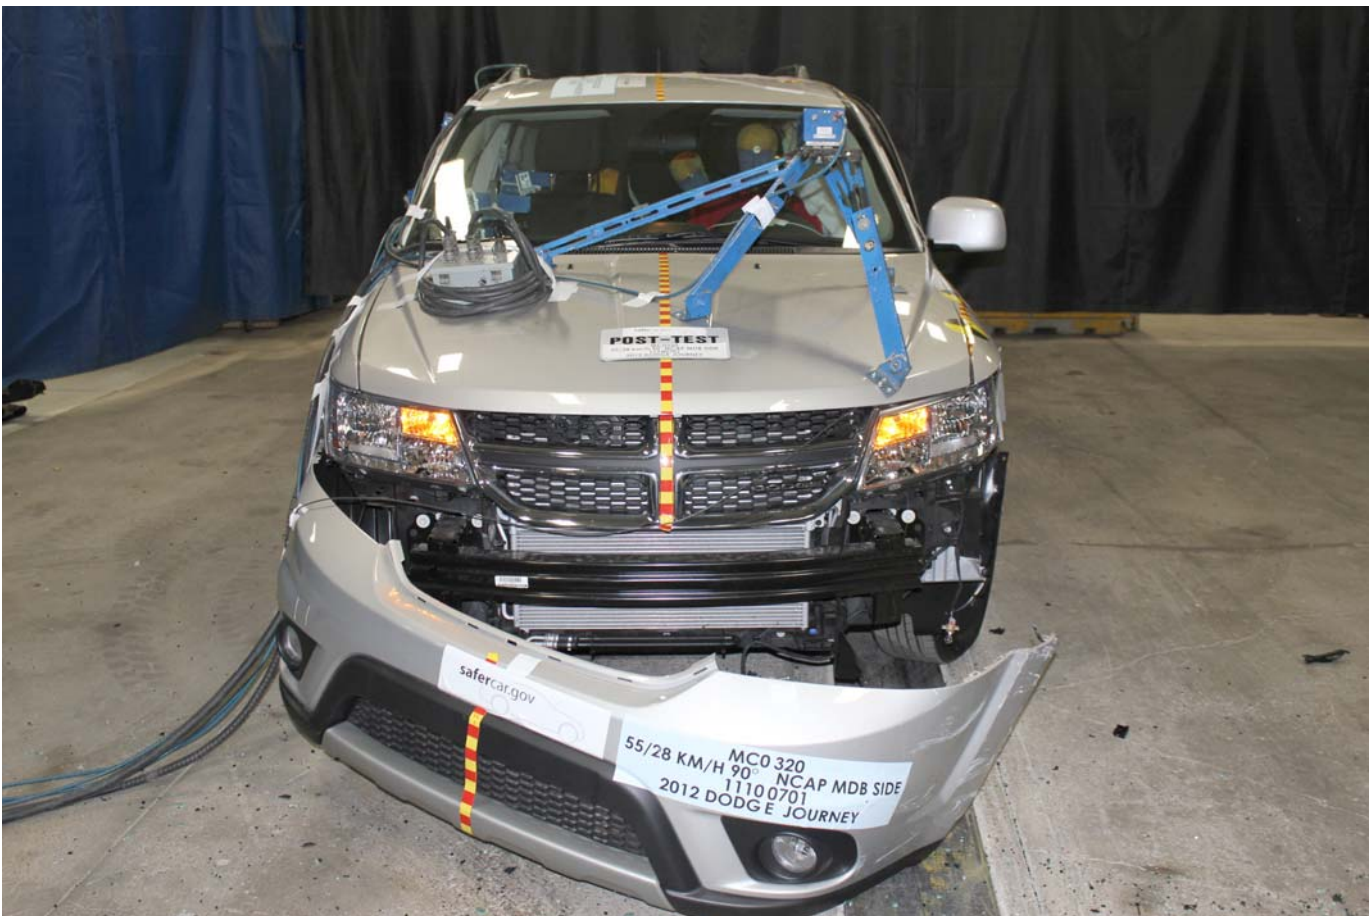
Post-Test Frontal View of Test Vehicle

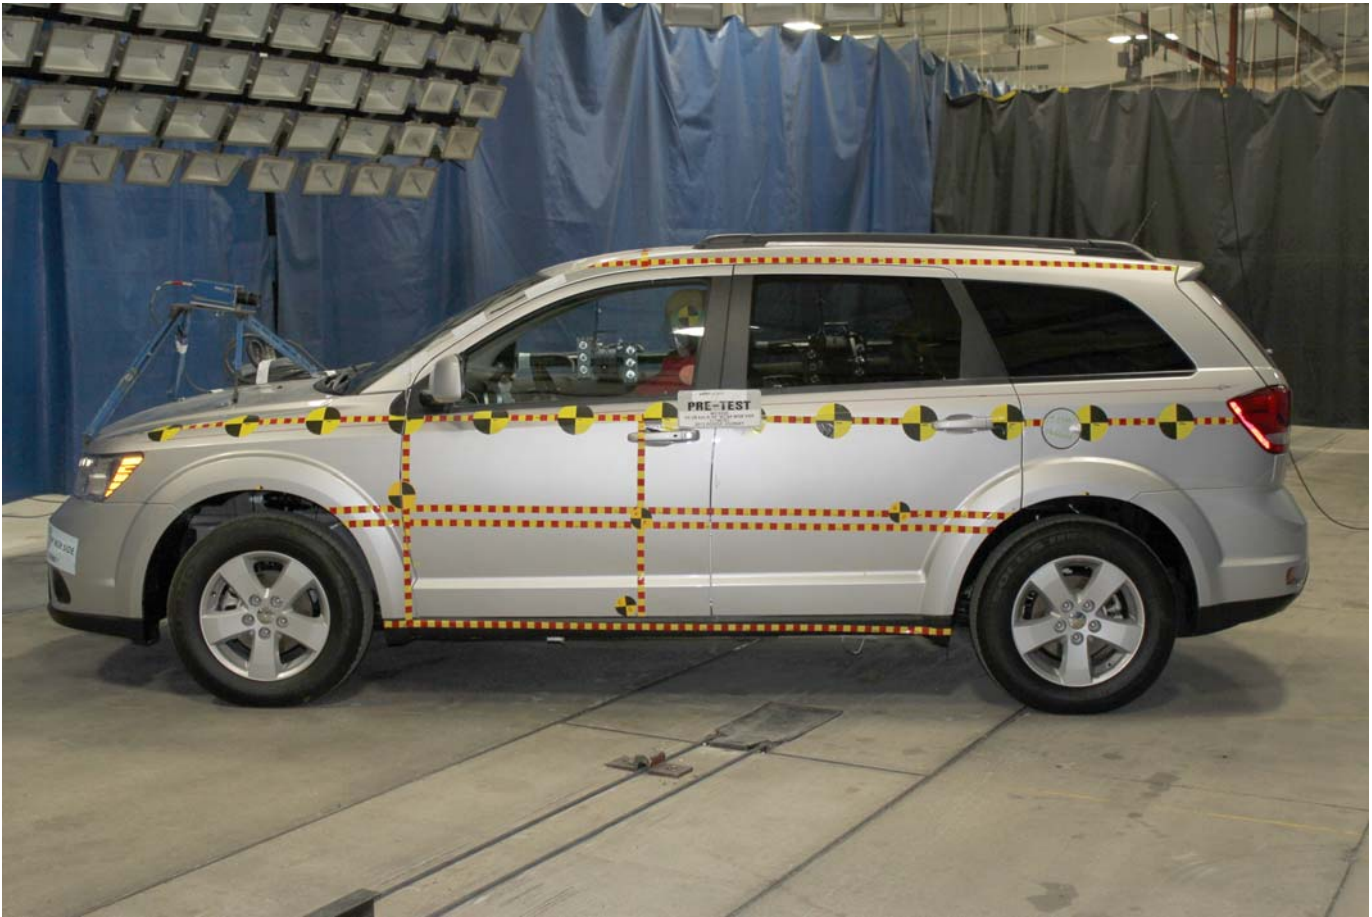
Pre-Test Left Side View of Test Vehicle

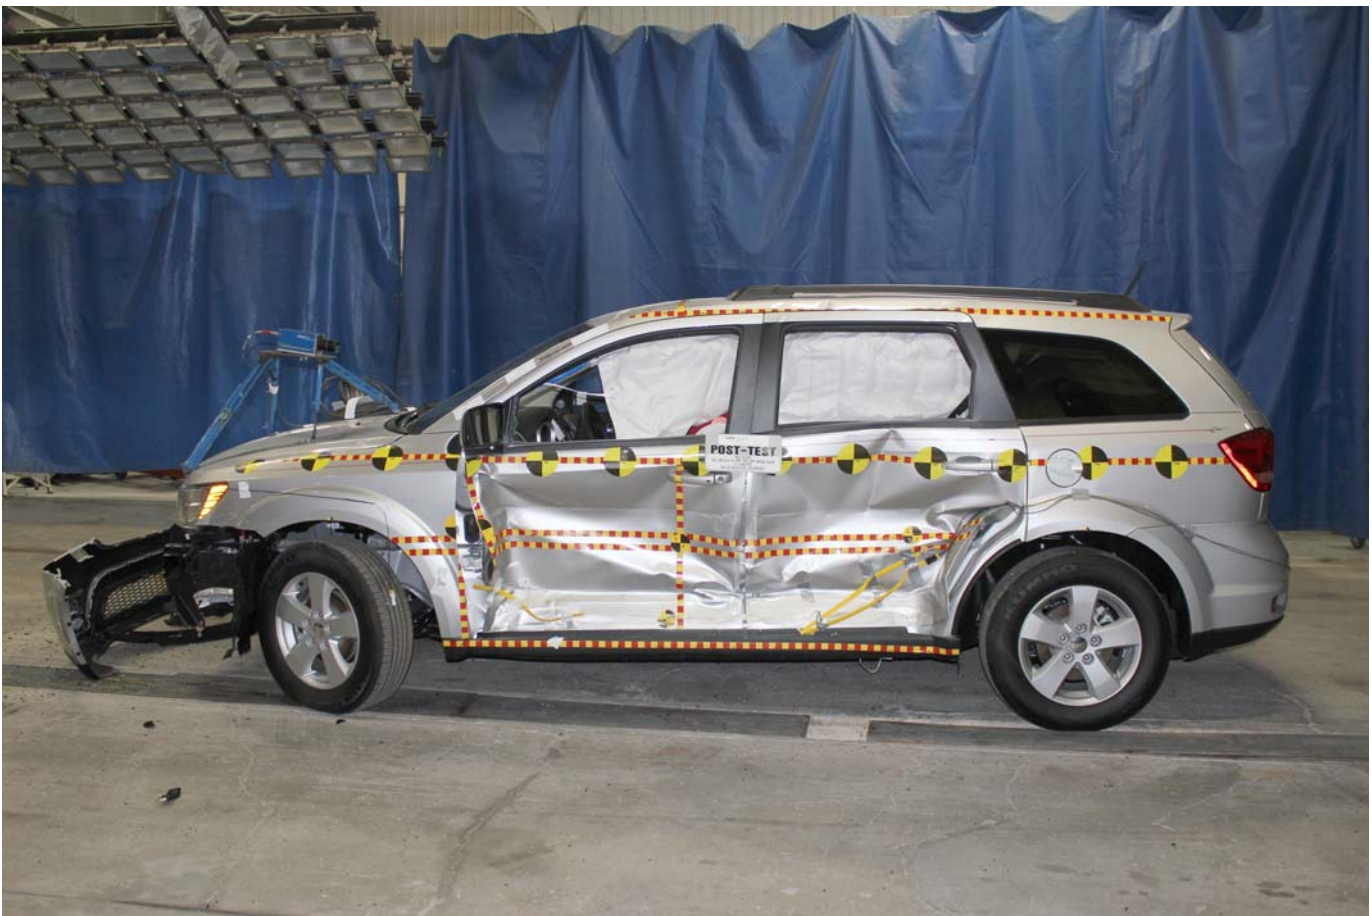
Post-Test Left Side View of Test Vehicle

Critical Areas of Performance	Observations and Conclusions
Pillar Performance	No Separation
Sill Separation	None
Windshield Damage	None
Side Window Damage	Left Front and Left Rear Window Broke
Other Notable Effects	None

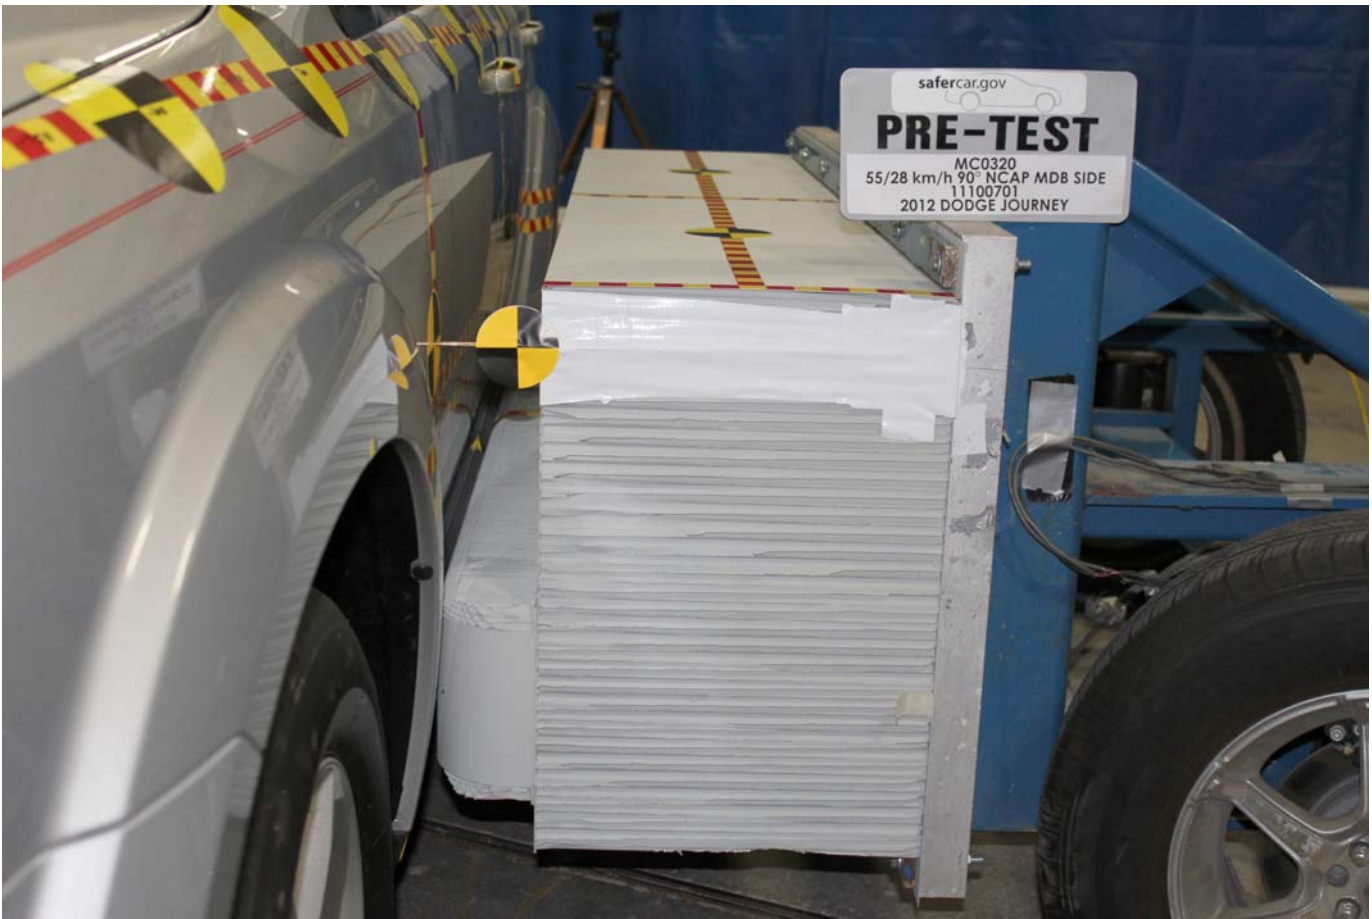
Pre-Test Left Side View of MDB Positioned Against Side of Test Vehicle

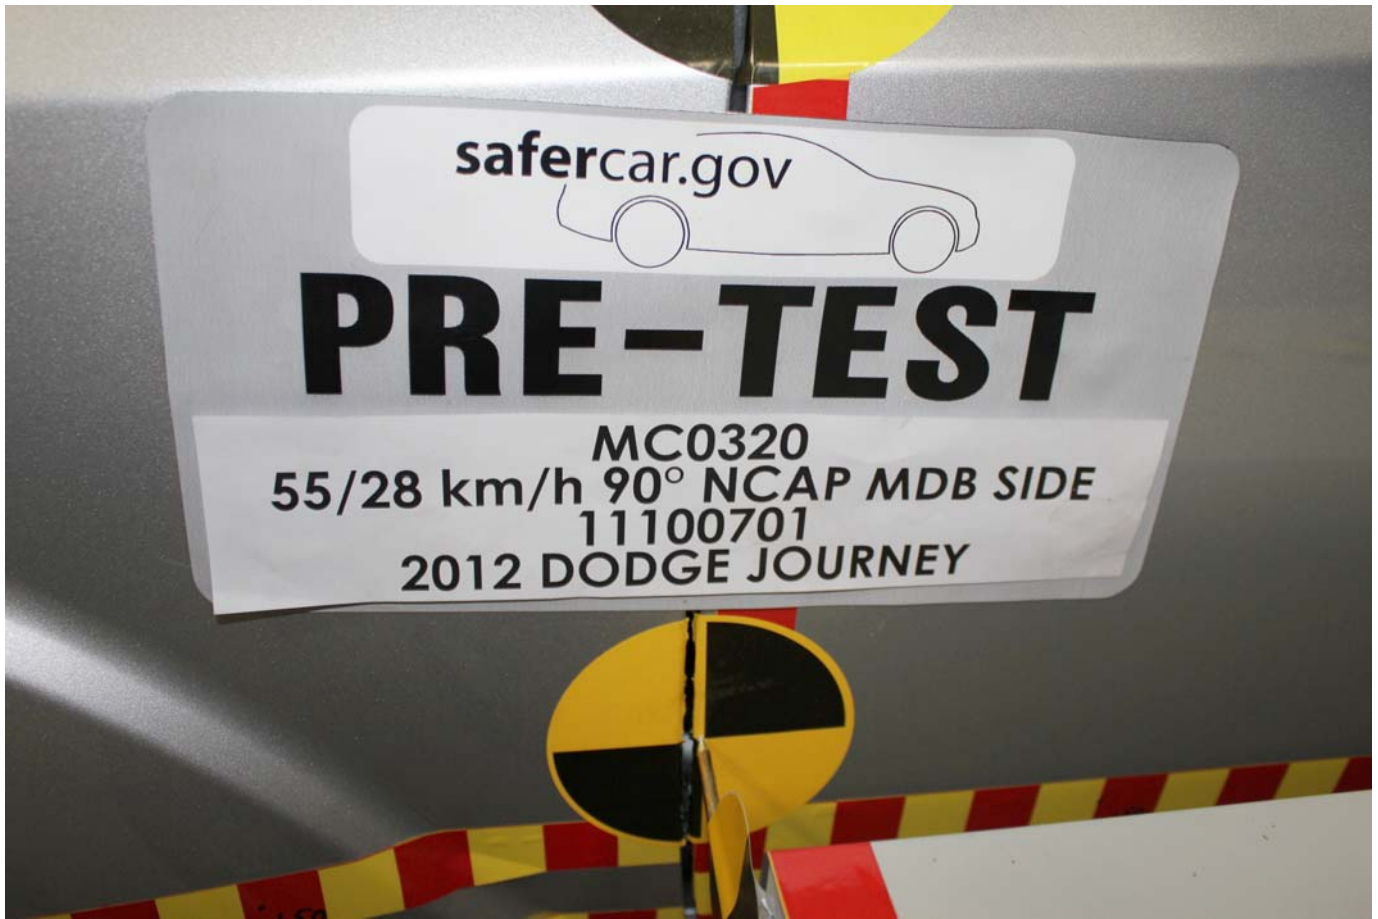
Pre-Test Close-Up View of Impact Point Target

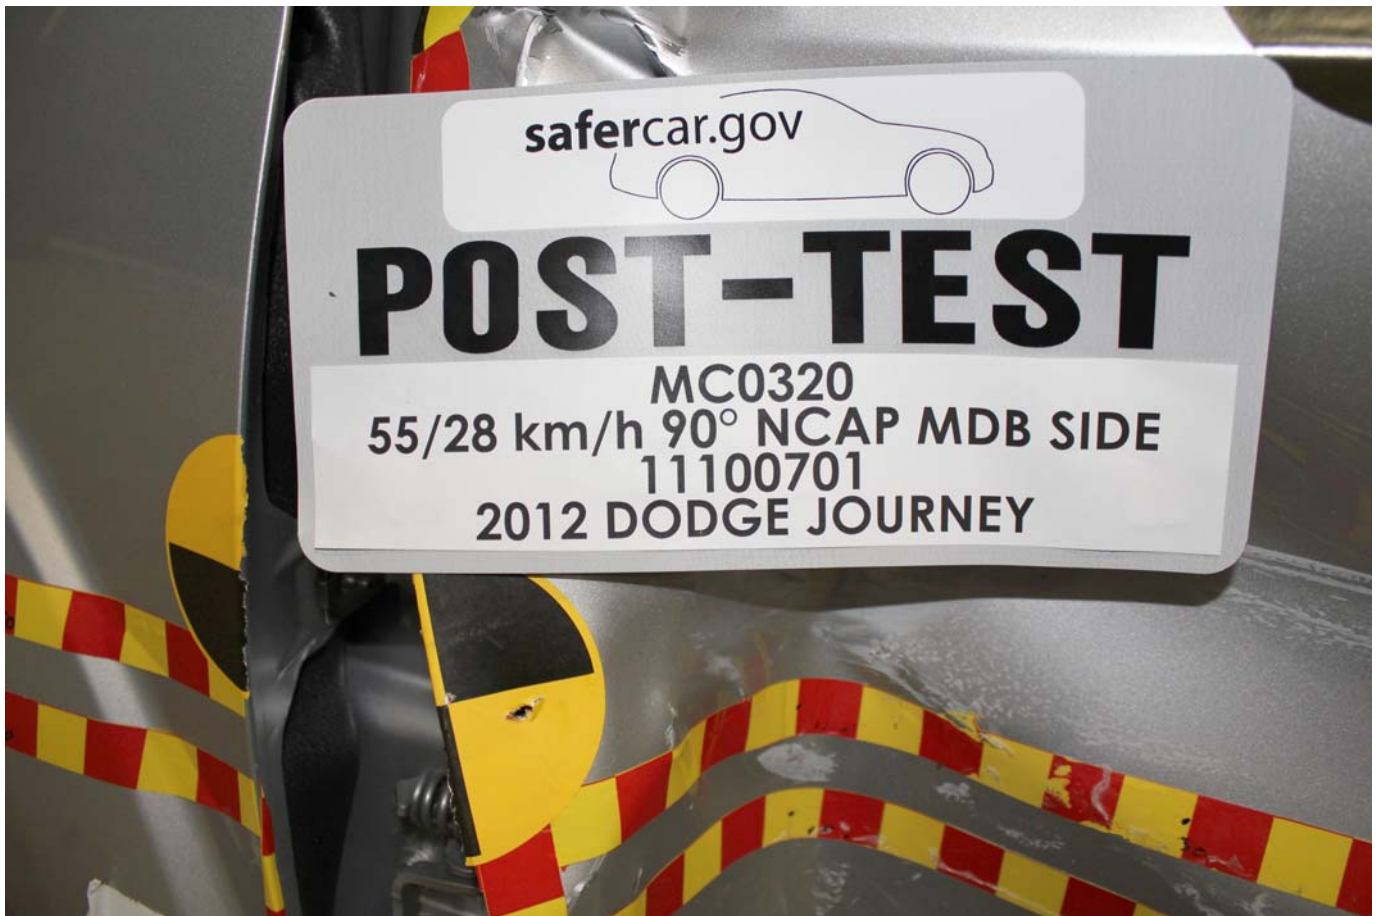
Post-Test Close-Up View of Impact Point Target

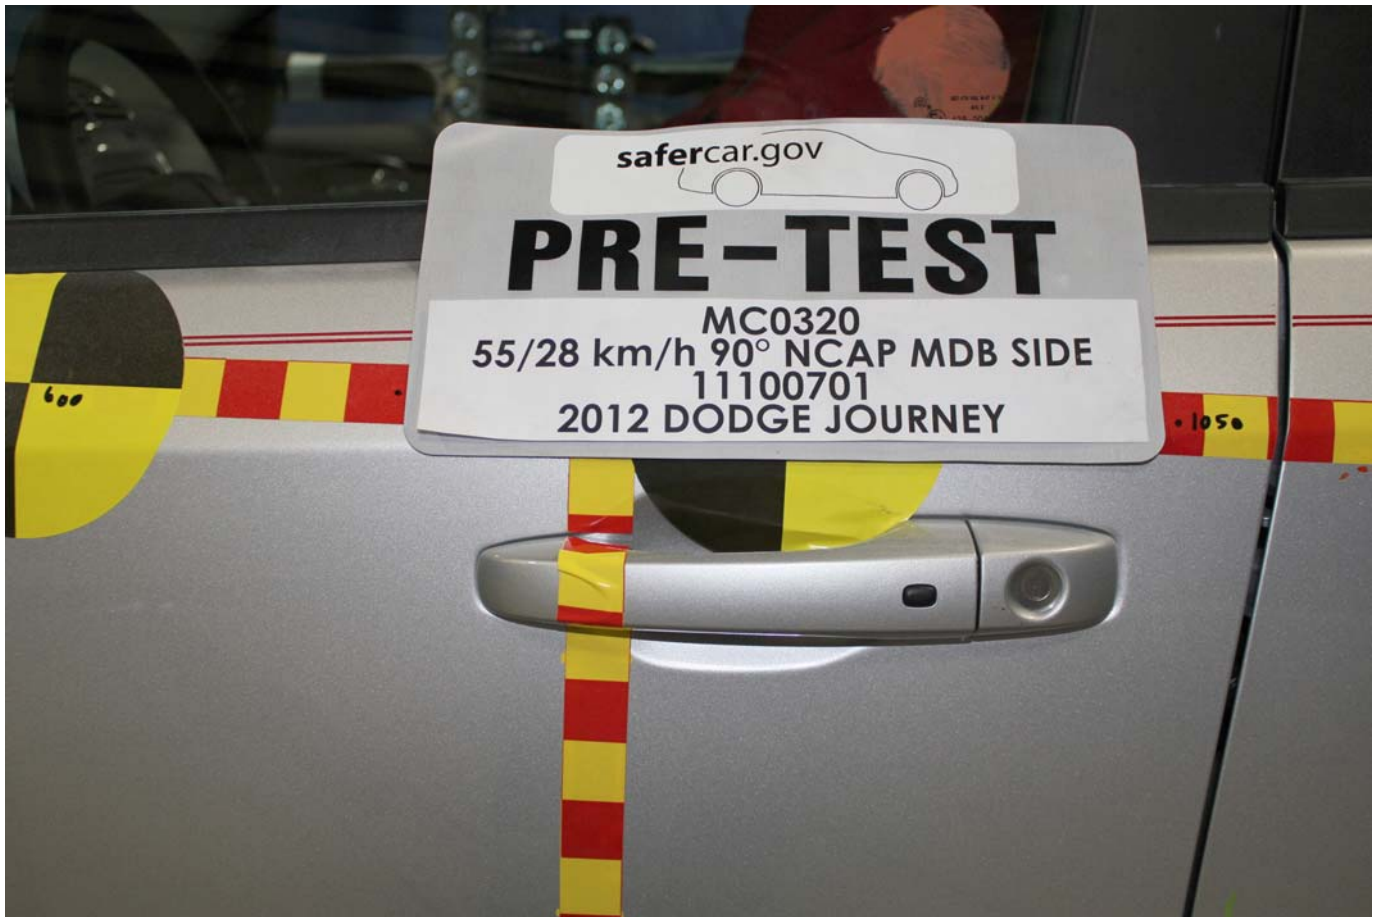
Pre-Test Left Front Door Latch Close-Up

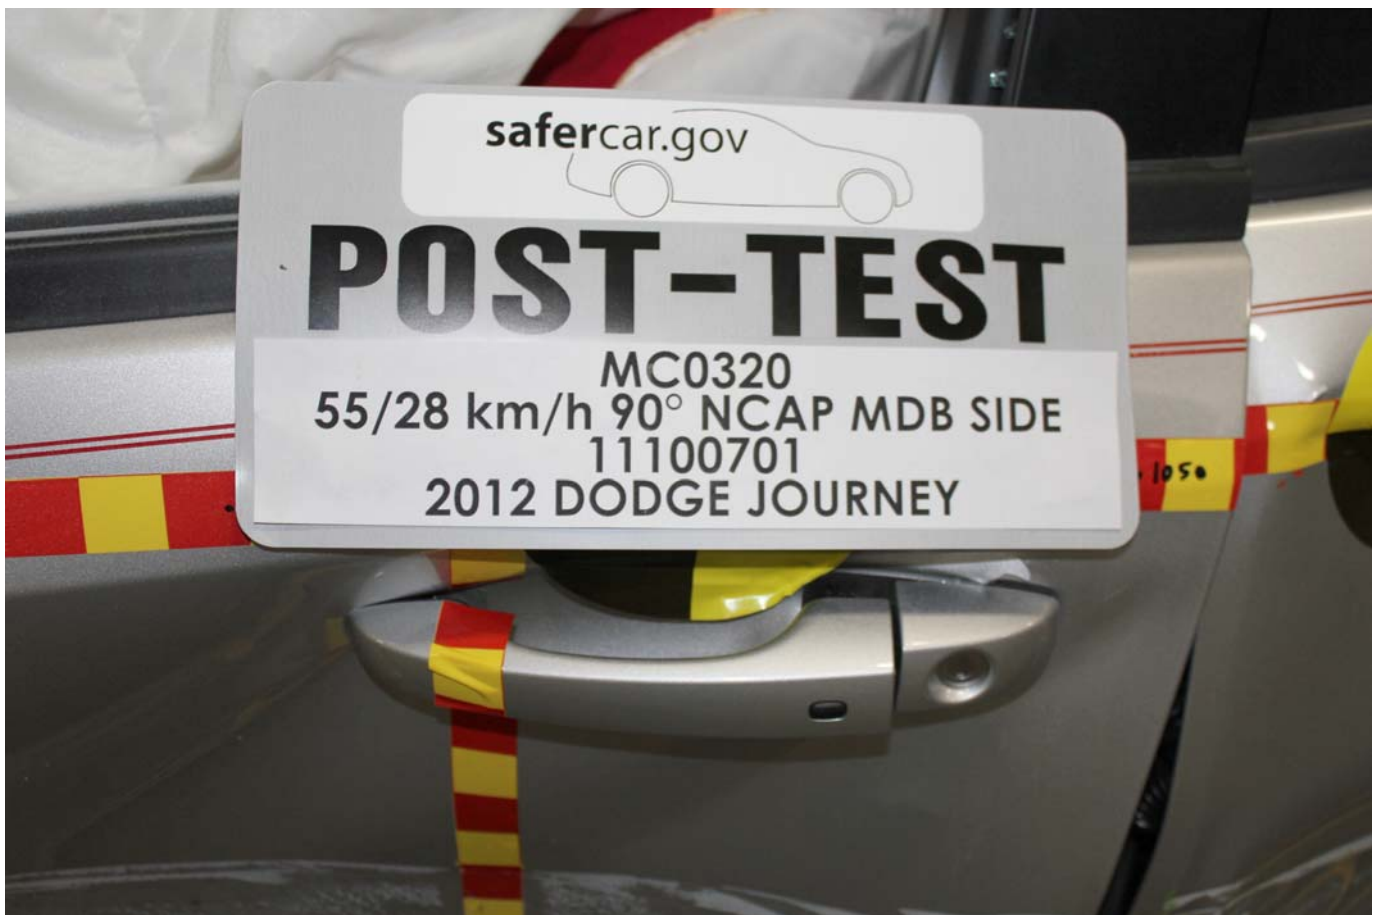
Post-Test Left Front Door Latch Close-Up

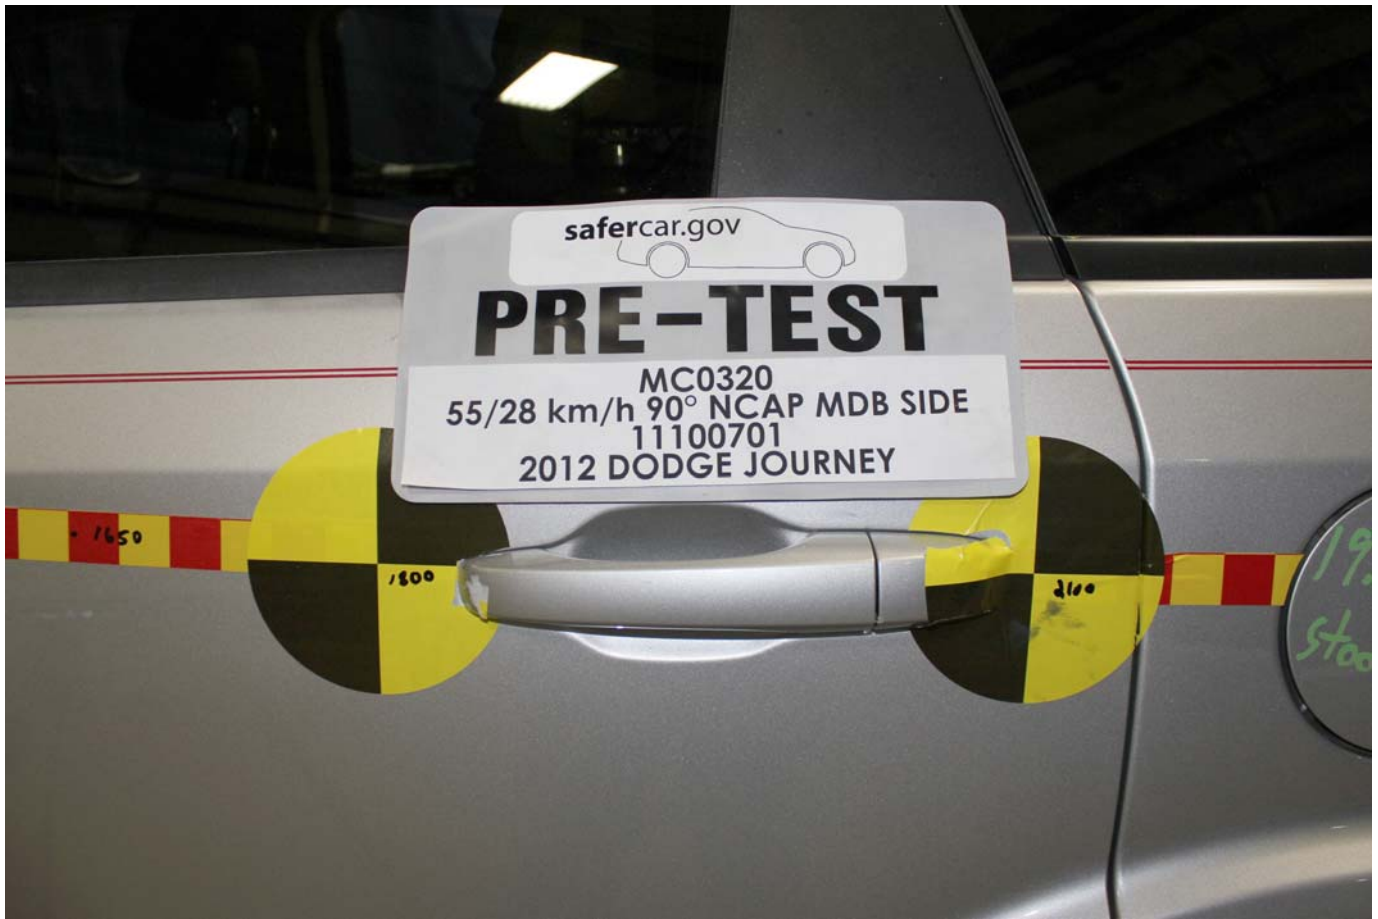
Pre-Test Left Rear Door Latch Close-Up

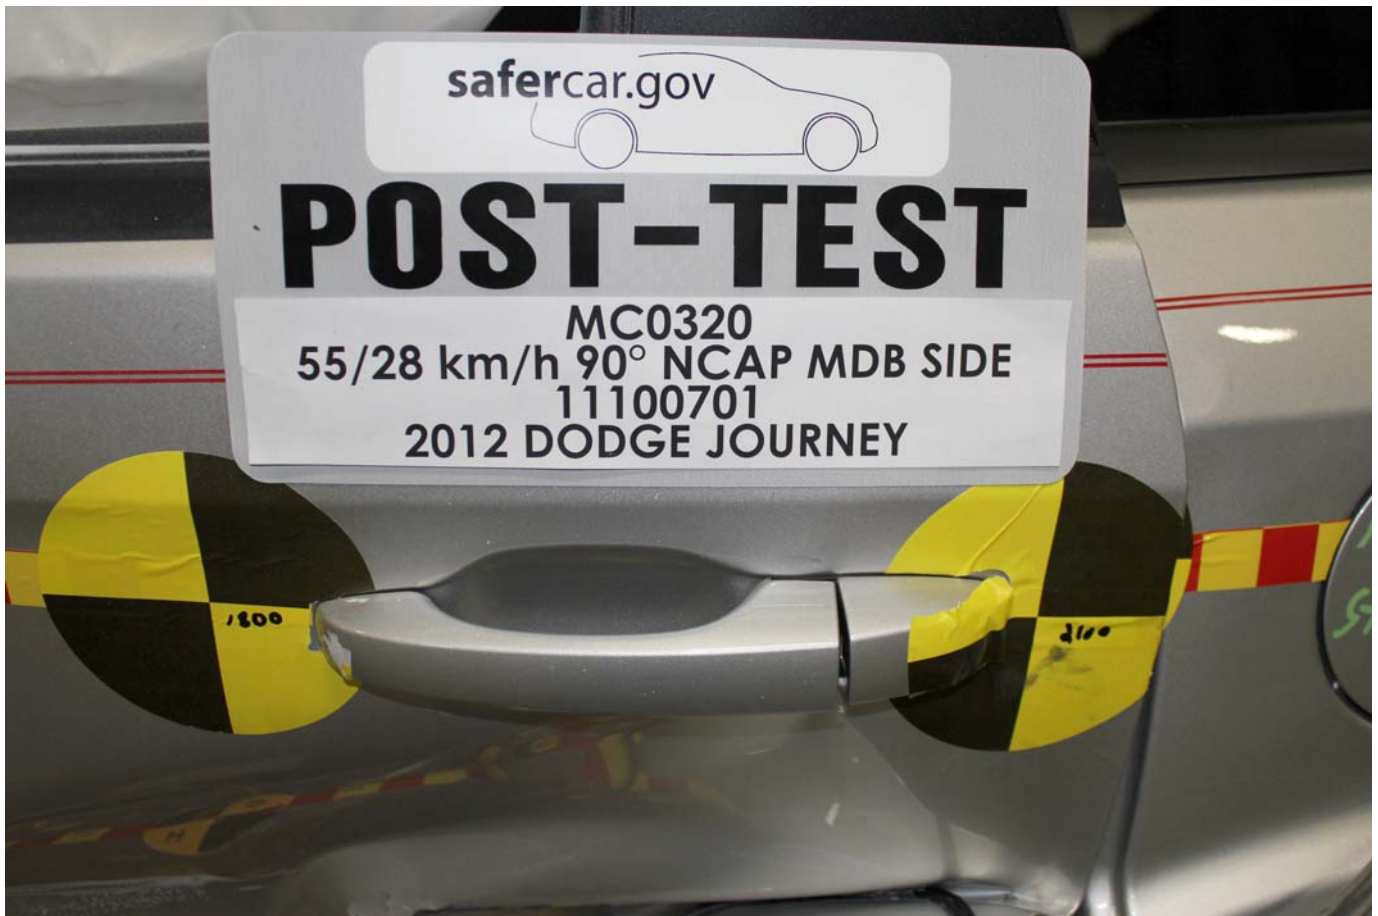
Post-Test Left Rear Door Latch Close-Up

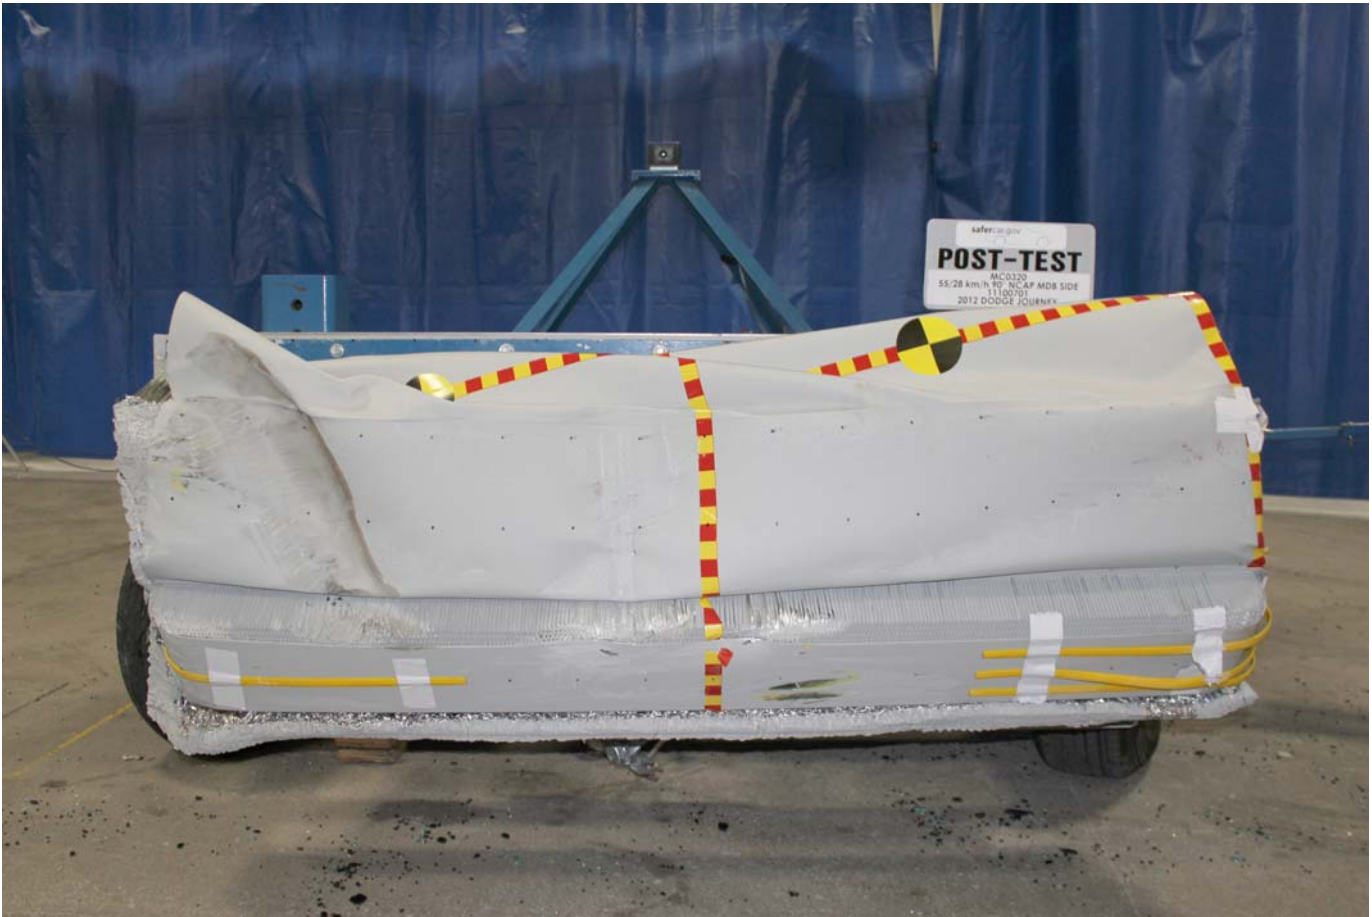
Post-Test Front View of MDB Impactor Face

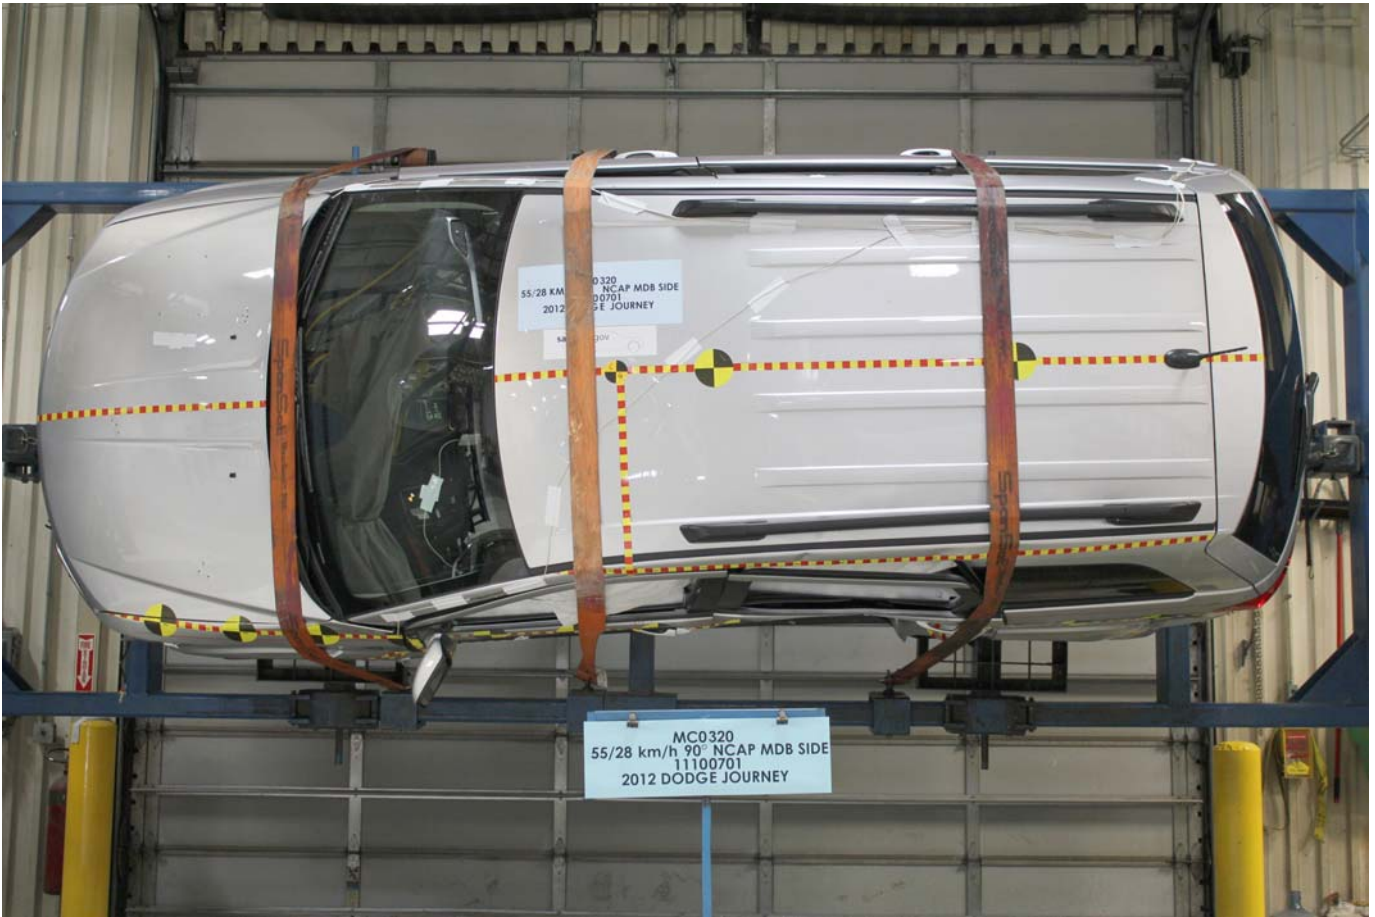
FMVSS No. 301 Static Rollover 90 Degrees

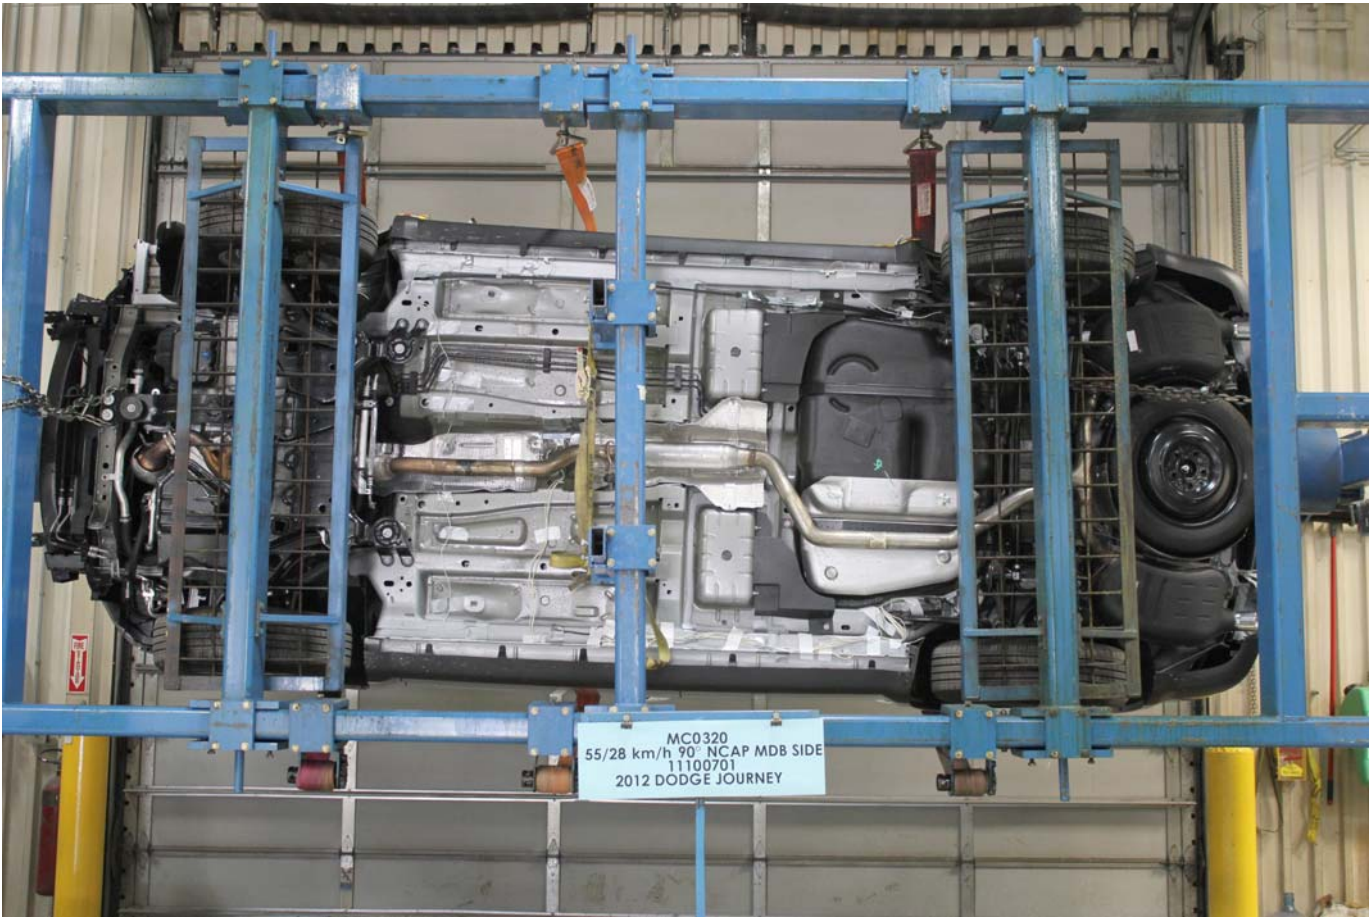
FMVSS No. 301 Static Rollover 270 Degrees

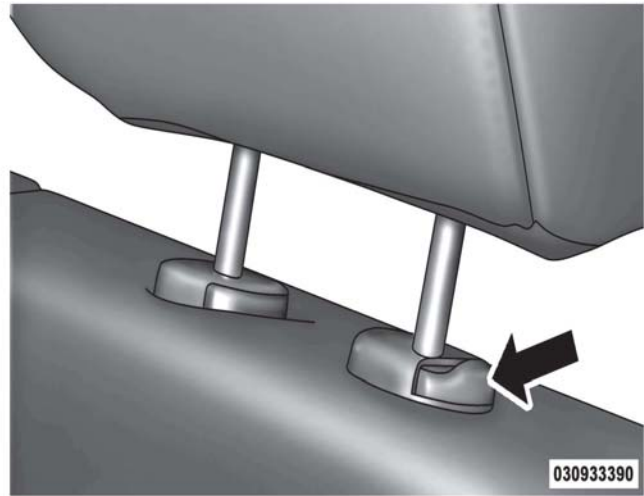
Adjustment Button

Head Restraints — Second Row Seats
