**REPORT NUMBER: SINCAP-MGA-2012-014**

**NEW CAR ASSESSMENT PROGRAM (NCAP)  
Moving Deformable Barrier Side Impact Test**

**VOLKSWAGEN GROUP OF AMERICA  
2012 Volkswagen Passat S 4-Dr Sedan  
NHTSA No.: VC5801**

**FINAL REPORT**

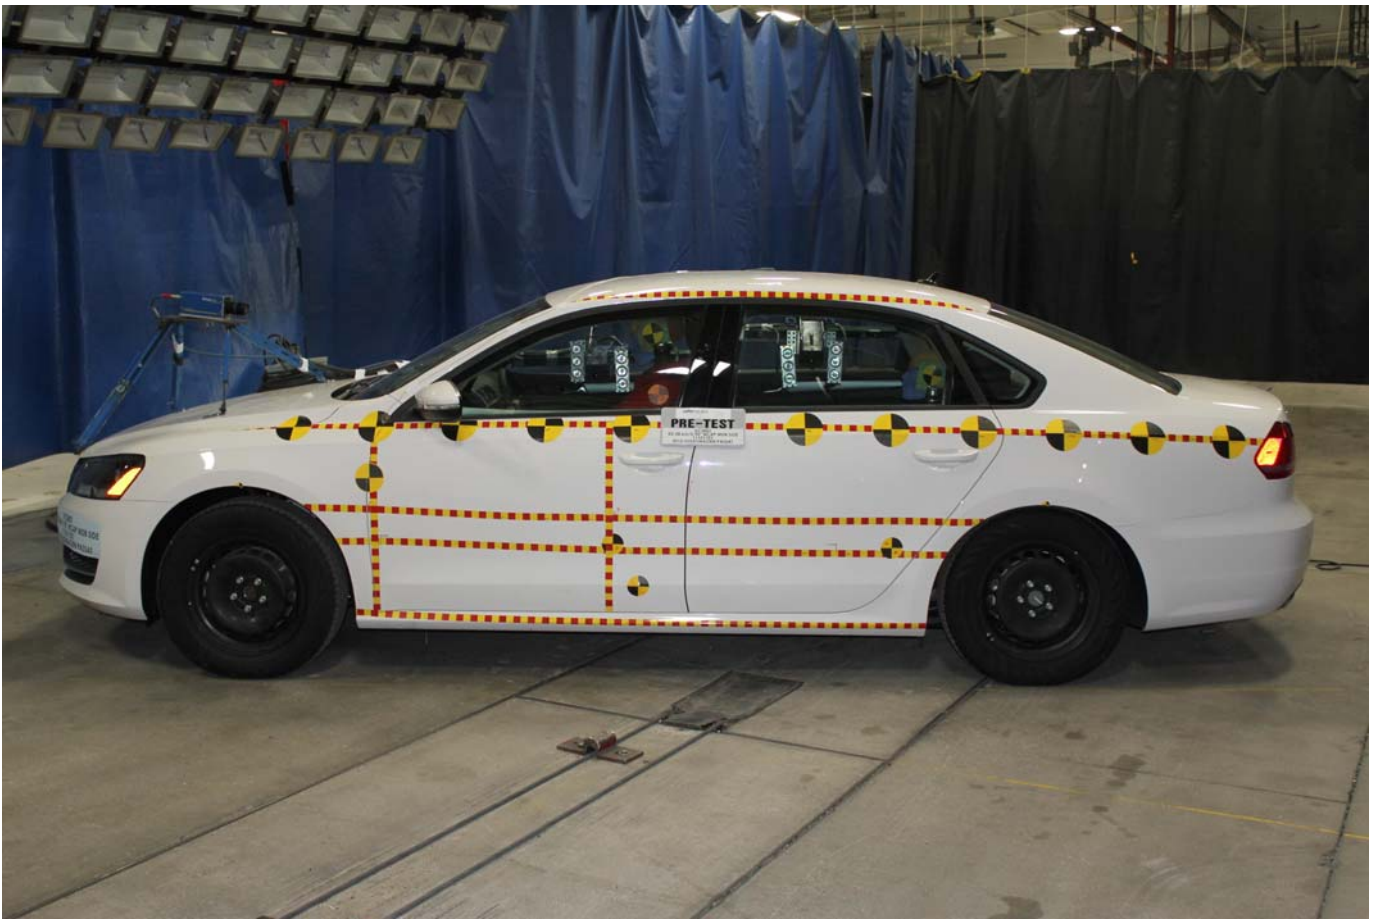
Pre-Test Left Side View of Test Vehicle

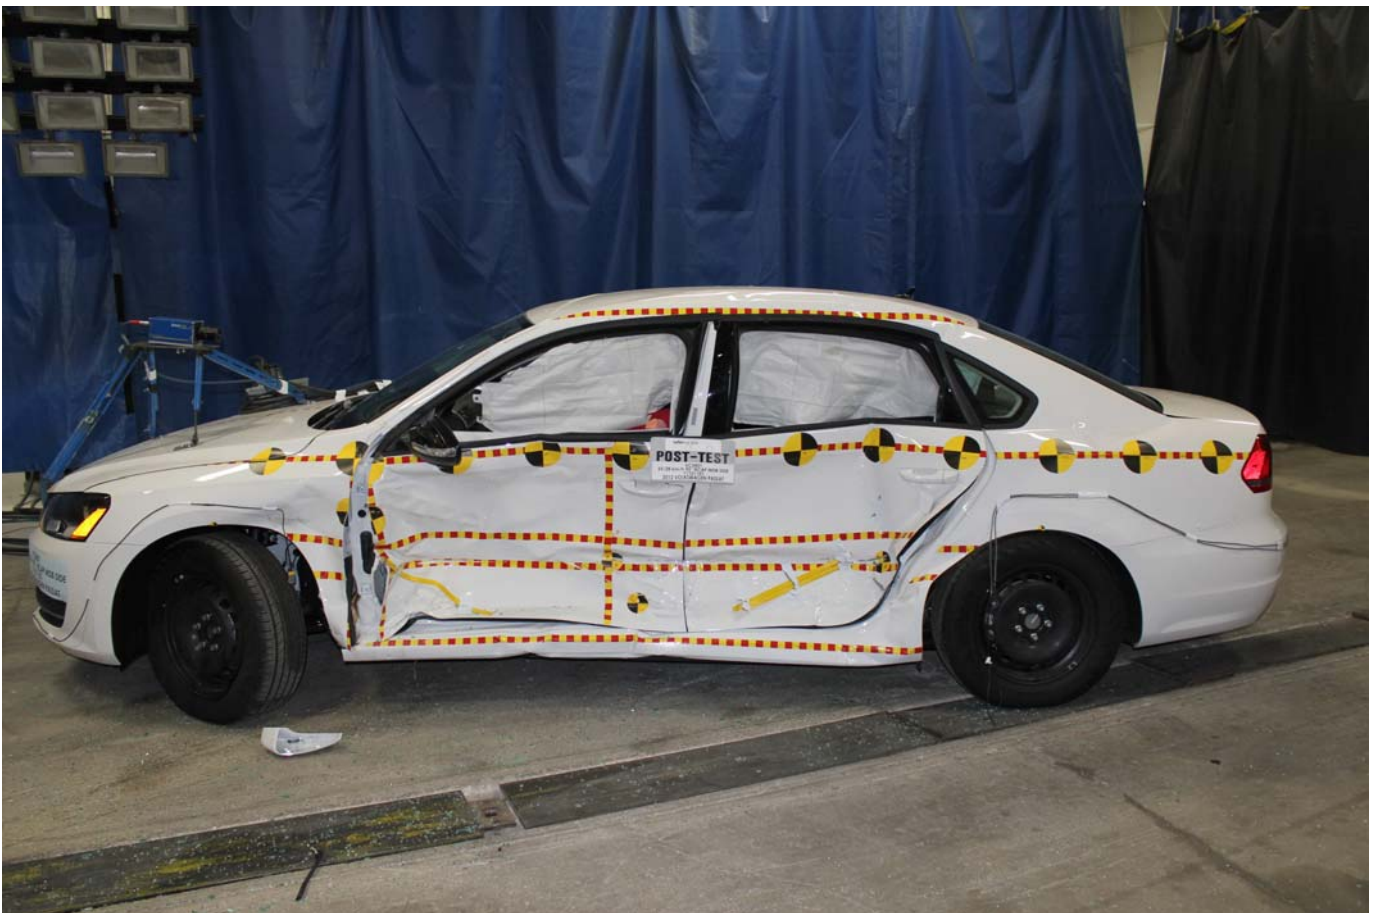
Post-Test Left Side View of Test Vehicle

| Critical Areas of Performance | Observations and Conclusions |
|---|---|
| Side Window Damage | Left Front and Left Rear Windows Broke |

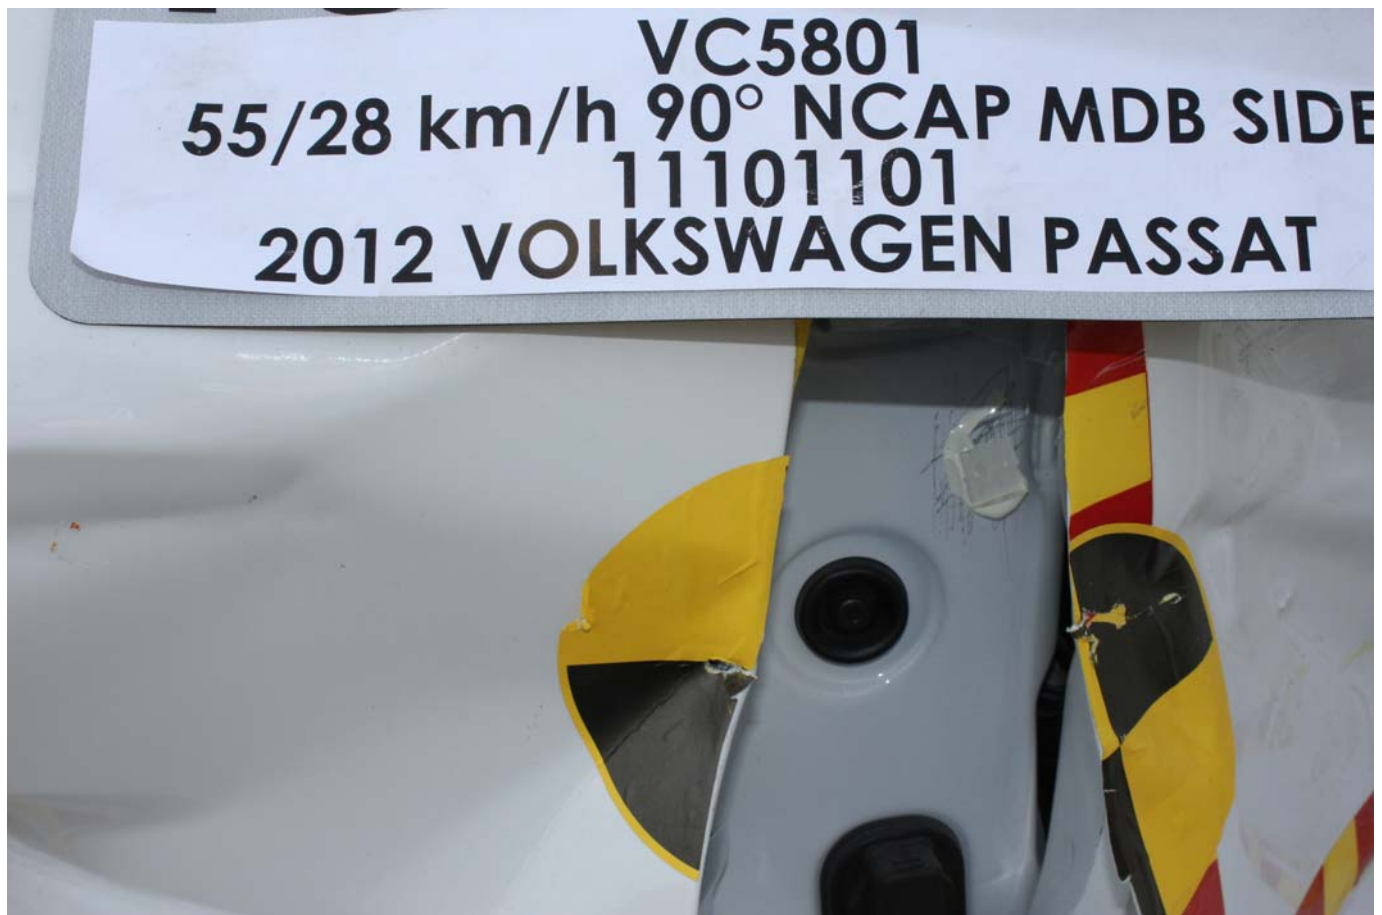
Post-Test Close-Up View of Impact Point Target

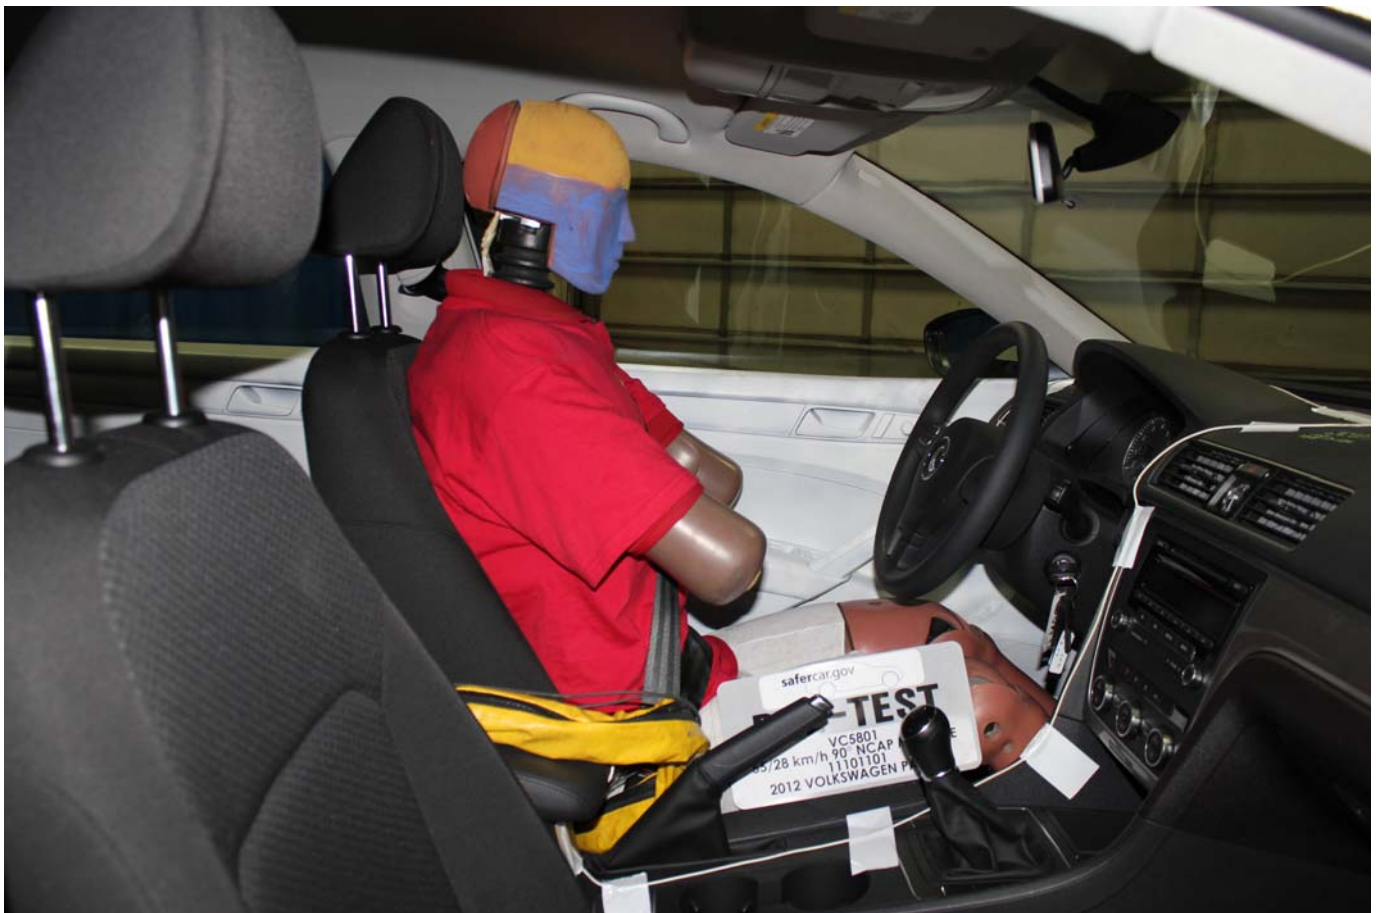
Post-Test Driver Dummy and Door Clearance View

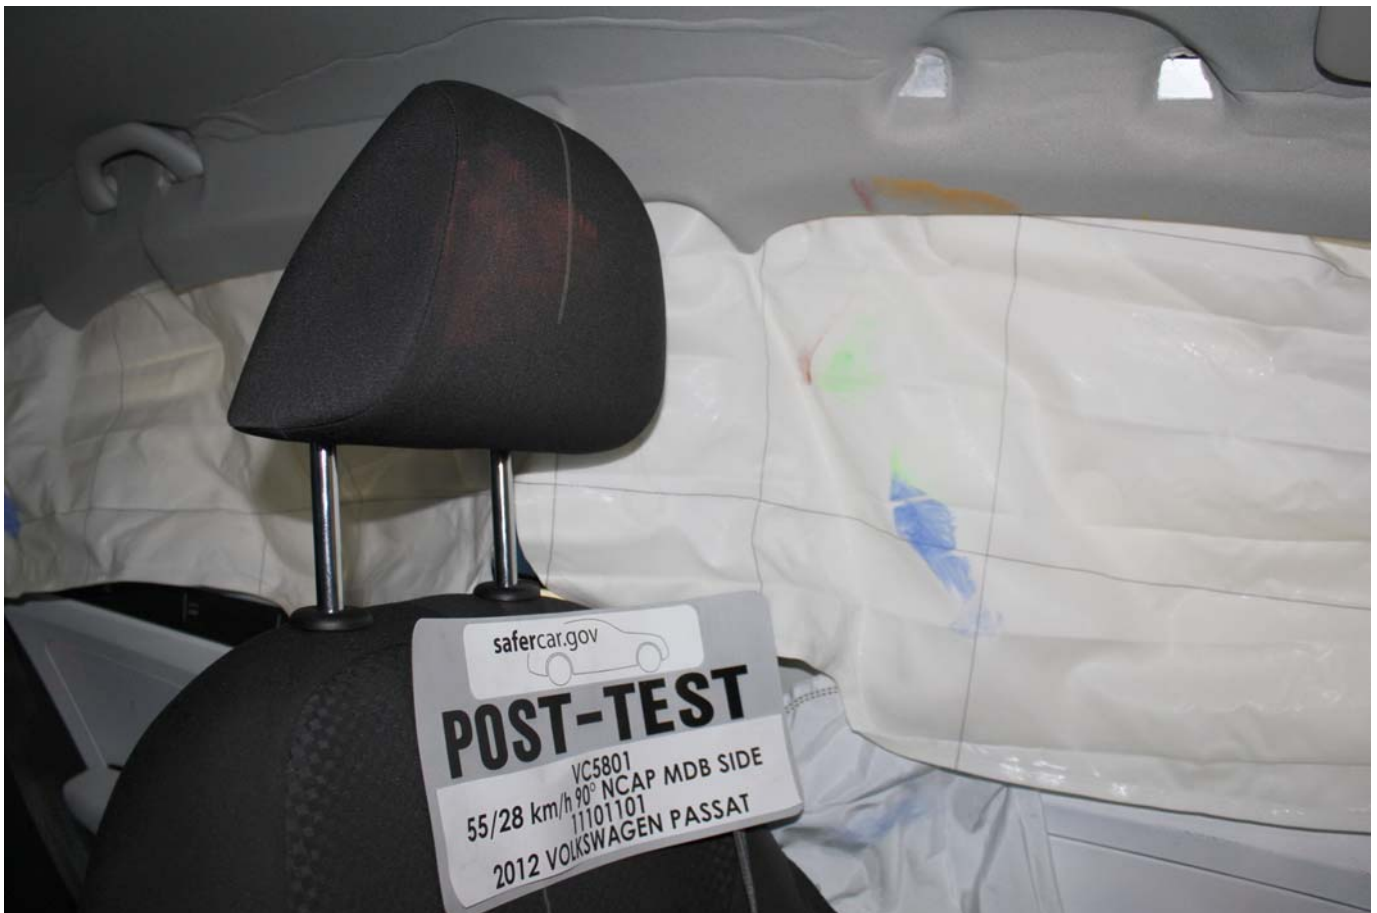
Post-Test Driver Dummy Close-up Head Contact with Vehicle Interior View

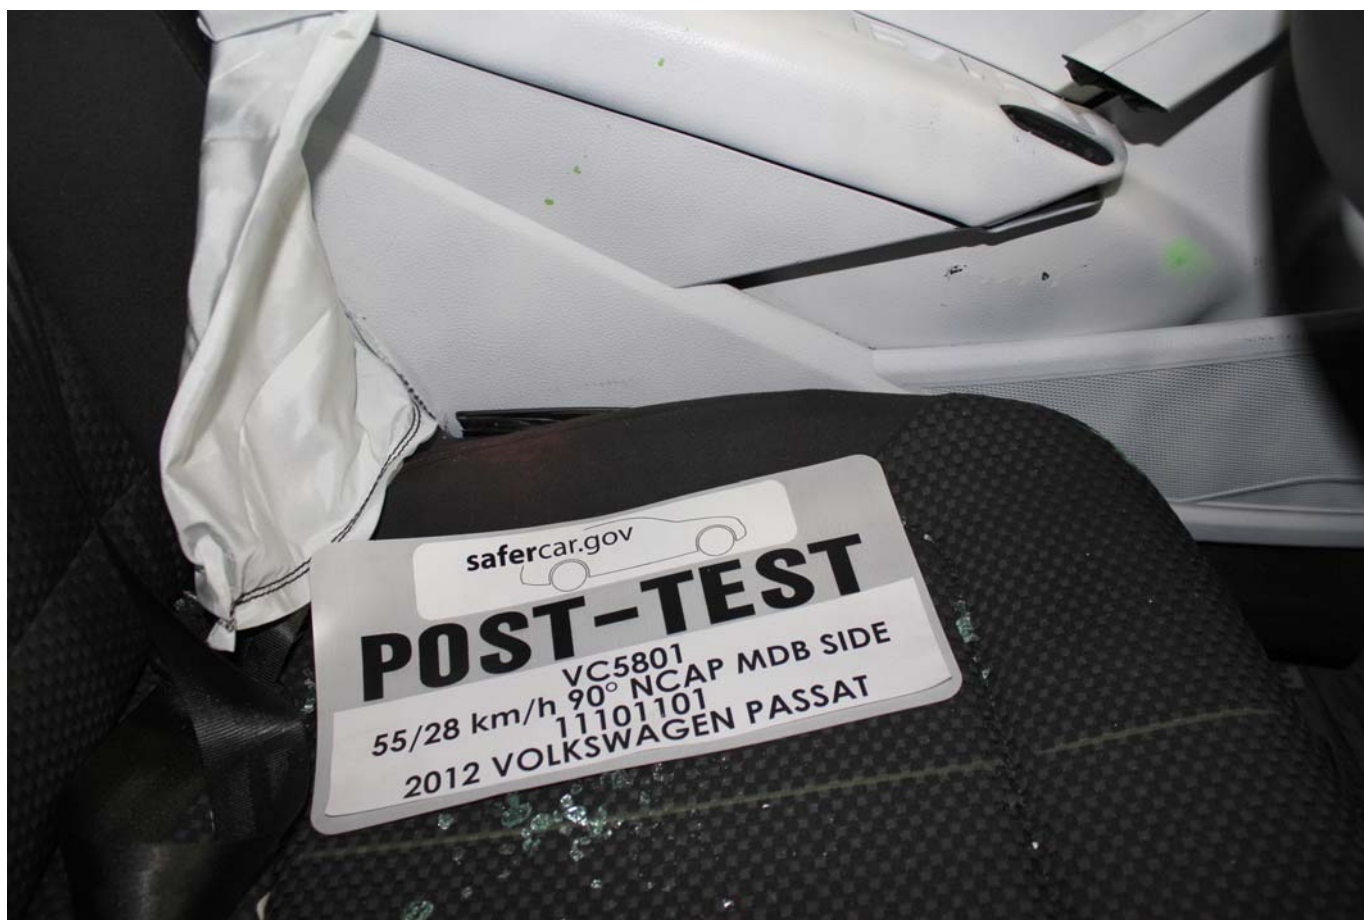
Post-Test Driver Dummy Close-up Pelvis Contact with Vehicle Interior View

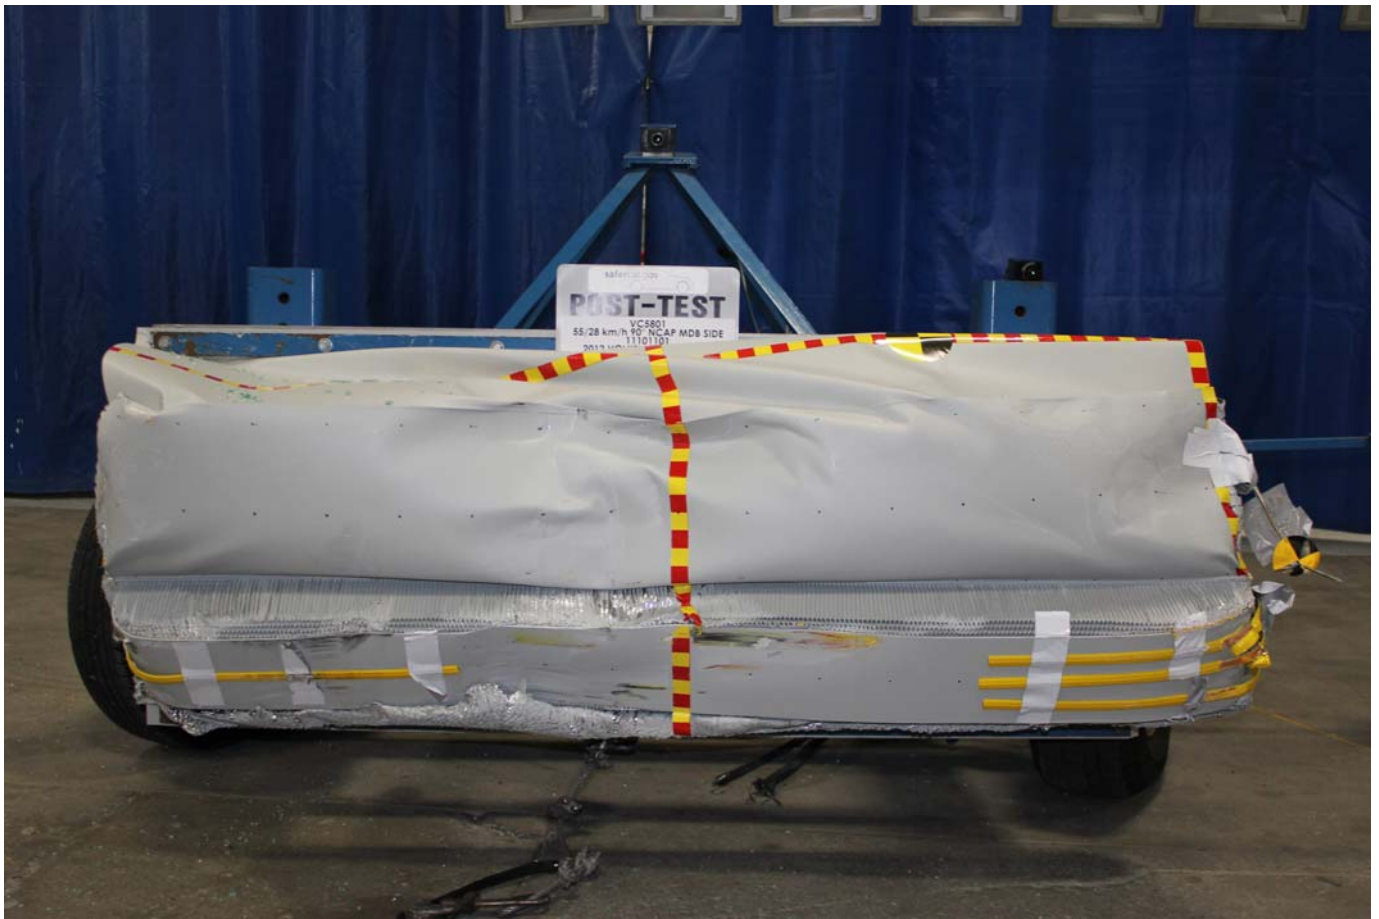
Post-Test Front View of MDB Impactor Face

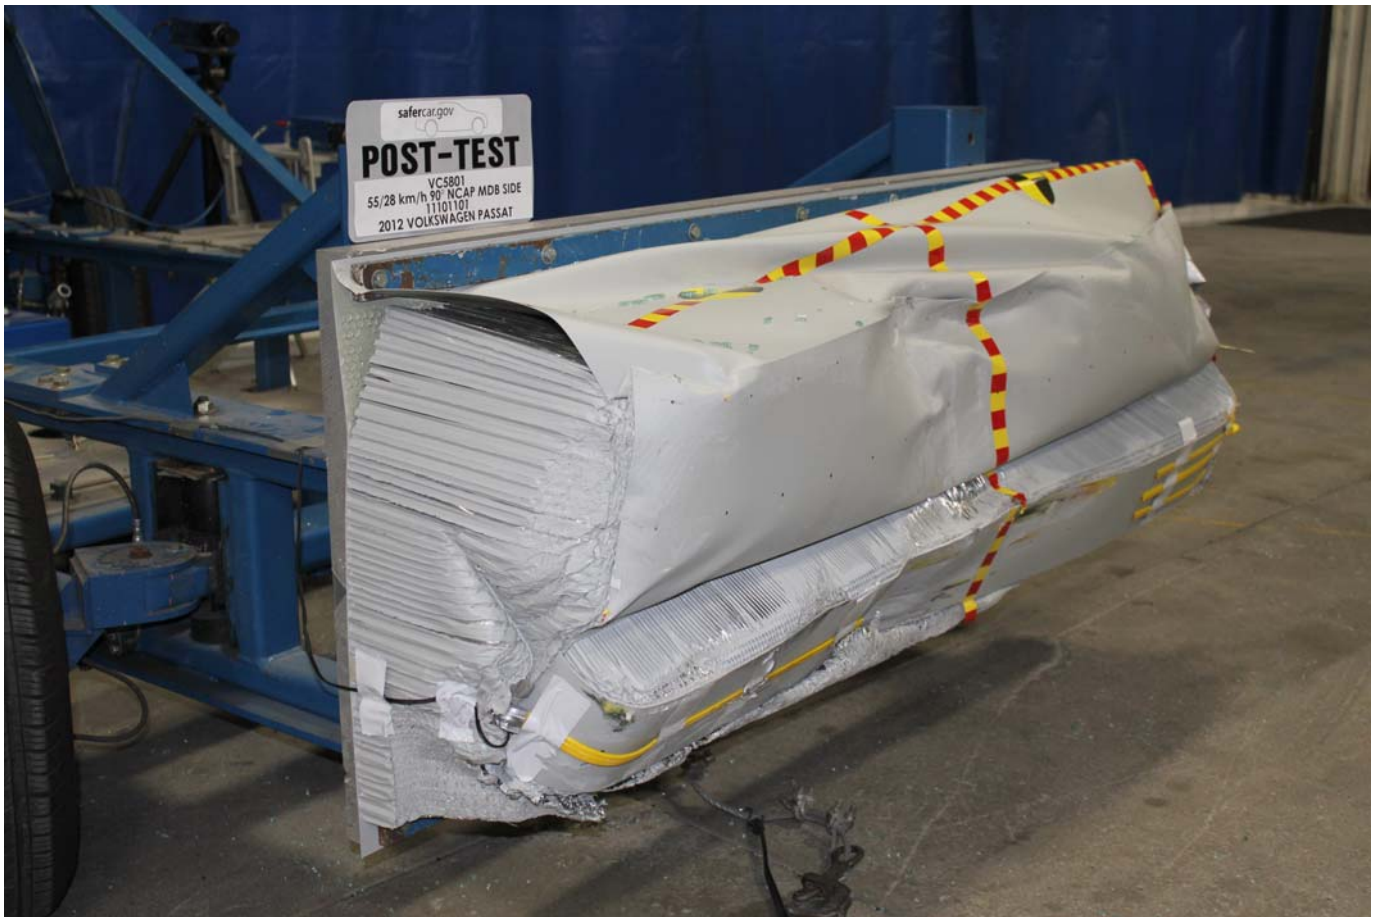
Pre-Test Right Side View of MDB Impactor Face

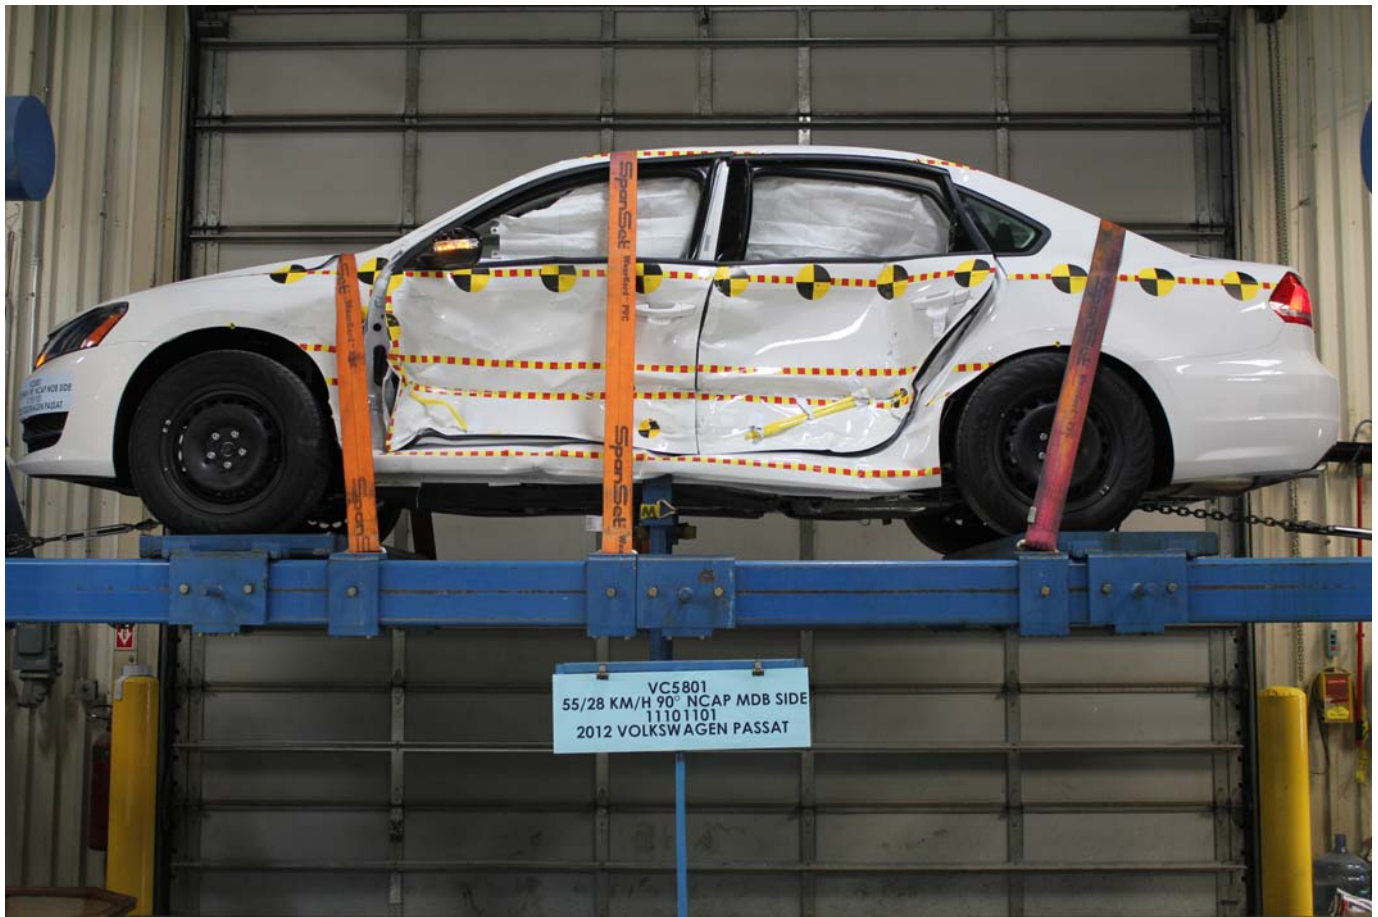
FMVSS No. 301 Static Rollover 0 Degrees

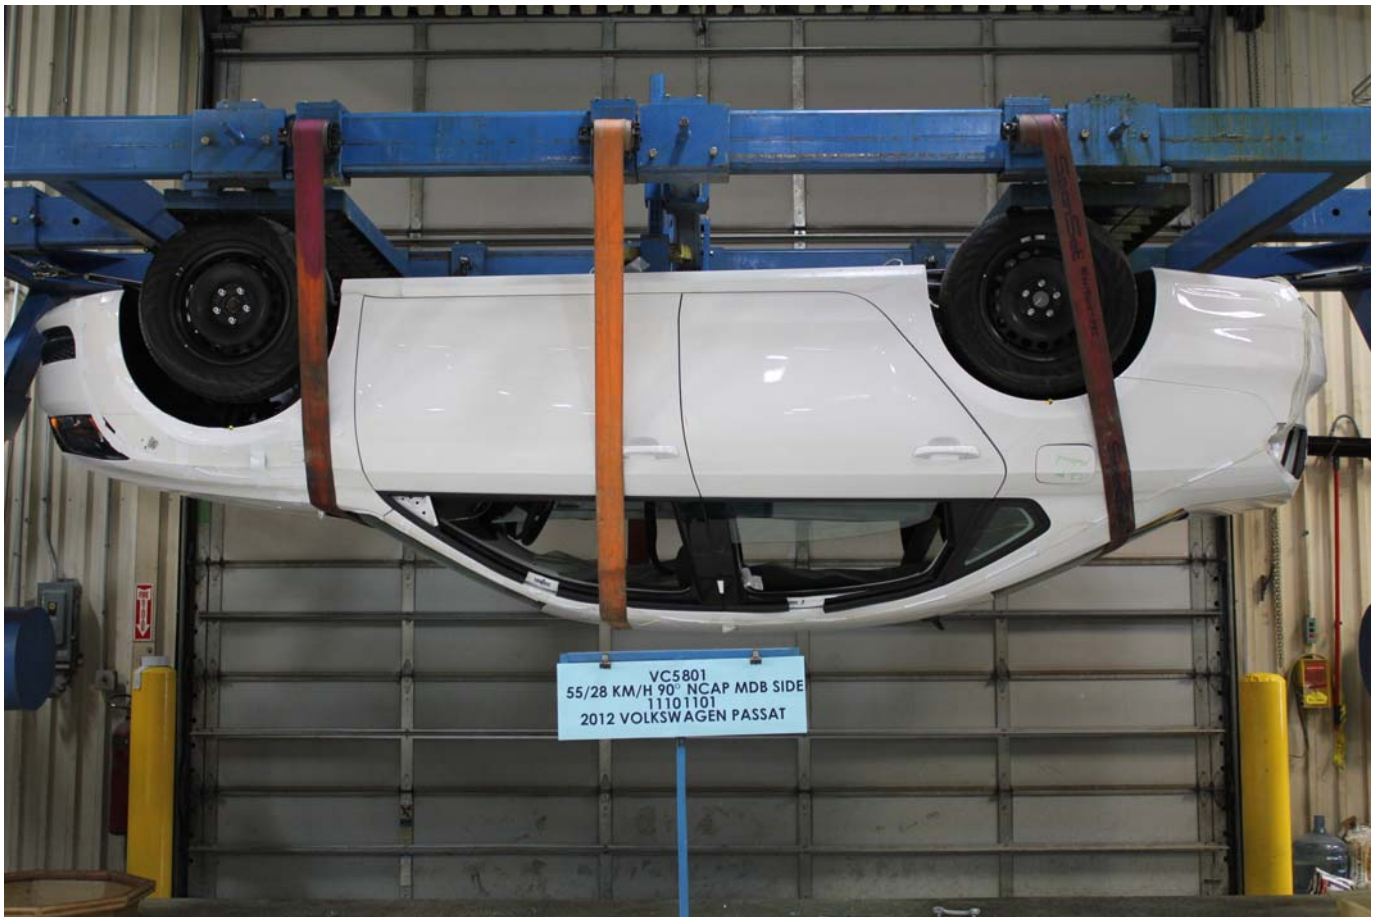
FMVSS No. 301 Static Rollover 180 Degrees
