**REPORT NUMBER: SPNCAP-KAR-12-010**

**NEW CAR ASSESSMENT PROGRAM (NCAP)  
SIDE IMPACT POLE TEST**

**HYUNDAI MOTOR COMPANY  
2012 HYUNDAI TUCSON GLS 5-DOOR MPV**

**FINAL REPORT**

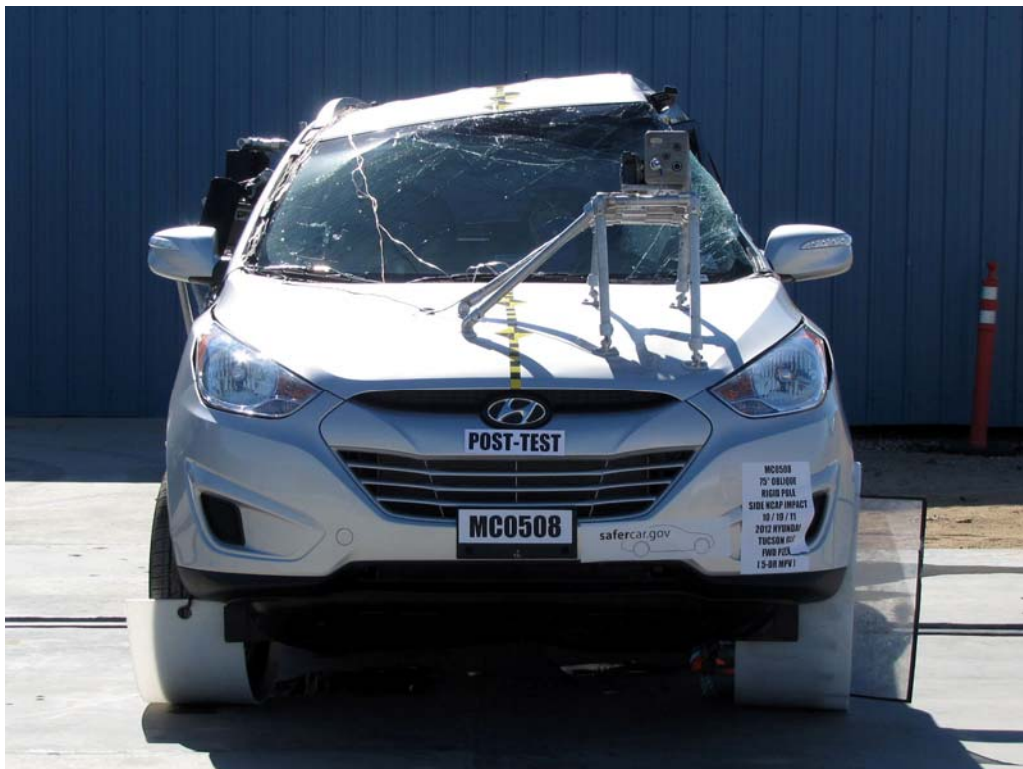
FIGURE 4. Post-Test Frontal View of Test Vehicle

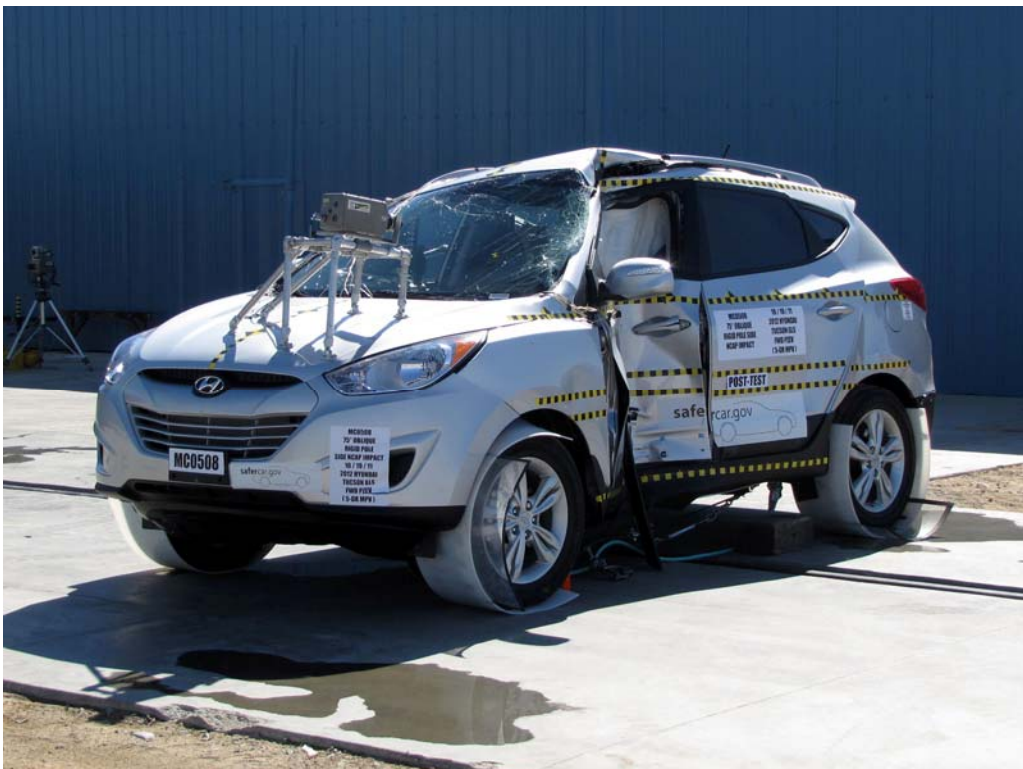
FIGURE 6. Post-Test Left Front Three-Quarter View of Test Vehicle

Both the front and rear doors on the struck side of the vehicle remained closed and latched. There was no separation at the hinges or latches. Both doors on the non-struck side remained closed and latched. There were no ATD values that exceeded limits.

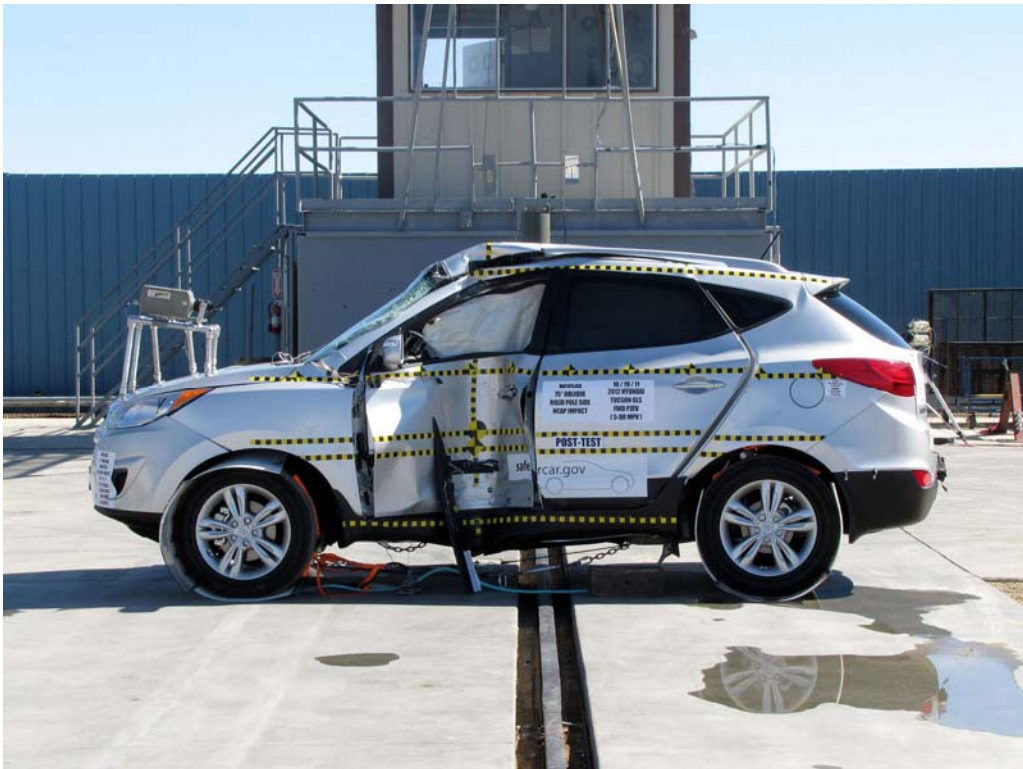
FIGURE 8. Post-Test Left Side View of Test Vehicle

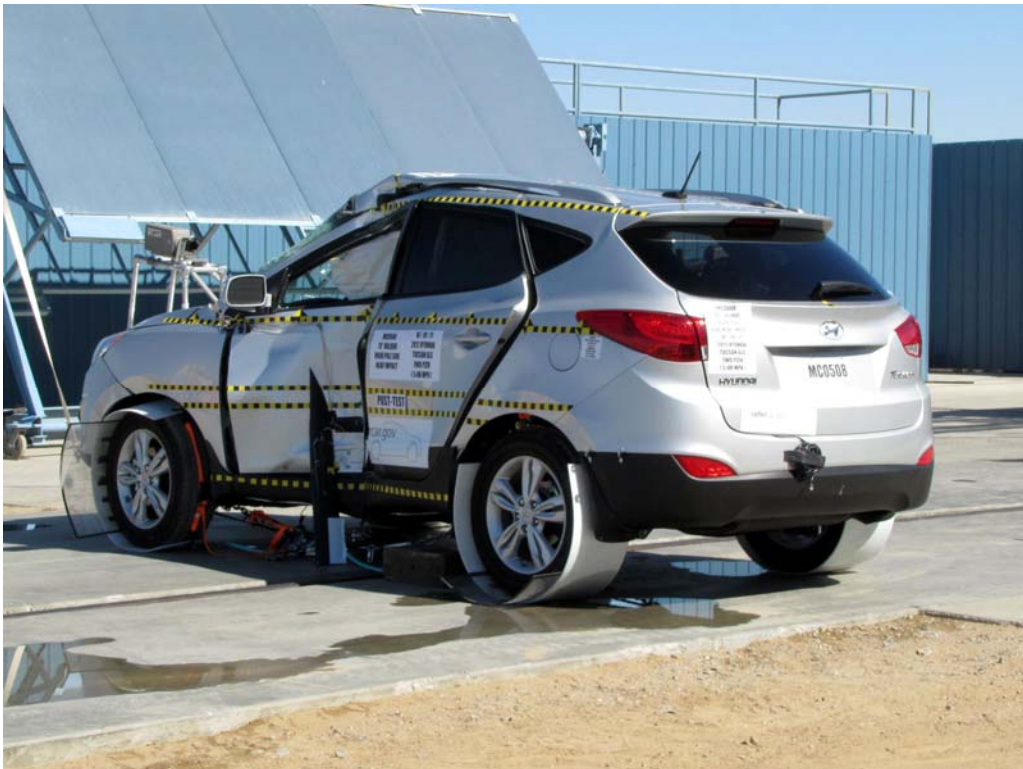
FIGURE 10. Post-Test Left Rear Three-Quarter View of Test Vehicle

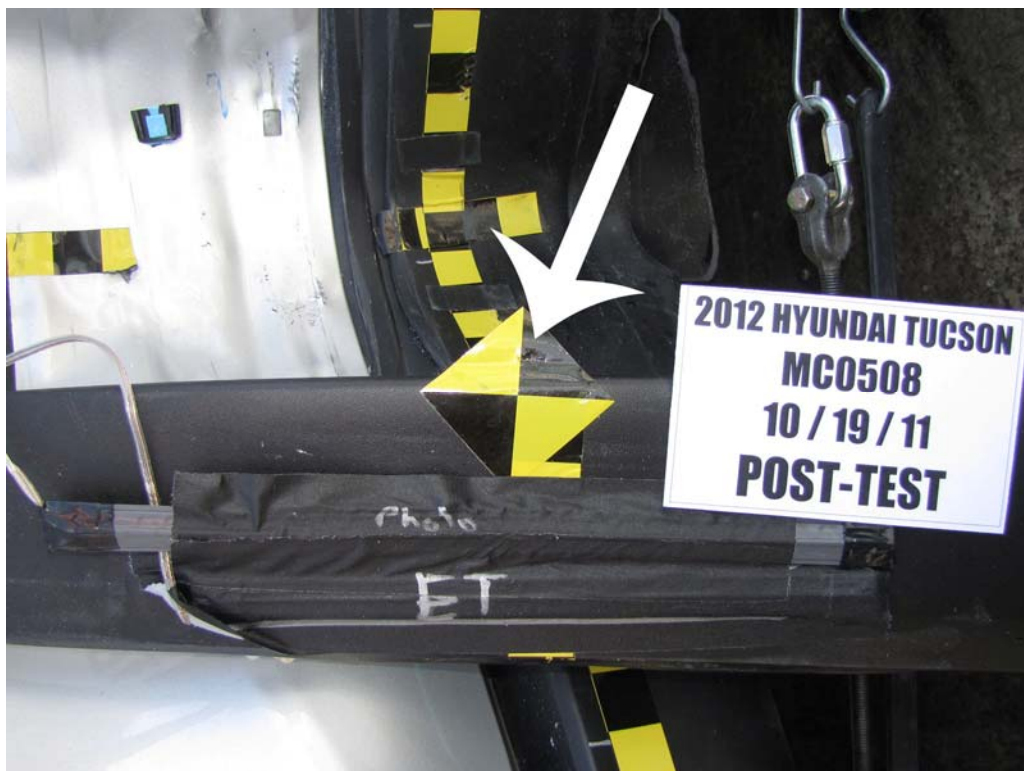
FIGURE 20. Post-Test Close-Up View of Impact Point Target Showing Impact Location

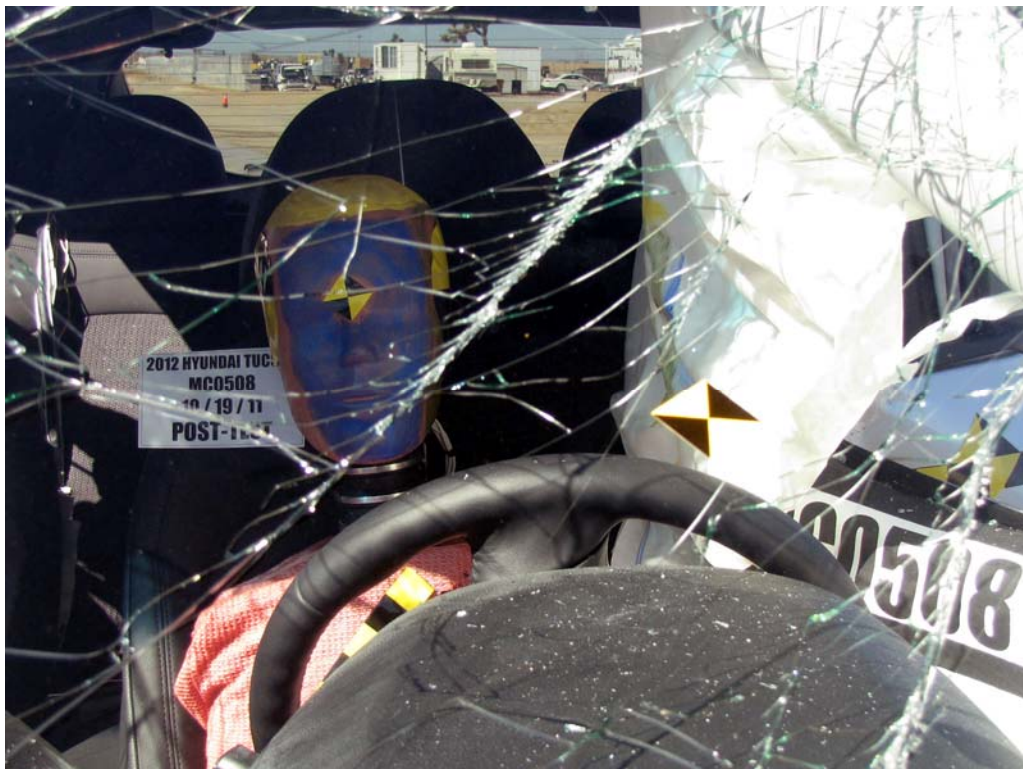
FIGURE 22. Post-Test Front Close-Up View of Dummy

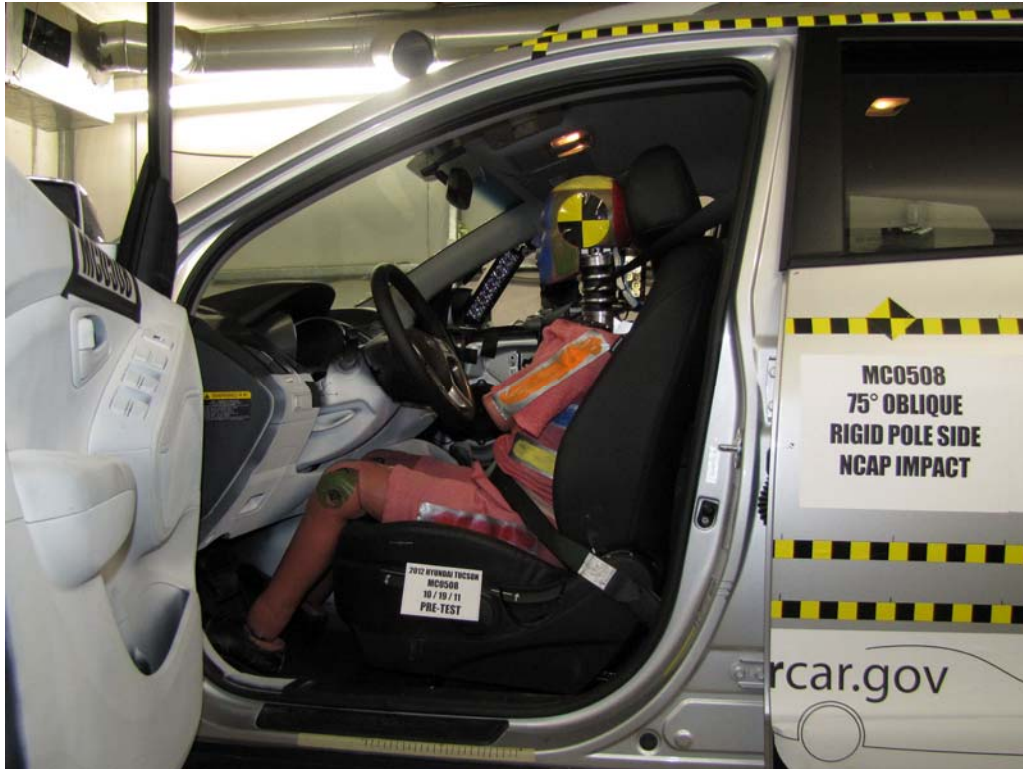
FIGURE 23. Pre-Test Left Side View of Dummy Showing Belt, Chalking, and Contact Switches

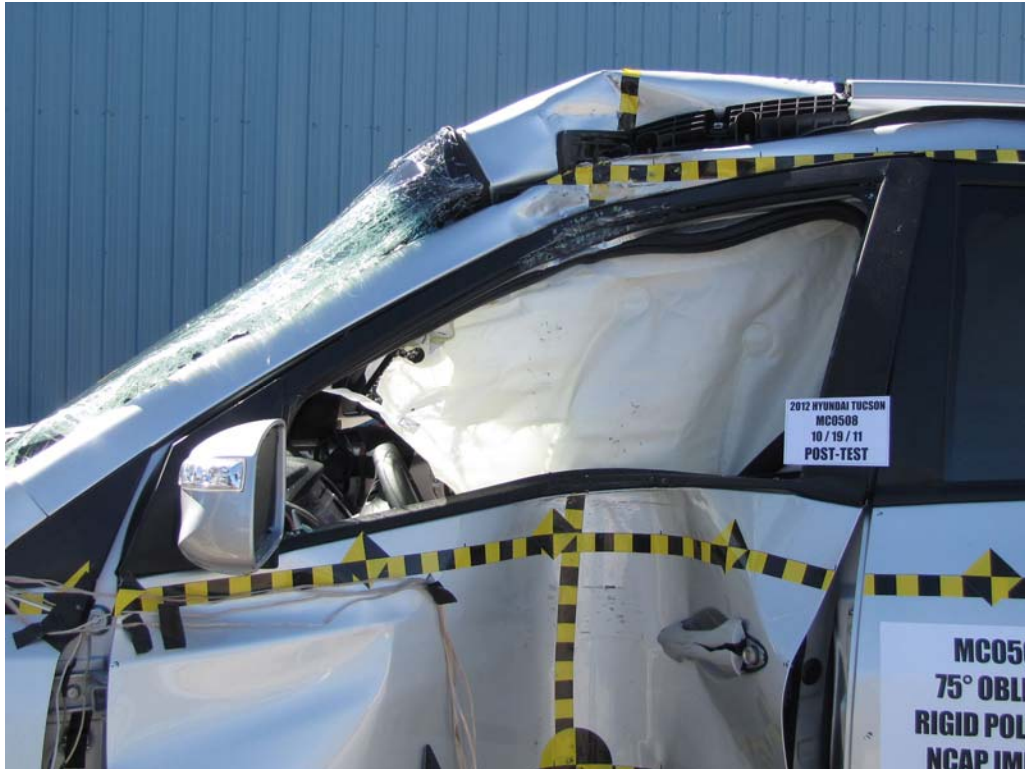
FIGURE 25. Post-Test Left Side View of Dummy Shoulder and Door Top View

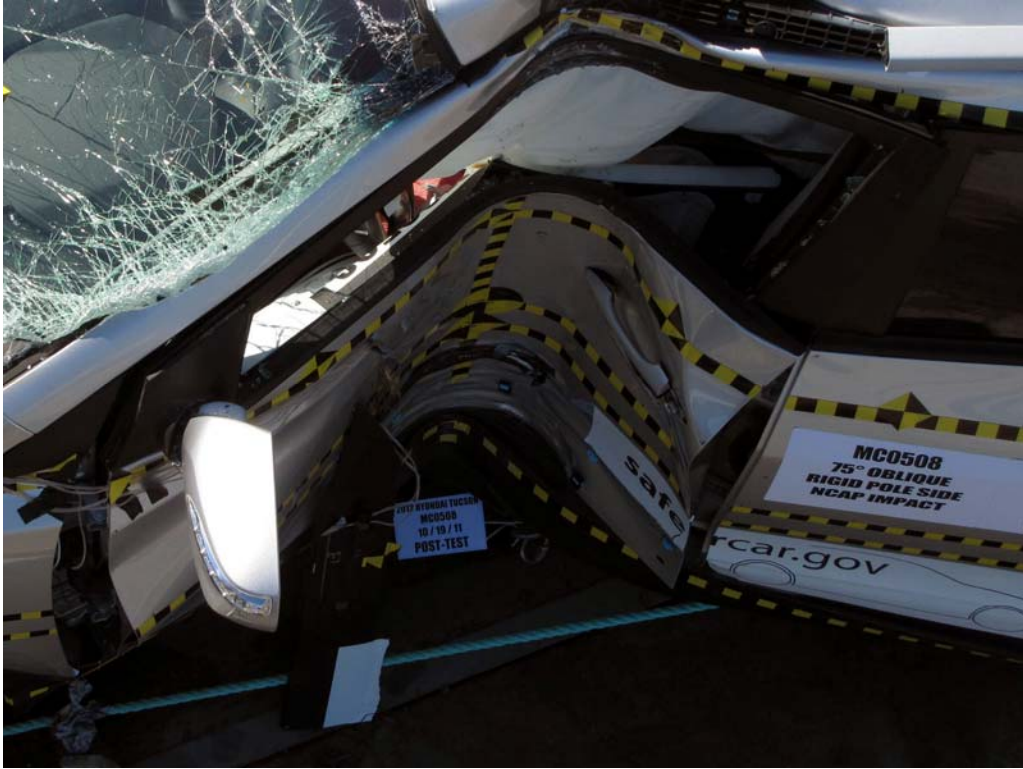
FIGURE 41. Post-Test Driver Dummy and Door Clearance

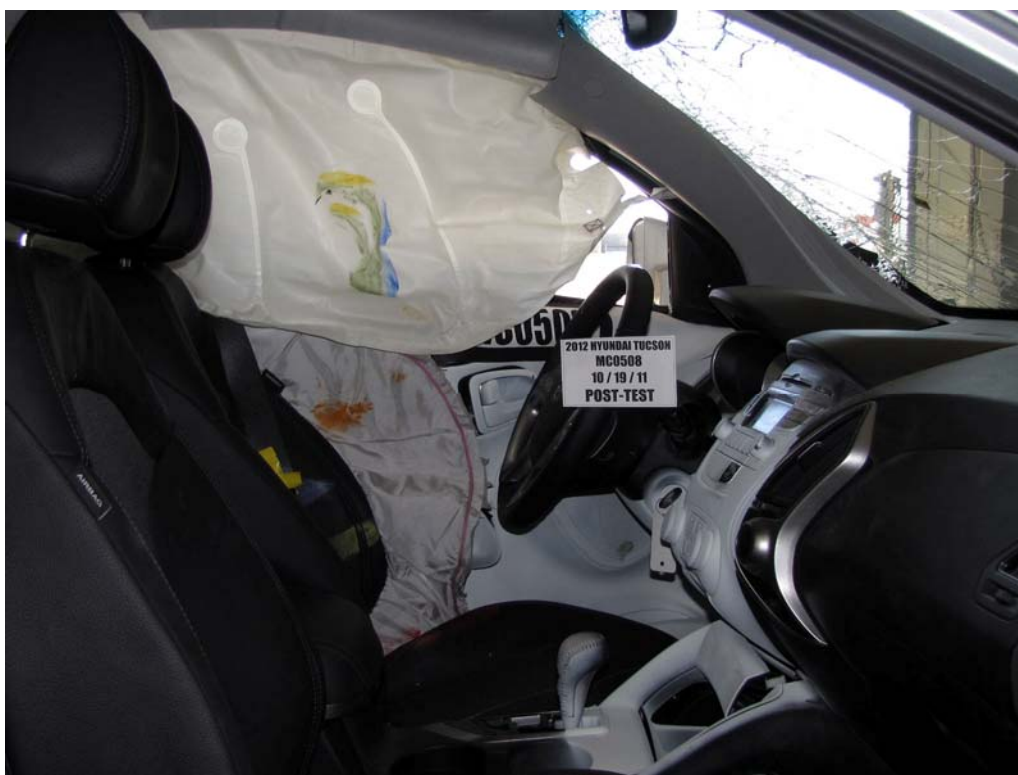
FIGURE 45. Post-Test Inner Driver Door Panel View  
Showing Dummy Contact Locations

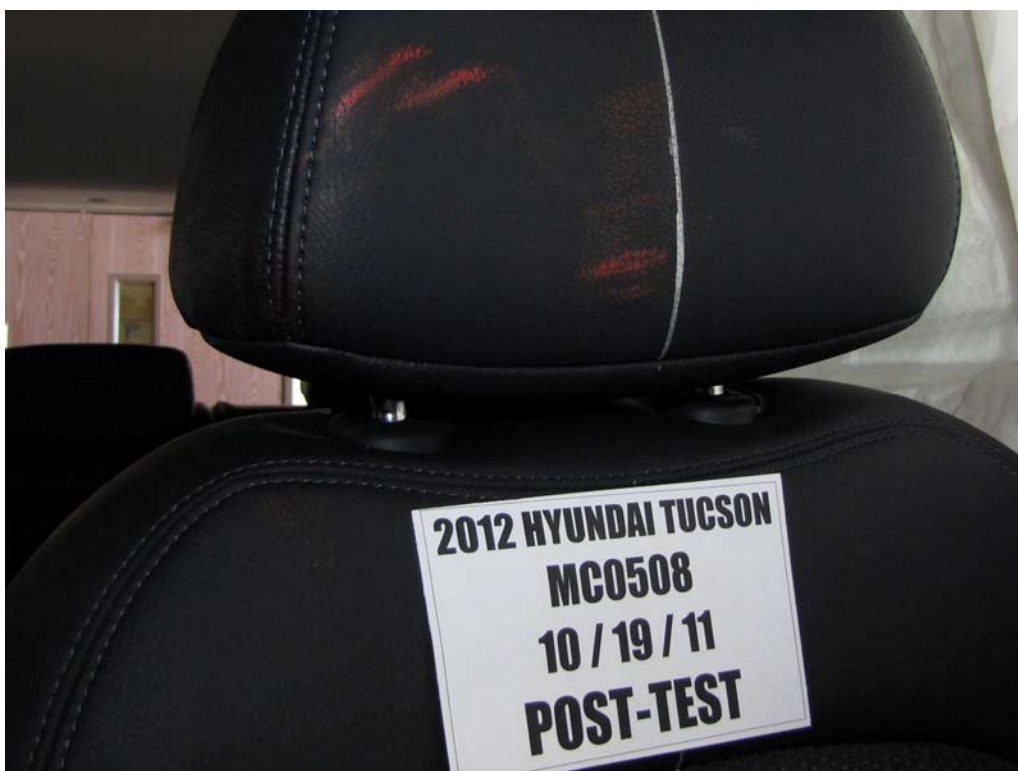
FIGURE 46. Post-Test Dummy Close-Up Head Contact with Vehicle Interior View

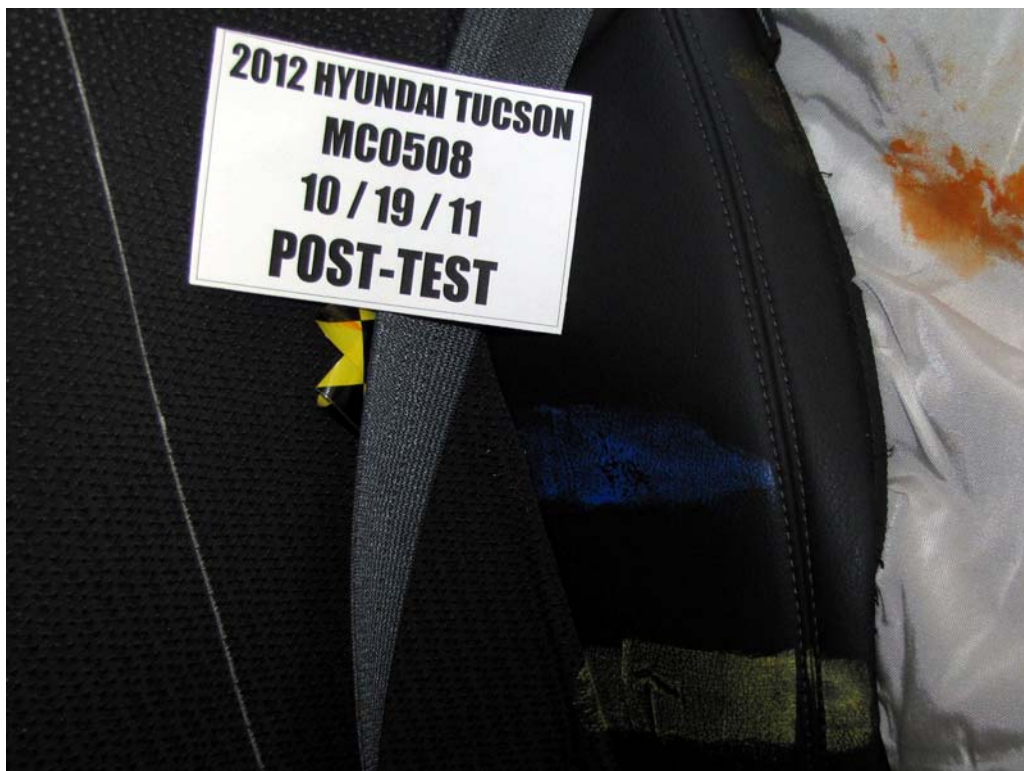
FIGURE 48. Post-Test Dummy Close-Up Torso Contact with Vehicle Interior View

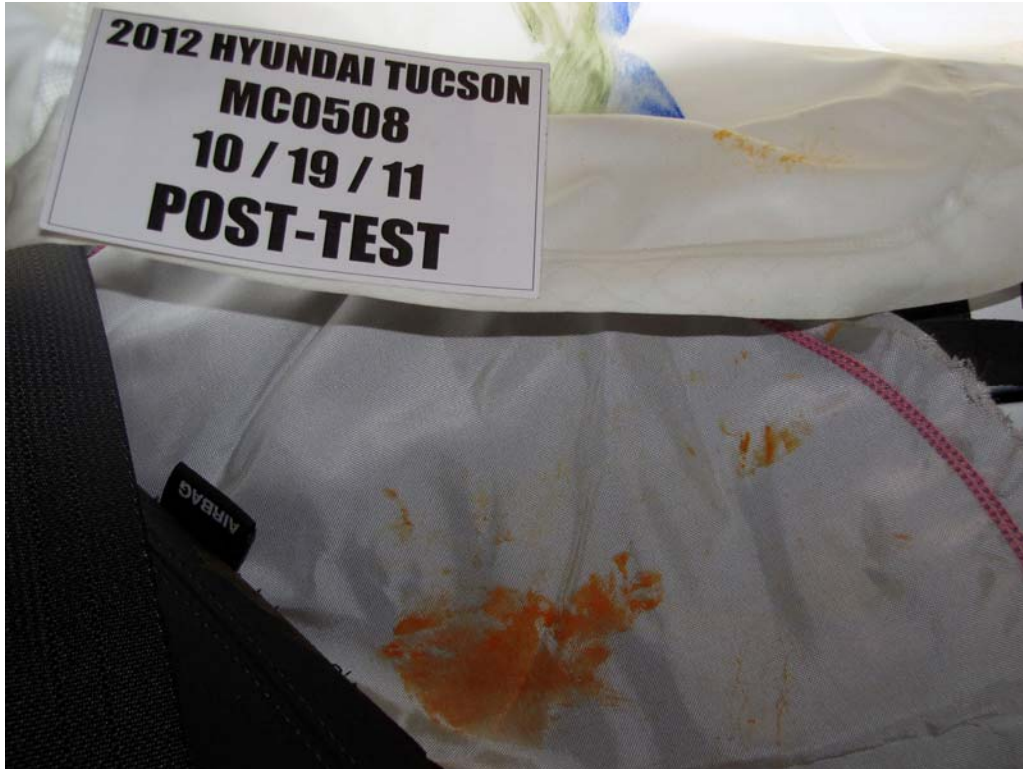
FIGURE 49. Post-Test Dummy Close-Up Torso Contact with Side Airbag View

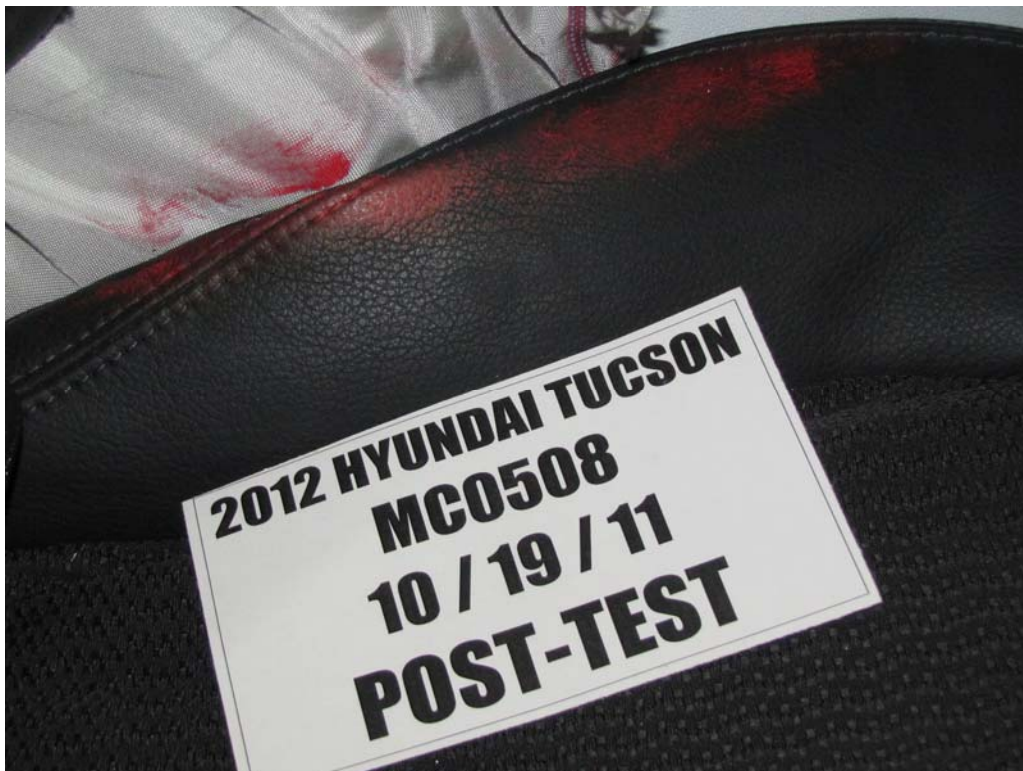
FIGURE 50. Post-Test Dummy Close-Up Pelvis Contact with Vehicle Interior View

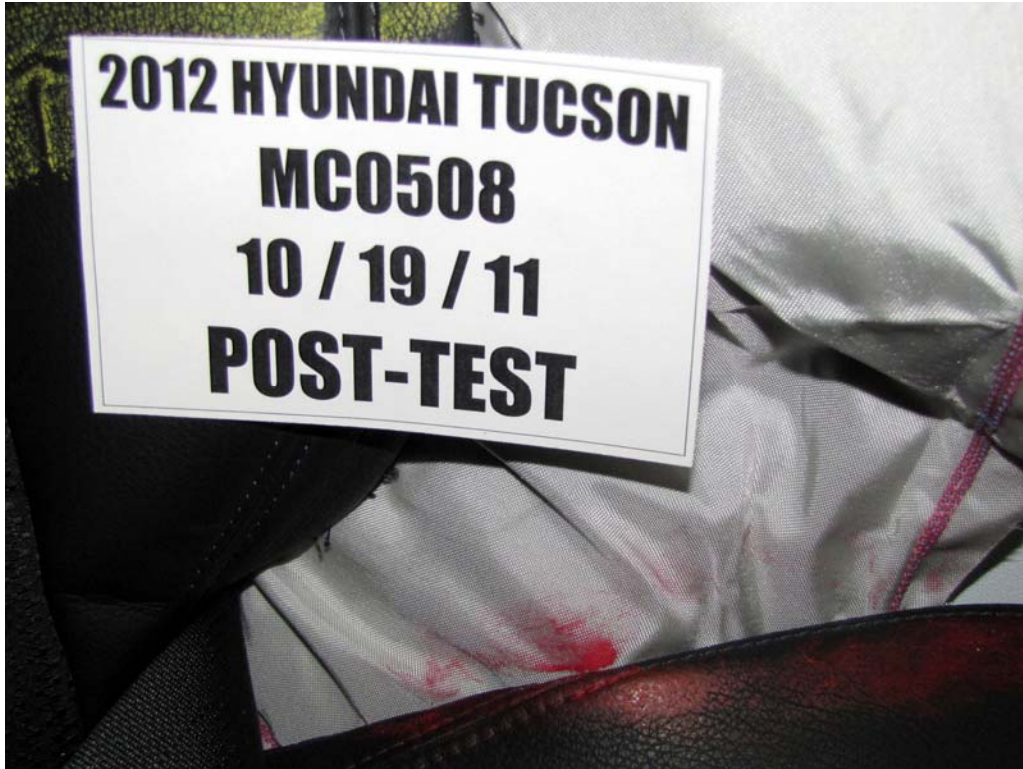
FIGURE 51. Post-Test Dummy Close-Up Pelvis Contact with Side Airbag View

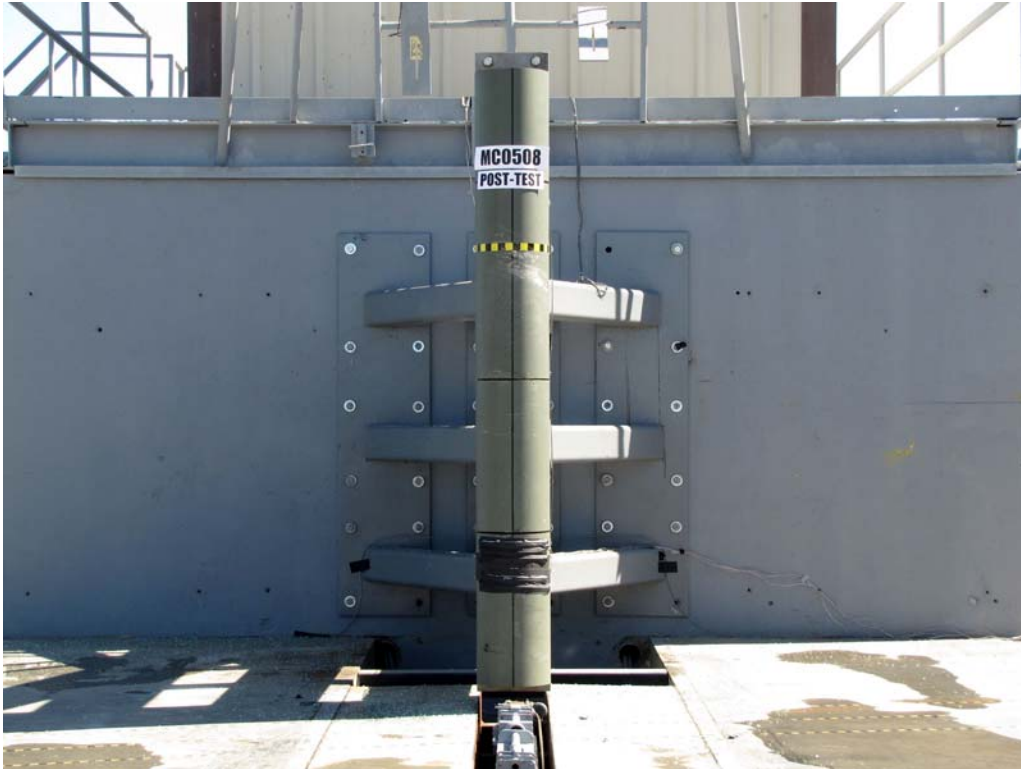
FIGURE 57. Post-Test Pole Barrier Front View

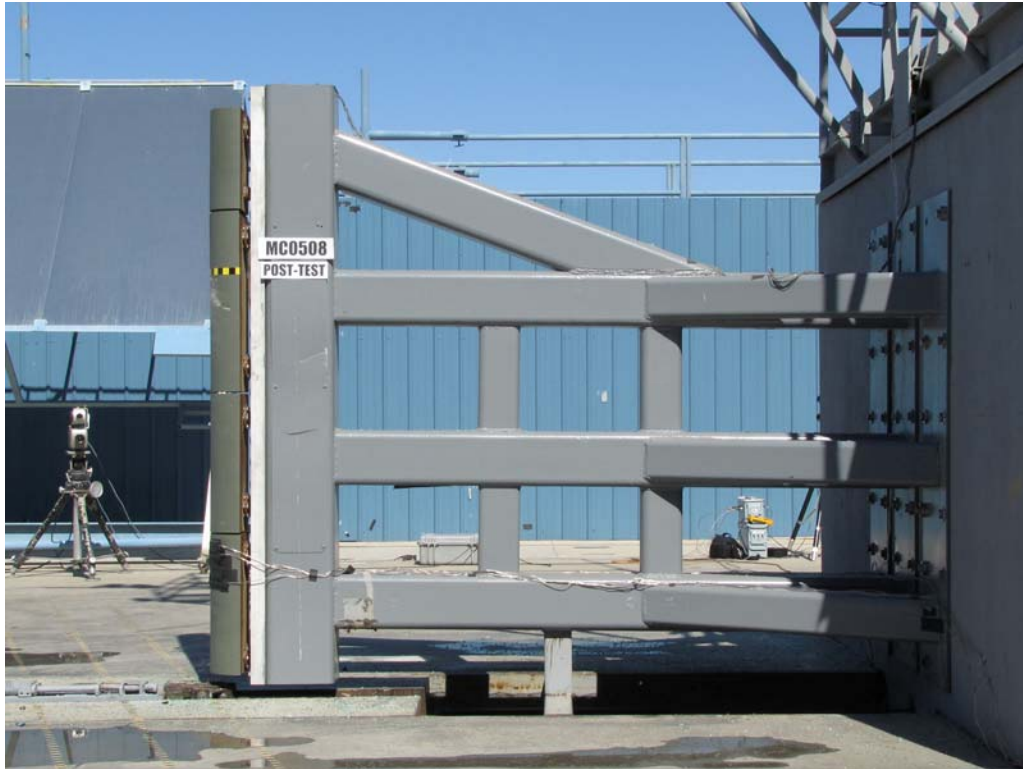
FIGURE 59. Post-Test Pole Barrier Side View

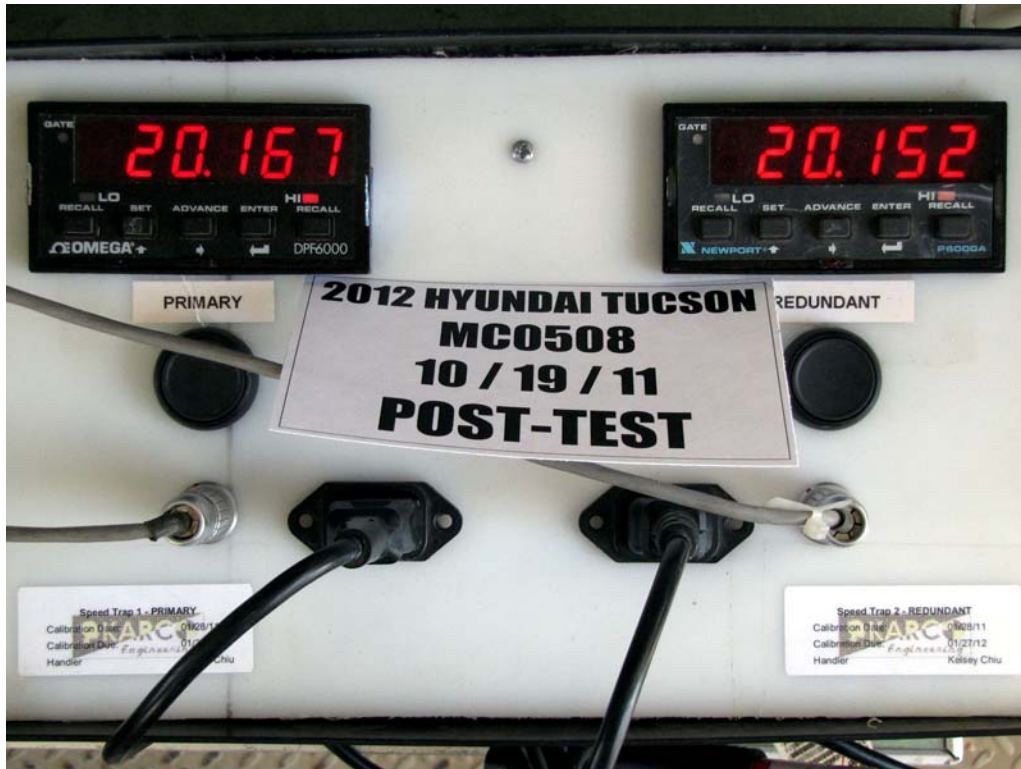
FIGURE 61. Post-Test Primary and Redundant Speed Trap Read-Out

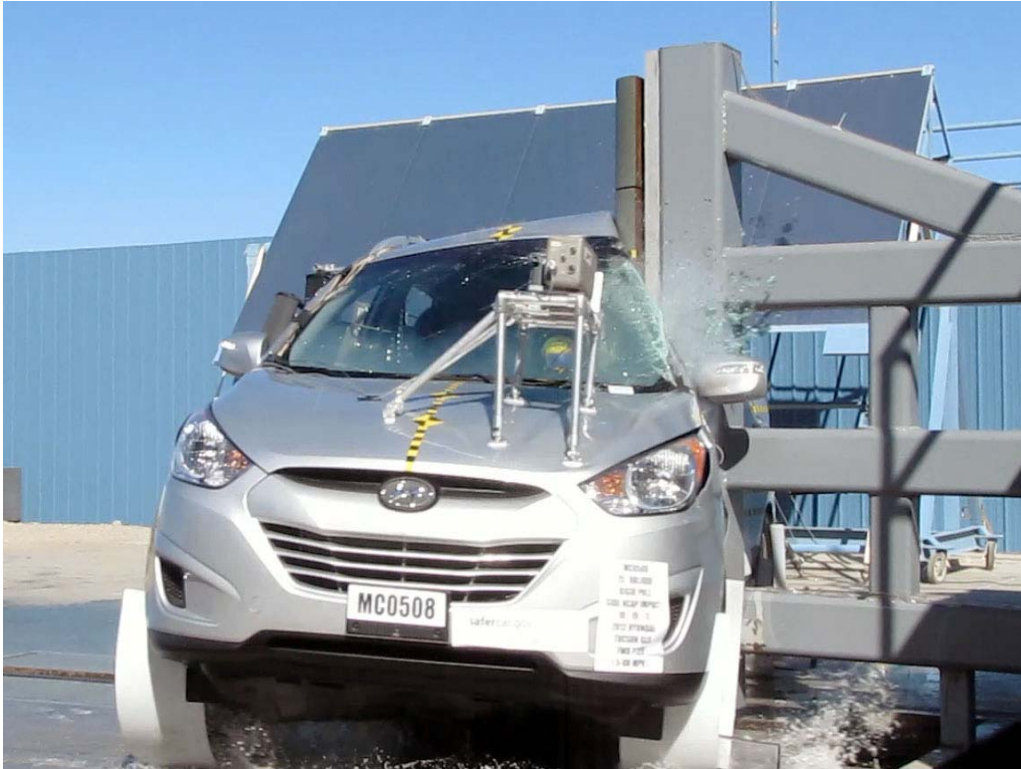
FIGURE 67. Impact Event

A rigid pole side impact test was conducted on a 2012 Hyundai Tucson GLS 5-door MPV. The subject vehicle was towed into the rigid pole at an angle of 74.4° and a velocity of 32.5 km/h. The test was conducted by KARCO Engineering, LLC. in Adelanto, California, on October 19, 2011. Pre- and post-test photographs of the test vehicle and side impact dummy (SID-IIs) are included in Appendix A of this report.
