REPORT NUMBER: SPNCAP-MCW-12-01

NEW CAR ASSESSMENT PROGRAM (NCAP)
SIDE IMPACT POLE TEST

FORD MOTOR COMPANY
2012 FORD EXPLORER 5-DOOR SUV

NHTSA NUMBER: MC 0206

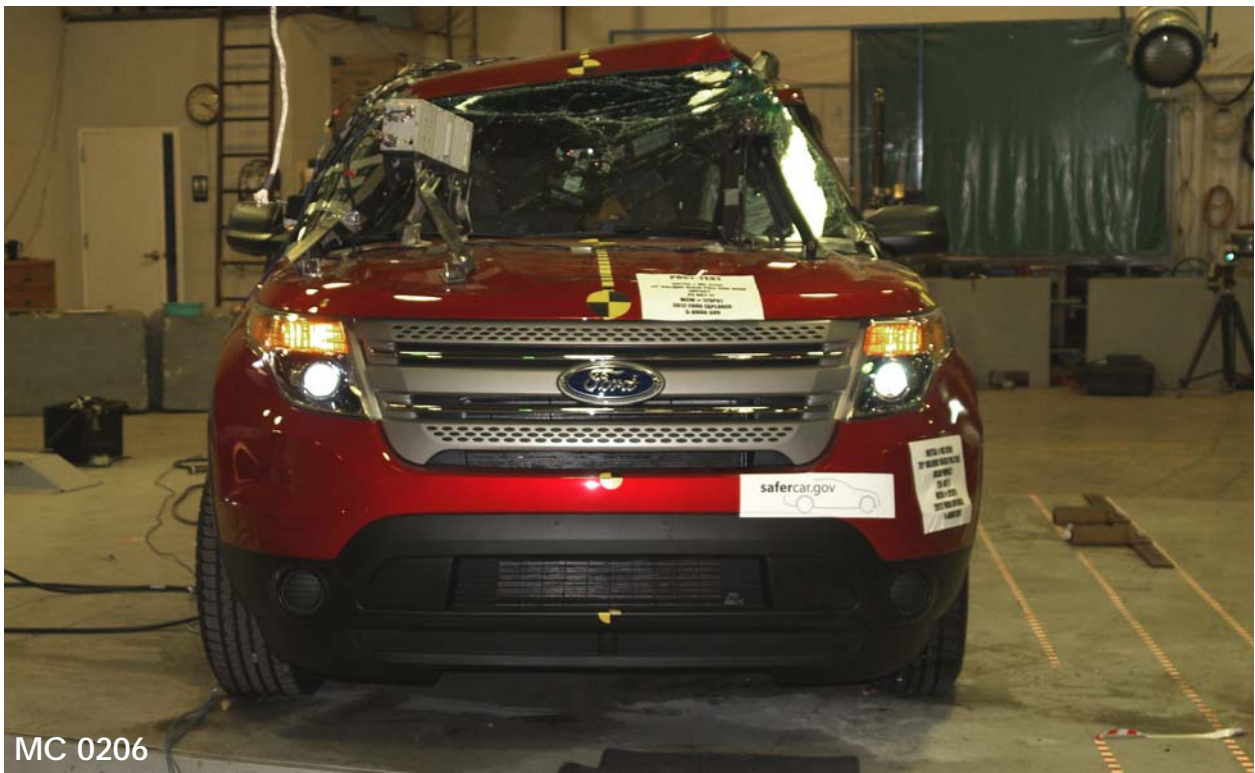
Figure 004: Post-Test Frontal View of Test Vehicle

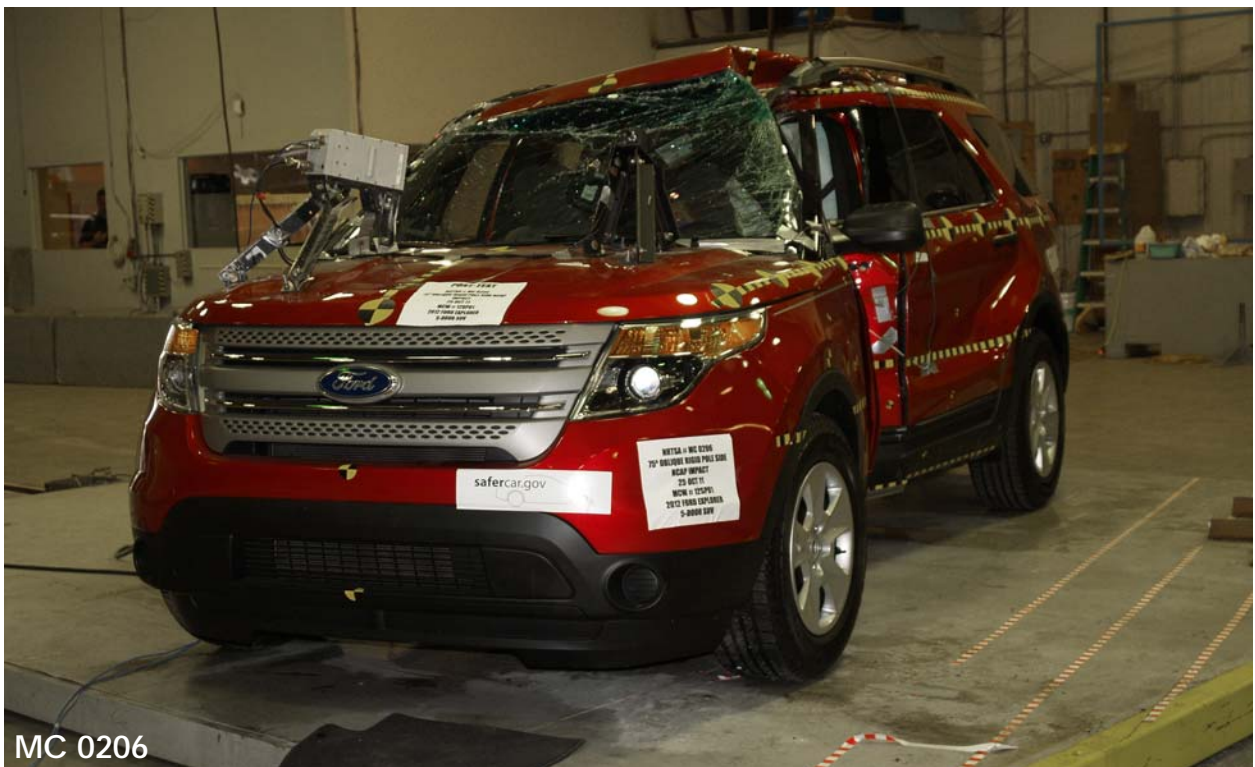
Figure 006: Post-Test Left Front 3-4 View of Test Vehicle

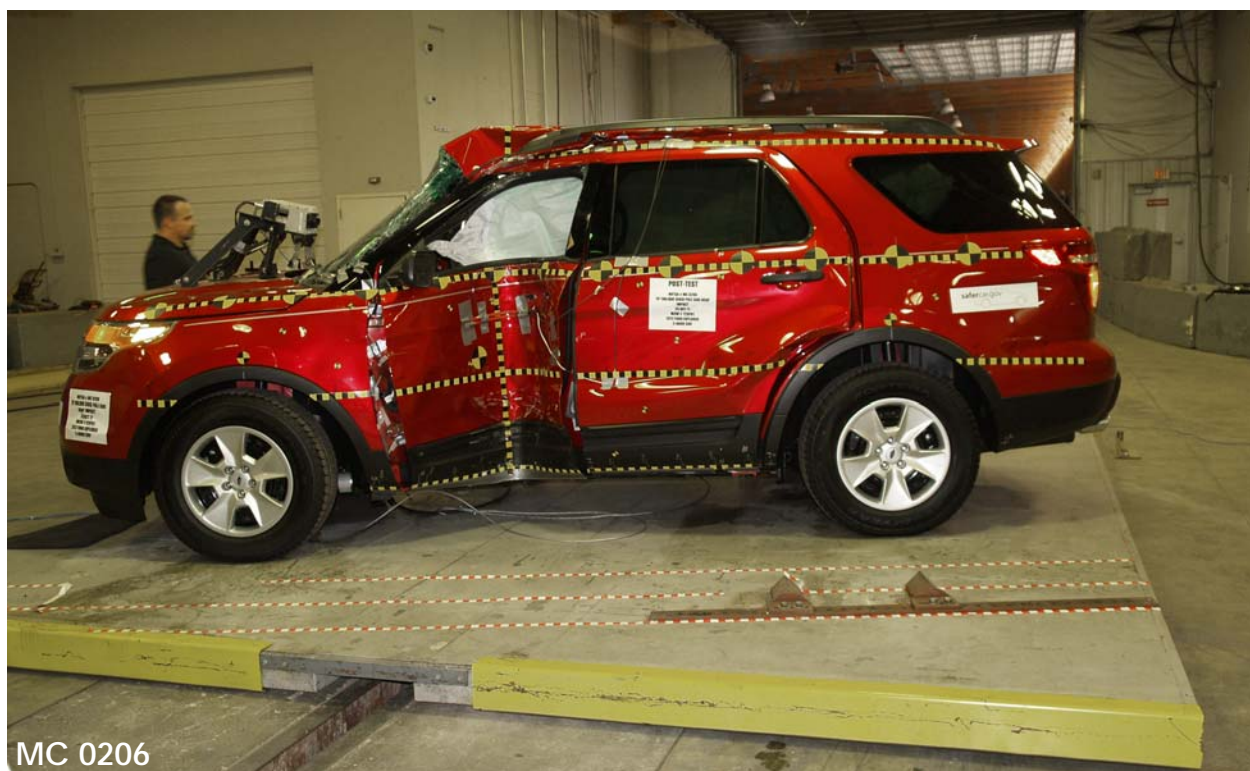
Figure 008: Post-Test Left Side View of Test Vehicle

The test vehicle sustained a maximum static crush of 558 mm at level 2 & 3, 0 mm rearward of the vertical impact line.

POST TEST STRUCTURAL OBSERVATIONS	
Critical Areas of Performance	Observations/Conclusions
Pillar Performance	No Separation
Sill Separation	Max Sill Separation of 73 mm Along Top of Door at B-pillar; Door Remained Latched
Windshield Damage	Cracking Along Entire Windshield
Window Damage	No Damage
Other Notable Effects	None Noted

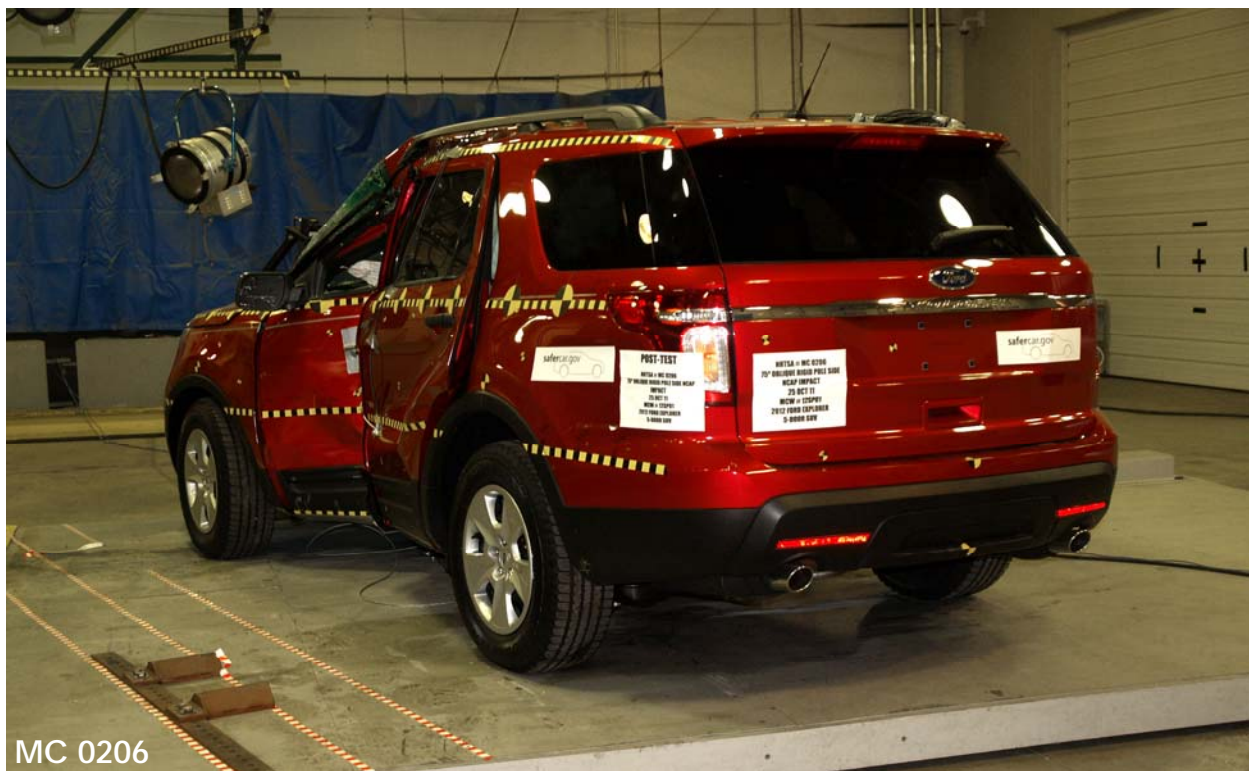
Figure 010: Post-Test Left Rear 3-4 View of Test Vehicle

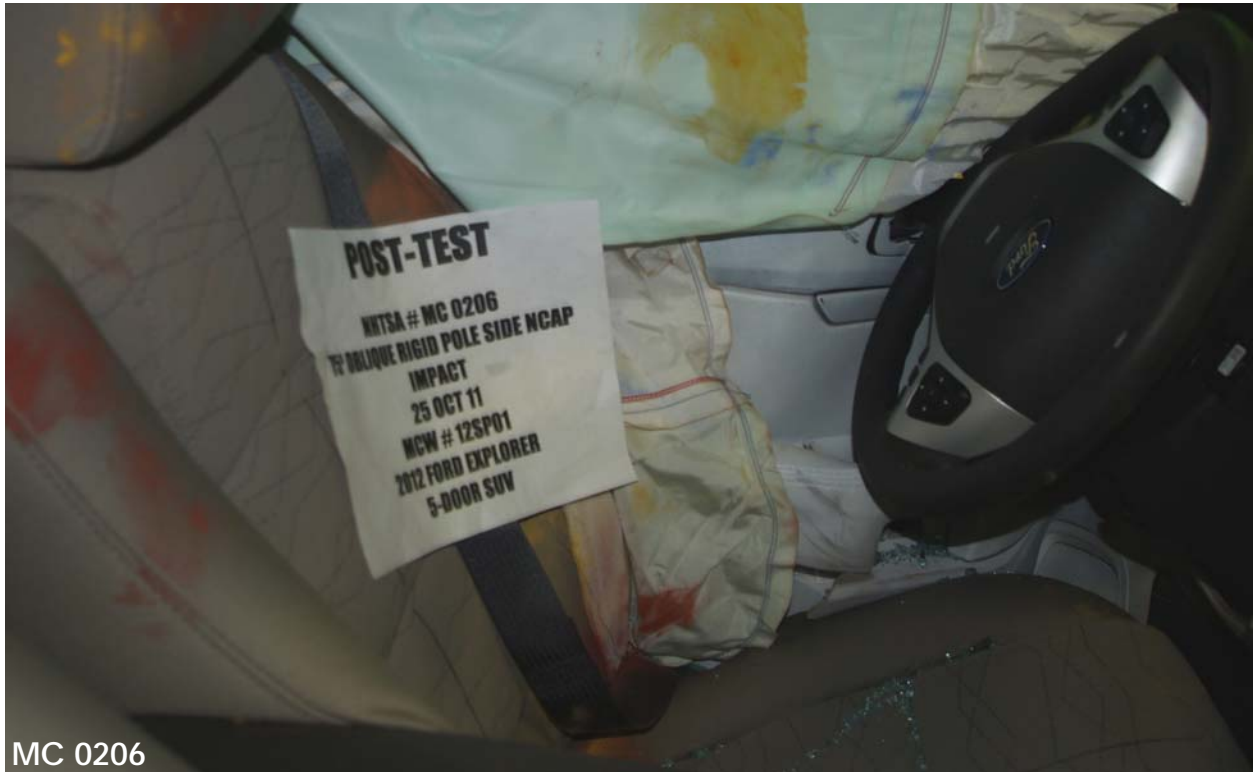
Figure 045: Post-Test Inner Door Panel View Showing Dummy Contact Locations

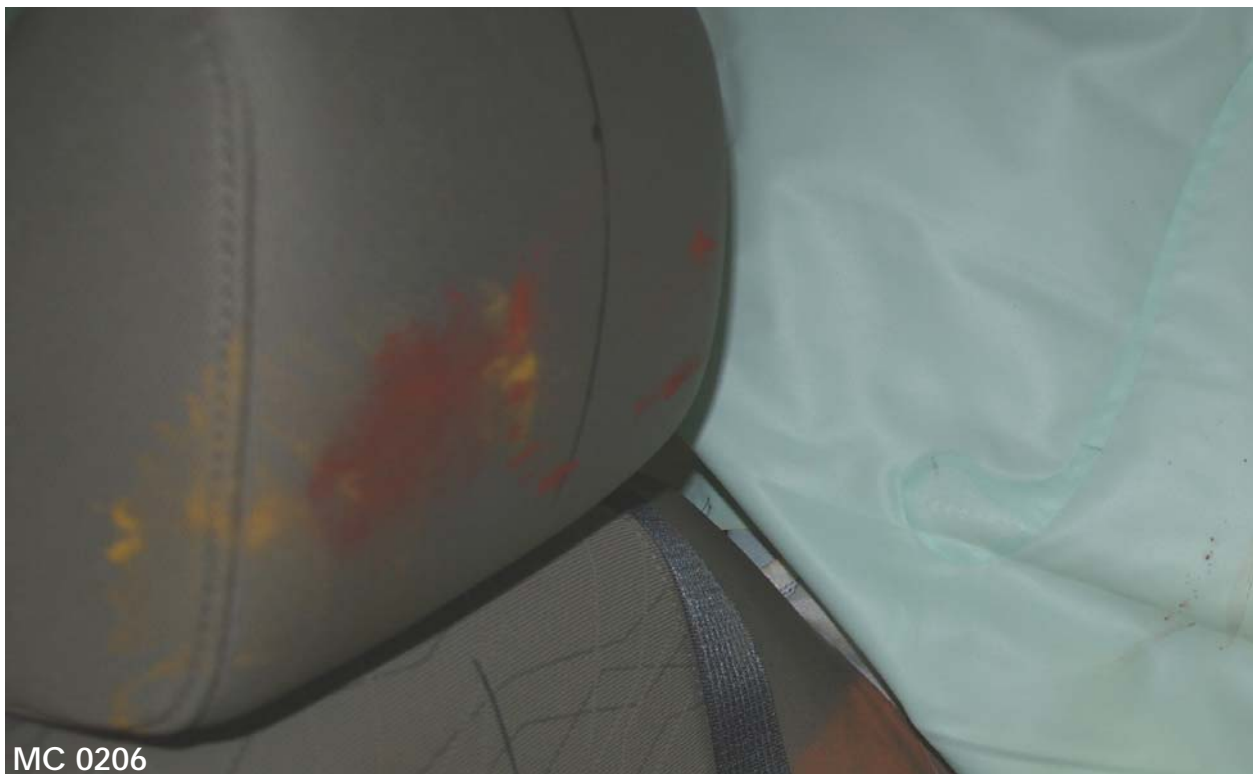
Figure 046 Post-Test Dummy Close-Up Head Contact with Vehicle Interior View
