REPORT NUMBER: SINCAP-MCW-12-02

NEW CAR ASSESSMENT PROGRAM (NCAP)
MOVING DEFORMABLE BARRIER SIDE IMPACT TEST

FORD MOTOR COMPANY
2012 FORD EXPLORER 5-DOOR SUV
NHTSA NUMBER: MC 0205

FINAL REPORT

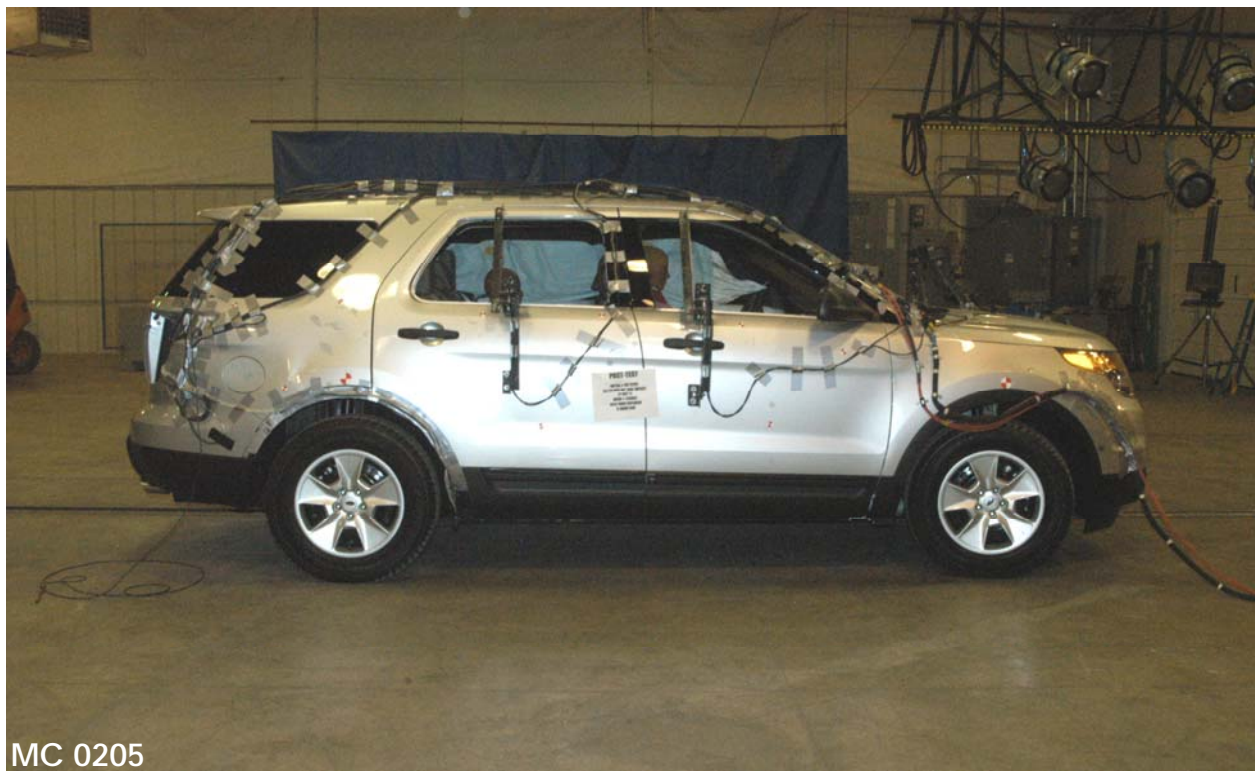
Figure A-14: Post-Test Right Side View of Test Vehicle

POST TEST STRUCTURAL OBSERVATIONS	
Critical Areas of Performance	Observations/Conclusions
Pillar Performance	No Damage
Sill Separation	Max Sill Separation of 67 mm at C-Pillar Along Upper Window Sill
Windshield Damage	No Damage
Window Damage	No Damage
Other Notable Effects	None Noted

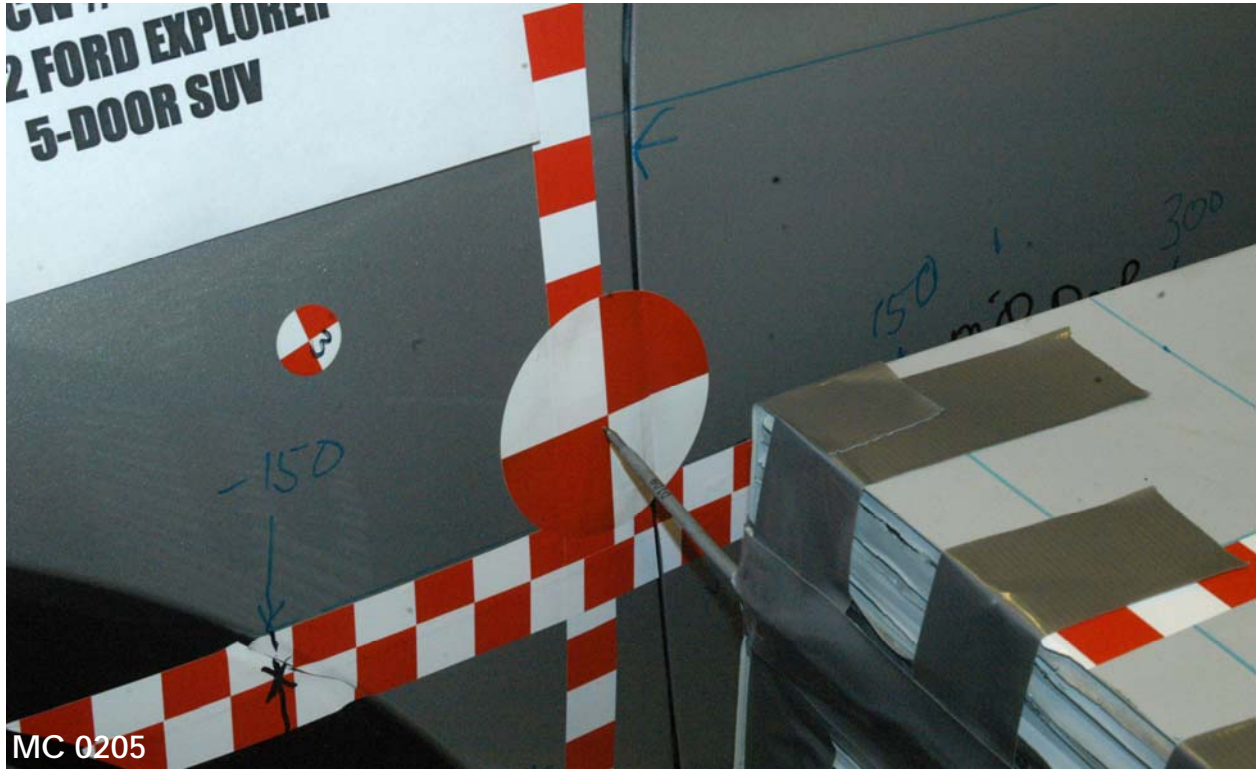
Figure A-19: Pre-Test Close-Up View of Impact Point Target

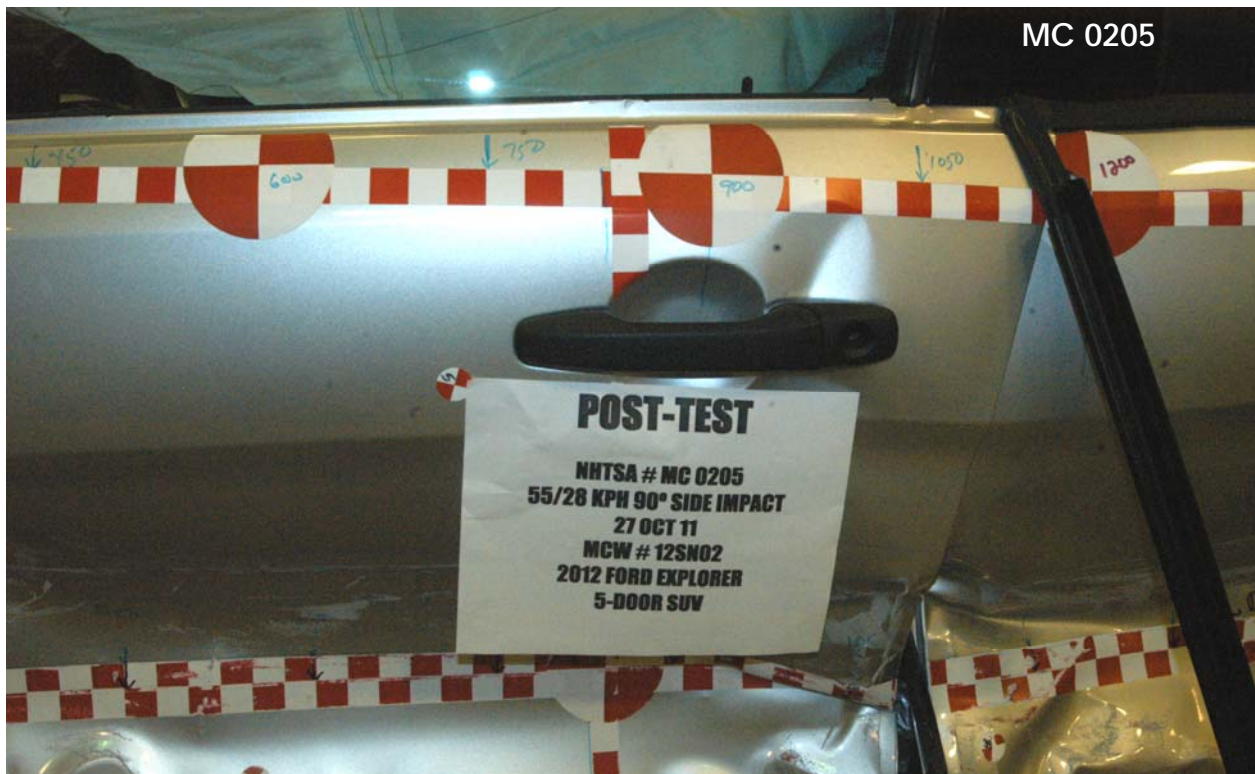
Figure A-22: Post-Test Left Front Door Latch Close-Up

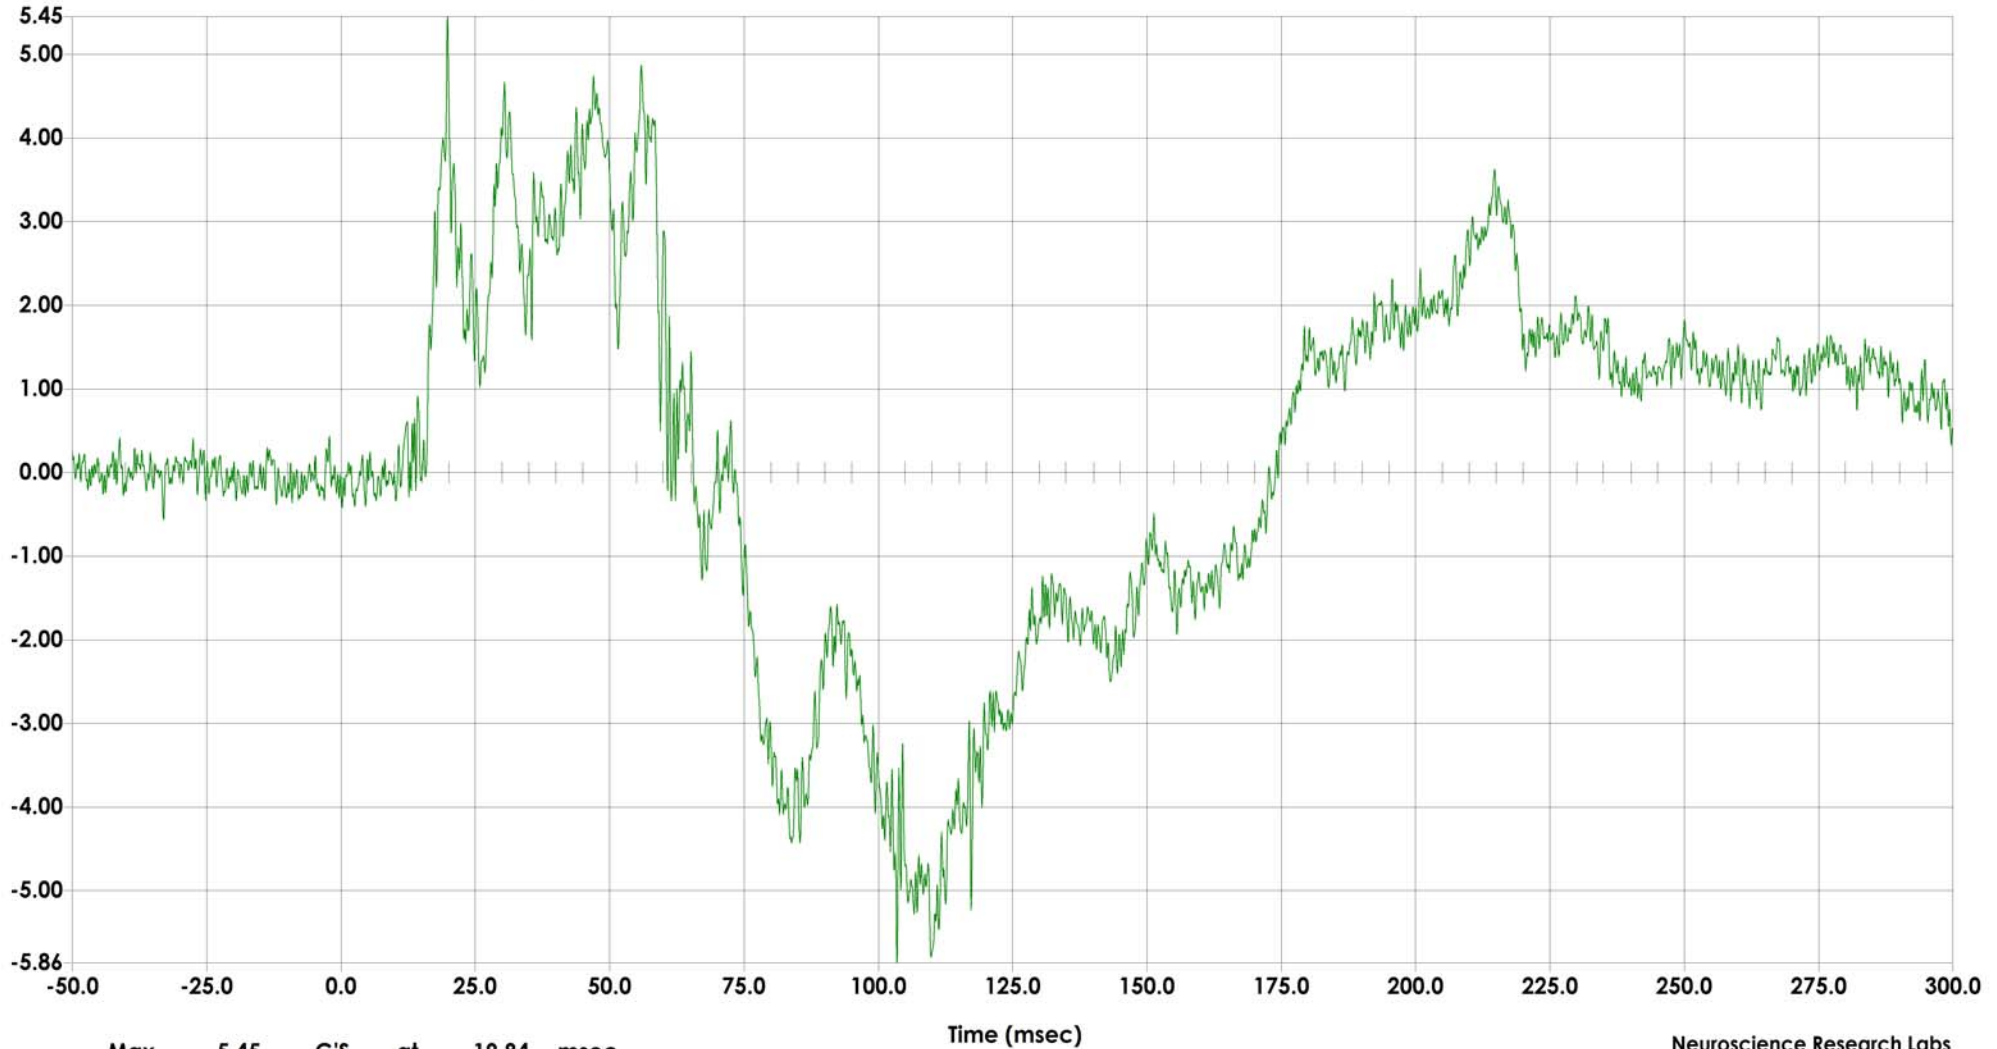
G'S Driver Head Acceleration (Z) Primary vs. Time

Max 5.45 G'S at 19.84 msec
Min -5.86 G'S at 103.44 msec
