**REPORT NUMBER: SINCAP-MGA-2012-017**

**NEW CAR ASSESSMENT PROGRAM (NCAP)  
Moving Deformable Barrier Side Impact Test**

**GENERAL MOTORS OF CANADA LTD.  
2012 Chevrolet Camaro 1LS 2-Dr Coupe  
NHTSA No.: MC0107**

**MGA RESEARCH CORPORATION  
5000 Warren Road  
Burlington, WI 53105**

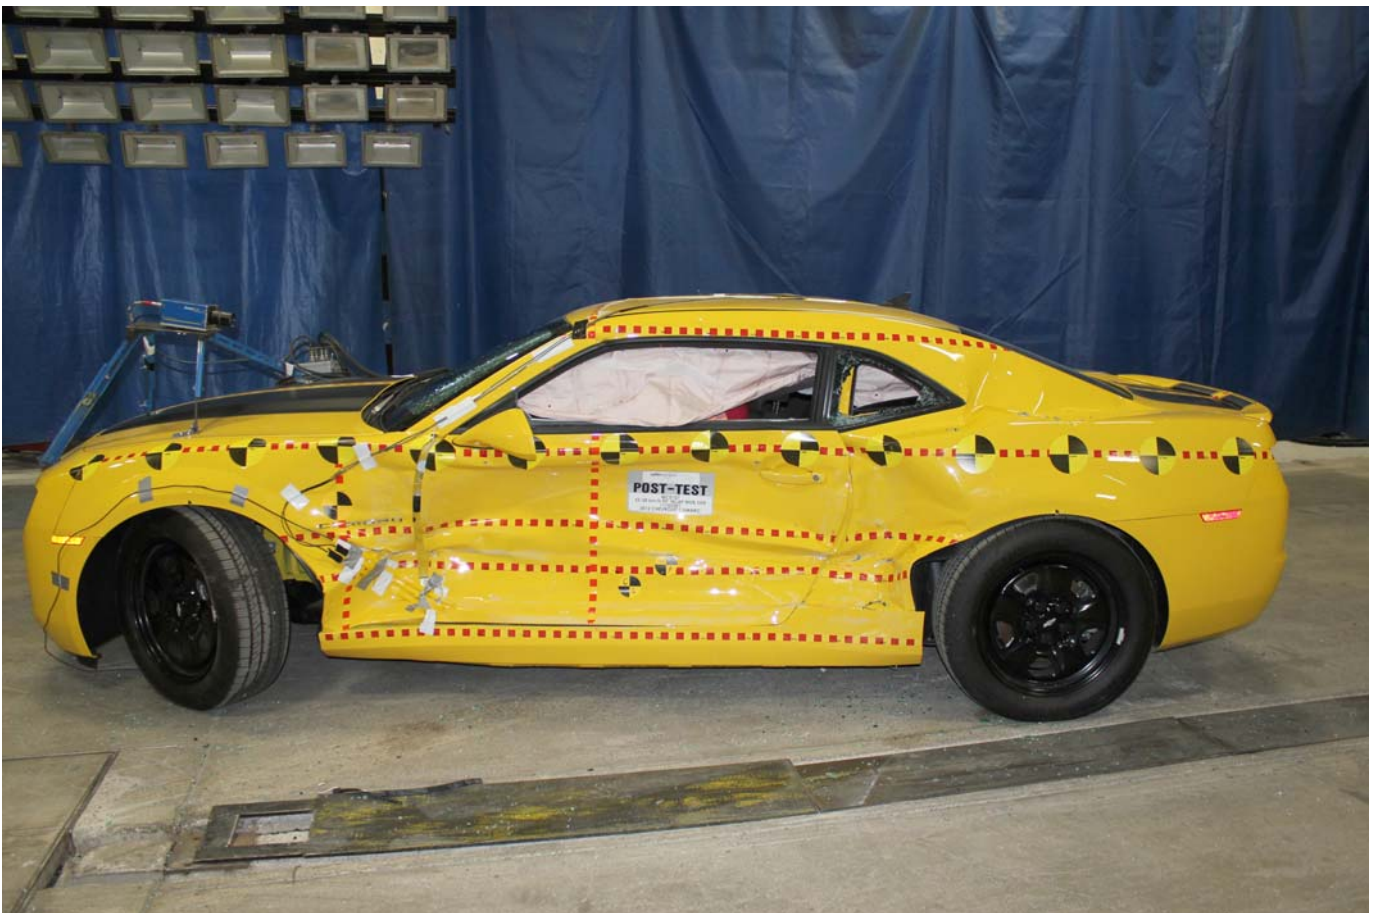
Post-Test Left Side View of Test Vehicle

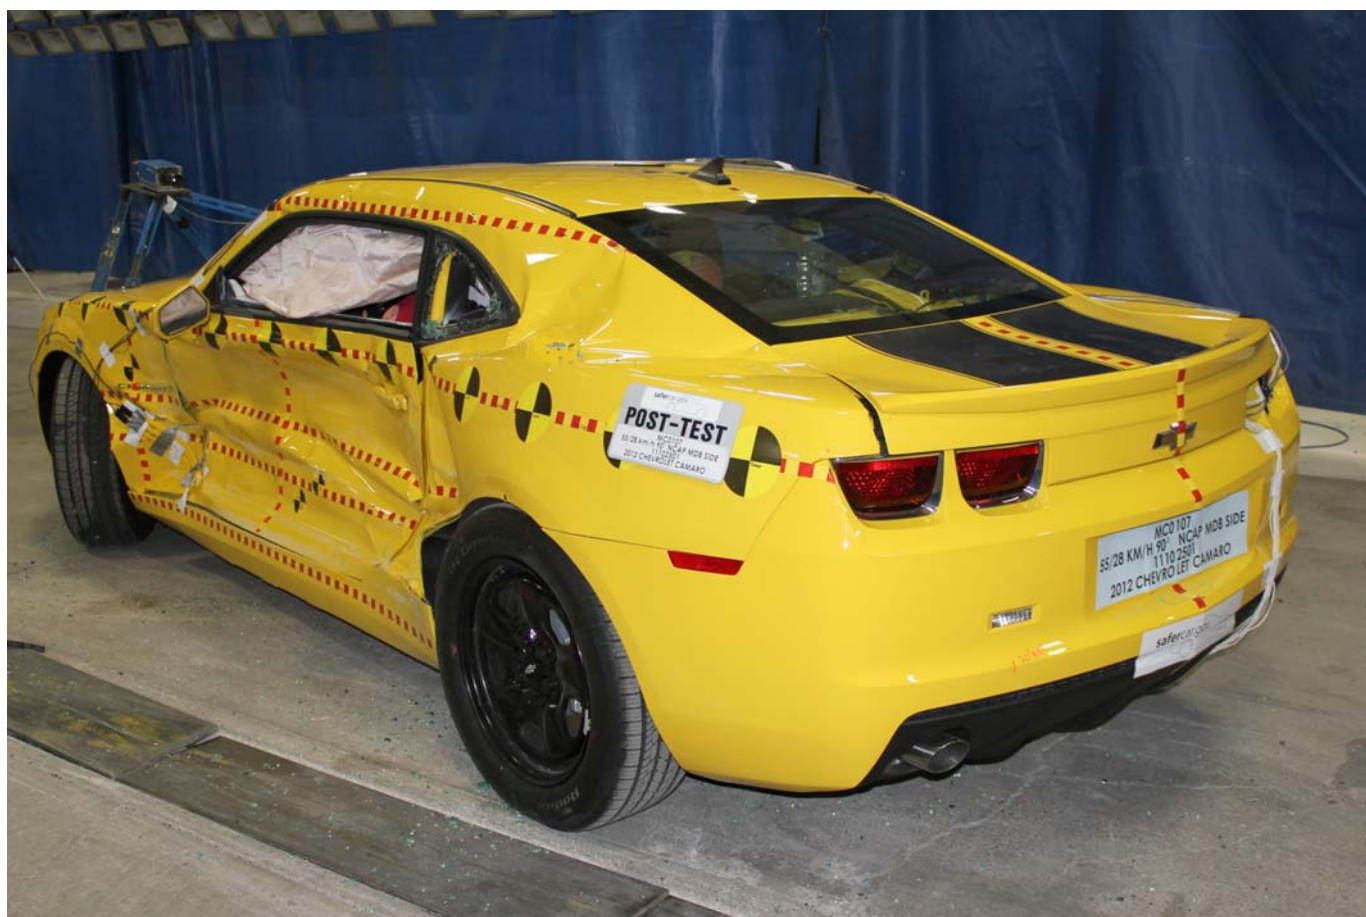
Post-Test Left Three-Quarter Rear View of Test Vehicle

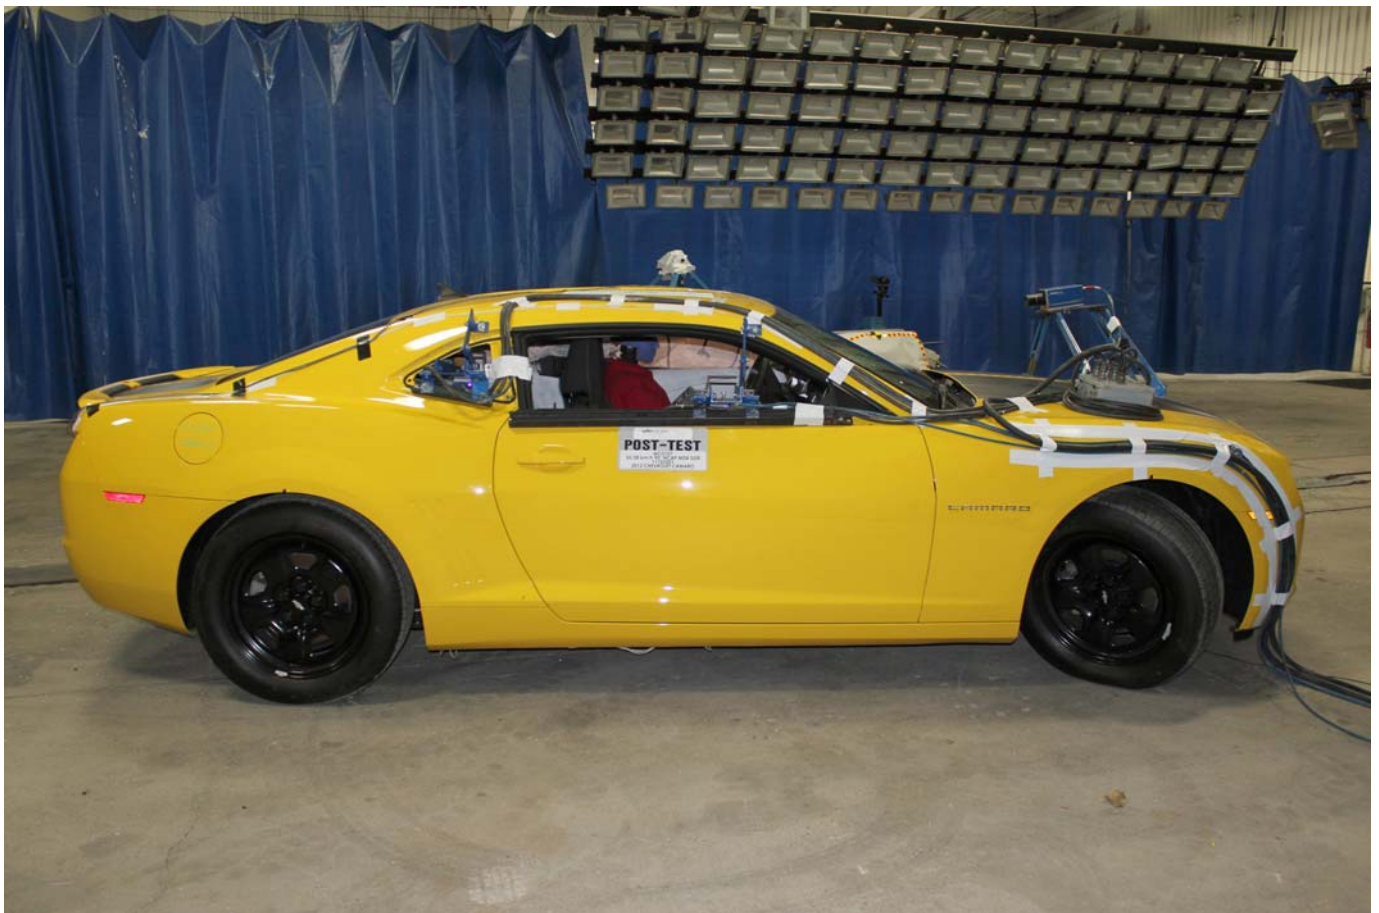
Post-Test Right Side View of Test Vehicle

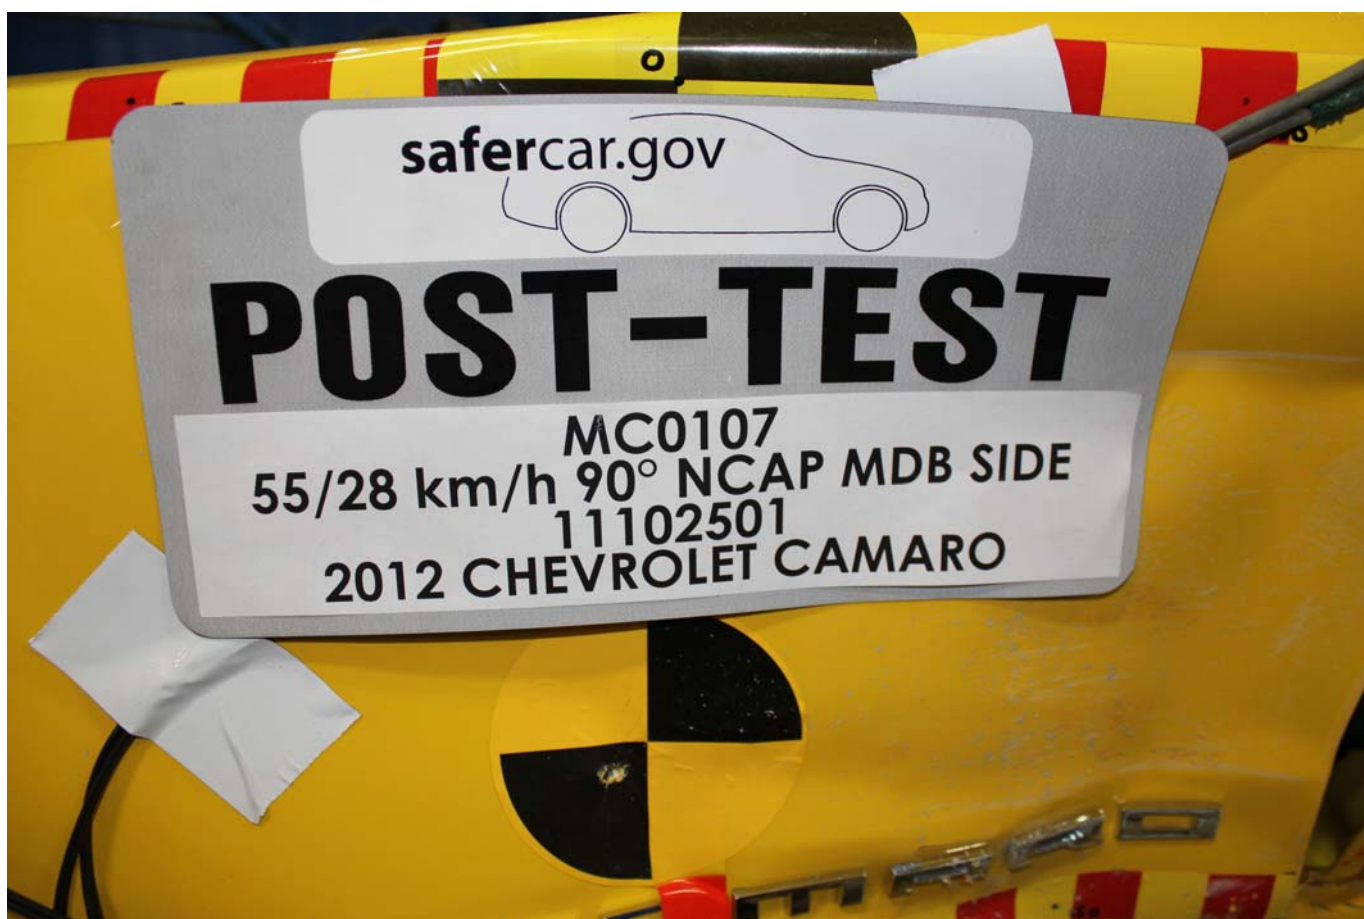
Post-Test Close-Up View of Impact Point Target

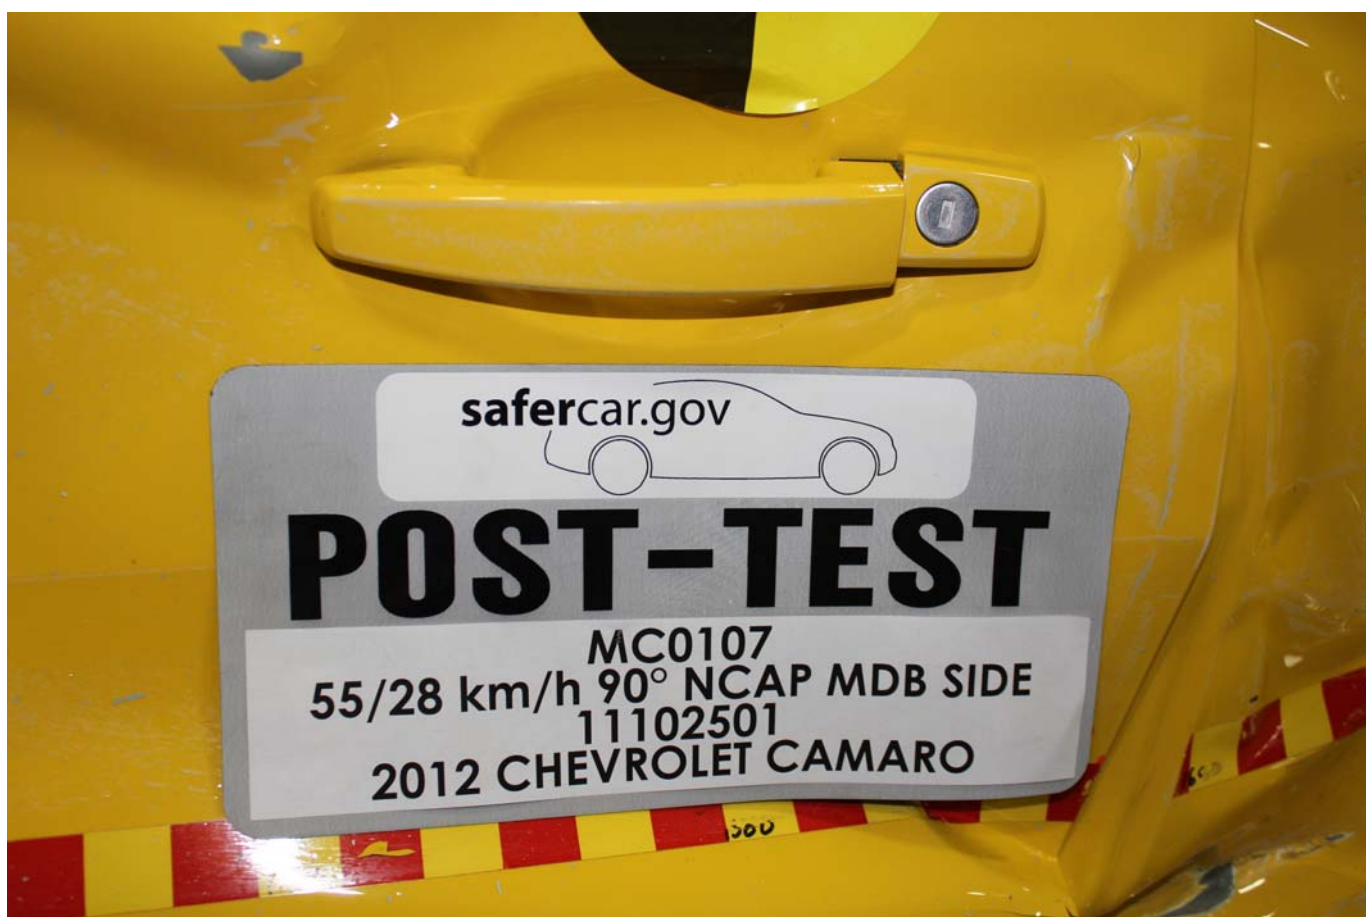
Post-Test Left Front Door Latch Close-Up

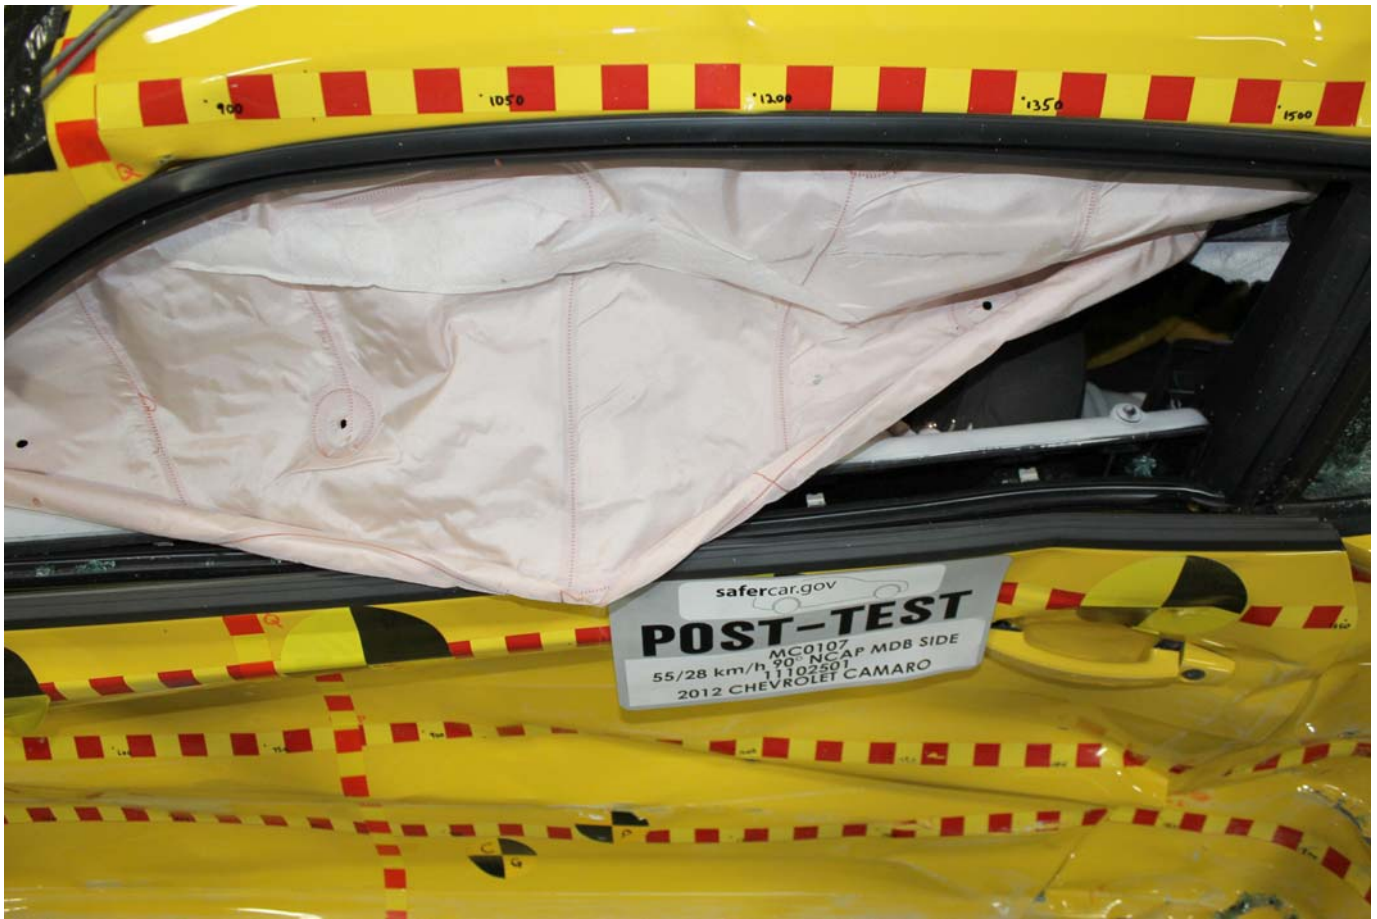
Post-Test Driver Dummy and Door Clearance View

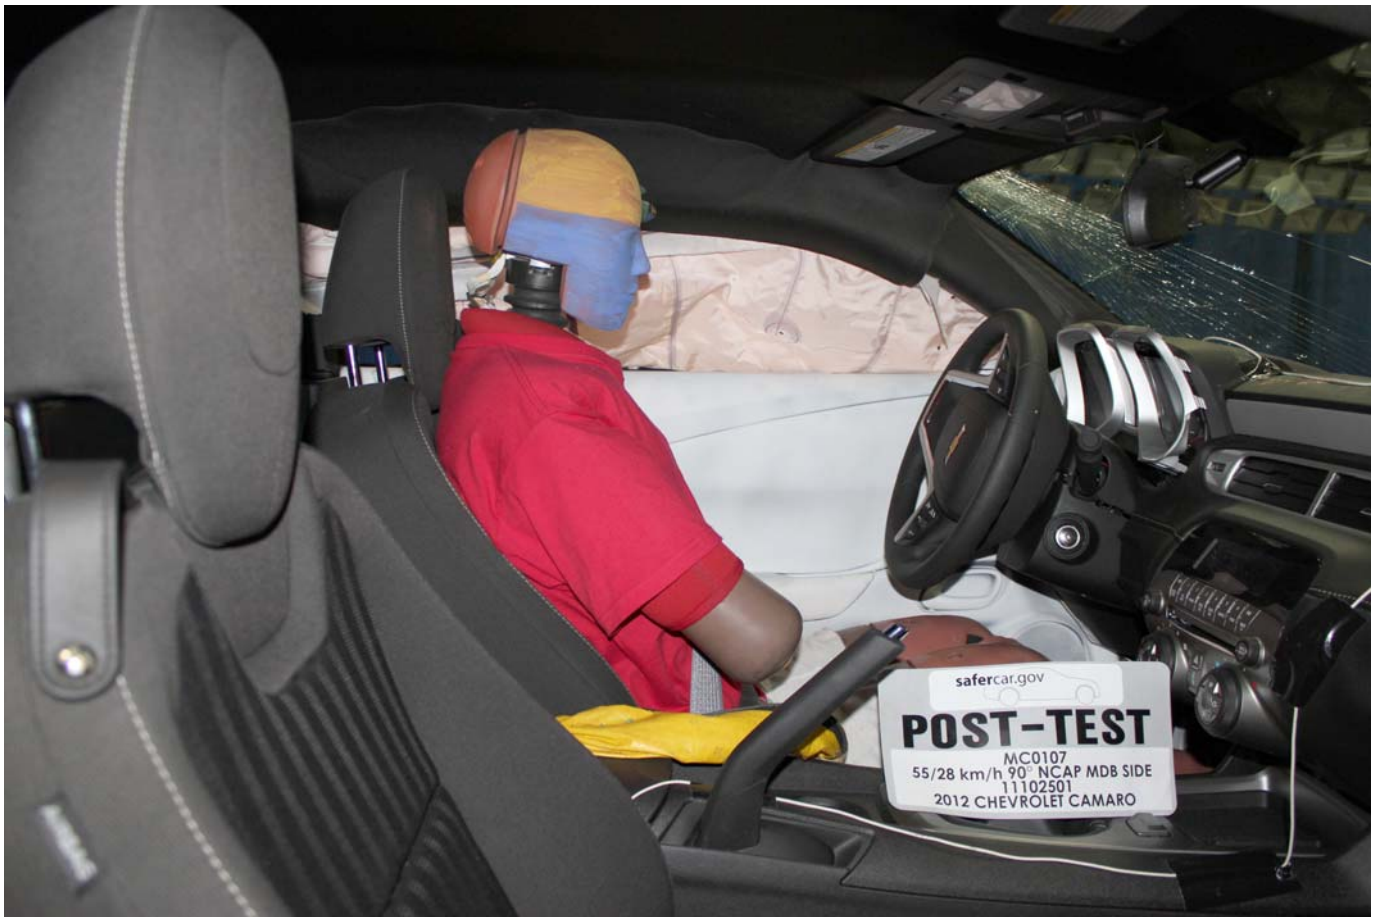
Post-Test Right Side View of Driver Dummy and Front Seat of Occupant Compartment

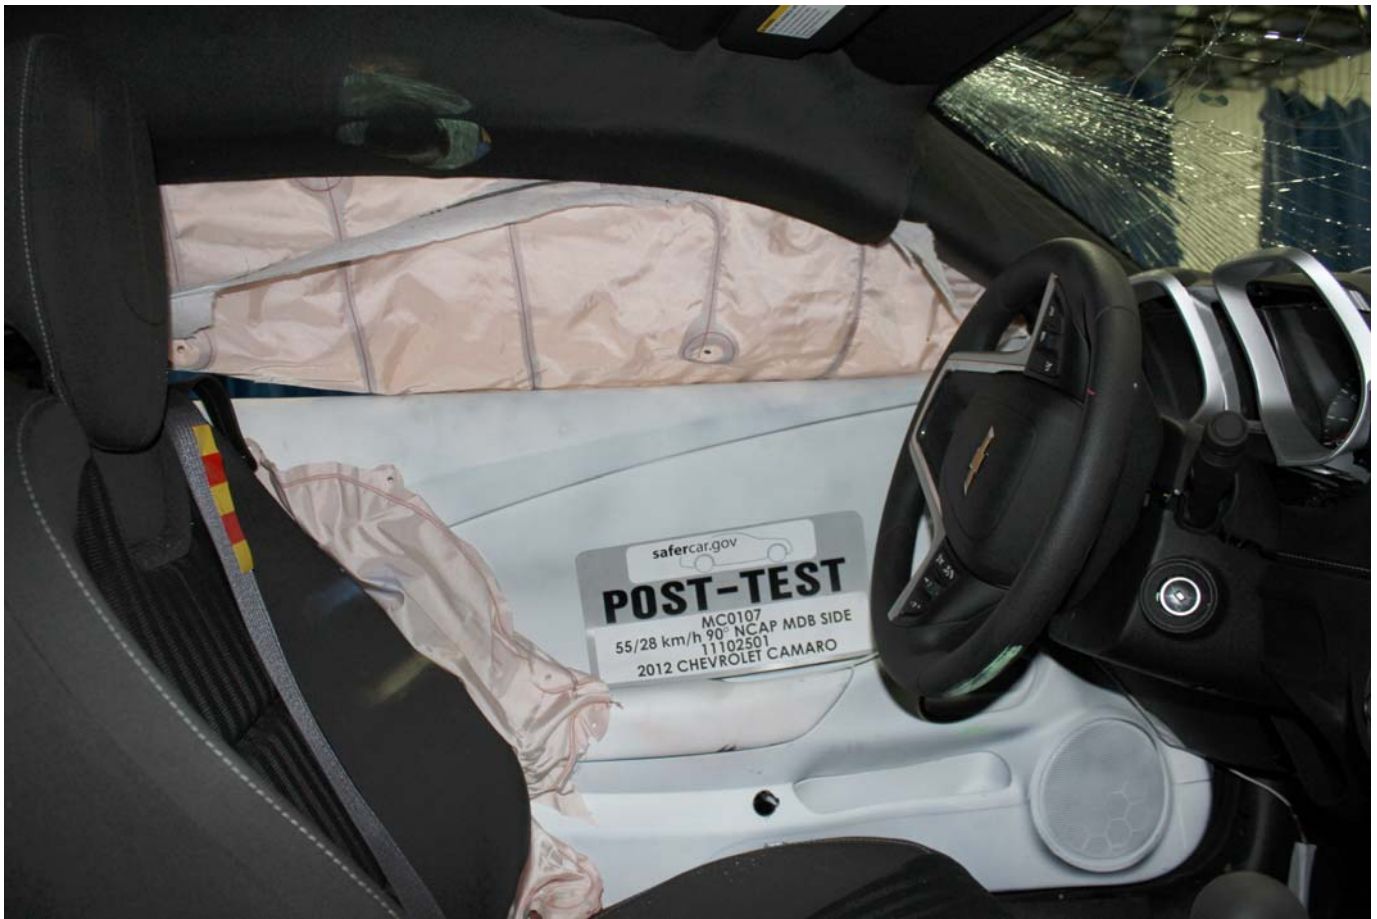
Post-Test Driver Inner Door Panel View

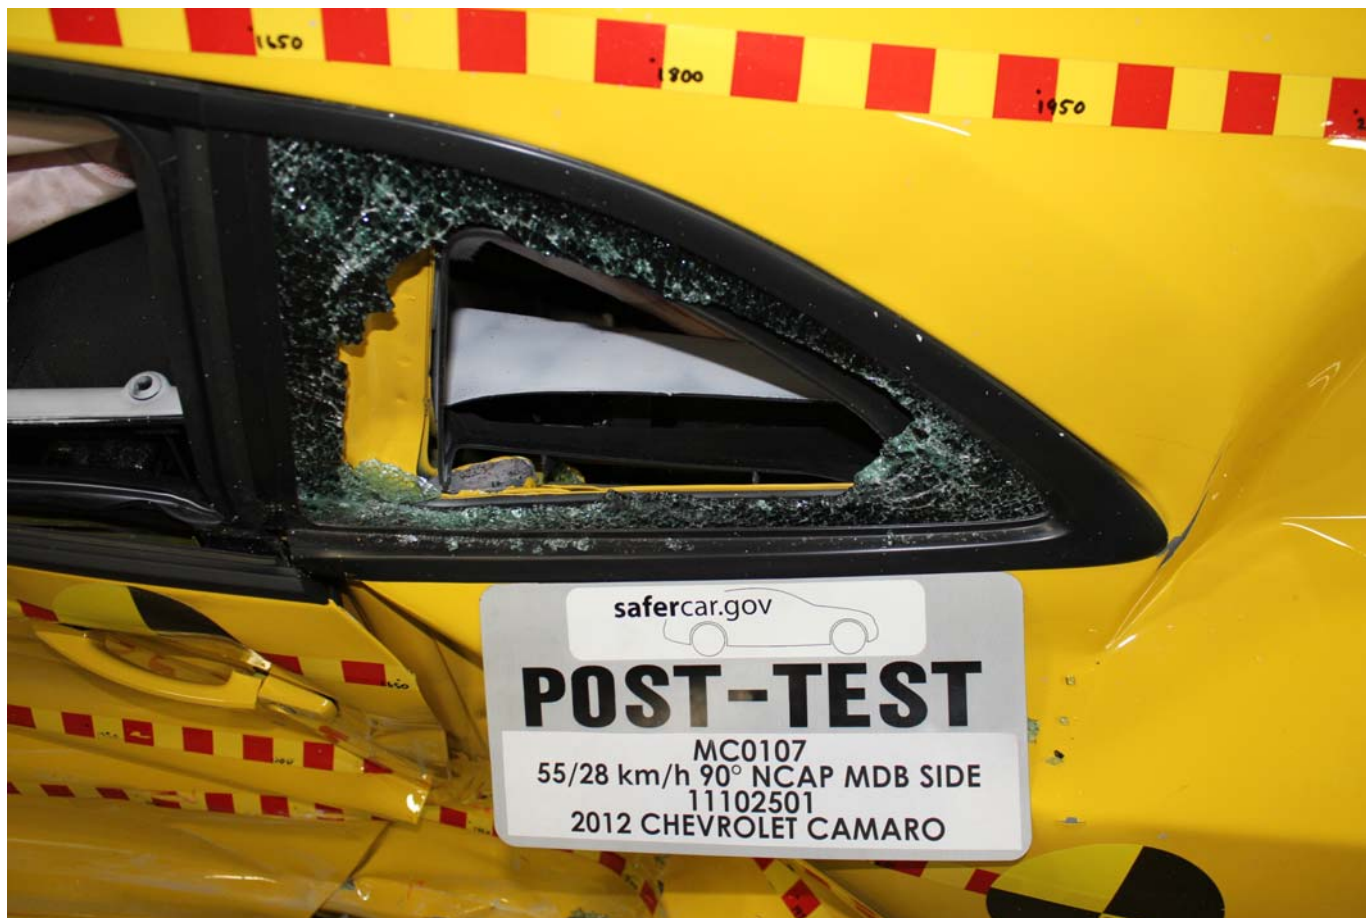
Post-Test Rear Passenger Dummy and Door Clearance View

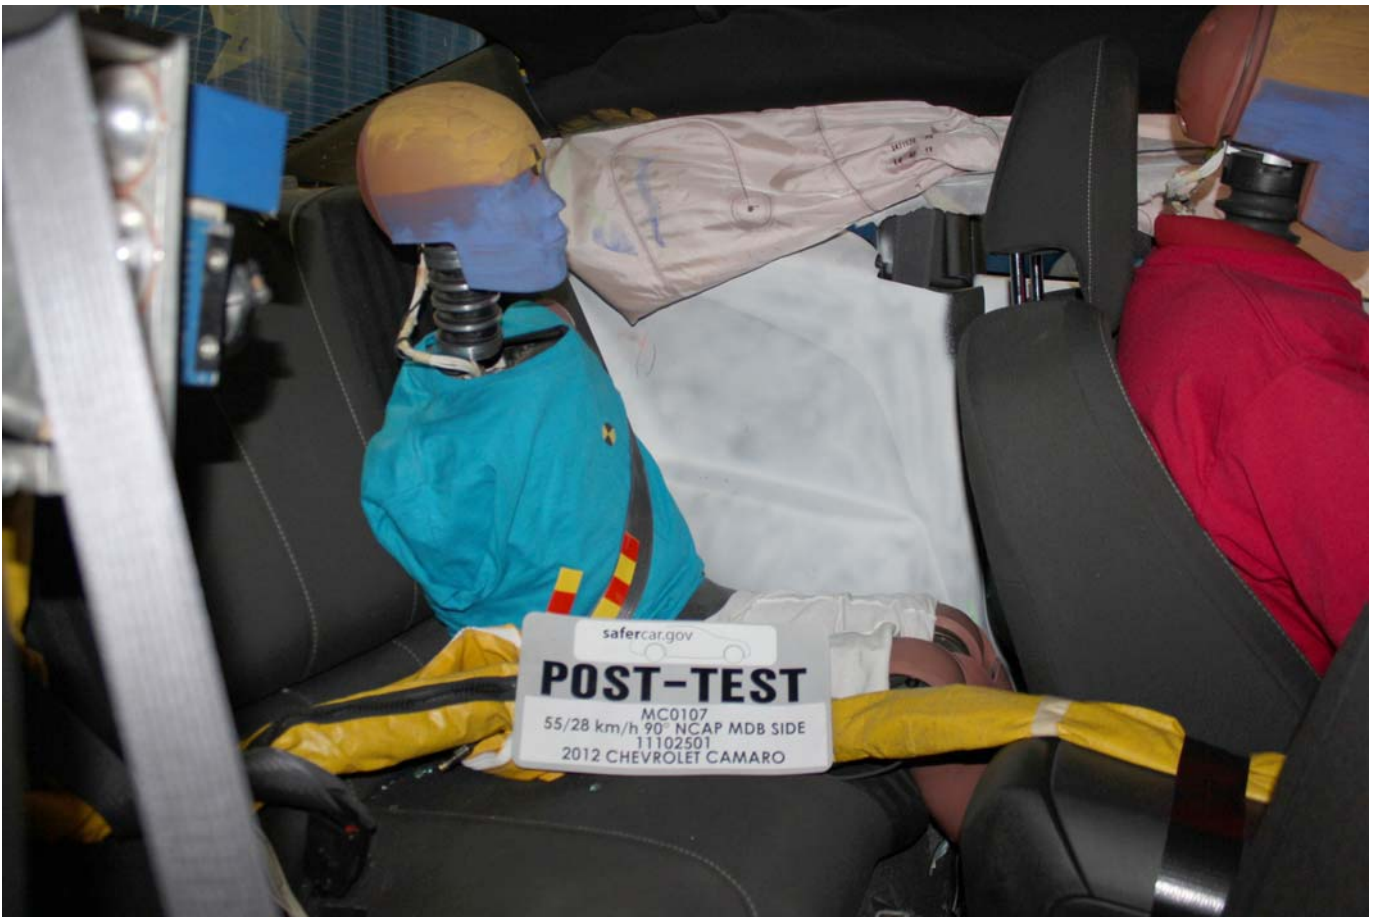
Post-Test Right Side View of Rear Passenger Dummy and Rear Seat Occupant Compartment

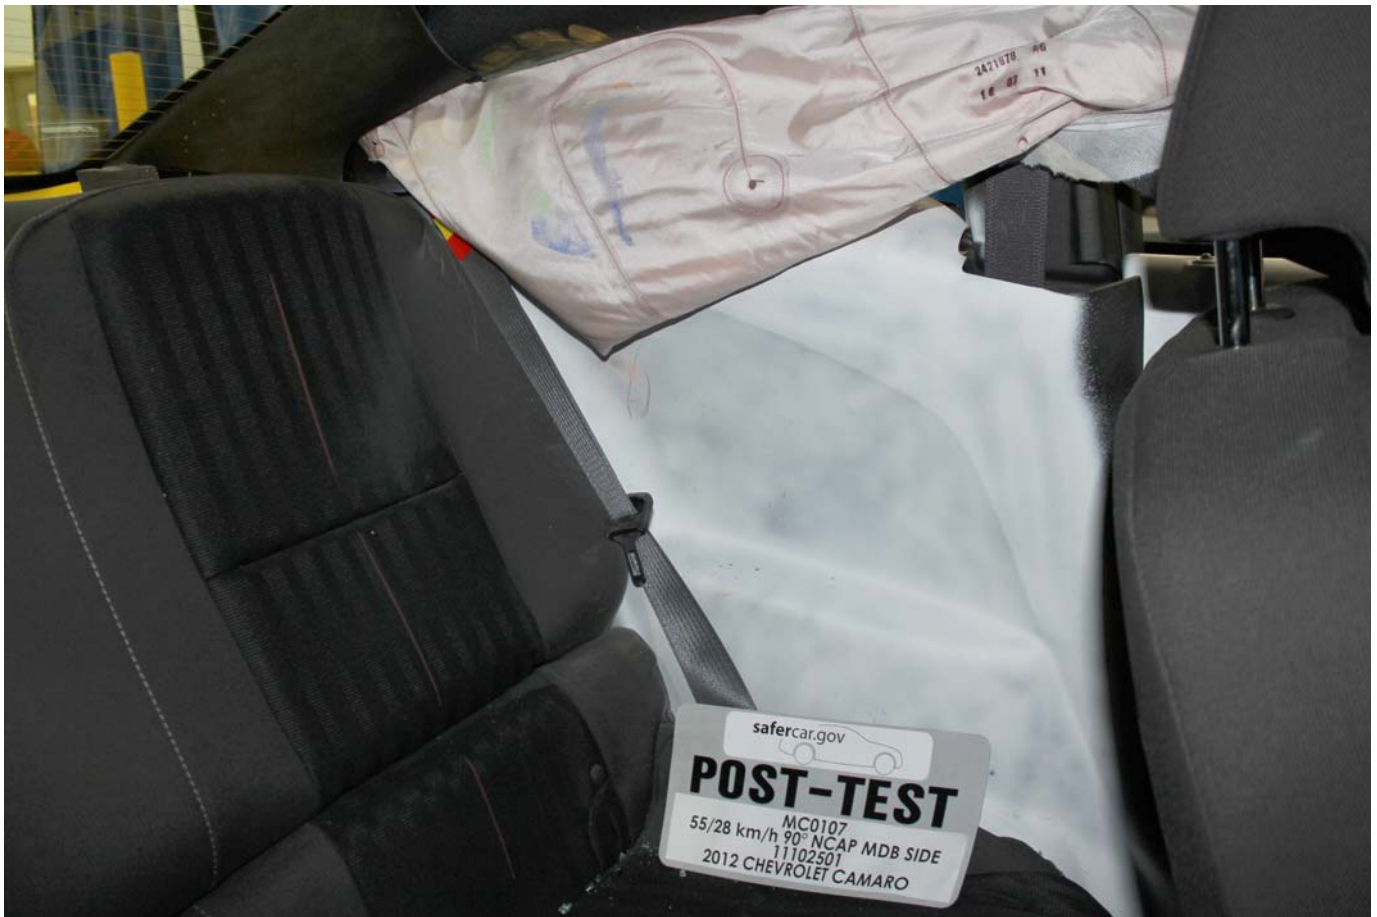
Post-Test Rear Passenger Inner Door Panel View

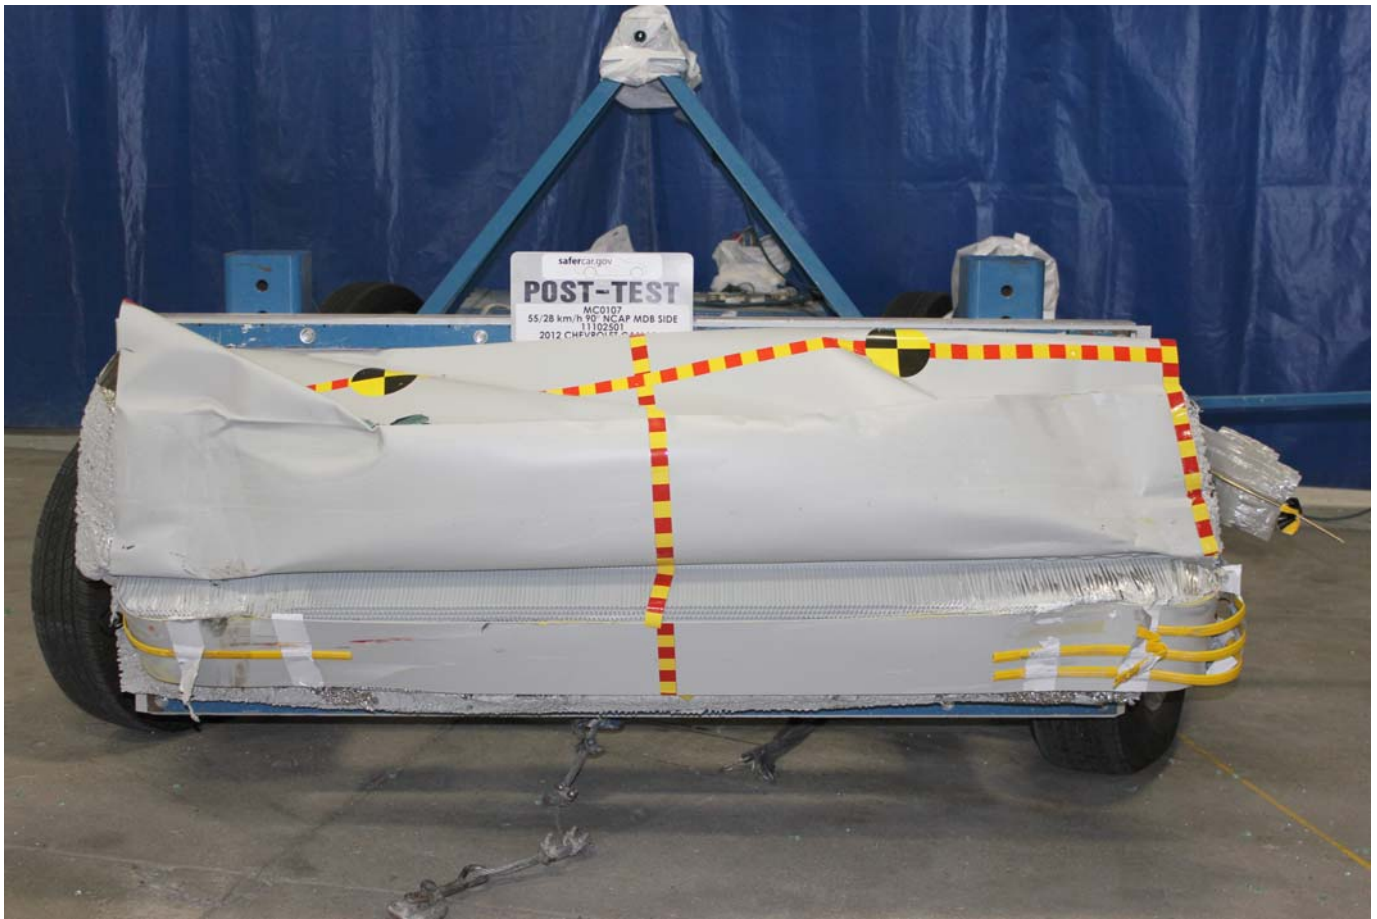
Post-Test Front View of MDB Impactor Face

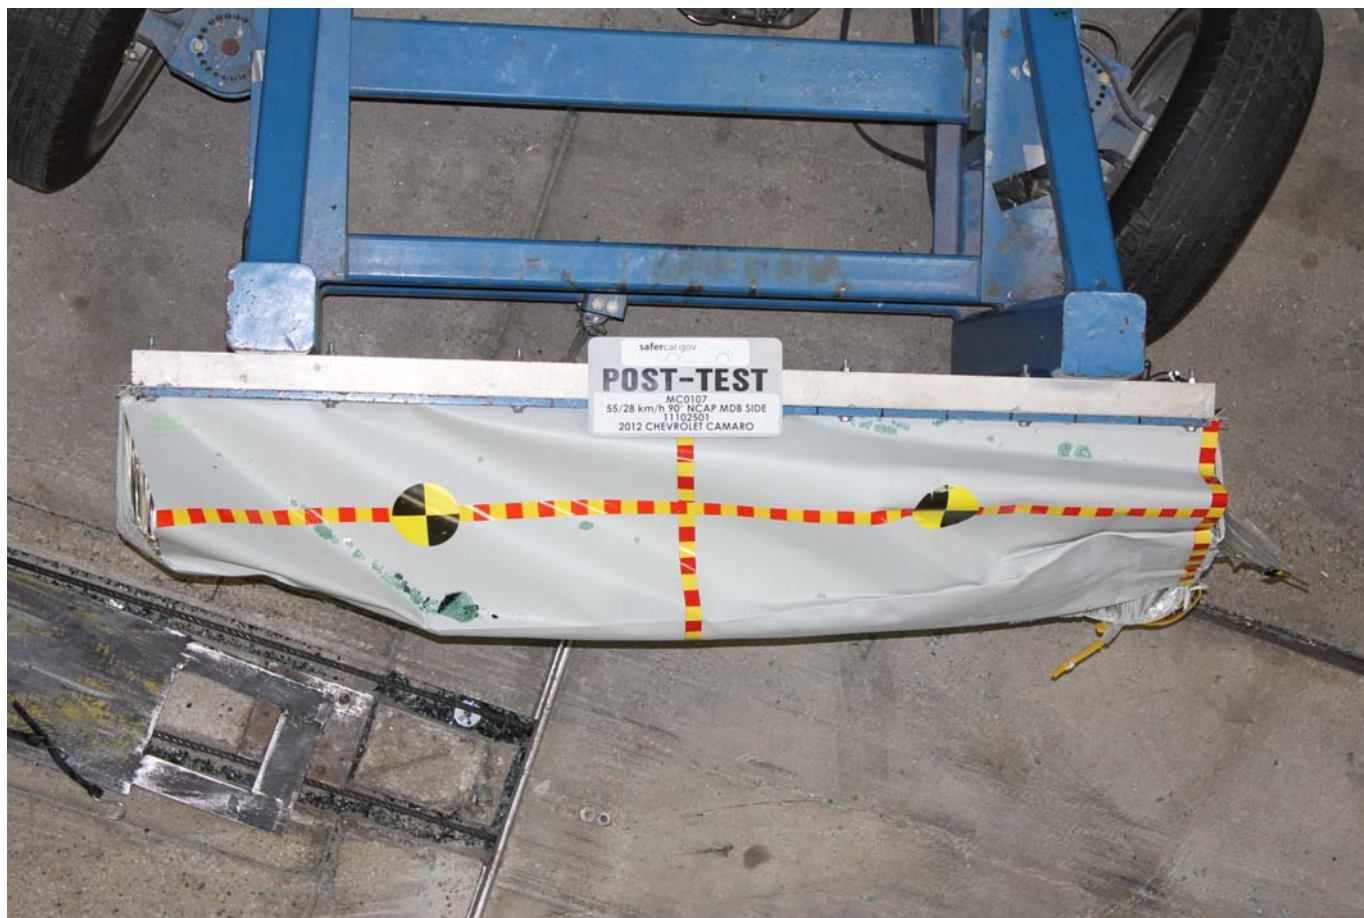
Post-Test Top View of MDB Impactor Face

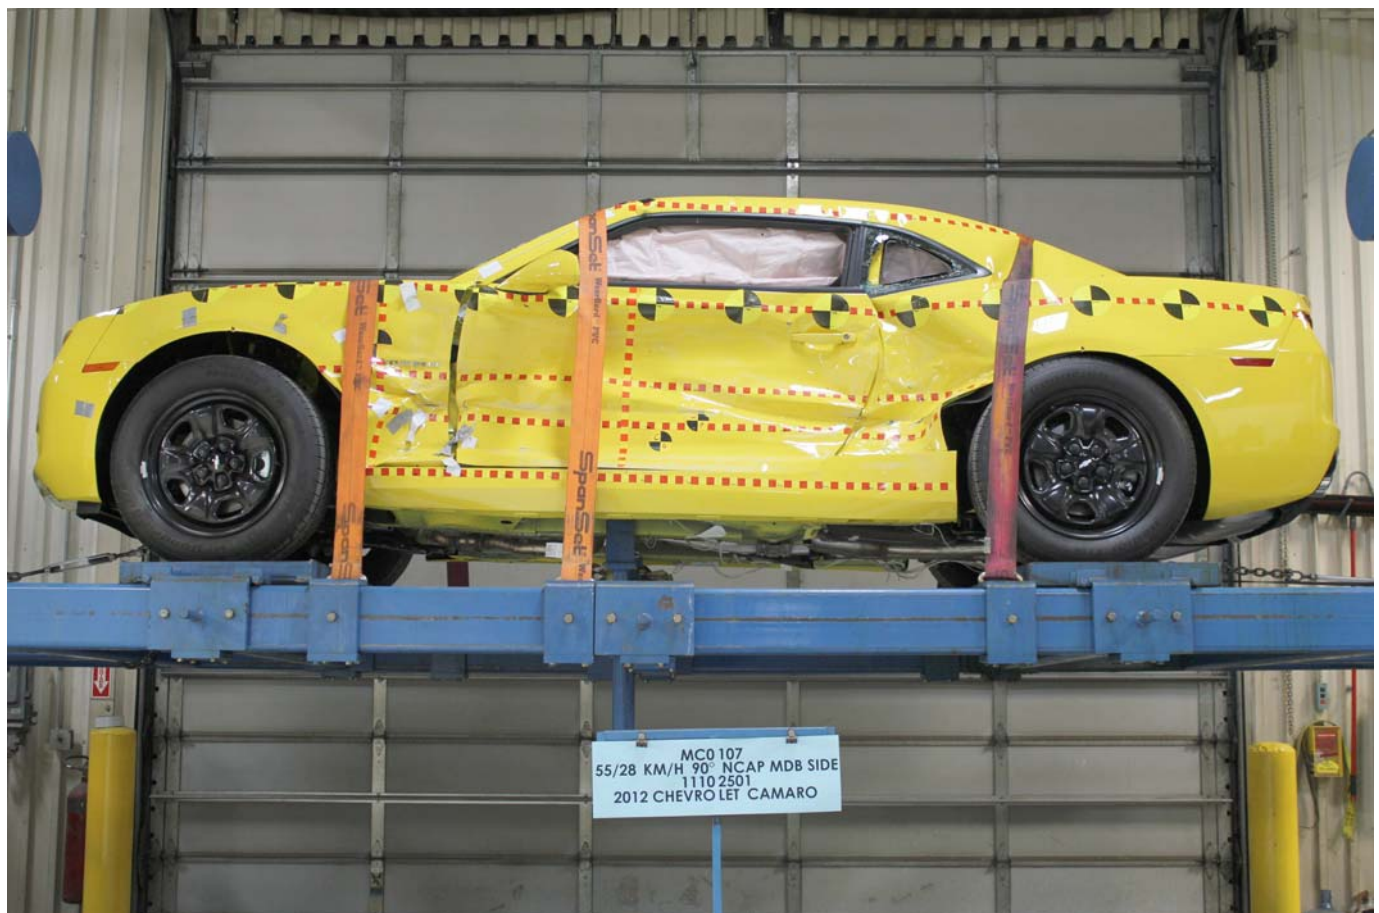
FMVSS No. 301 Static Rollover 0 Degrees

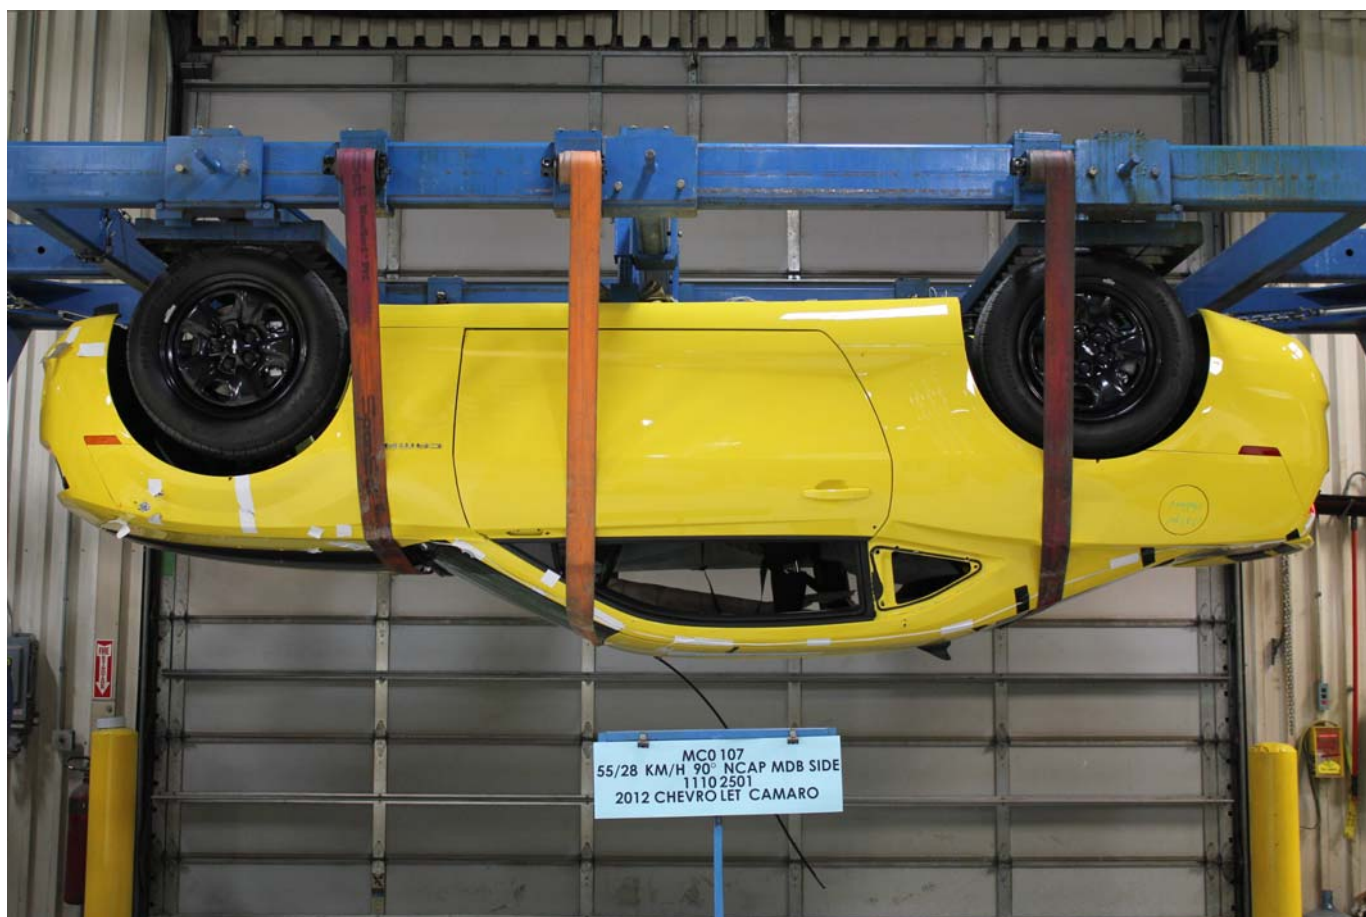
FMVSS No. 301 Static Rollover 180 Degrees

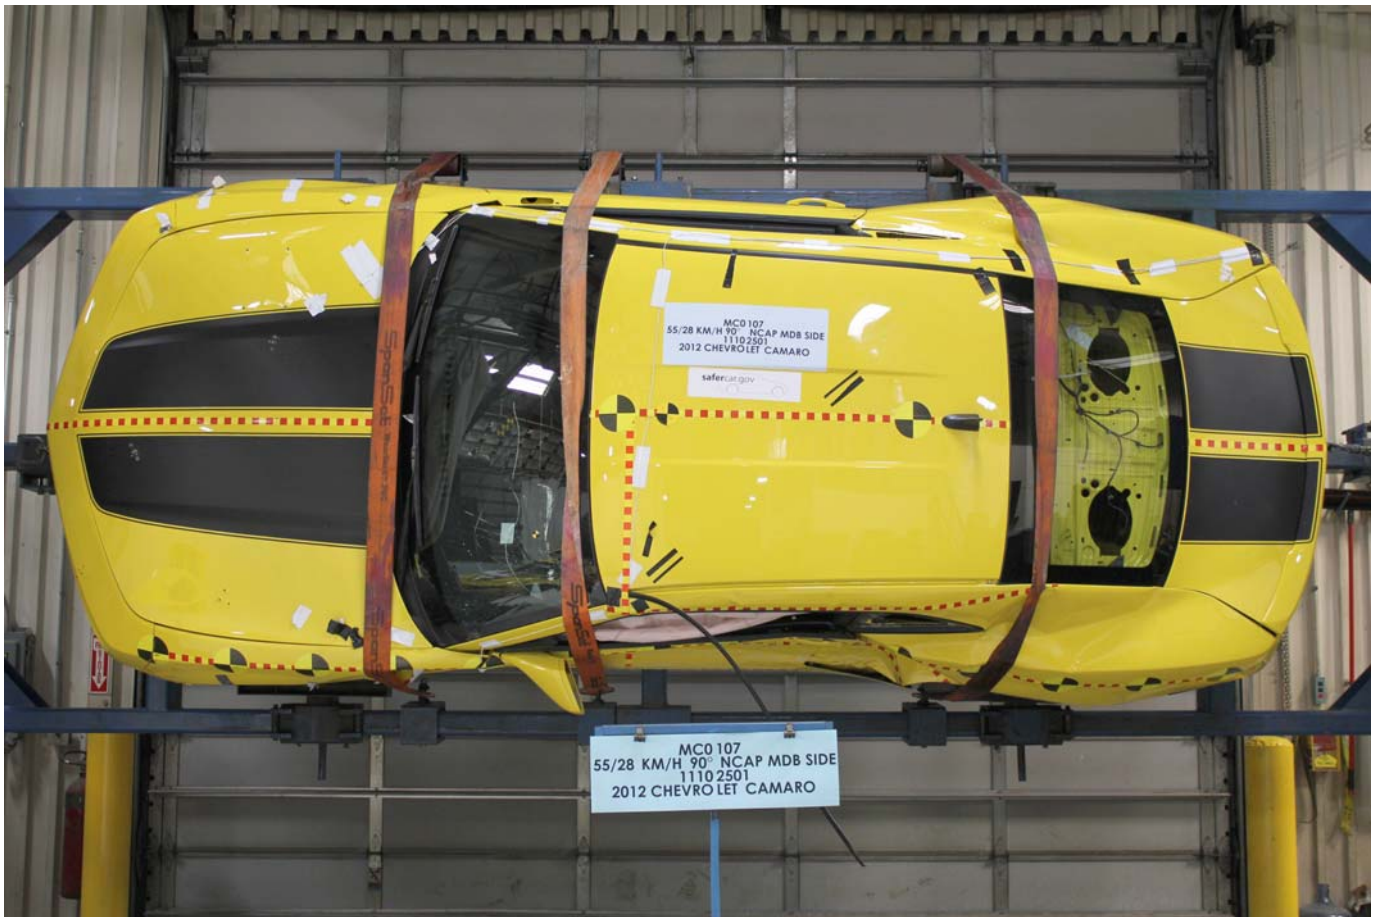
FMVSS No. 301 Static Rollover 270 Degrees

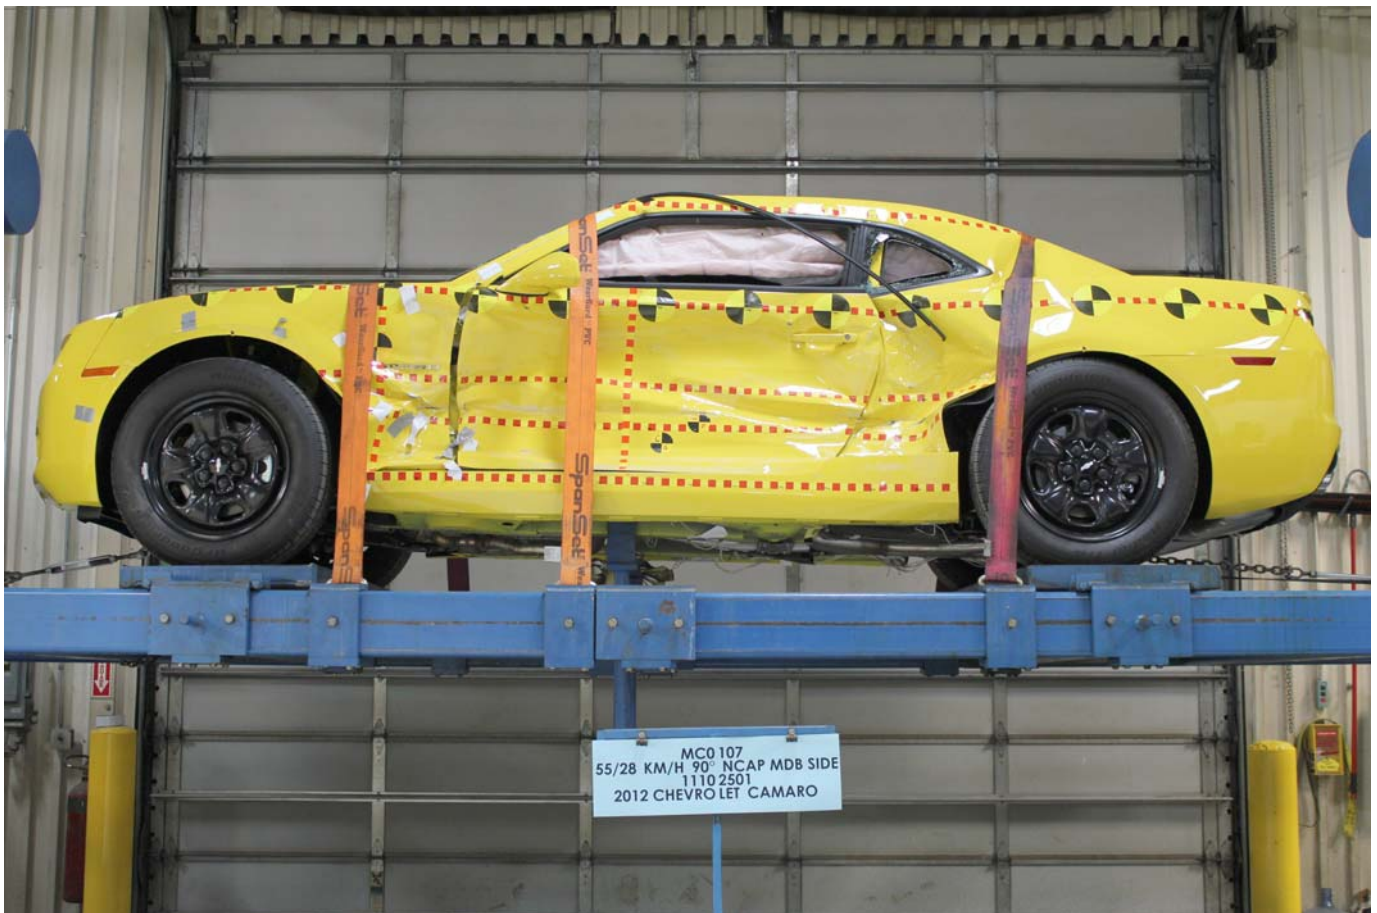
FMVSS No. 301 Static Rollover 360 Degrees
