**REPORT NUMBER: NCAP-MGA-2012-018**

**NEW CAR ASSESSMENT PROGRAM (NCAP)  
Frontal Barrier Impact Test**

**GENERAL MOTORS OF CANADA LTD.  
2012 Chevrolet Camaro 1LS 2-Dr Coupe  
NHTSA No.: MC0106**

**MGA RESEARCH CORPORATION  
5000 Warren Road  
Burlington, WI 53105**

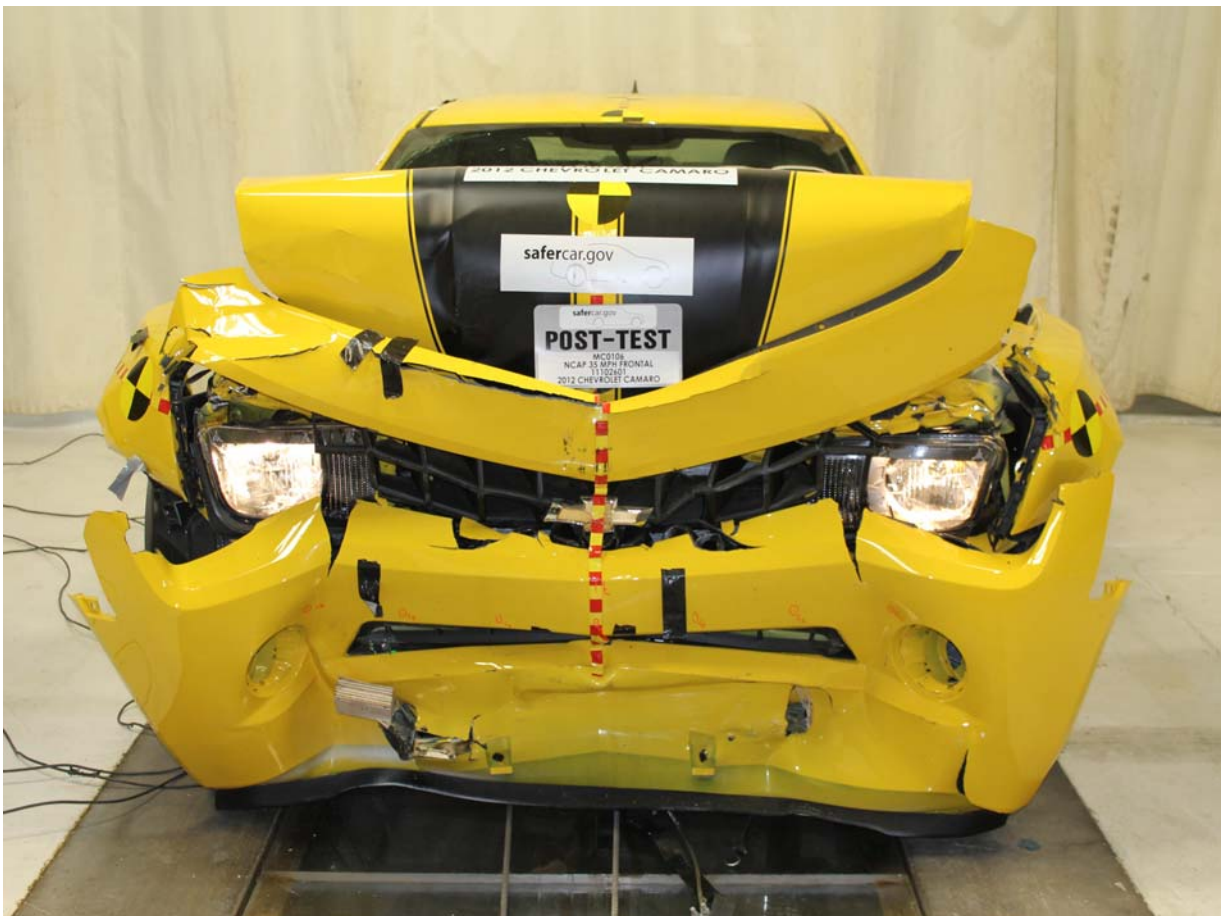
Post-Test Front View of Test Vehicle

The maximum static crush of the vehicle was 535 mm and both the driver and passenger side doors remained closed during the impact event and were operable after the impact.

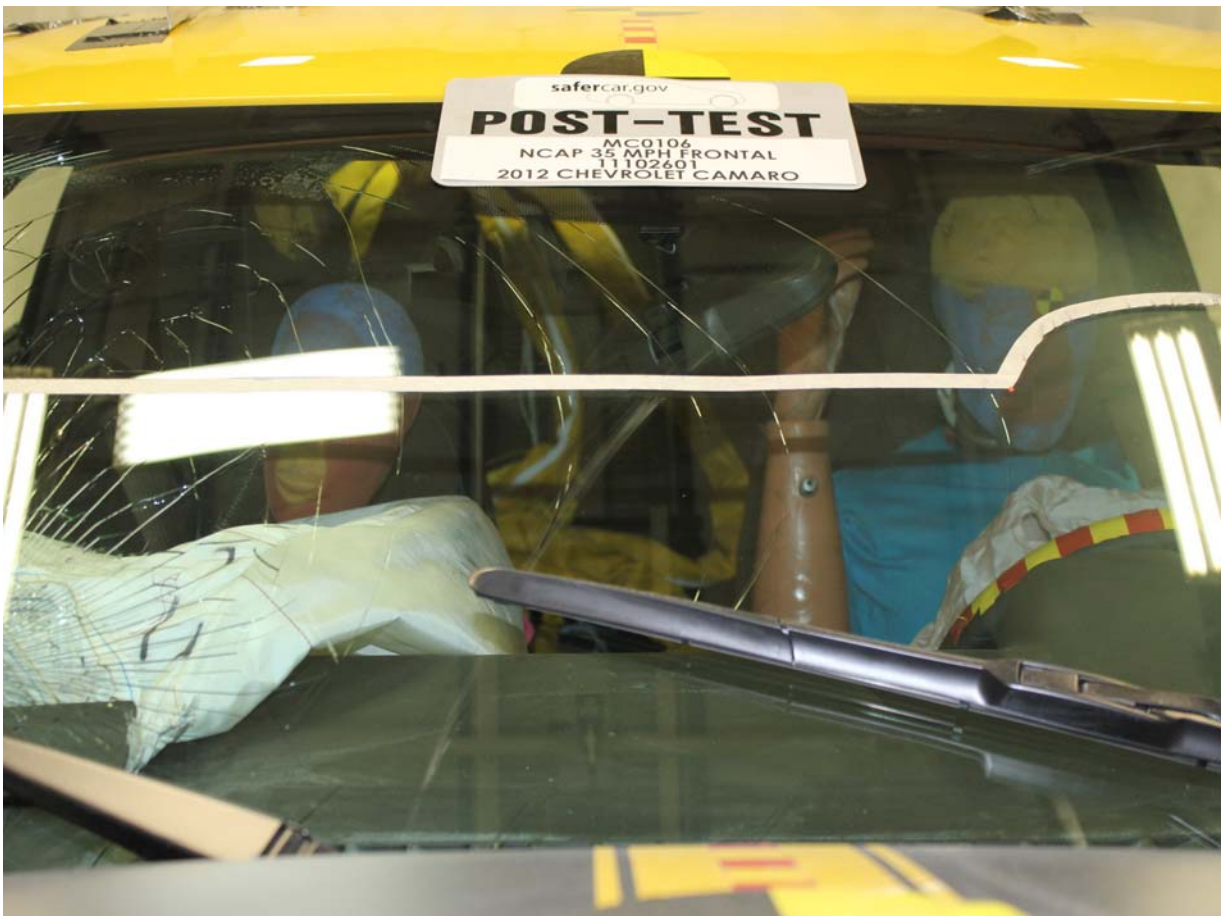
Post-Test Windshield View

There was 100 percent windshield retention and no intrusion into the protected zone of the windshield during the event. There was no Stoddard Solvent leakage after the event or during any phase of the static rollover.

| Critical Areas of Performance | Observations and Conclusions |
|---|---|
| Windshield Damage | Cracked |

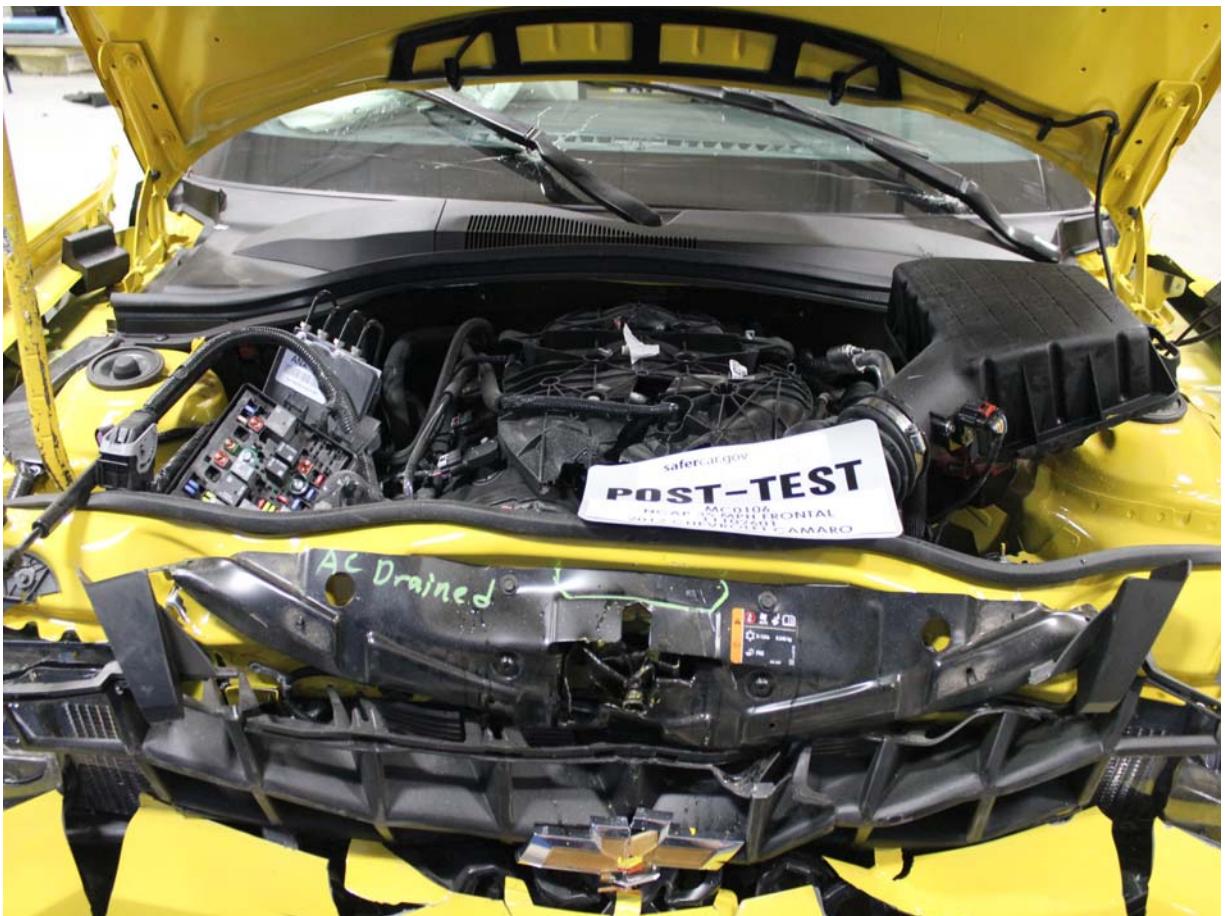
Post-Test Engine Compartment View

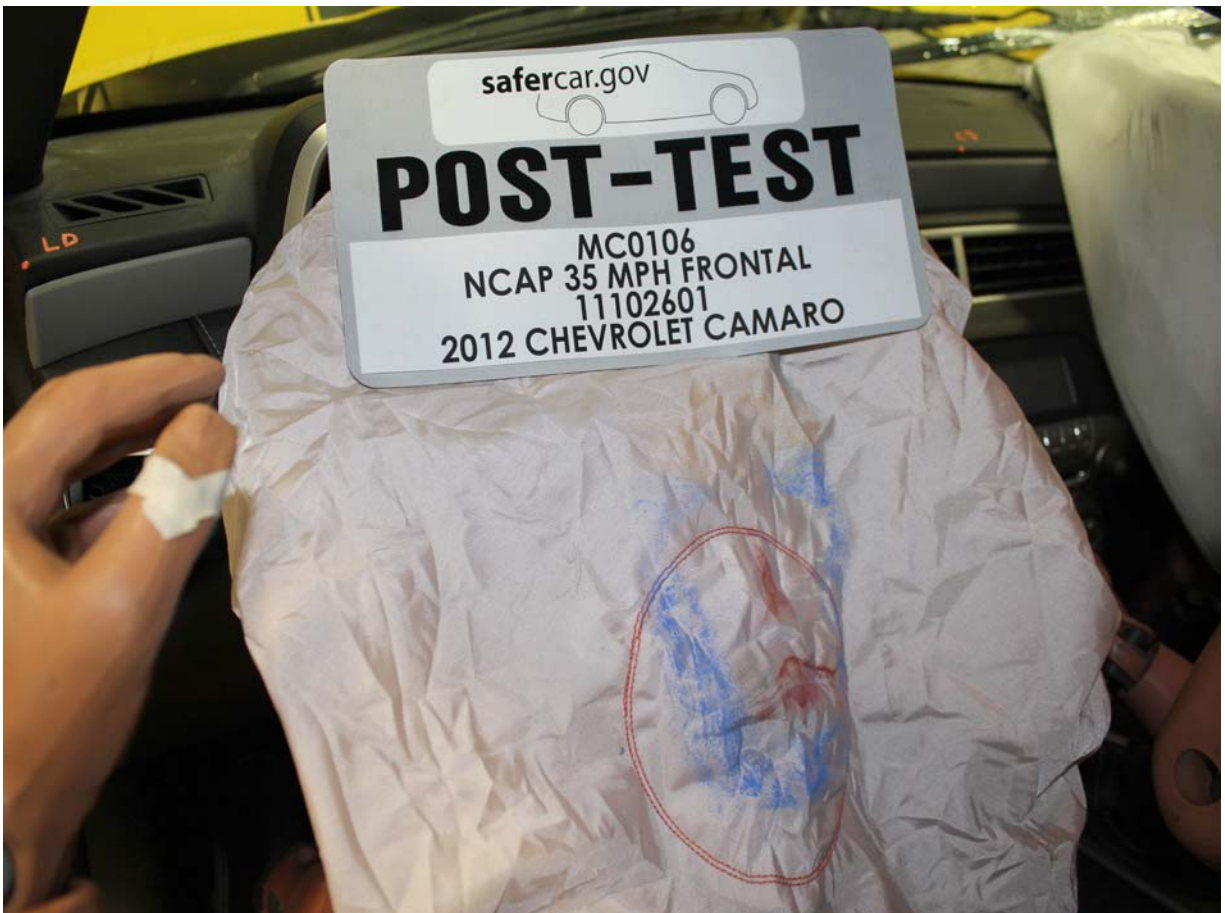
Post-Test Driver Dummy Contact with Airbag

The driver's visible contact points were as follows: The driver's head and chest contacted the airbag. The driver's head also contacted the headrest. The driver's knees contacted the knee bolster. The passenger's visible contact points were as follows: The passenger's head contacted the airbag. The passenger's head also contacted the headrest. The passenger's knees contacted the glovebox.

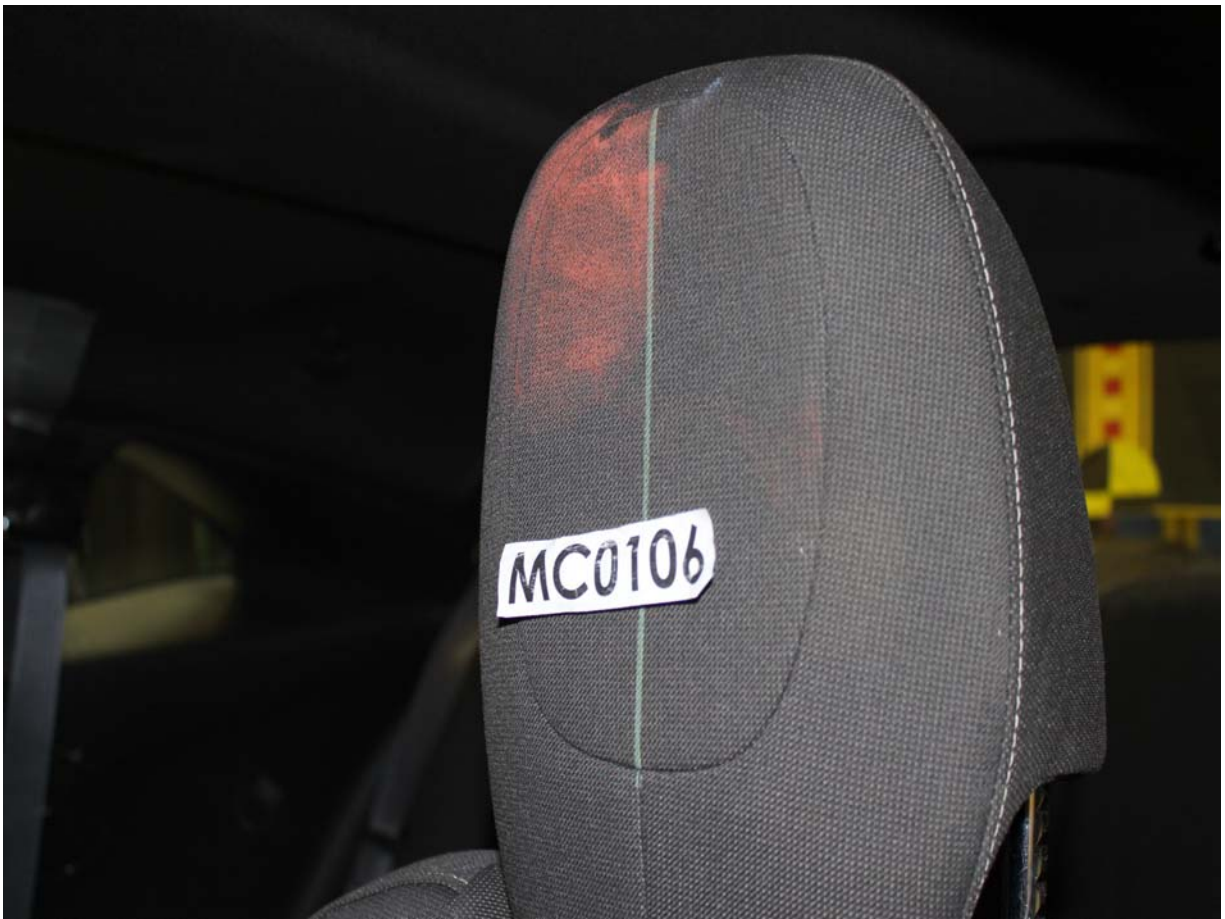
Post-Test Driver Dummy Contact with Headrest

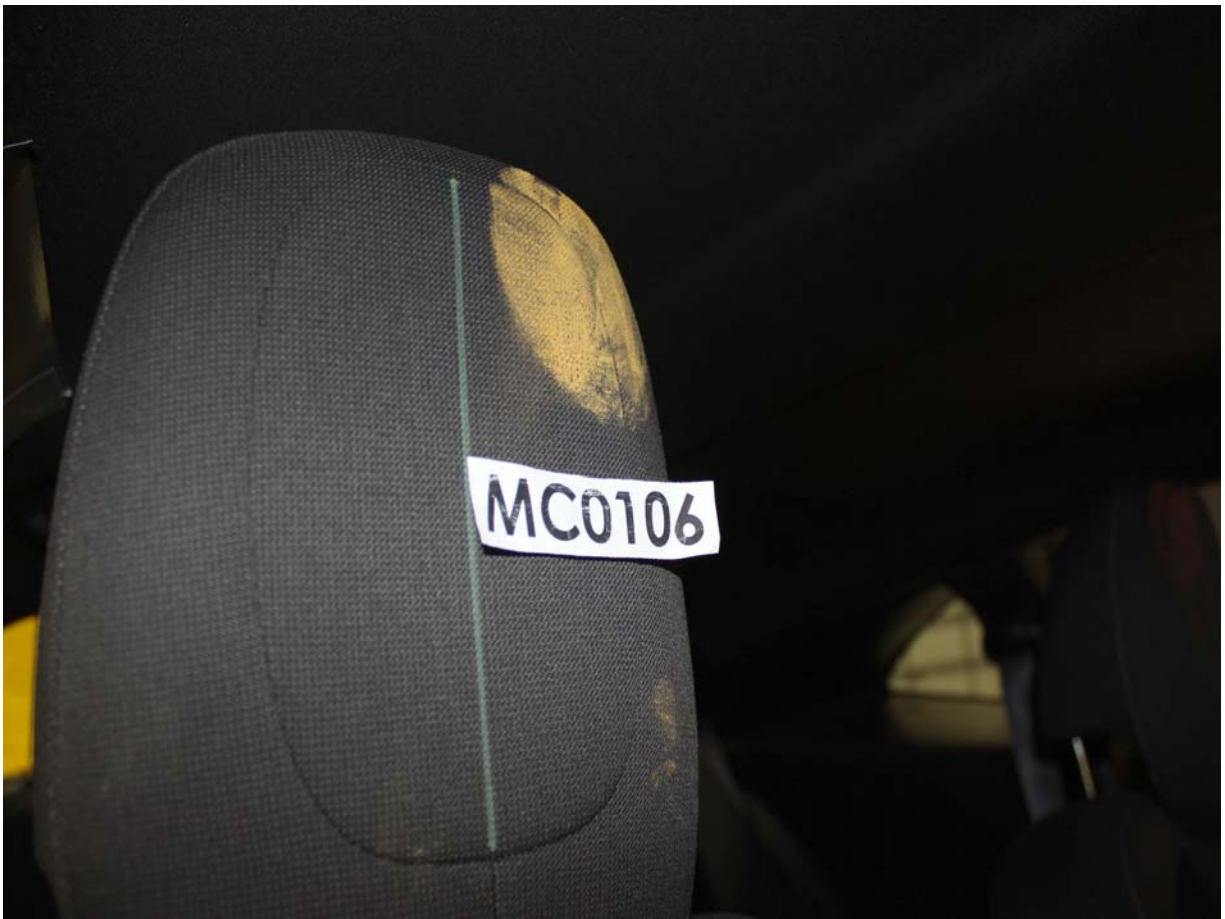
Post-Test Passenger Dummy Contact with Headrest

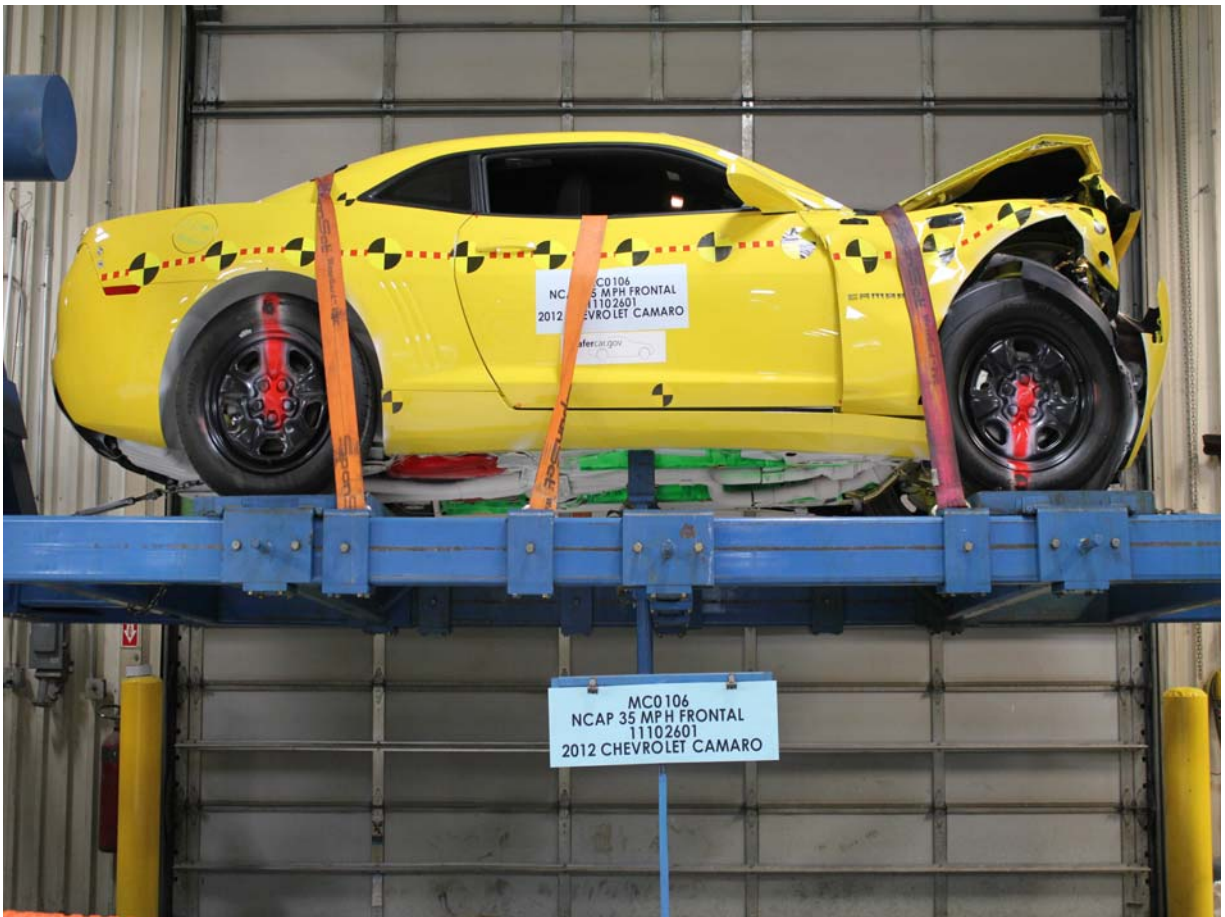
Vehicle at 0 Degrees on Static Rollover Device

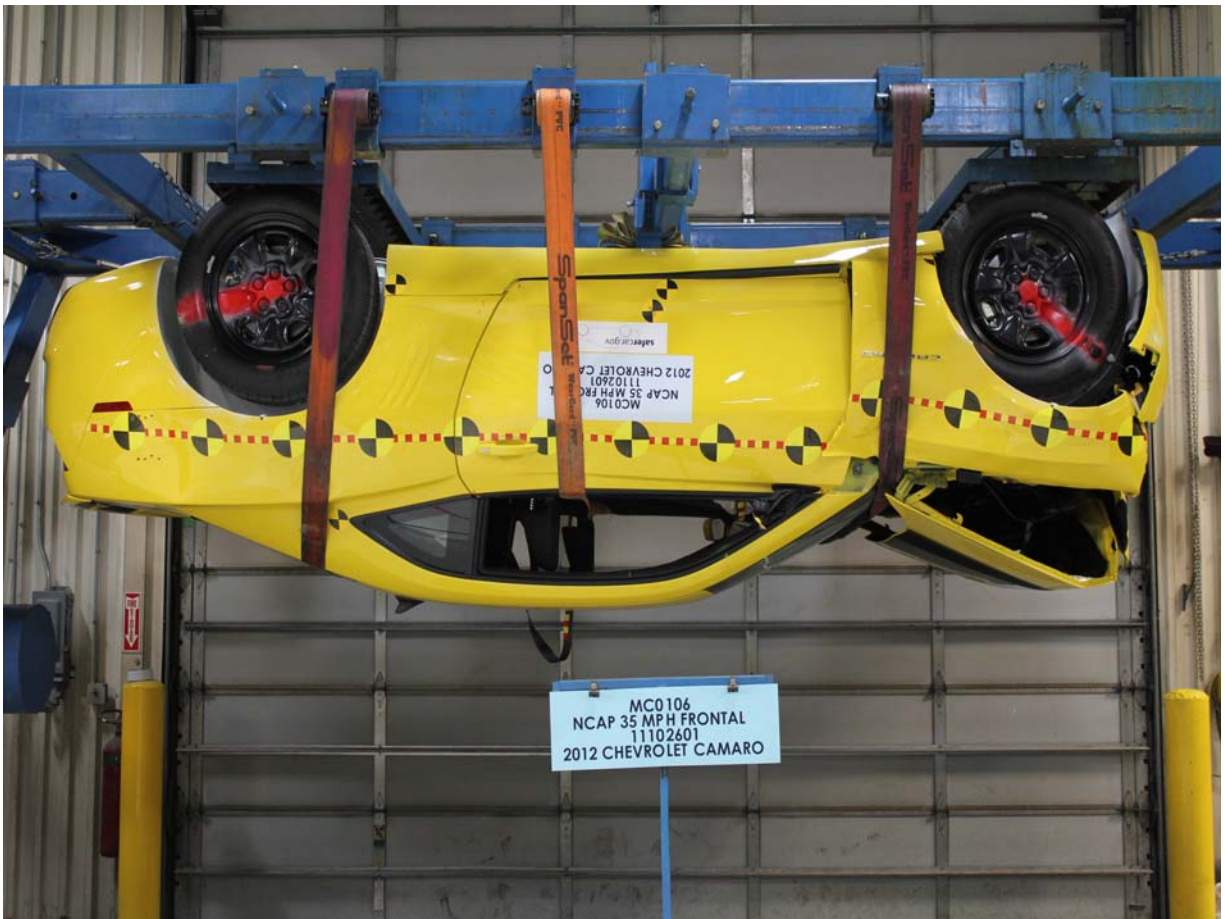
Vehicle at 180 Degrees on Static Rollover Device

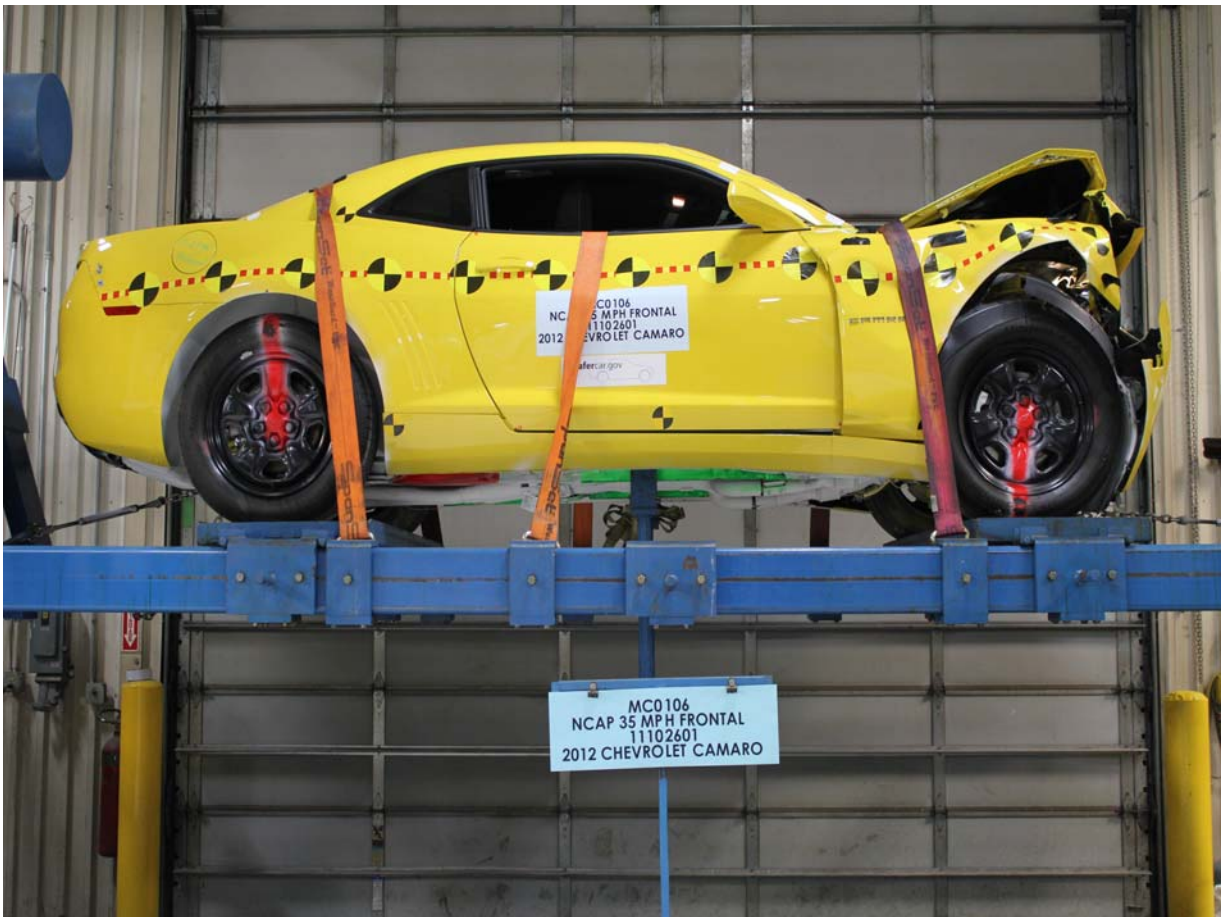
Vehicle at 360 Degrees on Static Rollover Device
