REPORT NUMBER: NCAP-MGA-2012-019

**NEW CAR ASSESSMENT PROGRAM (NCAP)
Frontal Barrier Impact Test**

**FORD MOTOR COMPANY
2012 Ford Explorer XLT 4WD SUV
NHTSA No.: MC0204**

**MGA RESEARCH CORPORATION
5000 Warren Road
Burlington, WI 53105**

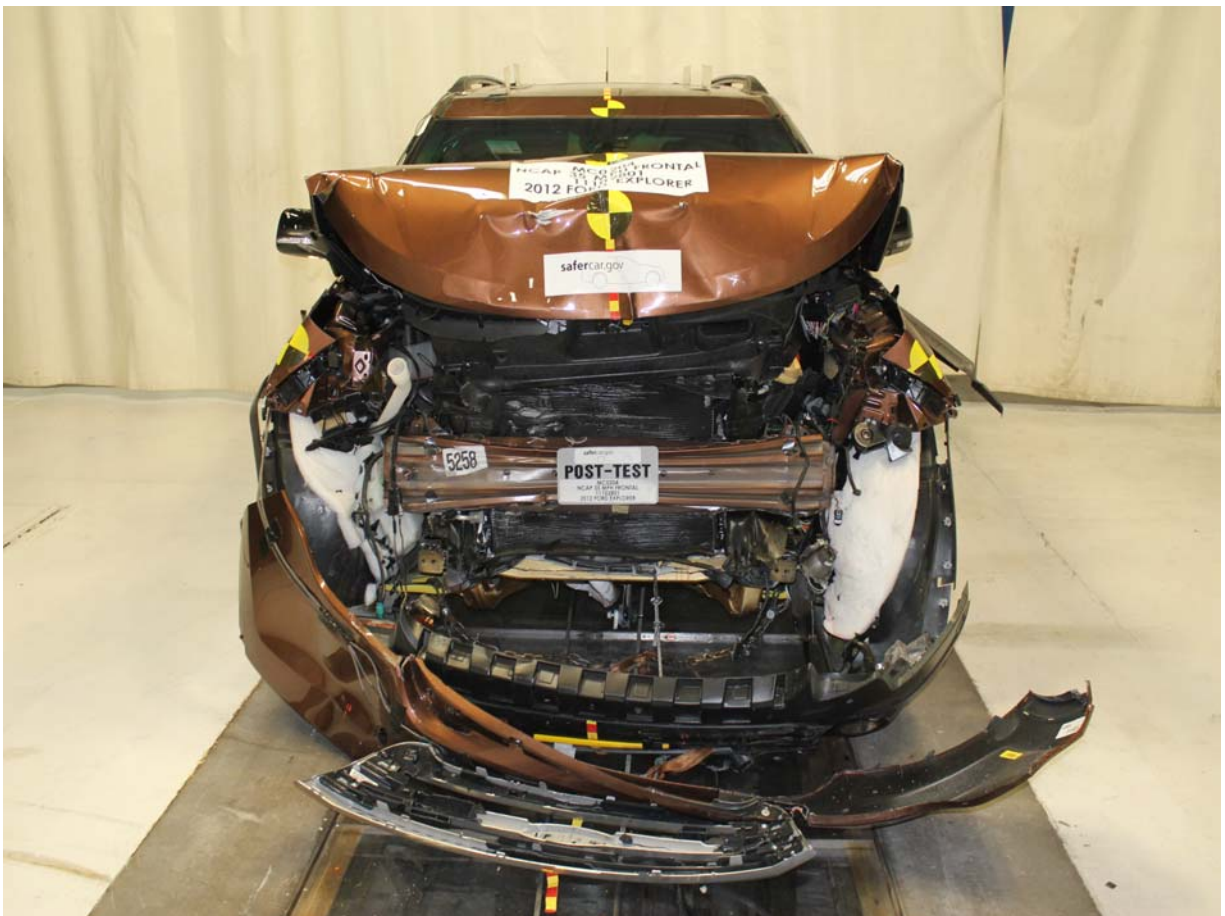
Post-Test Front View of Test Vehicle

The maximum static crush of the vehicle was 641 mm and both the driver and passenger side doors remained closed during the impact event and were operable after the impact.

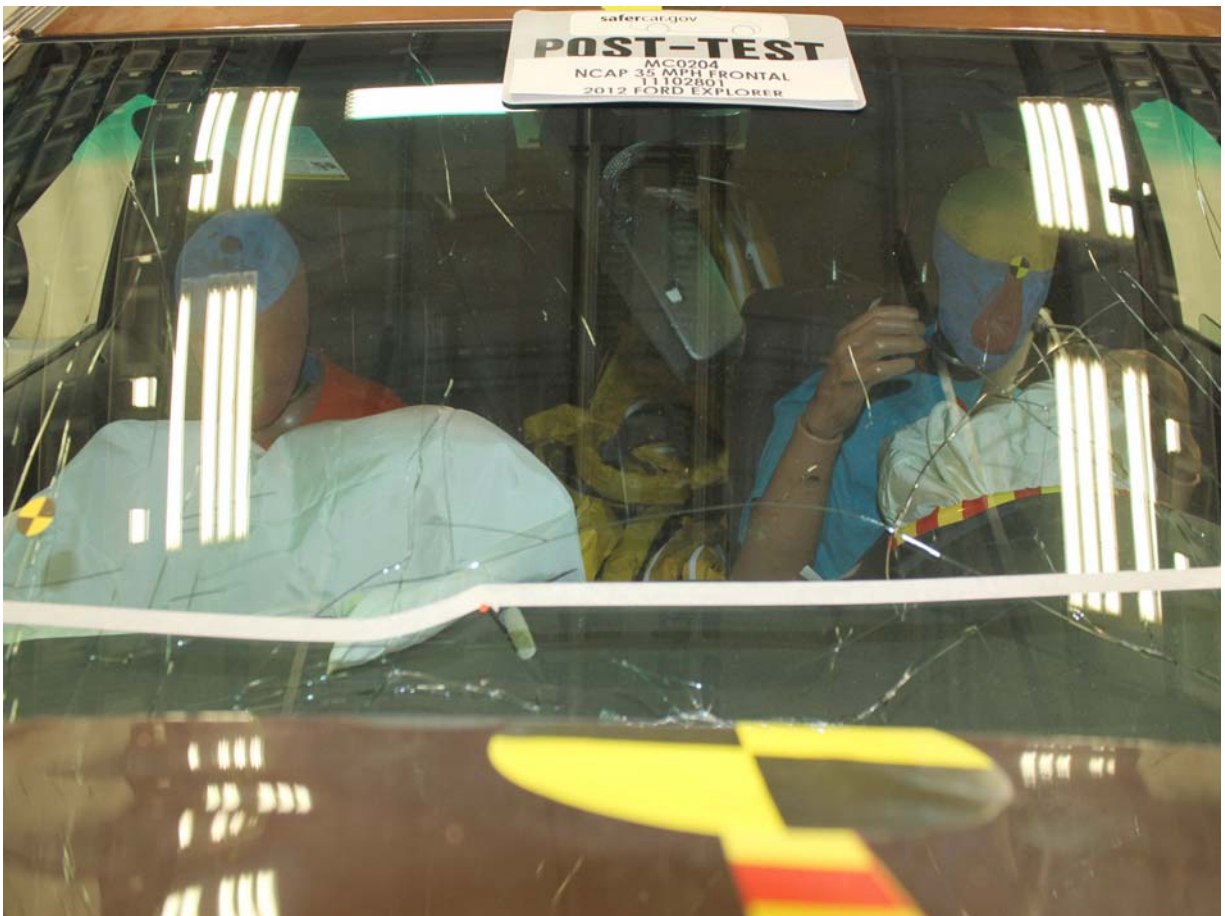
Post-Test Windshield View

There was 100 percent windshield retention and no intrusion into the protected zone of the windshield during the event. There was a trace amount of Stoddard Solvent leakage during multiple phases of the static rollover, see Data Sheet 16.

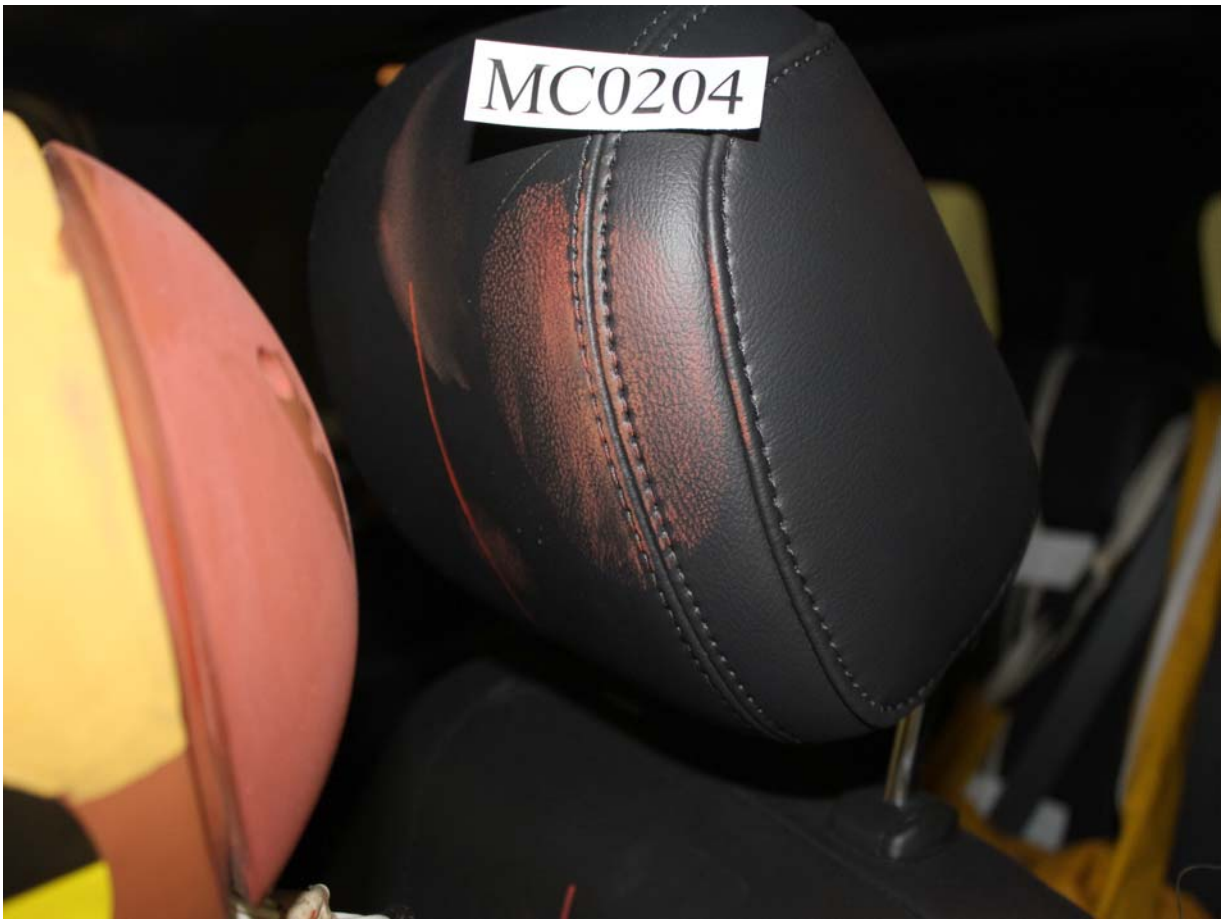
Post-Test Driver Dummy Contact with Headrest

The driver's visible contact points were as follows: The driver's head and chest contacted the airbag. The driver's head also contacted the headrest. The driver's knees contacted the knee bolster. The passenger's visible contact points were as follows: The passenger's head and chest contacted the airbag. The passenger's head also contacted the headrest. The passenger's knees contacted the glovebox.
