**REPORT NUMBER: SPNCAP-MGA-2012-020**

**NEW CAR ASSESSMENT PROGRAM (NCAP)  
Side Impact Pole Test**

**HYUNDAI MOTOR COMPANY  
2012 Hyundai Accent GLS 4-Dr Sedan  
NHTSA No.: MC0505**

**FINAL REPORT**

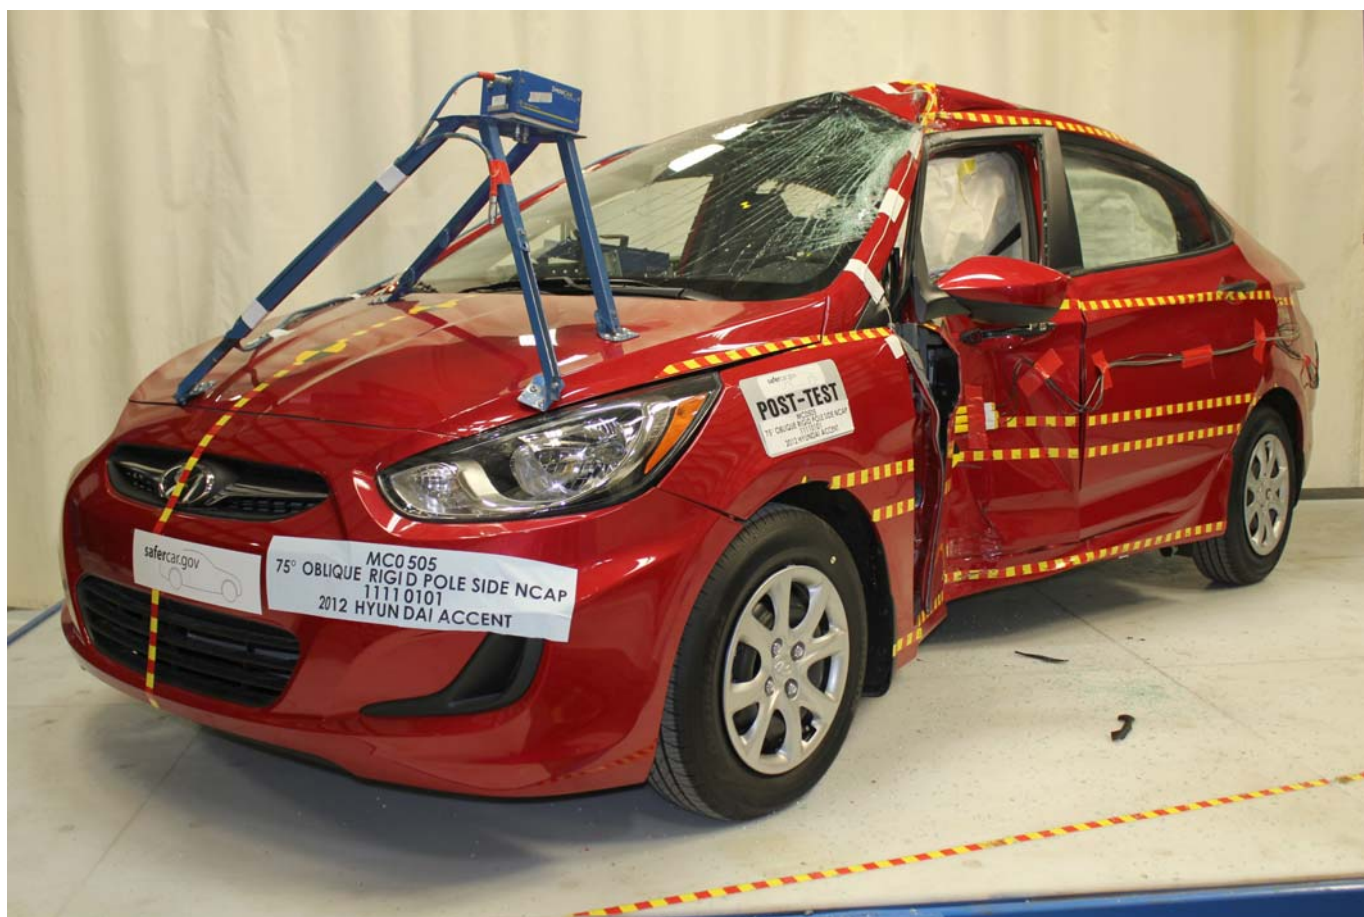
Post-Test Left Front  $\frac{3}{4}$  View of Test Vehicle

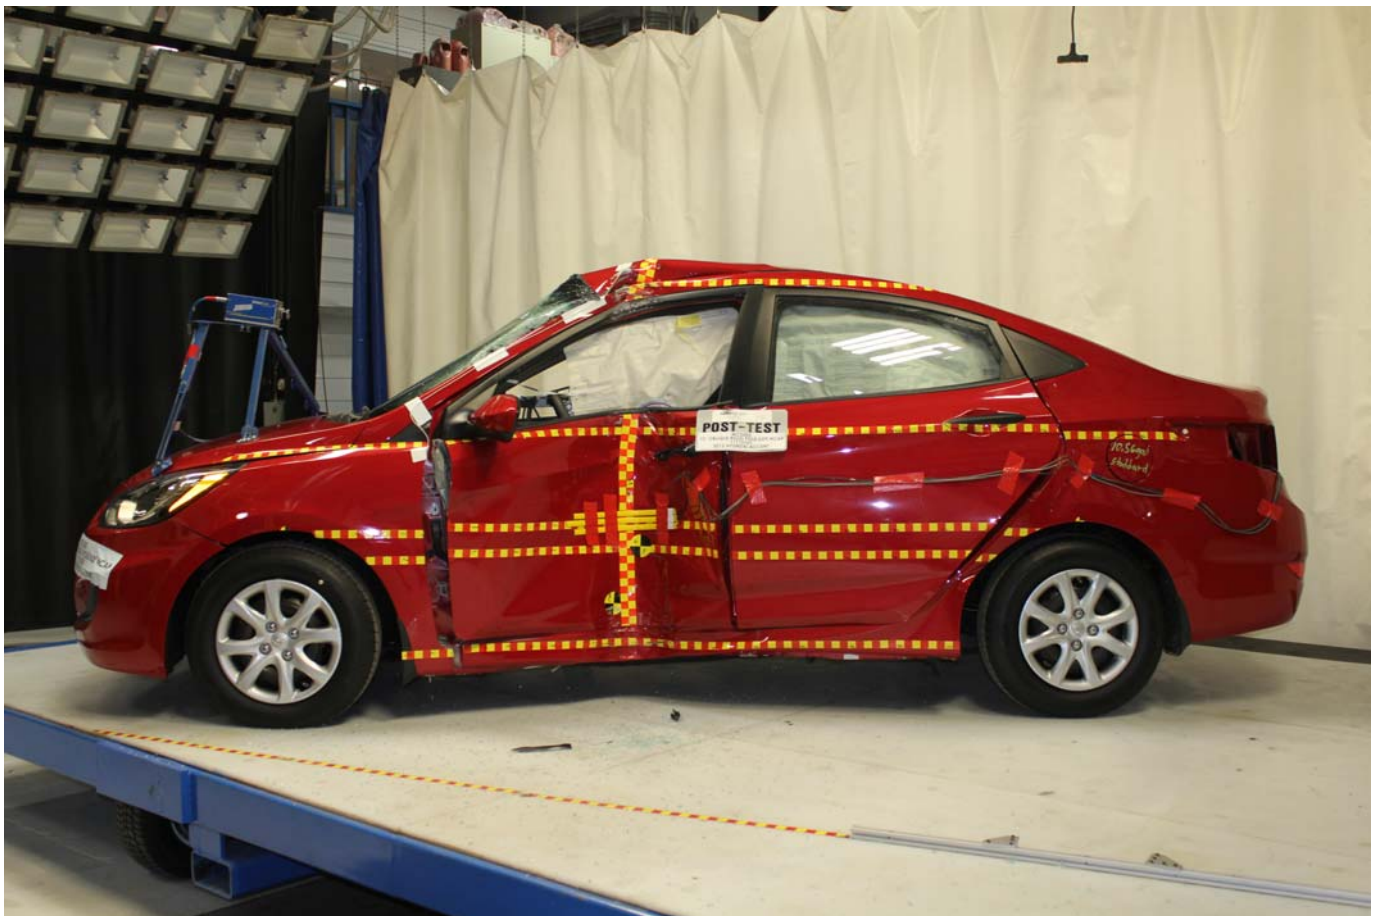
Post-Test Left Side View of Test Vehicle

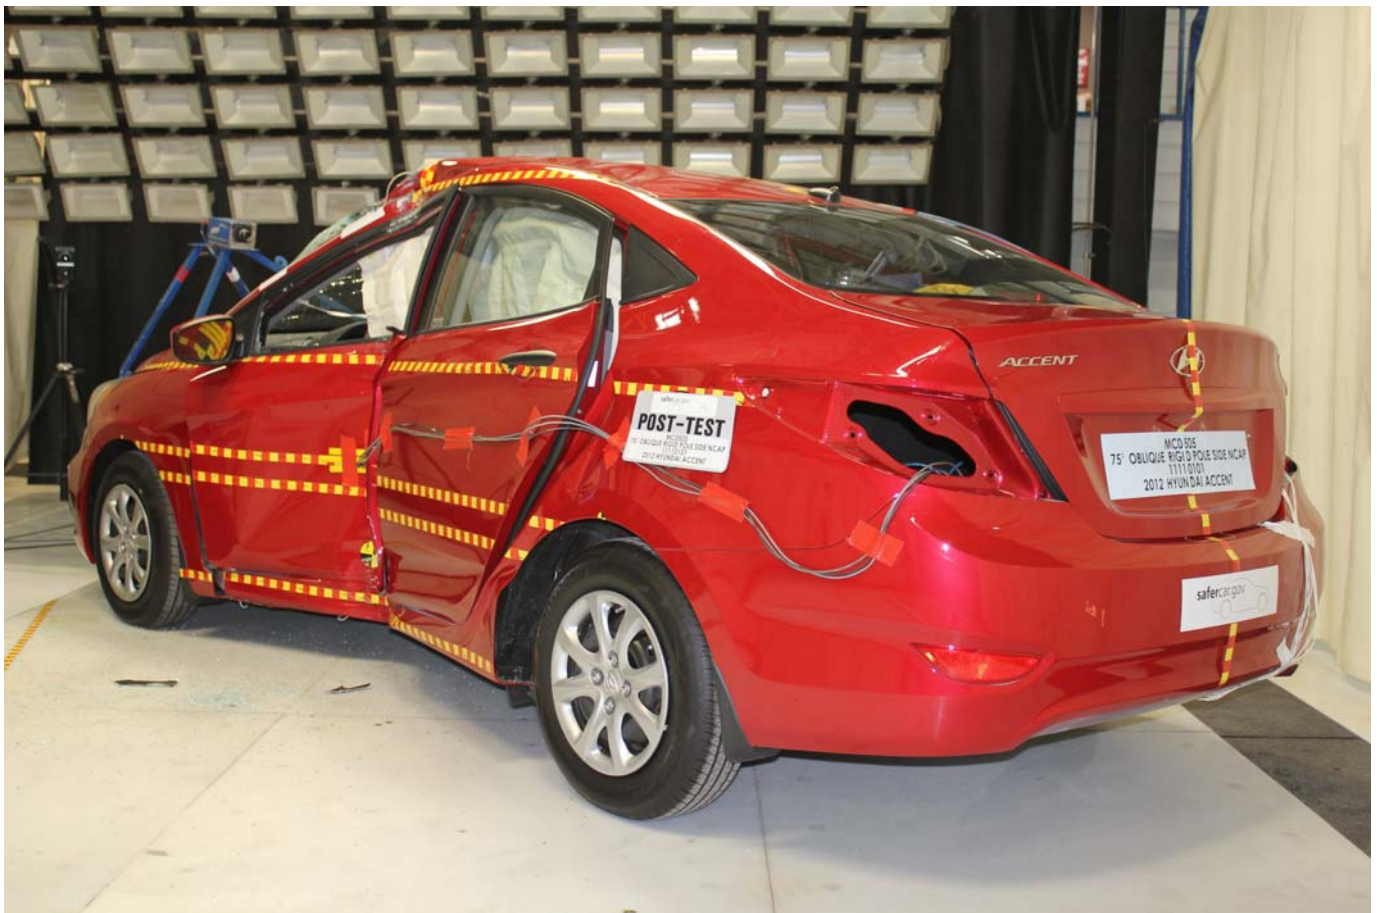
Post-Test Left Rear  $\frac{3}{4}$  View of Test Vehicle

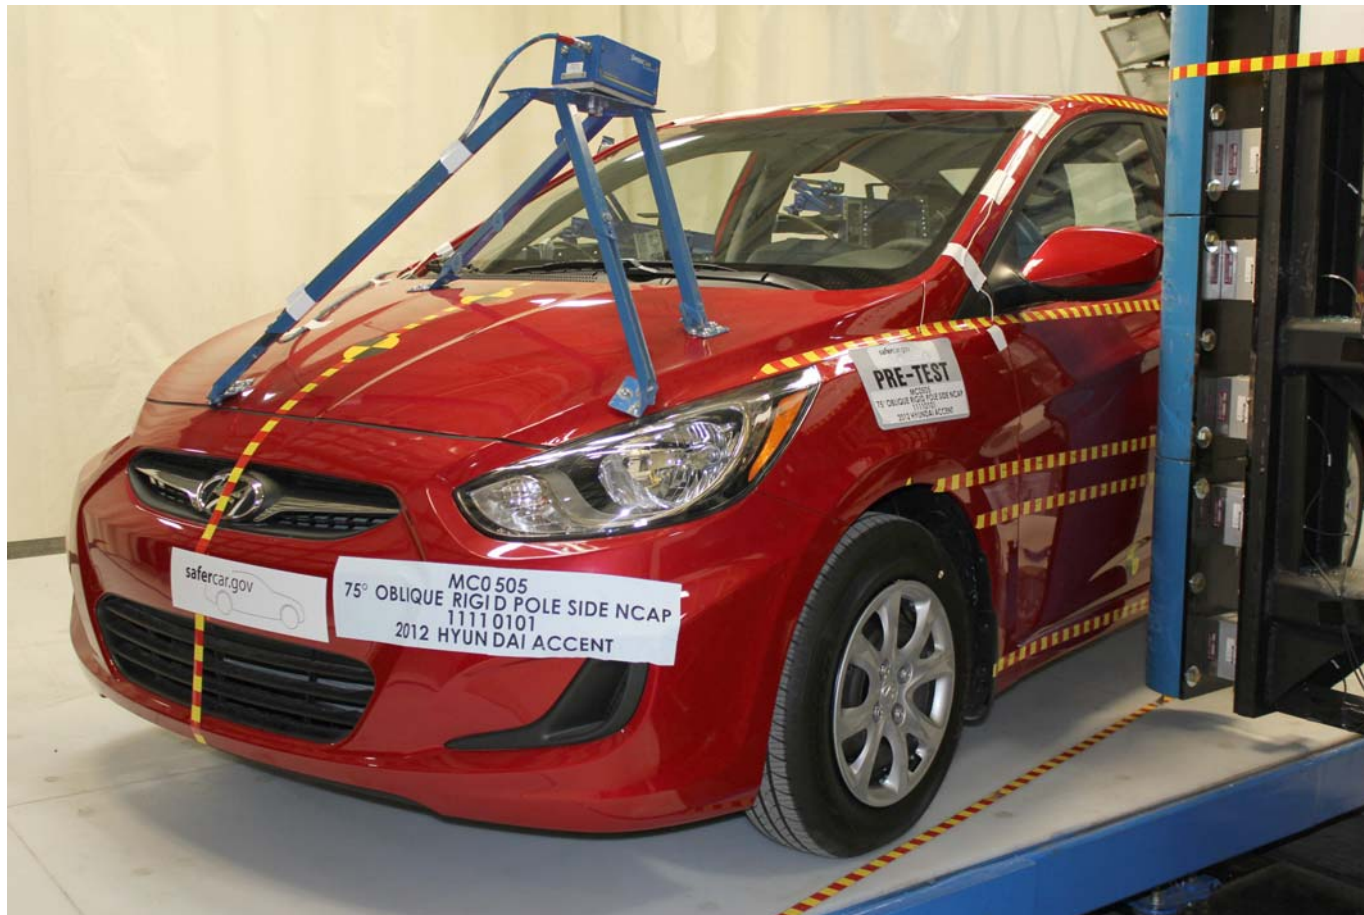
Pre-Test Left Side View of Pole Positioned Against Side of Vehicle

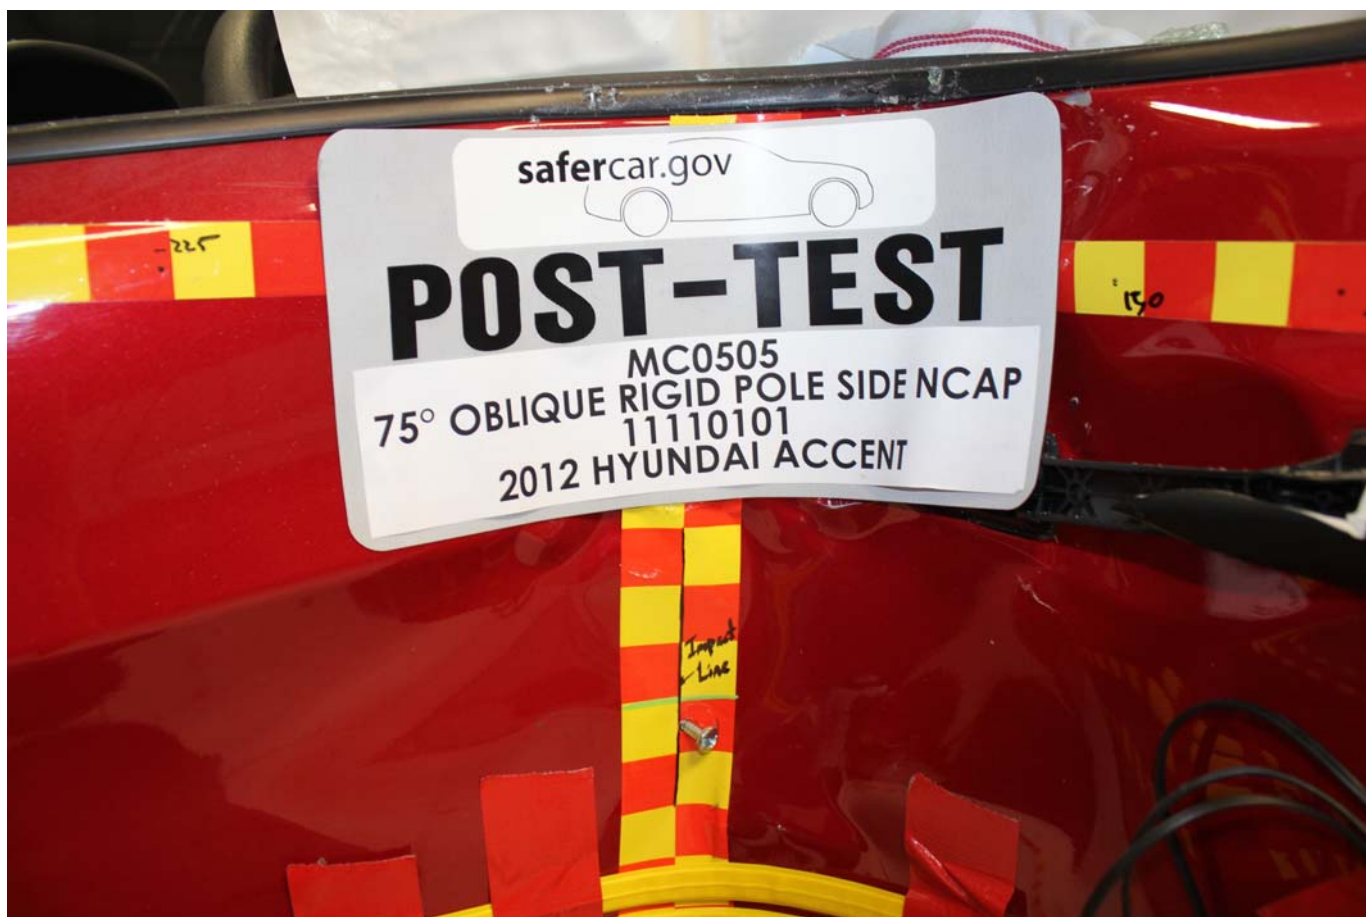
Post-Test Close-Up View of Impact Point Target Showing Impact Location

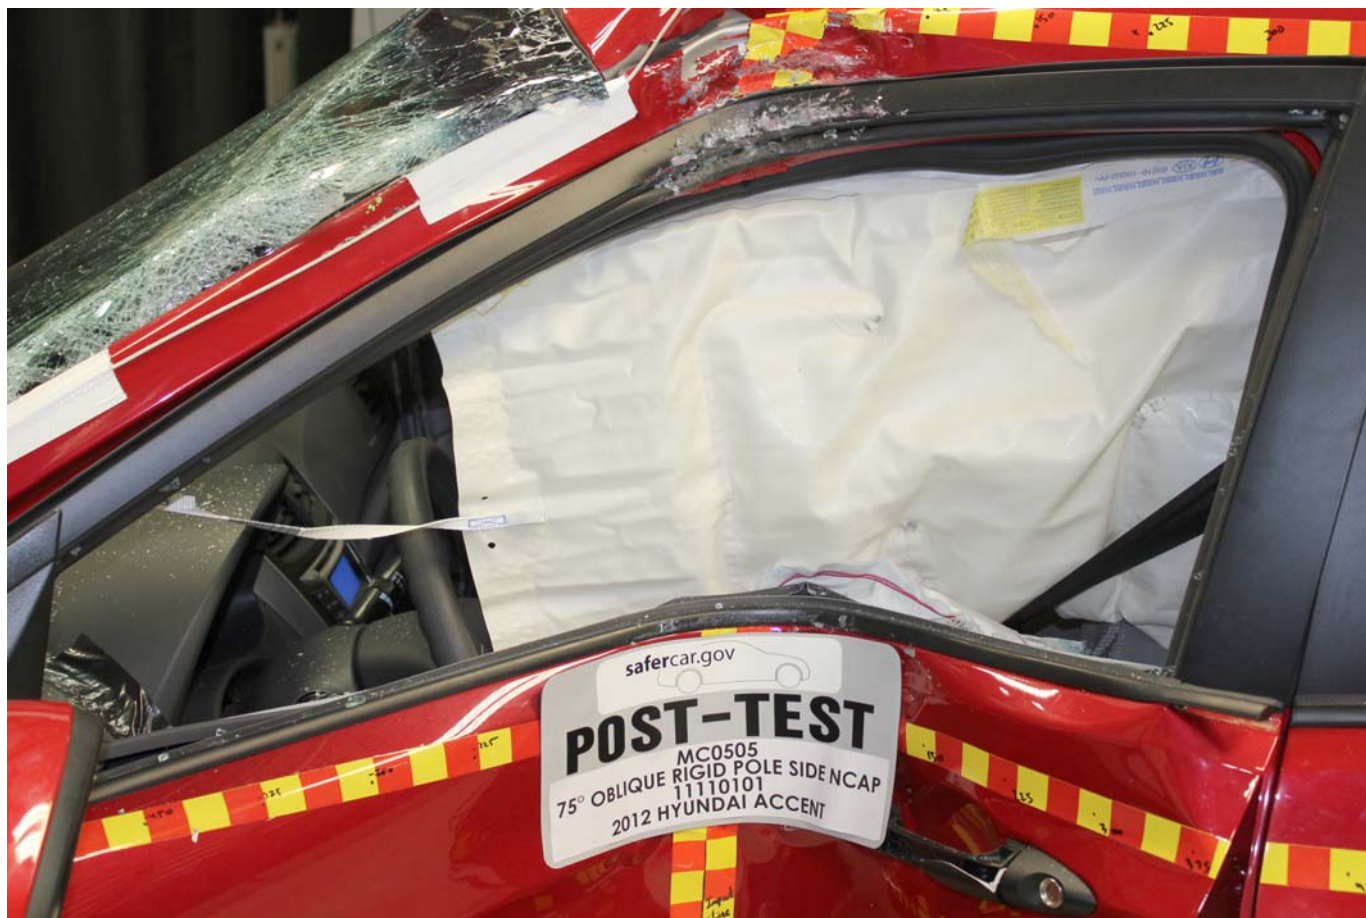
Post-Test Left Side View of Dummy Shoulder and Door Top View

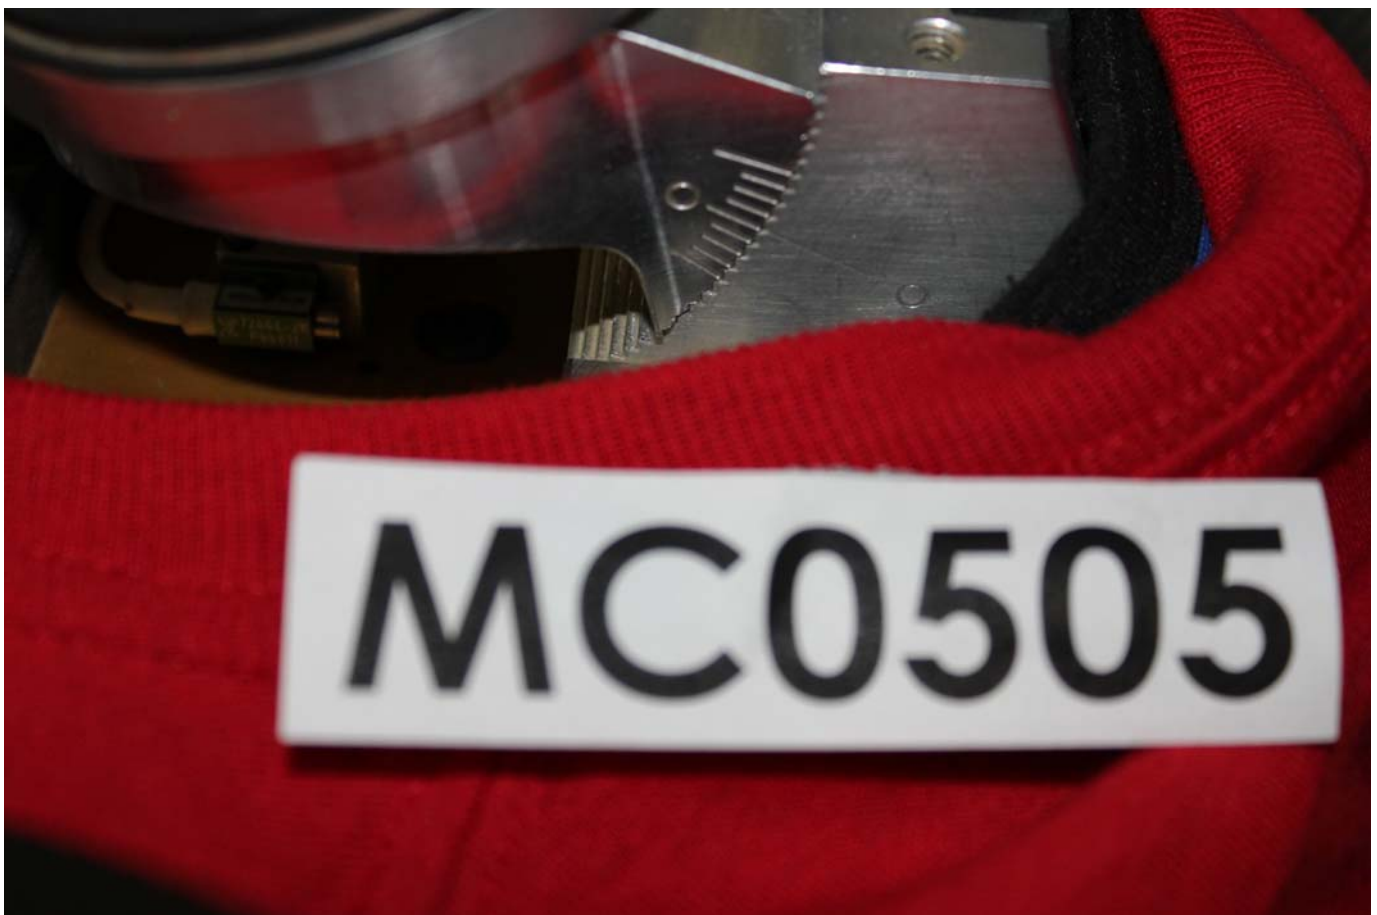
Pre-Test Left Side View of Dummy's Neck Showing Position of Adjustable Neck Bracket

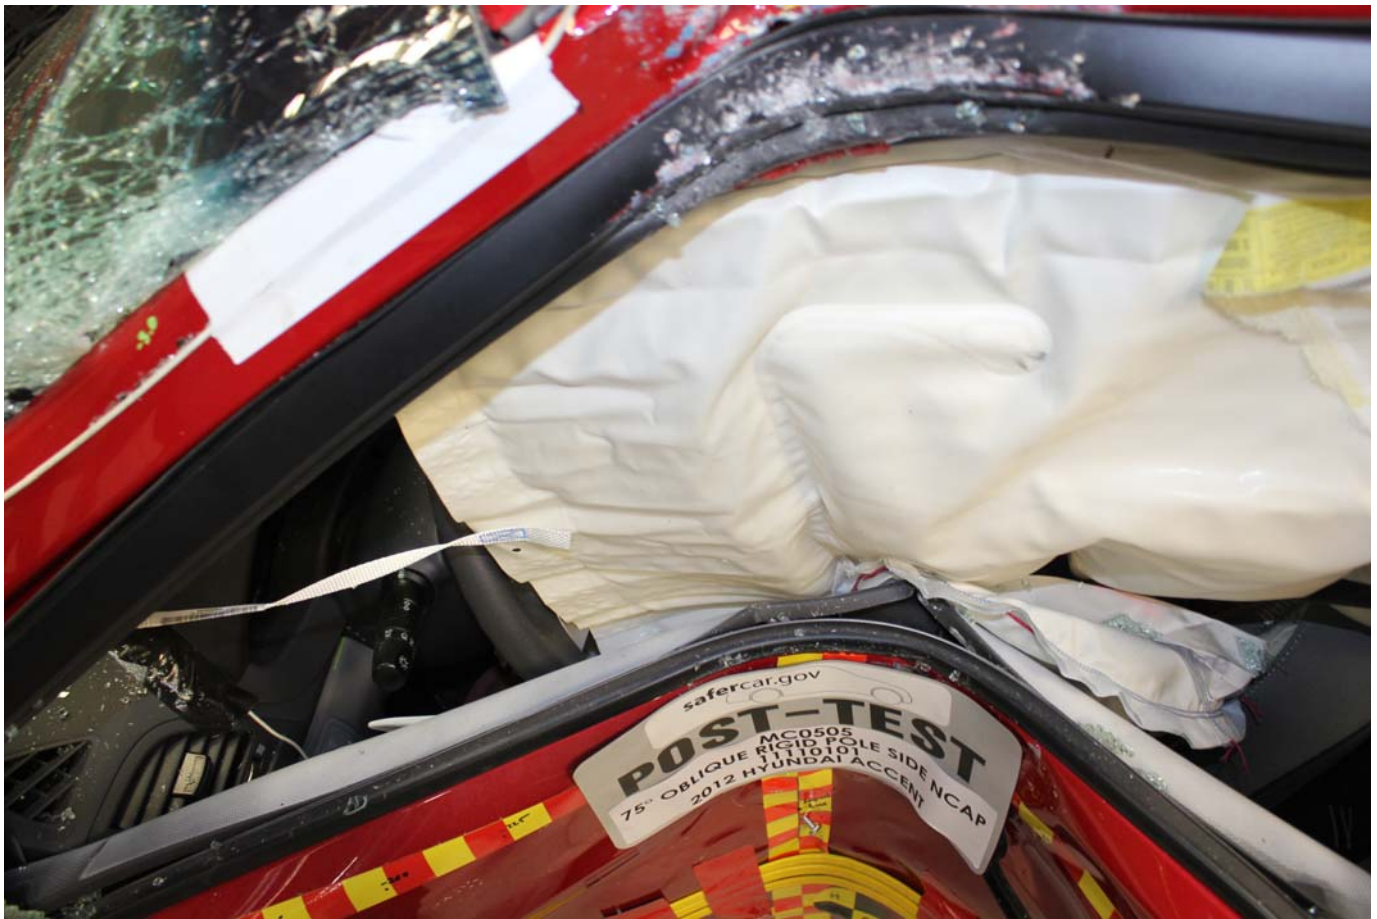
Post-Test Dummy and Door Clearance View

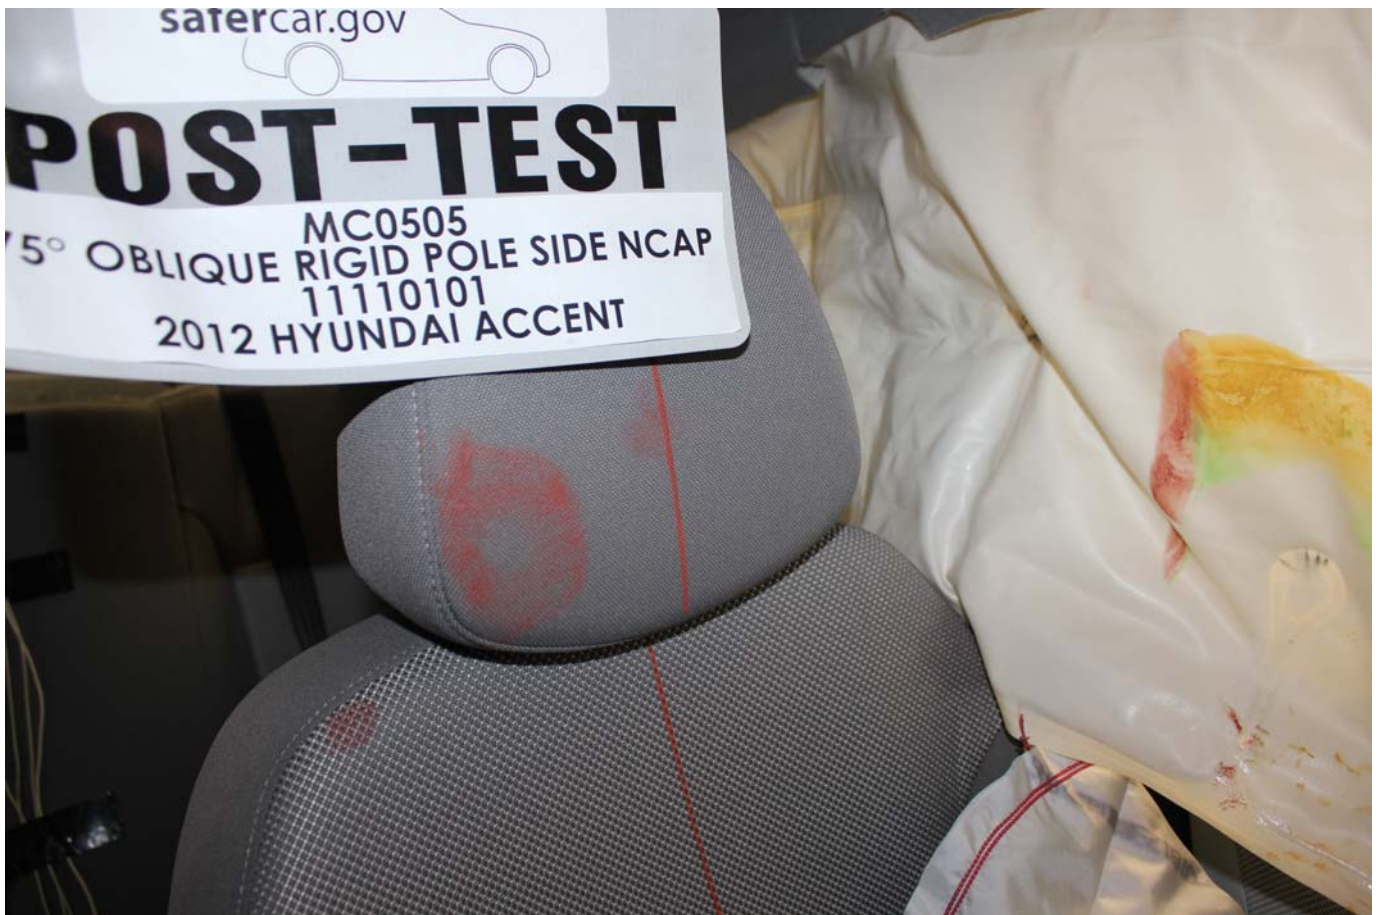
Post-Test Dummy Close-Up Head Contact with Vehicle Interior View

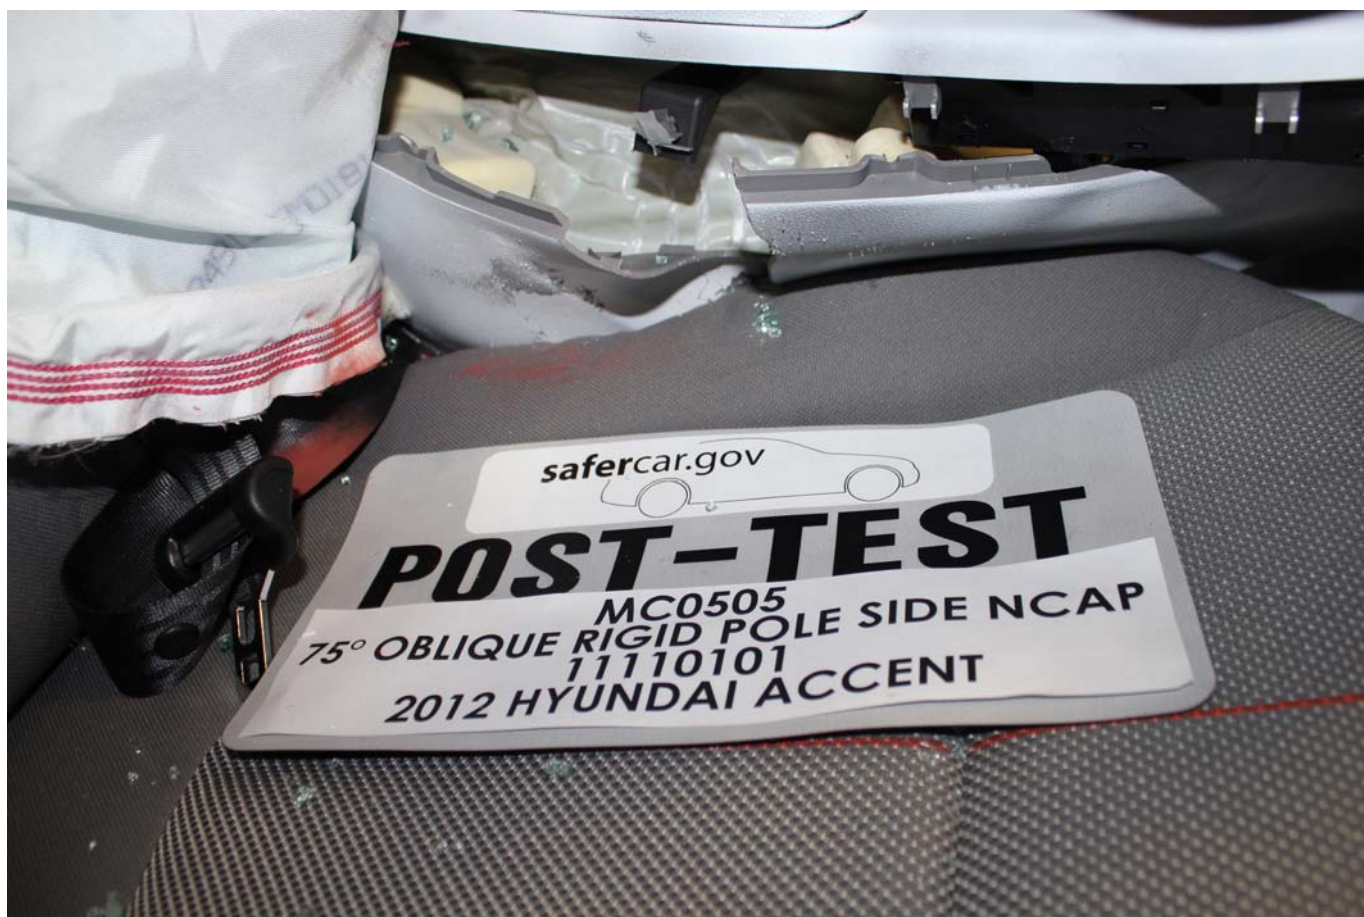
Post-Test Dummy Close-Up Pelvis Contact with Vehicle Interior View

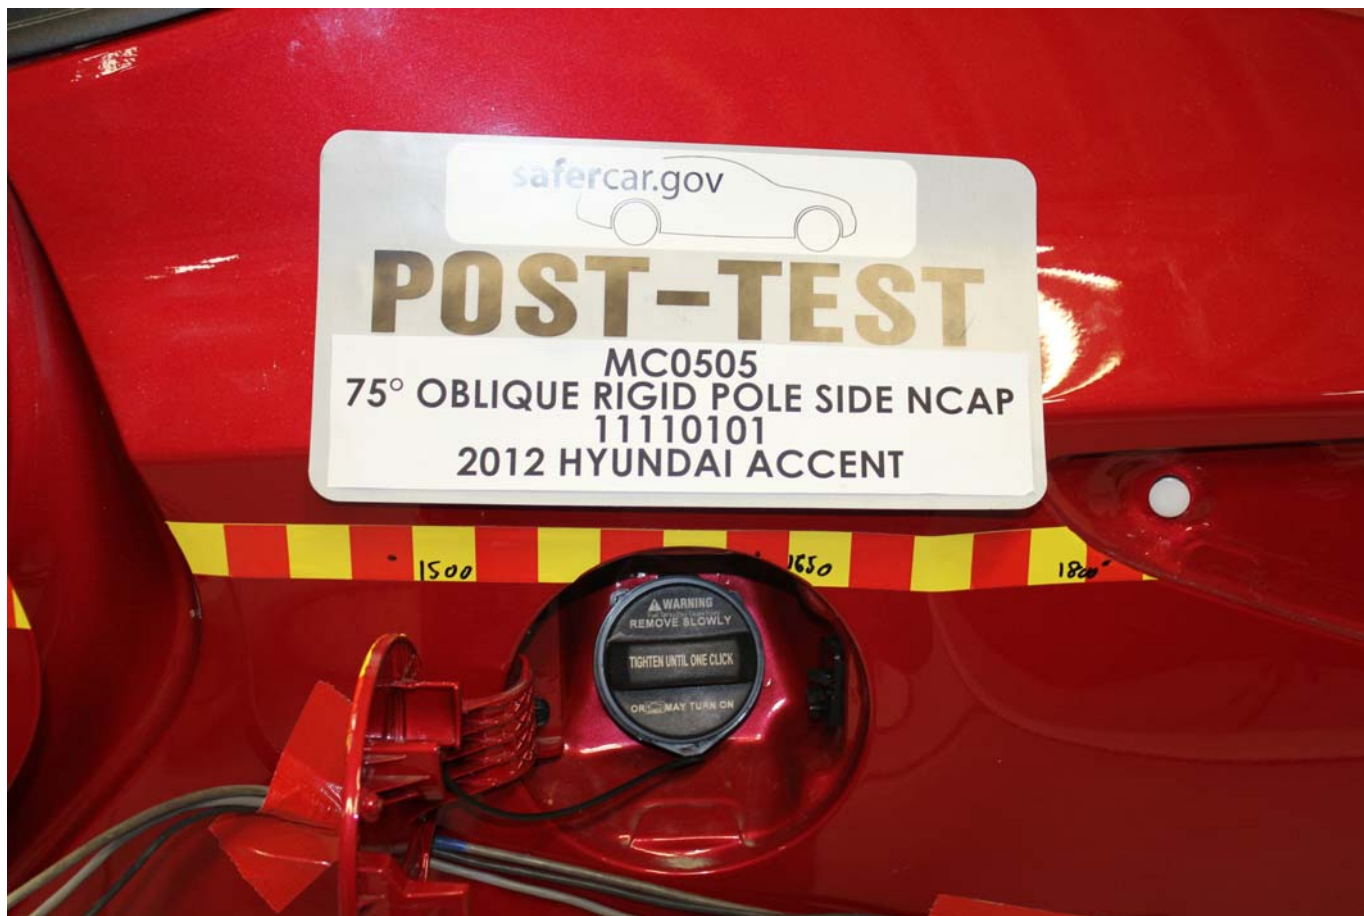
Post-Test View of Fuel Filler Cap or Fuel Filler Neck

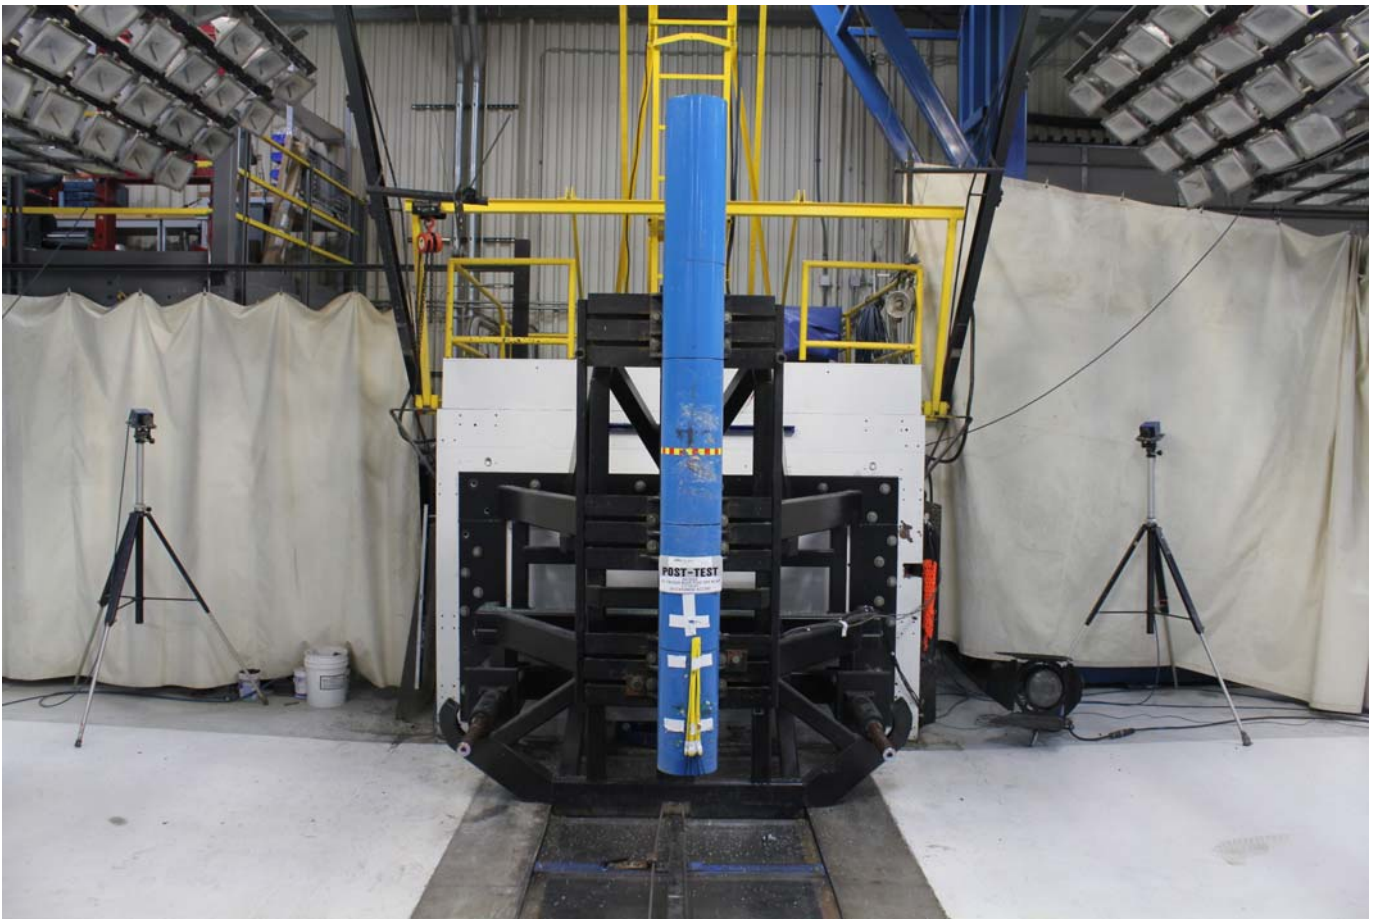
Post-Test Pole Barrier Front View

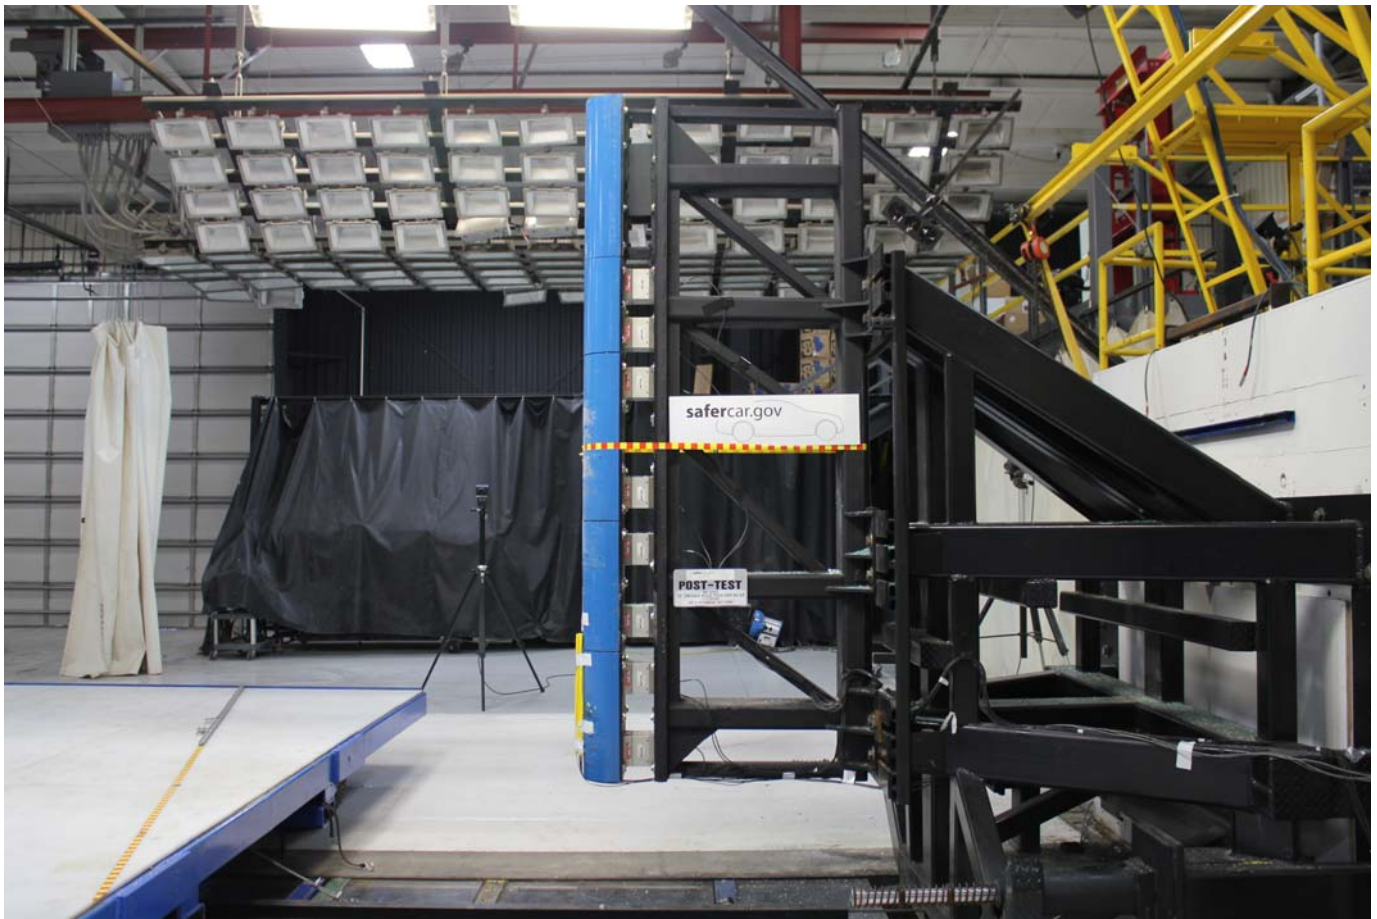
Post-Test Pole Barrier Side View

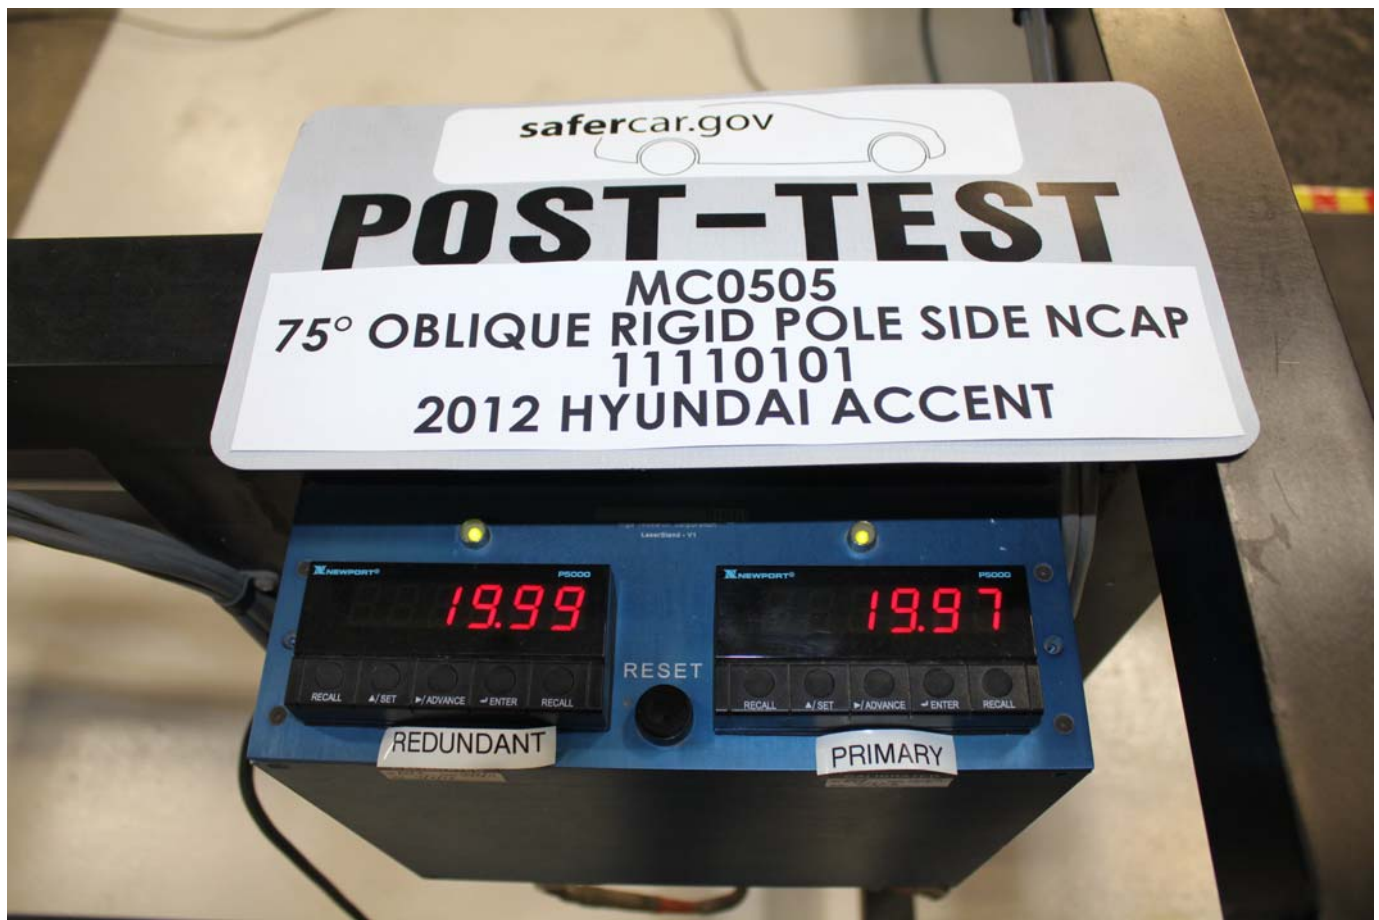
Post-Test Primary and Redundant Speed Trap Read-Out

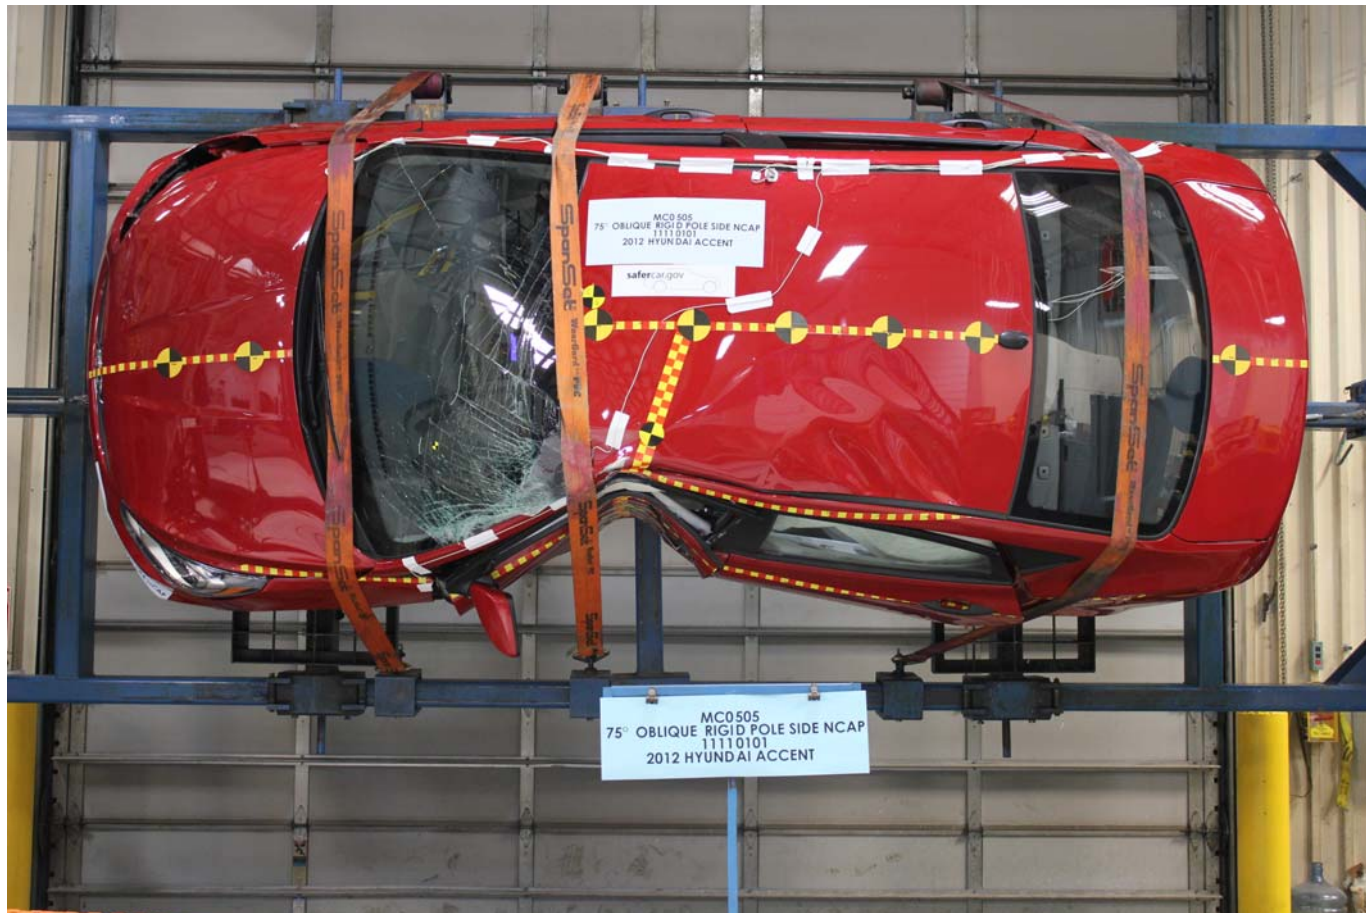
FMVSS No. 301 Static Rollover 90 Degrees

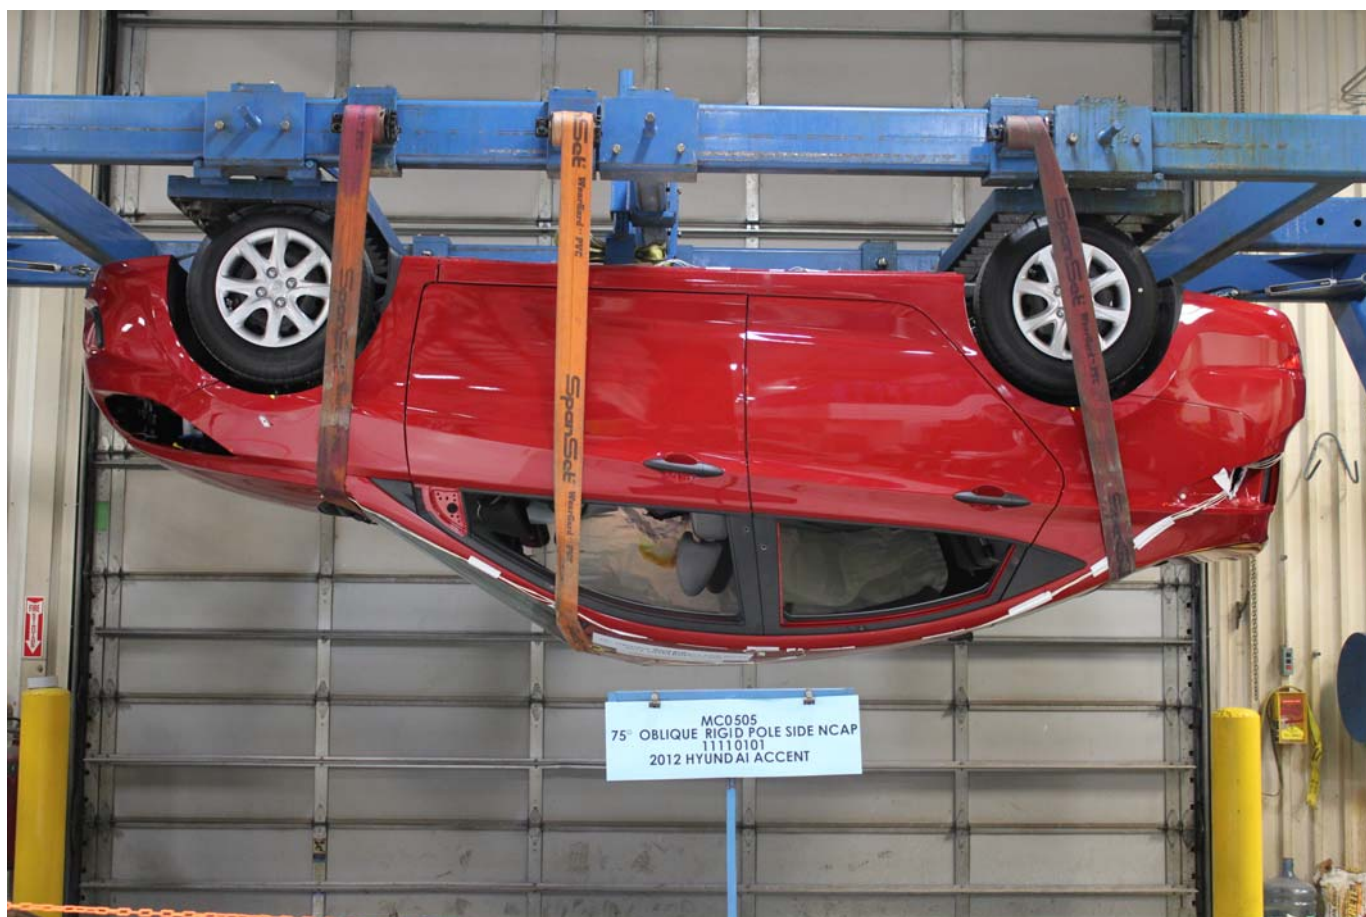
FMVSS No. 301 Static Rollover 180 Degrees

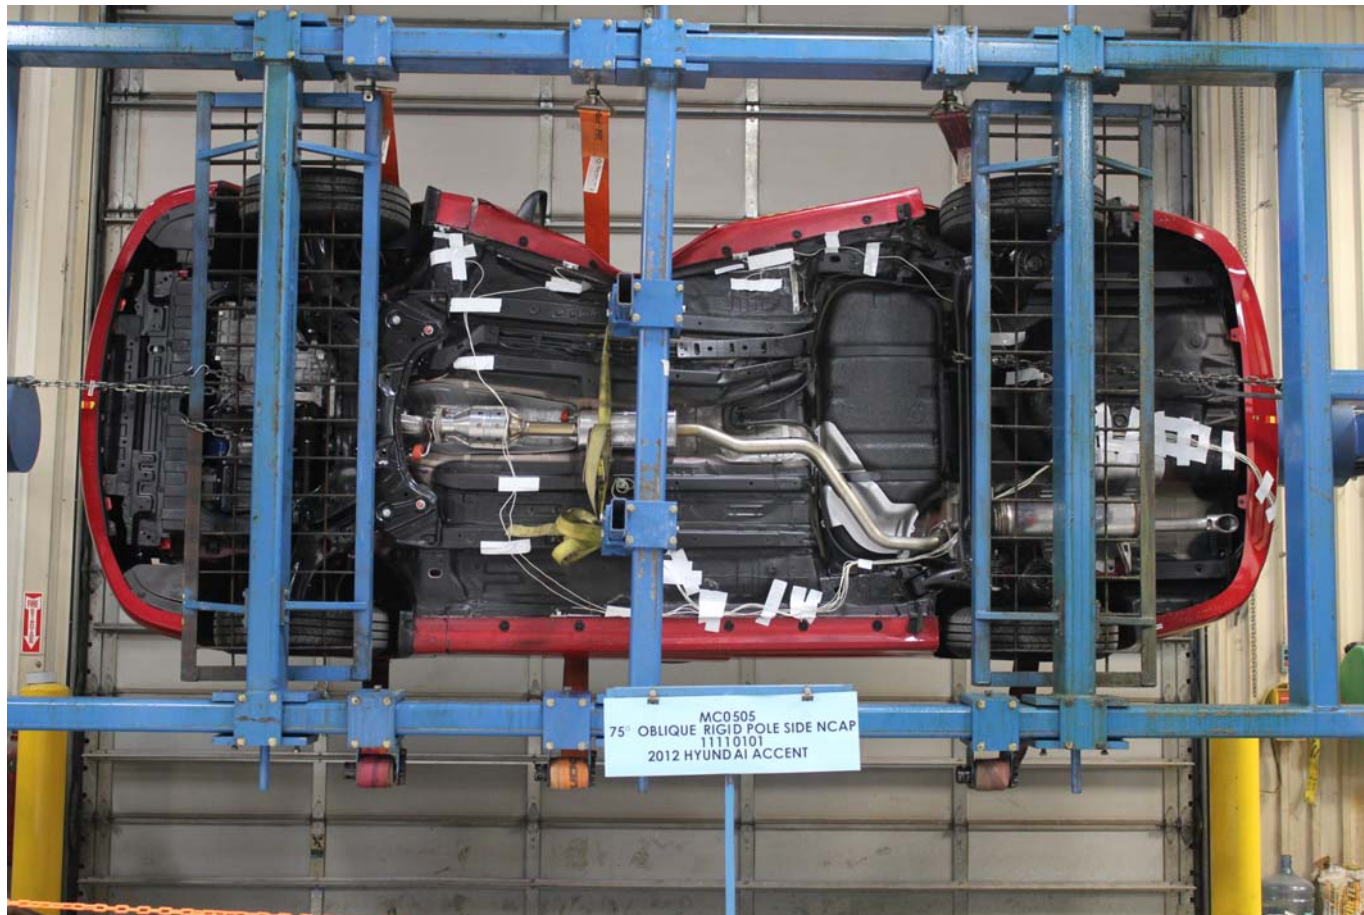
FMVSS No. 301 Static Rollover 270 Degrees

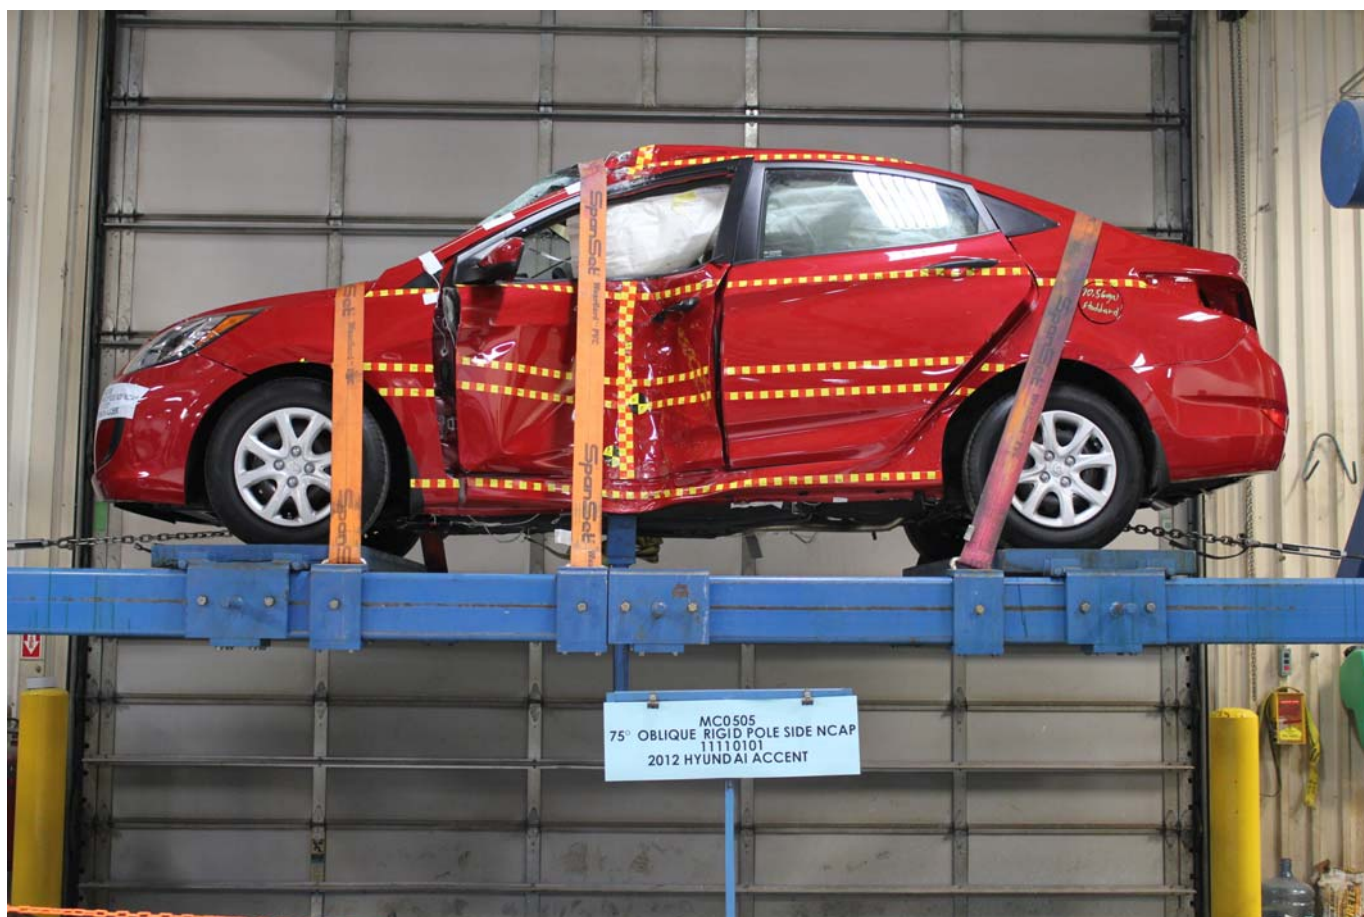
FMVSS No. 301 Static Rollover 360 Degrees
