**REPORT NUMBER: SPNCAP-MGA-2012-020**

**NEW CAR ASSESSMENT PROGRAM (NCAP)  
Side Impact Pole Test**

**HYUNDAI MOTOR COMPANY  
2012 Hyundai Accent GLS 4-Dr Sedan  
NHTSA No.: MC0505**

**FINAL REPORT**

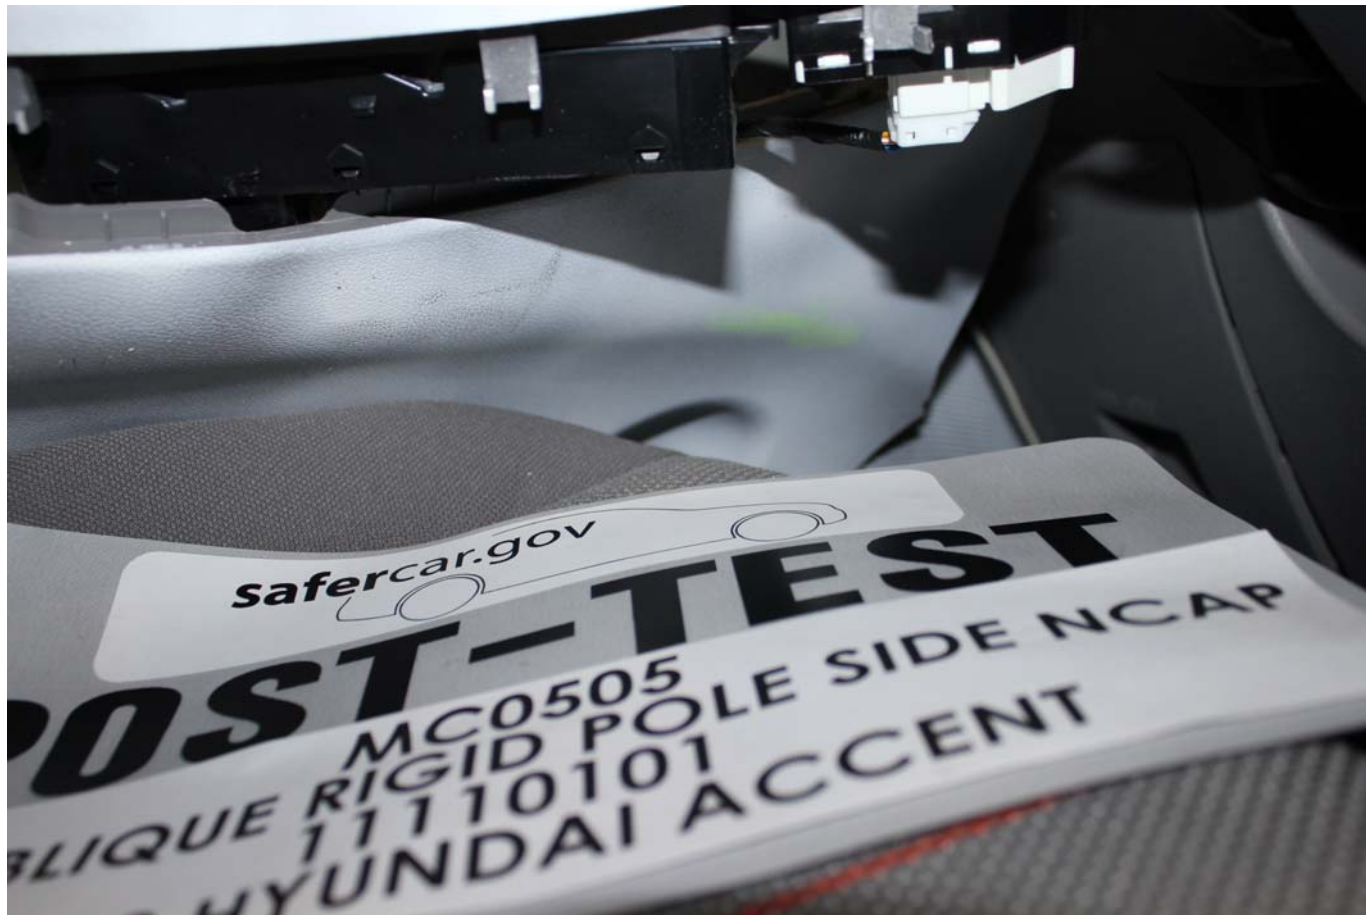
Post-Test Dummy Close-Up Knee Contact with Vehicle Interior View
