REPORT NUMBER: SINCAP-MGA-2012-021

**NEW CAR ASSESSMENT PROGRAM (NCAP)
Moving Deformable Barrier Side Impact Test**

**HYUNDAI MOTOR COMPANY
2012 Hyundai Accent GLS 4-Dr Sedan
NHTSA No.: MC0504**

**MGA RESEARCH CORPORATION
5000 Warren Road
Burlington, WI 53105**

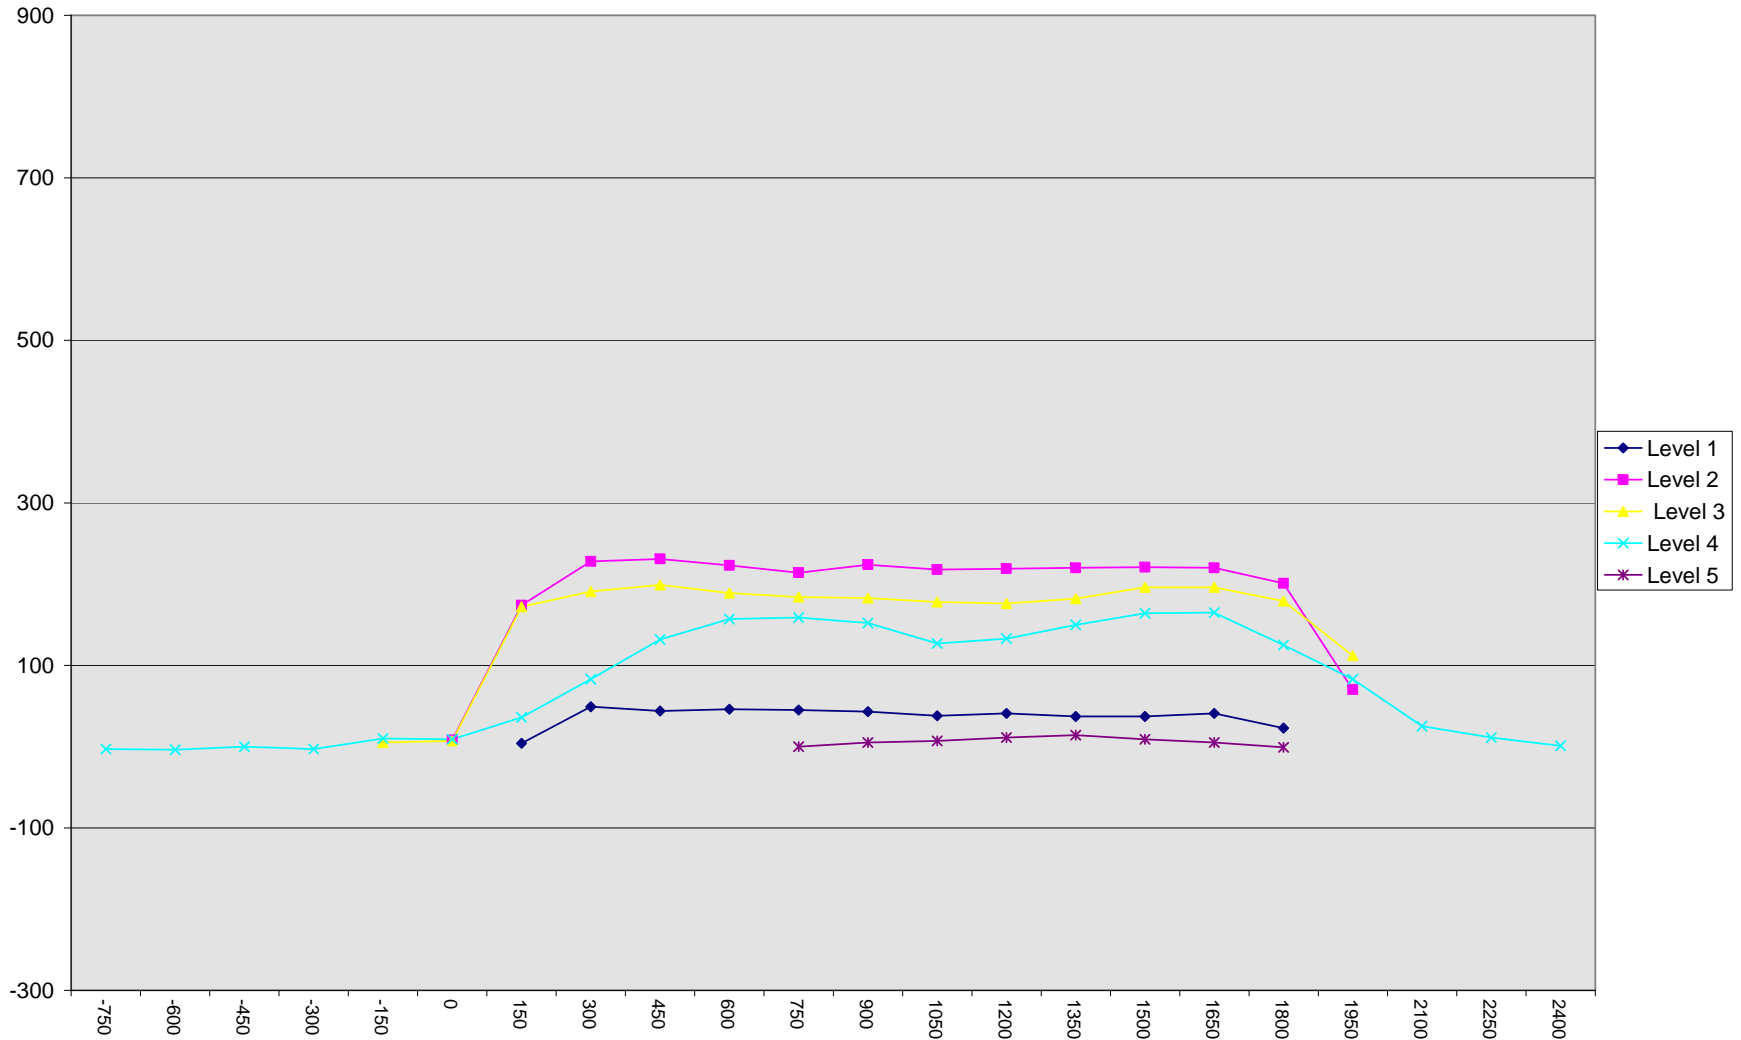
NOTE: Pre-test measurements are taken when the vehicle is in the "As Tested" weight condition. Vehicle measurements forward of the vertical impact reference line are negative. The crush profile grid is established prior to the test based on an estimated impact point.

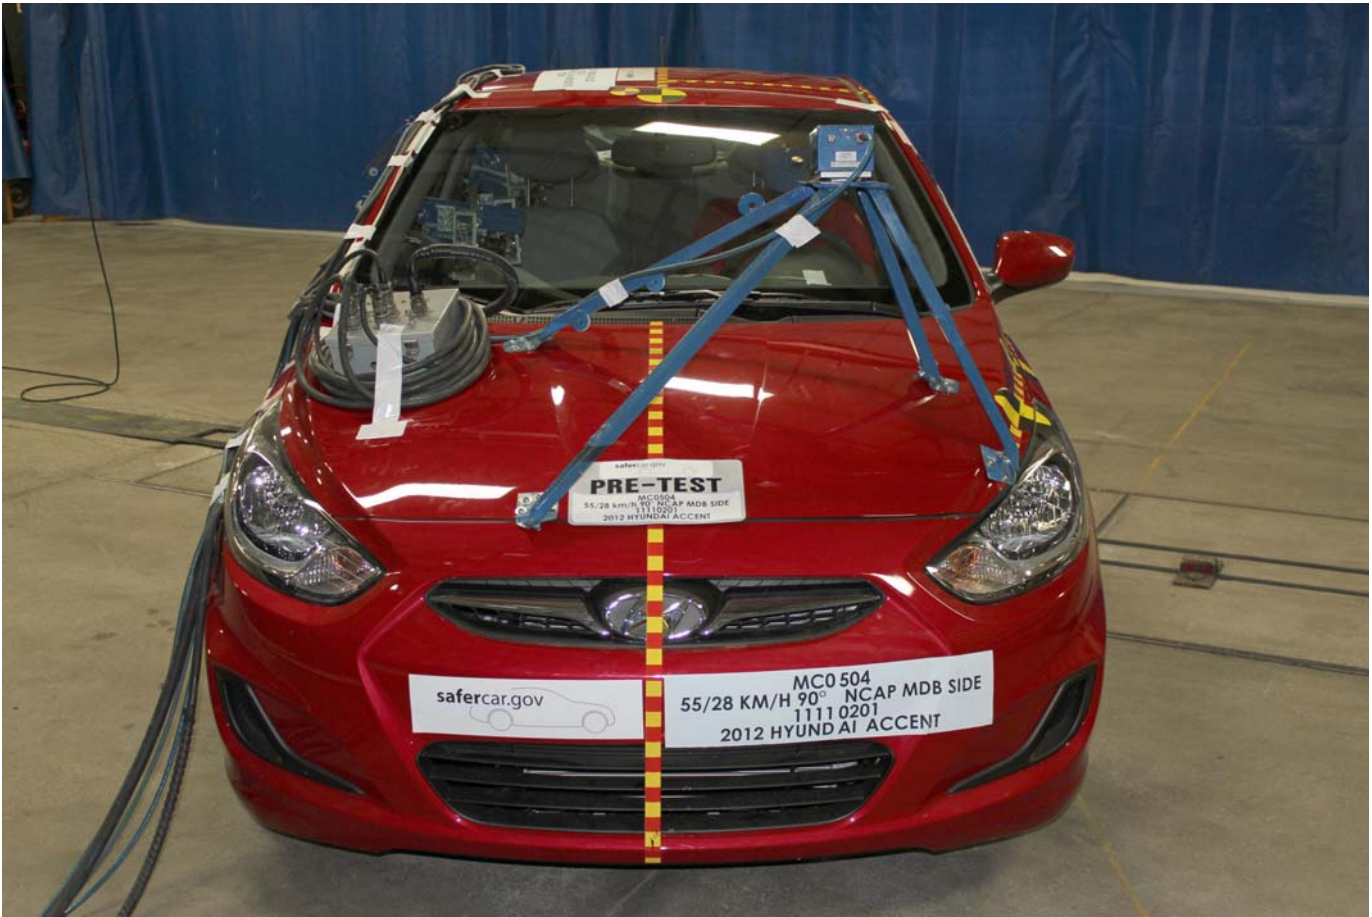
Pre-Test Frontal View of Test Vehicle

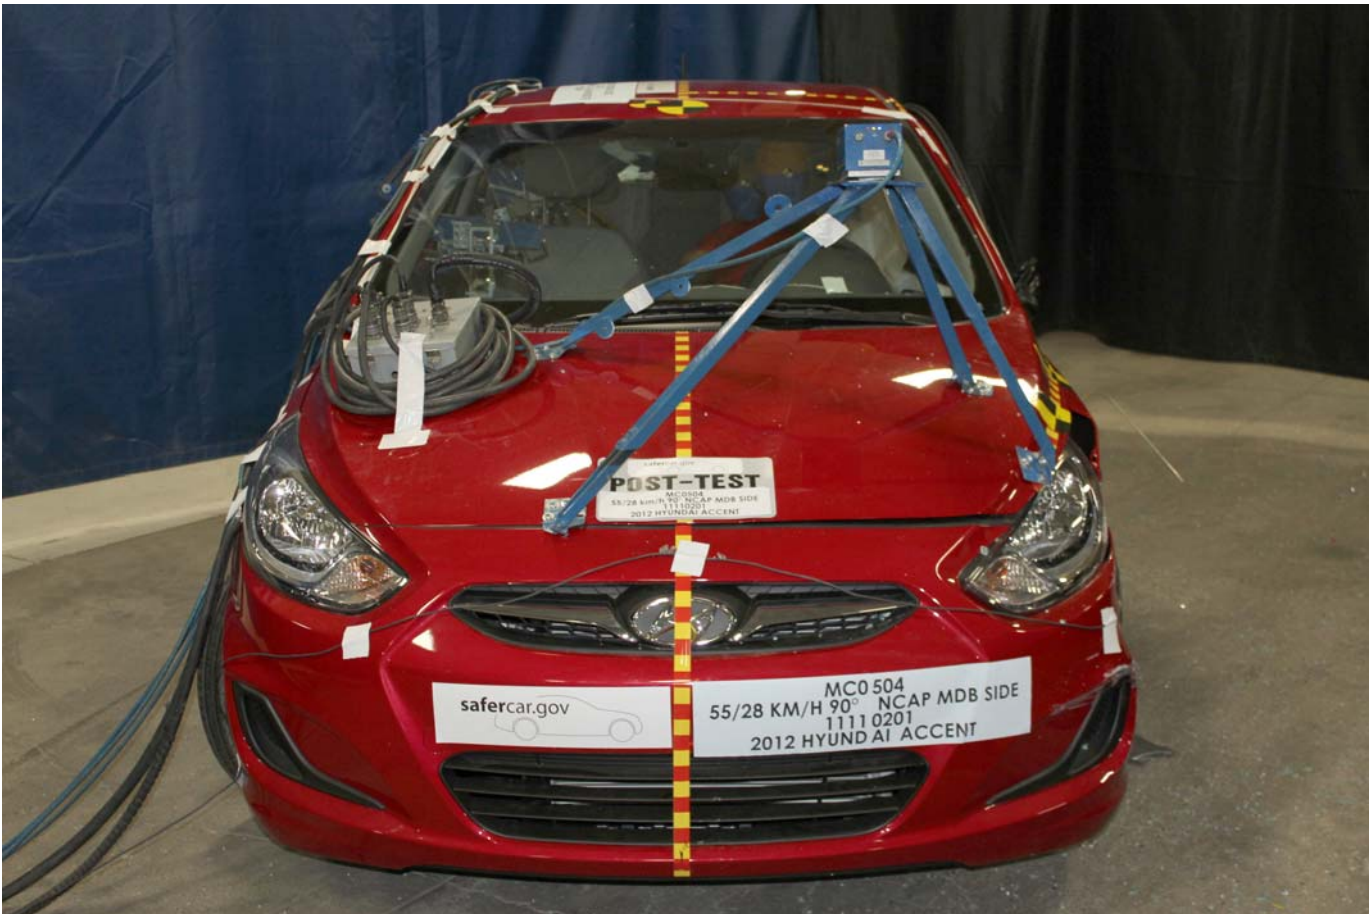
Post-Test Frontal View of Test Vehicle

Critical Areas of Performance	Observations and Conclusions
Pillar Performance	No Separation
Sill Separation	None
Windshield Damage	None
Side Window Damage	Left Front and Left Rear Windows Broke
Other Notable Effects	None

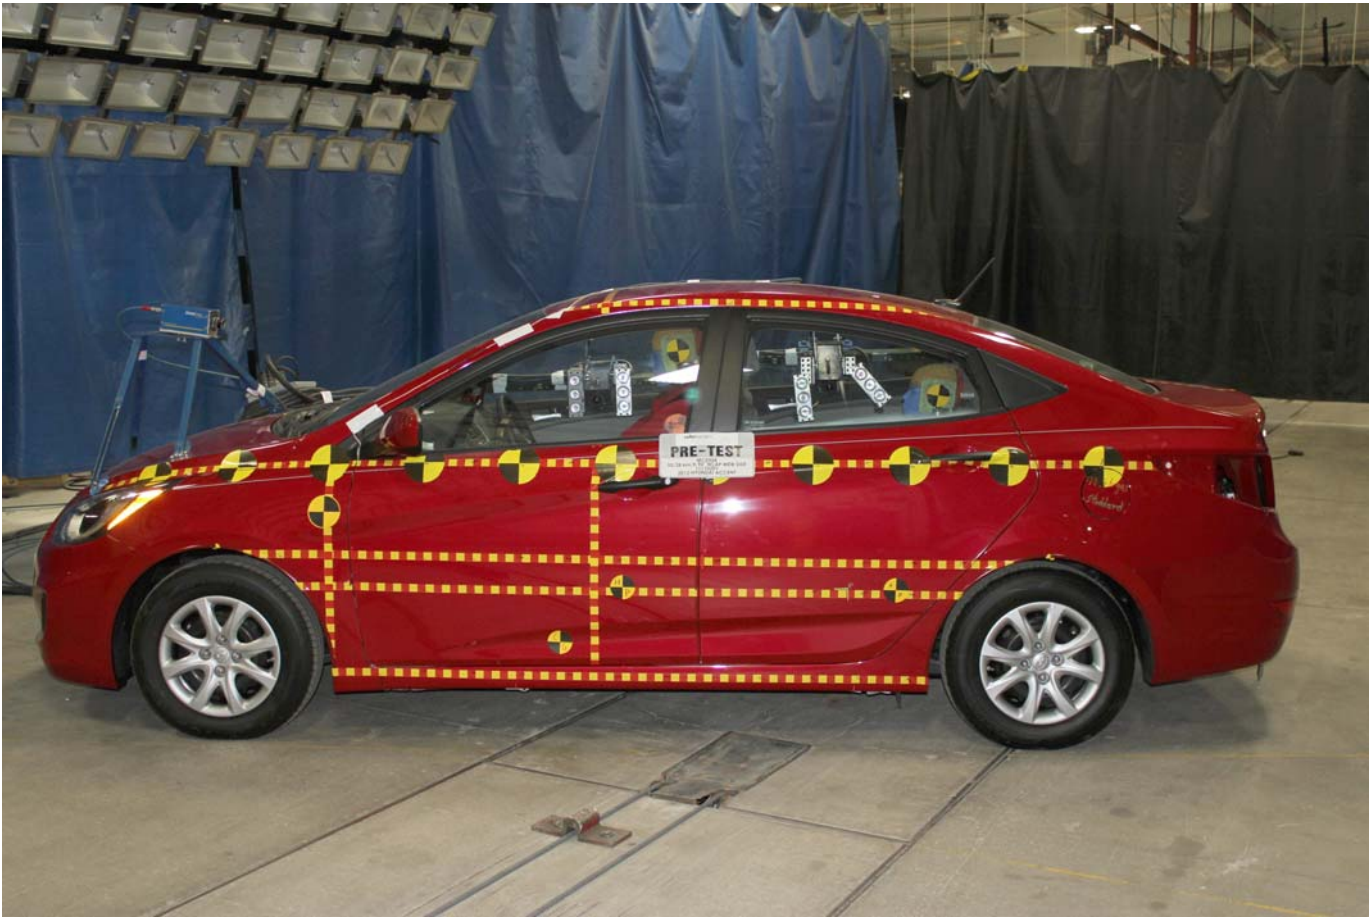
Pre-Test Left Side View of Test Vehicle

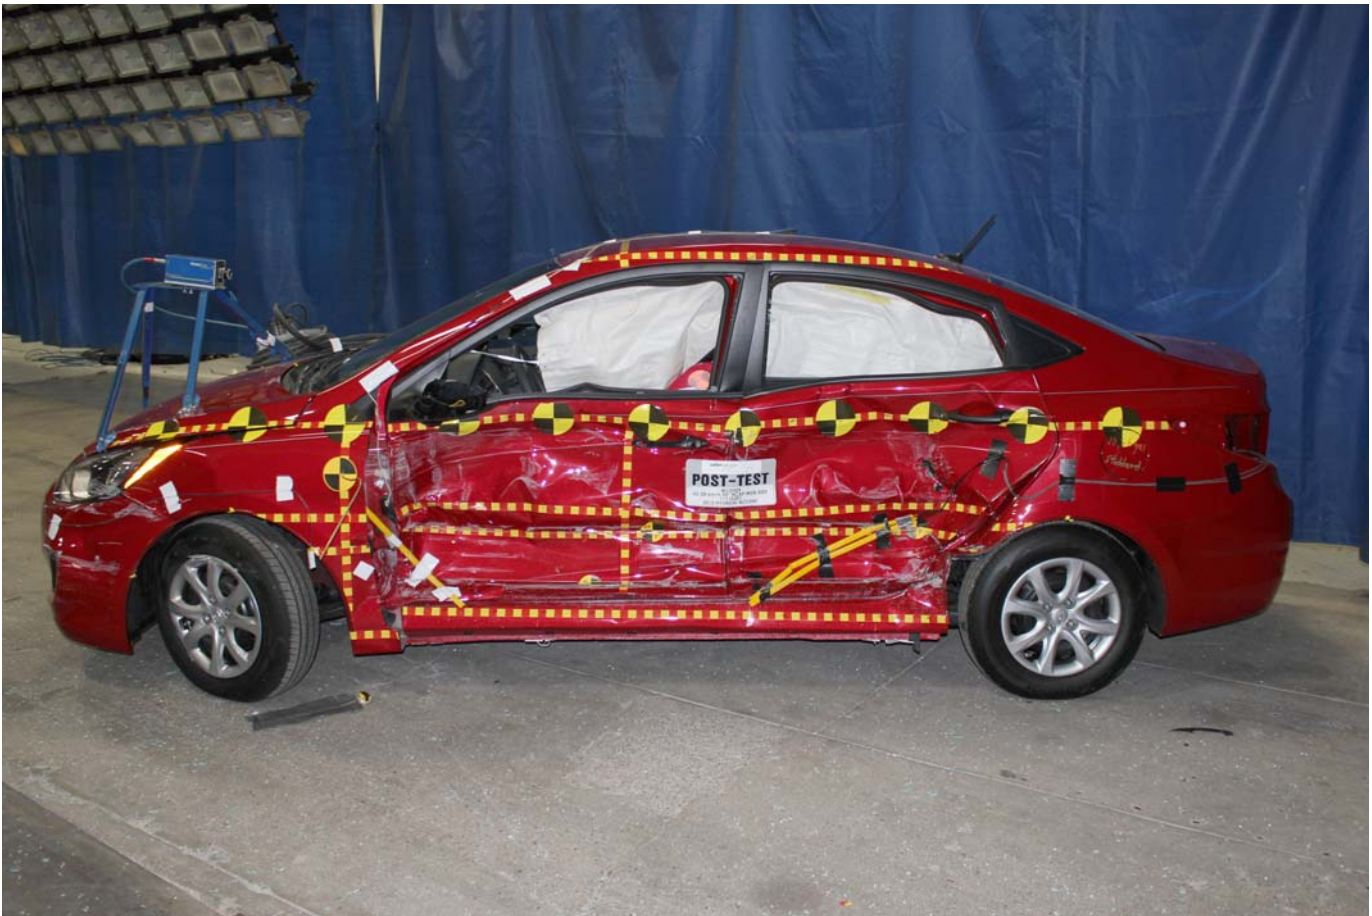
Post-Test Left Side View of Test Vehicle

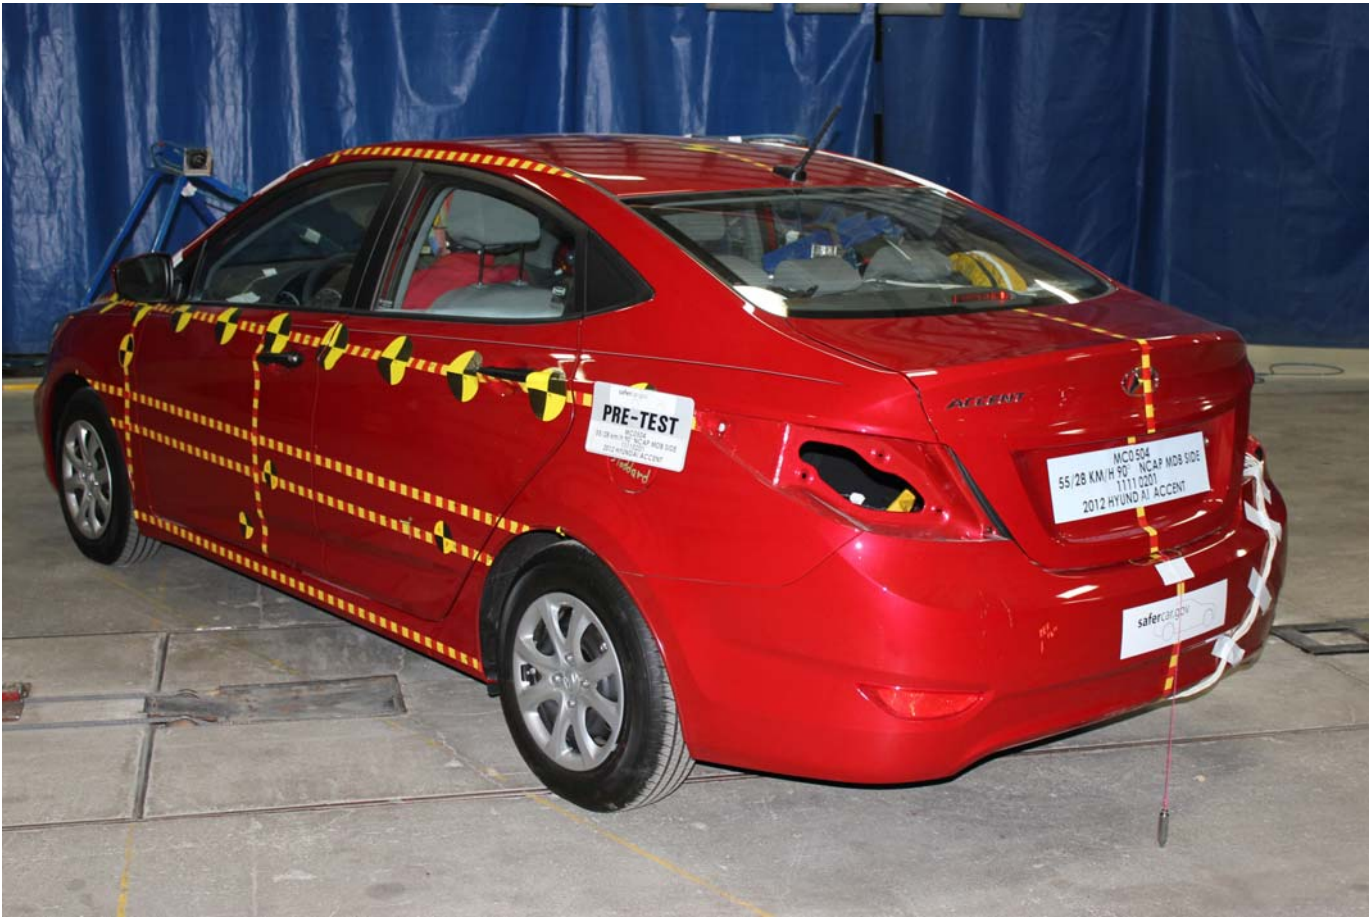
Pre-Test Left Three-Quarter Rear View of Test Vehicle

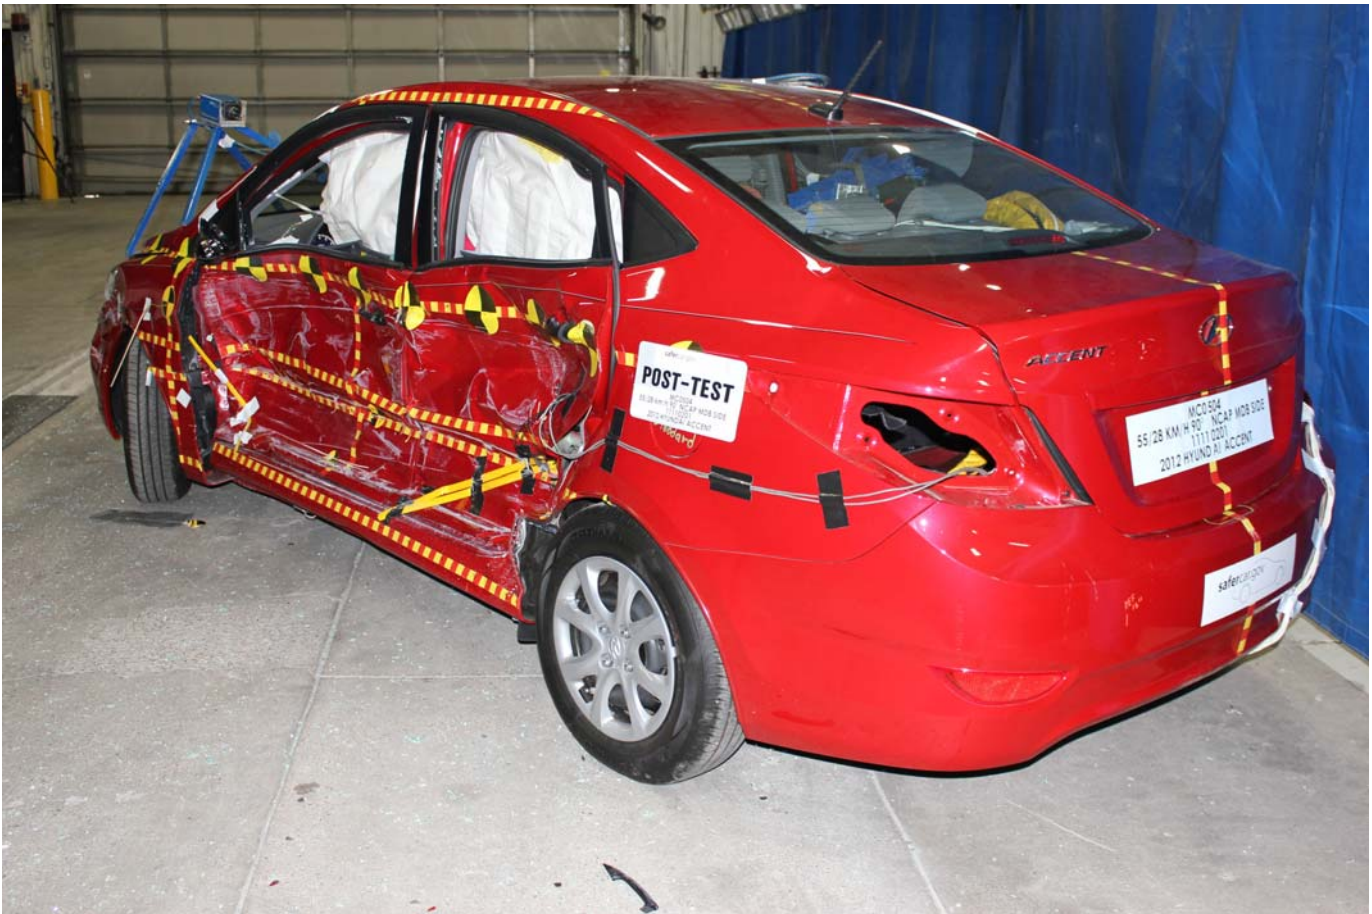
Post-Test Left Three-Quarter Rear View of Test Vehicle

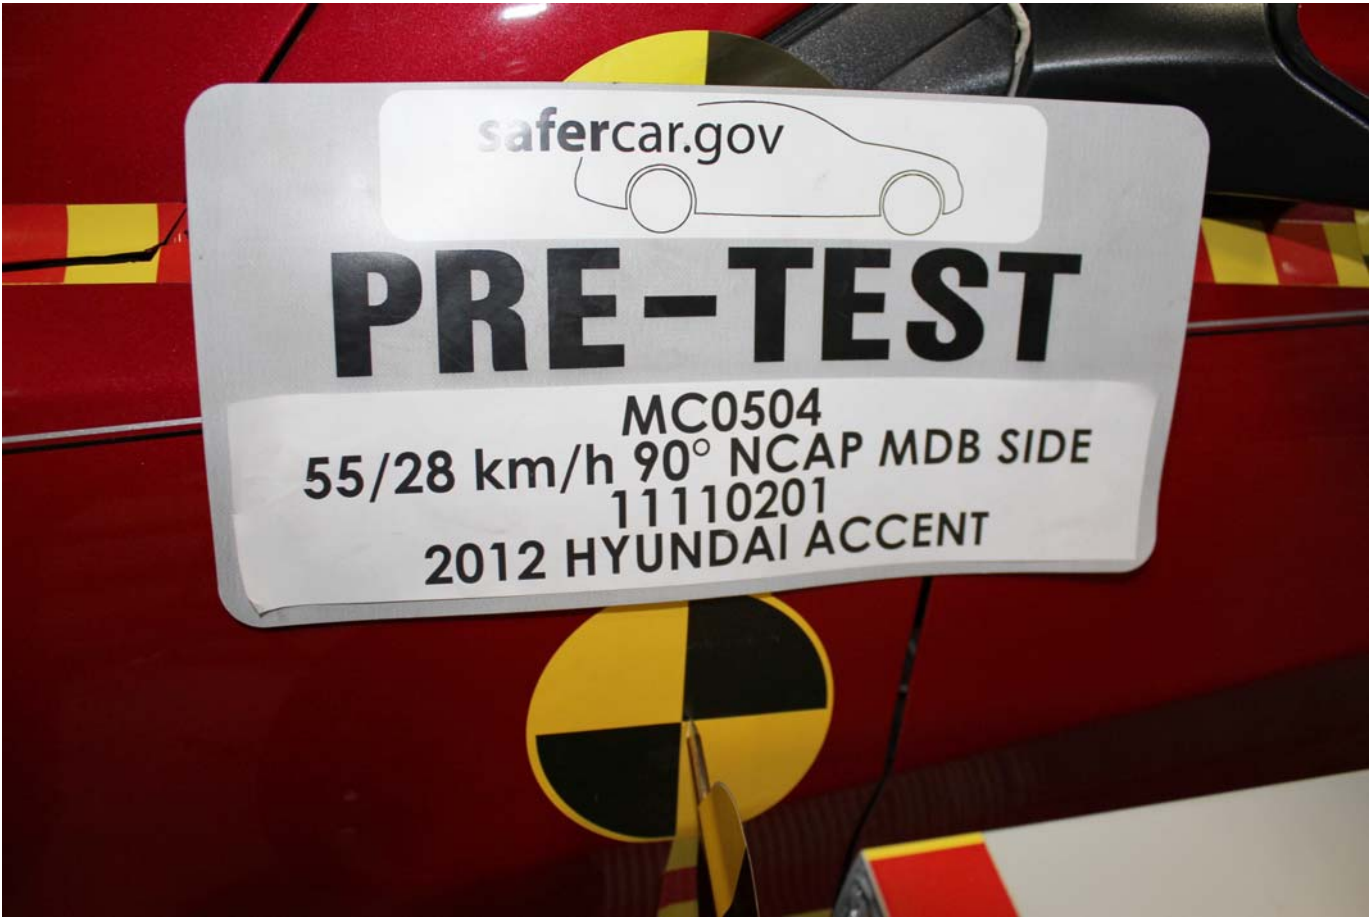
Pre-Test Close-Up View of Impact Point Target

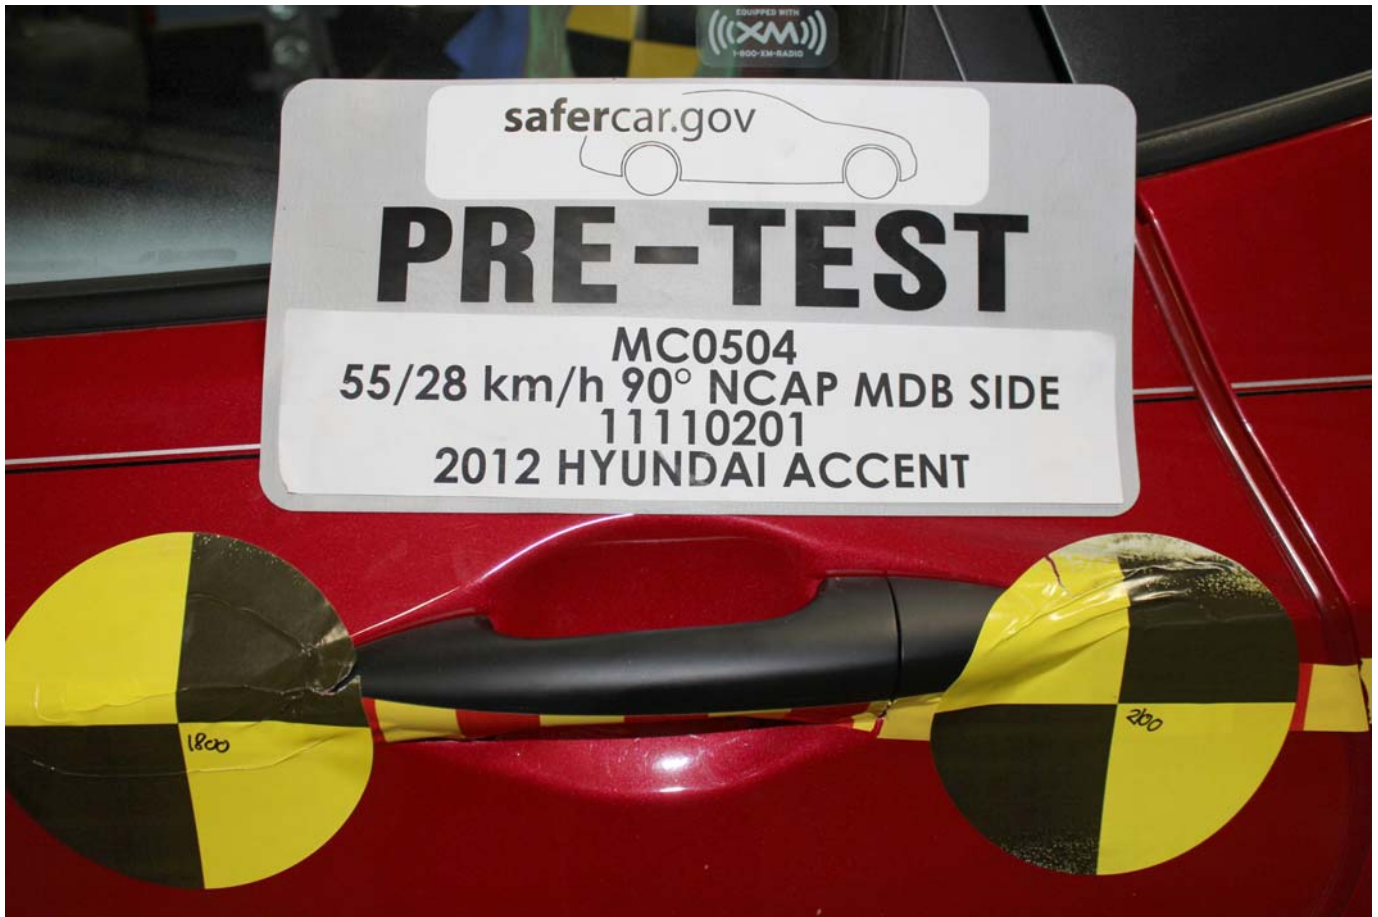
Pre-Test Left Rear Door Latch Close-Up

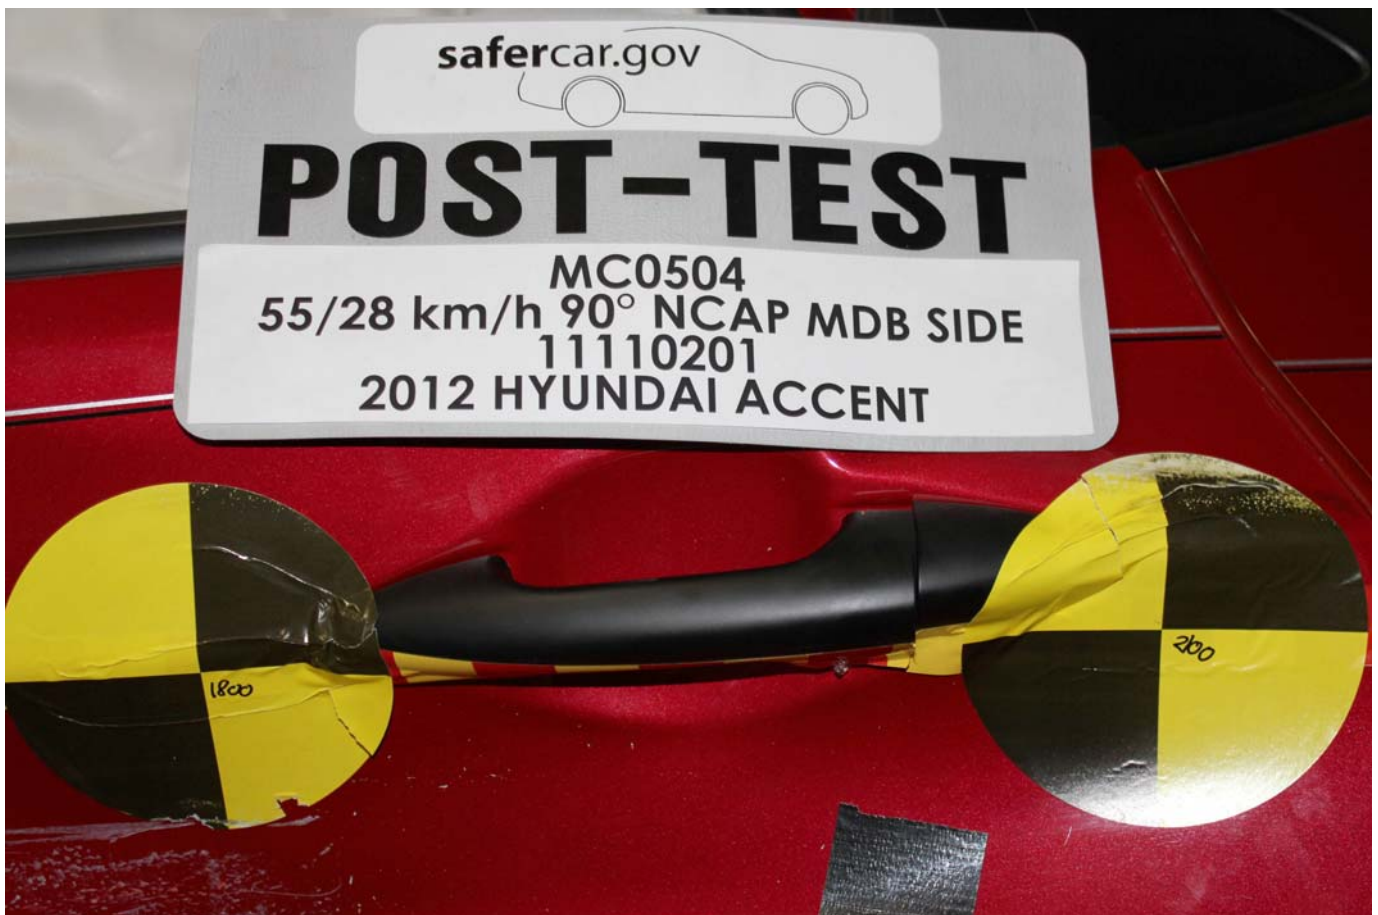
Post-Test Left Rear Door Latch Close-Up

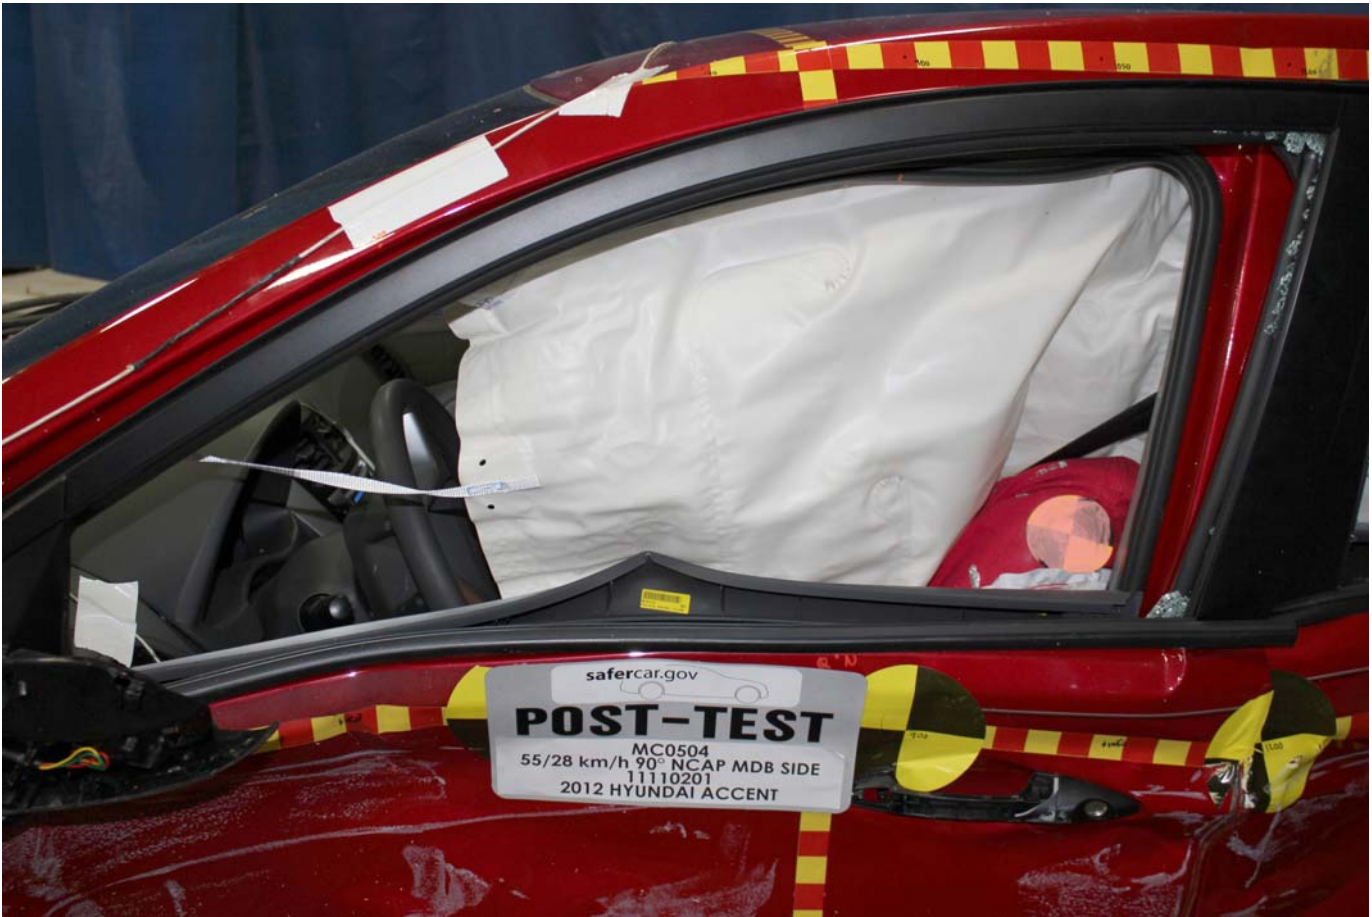
Post-Test Left Side View of Driver Dummy Shoulder and Door Top View

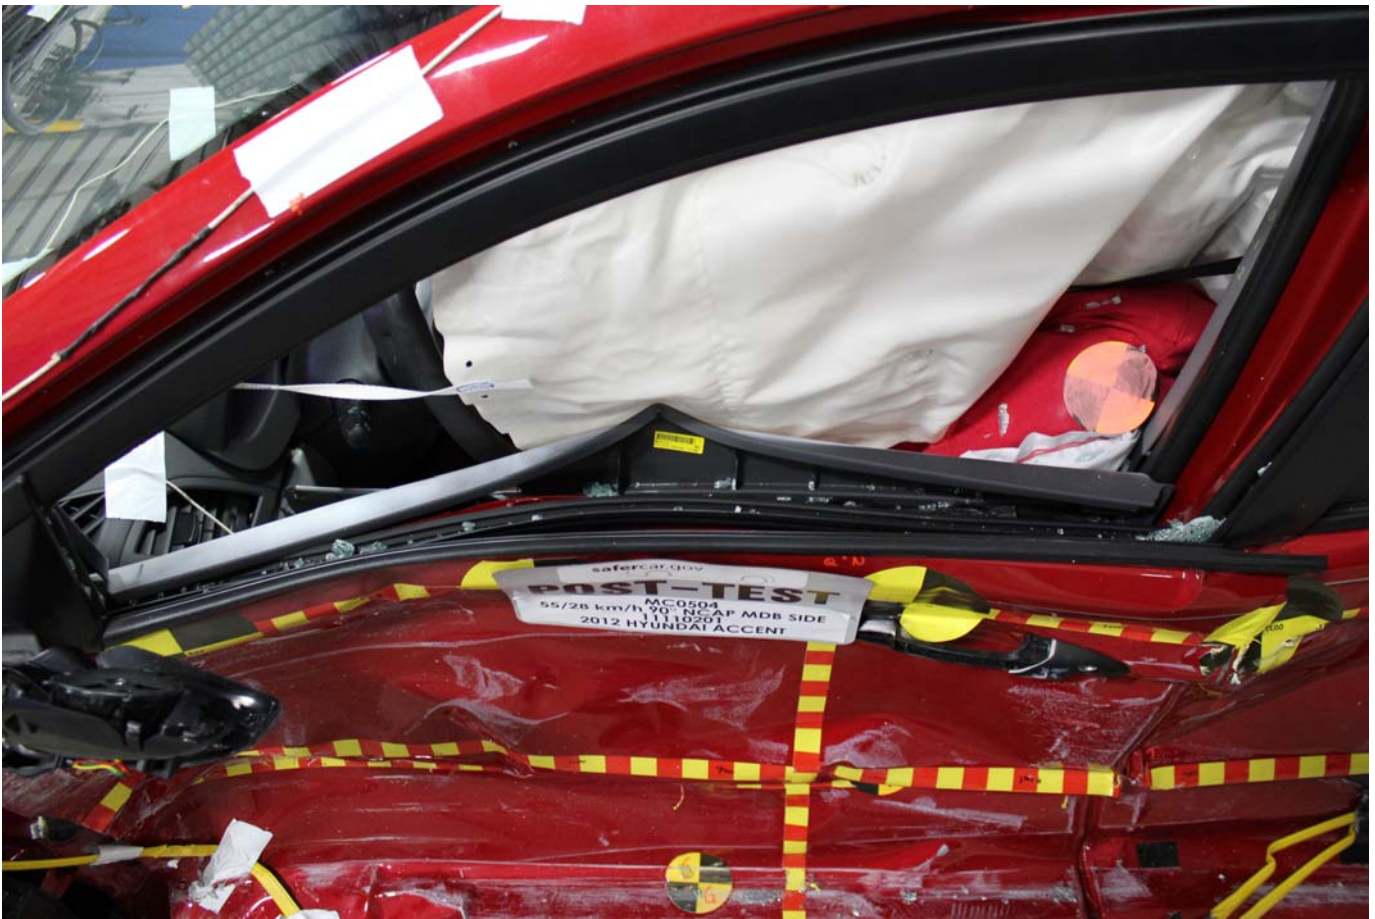
Post-Test Driver Dummy and Door Clearance View

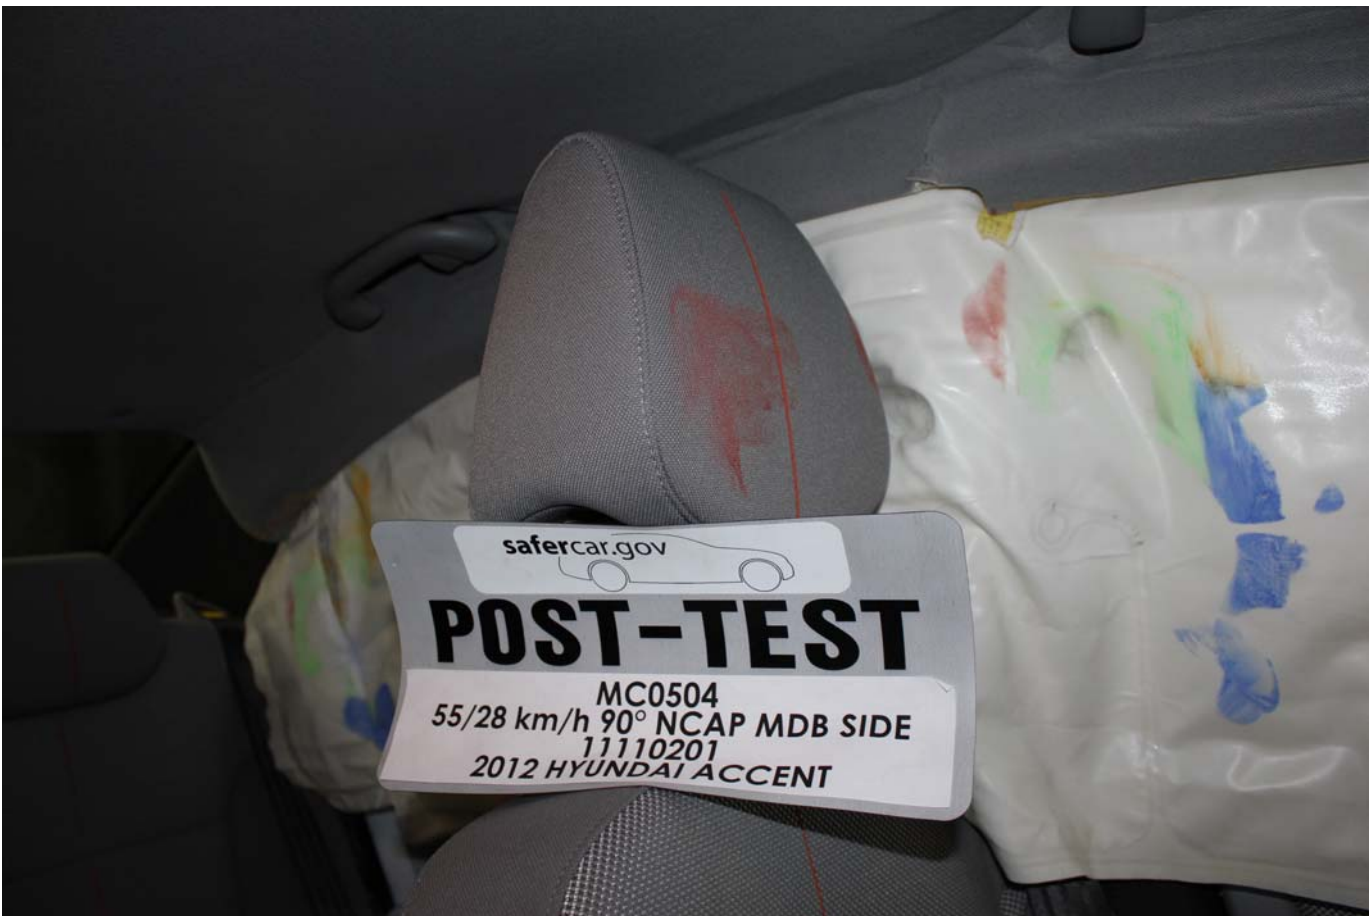
Post-Test Driver Dummy Close-up Head Contact with Vehicle Interior View

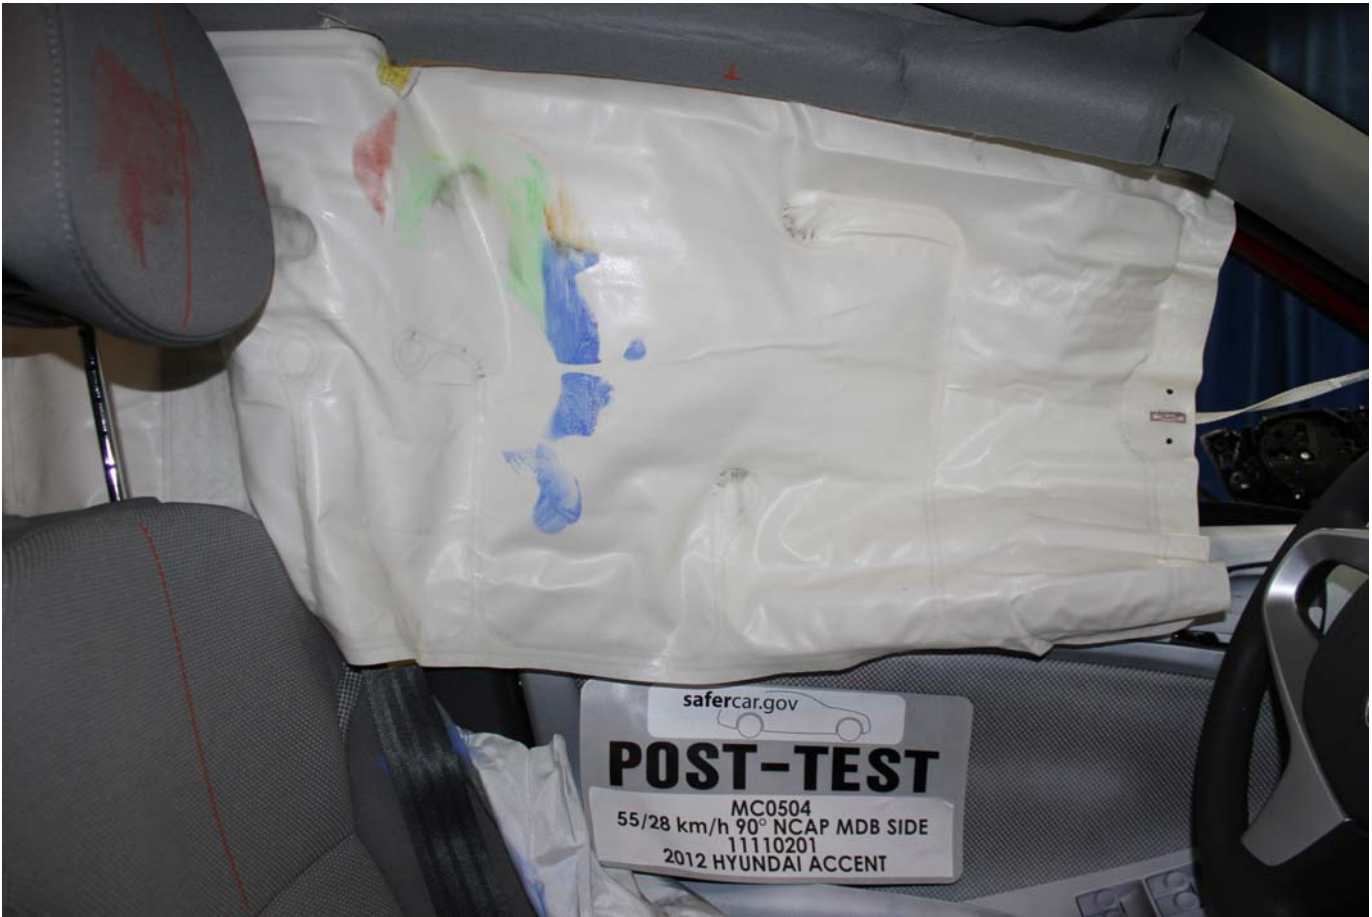
Post-Test Driver Dummy Close-up Head Contact with Side Airbag View

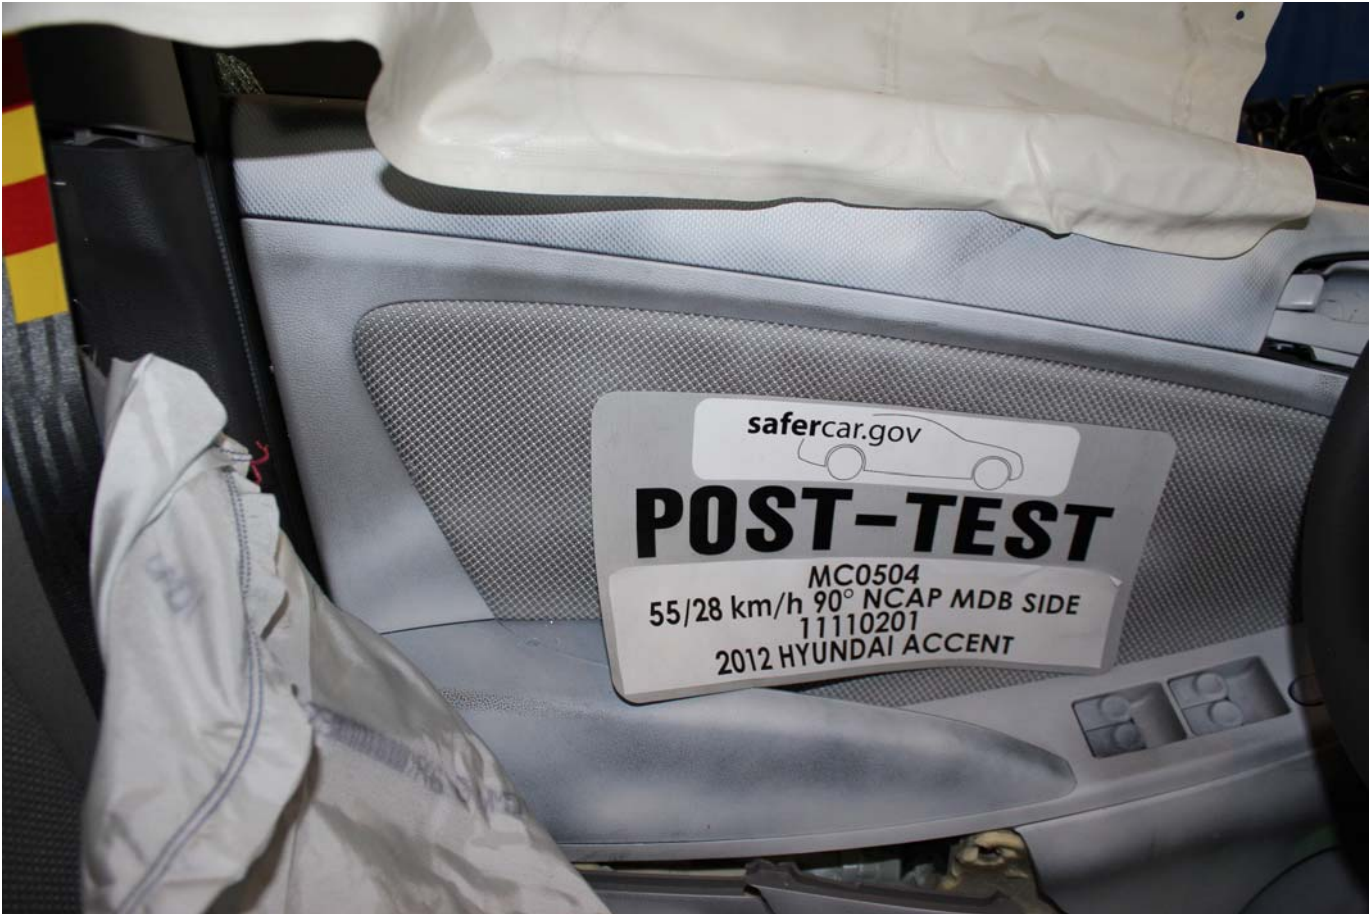
Post-Test Driver Dummy Close-up Torso Contact with Vehicle Interior View

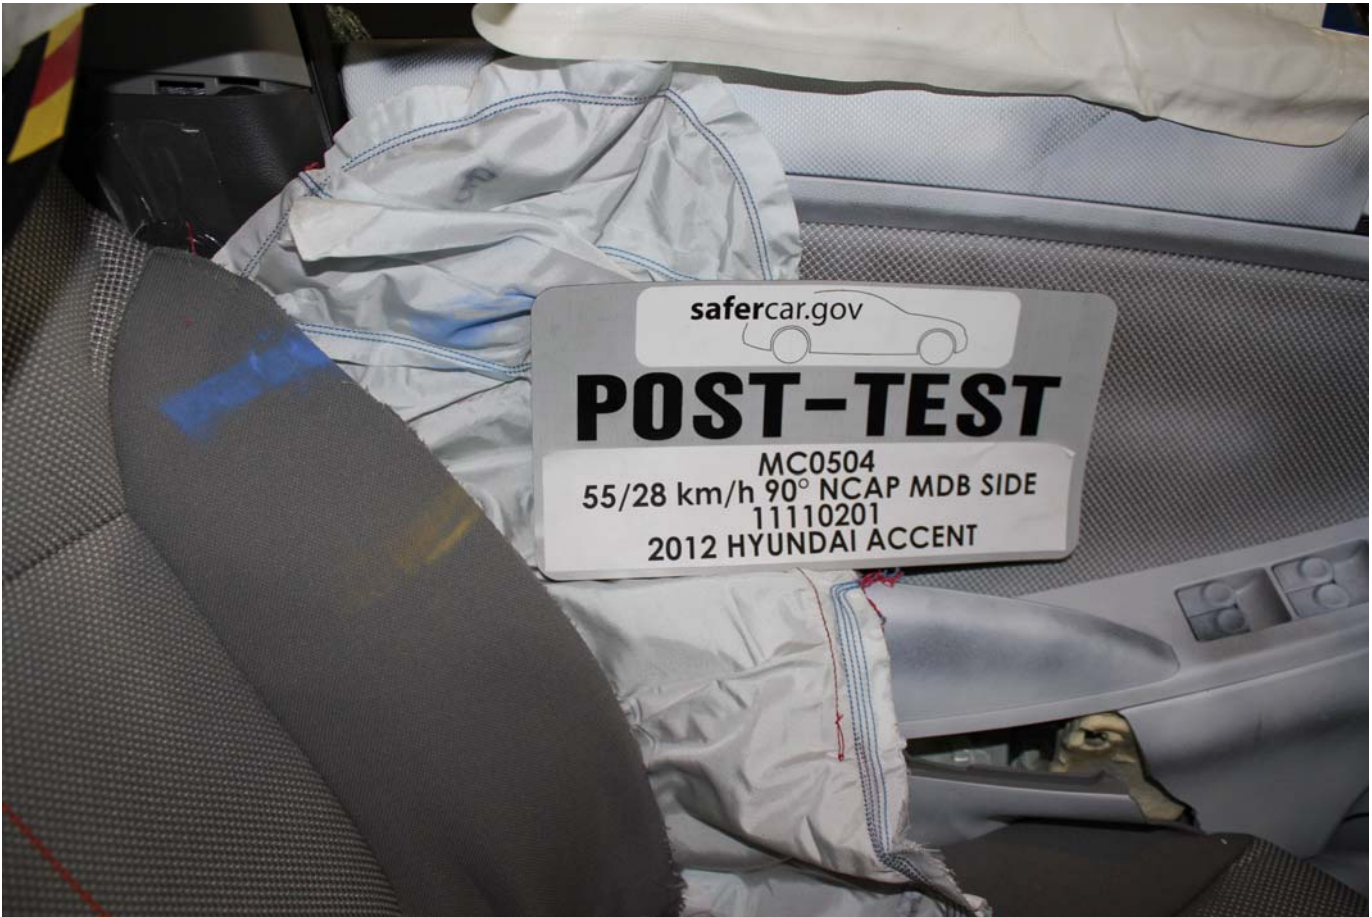
Post-Test Driver Dummy Close-up Torso Contact with Side Airbag View

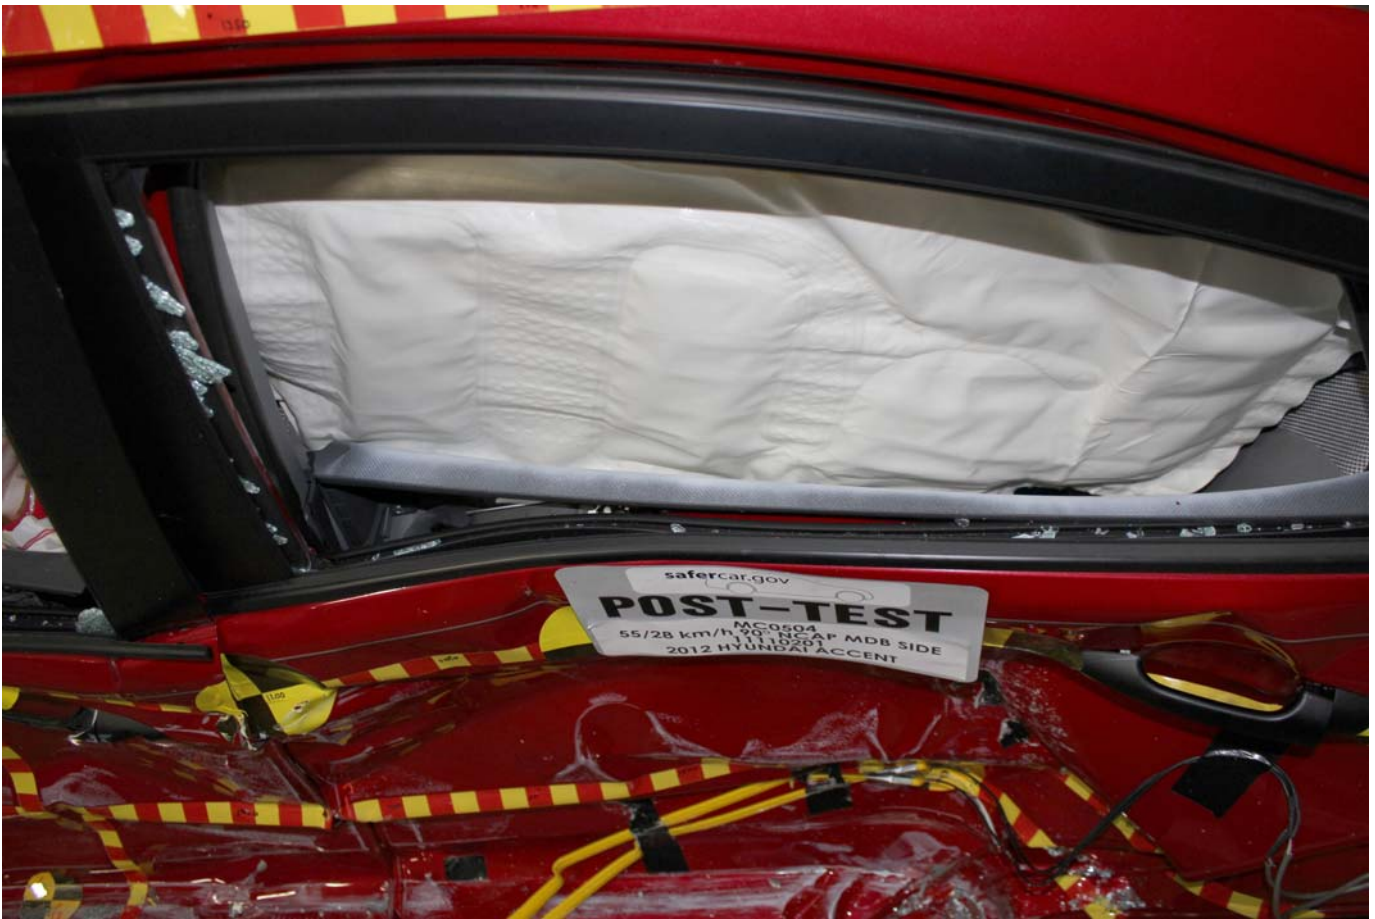
Post-Test Rear Passenger Dummy and Door Clearance View
