REPORT NUMBER: SINCAP-MGA-2012-021

**NEW CAR ASSESSMENT PROGRAM (NCAP)
Moving Deformable Barrier Side Impact Test**

**HYUNDAI MOTOR COMPANY
2012 Hyundai Accent GLS 4-Dr Sedan
NHTSA No.: MC0504**

**MGA RESEARCH CORPORATION
5000 Warren Road
Burlington, WI 53105**

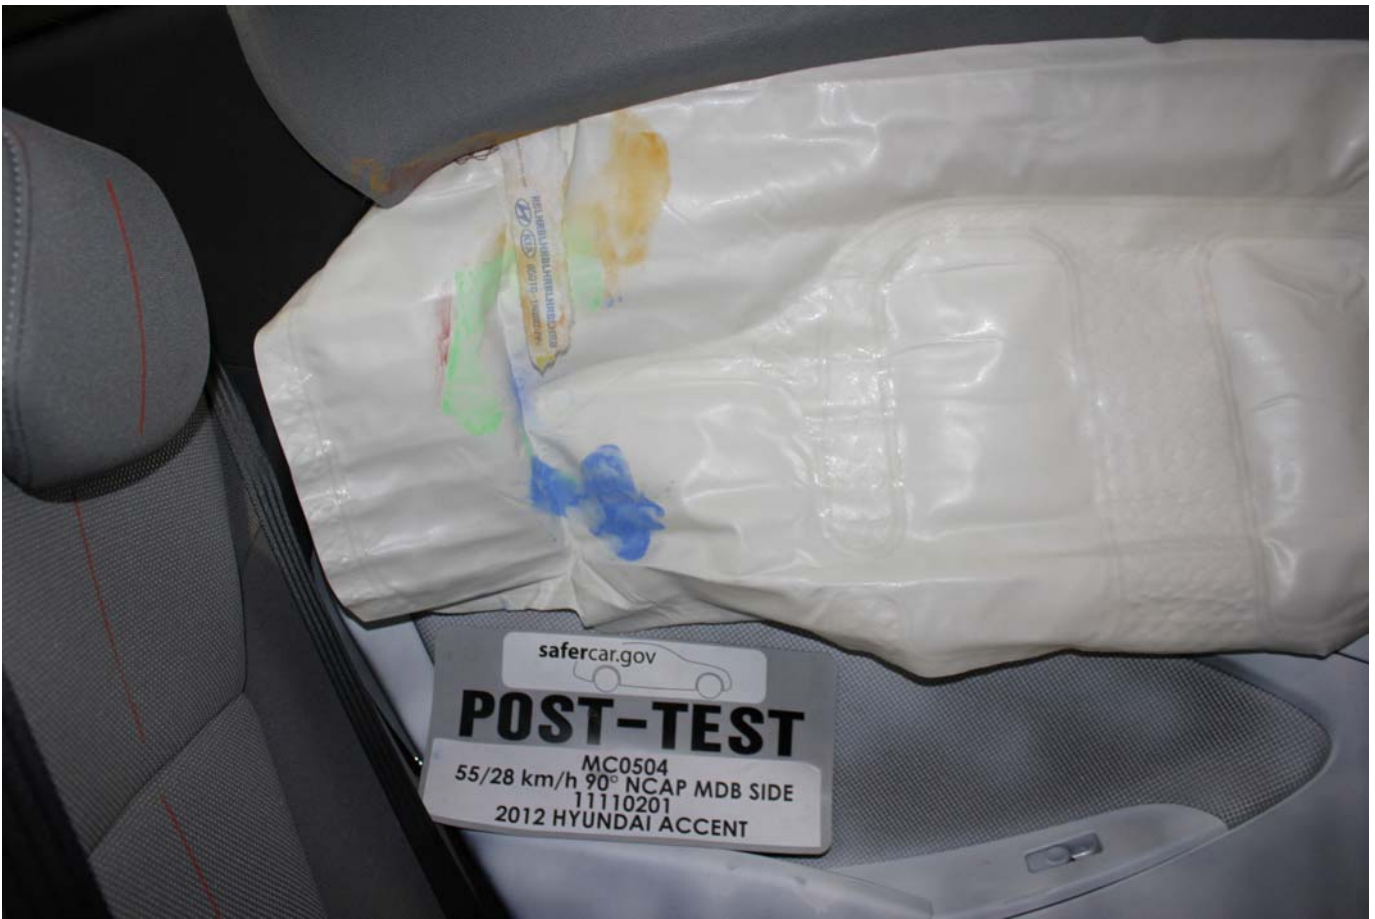
Post-Test Rear Passenger Dummy Close-up Head Contact with Side Airbag View

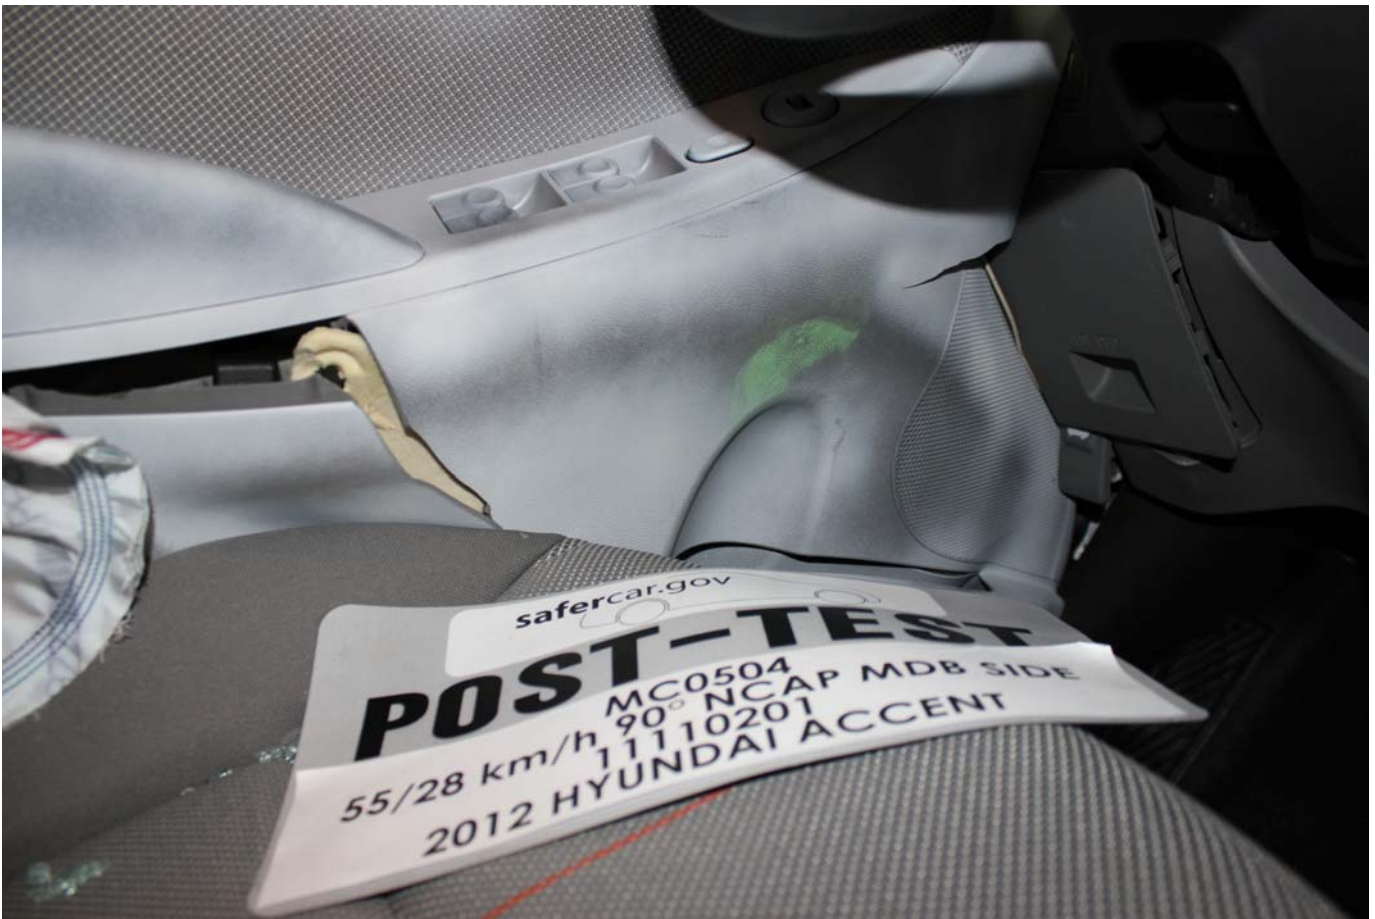
Post-Test Driver Dummy Close-up Knee Contact with Vehicle Interior View

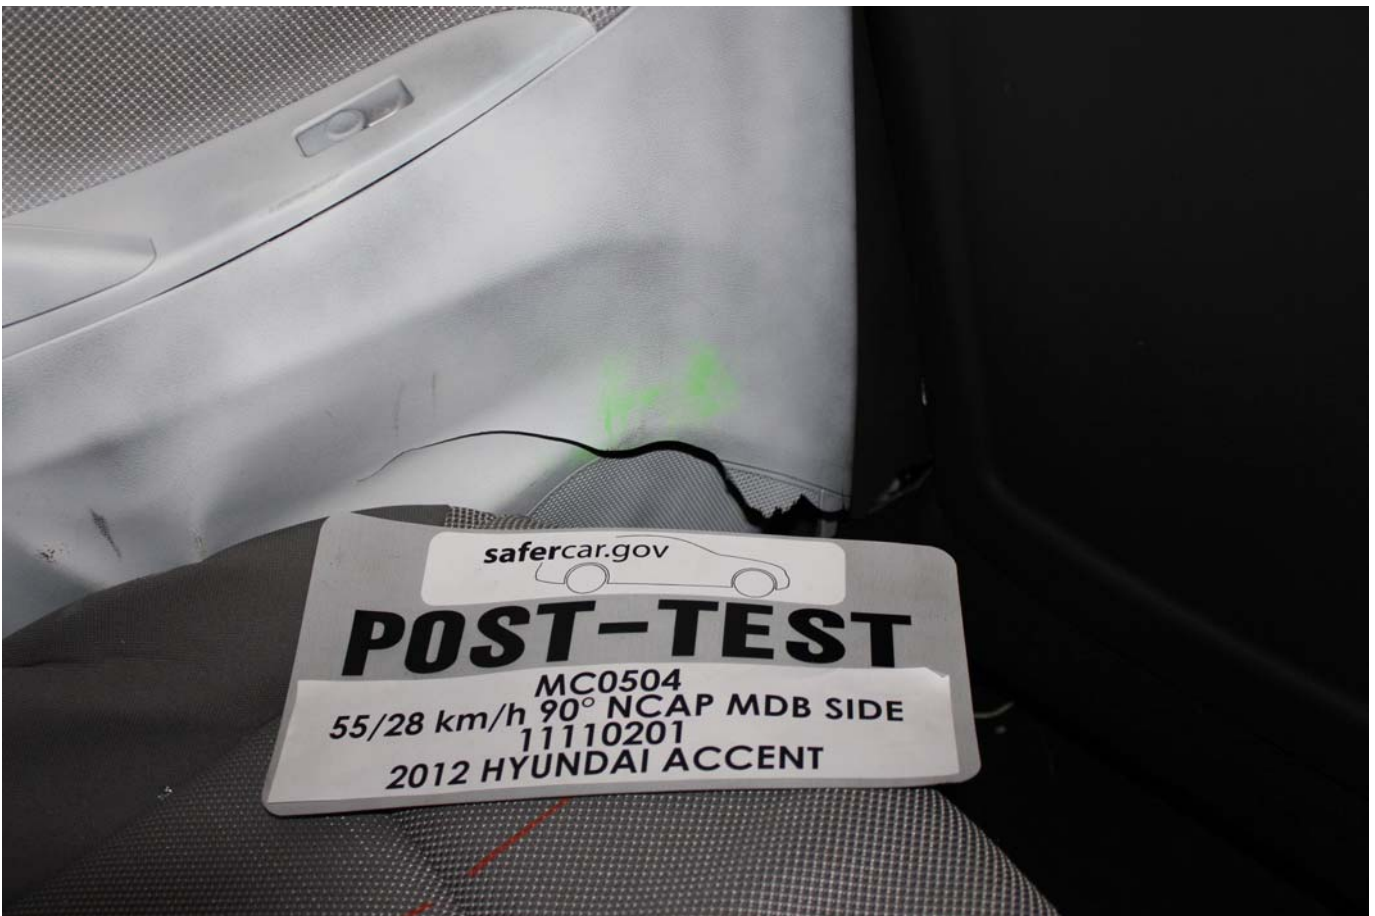
Post-Test Rear Passenger Dummy Close-up Knee Contact with Vehicle Interior View
