REPORT NUMBER: NCAP-KAR-12-012

NEW CAR ASSESSMENT PROGRAM (NCAP) FRONTAL BARRIER IMPACT TEST

CHRYSLER GROUP LLC 2012 FIAT 500 3-DOOR HATCHBACK

FINAL REPORT

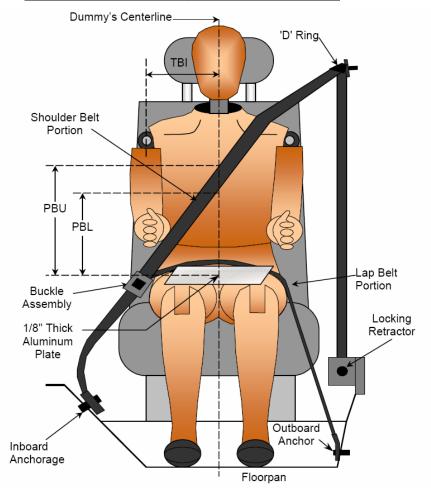
FRONT VIEW OF DUMMY

SEAT BELT POSITIONING MEASUREMENTS

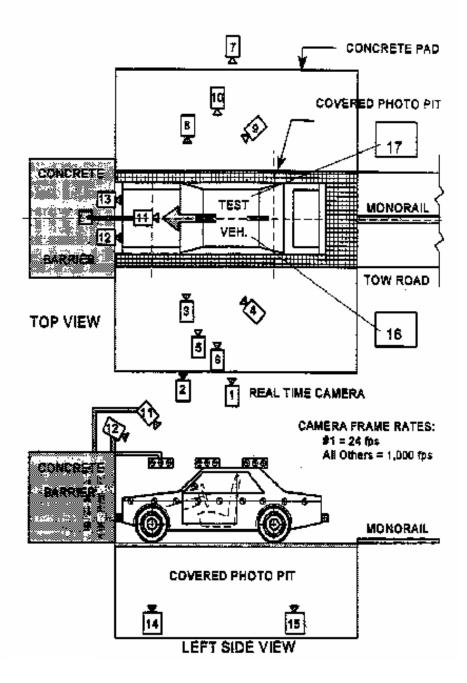
CAMERA POSITIONS FOR FRONTAL IMPACTS

HIGH-SPEED CAMERA LOCATIONS AND DATA

Three (3) real-time cameras and fourteen (14) high-speed cameras were used to document the frontal barrier impact event. Camera locations and other pertinent camera information can be found in Data Sheet 6 of this report.

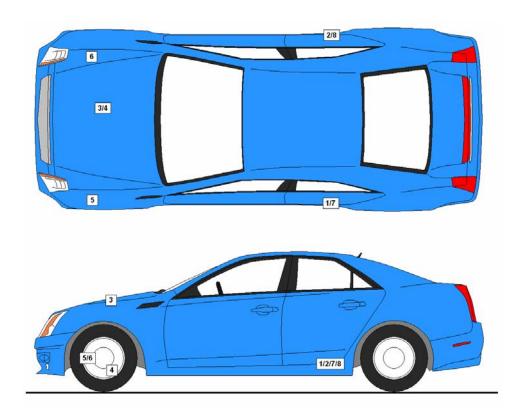
VEHICLE ACCELEROMETER PRE-TEST LOCATIONS

No	No. Description		Location	
NO.	Description	X	Y	Z
1	Left Rear Accelerometer X-Direction	1630	-560	-340
2	Right Rear Accelerometer X-Direction	1630	560	-340
3	Engine Top X	3140	210	-835
4	Engine Bottom X	2810	350	-158
5	Left Brake Caliper X	3140	-695	-280
6	Right Brake Caliper X	3140	695	-280
7	Left Rear Accelerometer Z-Direction	1630	-560	-340
8	Right Rear Accelerometer Z-Direction	1630	560	-340

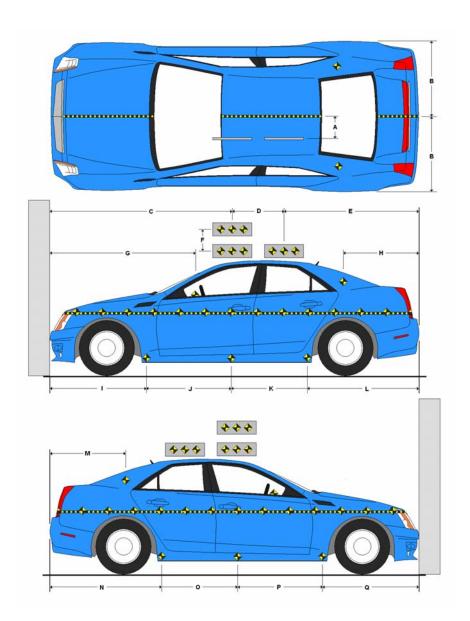
DATA SHEET NO. 9 LOAD CELL LOCATIONS ON FIXED BARRIER

Item	Value
А	335
В	1760
С	1875
D	610
Е	1028
F	305
G	1350
Н	583
I	1103
J	749
K	749
L	922
М	610
N	932
0	748
Р	748
Q	1102

All measurements in millimeters.

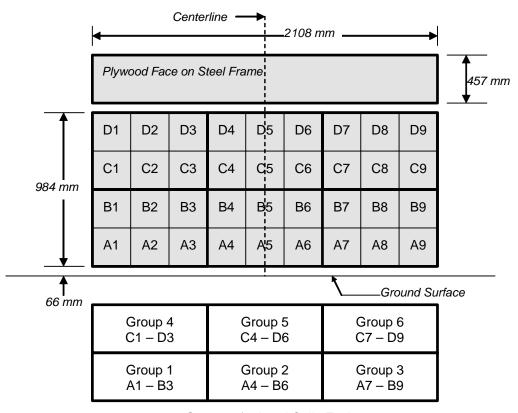
36 Load Cell Rigid Barrier (NHTSA Standard) Load Cell Locations on Fixed Barrier

6 Groups of 6 Load Cells Each

A load cell barrier consisting of 36 load cells was impacted by a 2012 Fiat 500 3-door hatchback at a velocity of 56.03 km/h. The test was performed at KARCO Engineering, LLC. on November 8, 2011. Pre- and post-test photographs of the vehicle and dummies can be found in Appendix A of this report.

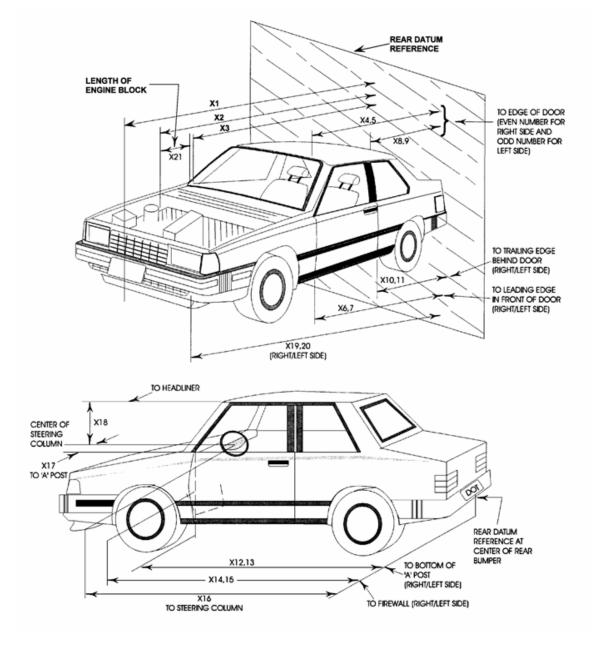
DATA SHEET NO. 12 ... (CONTINUED) VEHICLE PROFILE MEASUREMENTS

Collision Deformation Classification: 12FDEW2
Midpoint of Damage: Vehicle Centerline
Damage Region Length (mm): 1255
Impact Mode: Full Frontal

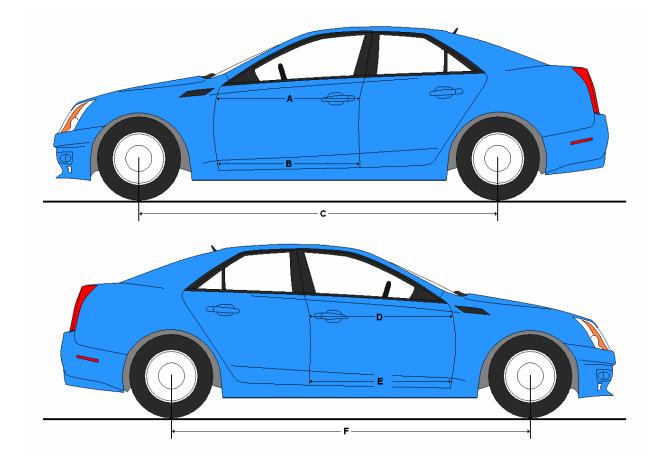
DATA SHEET NO. 14 ... (CONTINUED)

Item	Description	Units	Pre-Test	Post-Test	Difference
С	Left Side Wheelbase	mm	2305	2320	-15
F	Right Side Wheelbase	mm	2305	2310	-5

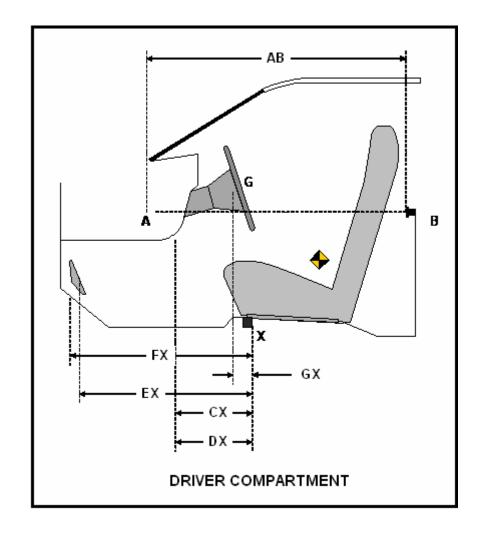
DATA SHEET NO. 14 ... (CONTINUED) VEHICLE INTRUSION MEASUREMENTS

Item	Description	Units	Pre-Test	Post-Test	Difference
AB	Door Opening (Inside Window Jam)	mm	1011	1013	-2
CX	Left Knee Bolster to X	mm	380	350	30
DX	Right Knee Bolster to X	mm	355	330	25
EX	Brake Pedal to X	mm	560	510	50
FX	Foot Rest to X	mm	600	610	-10
GX	Center of Steering Wheel Hub to X	mm	154	50	104

X = Front of Seat Track (Stationary)

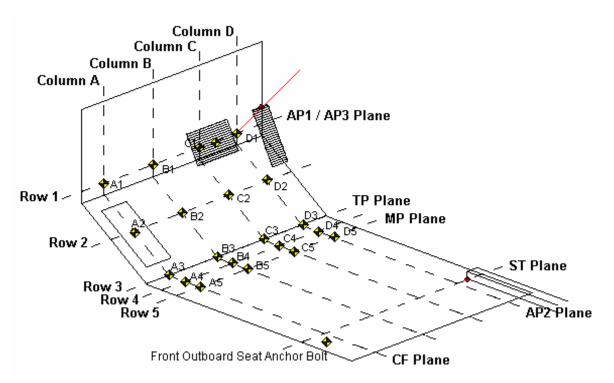
AP1: Y-Z Plane passing through D1

AP2: X-Z Plane passing through D1

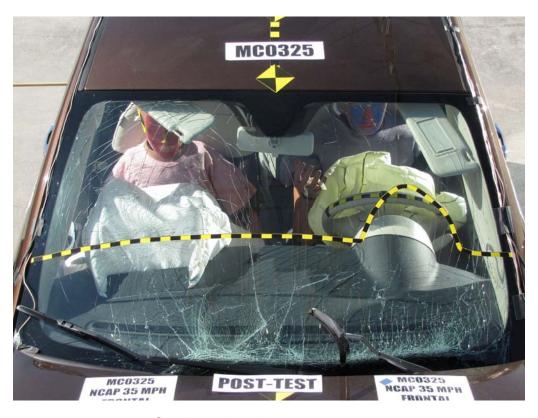
FIGURE 18. Post-Test Windshield View

There was 100% windshield retention and no intrusion into the protected zone of the windshield during the event. There was no Stoddard solvent leakage after the event or during any phase of the static rollover.
