**REPORT NUMBER: SPNCAP-MGA-2012-023**

**NEW CAR ASSESSMENT PROGRAM (NCAP)  
Side Impact Pole Test**

**GENERAL MOTORS LLC  
2012 Chevrolet Suburban 2WD 1/2 Ton LS SUV  
NHTSA No.: MC0105**

**FINAL REPORT**

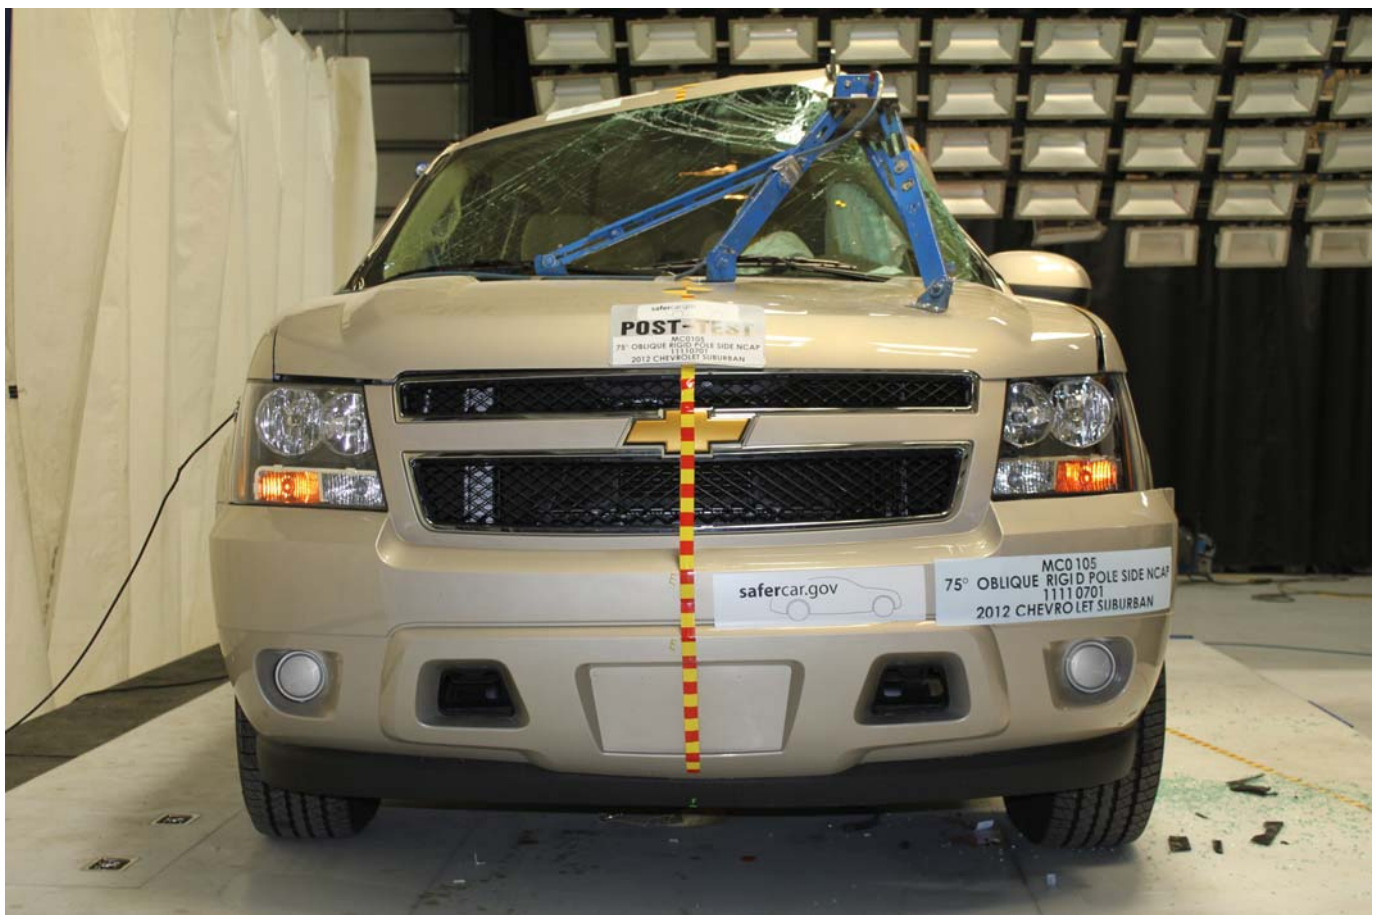
Post-Test Frontal View of Test Vehicle

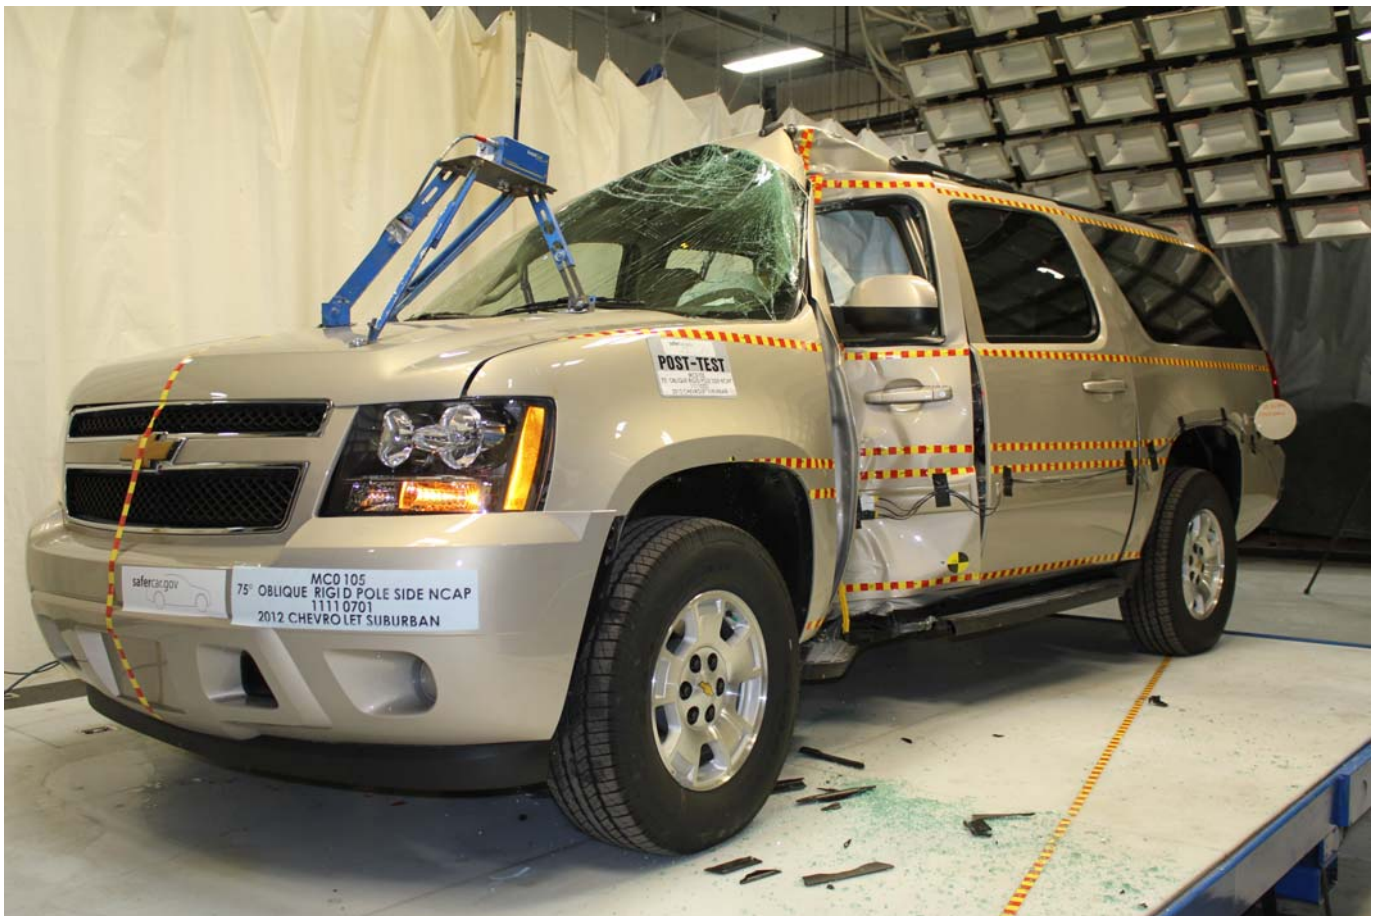
Post-Test Left Front  $\frac{3}{4}$  View of Test Vehicle

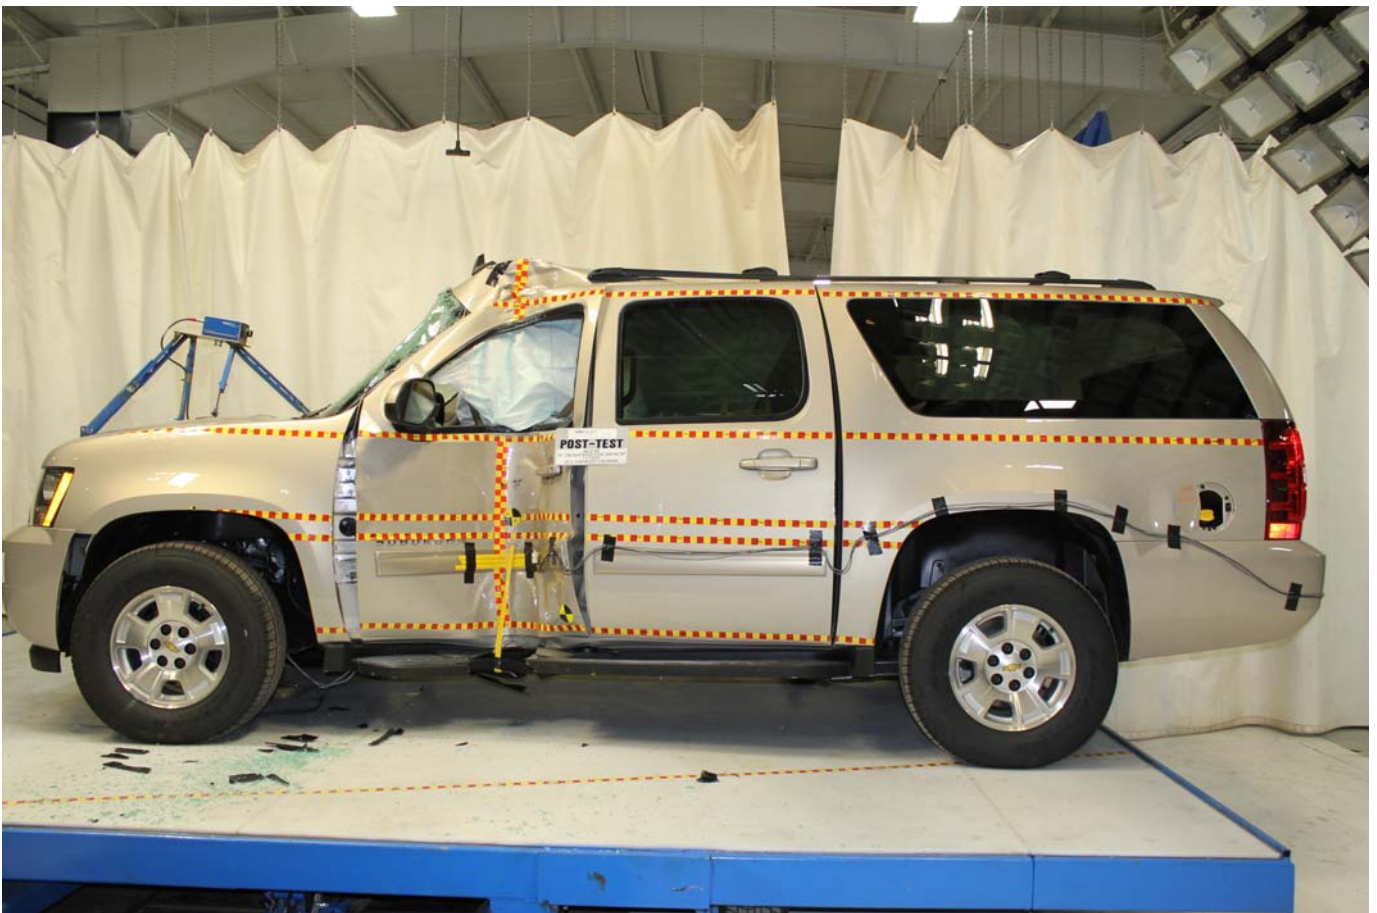
Post-Test Left Side View of Test Vehicle

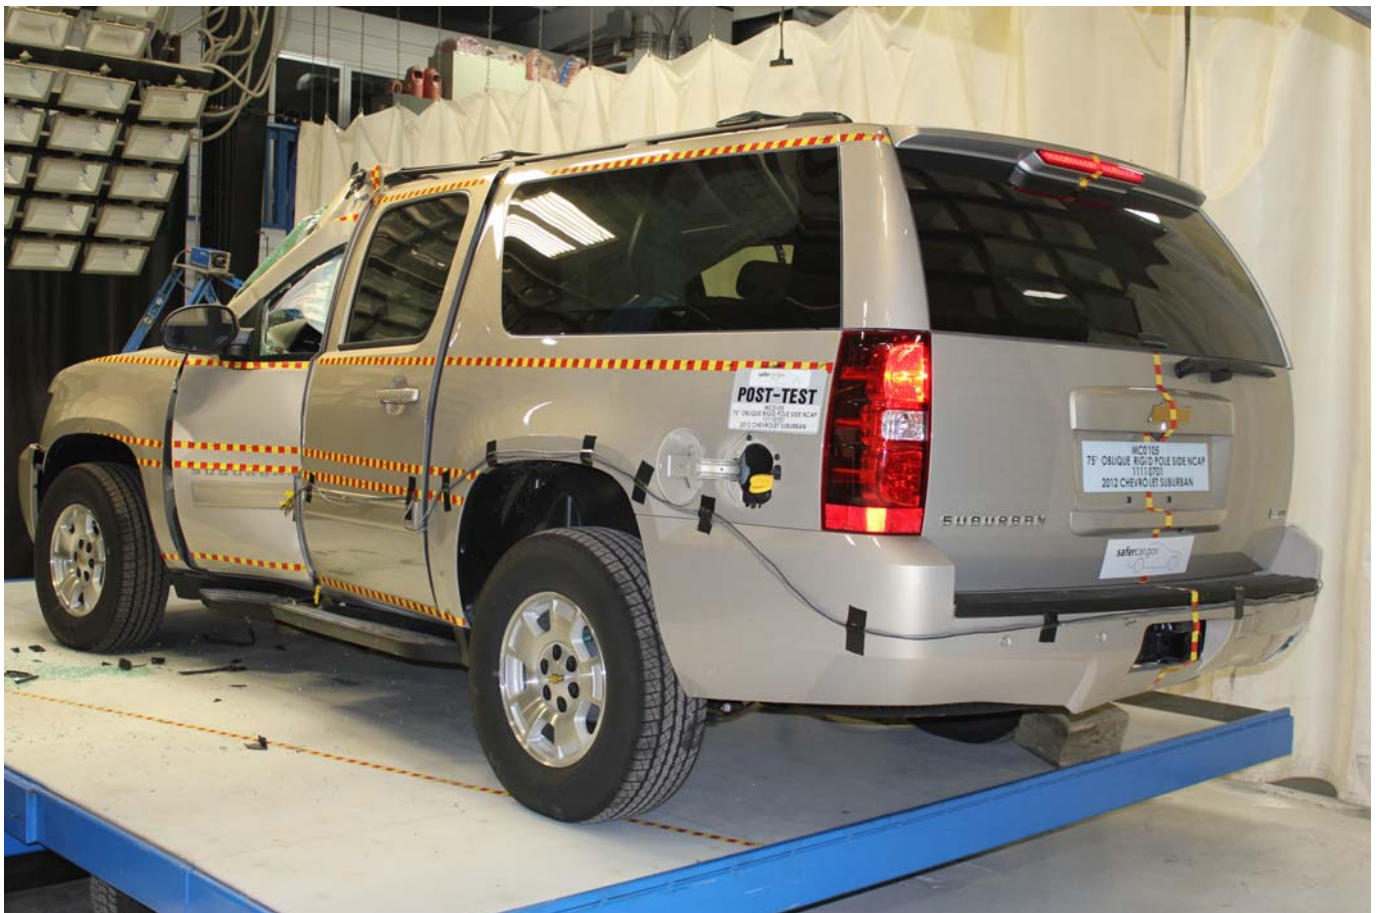
Post-Test Left Rear  $\frac{3}{4}$  View of Test Vehicle

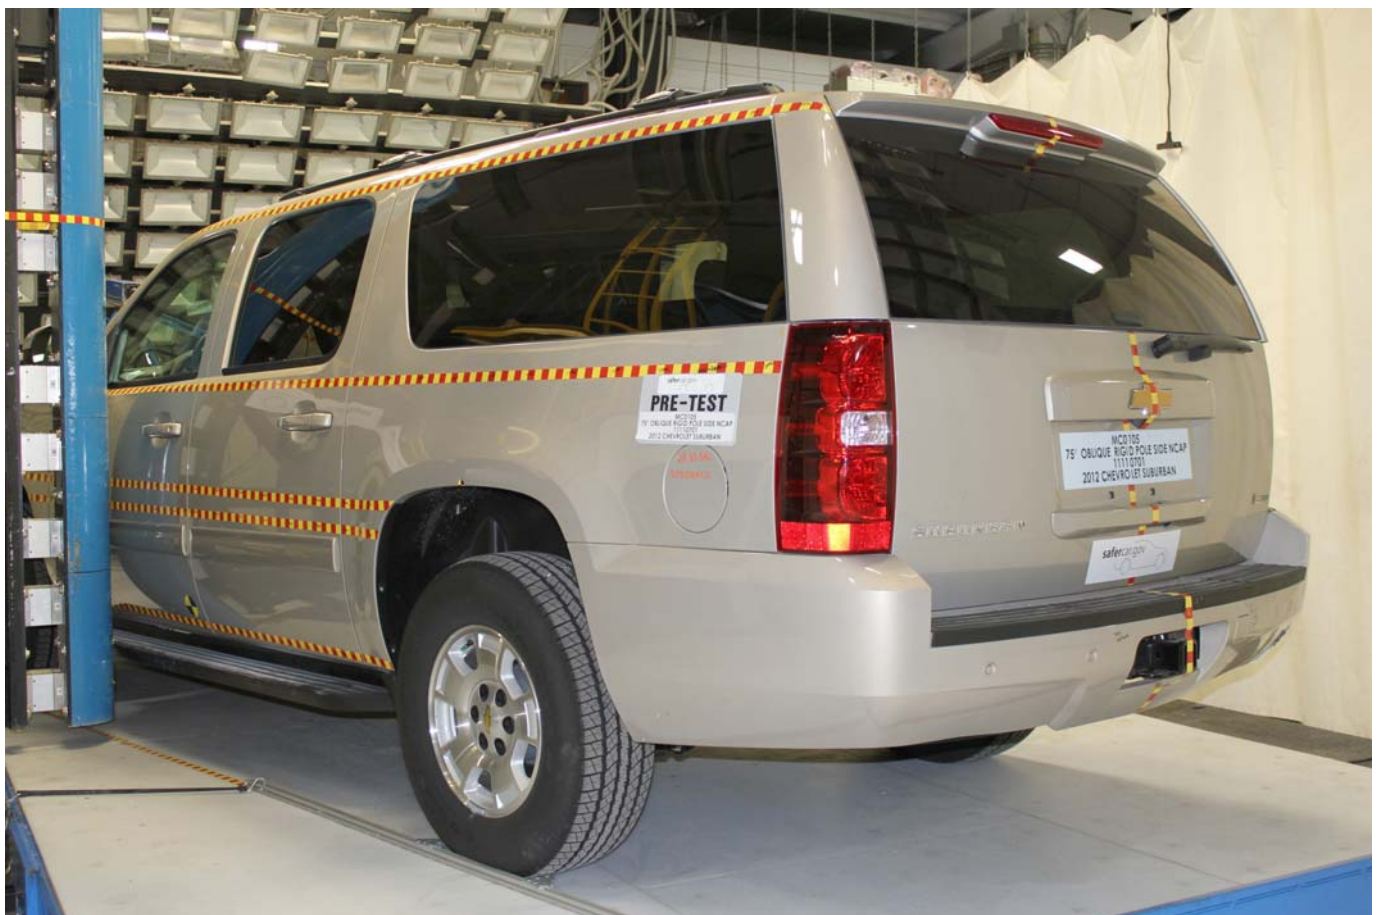
Pre-Test Left Side View of Pole Positioned Against Side of Vehicle

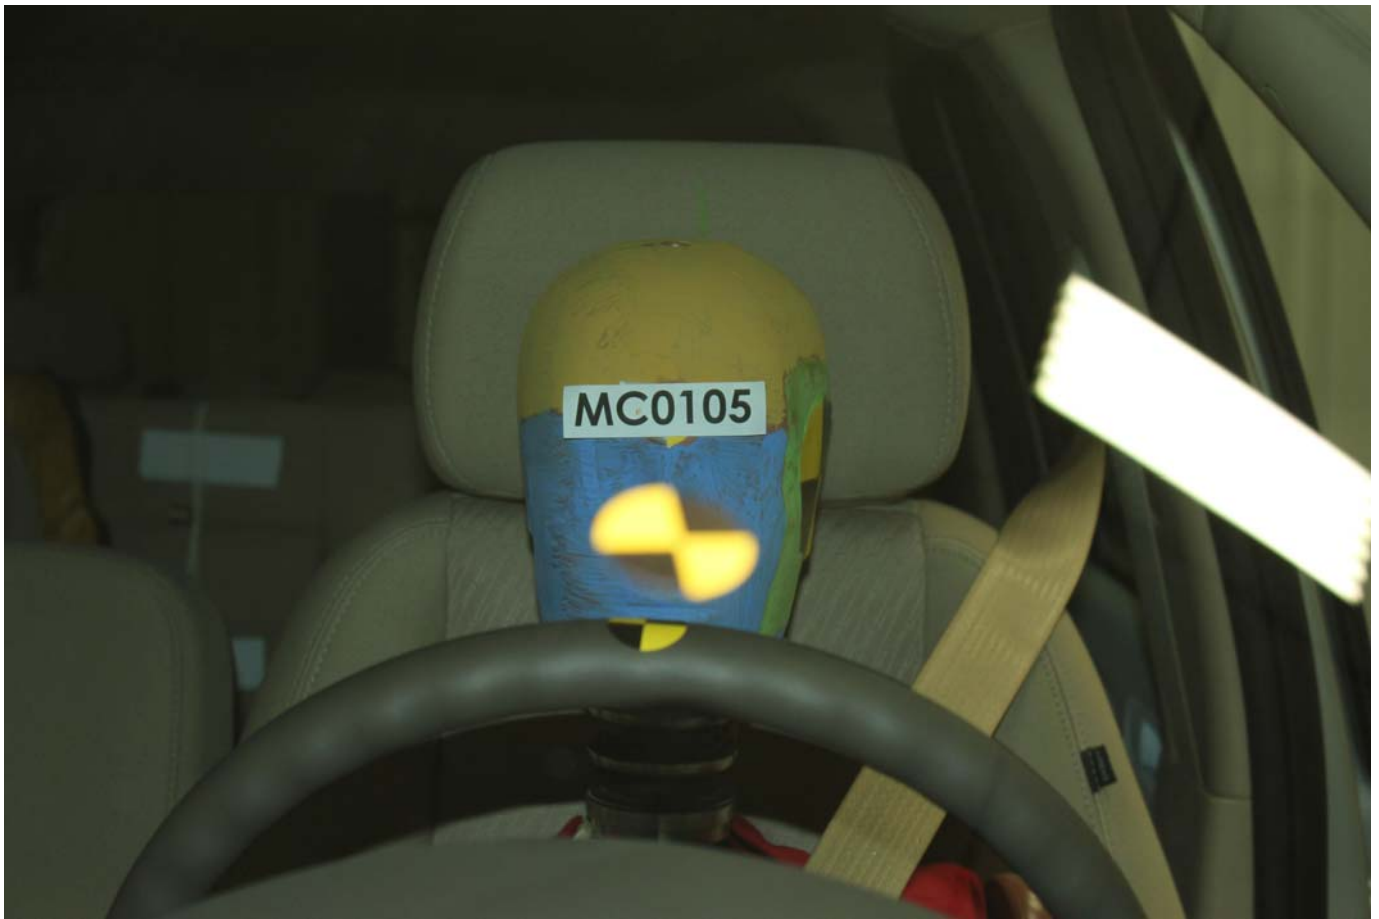
Post-Test Close-Up View of Impact Point Target Showing Impact Location

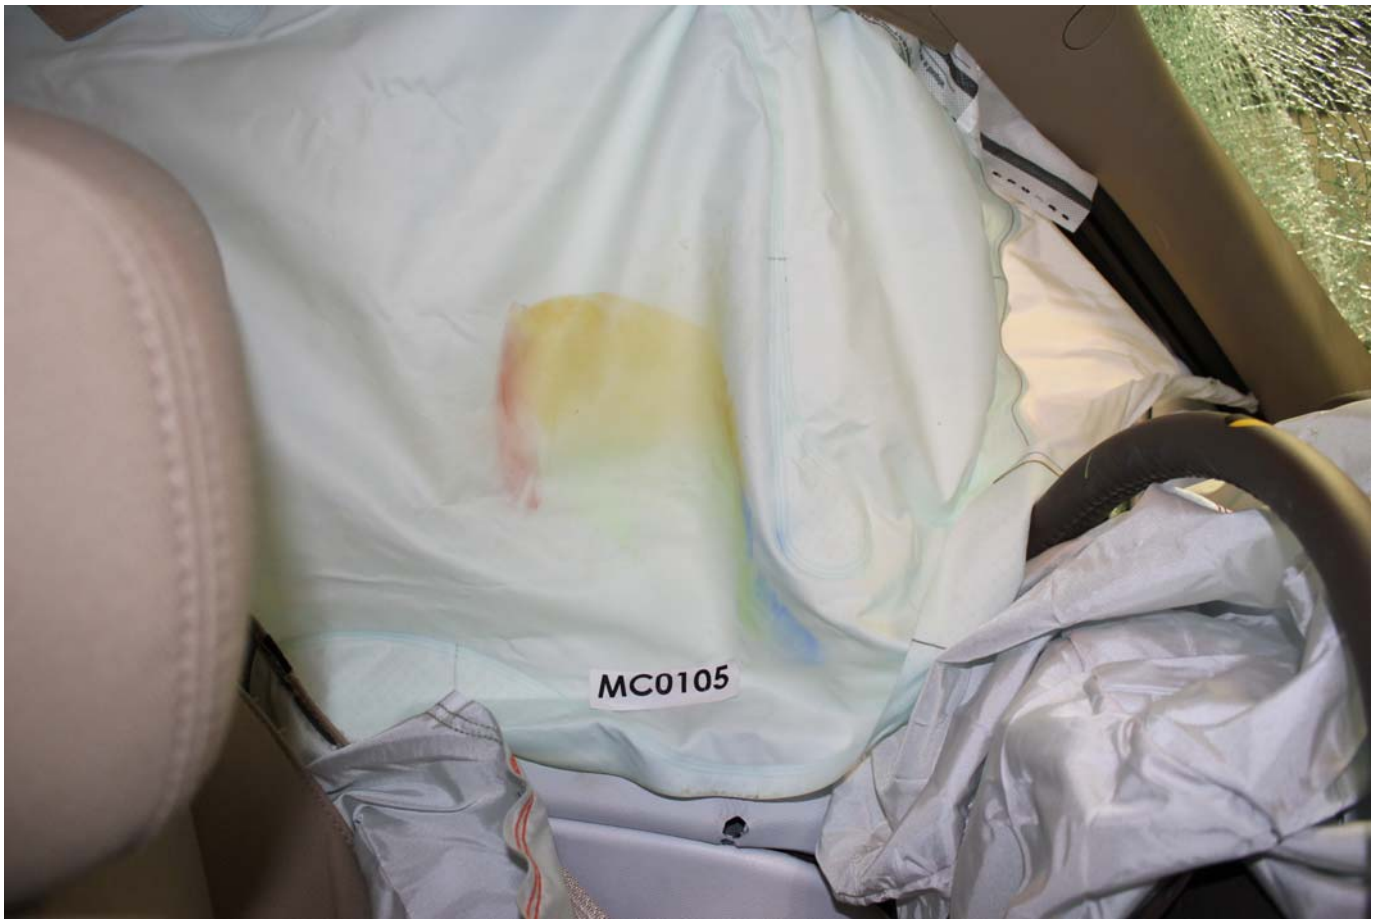
Post-Test Dummy Close-Up Head Contact with Vehicle Interior View

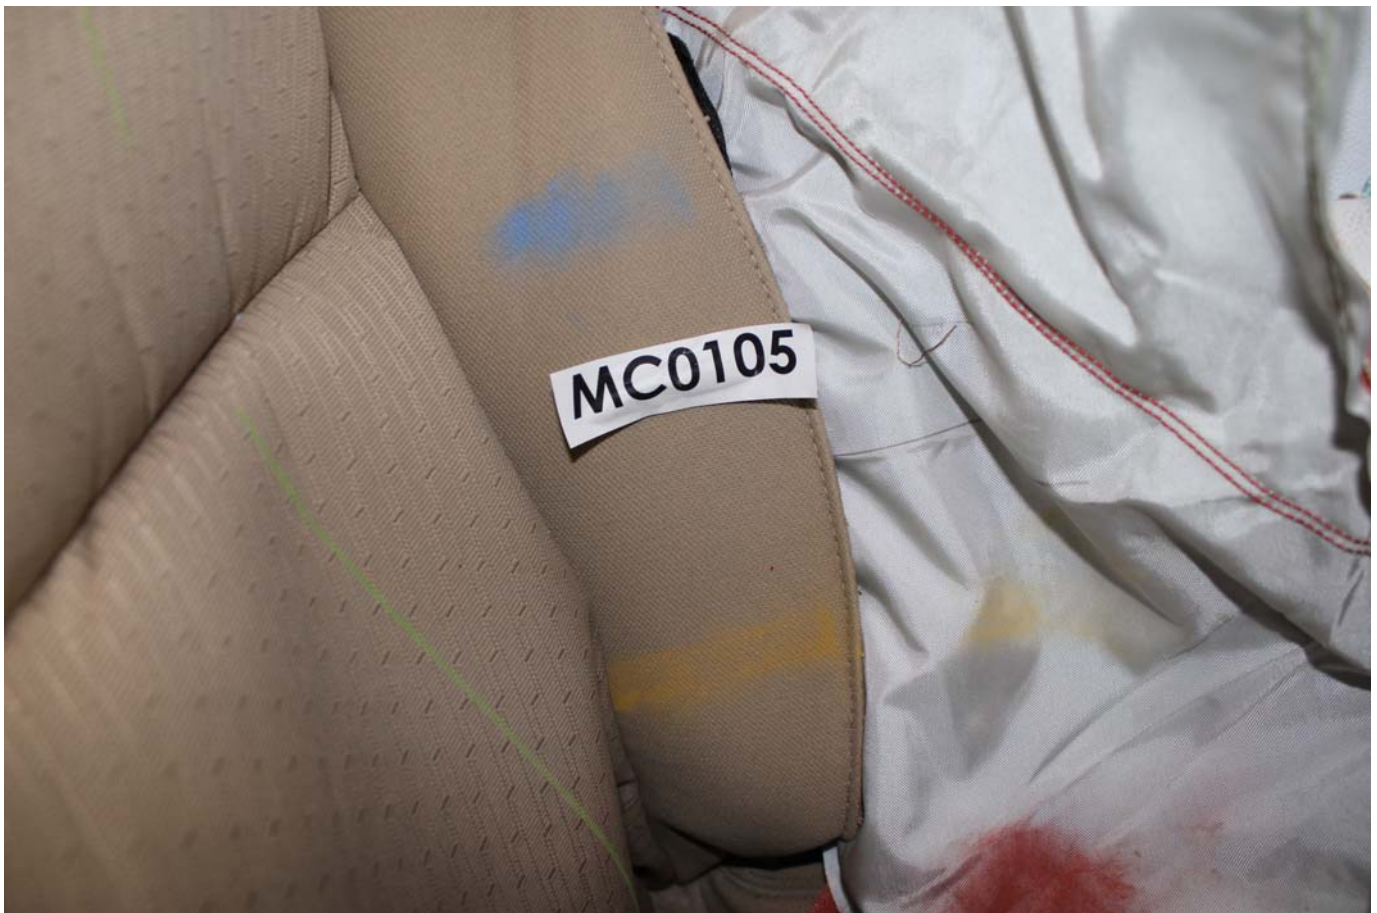
Post-Test Dummy Close-Up Head Contact with Side Air Bag View

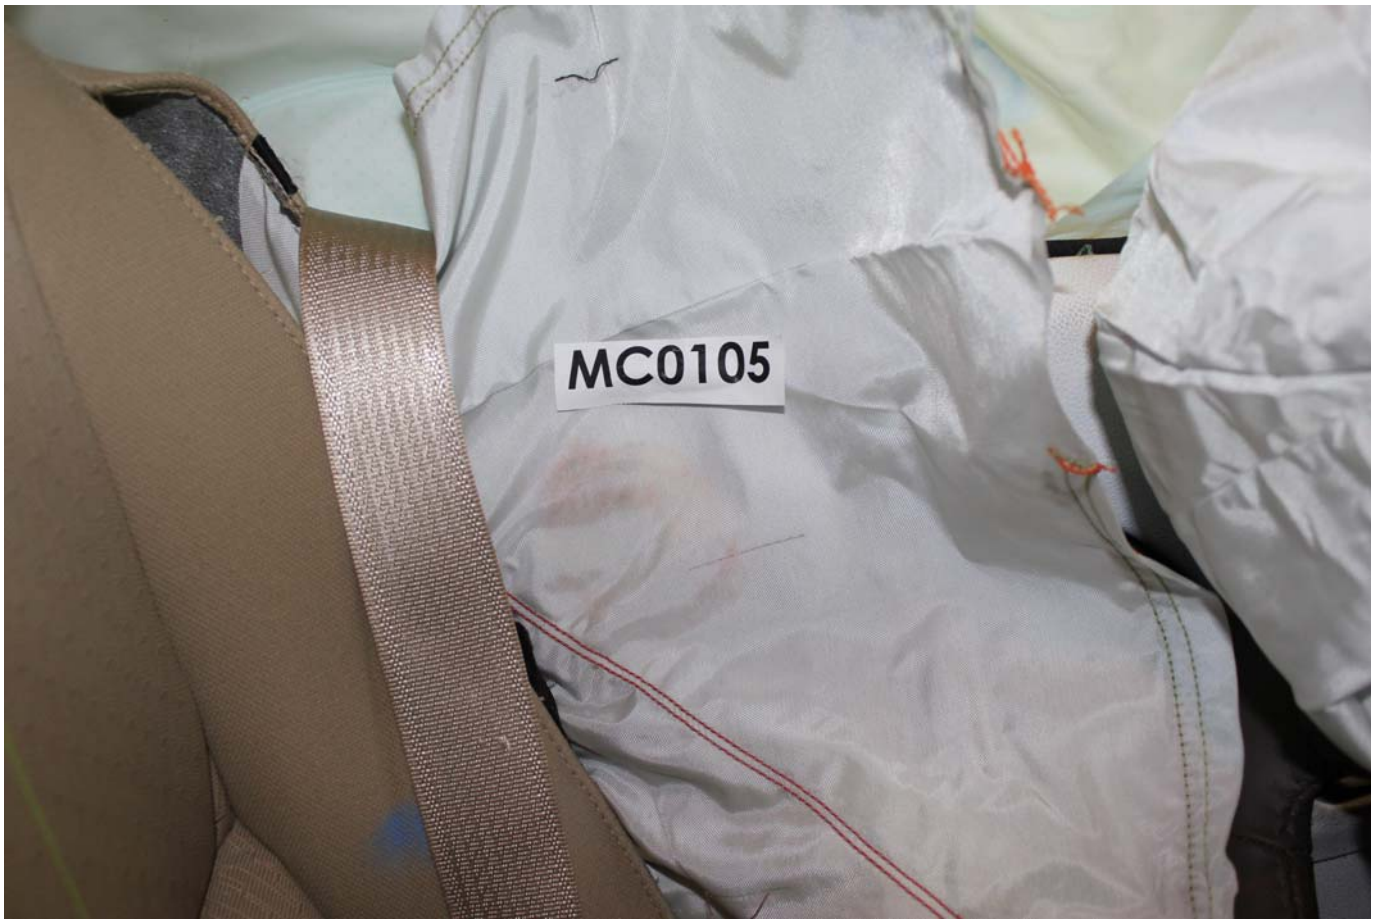
Post-Test Dummy Close-Up Torso Contact with Vehicle Interior View

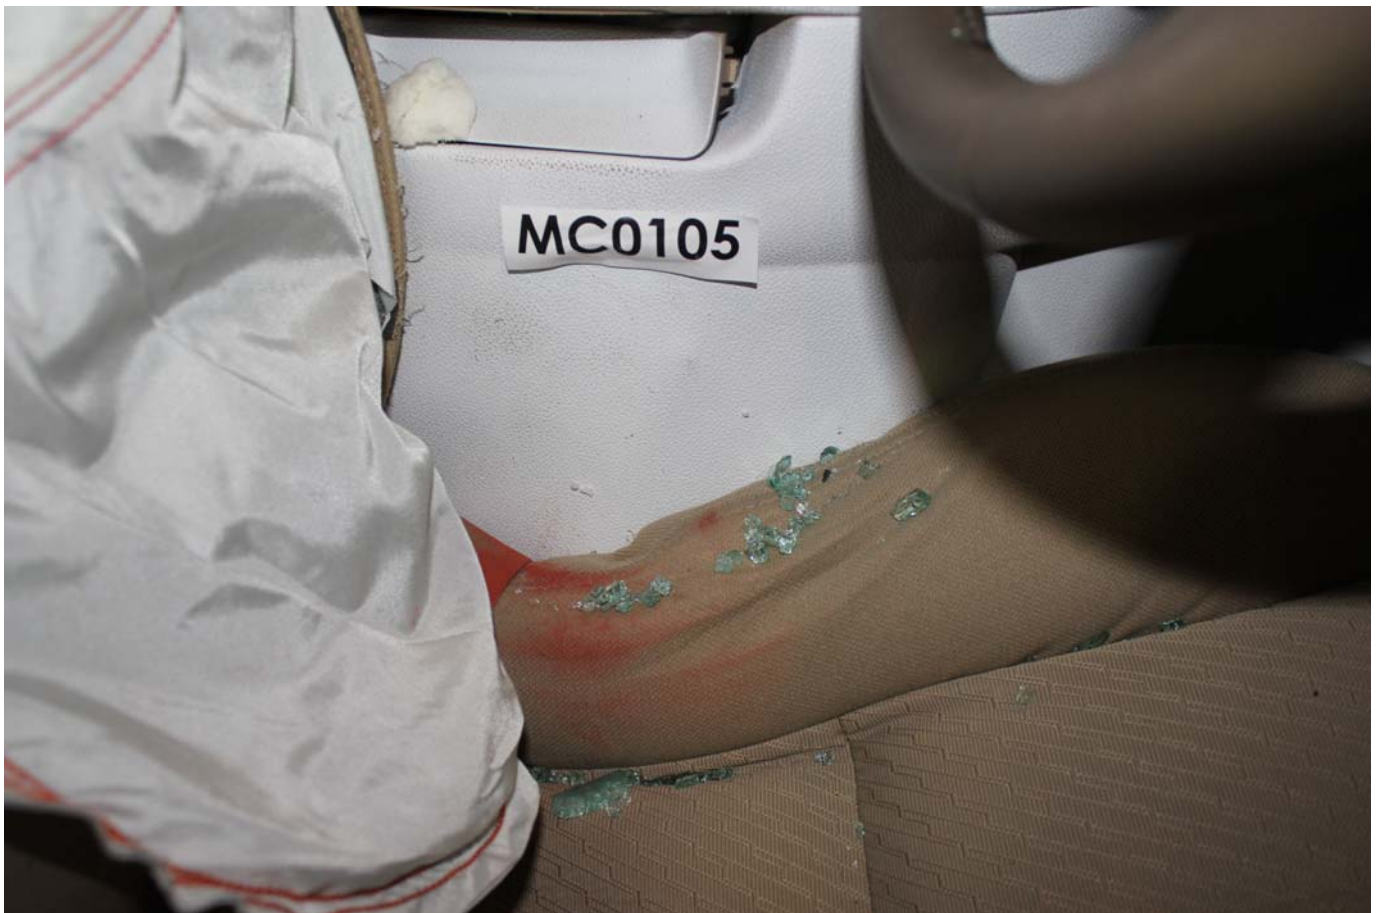
Post-Test Dummy Close-Up Torso Contact with Side Air Bag View

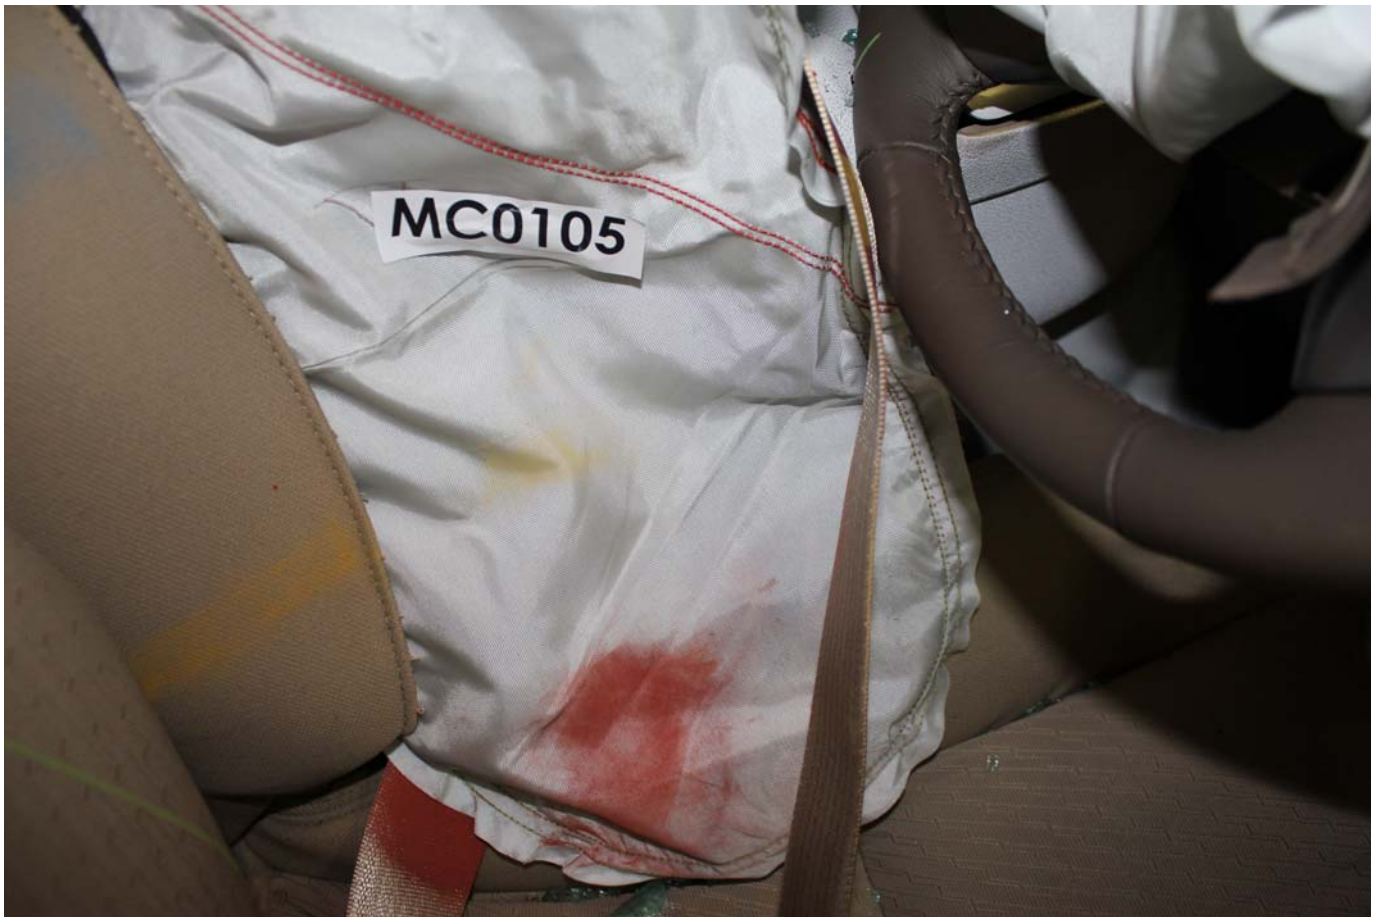
Post-Test Dummy Close-Up Pelvis Contact with Vehicle Interior View
