**REPORT NUMBER: SINCAP-CAL-12-007**

**NEW CAR ASSESSMENT PROGRAM (NCAP)  
Moving Deformable Barrier Side Impact Test**

**HYUNDAI MOTOR MANUFACTURING ALABAMA, LLC  
2012 Hyundai Elantra PZEV  
Four Door Sedan**

**NHTSA No: MC0501**

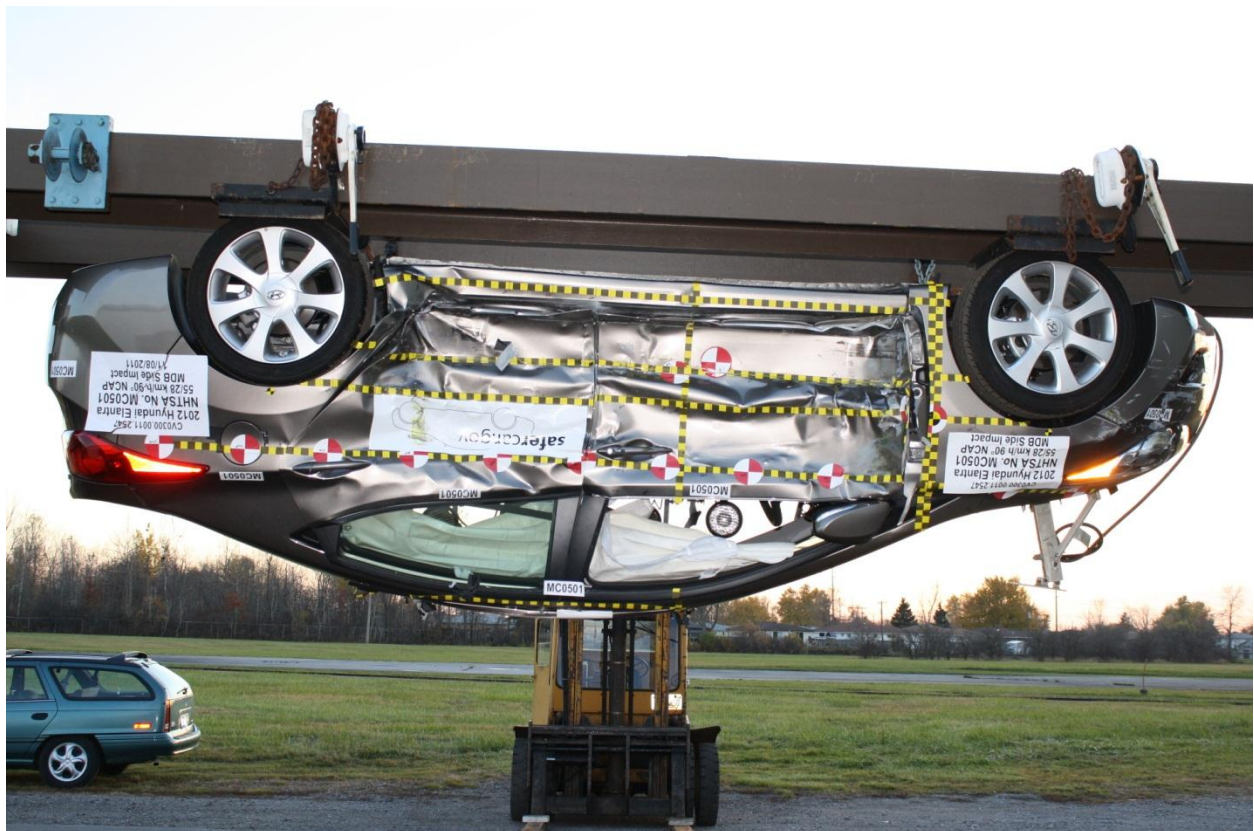
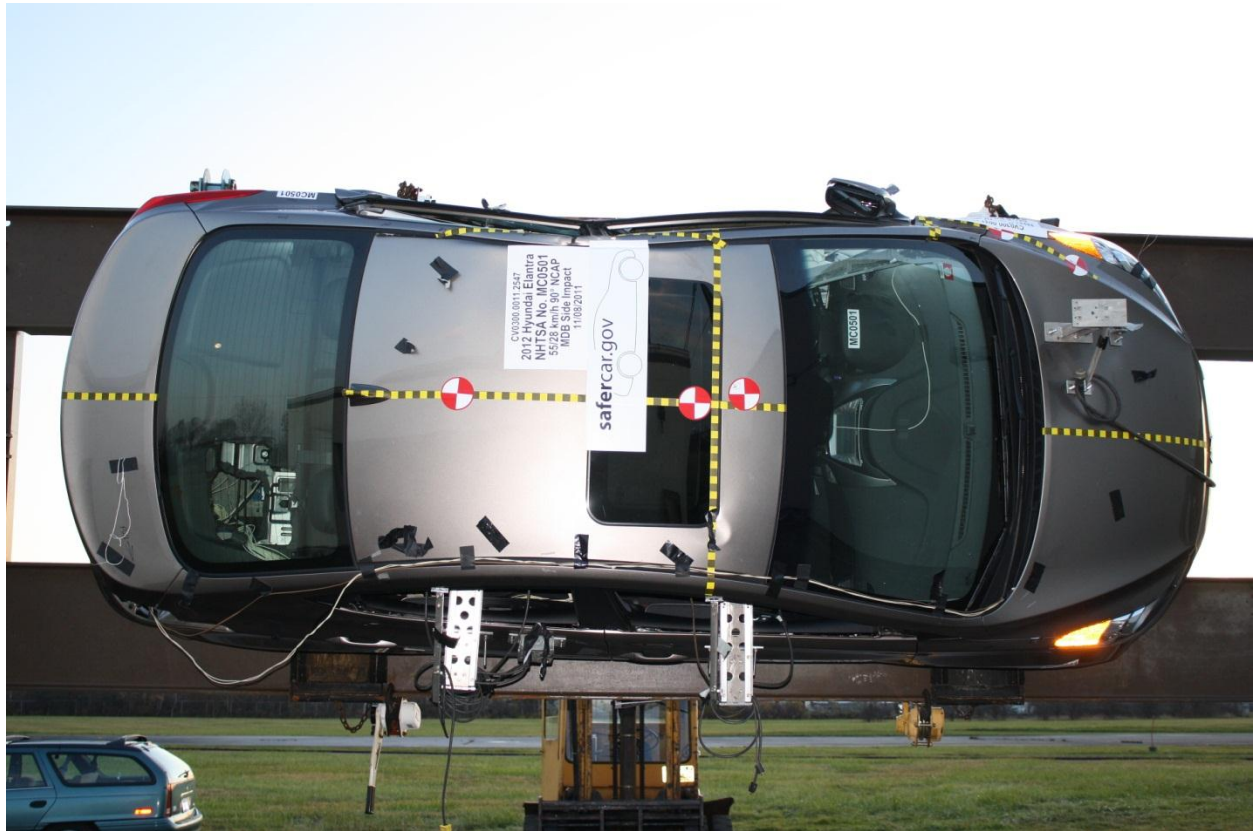
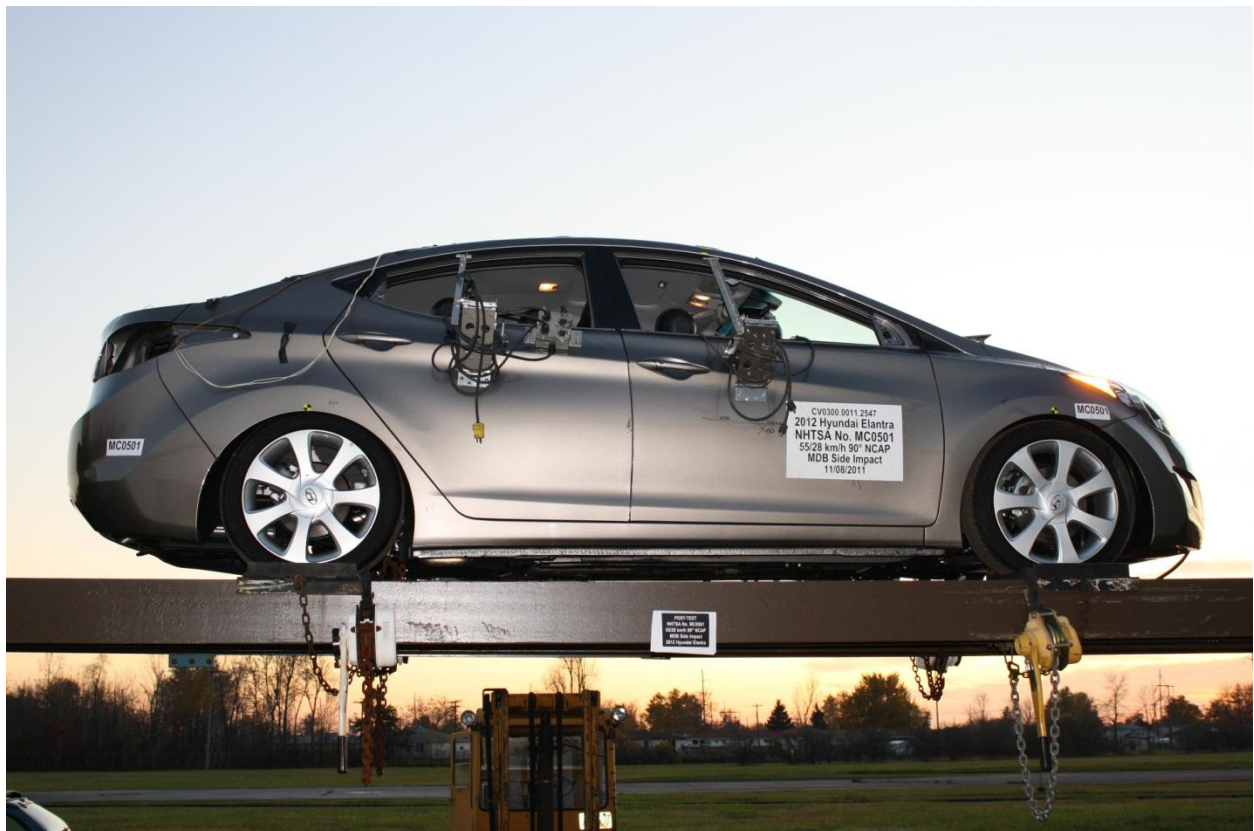
**Figure A-95: FMVSS No. 301 Static Rollover 90 Degrees**

**Figure A-96: FMVSS No. 301 Static Rollover 180 Degrees**

**Figure A-97: FMVSS No. 301 Static Rollover 270 Degrees**

**Figure A-98: FMVSS No. 301 Static Rollover 360 Degrees**
