REPORT NUMBER: SPNCAP-KAR-12-014

**NEW CAR ASSESSMENT PROGRAM (NCAP)
SIDE IMPACT POLE TEST**

**CHRYSLER GROUP LLC
2012 FIAT 500 3-DOOR HATCHBACK**

FINAL REPORT

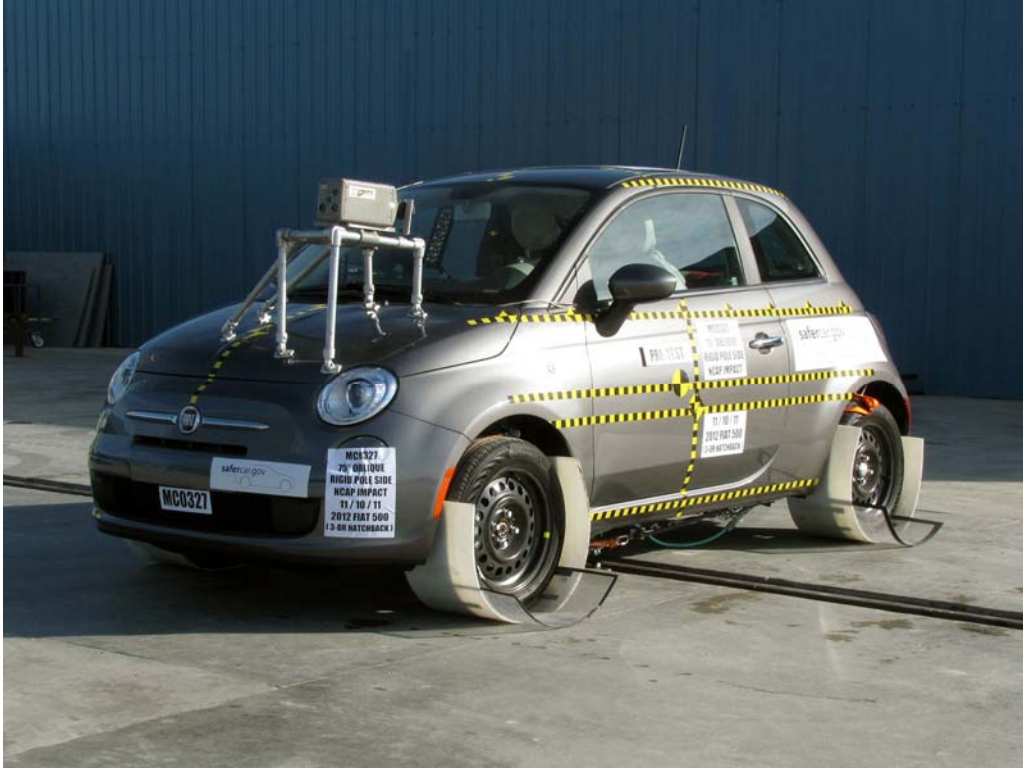
FIGURE 4. Post-Test Frontal View of Test Vehicle

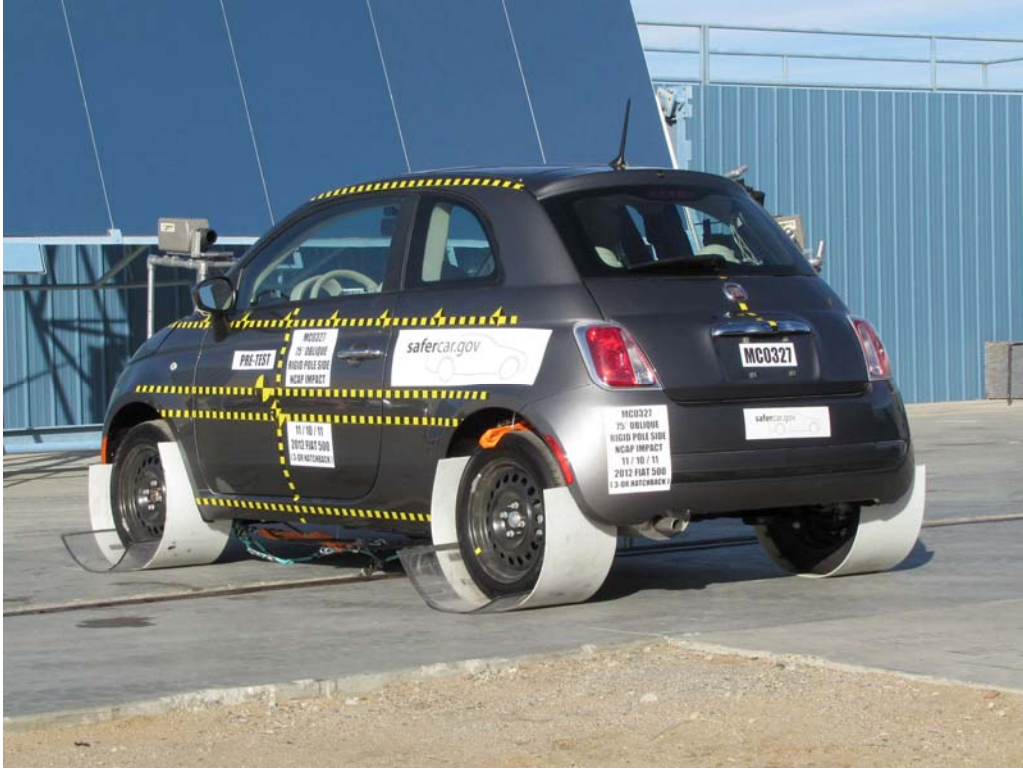
FIGURE 8. Post-Test Left Side View of Test Vehicle

The door on the struck side of the vehicle remained closed and latched. There was no separation at the hinges or latches. The door on the non-struck side remained closed and latched. There were no ATD values that exceeded limits.

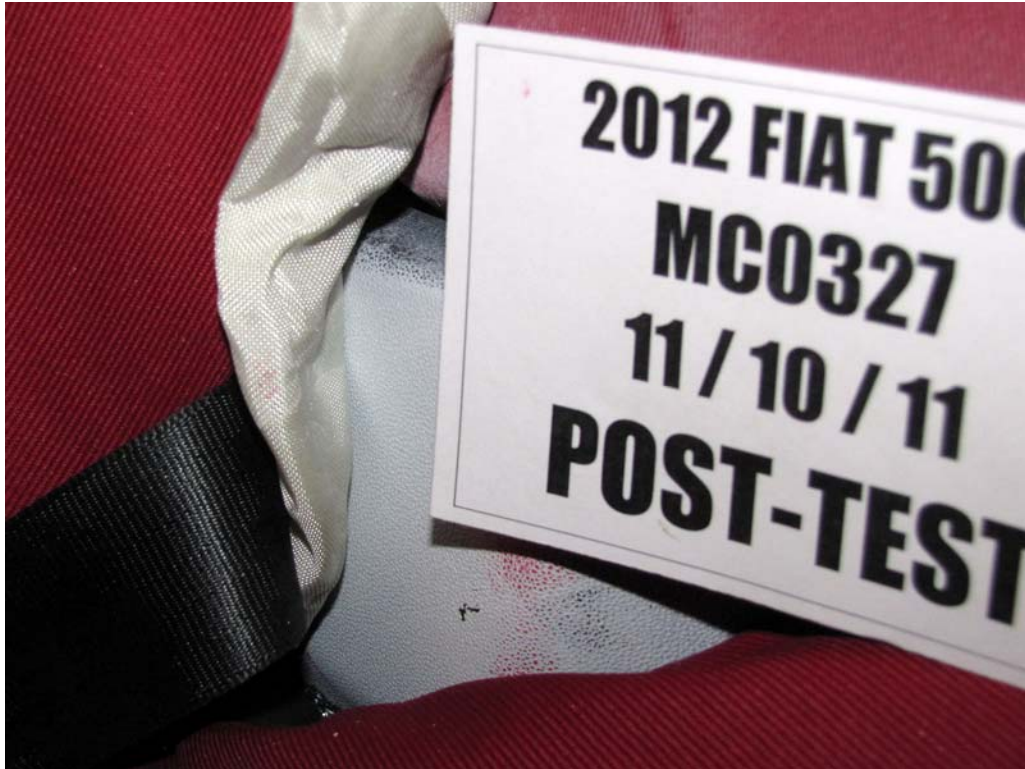
FIGURE 50. Post-Test Dummy Close-Up Pelvis Contact with Vehicle Interior View
