**REPORT NUMBER: SINCAP-MGA-2012-026**

**NEW CAR ASSESSMENT PROGRAM (NCAP)  
Moving Deformable Barrier Side Impact Test**

**TOYOTA MOTOR MANUFACTURING, NORTHERN KENTUCKY, INC.  
2012 Toyota Camry LE 4-Dr Sedan  
NHTSA No.: YC5101**

**FINAL REPORT**

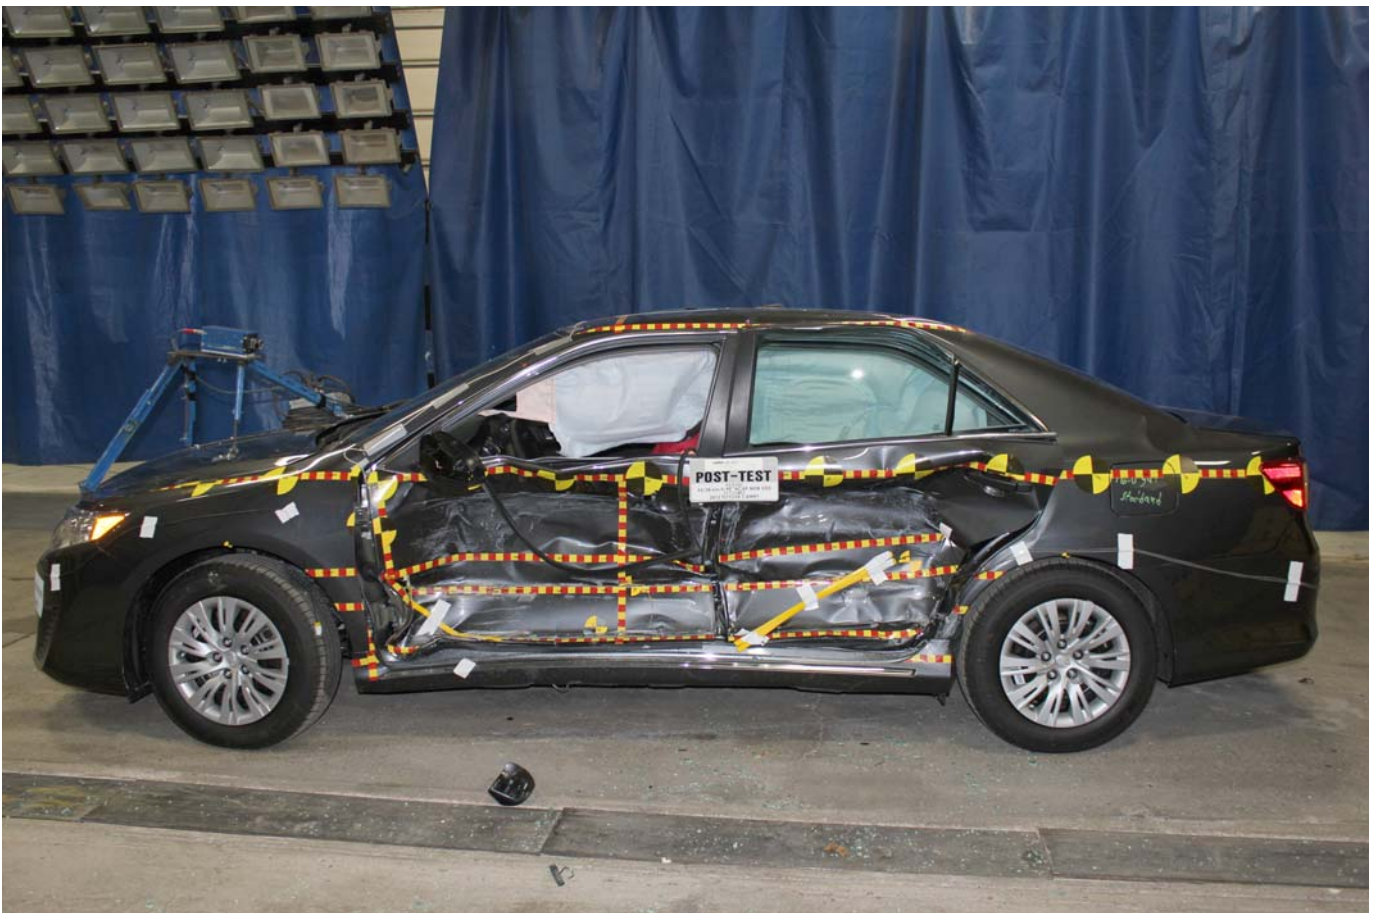
Post-Test Left Side View of Test Vehicle

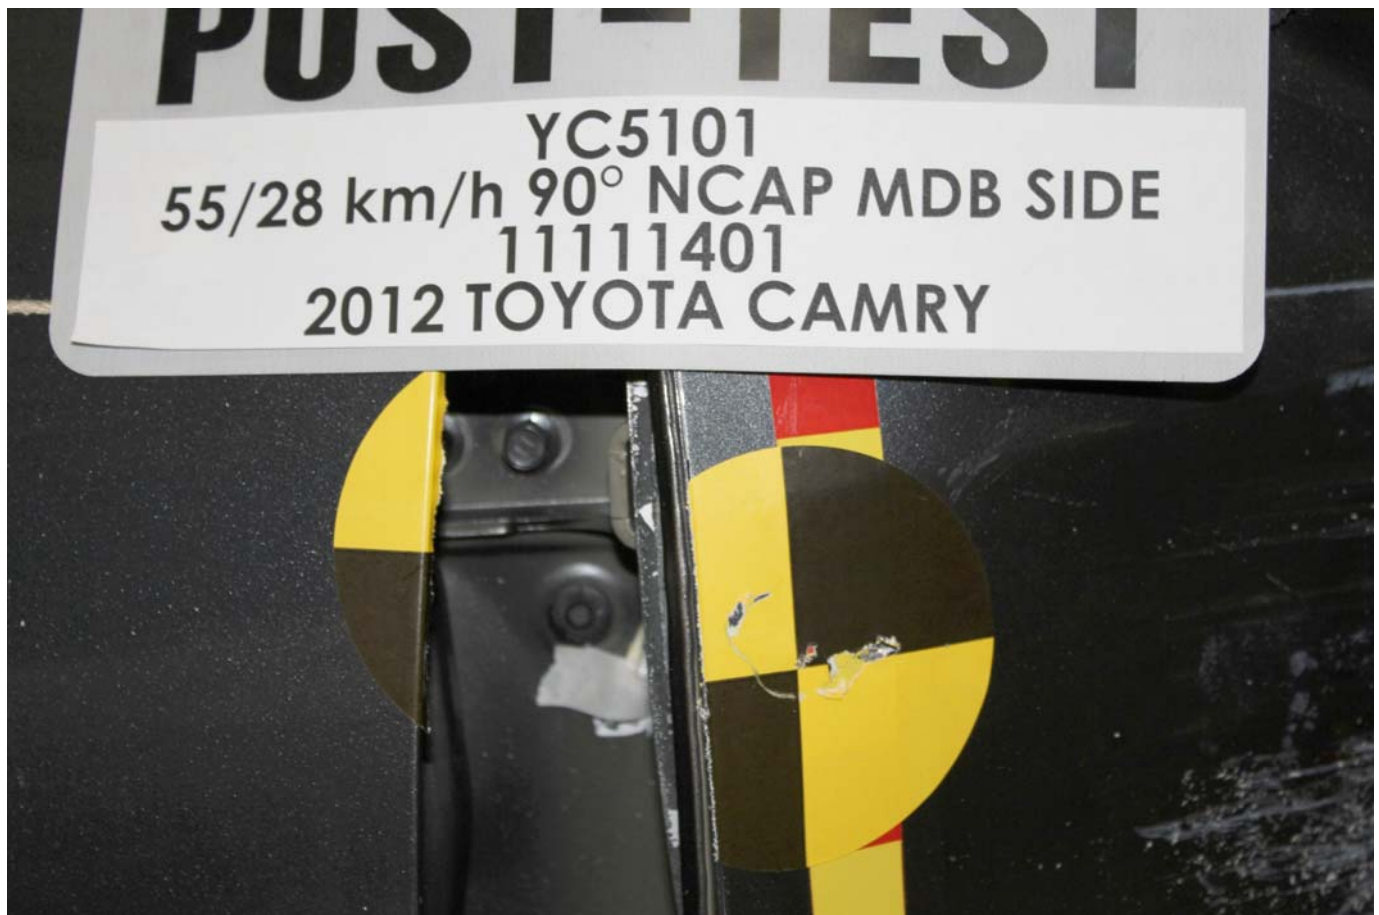
Post-Test Close-Up View of Impact Point Target

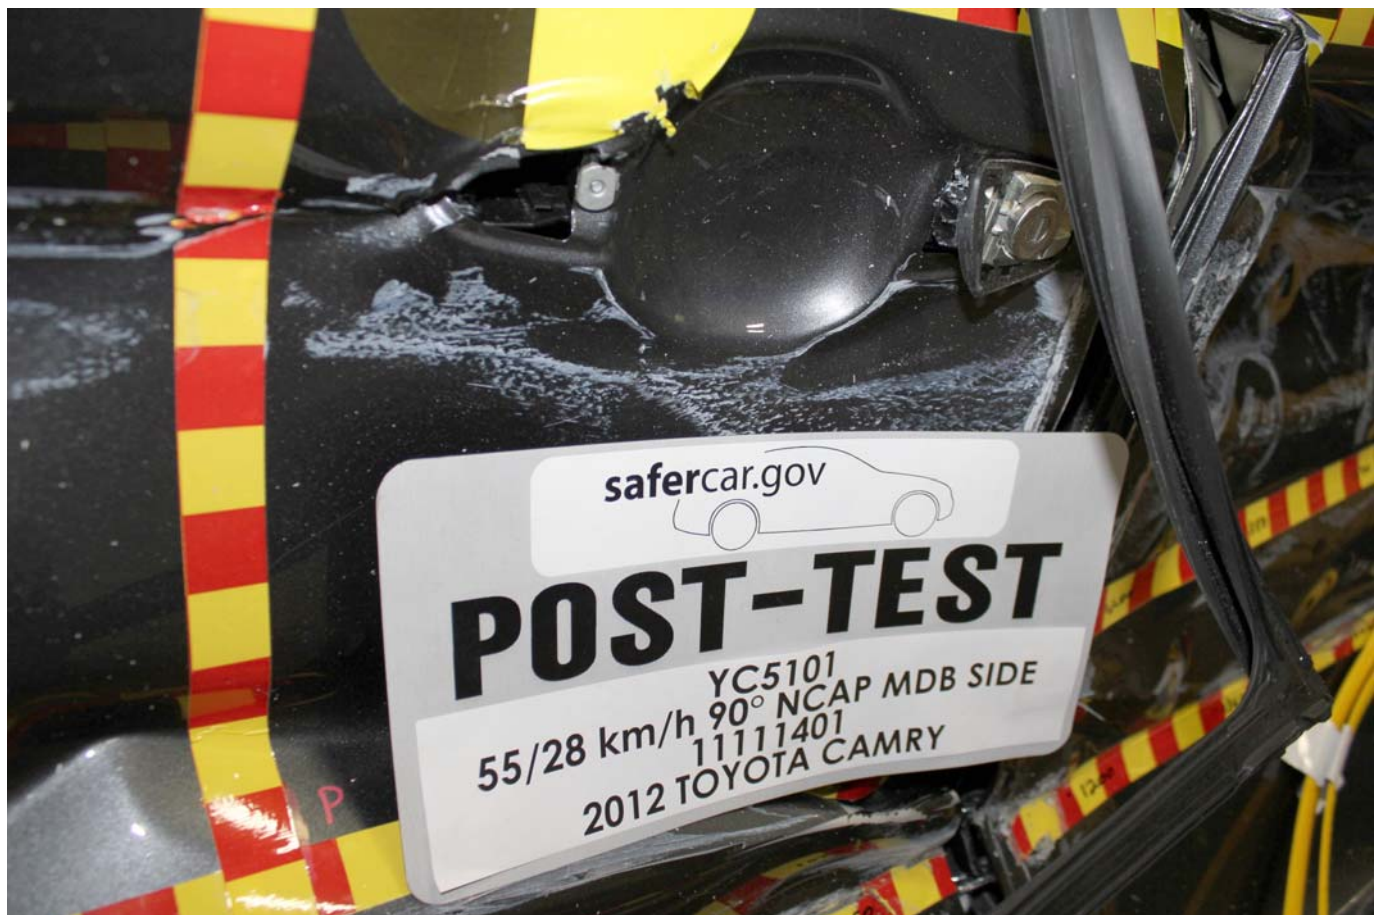
Post-Test Left Front Door Latch Close-Up

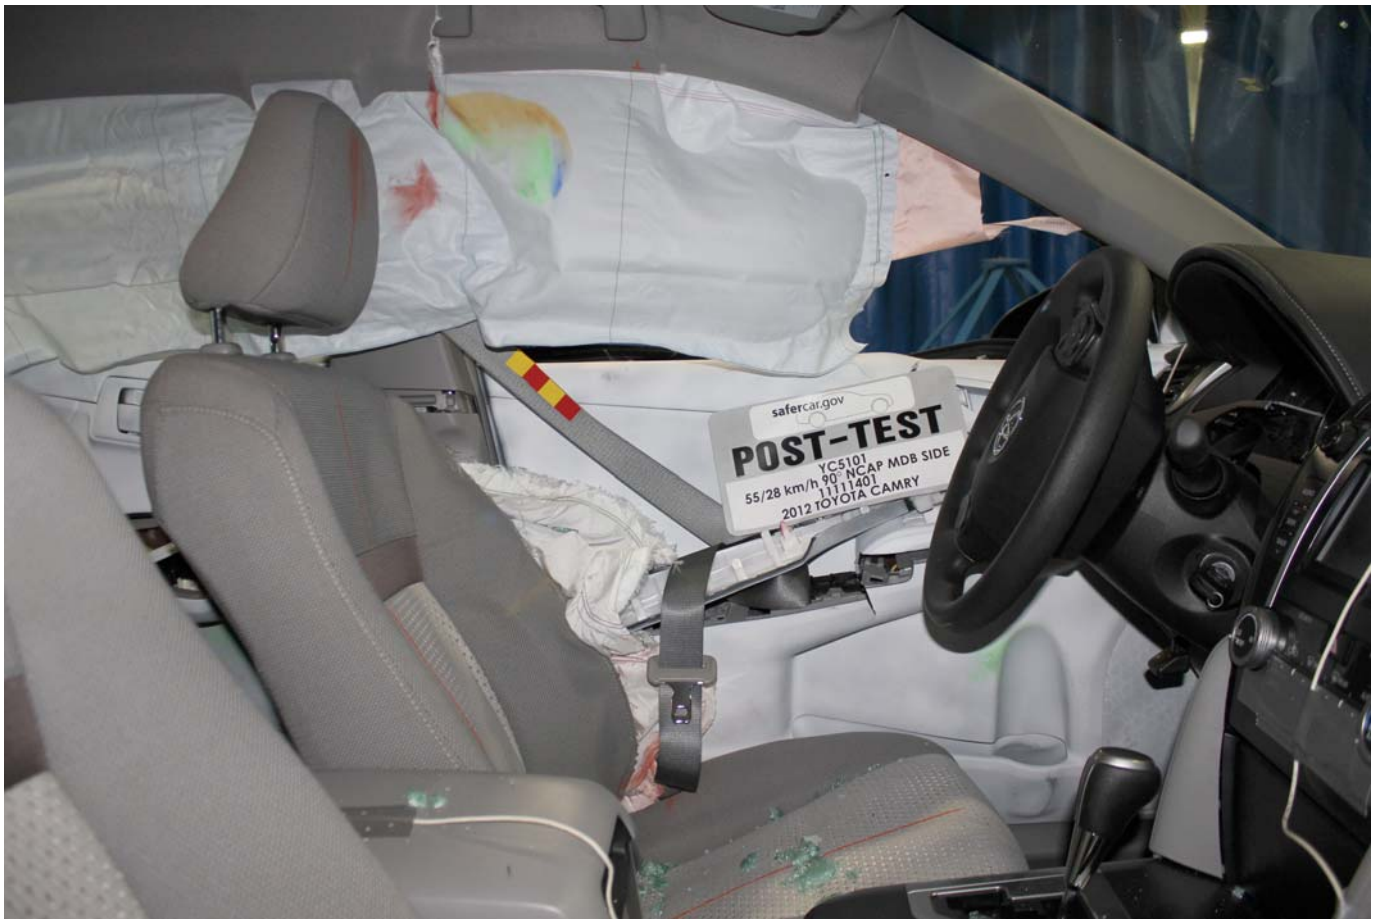
Post-Test Driver Inner Door Panel View

| Critical Areas of Performance | Observations and Conclusions |
|---|---|
| Side Window Damage | Left Front Window Broke |

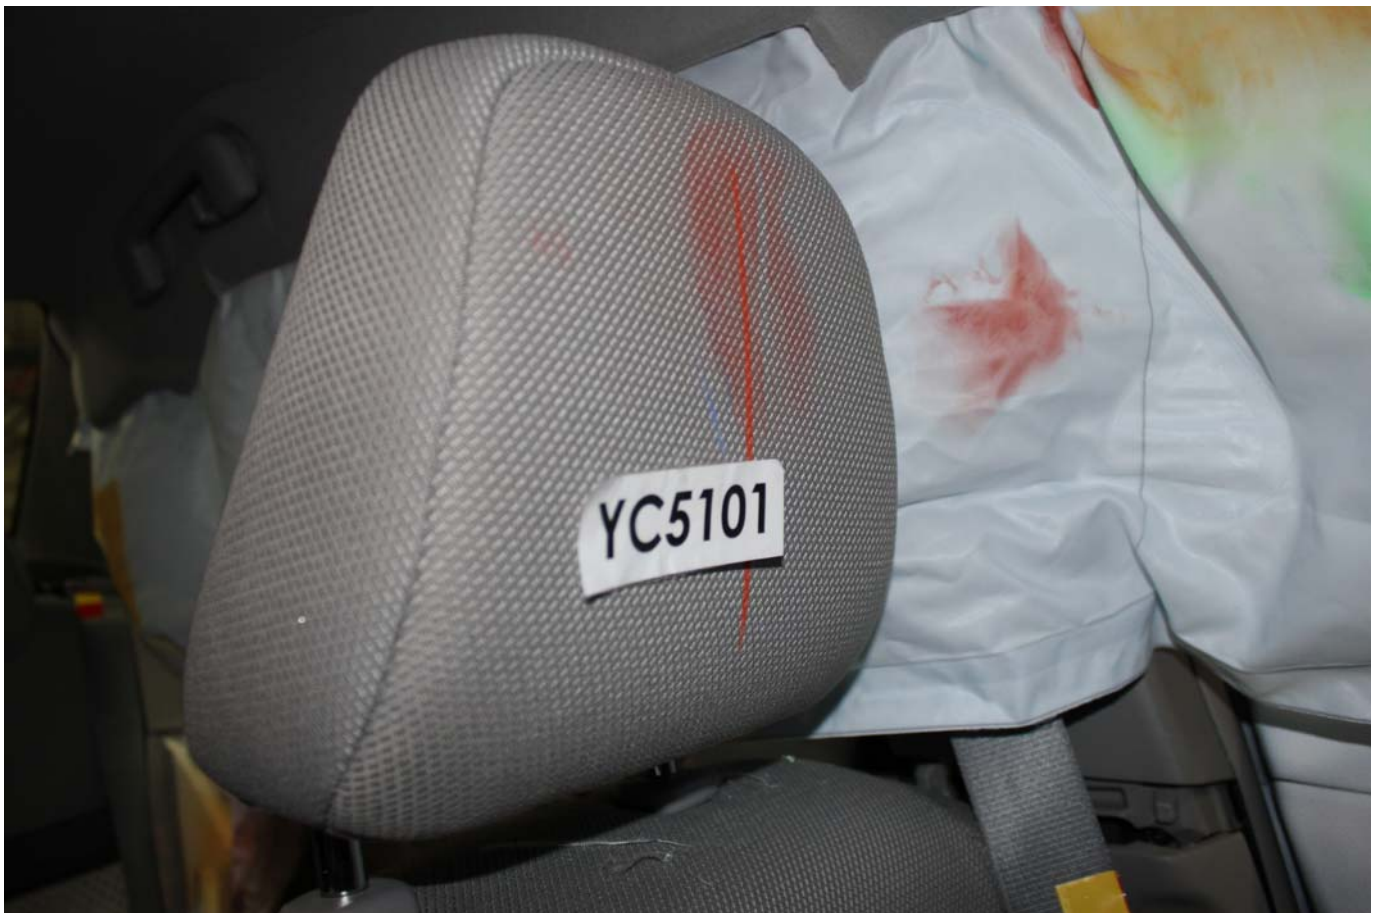
Post-Test Driver Dummy Close-up Head Contact with Vehicle Interior View

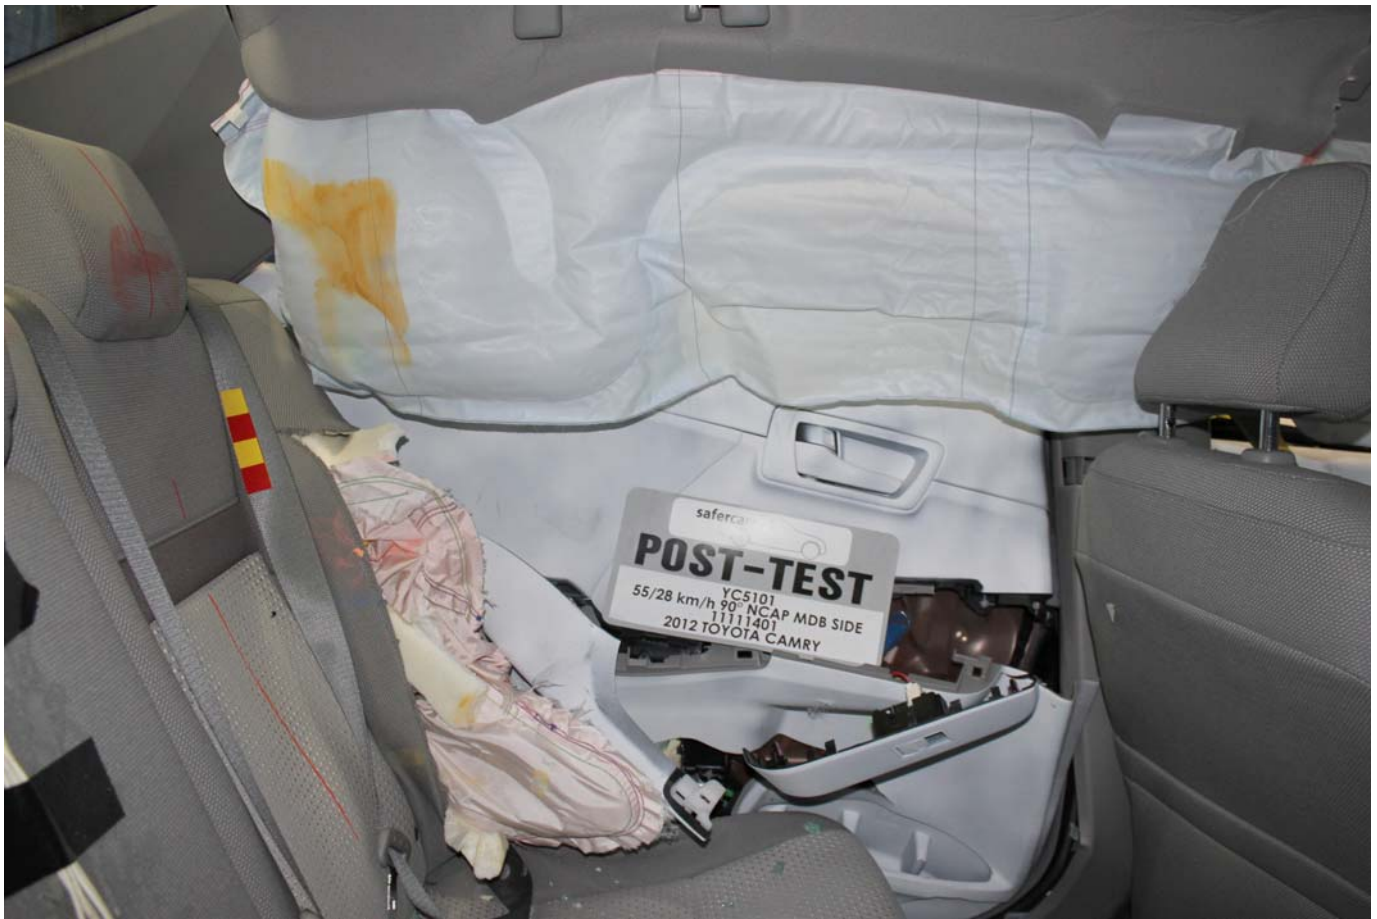
Post-Test Rear Passenger Inner Door Panel View

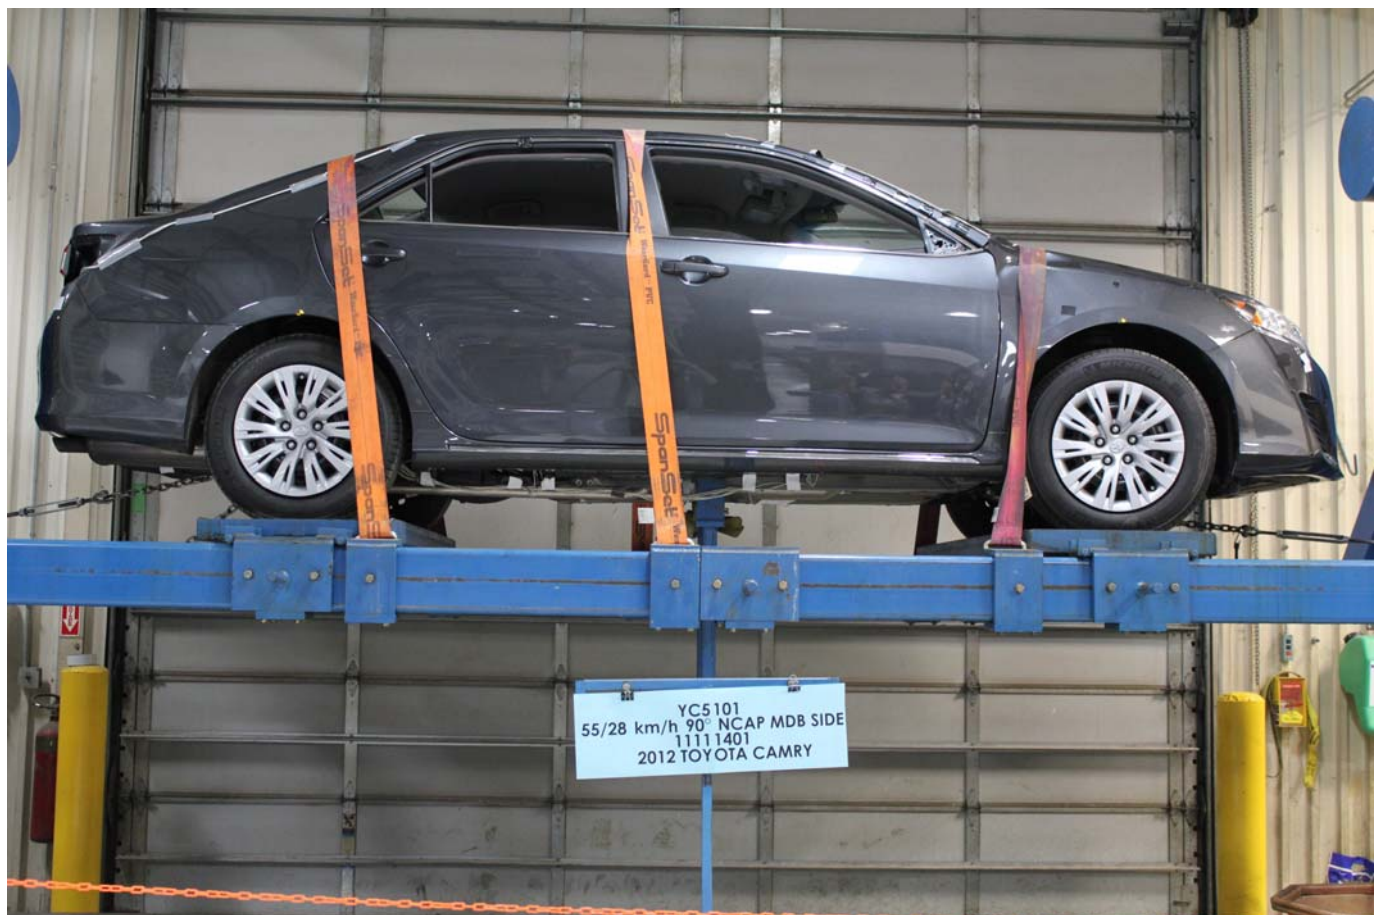
FMVSS No. 301 Static Rollover 0 Degrees

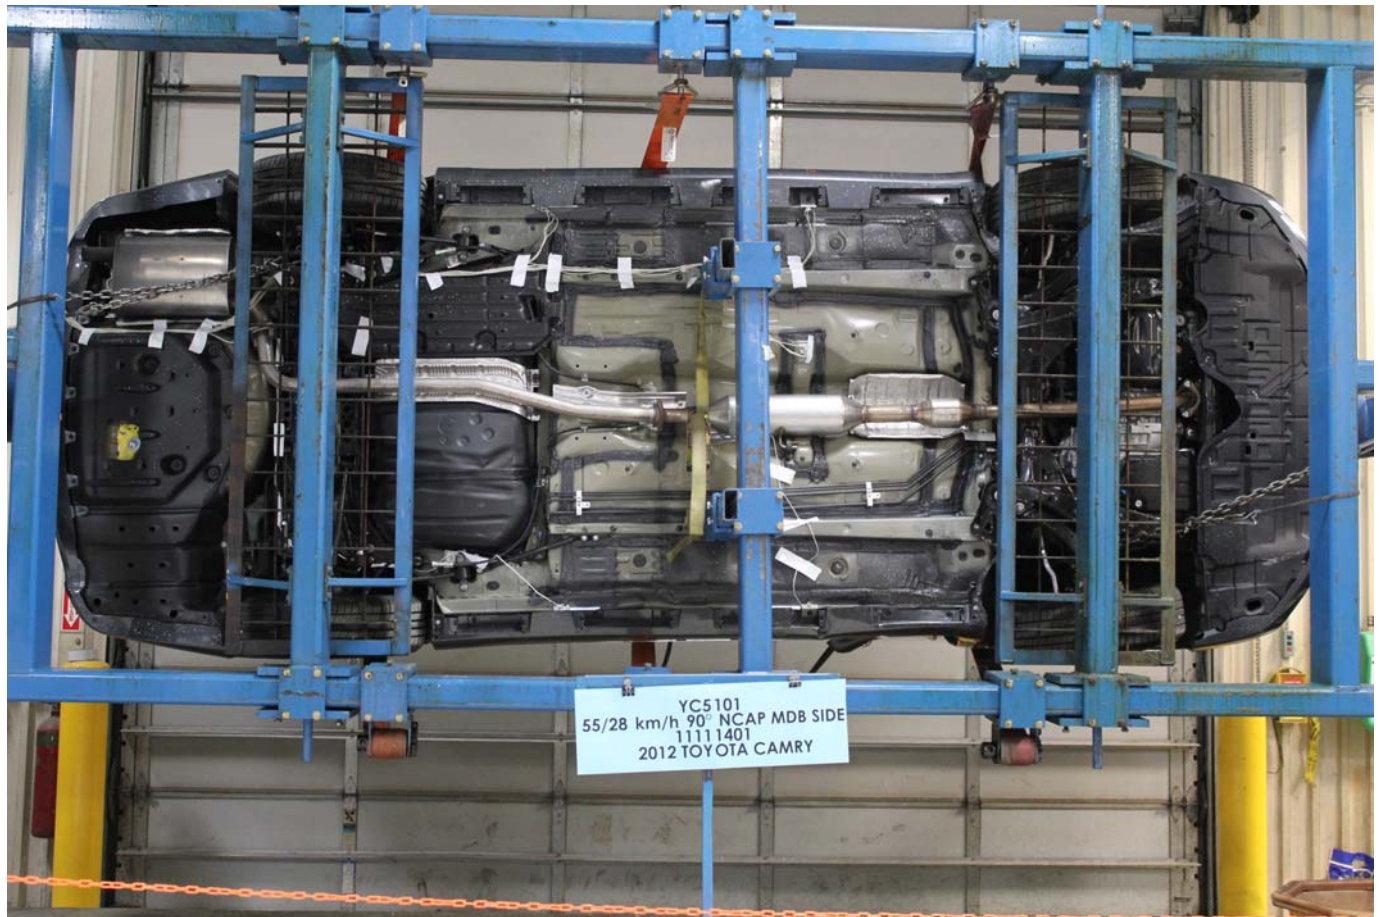
FMVSS No. 301 Static Rollover 90 Degrees
