**REPORT NUMBER: NCAP-MGA-2012-027**

**NEW CAR ASSESSMENT PROGRAM (NCAP)  
Frontal Barrier Impact Test**

**TOYOTA MOTOR MANUFACTURING, NORTHERN KENTUCKY, INC.  
2012 Toyota Camry LE 4-Dr Sedan  
NHTSA No.: YC5100**

**FINAL REPORT**

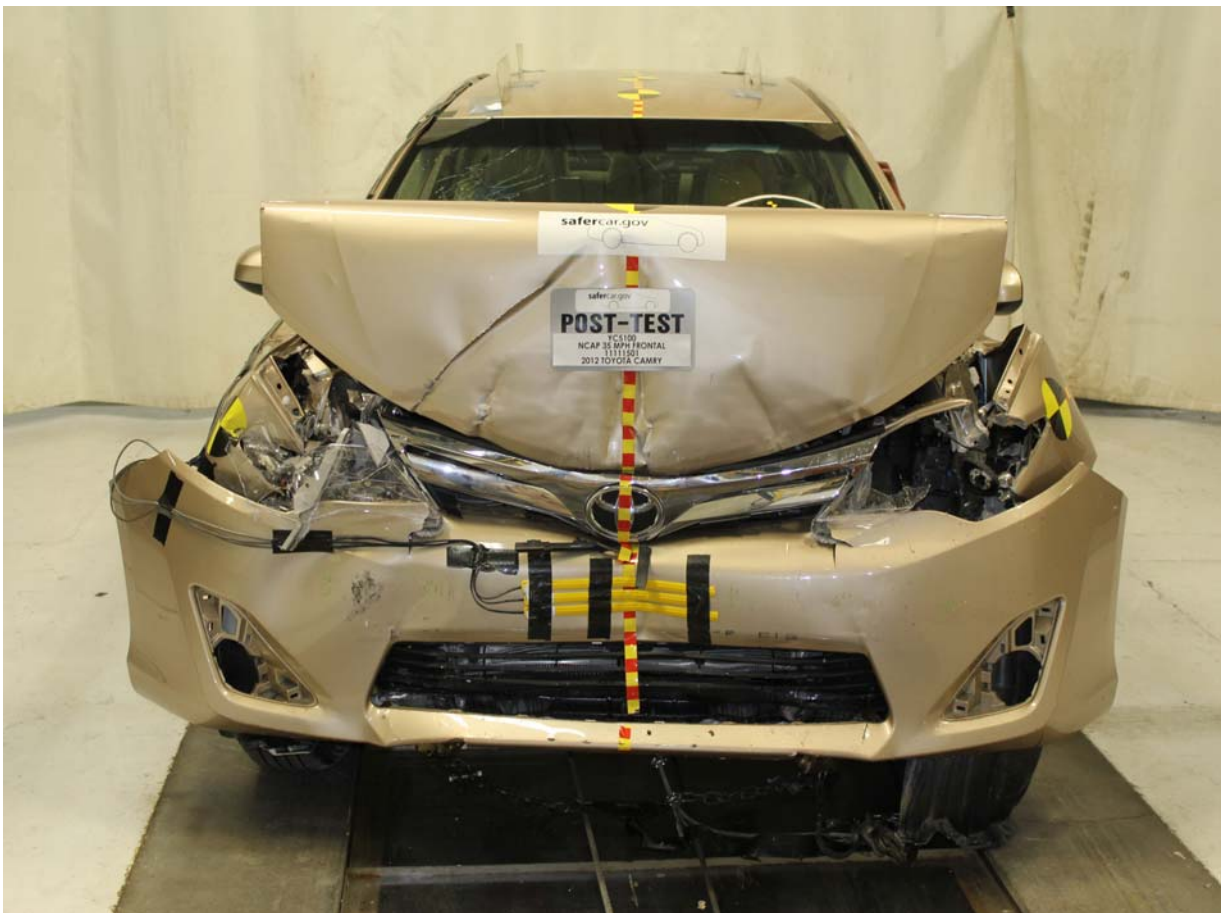
Post-Test Front View of Test Vehicle

The maximum static crush of the vehicle was 579 mm and both the driver and passenger side doors remained closed during the impact event and were operable after the impact.

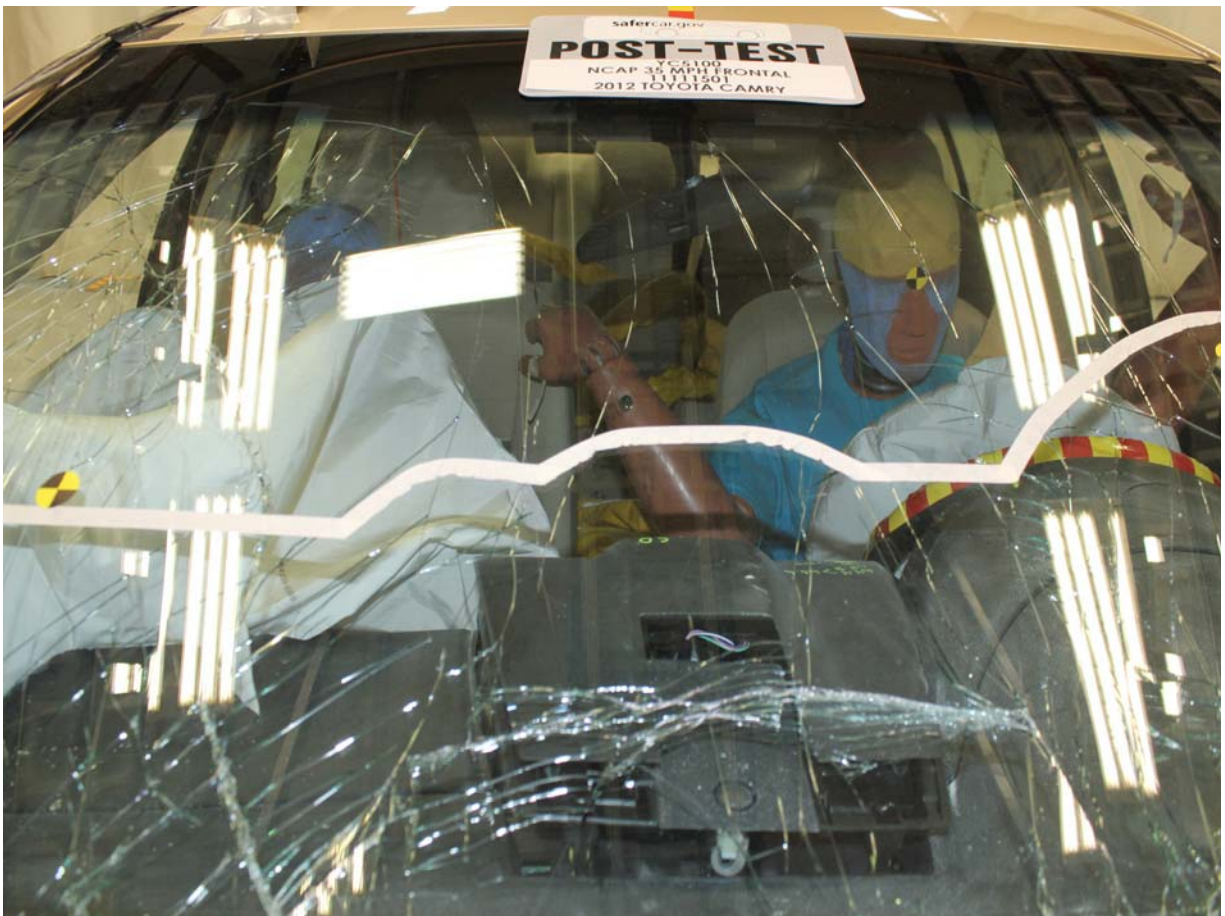
Post-Test Windshield View

There was 100 percent windshield retention and no intrusion into the protected zone of the windshield during the event. There was no Stoddard Solvent leakage after the event or during any phase of the static rollover.

| Critical Areas of Performance | Observations and Conclusions |
|---|---|
| Windshield Damage | Cracked |

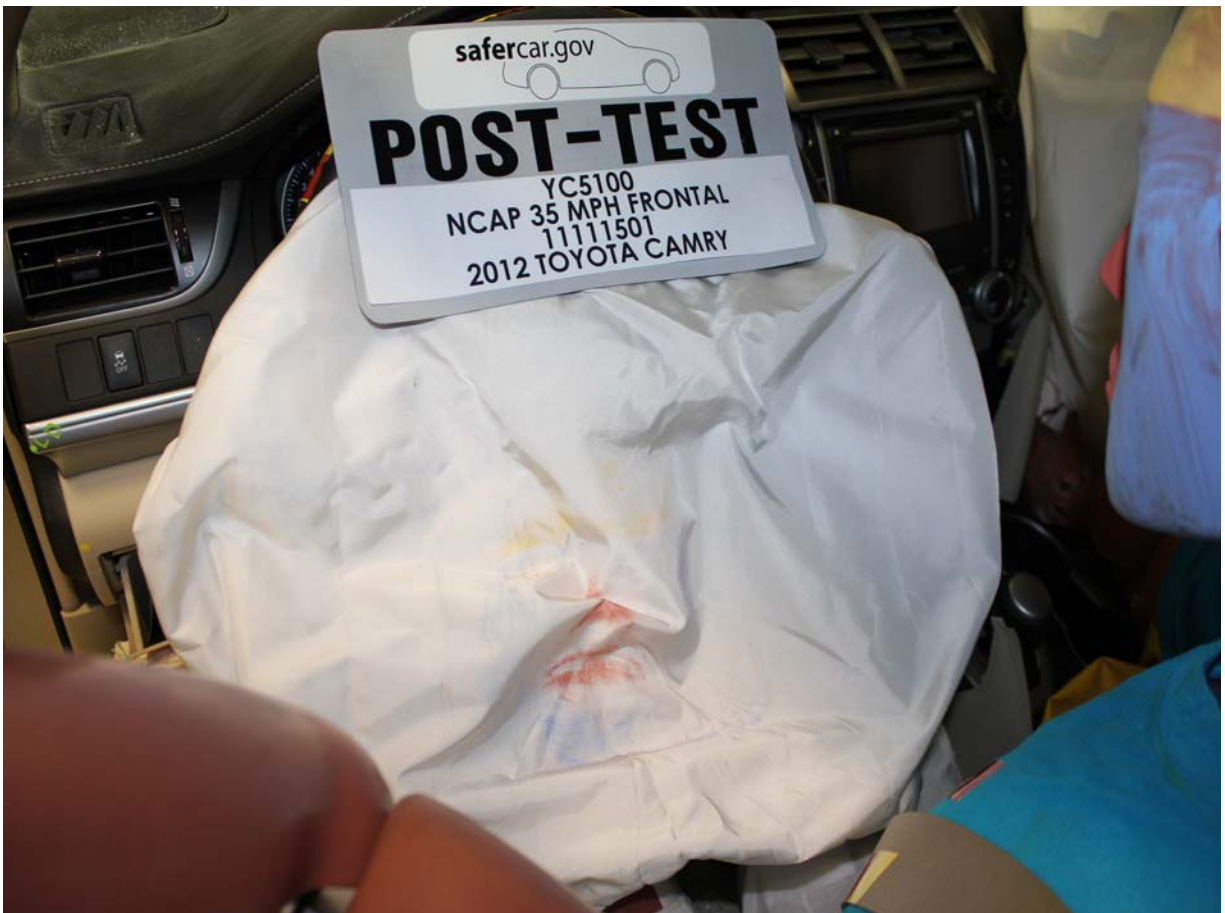
Post-Test Driver Dummy Contact with Airbag

The driver's visible contact points were as follows: The driver's head and chest contacted the airbag. The driver's head also contacted the headrest. The driver's knees contacted the knee airbag. The passenger's visible contact points were as follows: The passenger's head and chest contacted the airbag. The passenger's head also contacted the headrest and seatback. The passenger's knees contacted the knee airbag.

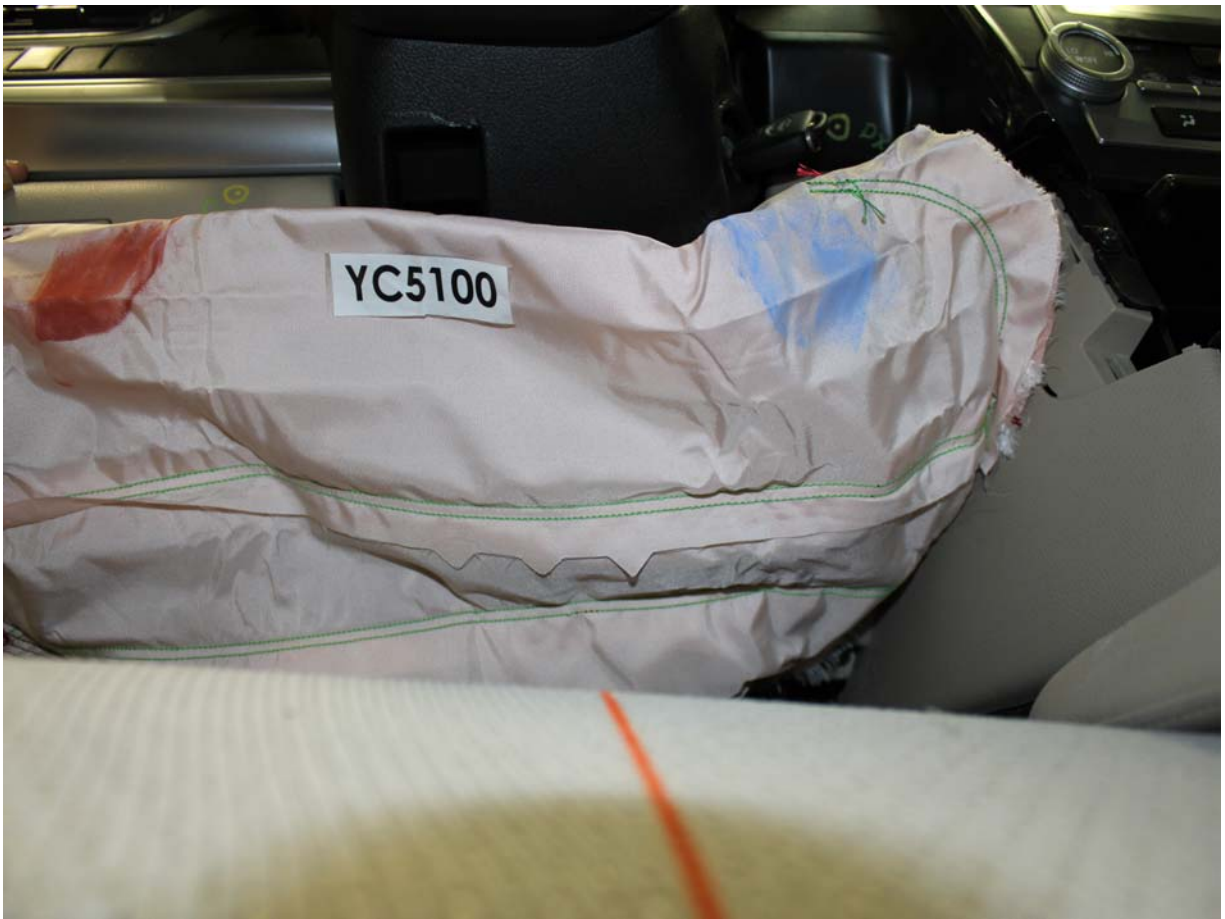
Post-Test Driver Dummy Contact with Knee Airbag

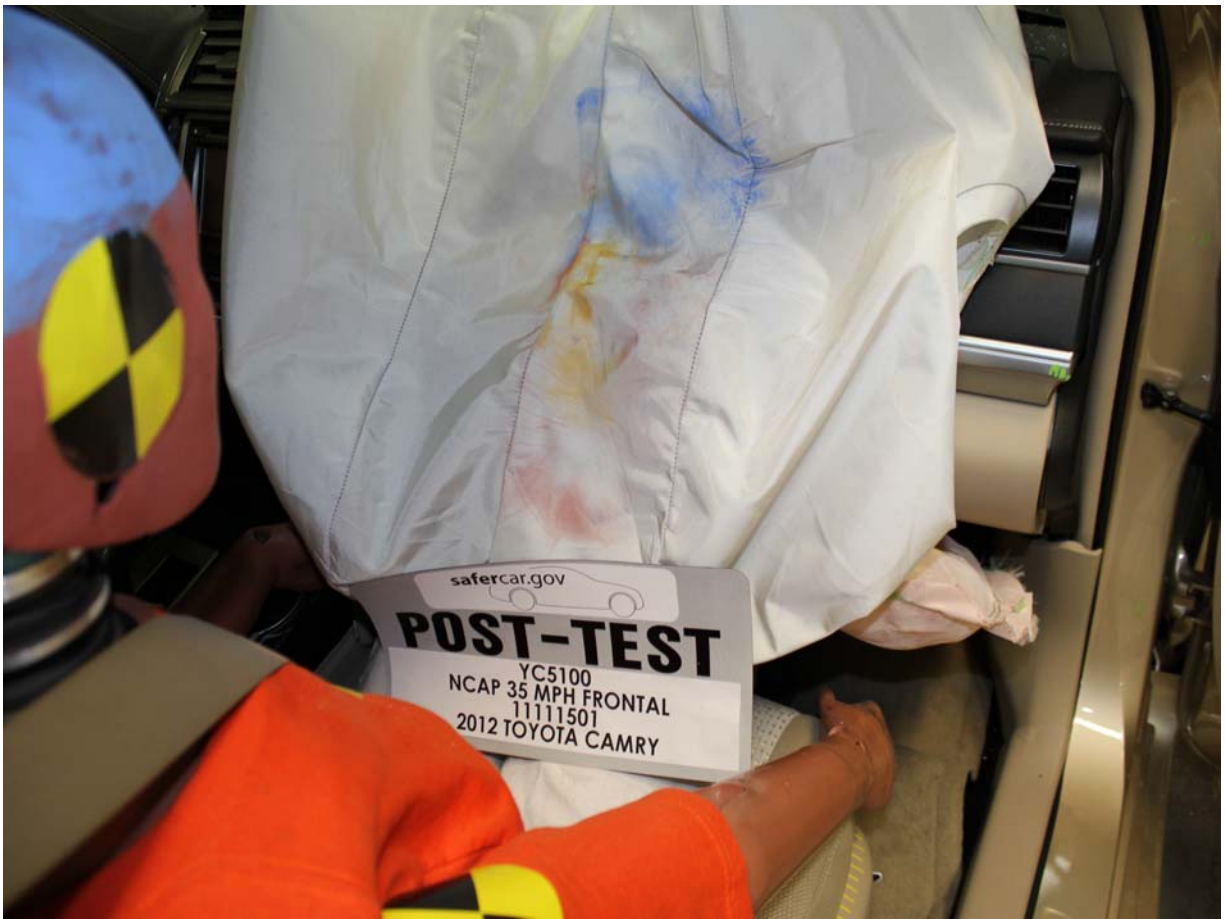
Post-Test Passenger Dummy Contact with Airbag

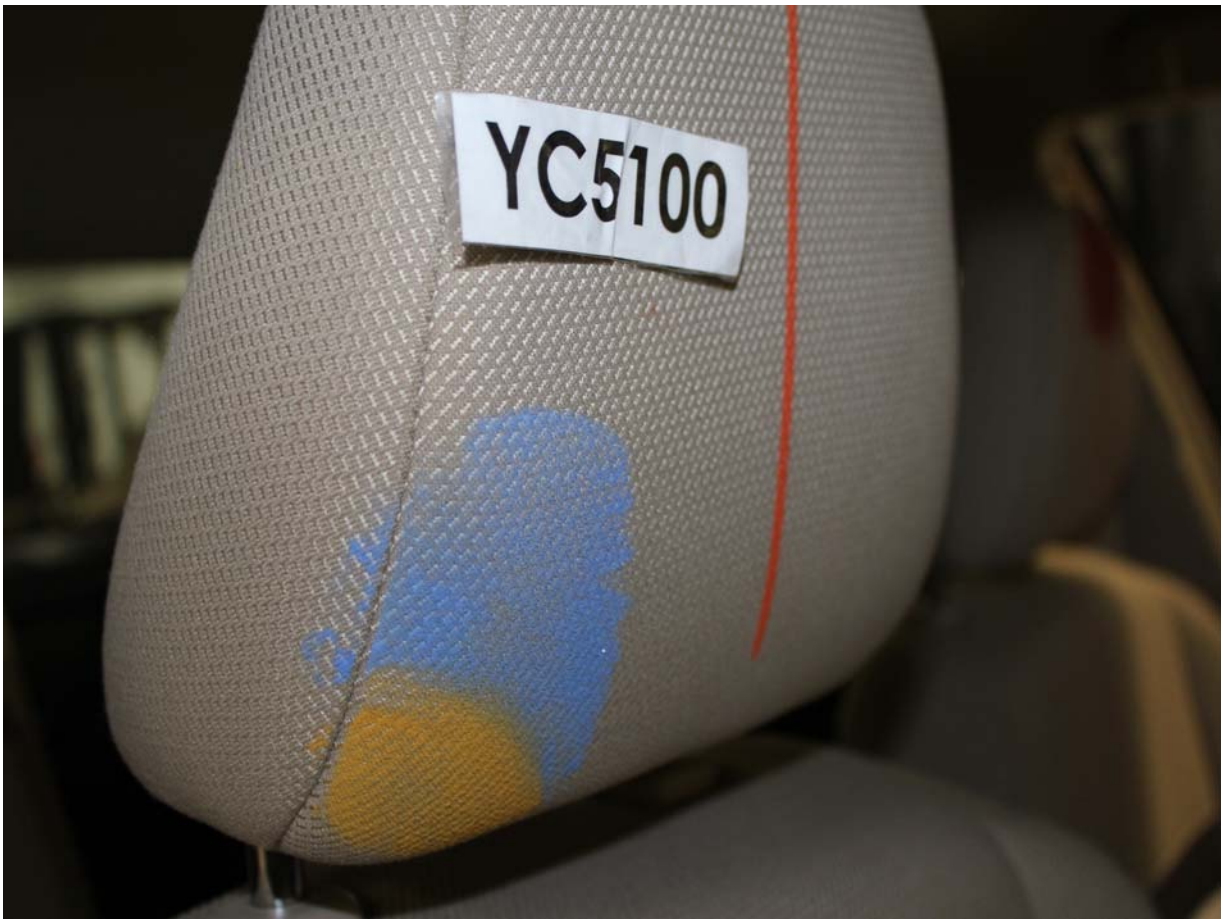
Post-Test Passenger Dummy Contact with Headrest

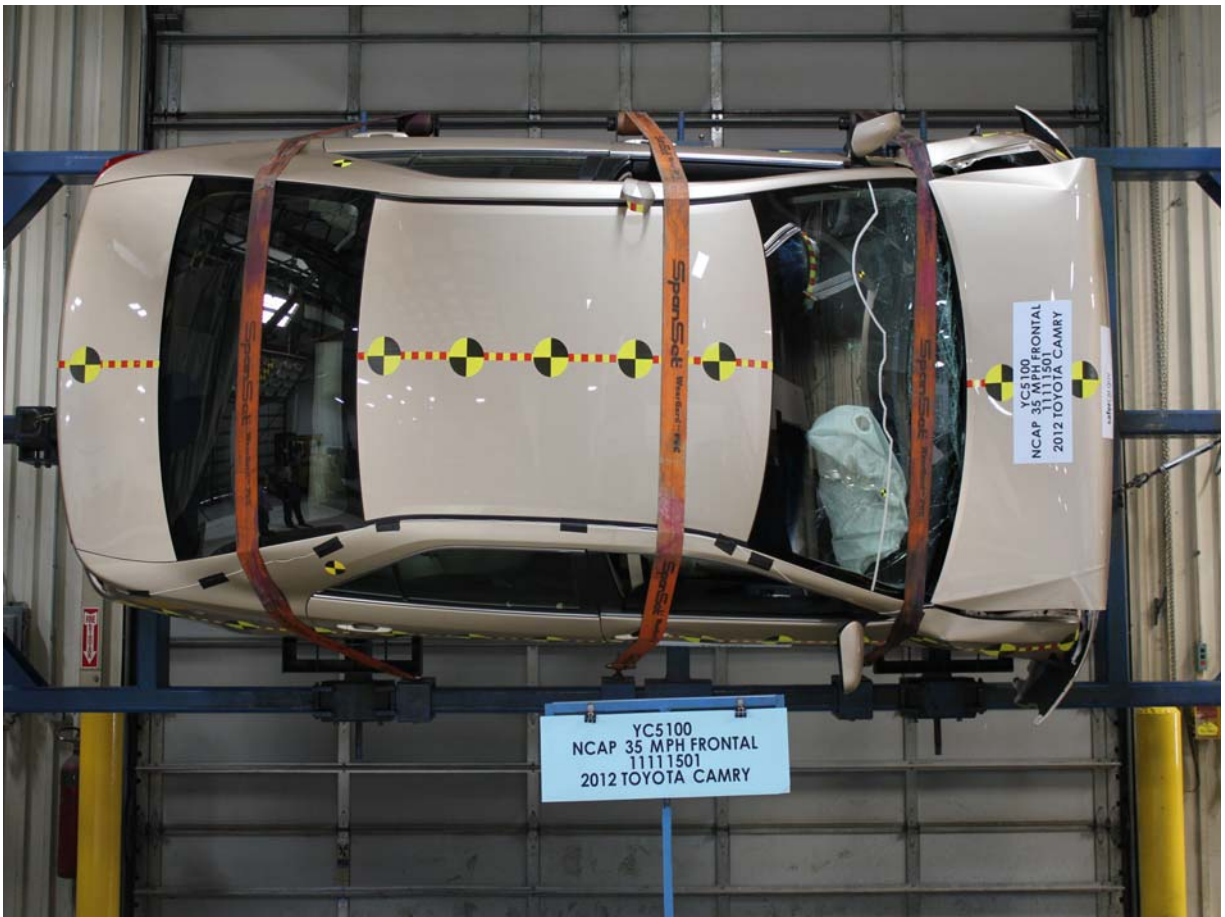
Vehicle at 270 Degrees on Static Rollover Device
