**REPORT NUMBER: SPNCAP-MGA-2012-028**

**NEW CAR ASSESSMENT PROGRAM (NCAP)  
Side Impact Pole Test**

**TOYOTA MOTOR MANUFACTURING, NORTHERN KENTUCKY, INC.  
2012 Toyota Camry LE 4-Dr Sedan  
NHTSA No.: YC5102**

**MGA RESEARCH CORPORATION  
5000 Warren Road  
Burlington, WI 53105**

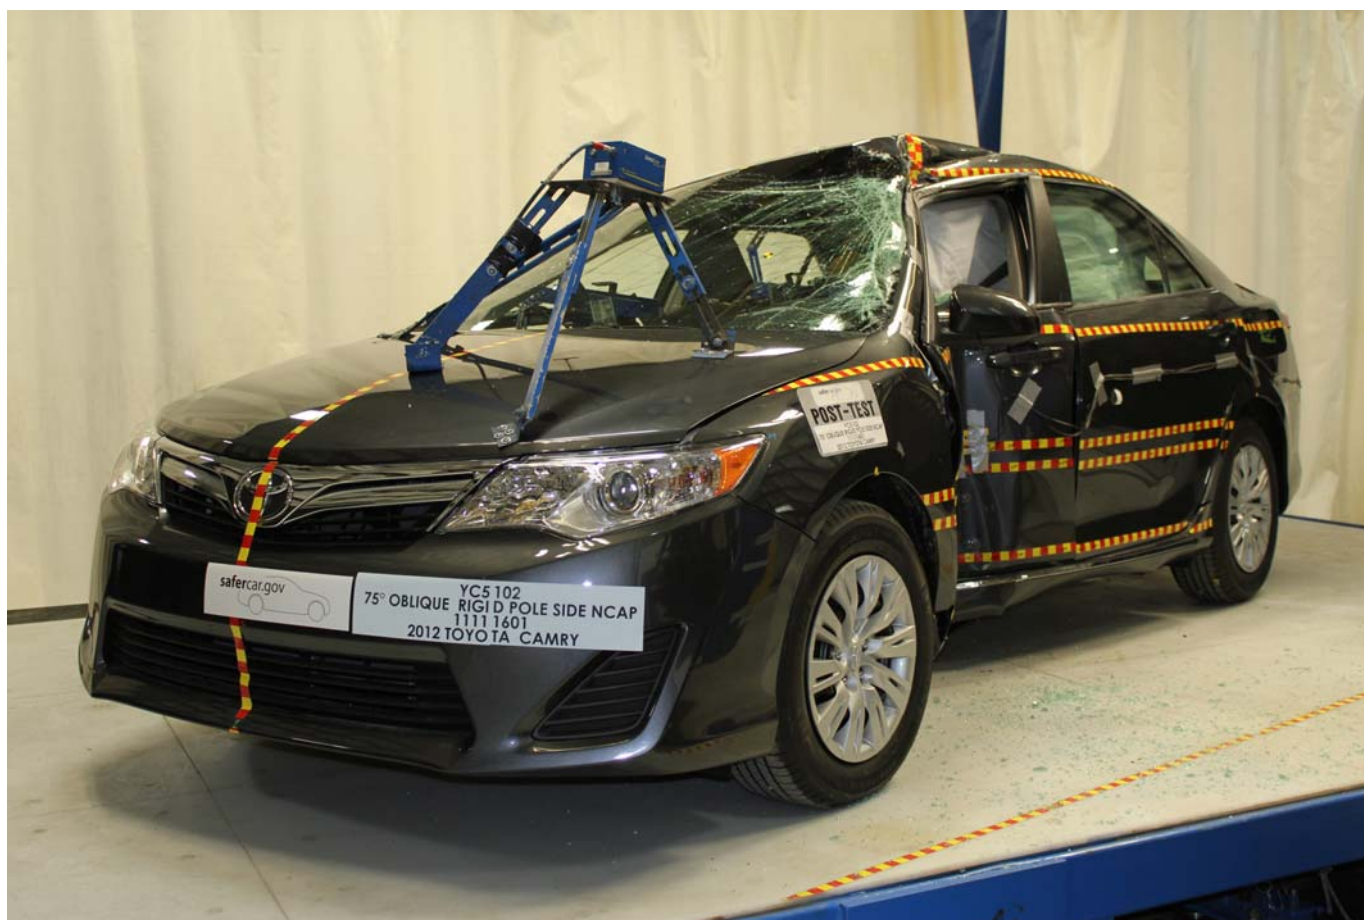
Post-Test Left Front  $\frac{3}{4}$  View of Test Vehicle

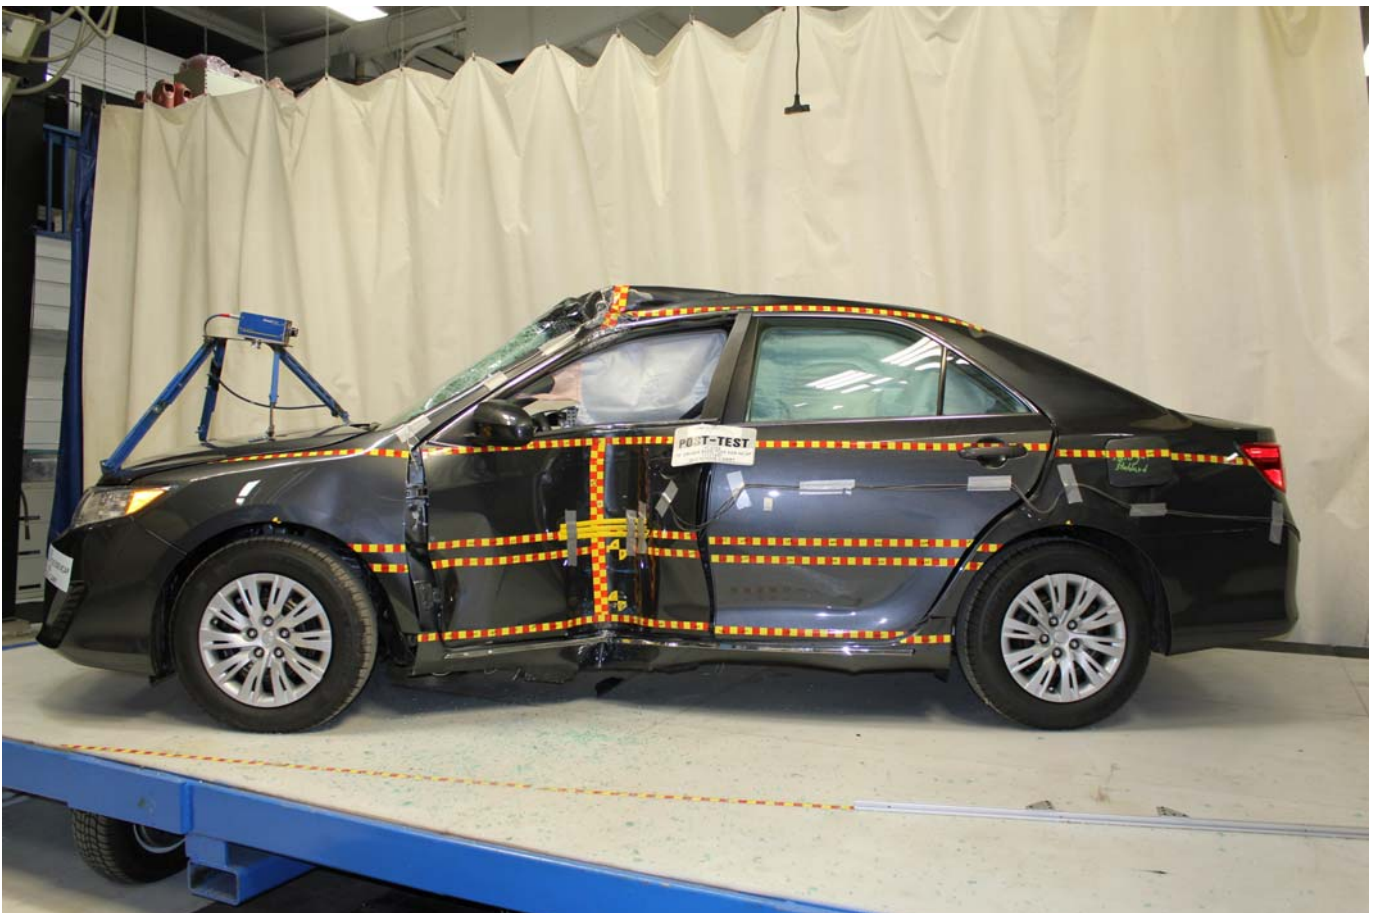
Post-Test Left Side View of Test Vehicle

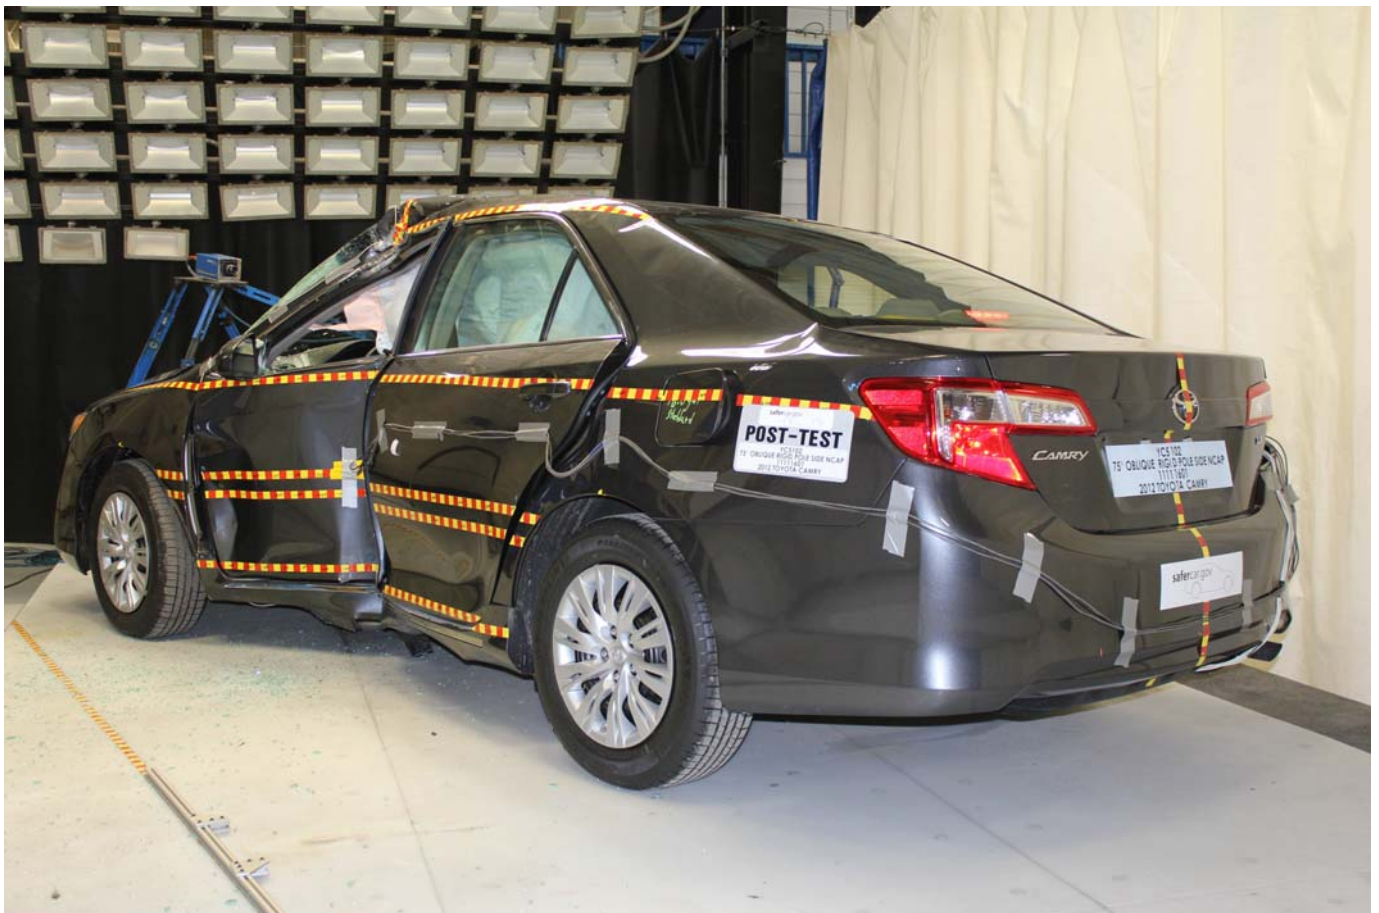
Post-Test Left Rear  $\frac{3}{4}$  View of Test Vehicle

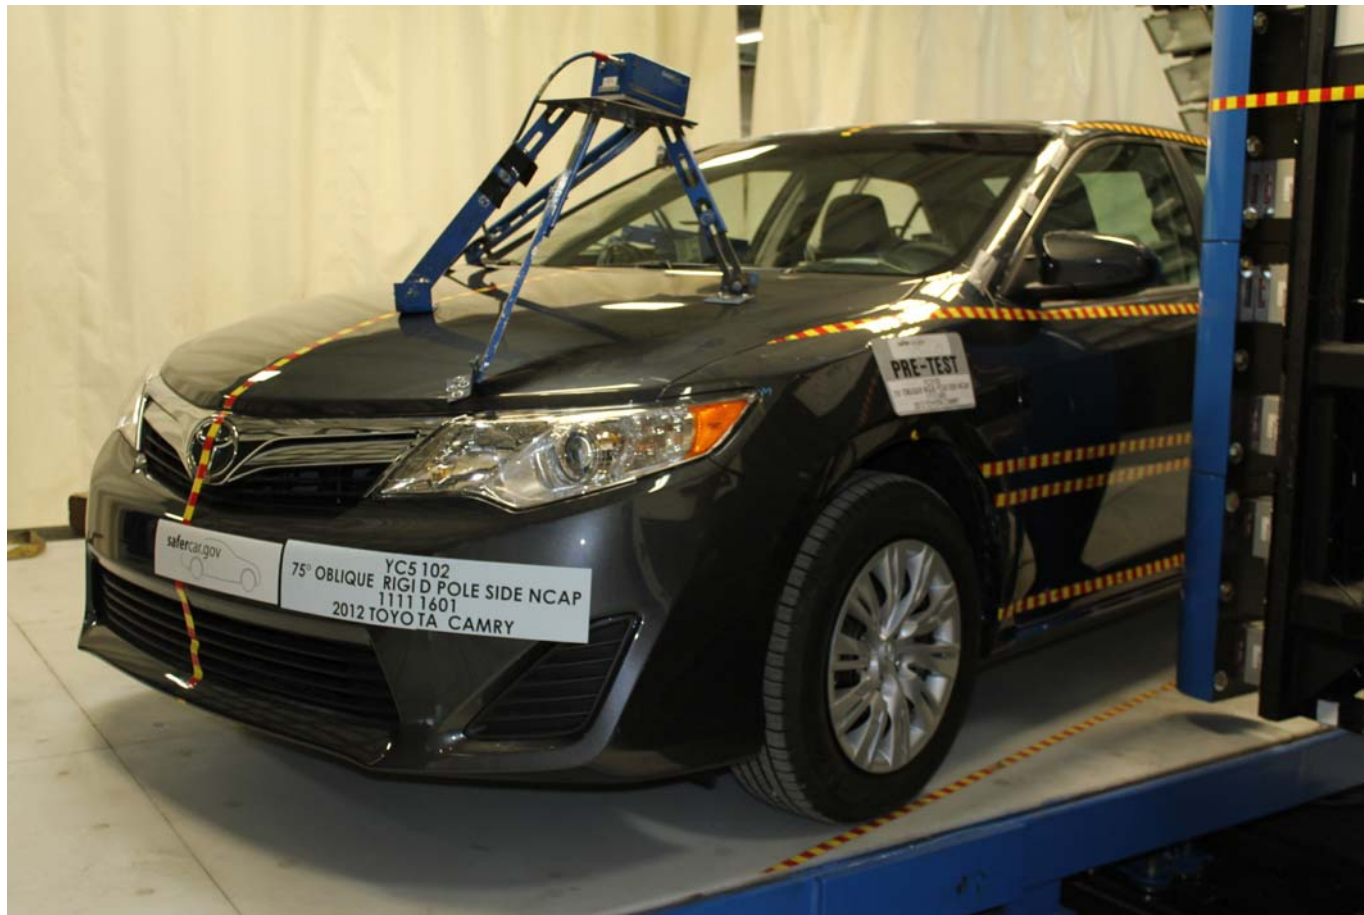
Pre-Test Left Side View of Pole Positioned Against Side of Vehicle

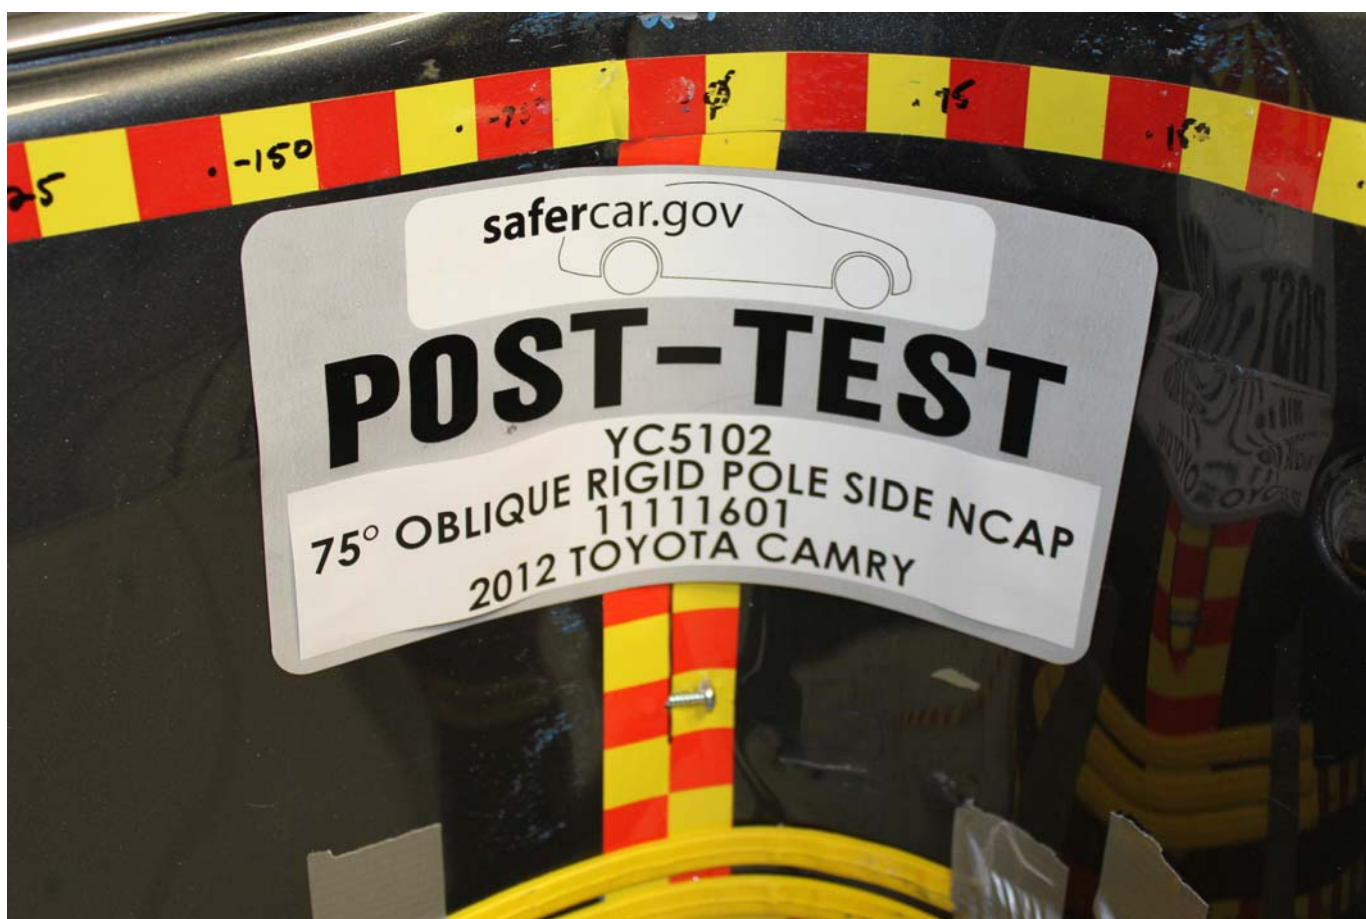
Post-Test Close-Up View of Impact Point Target Showing Impact Location

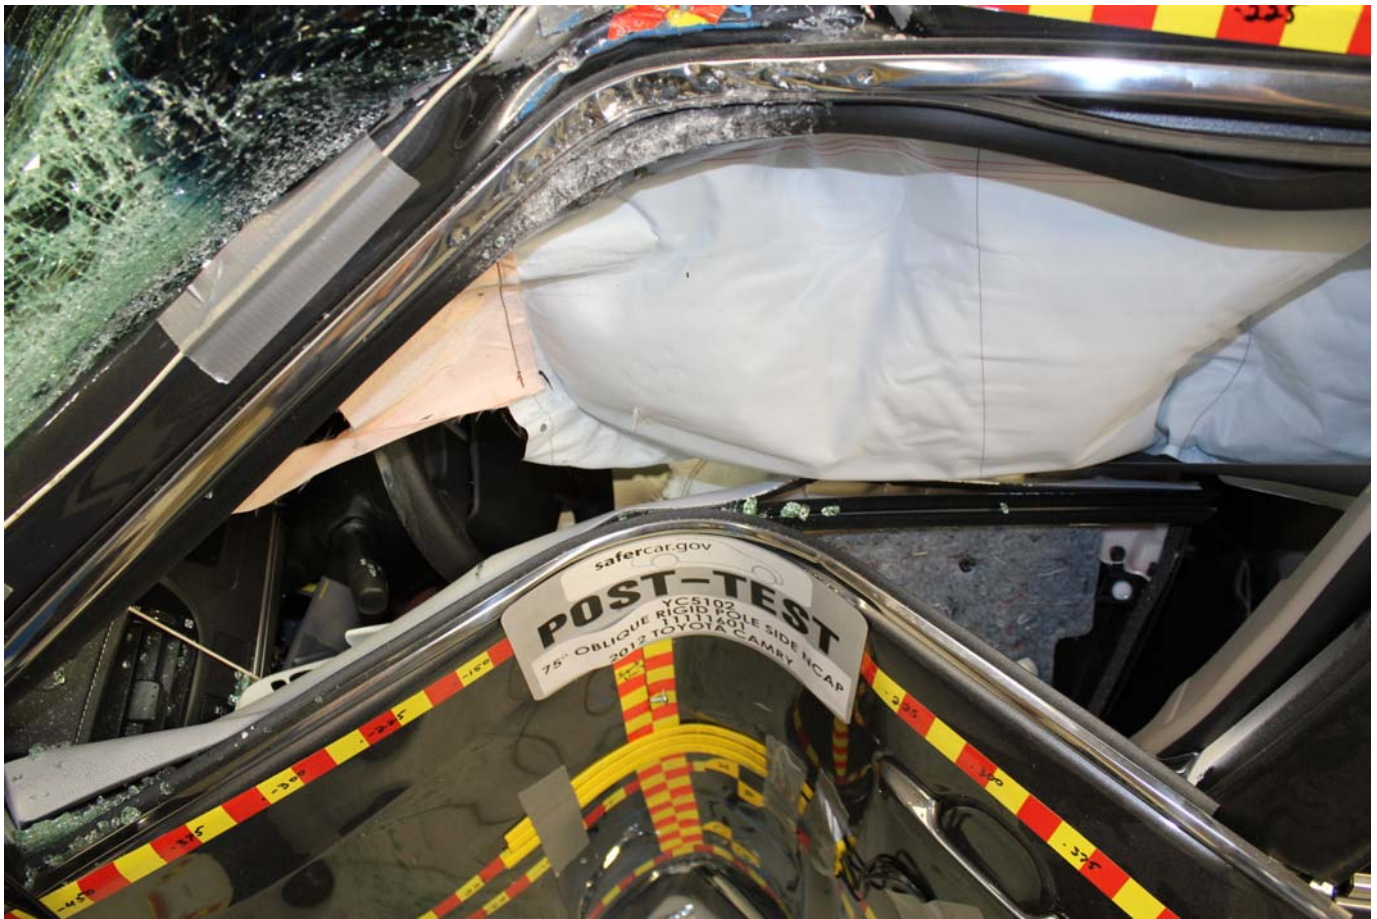
Post-Test Dummy and Door Clearance View

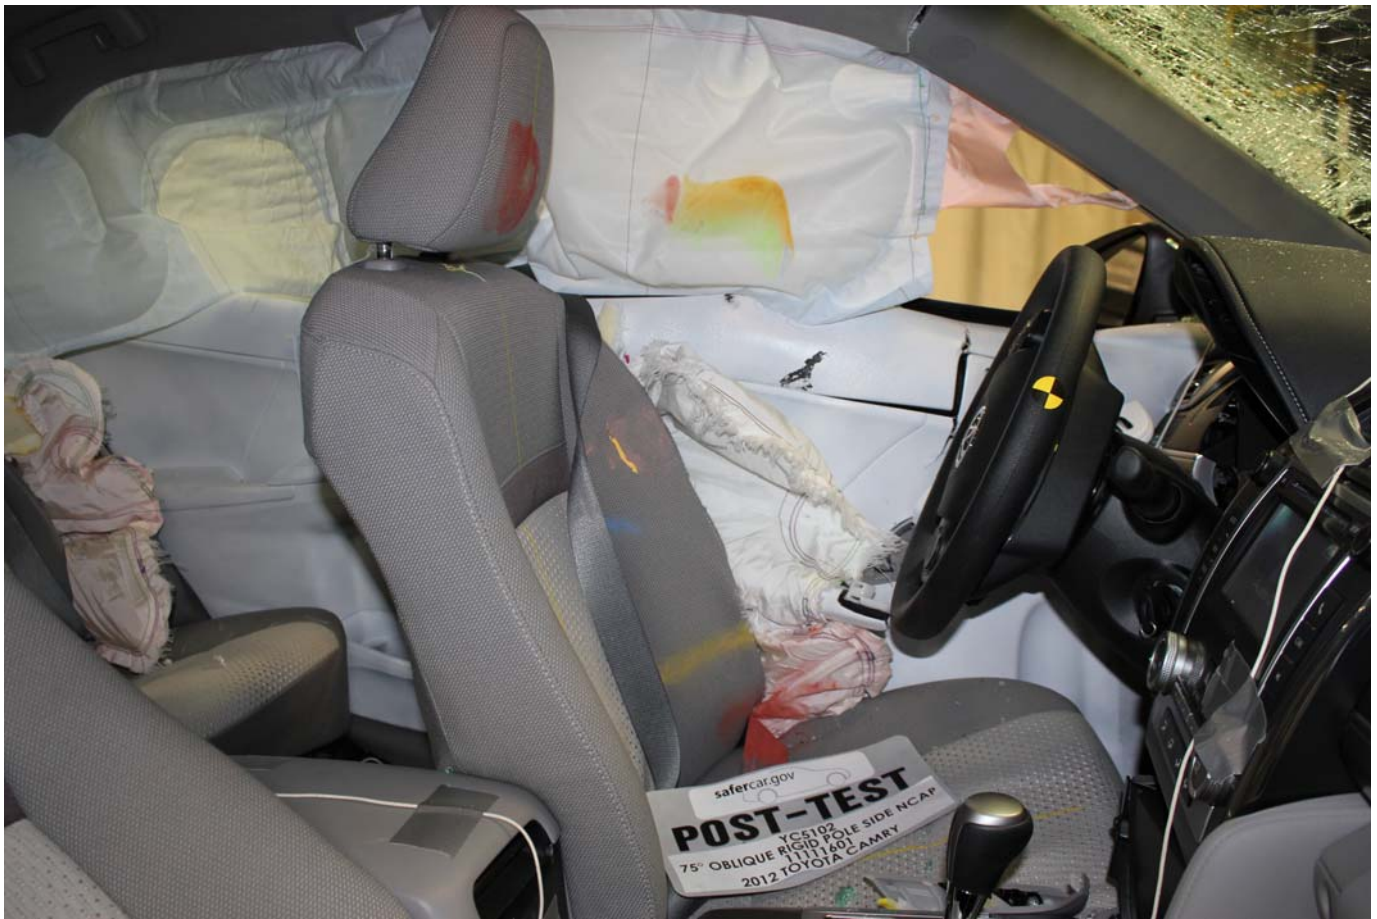
Post-Test Inner Door Panel View Showing Dummy Contact Location

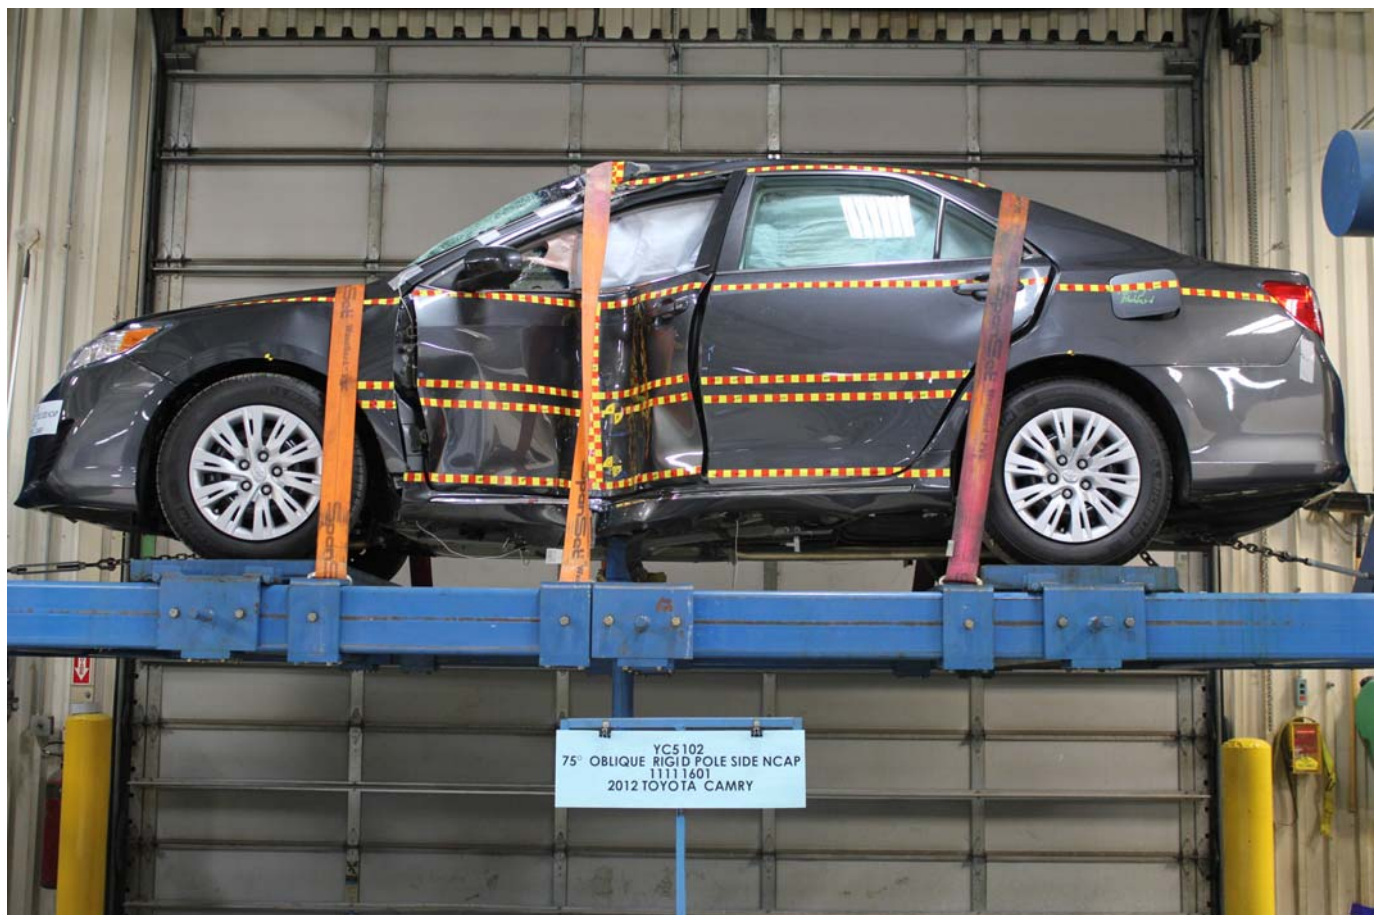
FMVSS No. 301 Static Rollover 0 Degrees

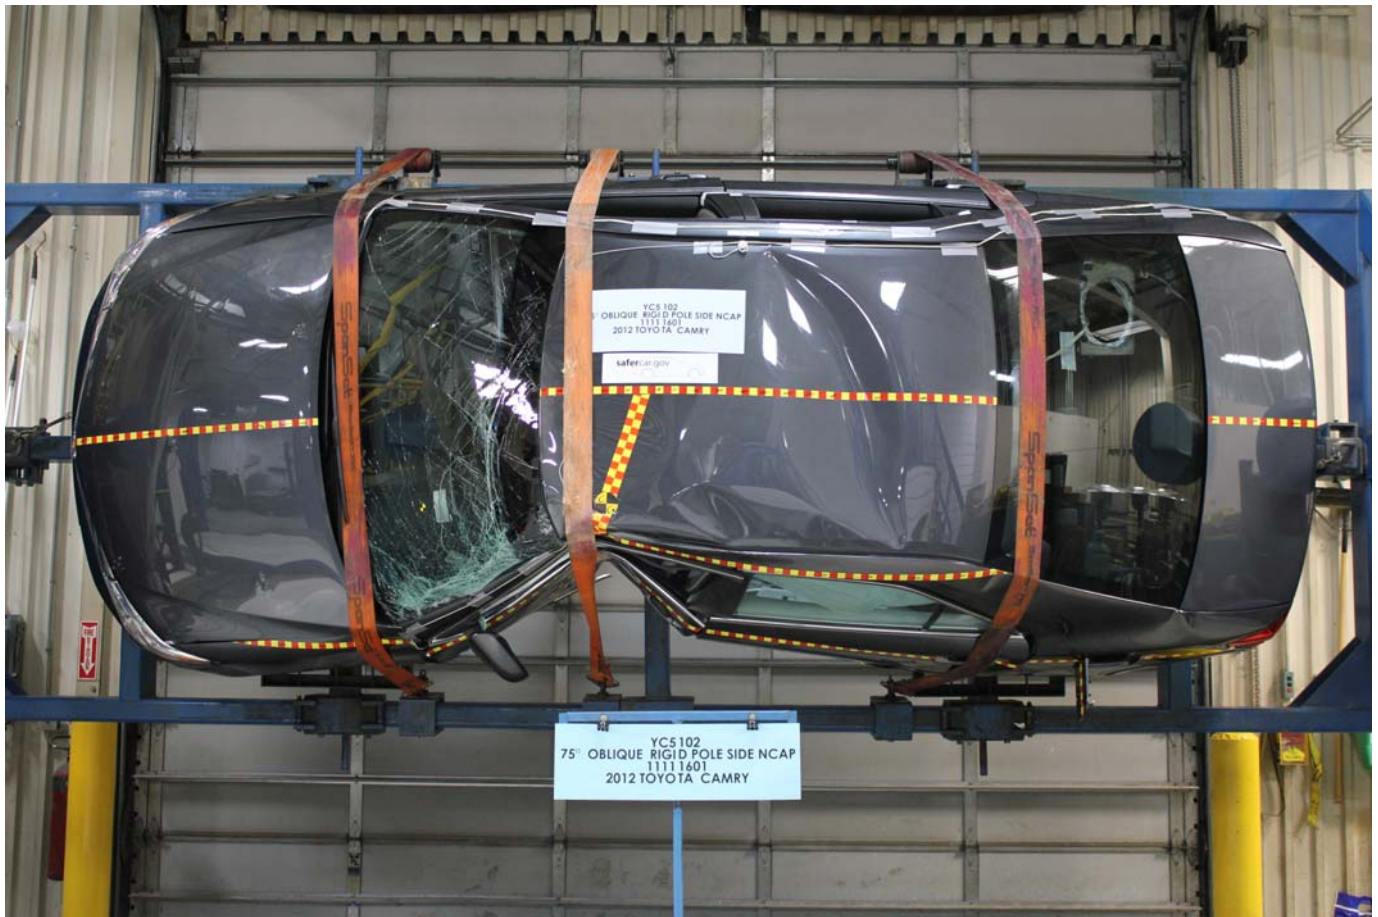
FMVSS No. 301 Static Rollover 90 Degrees

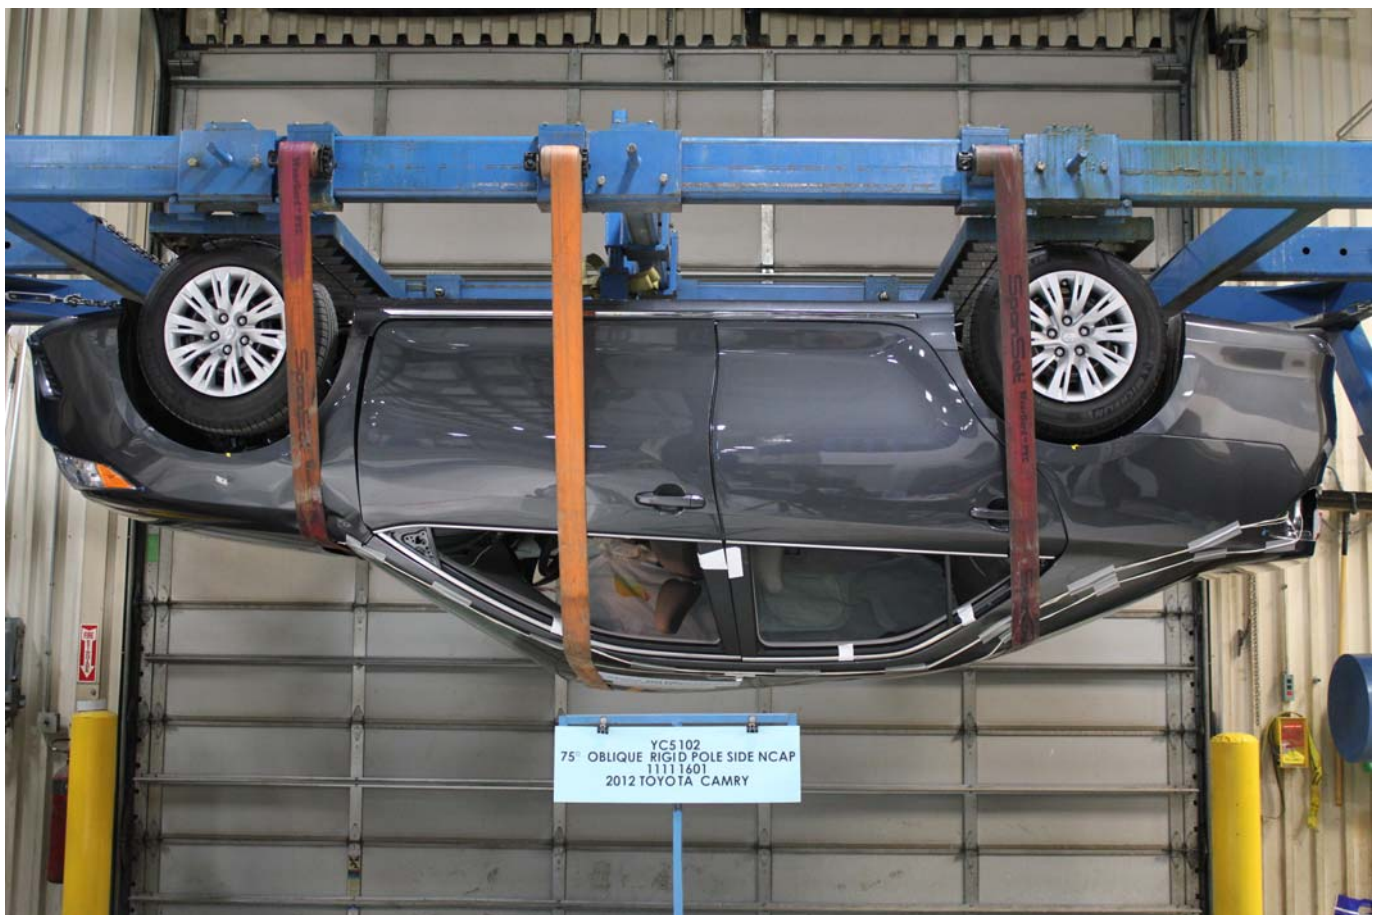
FMVSS No. 301 Static Rollover 180 Degrees
