REPORT NUMBER: NCAP-CAL-12-010

**NEW CAR ASSESSMENT PROGRAM (NCAP)
FRONTAL BARRIER IMPACT TEST**

**CHRYSLER GROUP LLC
2012 Dodge Durango SXT
Utility Vehicle**

NHTSA No: MC0322

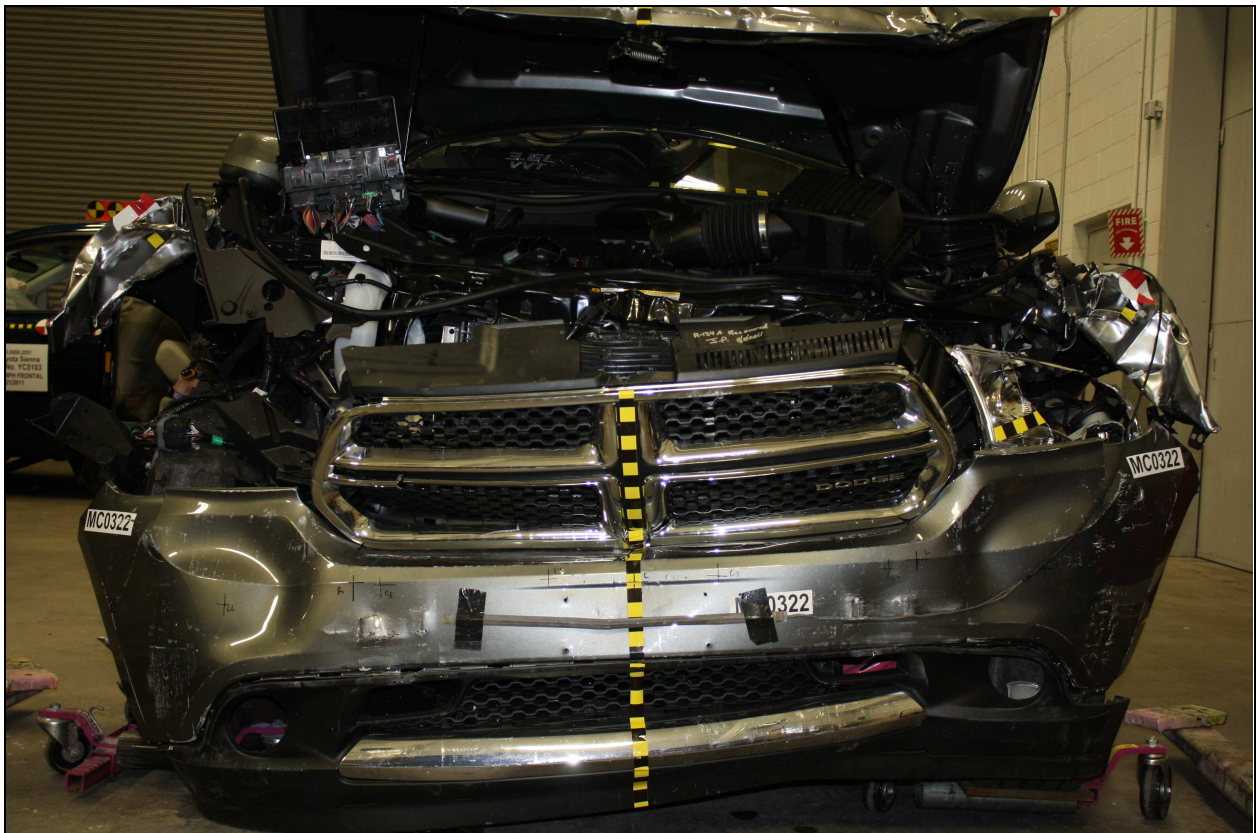
Figure A-8: Post-Test Front View of Test Vehicle

The maximum static crush of the vehicle was 446 mm and both the driver and passenger side doors remained closed during the impact event and were operable after the impact.

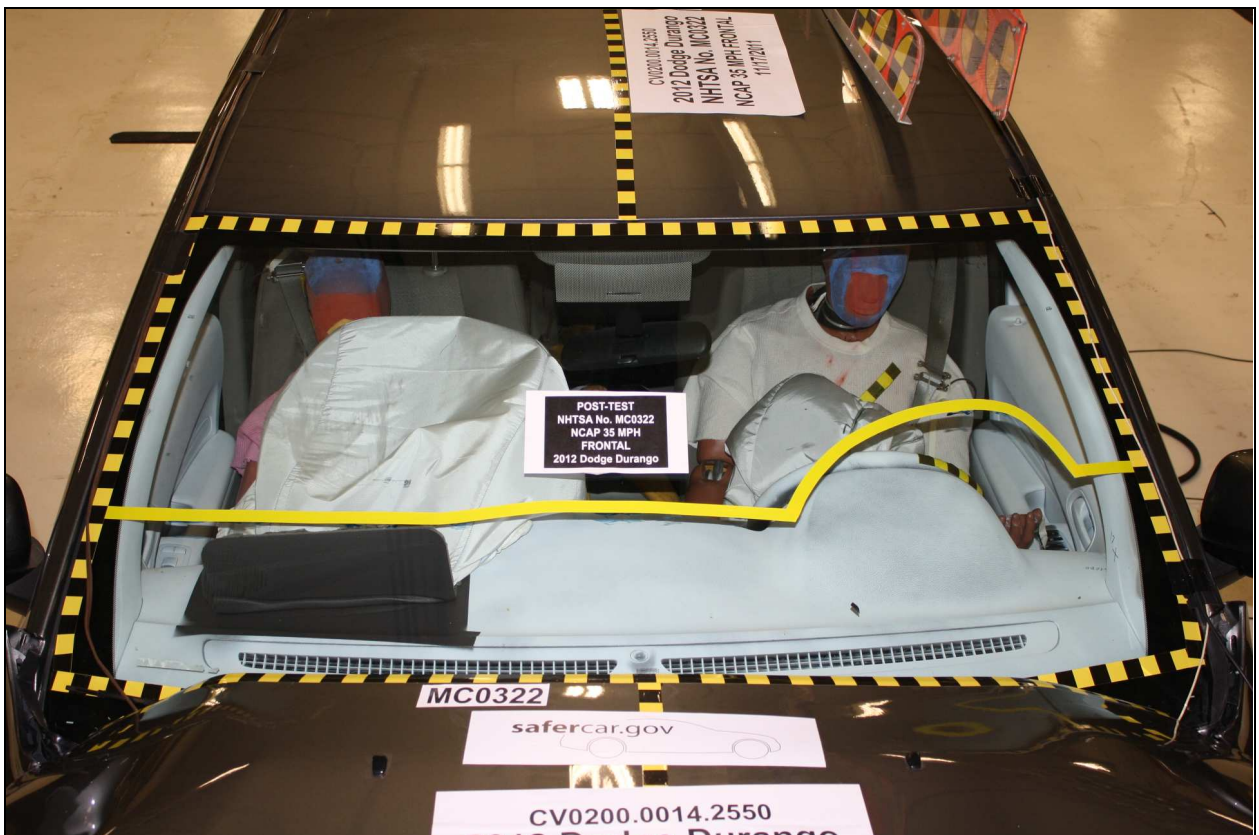
Figure A-18: Post-Test Windshield View

There was 100 percent windshield retention and no intrusion into the protected zone of the windshield during the event. There was no Stoddard solvent leakage after the event or during any phase of the static rollover.

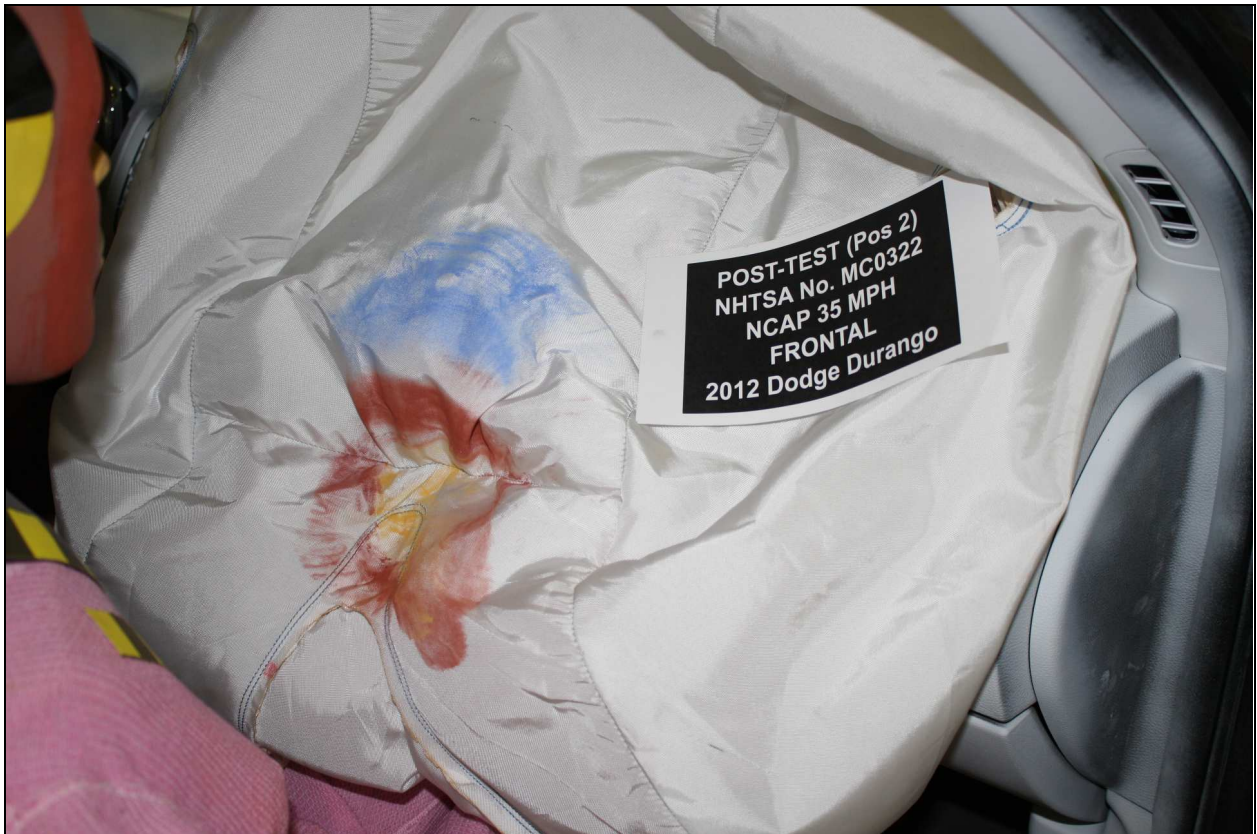
Figure A-62: Post-Test Passenger Dummy Contact with Airbag

The passenger's visible contact points were as follows: Face and Upper Torso with Frontal airbag with the back of head with the head restraint; both knees contacted the lower glovebox door.
