**REPORT NUMBER: SPNCAP-CAL-12-009**

**NEW CAR ASSESSMENT PROGRAM (NCAP)  
SIDE IMPACT POLE TEST**

**HYUNDAI MOTOR COMPANY  
2012 Hyundai Elantra PZEV  
Four Door Sedan**

**FINAL REPORT**

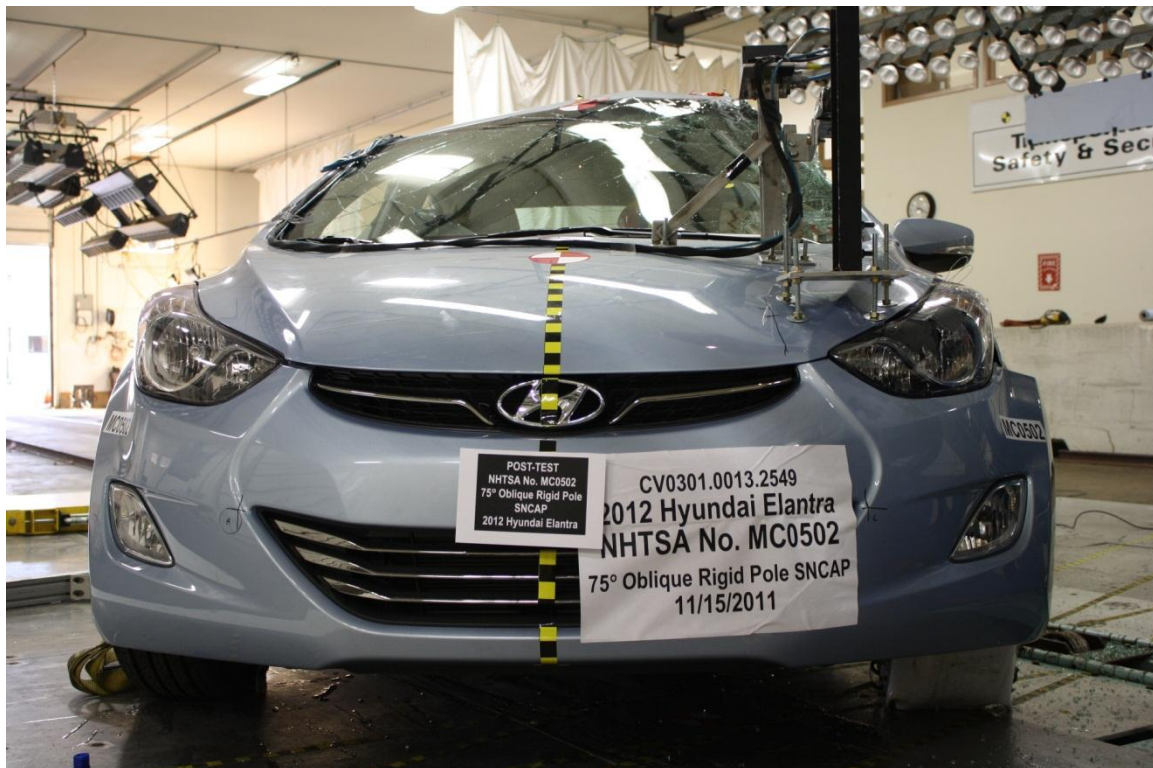
**Figure A-4: Post-Test Frontal View of Test Vehicle**

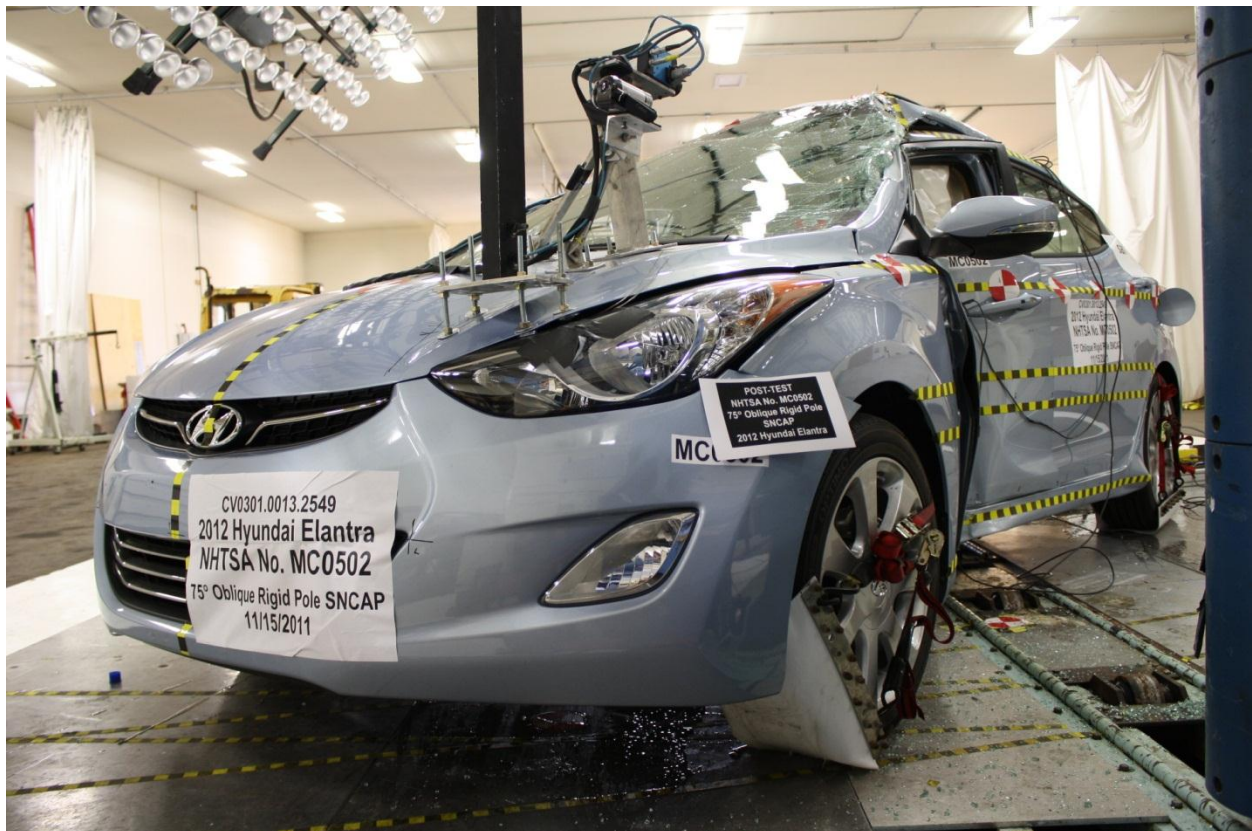
**Figure A-6: Post-Test Left Front  $\frac{3}{4}$  View Test Vehicle**

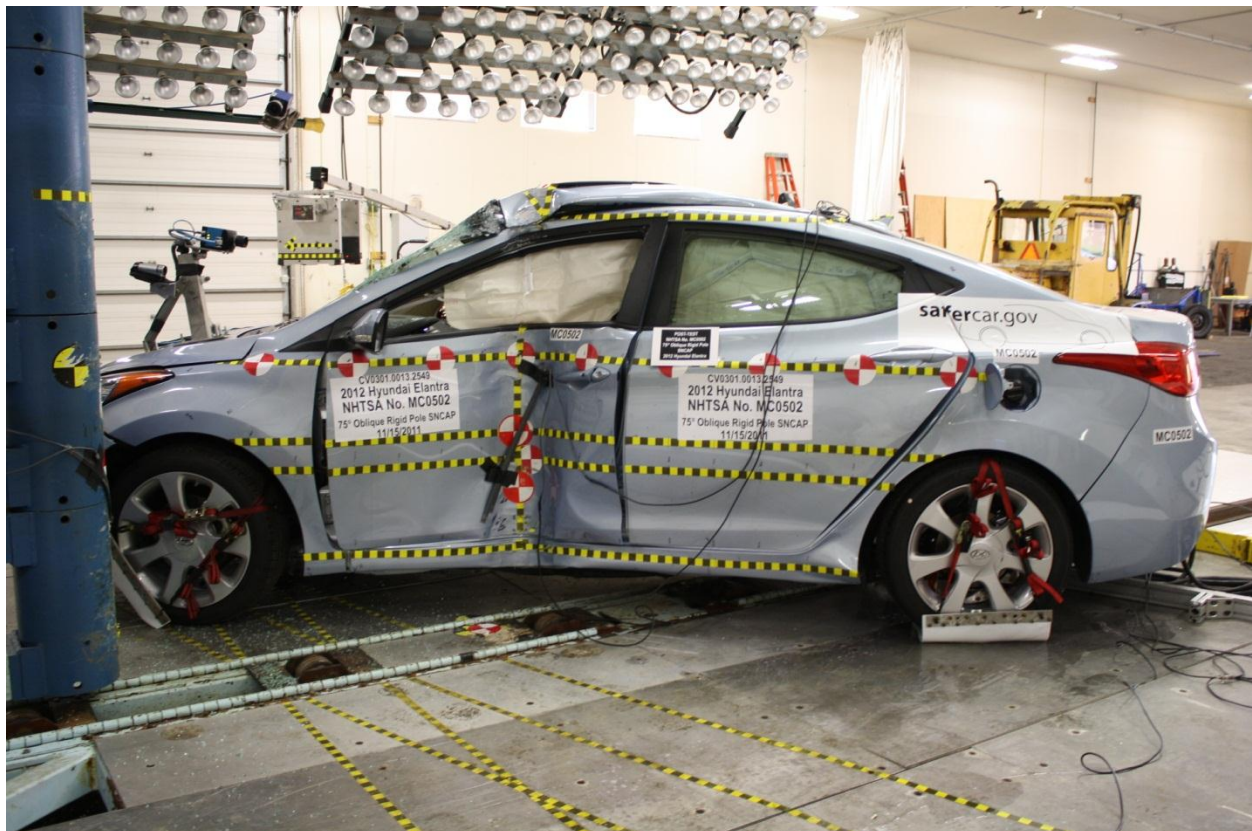
**Figure A-8: Post-Test Left Side View of Test Vehicle**

| Critical Areas of Performance | Observations and Conclusions |
|---|---|
| Pillar Performance | Slight A-Pillar deformation caused by the Pole |
| Windshield Damage | Small tear along the A-Pillar |
| Side Window Damage | Driver's side window shattered on impact |

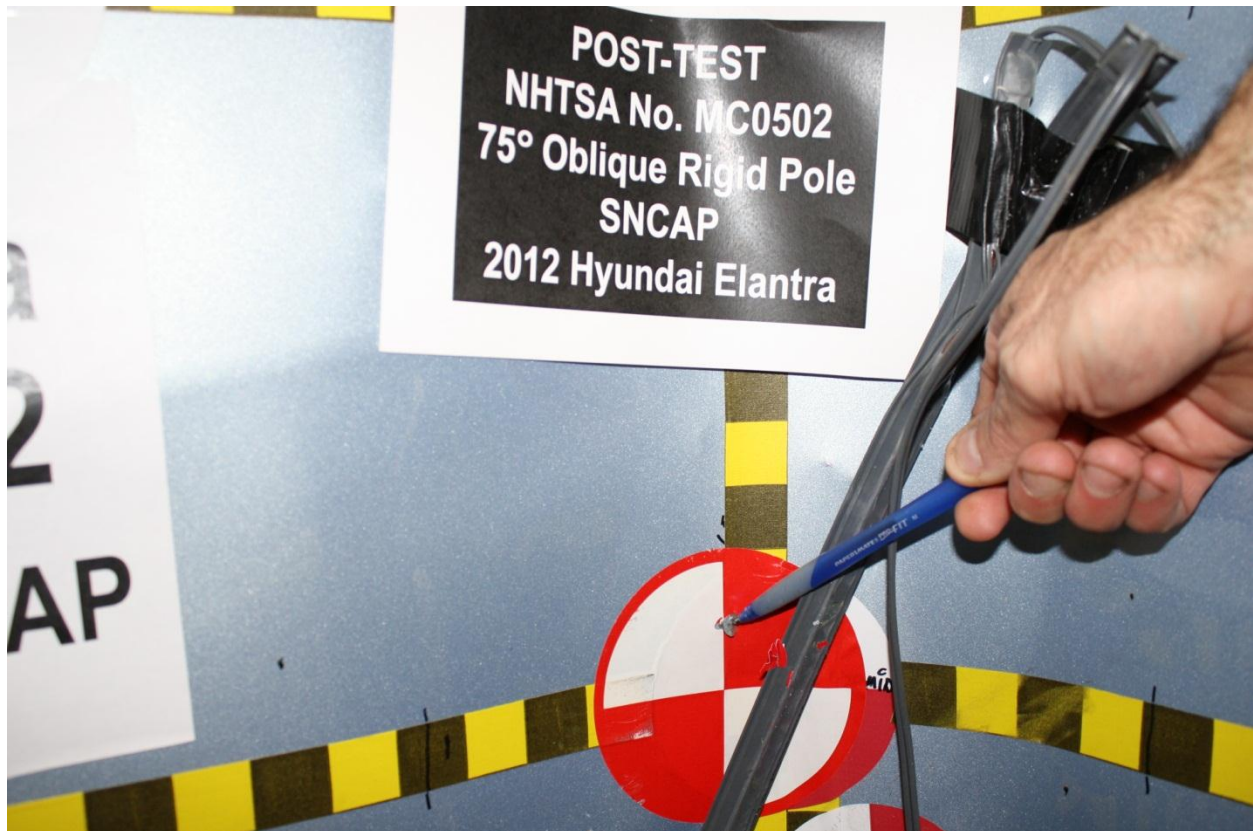
Figure A-20: Post-Test Close-Up View of Impact Point Target Showing Impact Location

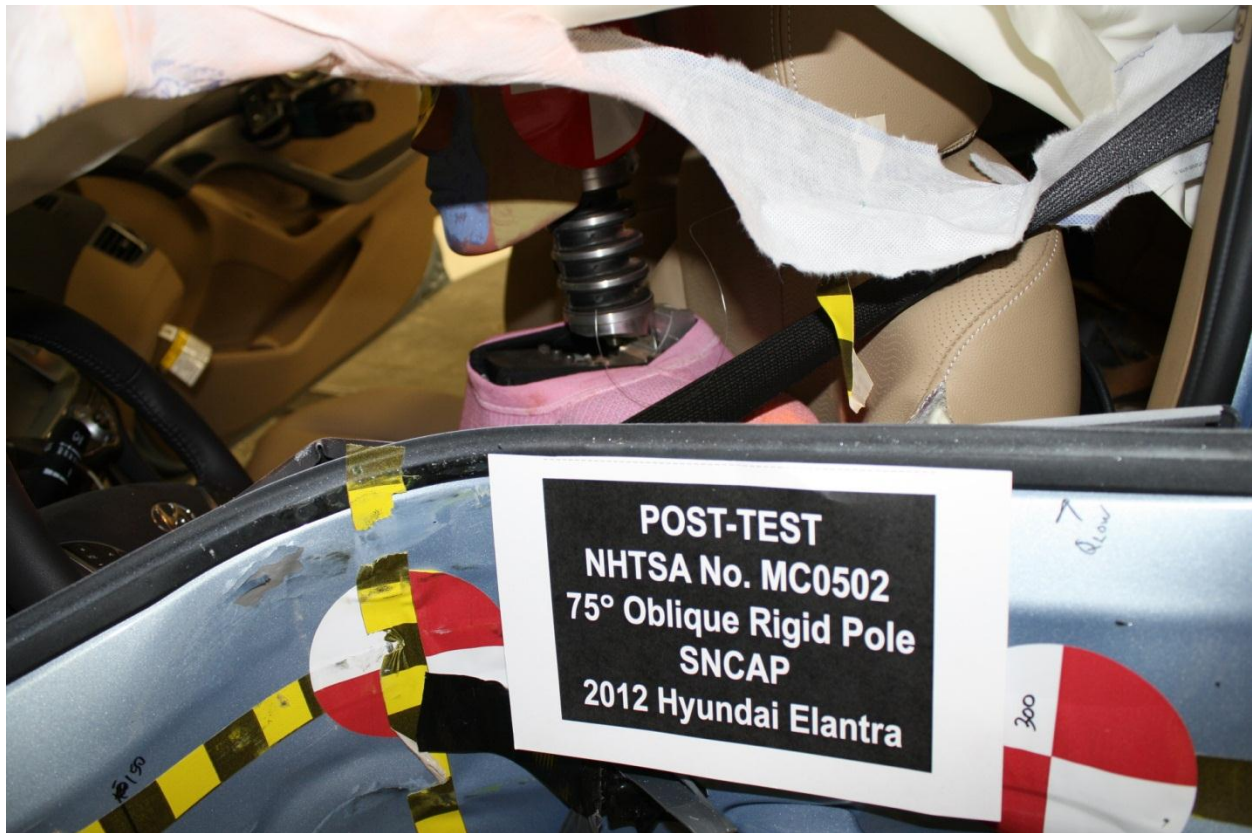
**Figure A-41: Post-Test Dummy and Door Clearance View**

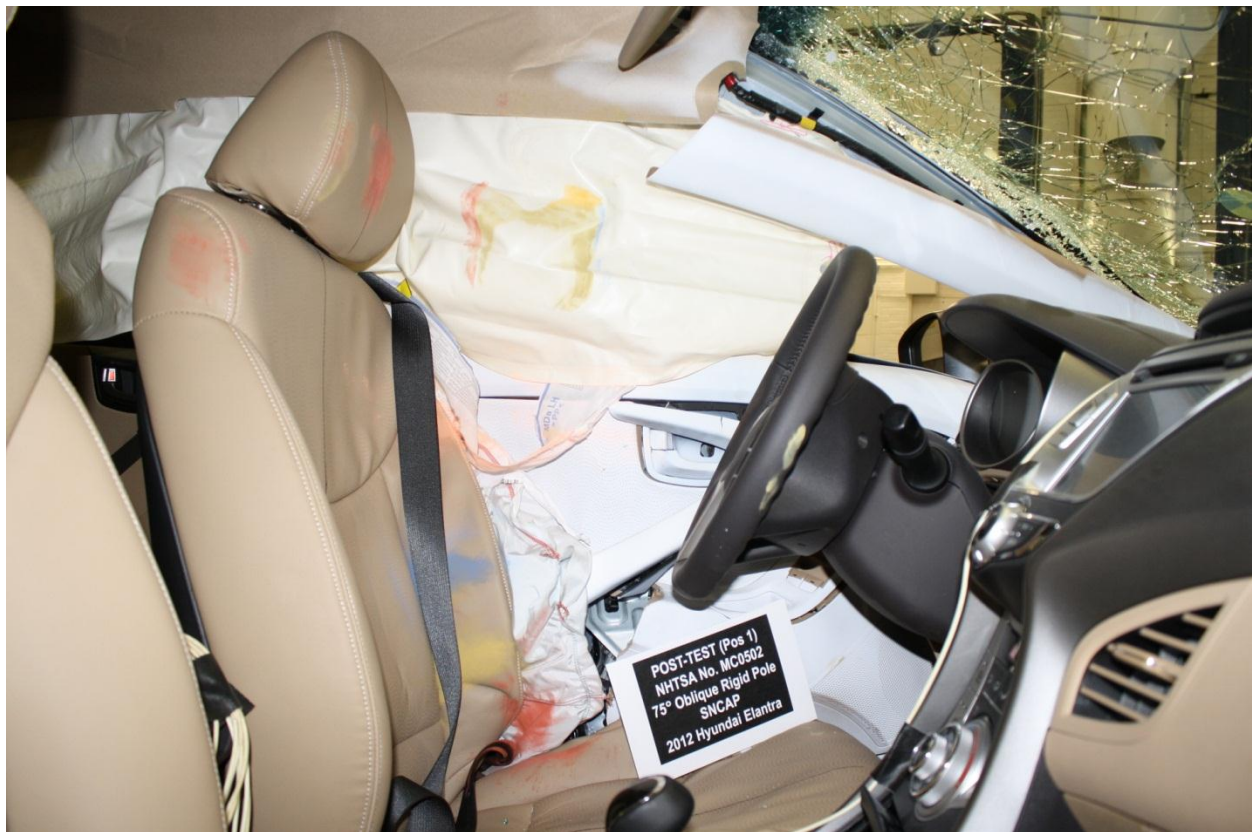
**Figure A-45: Post-Test Inner Door Panel View Showing Dummy Contact Location**

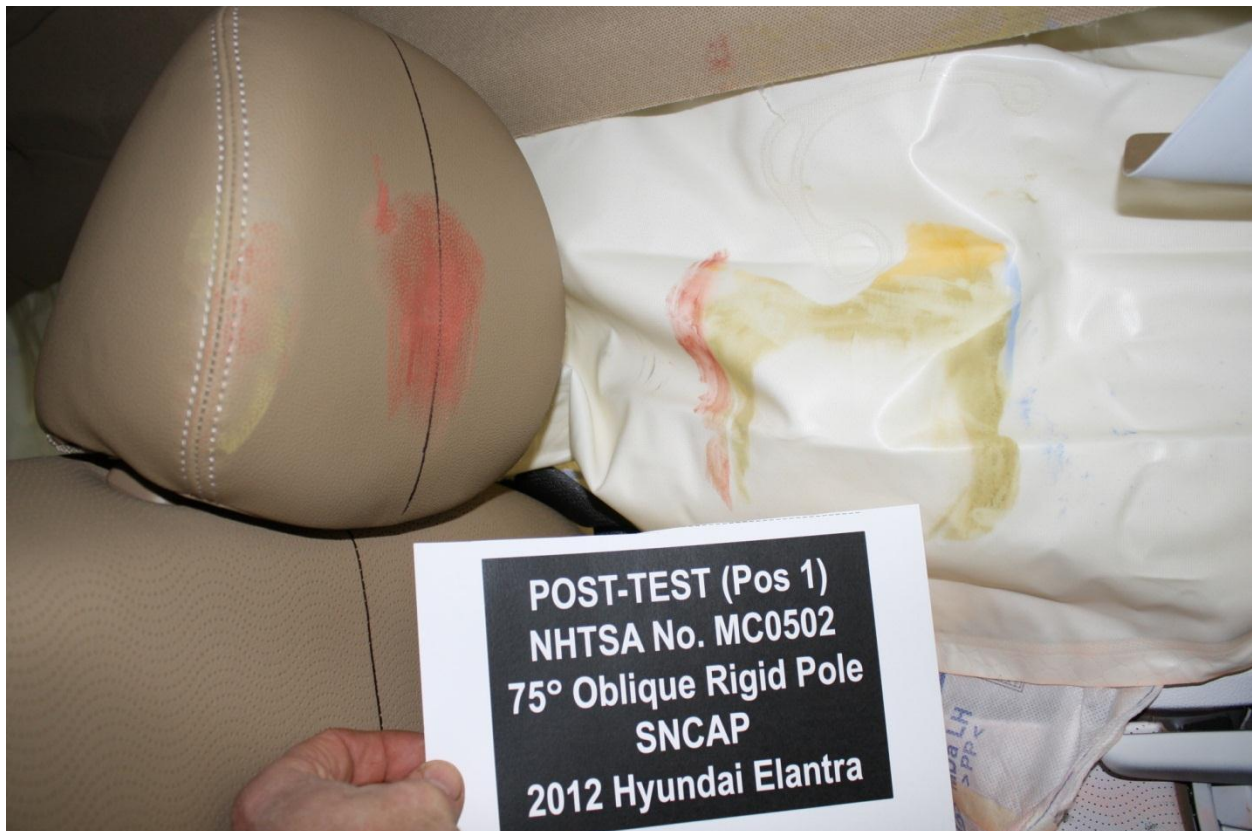
**Figure A-46: Post-Test Dummy Close-Up Head Contact with Vehicle View**

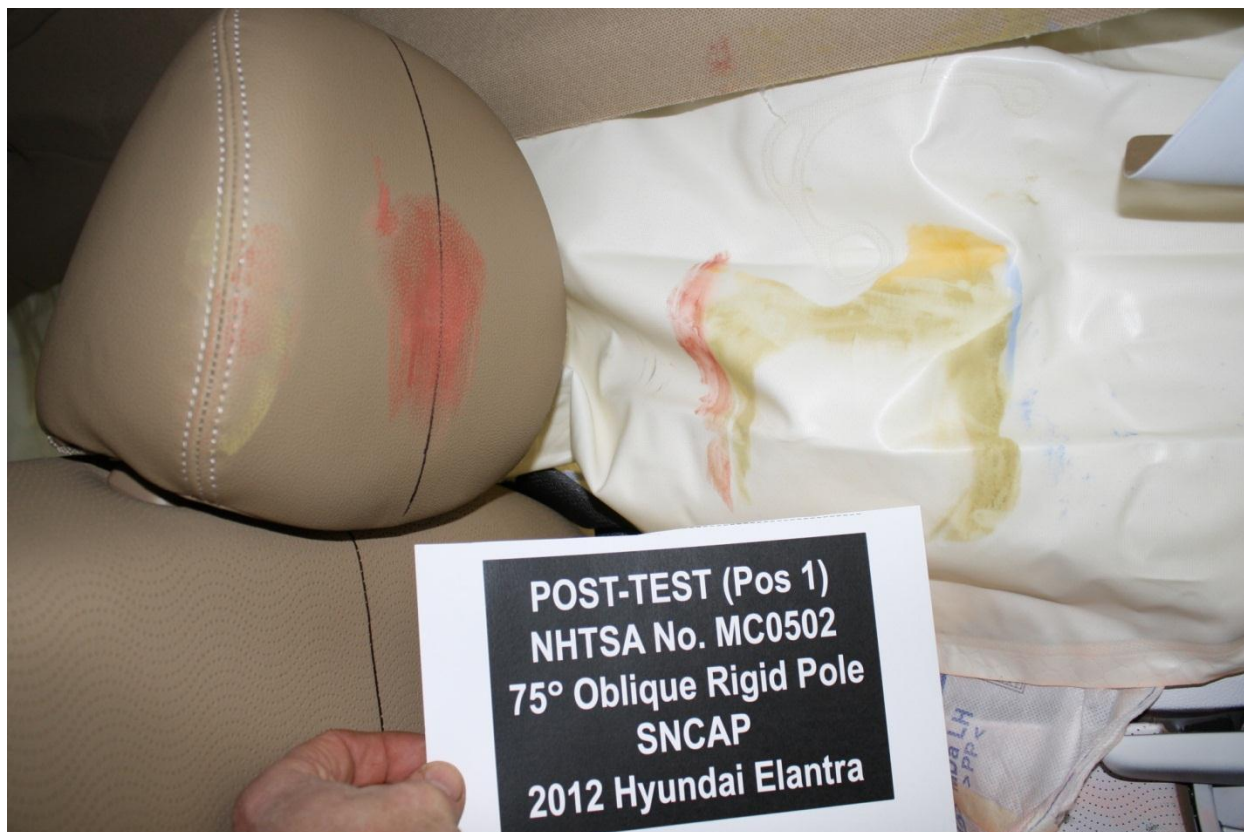
**Figure A-47: Post-Test Dummy Close-Up Head Contact with Side Airbag View**

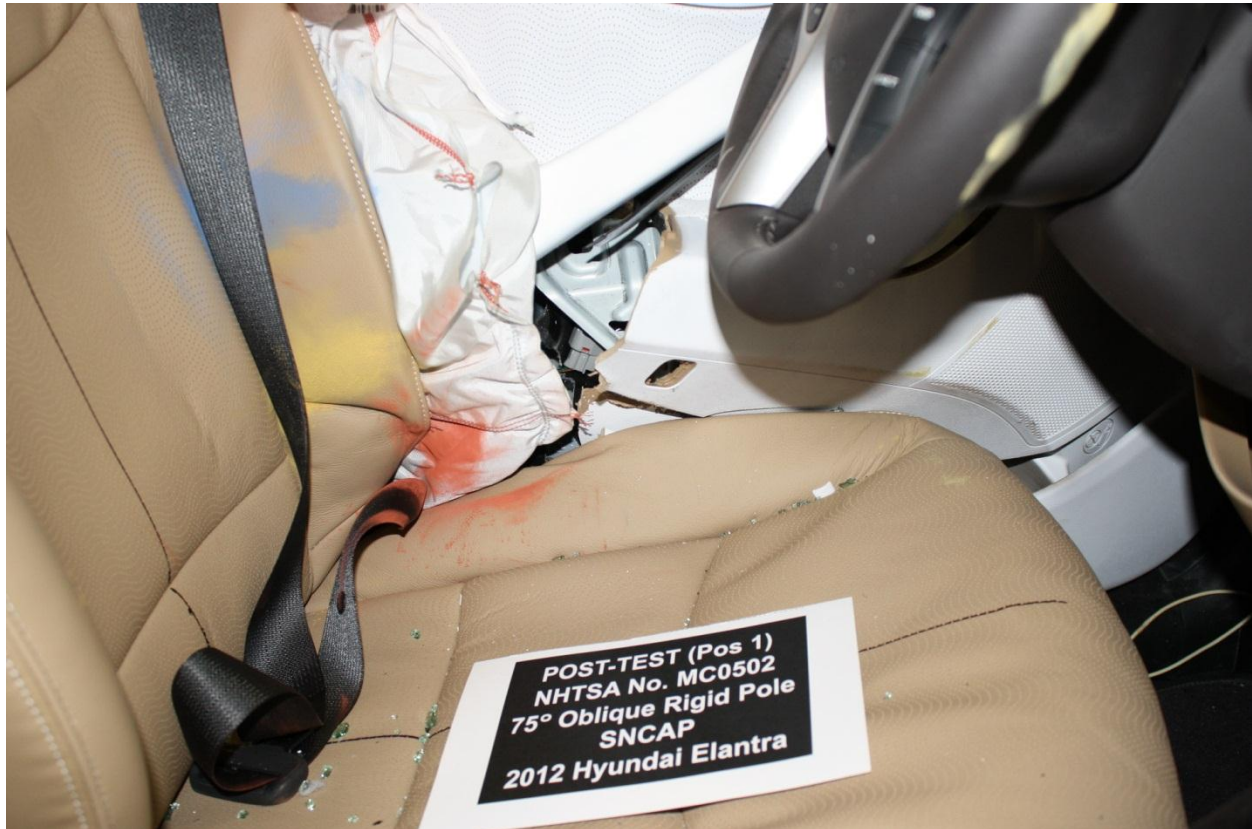
**Figure A-49: Post-Test Dummy Close-Up Torso Contact with Side Airbag View**

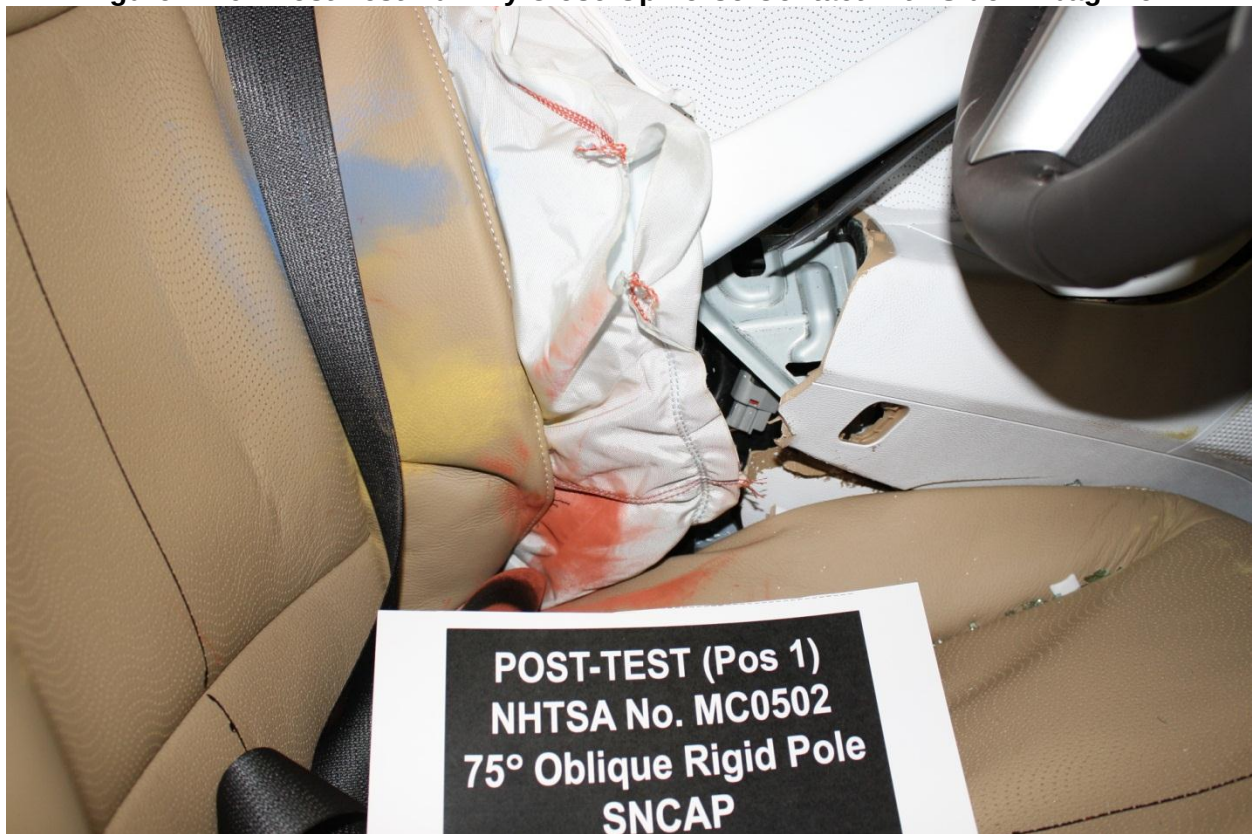
**Figure A-50: Post-Test Dummy Close-Up Pelvis Contact View**

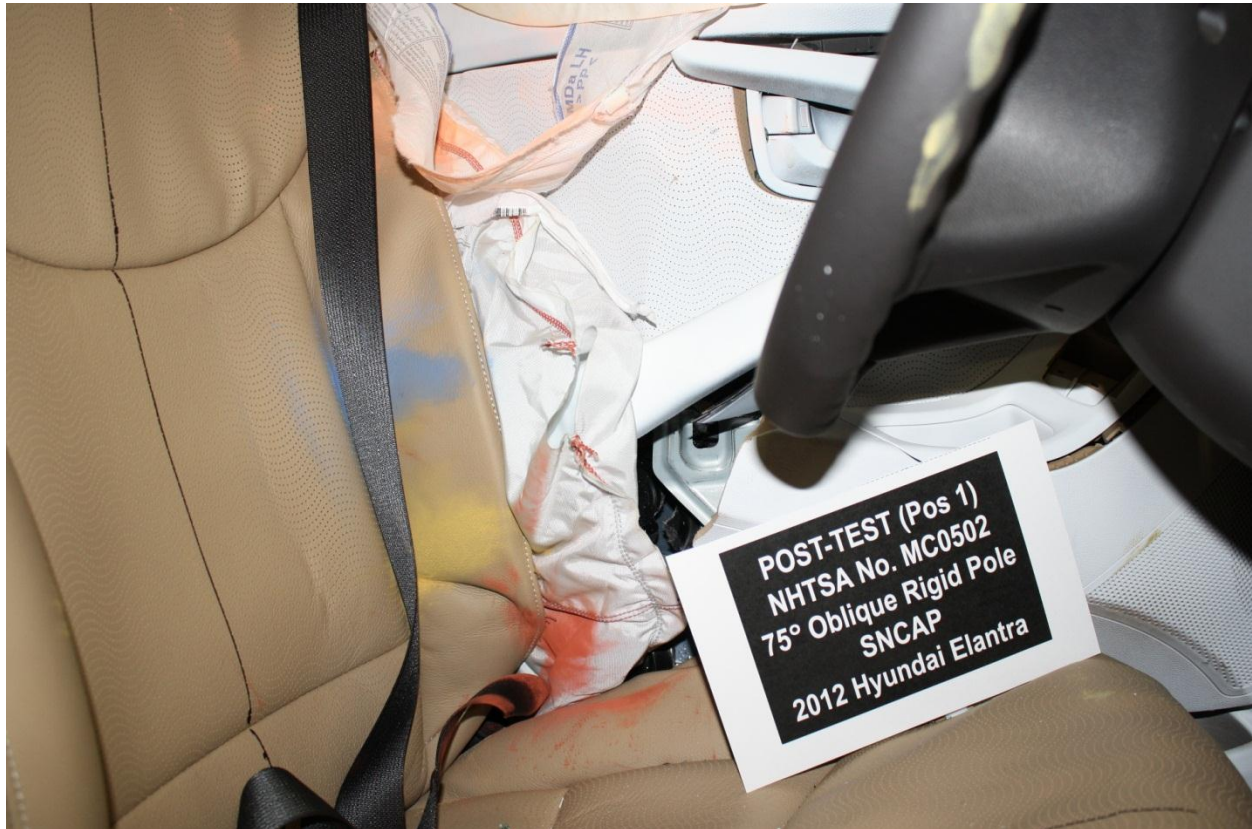
**Figure A-51: Post-Test Dummy Close-Up Pelvis Contact with Side Airbag View**

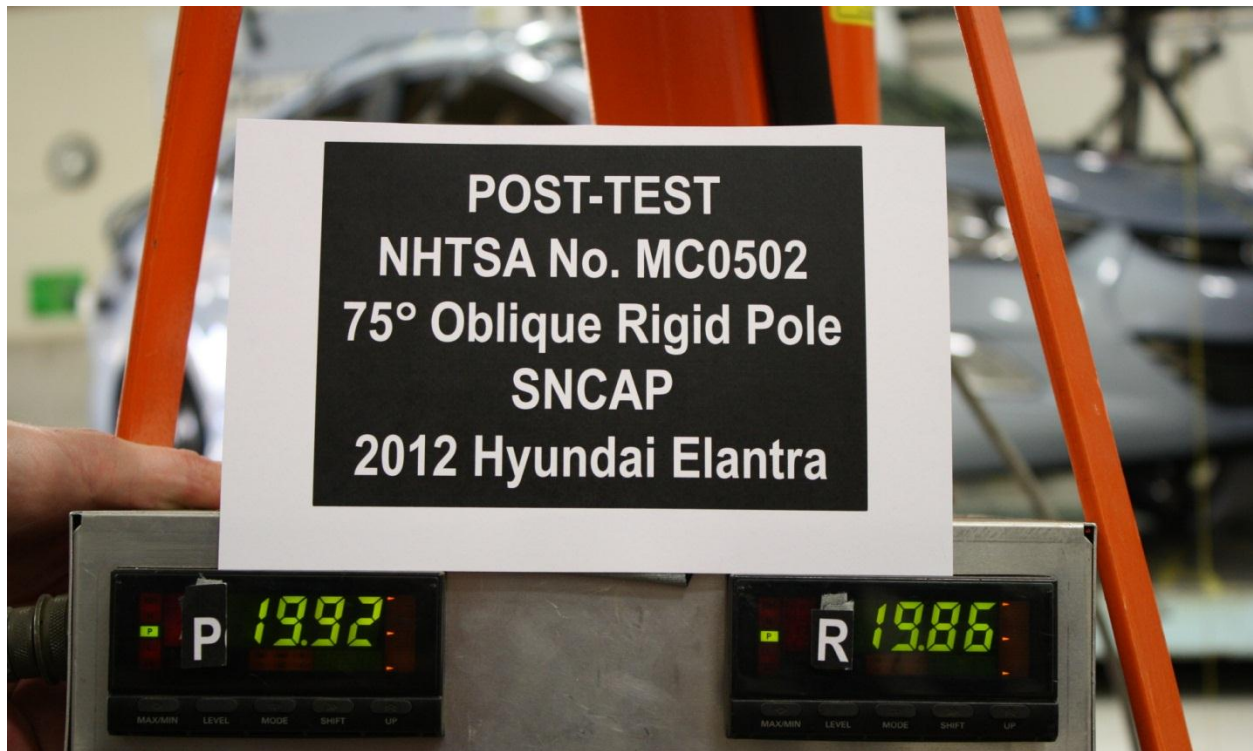
Figure A-61: Post-Test Primary and Redundant Speed Trap Read-Out

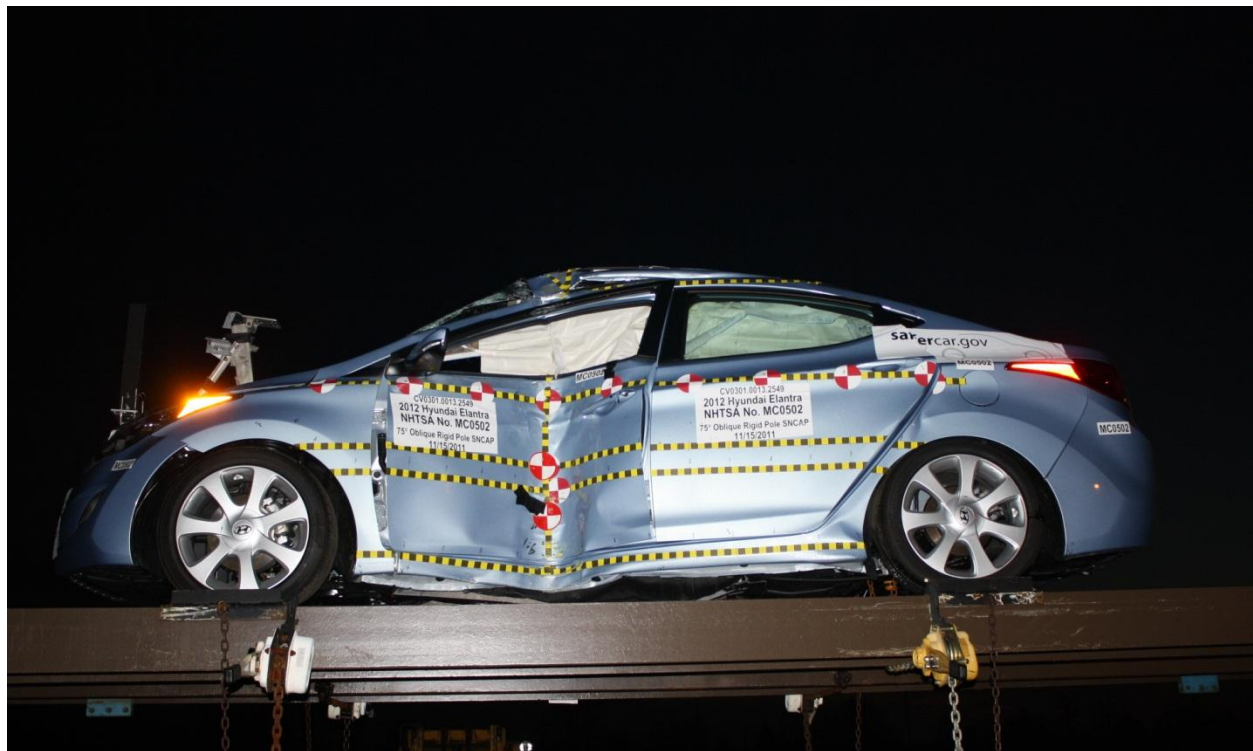
Figure A-62: FMVSS No. 301 Static Rollover 0 Degrees

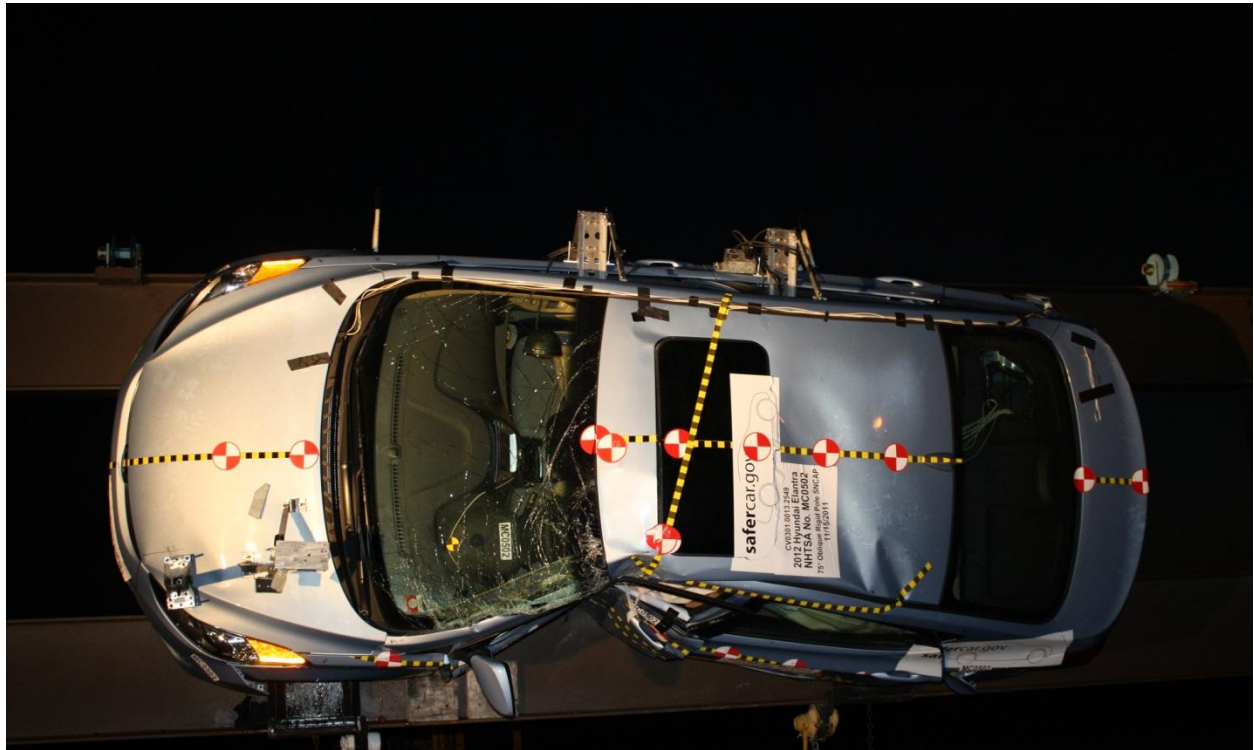
**Figure A-63: FMVSS No. 301 Static Rollover 90 Degrees**

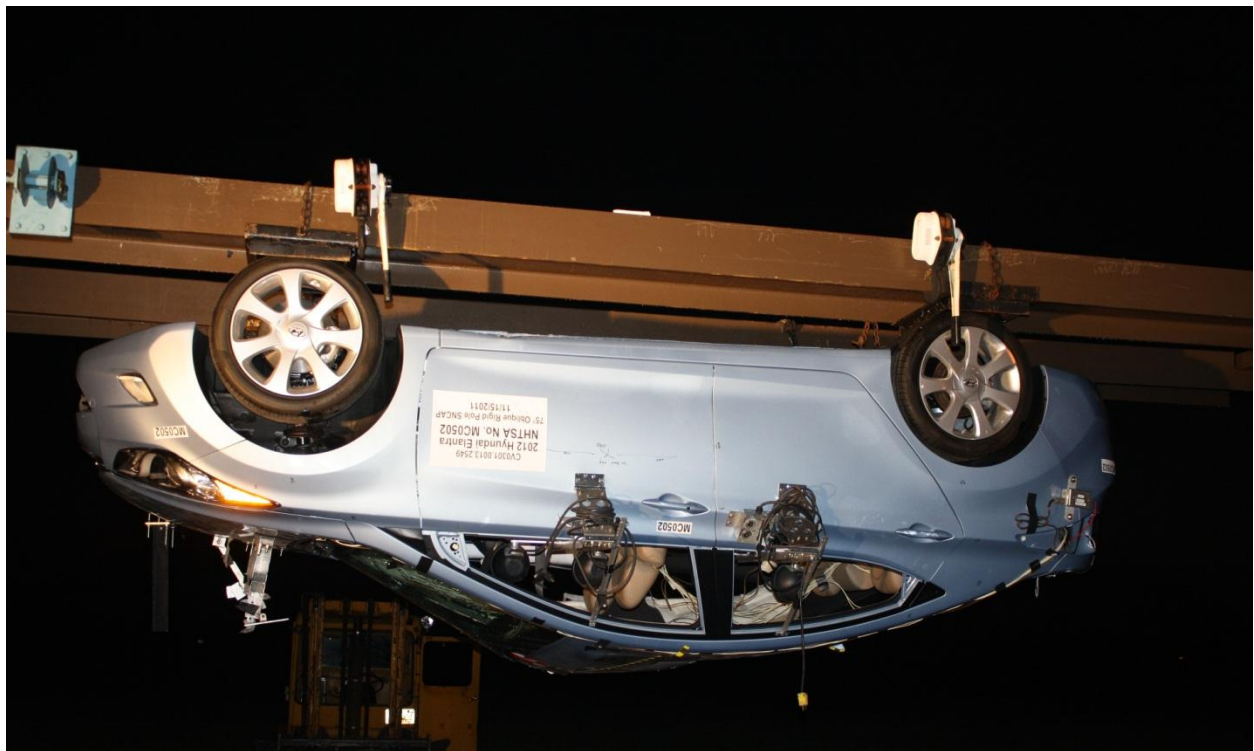
**Figure A-64: FMVSS No. 301 Static Rollover 180 Degrees**

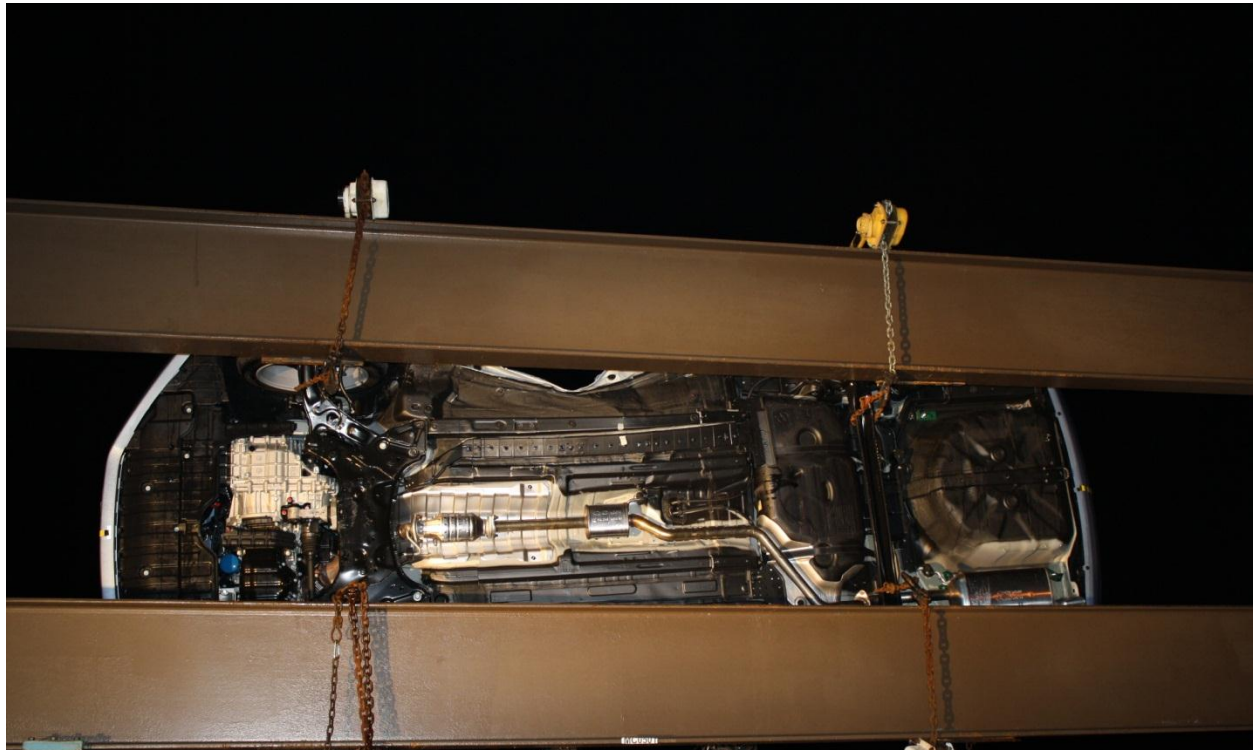
**Figure A-65: FMVSS No. 301 Static Rollover 270 Degrees**

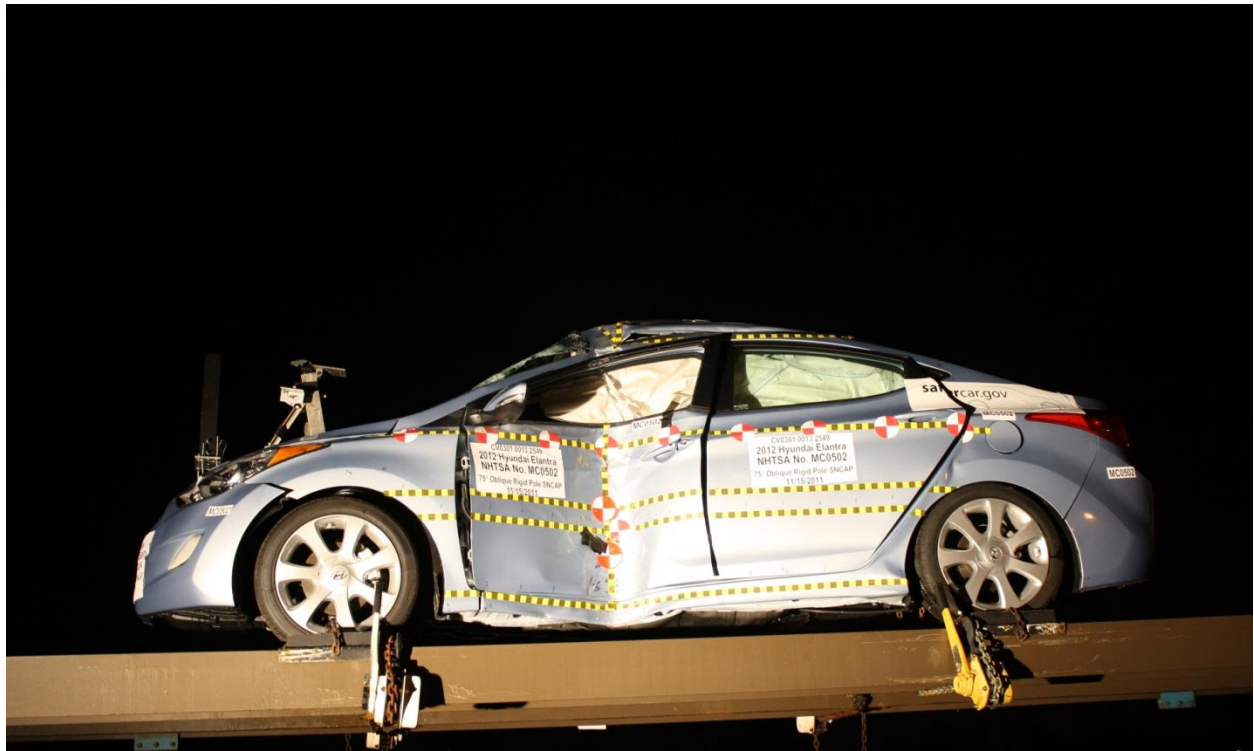
**Figure A-66: FMVSS No. 301 Static Rollover 360 Degrees**

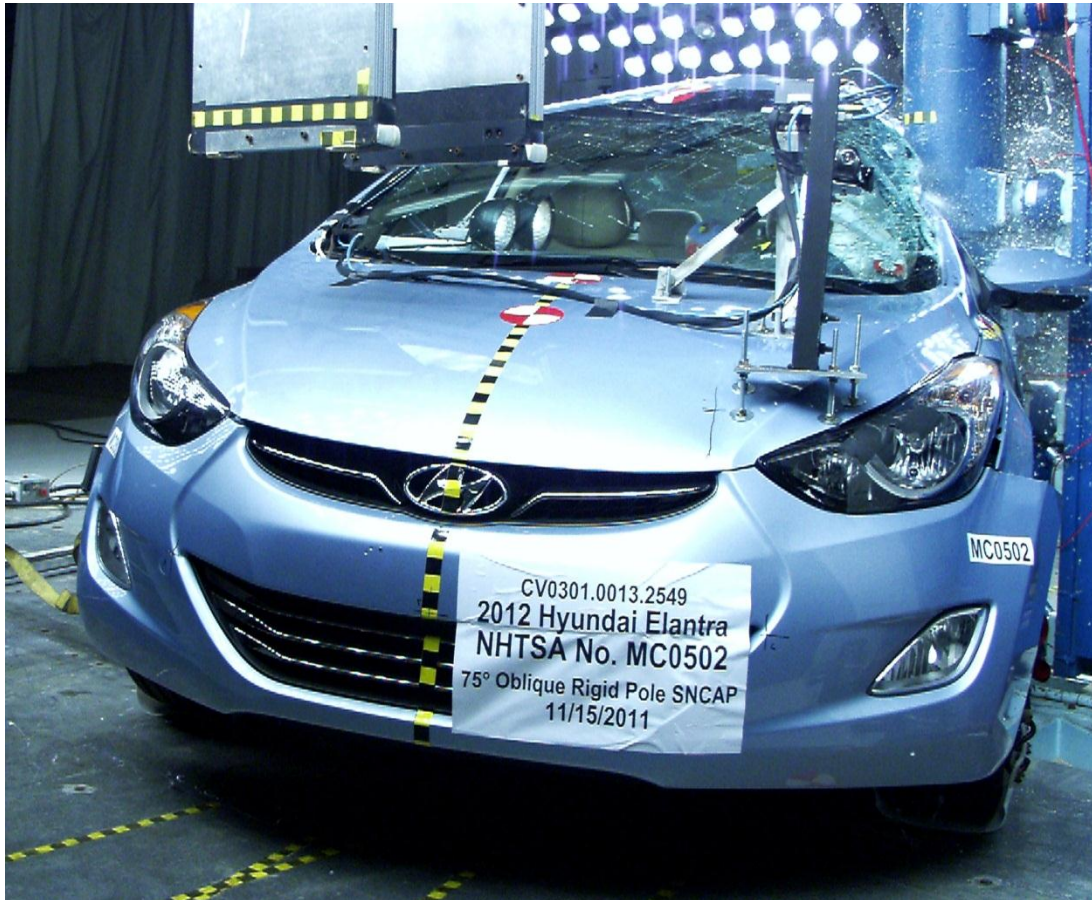
Figure A-67: Impact Event
