**REPORT NUMBER: SPNCAP-MGA-2012-031**

**NEW CAR ASSESSMENT PROGRAM (NCAP)  
Side Impact Pole Test**

**NISSAN MOTOR CO., LTD.  
2012 Nissan Maxima S 4-Dr Sedan  
NHTSA No.: MC5204**

**FINAL REPORT**

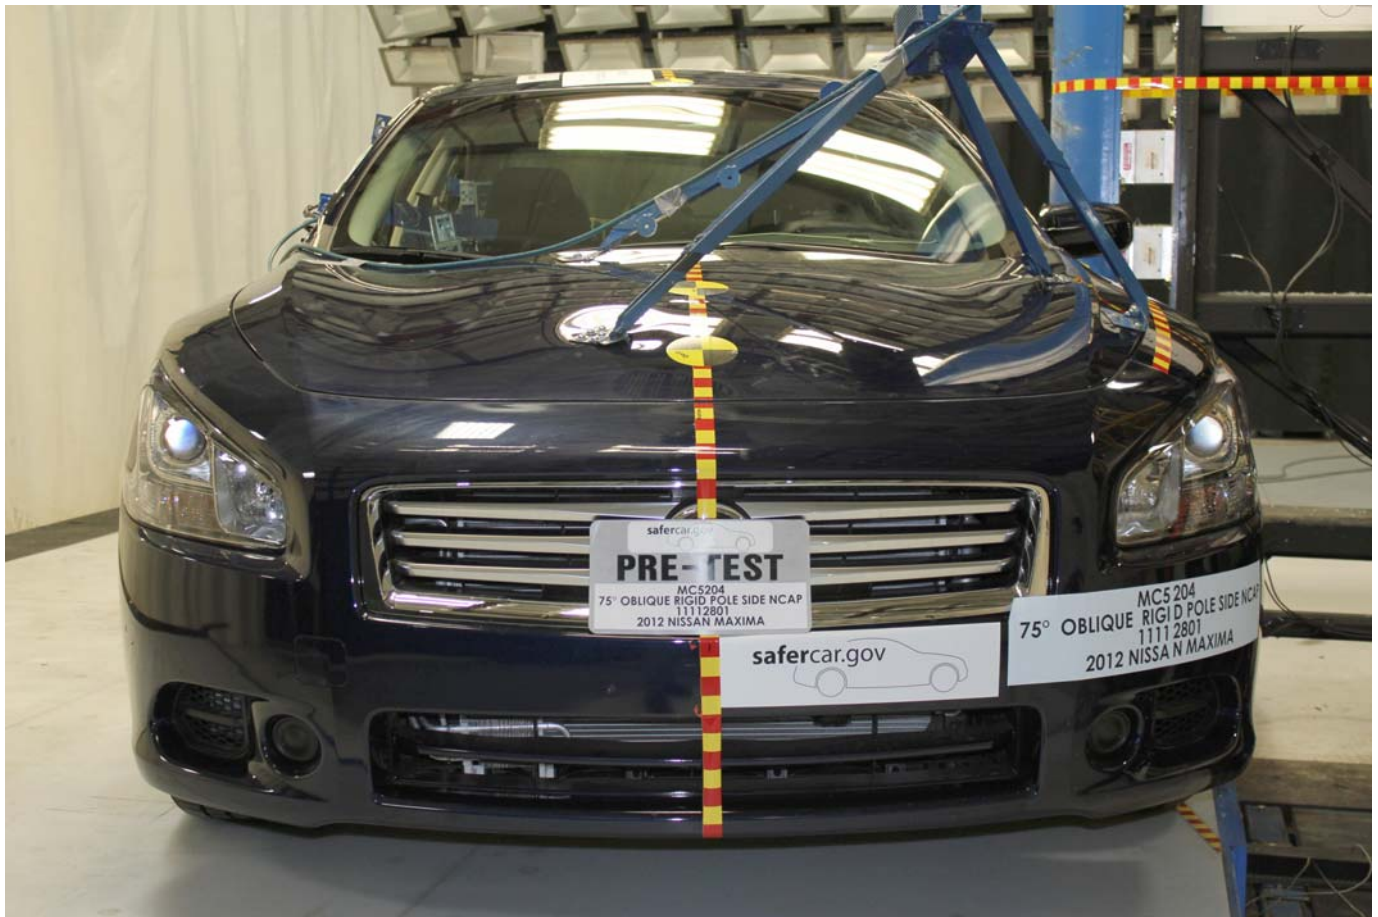
Pre-Test Frontal View of Test Vehicle

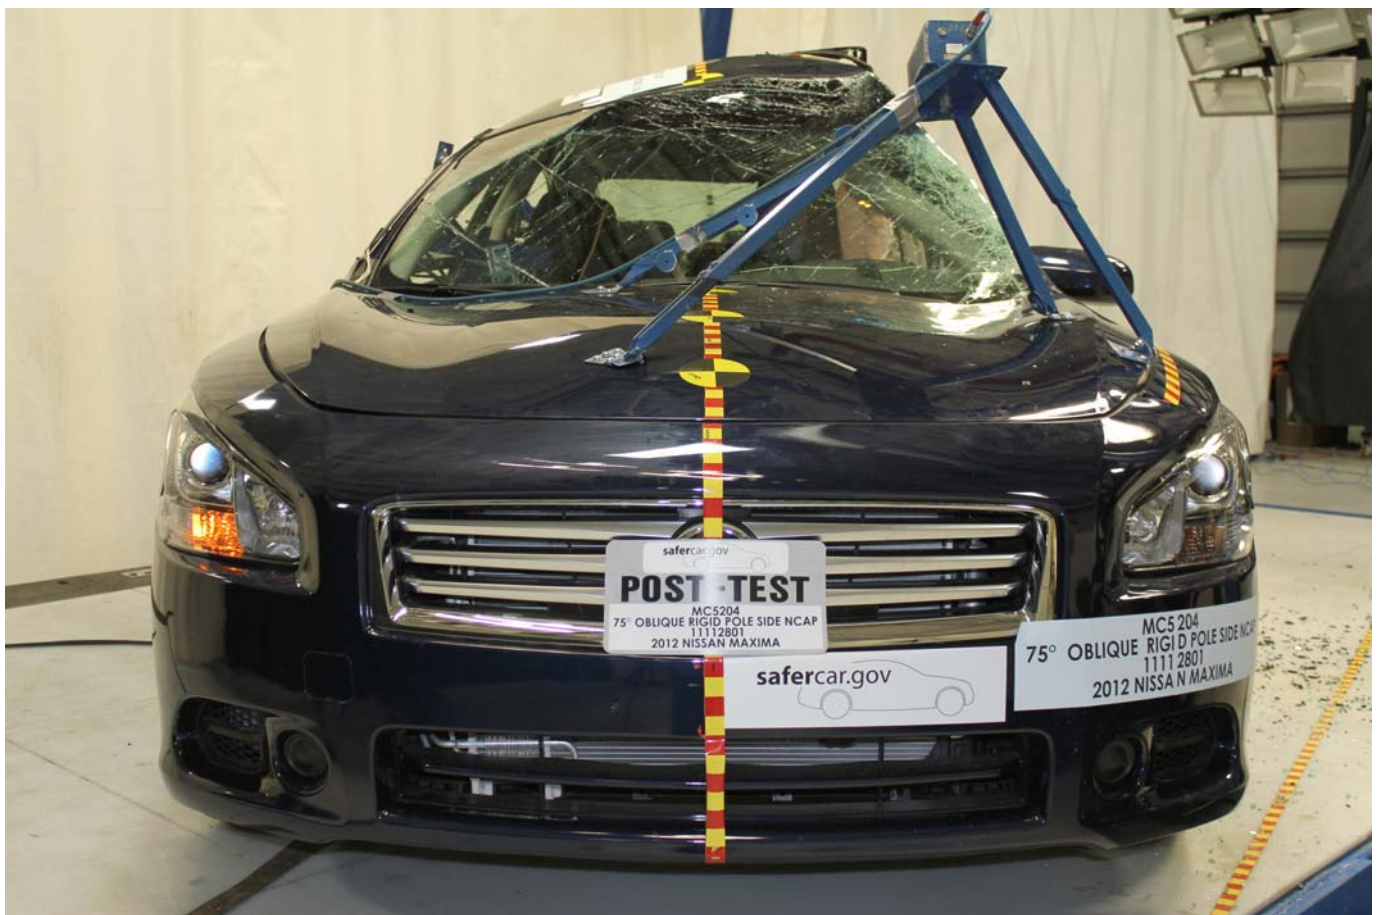
Post-Test Frontal View of Test Vehicle

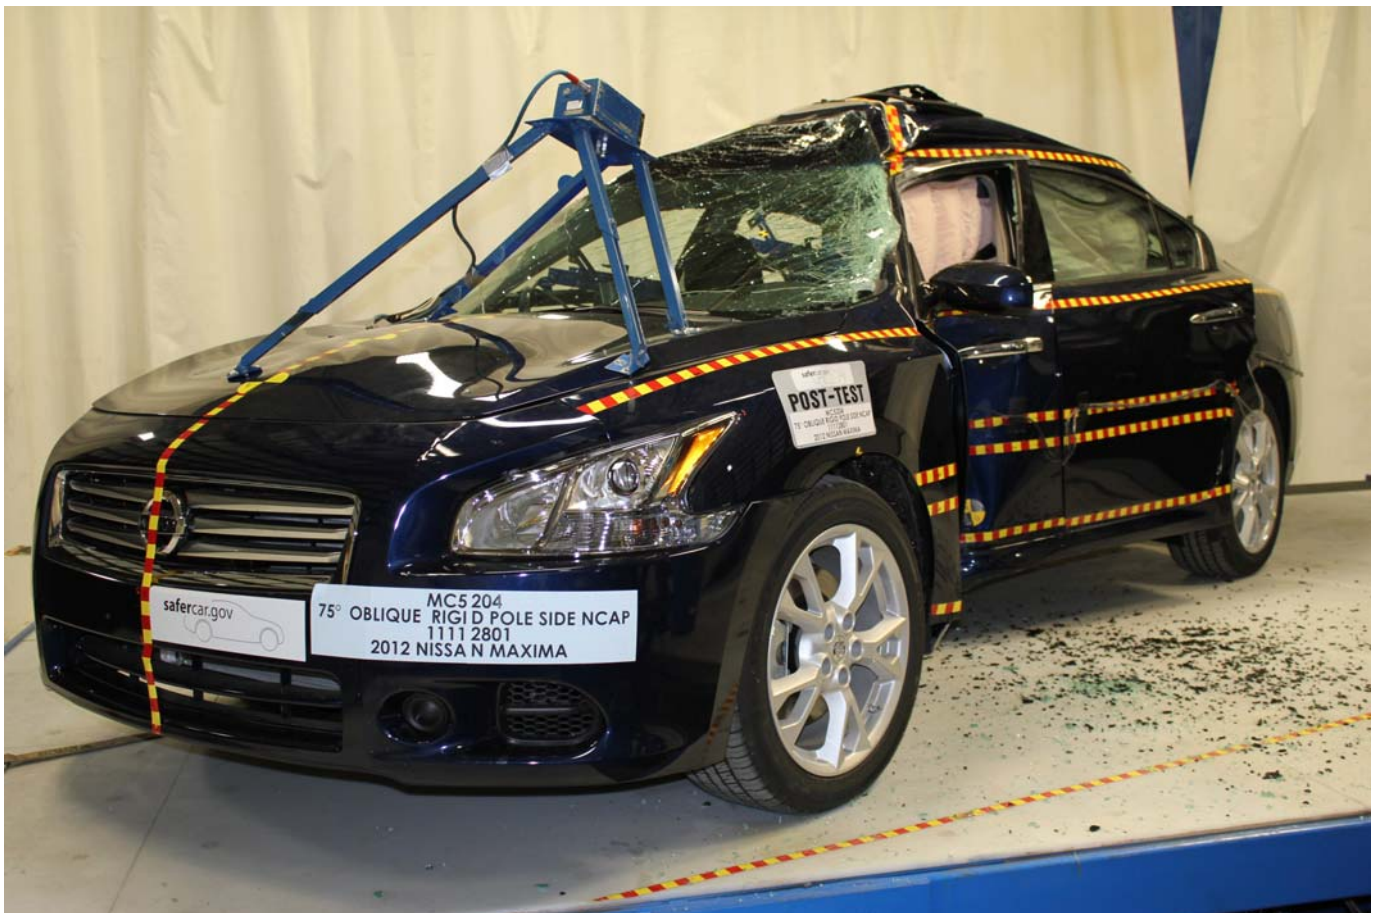
Post-Test Left Front  $\frac{3}{4}$  View of Test Vehicle

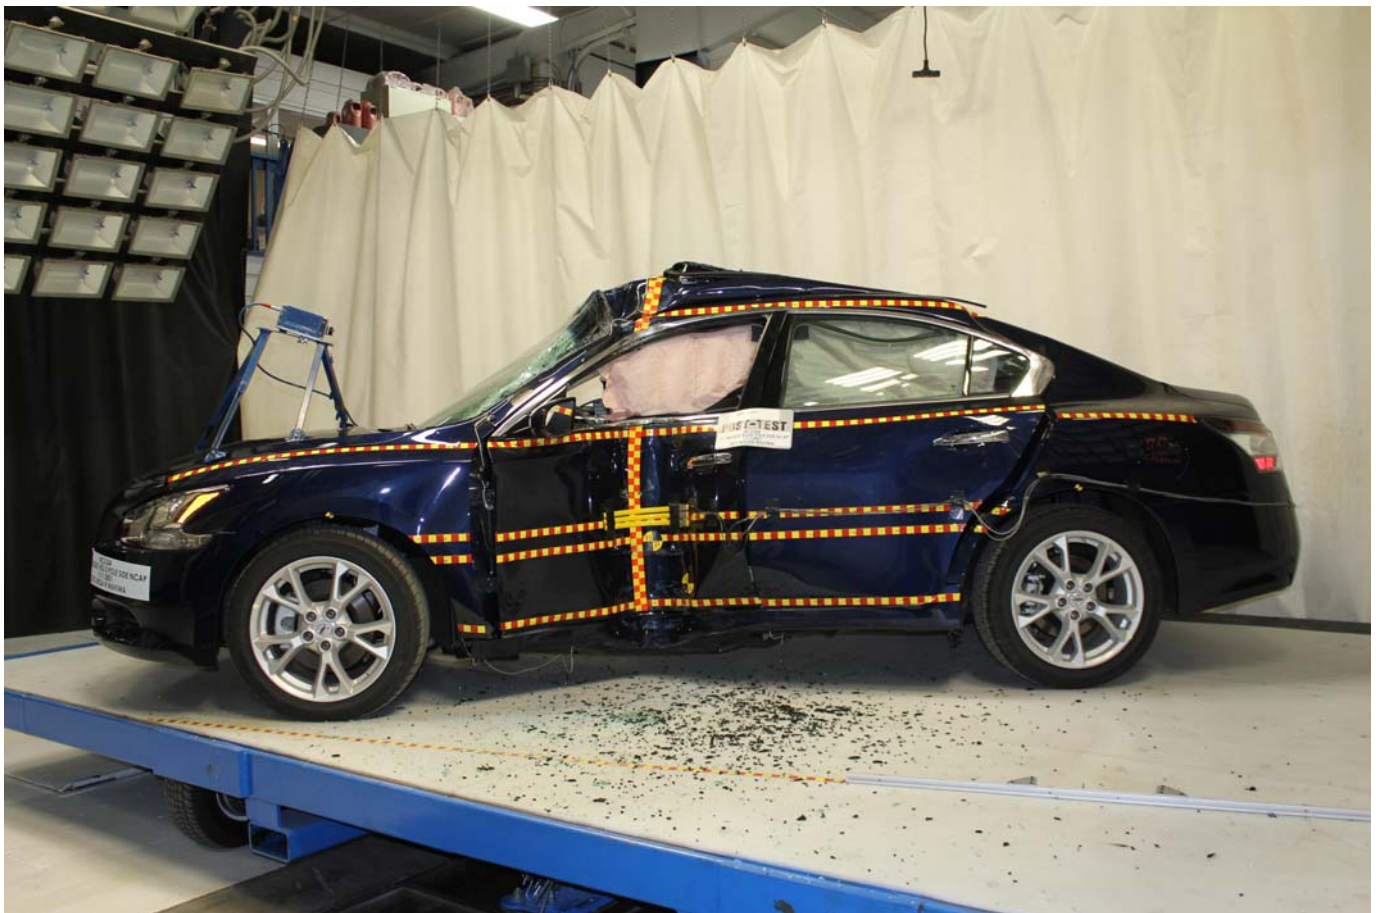
Post-Test Left Side View of Test Vehicle

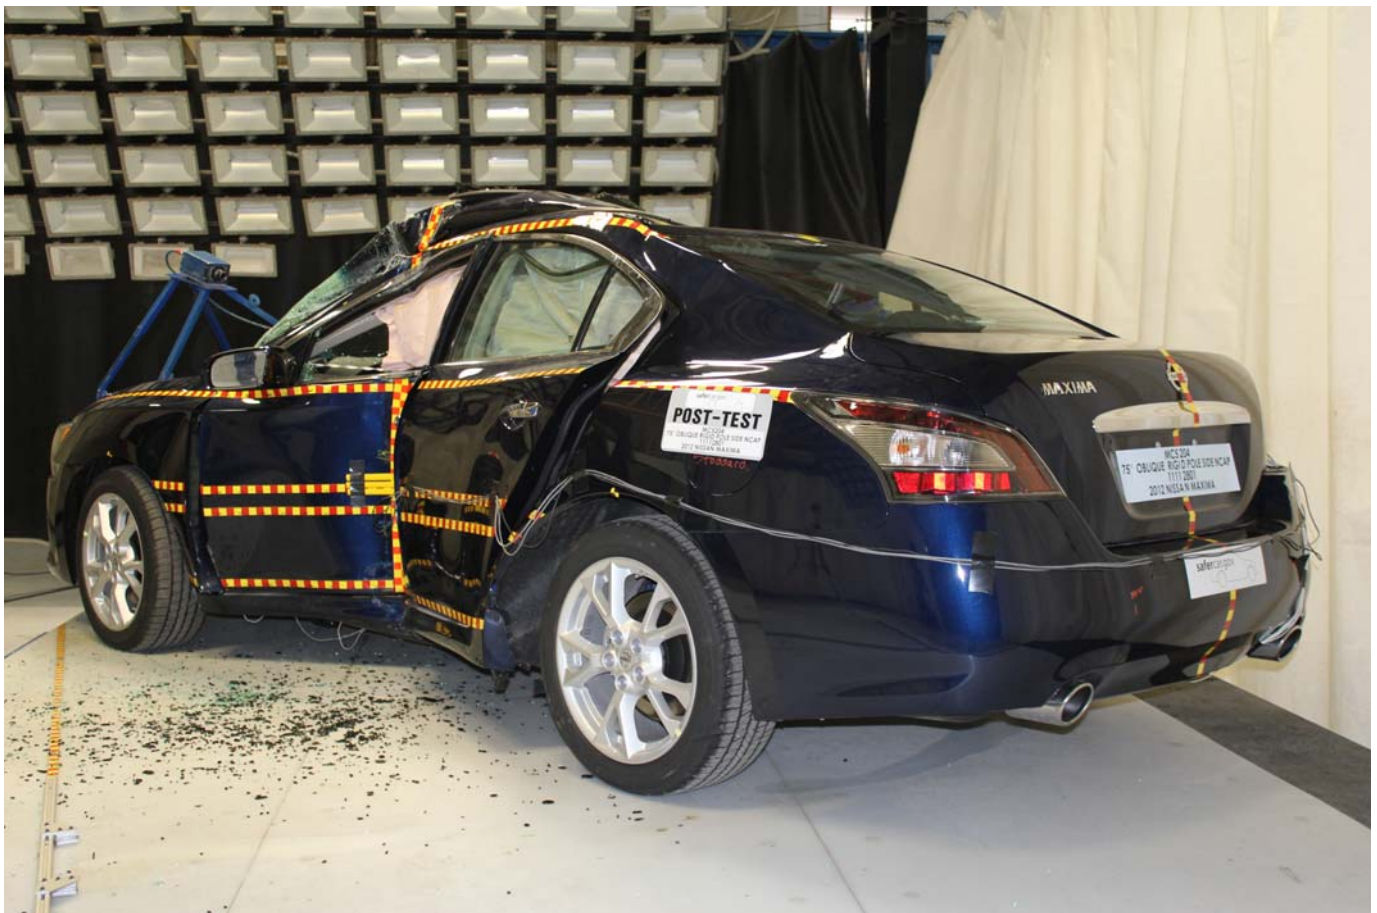
Post-Test Left Rear  $\frac{3}{4}$  View of Test Vehicle

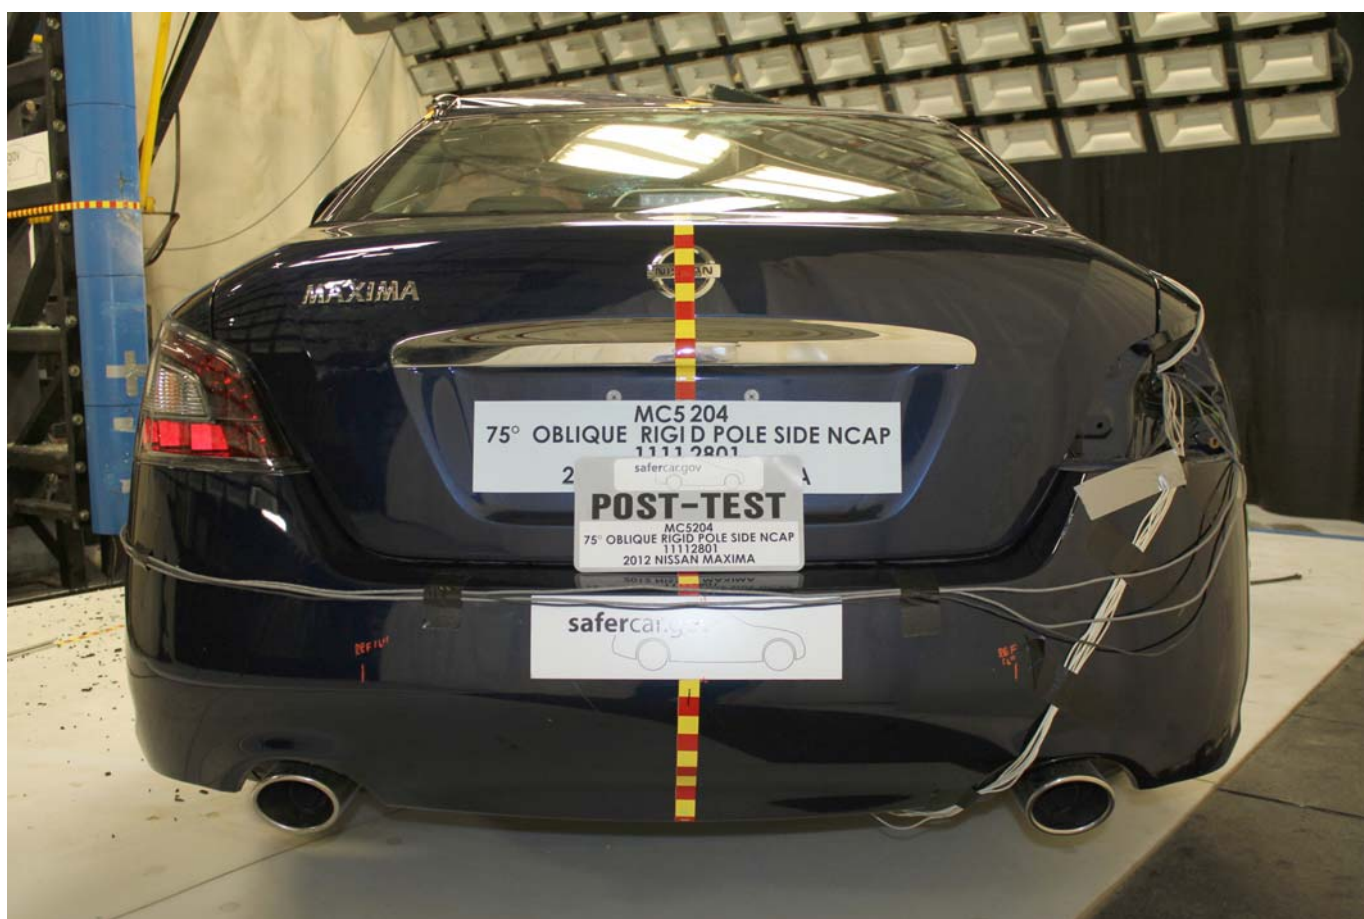
Post-Test Rear View of Test Vehicle

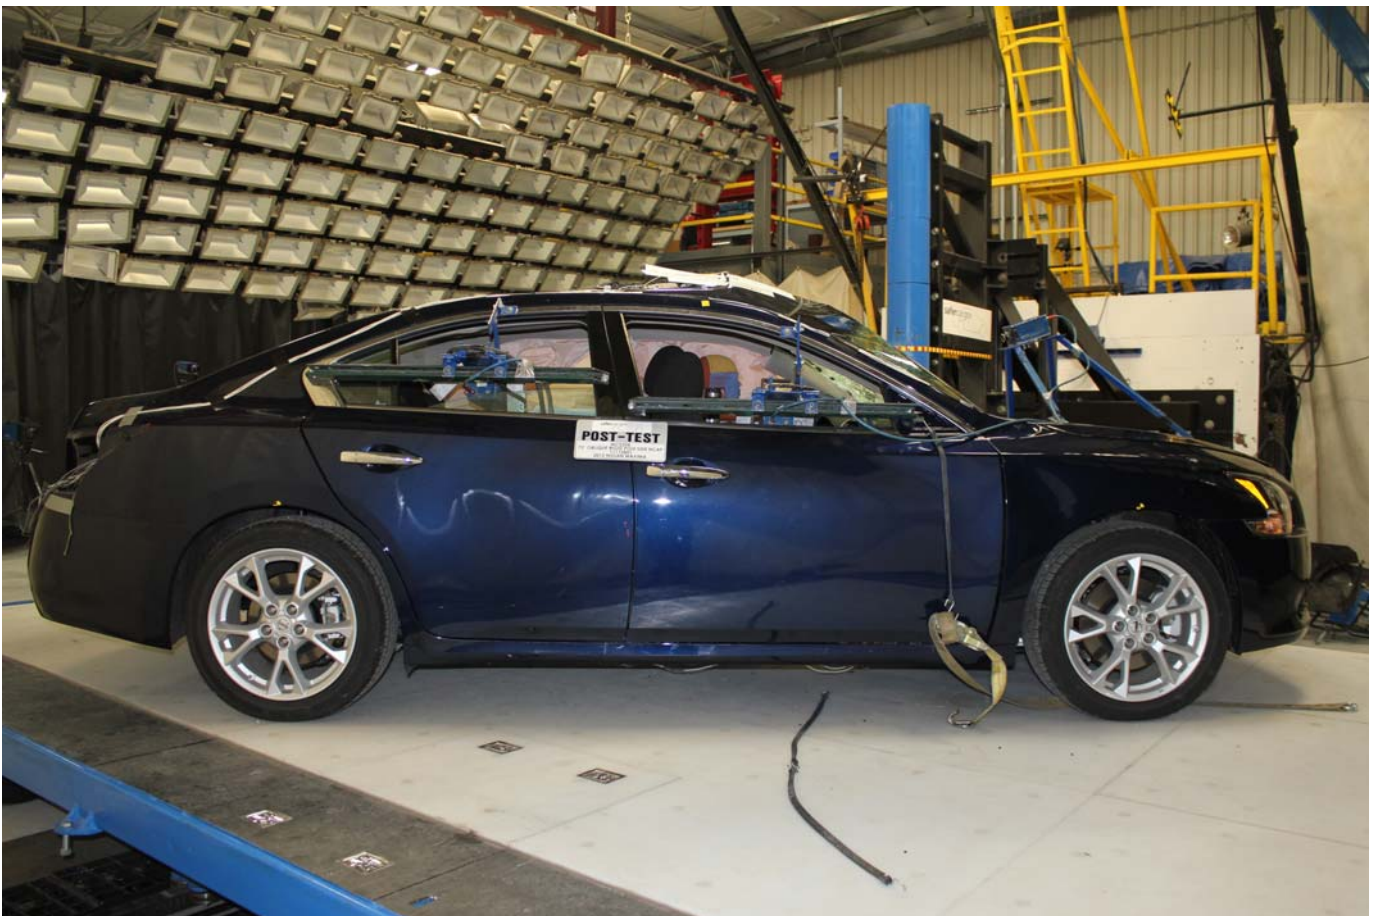
Post-Test Right Side View of Test Vehicle

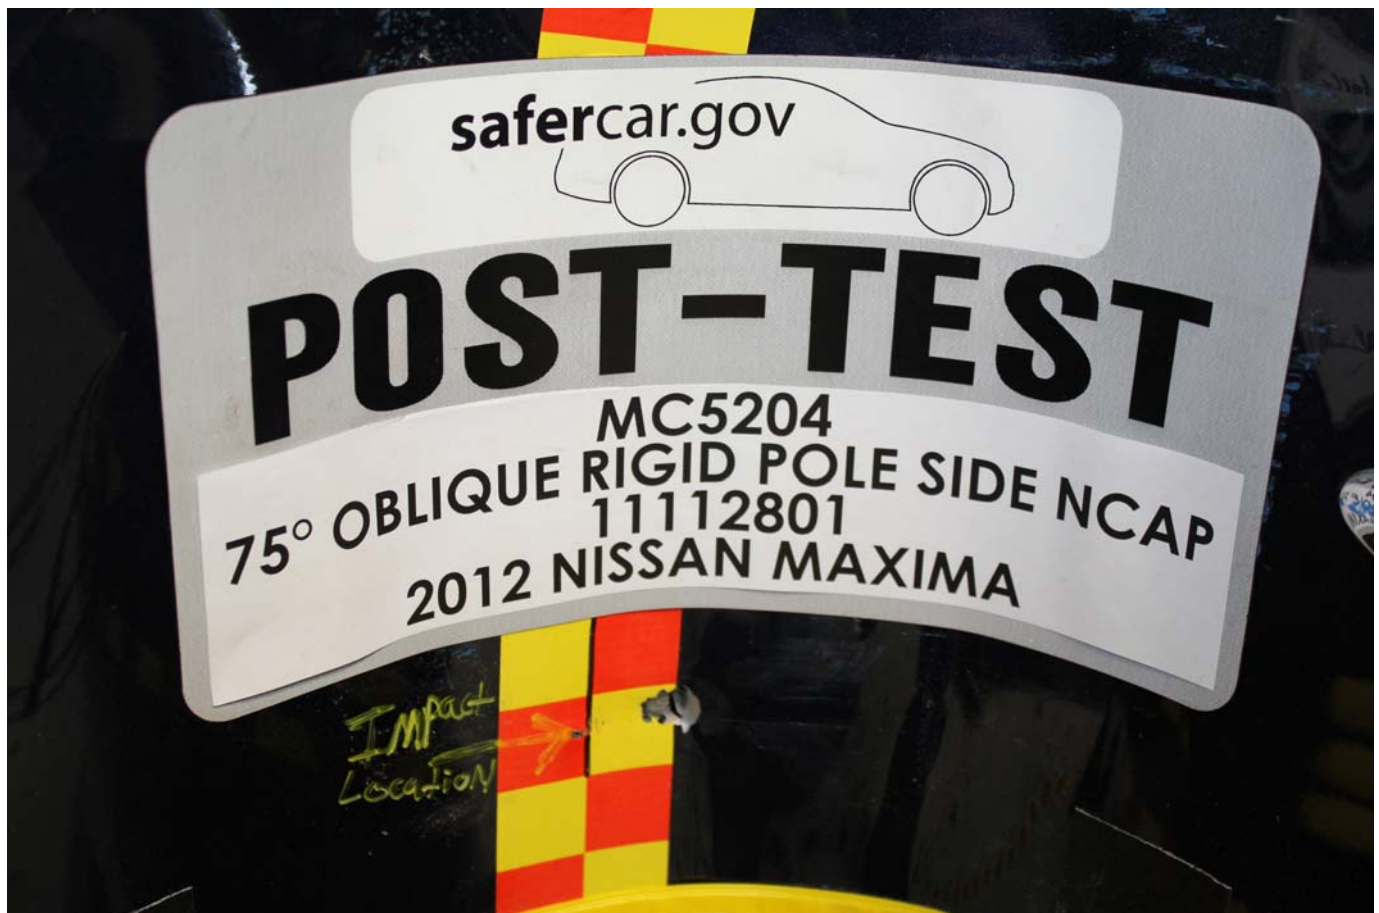
Post-Test Close-Up View of Impact Point Target Showing Impact Location

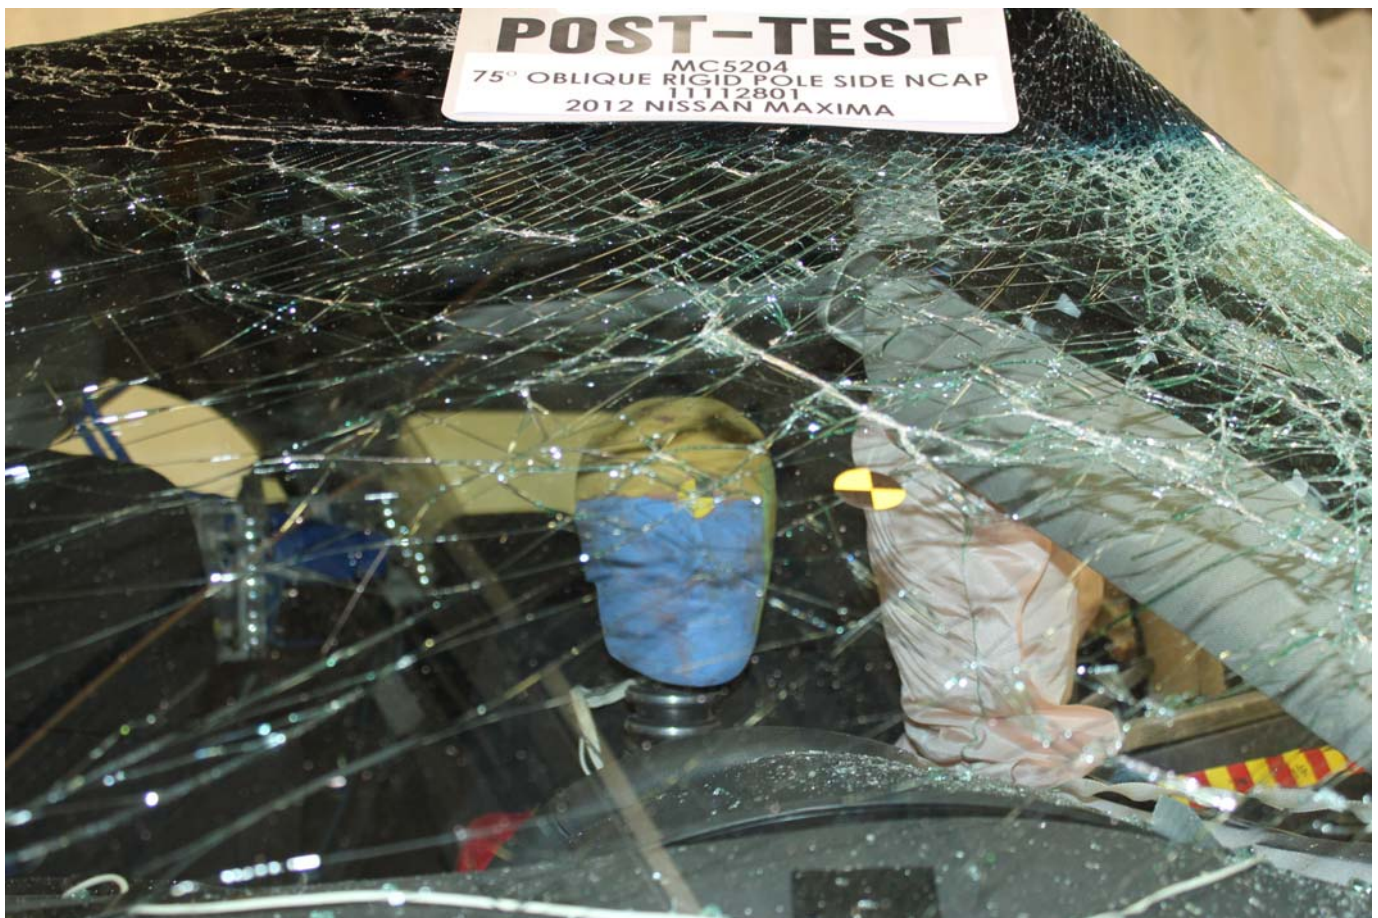
Post-Test Front Close-Up View of Dummy

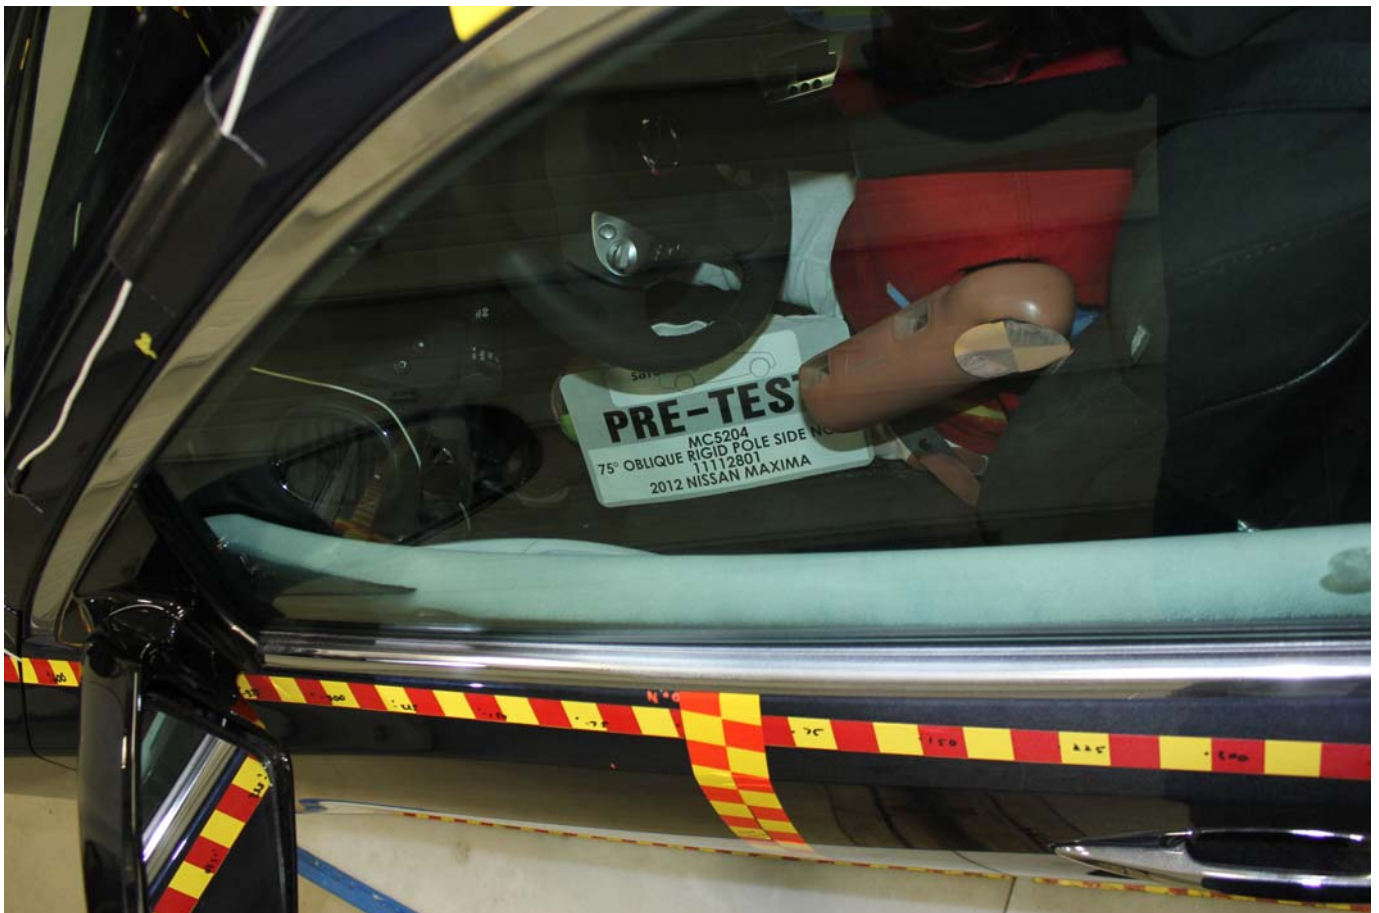
Post-Test Dummy and Door Clearance View

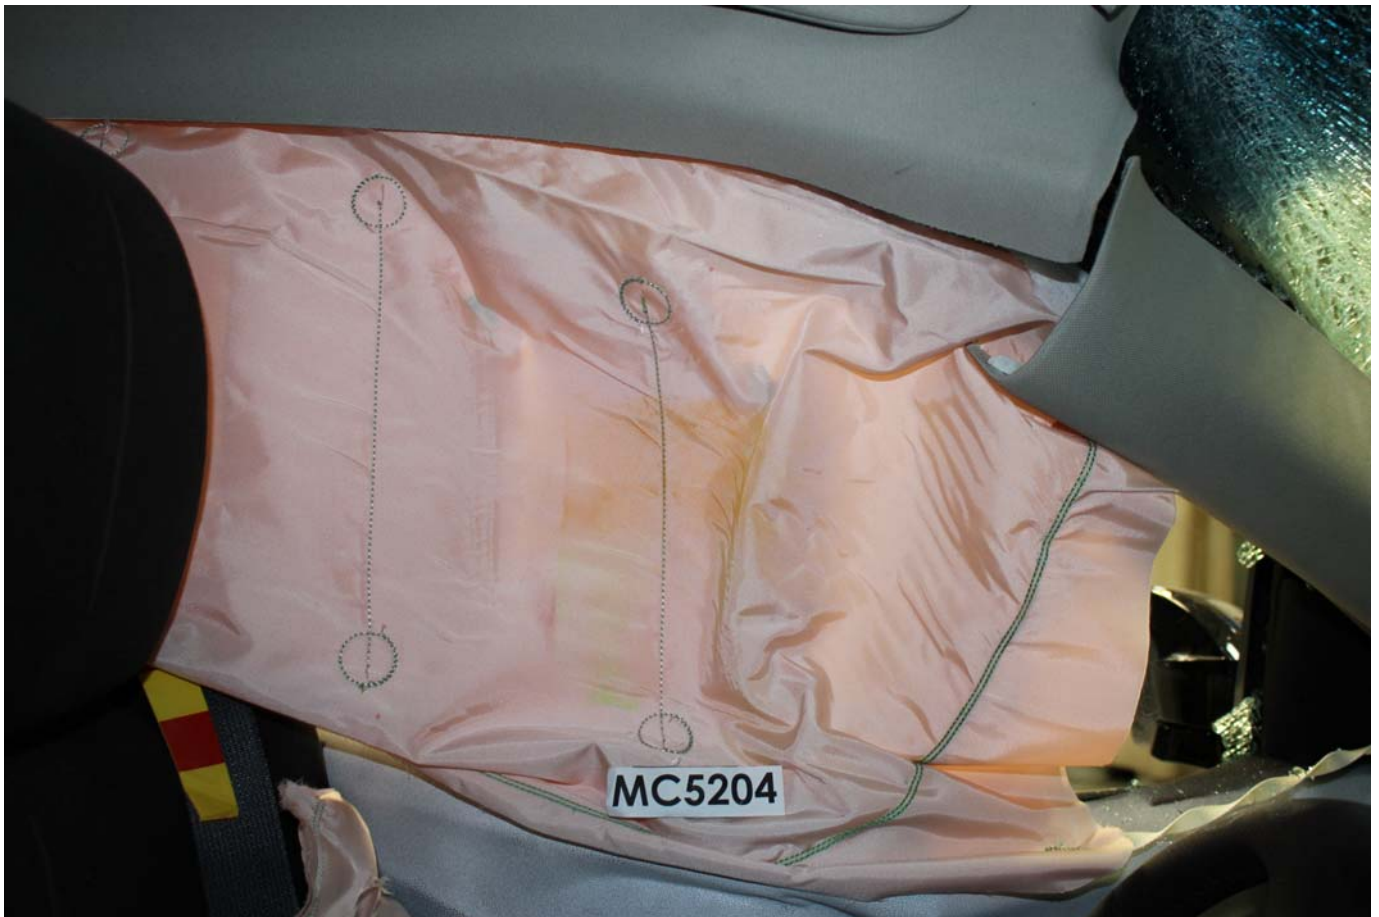
Post-Test Dummy Close-Up Head Contact with Side Air Bag View

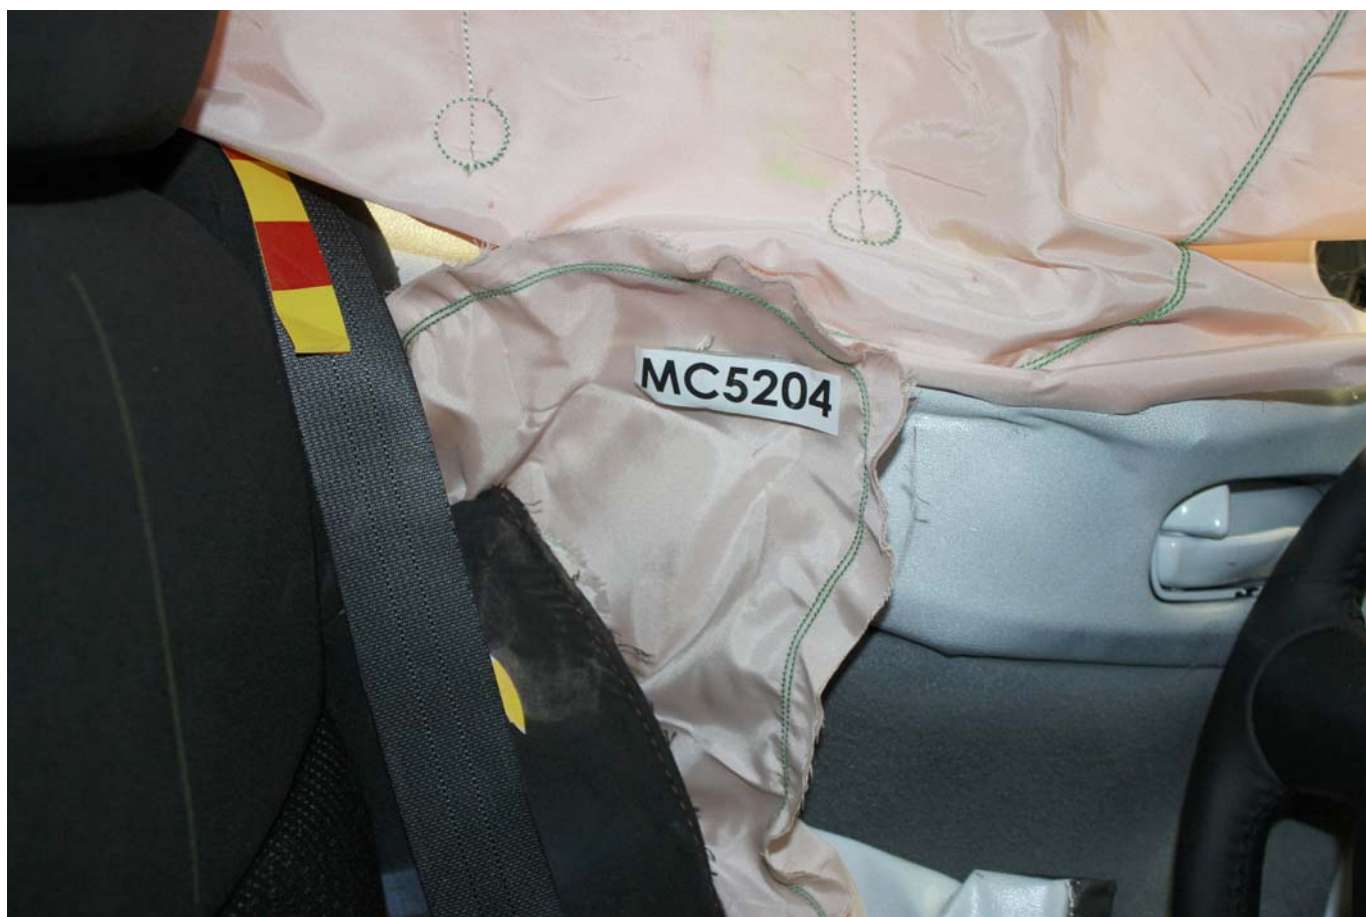
Post-Test Dummy Close-Up Torso Contact with Side Air Bag View

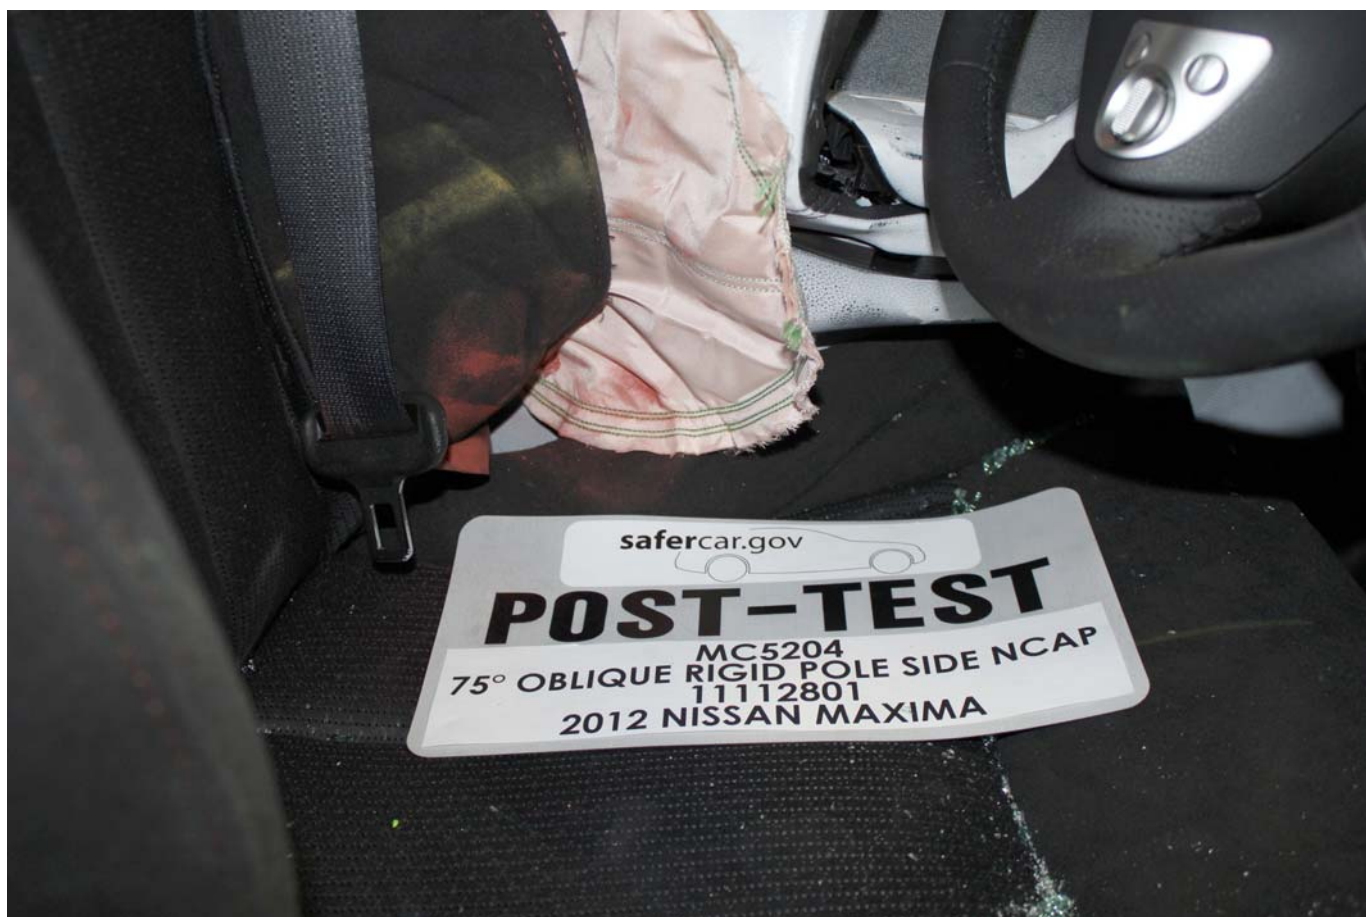
Post-Test Dummy Close-Up Pelvis Contact with Side Air Bag View

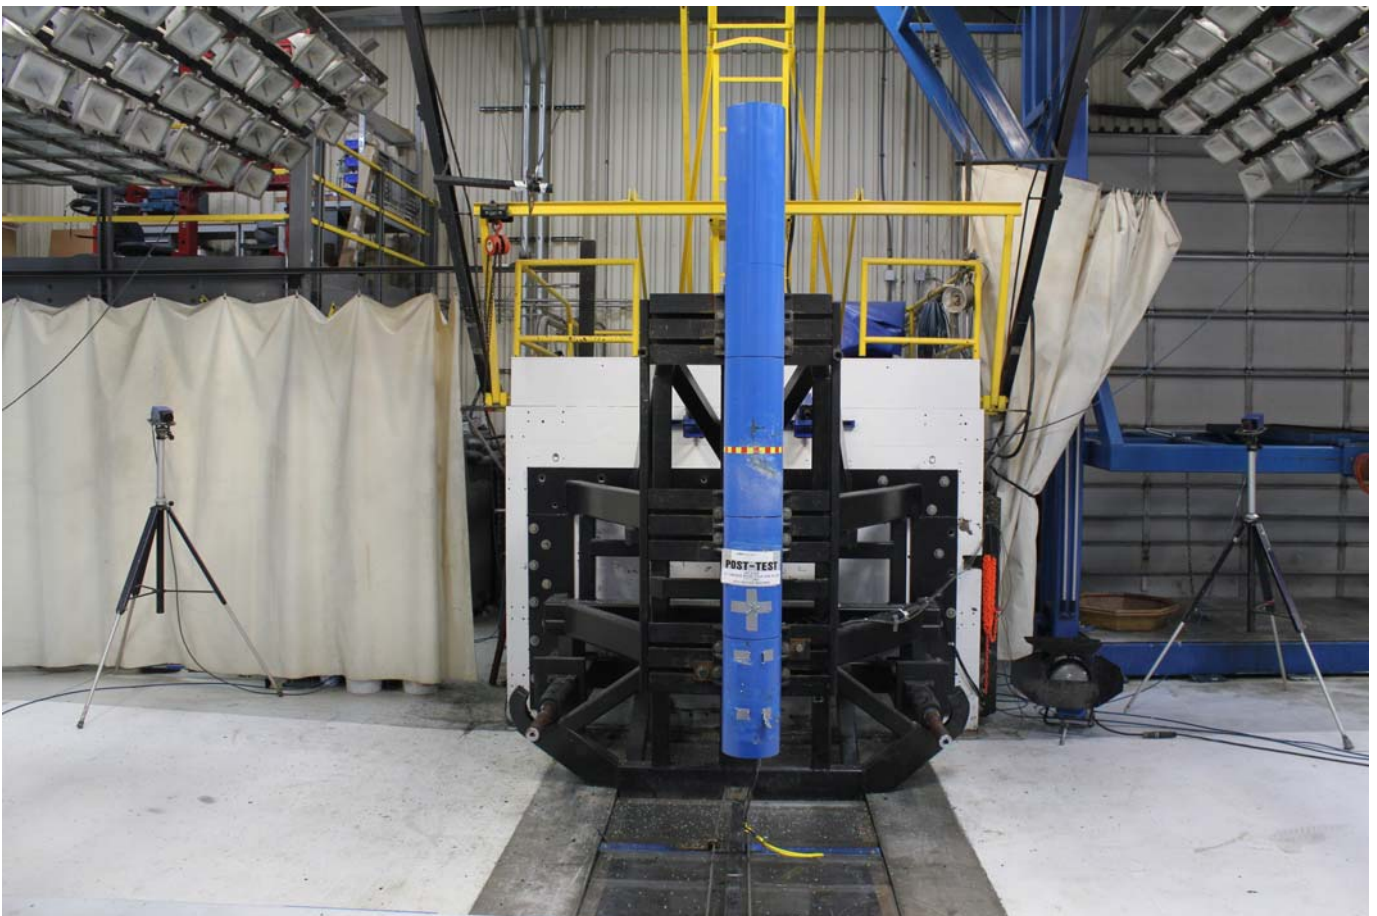
Post-Test Pole Barrier Front View

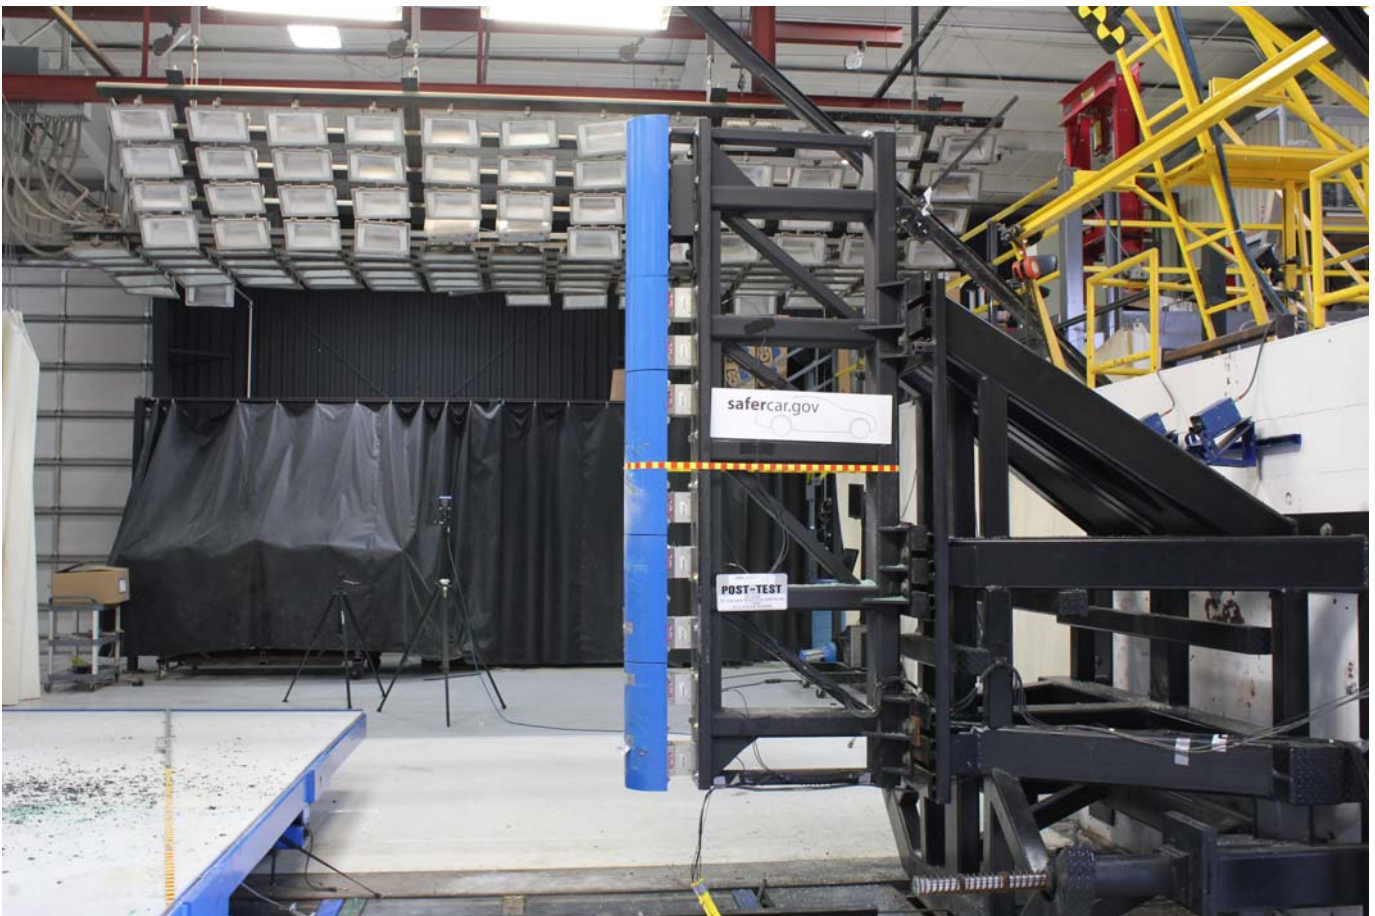
Post-Test Pole Barrier Side View
