REPORT NUMBER: NCAP-MGA-2012-033

**NEW CAR ASSESSMENT PROGRAM (NCAP)
Frontal Barrier Impact Test**

**NISSAN MOTOR CO., LTD.
2012 Nissan Maxima S 4-Dr Sedan
NHTSA No.: MC5202**

**MGA RESEARCH CORPORATION
5000 Warren Road
Burlington, WI 53105**

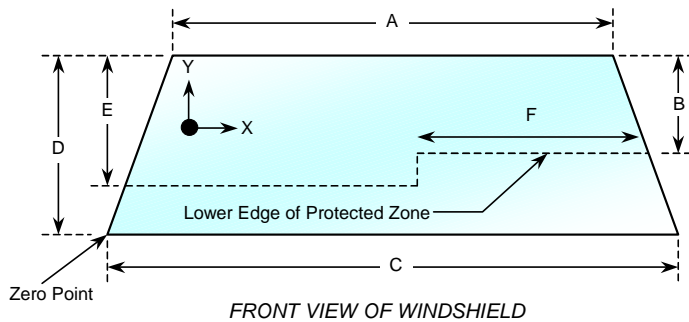
WINDSHIELD PERIPHERY MEASUREMENTS

Measurement	Pre-Test (mm)	Post-Test (mm)	% of Retention
Left Side	2221	2221	100
Right Side	2221	2221	100
Total	4442	4442	100

Item	Units	Value
A	mm	1198
B	mm	492
C	mm	1500
D	mm	872
E	mm	566
F	mm	430

AREA OF PROTECTED ZONE FAILURES - NONE

There was 100 percent windshield retention and no intrusion into the protected zone of the windshield during the event. There was no Stoddard Solvent leakage after the event or during any phase of the static rollover.

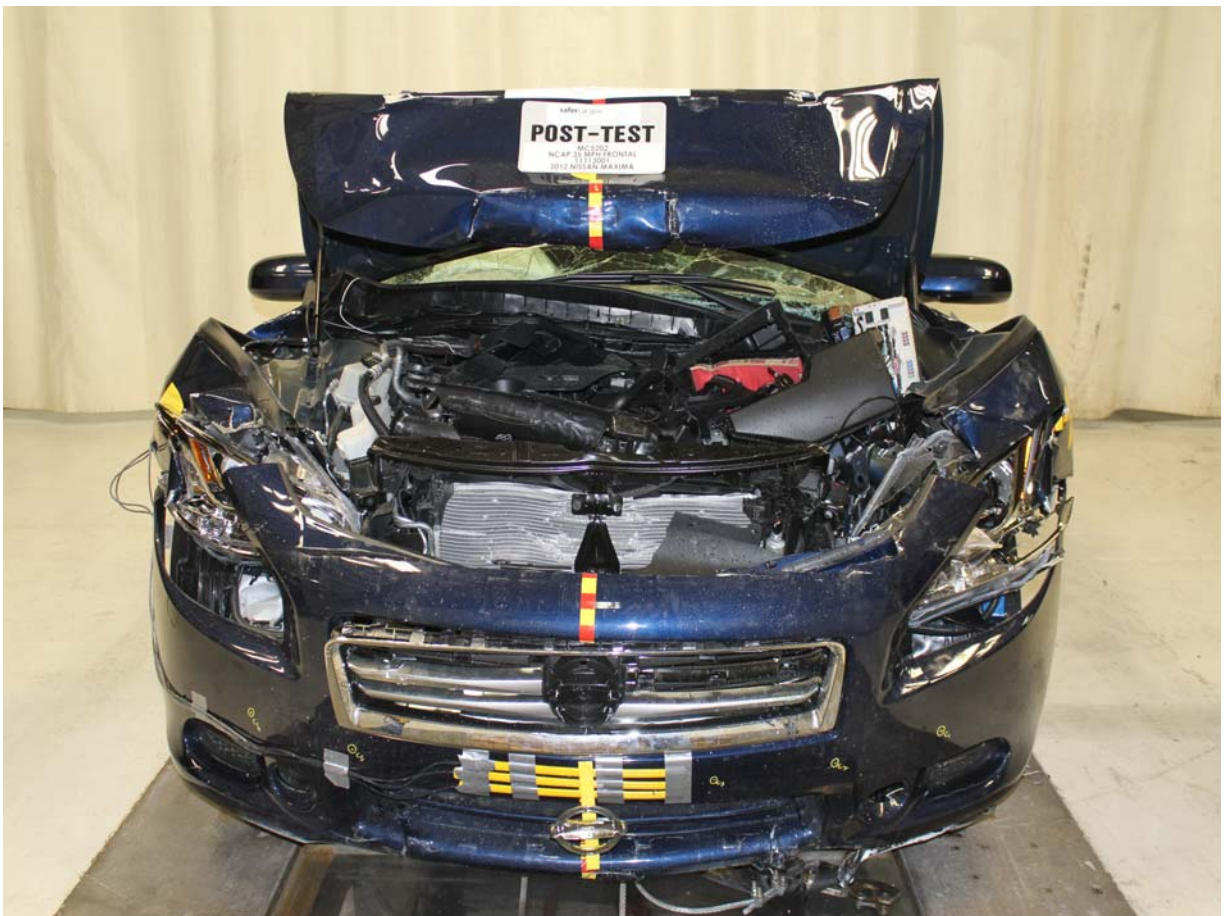
Post-Test Front View of Test Vehicle

The maximum static crush of the vehicle was 432 mm and both the driver and passenger side doors remained closed during the impact event and were operable after the impact.

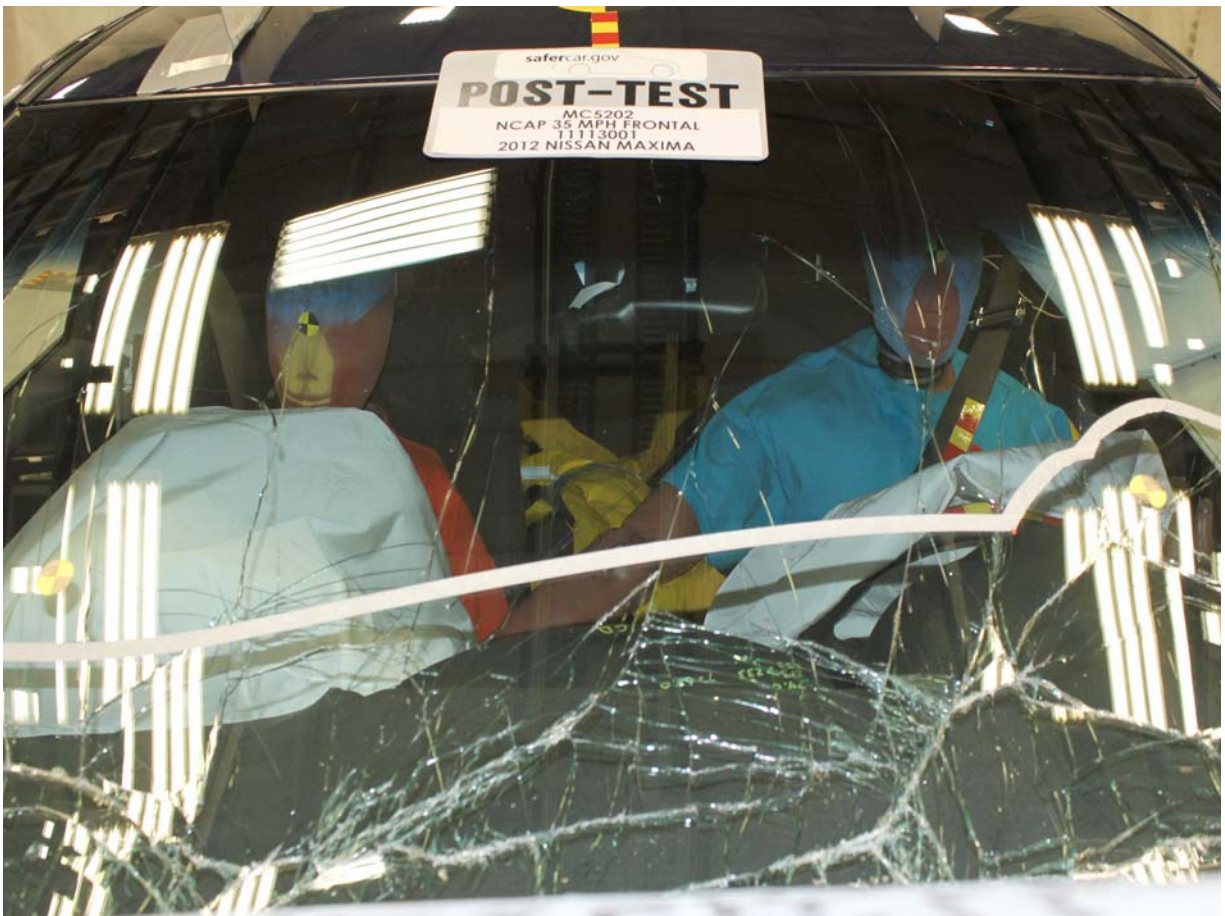
Post-Test Windshield View

Critical Areas of Performance	Observations and Conclusions
Windshield Damage	Cracked
Window Damage	None
Other Notable Effects	None

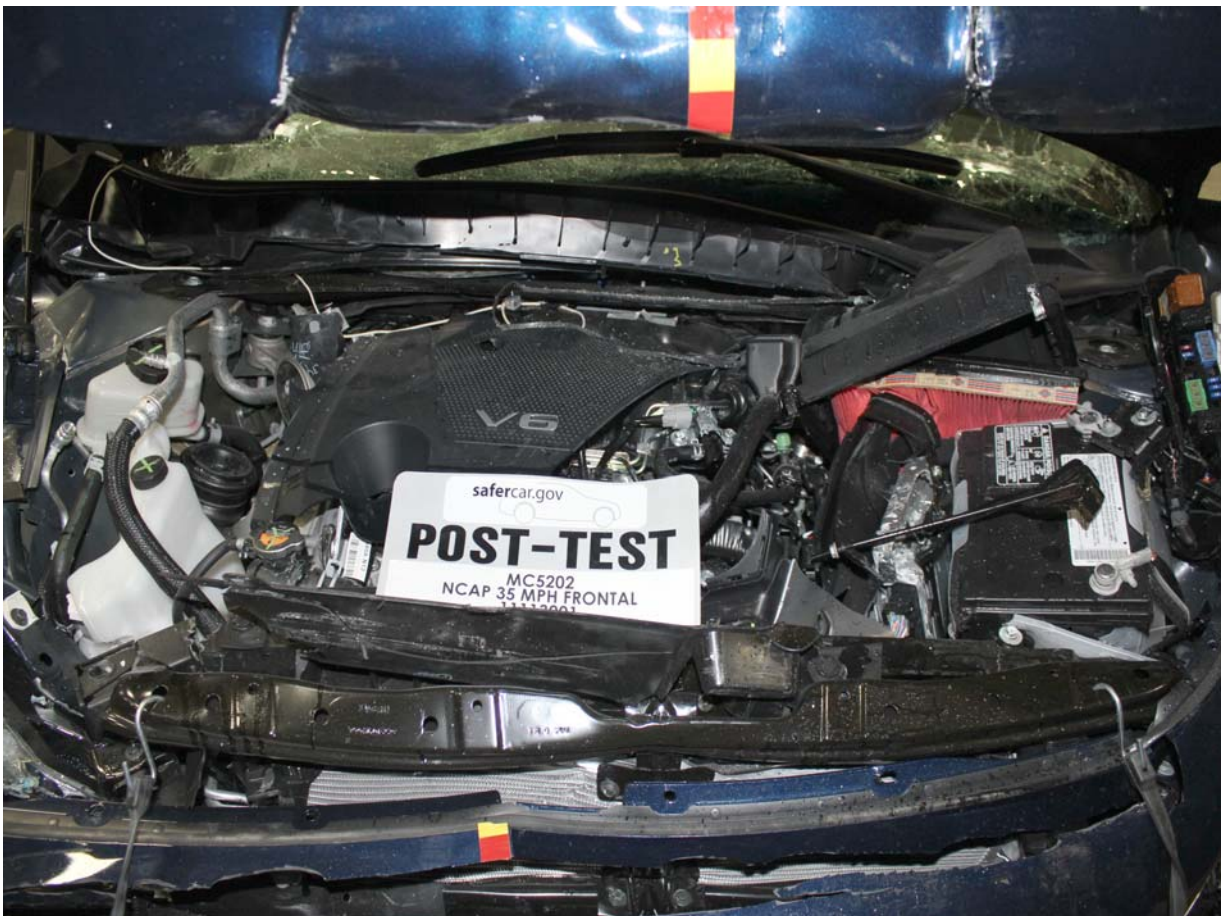
Post-Test Engine Compartment View

Top of Engine X after 37 msec.

Bottom of Engine X after 41 msec.

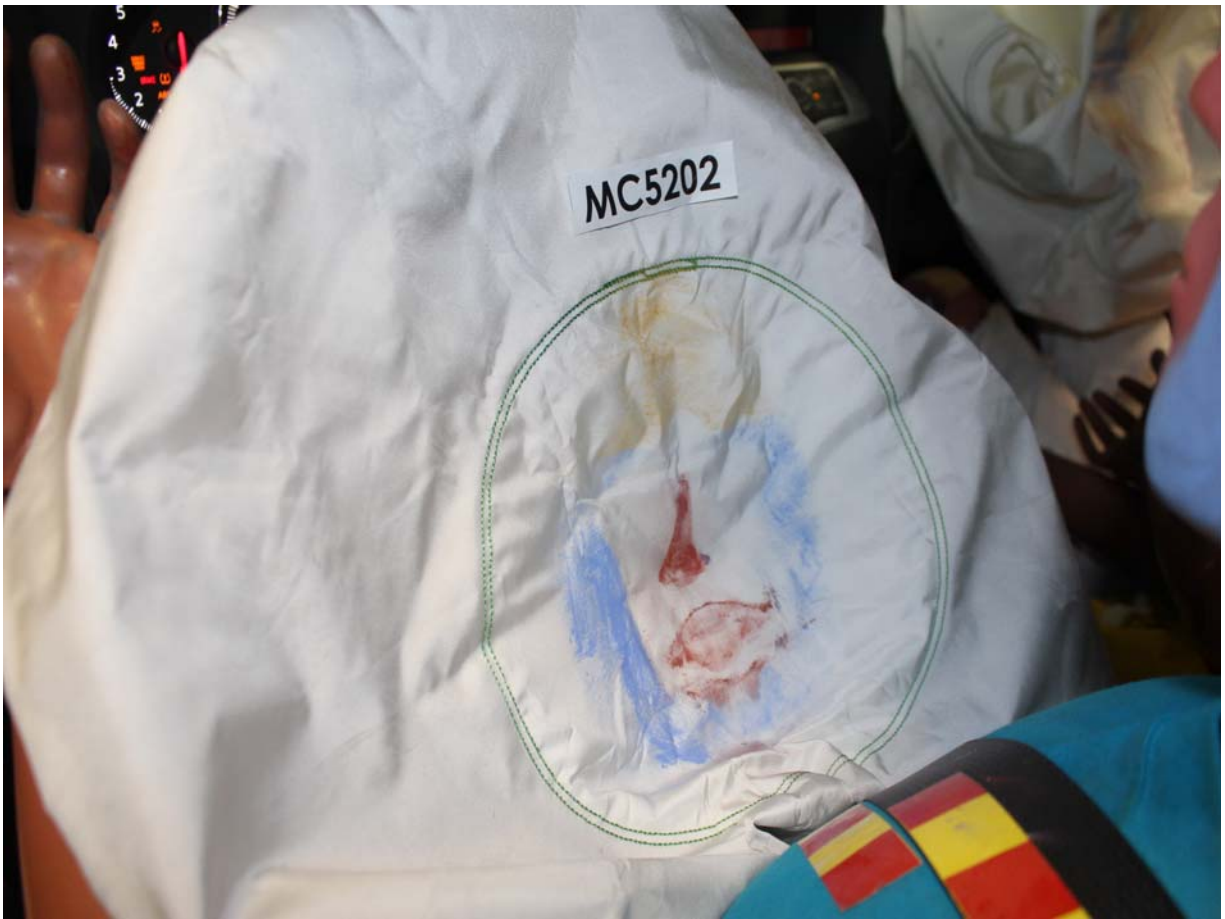
Post-Test Driver Dummy Contact with Airbag

The driver's visible contact points were as follows: The driver's head and chest contacted the airbag. The driver's head also contacted the headrest. The driver's knees contacted the knee bolster. The passenger's visible contact points were as follows: The passenger's head and chest contacted the airbag. The passenger's head also contacted the headrest. The passenger's knees contacted the glovebox.

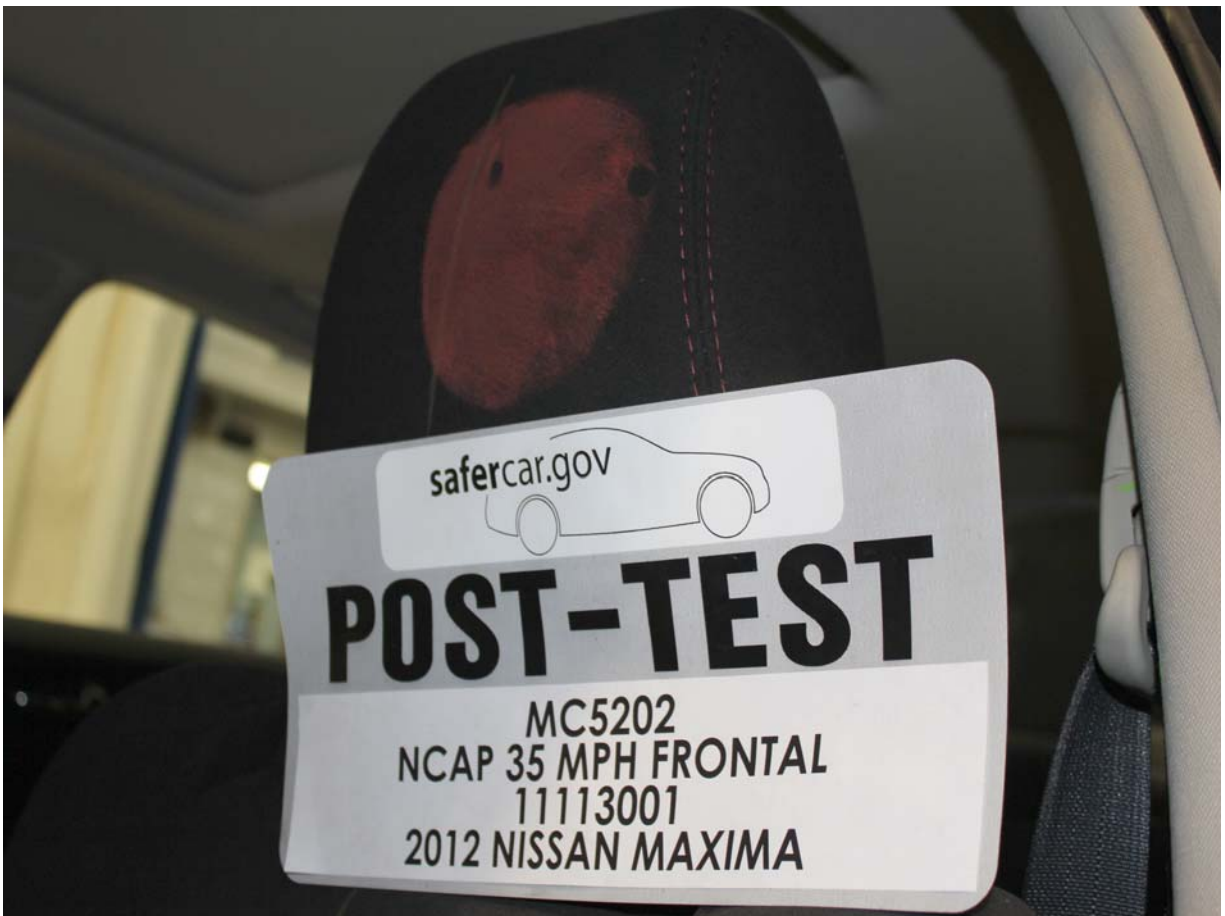
Post-Test Driver Dummy Contact with Headrest

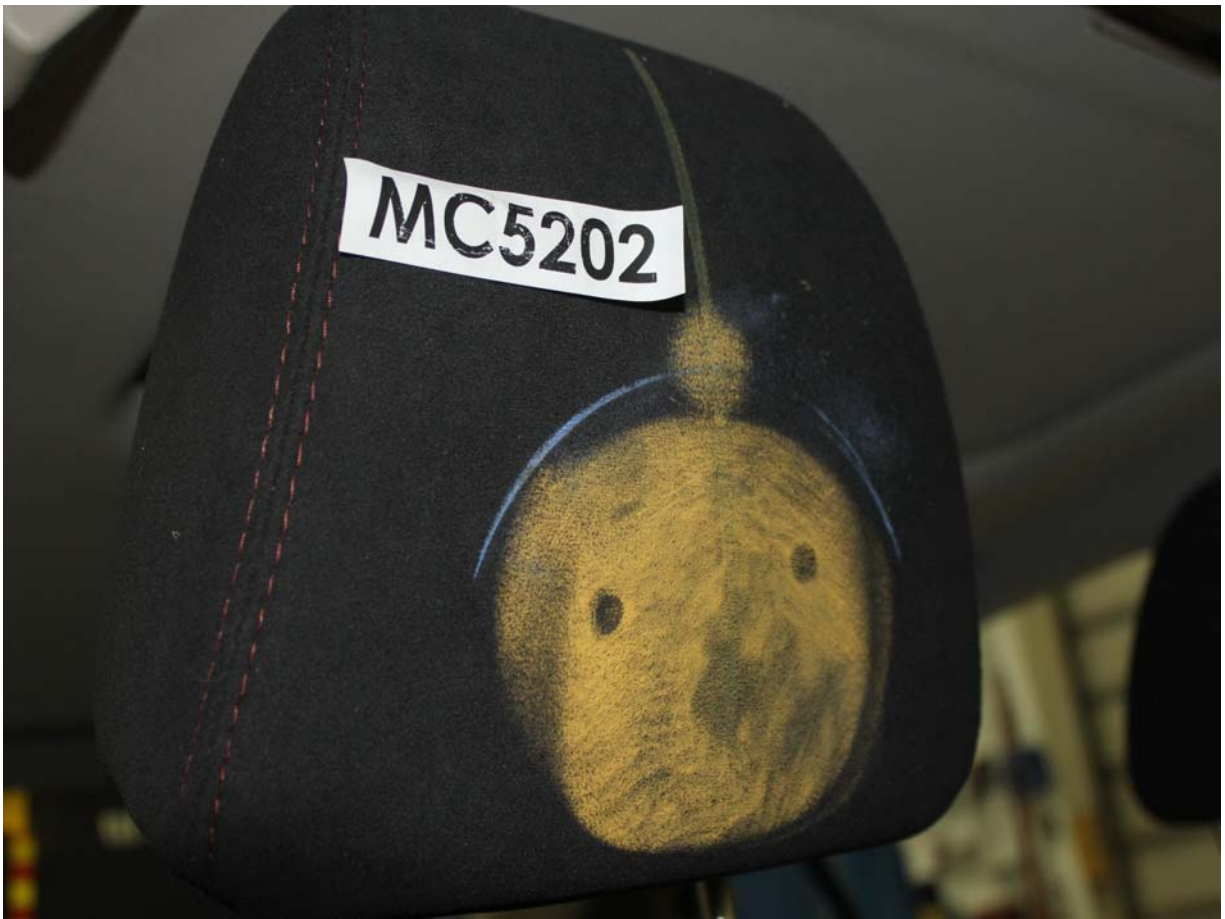
Post-Test Passenger Dummy Contact with Headrest

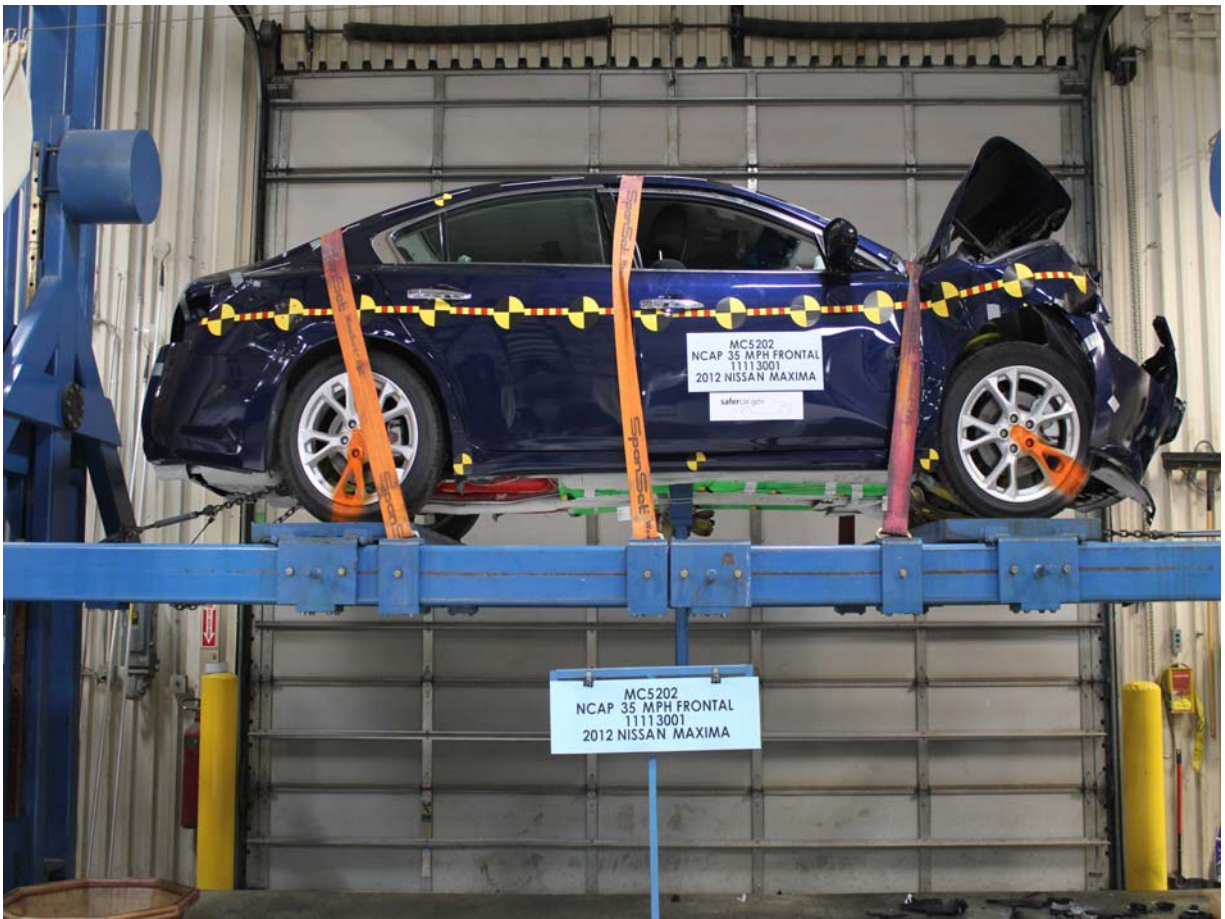
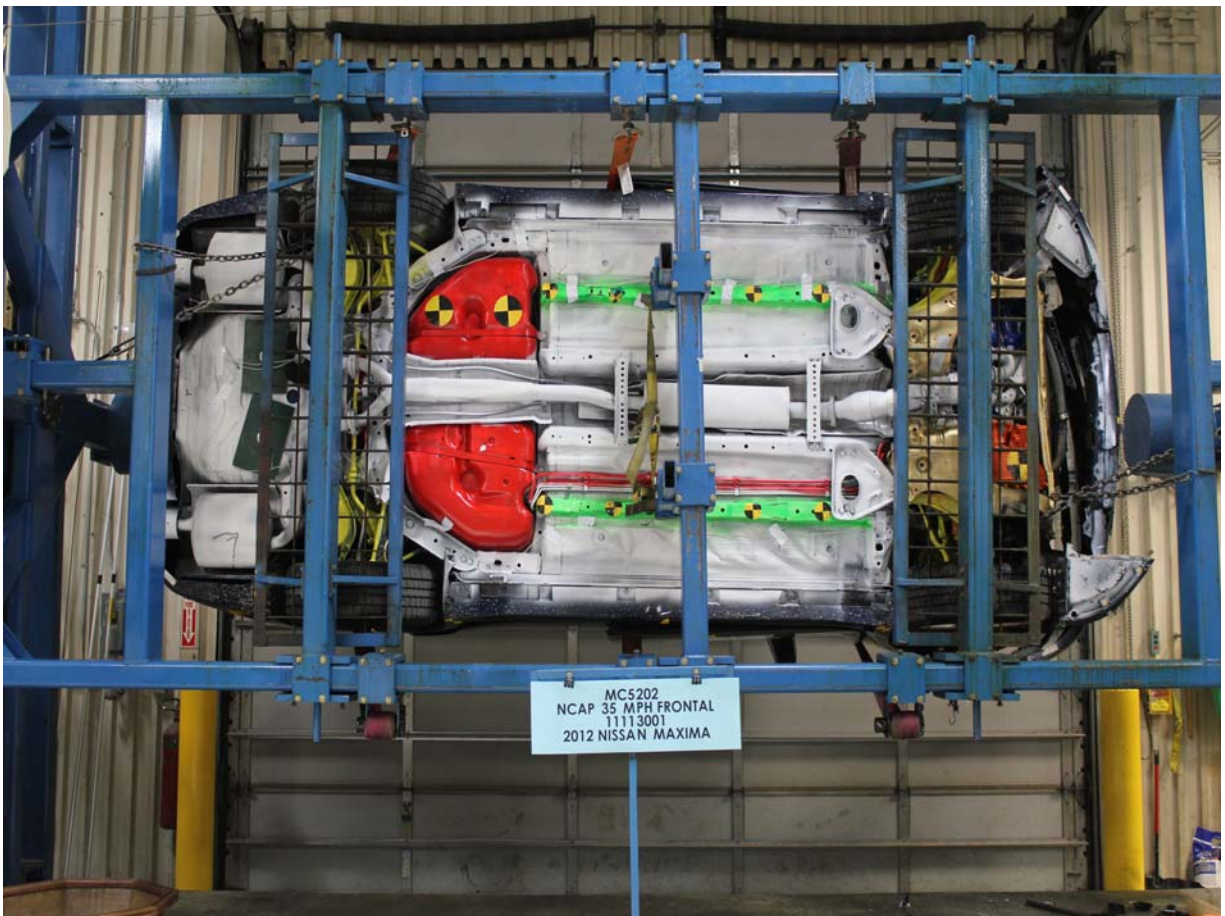
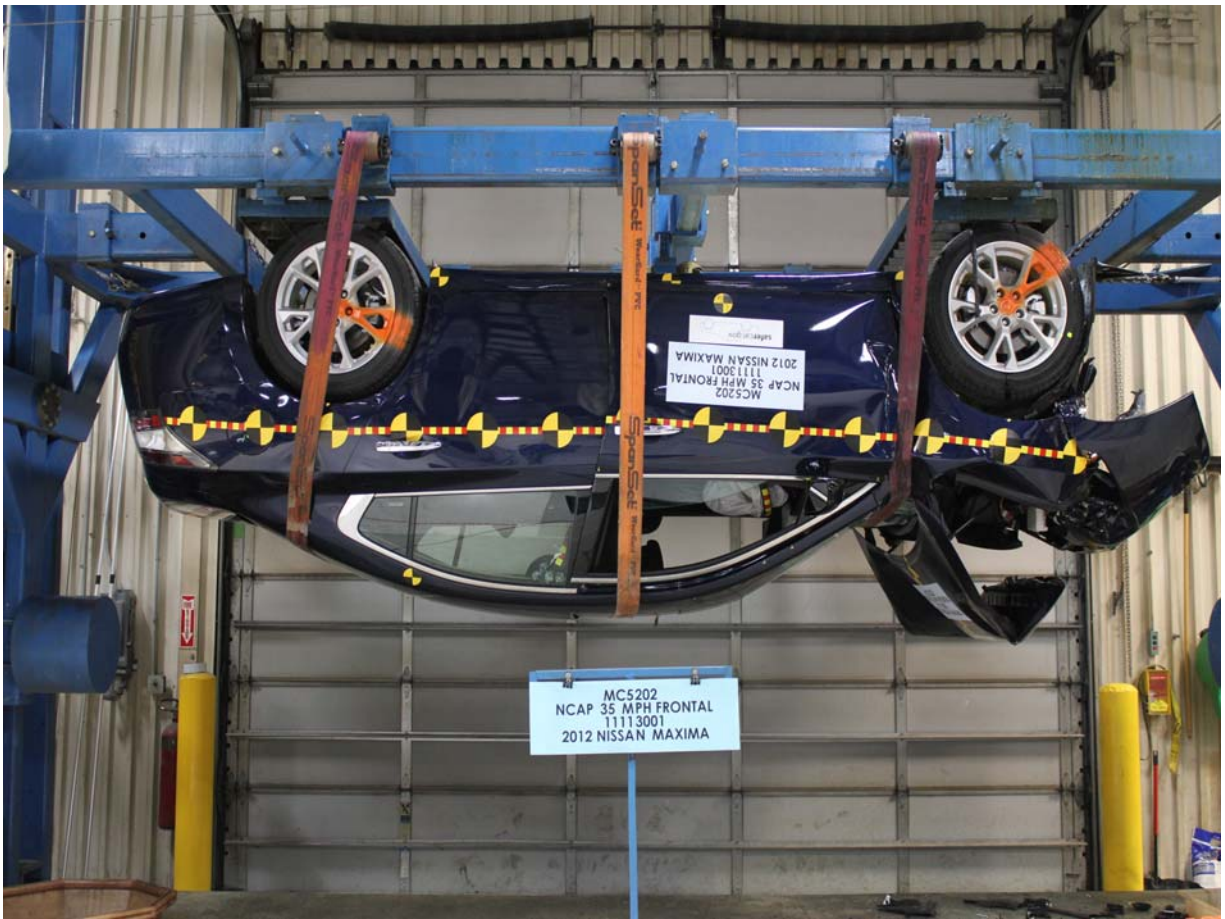
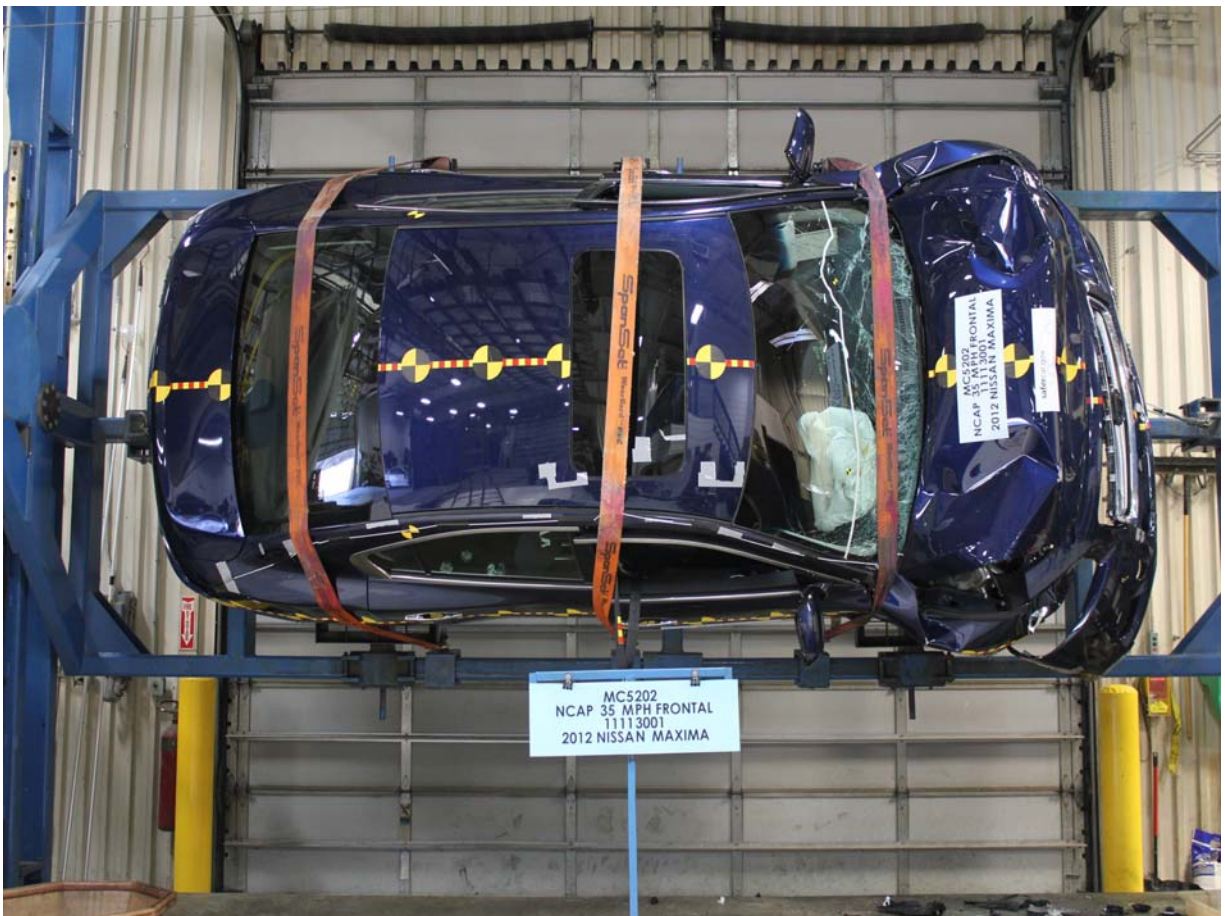
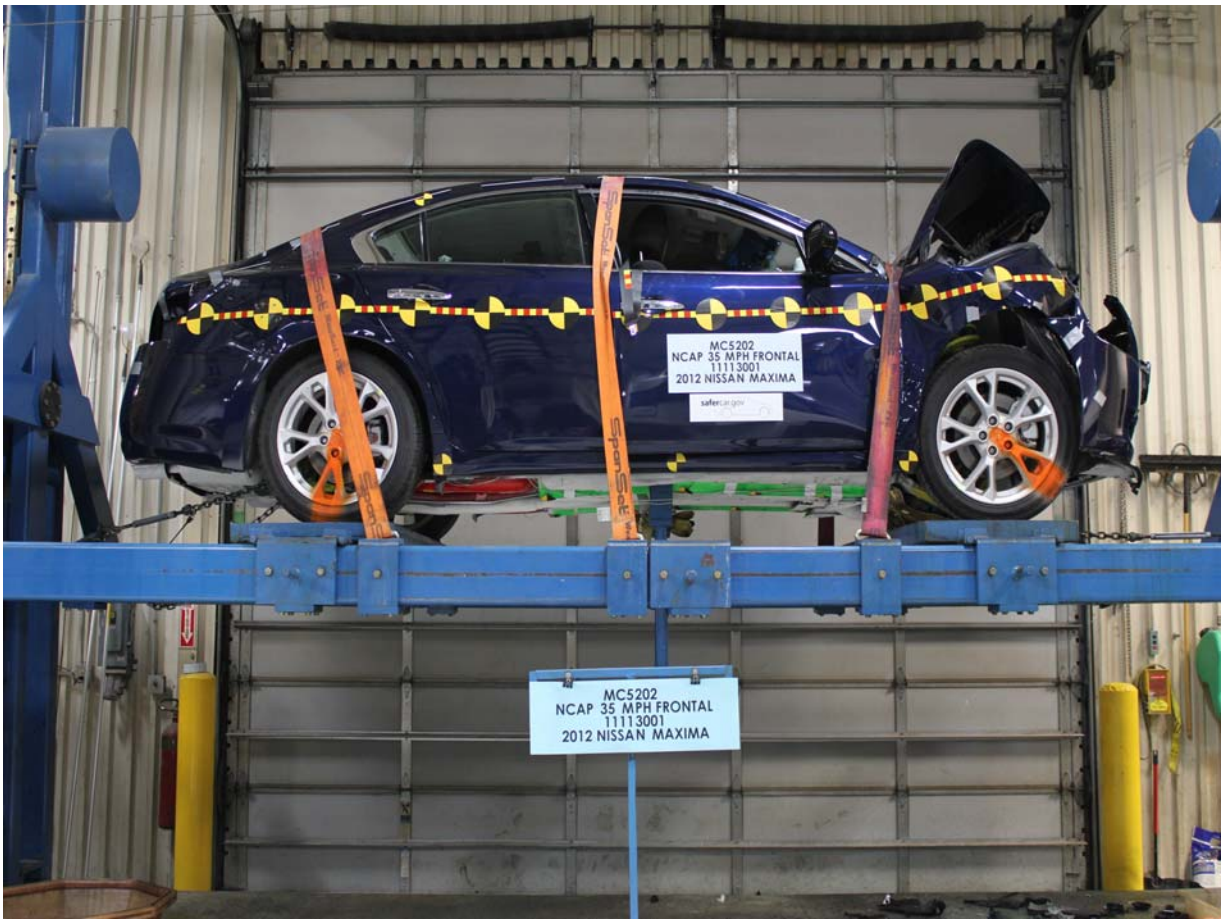
Vehicle at 0 Degrees on Static Rollover Device

Vehicle at 90 Degrees on Static Rollover Device

Vehicle at 180 Degrees on Static Rollover Device

Vehicle at 270 Degrees on Static Rollover Device

Vehicle at 360 Degrees on Static Rollover Device

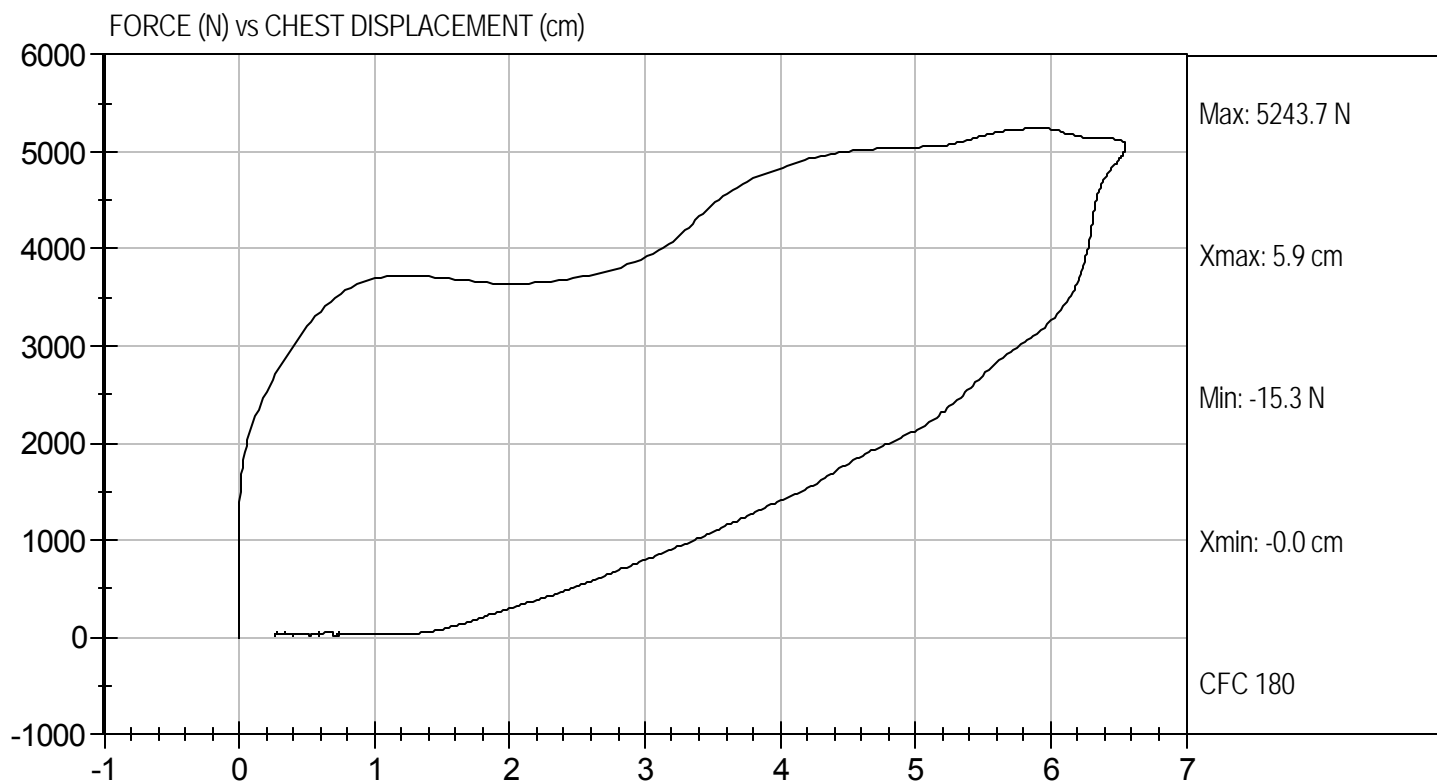
Test Desc: Thorax Impact
Component ID: D113914

Test Date: 11/22/11
Velocity: 22.22 ft/s, 6.77 m/s

Tested Parameter	Units	Specification	Result	Pass/Fail
Laboratory Temperature	deg C	20.6 to 22.2	21.4	Pass
Laboratory Relative Humidity	%	10 to 70	29	Pass
Probe Velocity	m/s	6.58 to 6.82	6.77	Pass
Peak Probe Force	N	5159 to 5893	5,244	Pass
Peak Sternum Displacement	cm	6.35 to 7.26	6.55	Pass
Internal Hysteresis	%	69 to 85	70	Pass
Overall Test Results				Pass

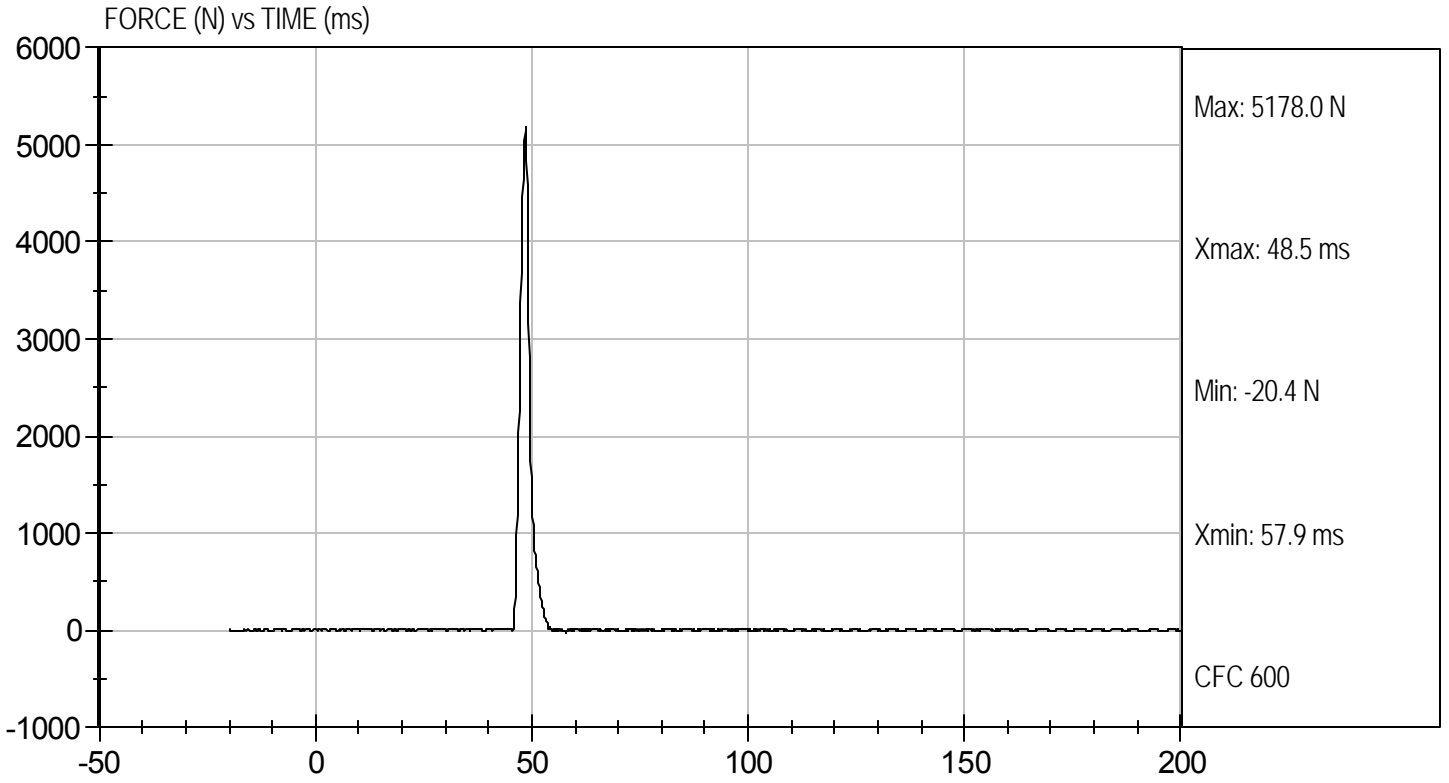
Test Desc: Right Knee
Component ID: D113915

Test Date: 11/22/11
Velocity: 6.97 ft/s, 2.12 m/s

Tested Parameter	Units	Specification	Result	Pass/Fail
Laboratory Temperature	deg C	18.9 to 25.5	21.9	Pass
Laboratory Relative Humidity	%	10 to 70	30	Pass
Probe Velocity	m/s	2.07 to 2.13	2.12	Pass
Peak Probe Force	Newtons	4715 to 5782	5,178	Pass
Overall Test Results				Pass

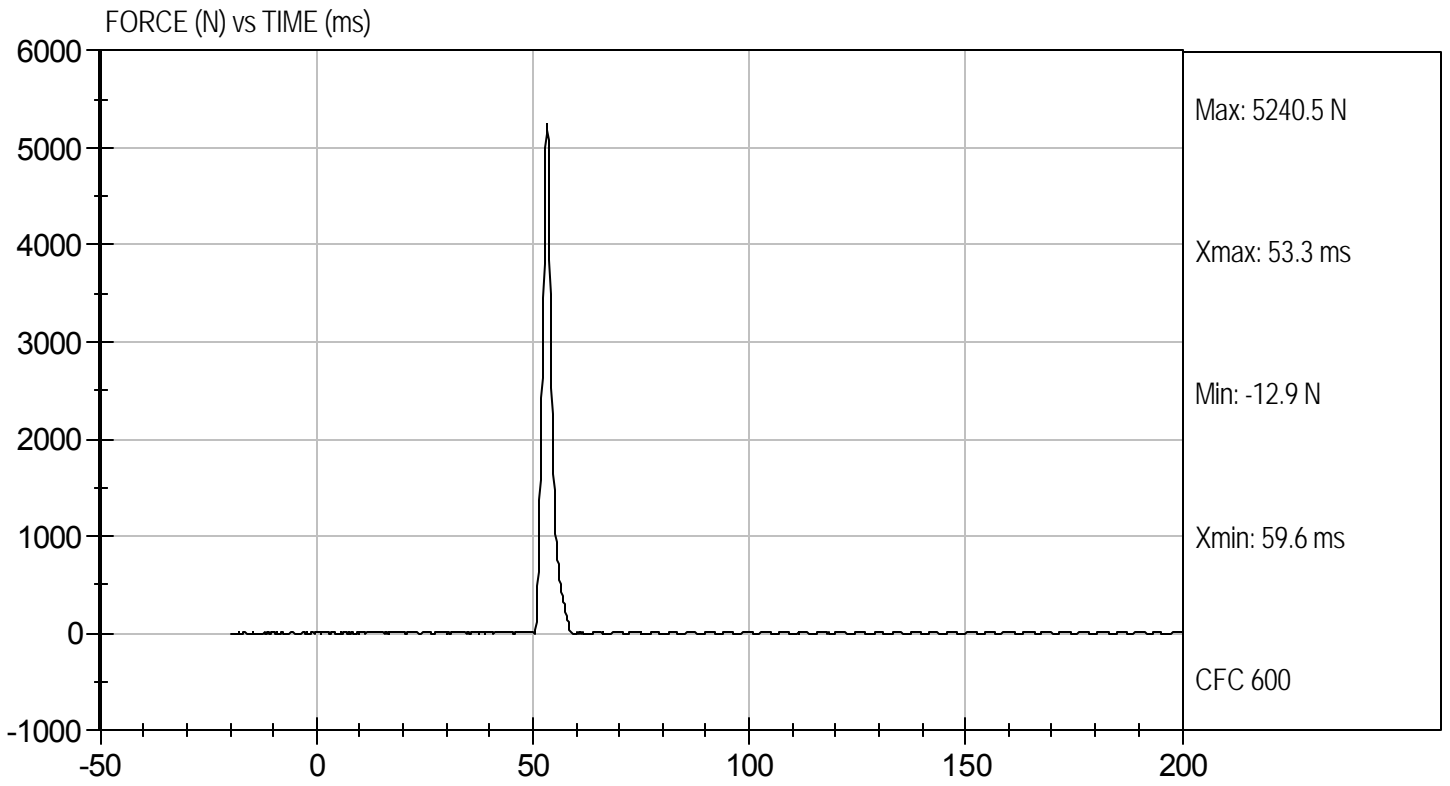
Test Desc: Left Knee
Component ID: D113916

Test Date: 11/22/11
Velocity: 6.97 ft/s, 2.12 m/s

Tested Parameter	Units	Specification	Result	Pass/Fail
Laboratory Temperature	deg C	18.9 to 25.5	21.9	Pass
Laboratory Relative Humidity	%	10 to 70	30	Pass
Probe Velocity	m/s	2.07 to 2.13	2.12	Pass
Peak Probe Force	Newtons	4715 to 5782	5,240	Pass
Overall Test Results				Pass

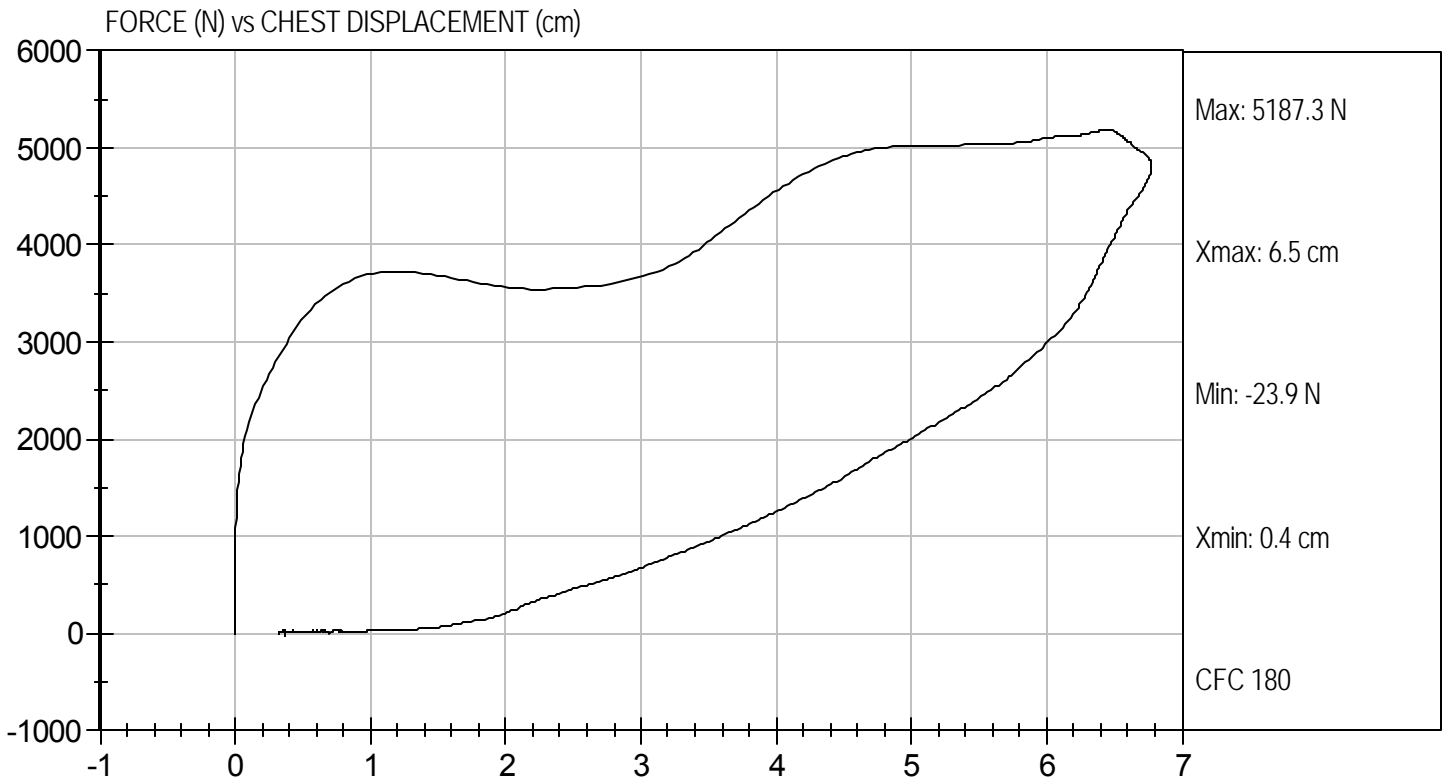
Test Desc: Thorax Impact
Component ID: D114014

Test Date: 12/1/11
Velocity: 22.2 ft/s, 6.77 m/s

Tested Parameter	Units	Specification	Result	Pass/Fail
Laboratory Temperature	deg C	20.6 to 22.2	21.1	Pass
Laboratory Relative Humidity	%	10 to 70	20	Pass
Probe Velocity	m/s	6.58 to 6.82	6.77	Pass
Peak Probe Force	N	5159 to 5893	5,187	Pass
Peak Sternum Displacement	cm	6.35 to 7.26	6.78	Pass
Internal Hysteresis	%	69 to 85	70	Pass
Overall Test Results				Pass

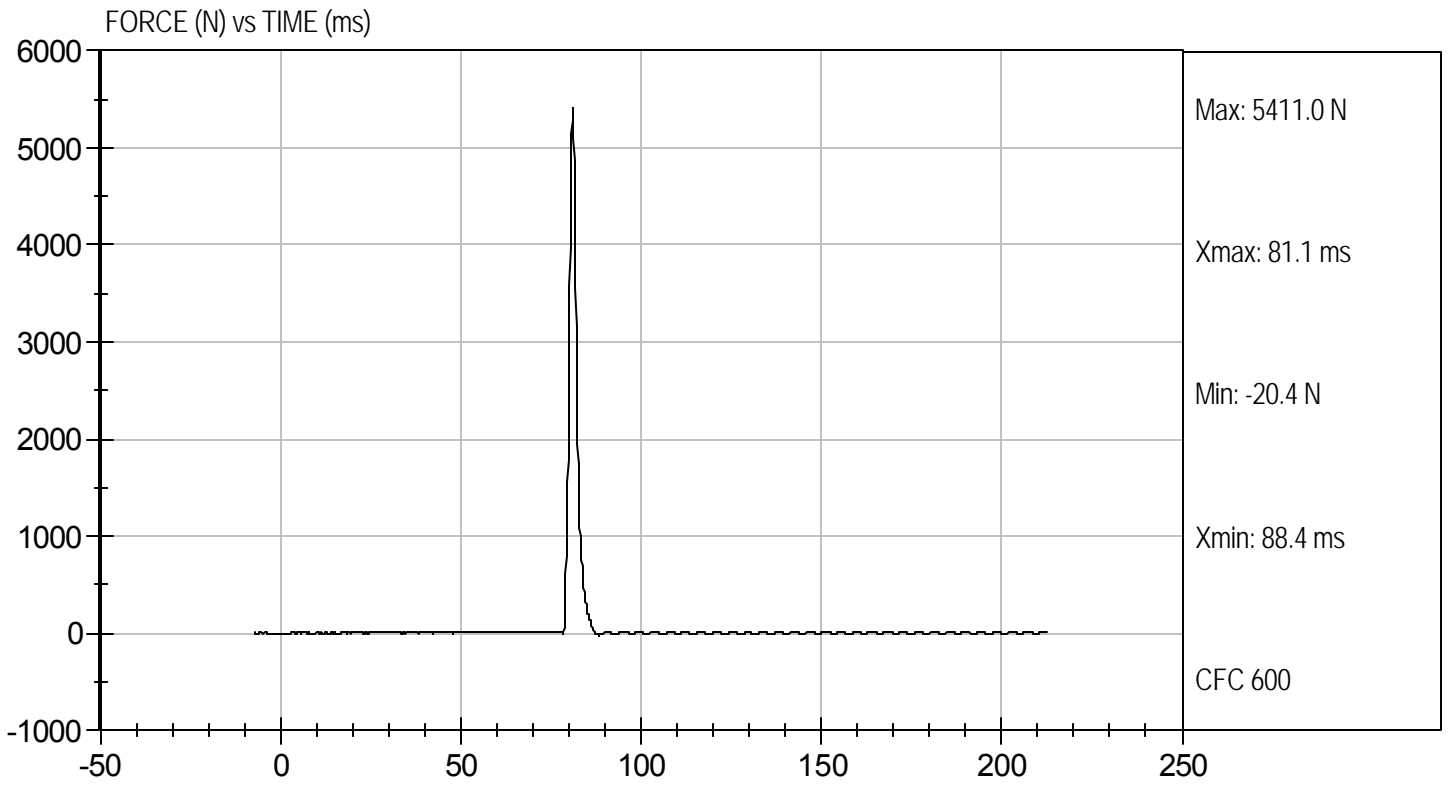
Test Desc: Right Knee
Component ID: D114015

Test Date: 11/30/11
Velocity: 6.97 ft/s, 2.12 m/s

Tested Parameter	Units	Specification	Result	Pass/Fail
Laboratory Temperature	deg C	18.9 to 25.5	21.5	Pass
Laboratory Relative Humidity	%	10 to 70	17	Pass
Probe Velocity	m/s	2.07 to 2.13	2.12	Pass
Peak Probe Force	Newtons	4715 to 5782	5,411	Pass
Overall Test Results				Pass

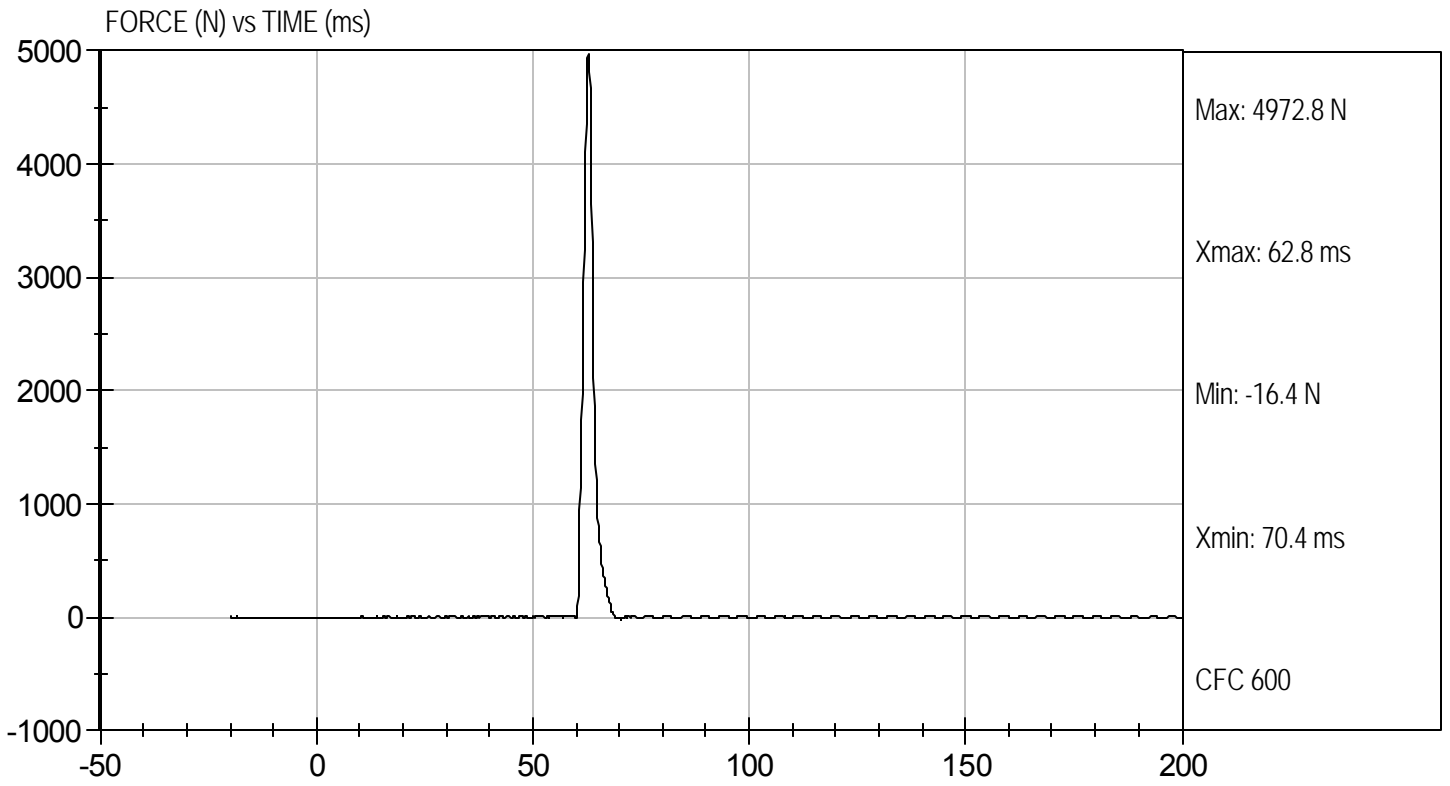
Test Desc: Left Knee
Component ID: D114016

Test Date: 11/30/11
Velocity: 6.97 ft/s, 2.12 m/s

Tested Parameter	Units	Specification	Result	Pass/Fail
Laboratory Temperature	deg C	18.9 to 25.5	21.5	Pass
Laboratory Relative Humidity	%	10 to 70	17	Pass
Probe Velocity	m/s	2.07 to 2.13	2.12	Pass
Peak Probe Force	Newtons	4715 to 5782	4,973	Pass
Overall Test Results				Pass
