REPORT NUMBER: SPNCAP-CAL-12-015

**NEW CAR ASSESSMENT PROGRAM (NCAP)
SIDE IMPACT POLE TEST**

**CHRYSLER GROUP LLC
2012 Jeep Liberty Sport 4x2
Utility Vehicle**

FINAL REPORT

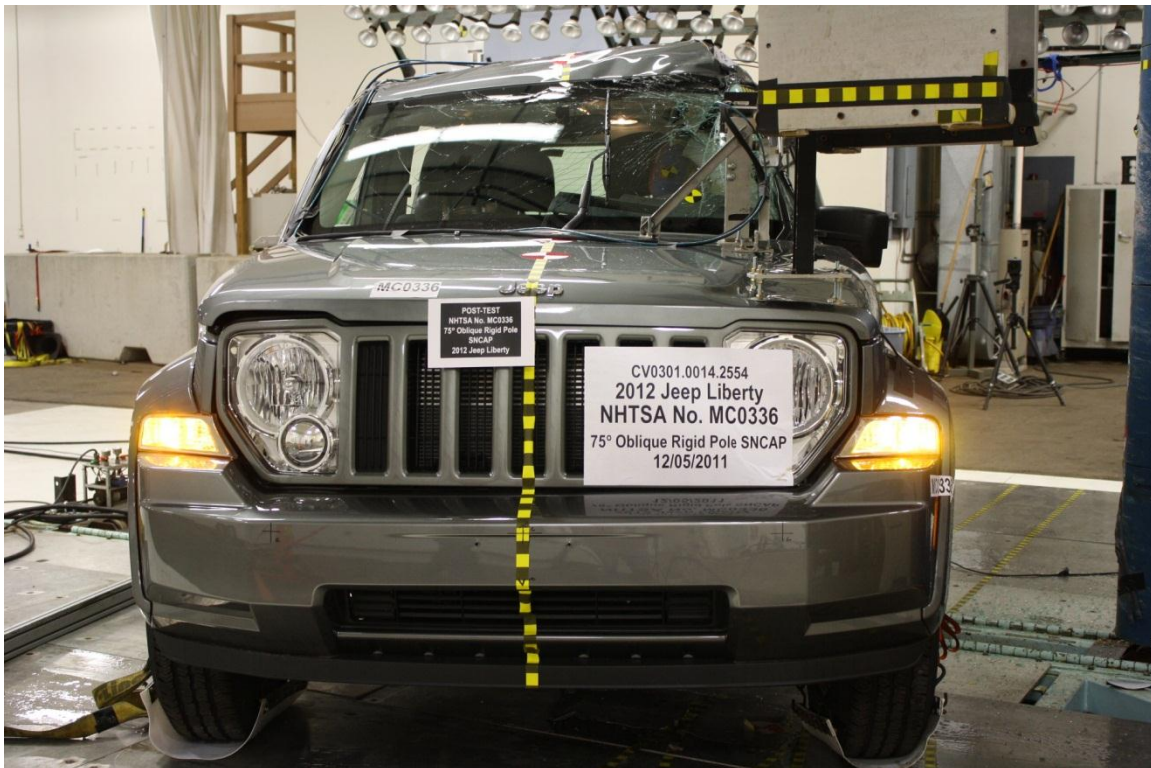
Figure A-4: Post-Test Frontal View of Test Vehicle

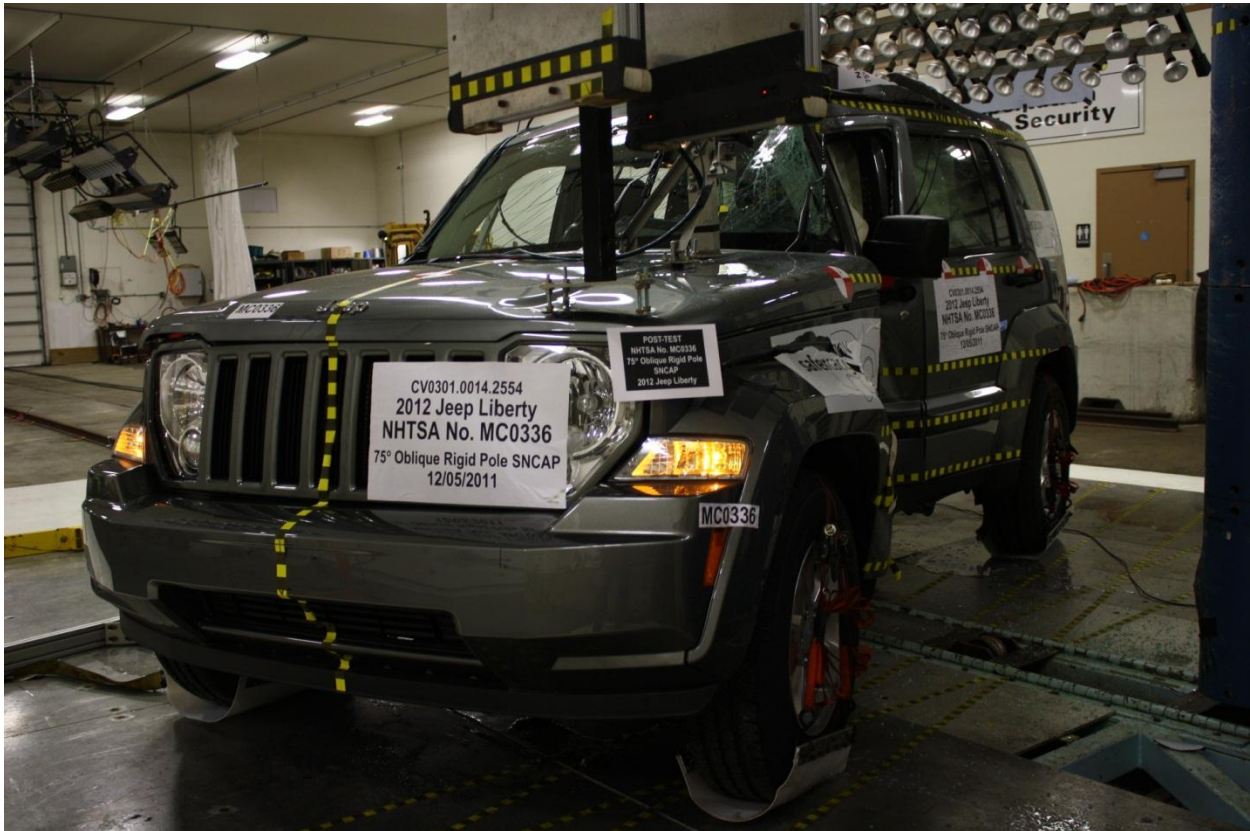
Figure A-6: Post-Test Left Front ¾ View Test Vehicle

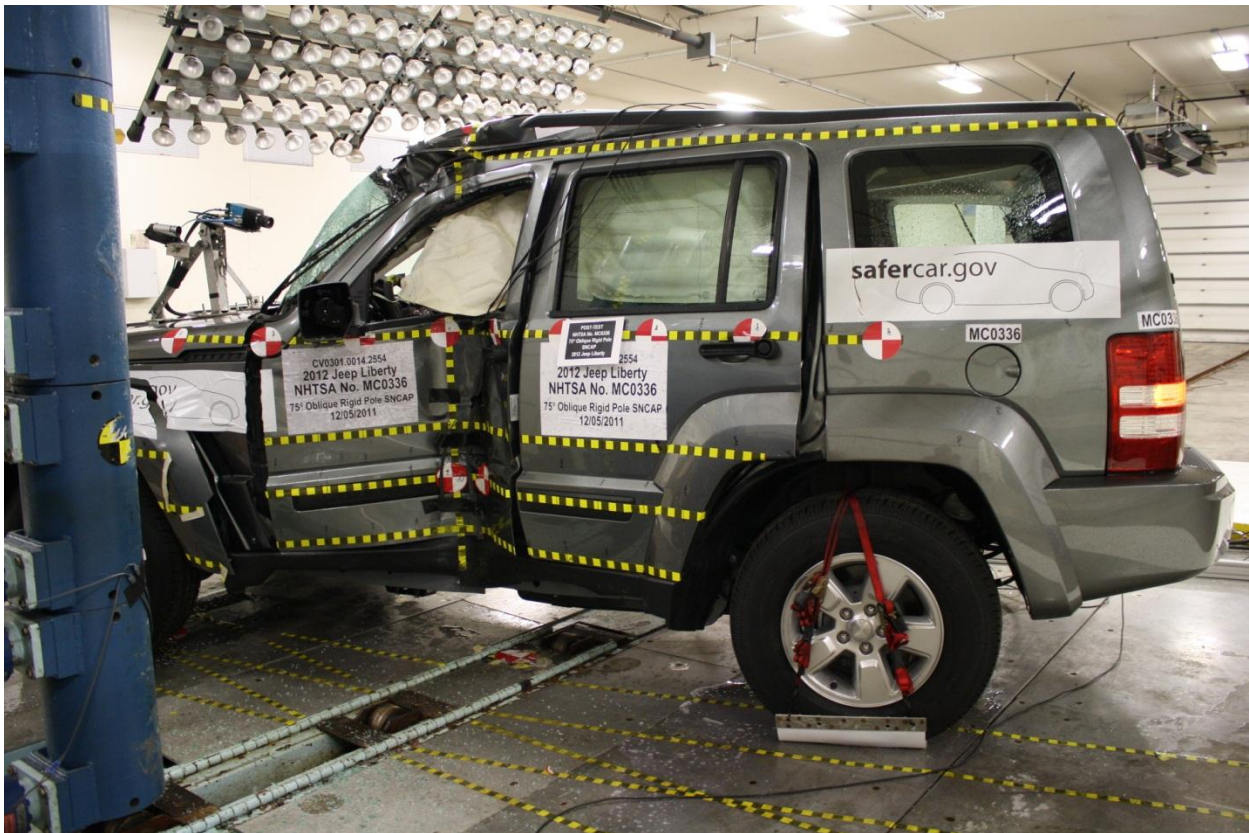
Figure A-8: Post-Test Left Side View of Test Vehicle

Critical Areas of Performance	Observations and Conclusions
Pillar Performance	Slight deformation along the A-Pillar
Sill Separation	None
Windshield Damage	Glass cracked along Driver's A-Pillar causing some separation between the windshield and vehicle
Side Window Damage	Driver's side window shattered during impact
Other Notable Effects	None

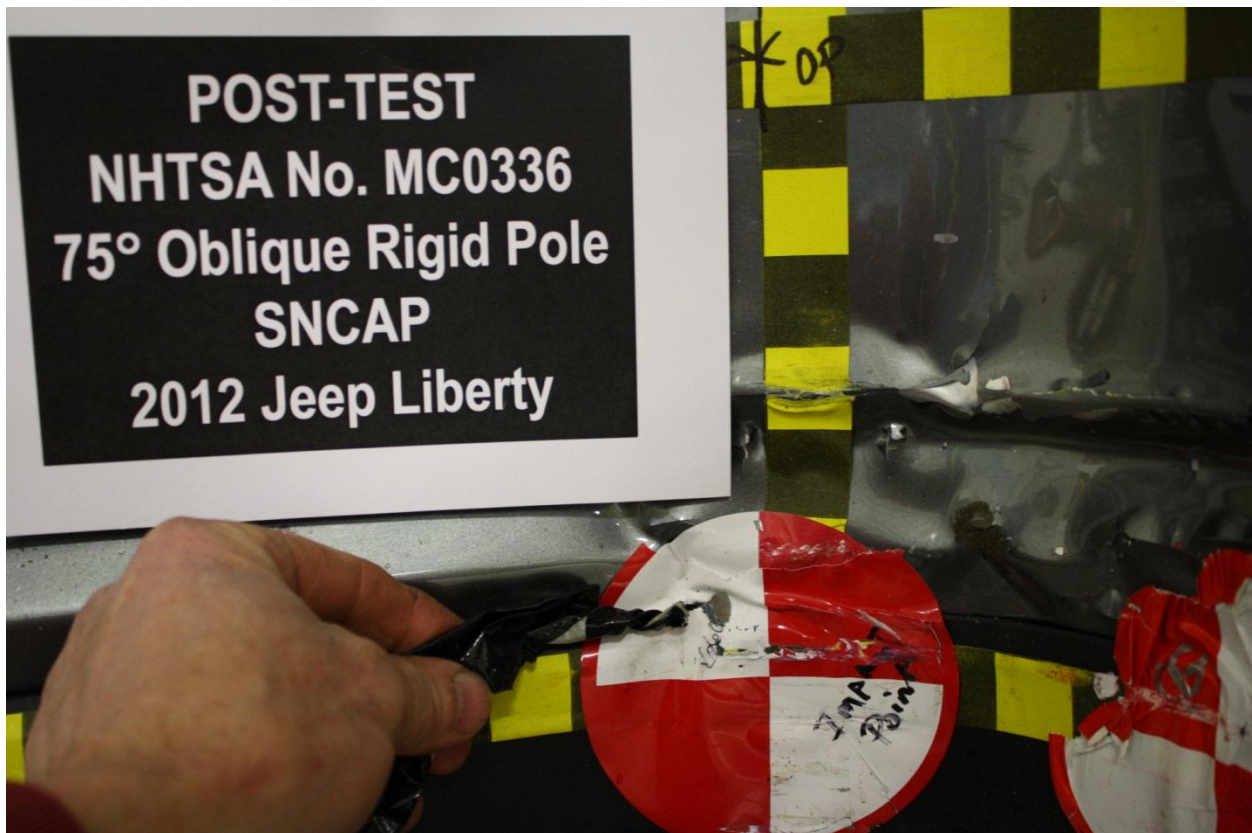
Figure A-20: Post-Test Close-Up View of Impact Point Target Showing Impact Location

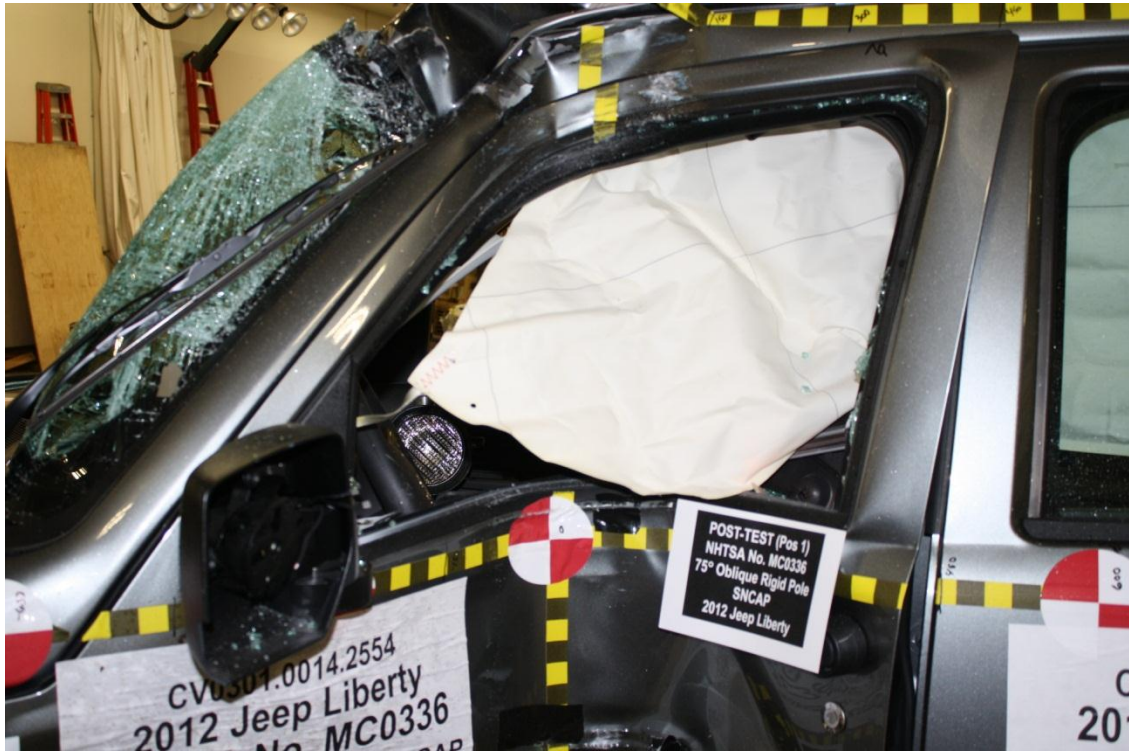
Figure A-25: Post-Test Left Side View of Dummy Shoulder and Door Top View

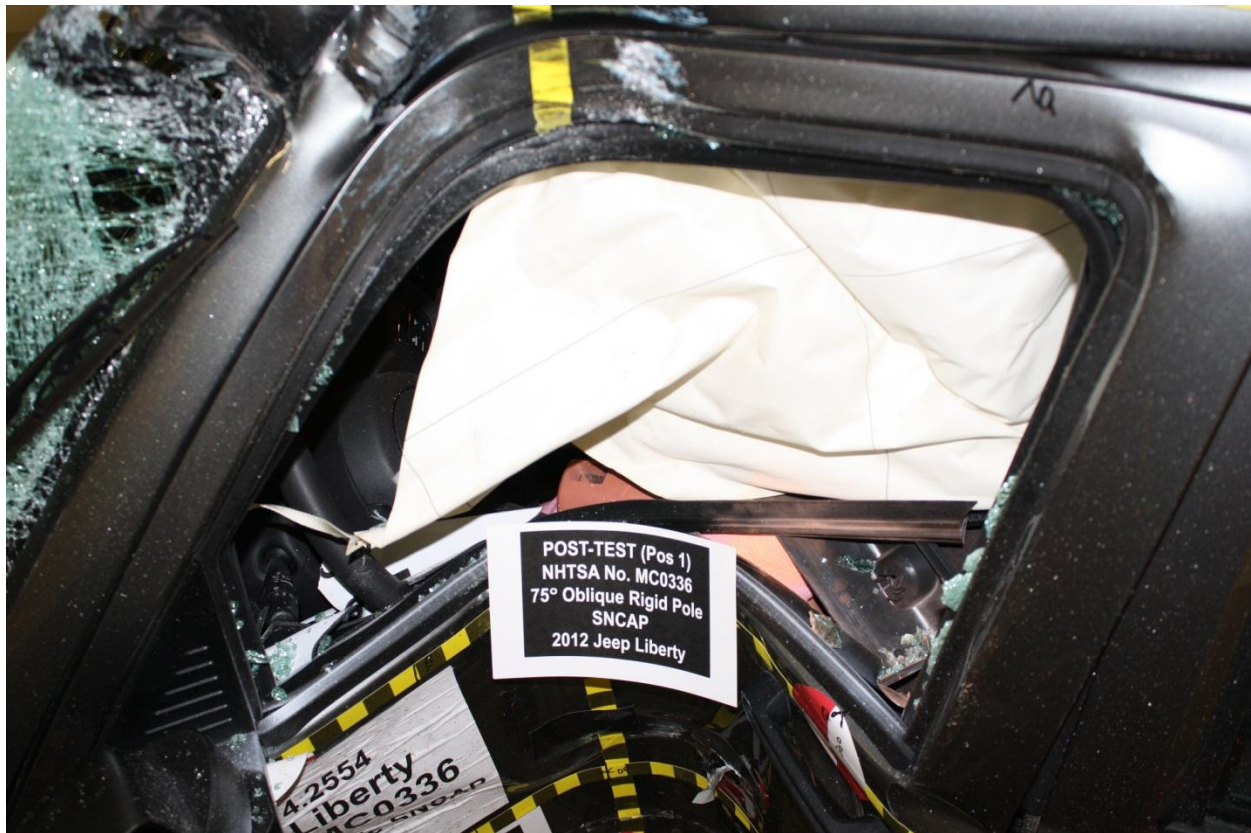
Figure A-41: Post-Test Dummy and Door Clearance View

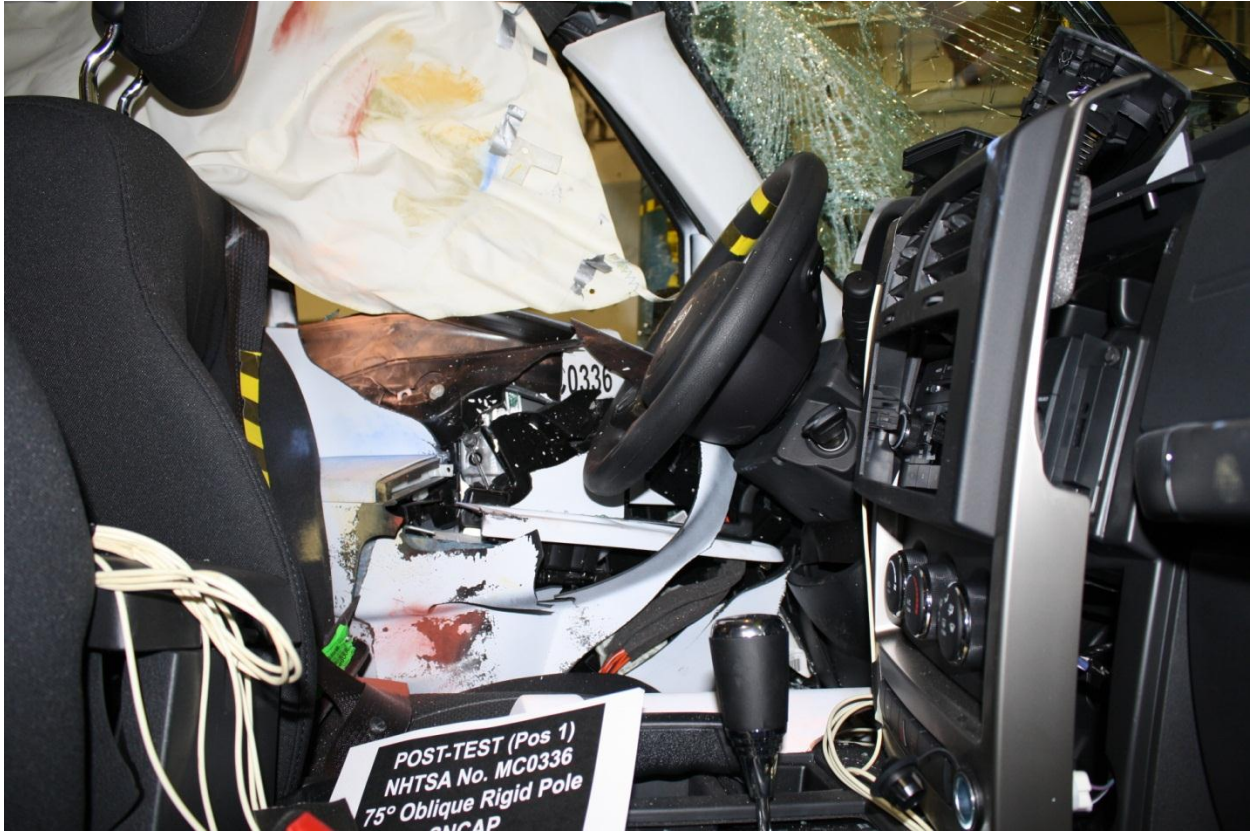
Figure A-45: Post-Test Inner Door Panel View Showing Dummy Contact Location

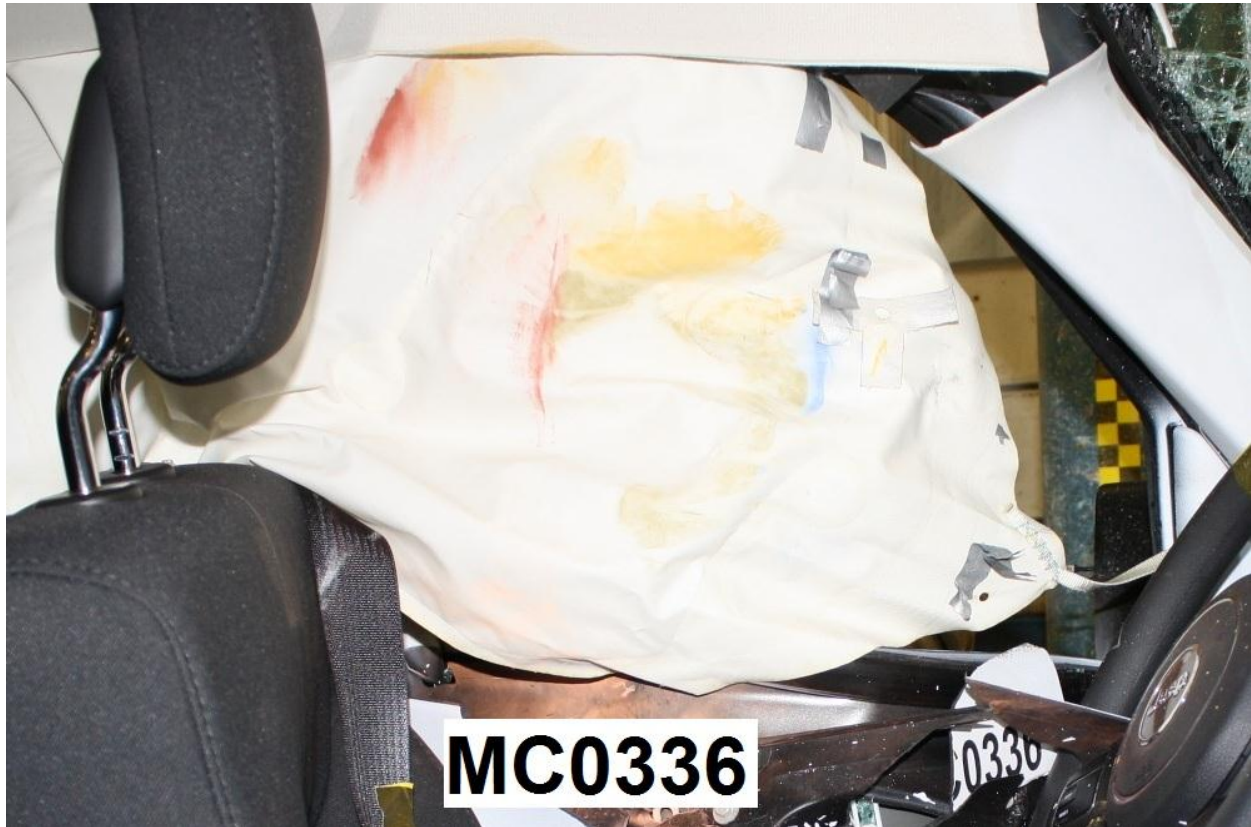
Figure A-47: Post-Test Dummy Close-Up Head Contact with Side Airbag View

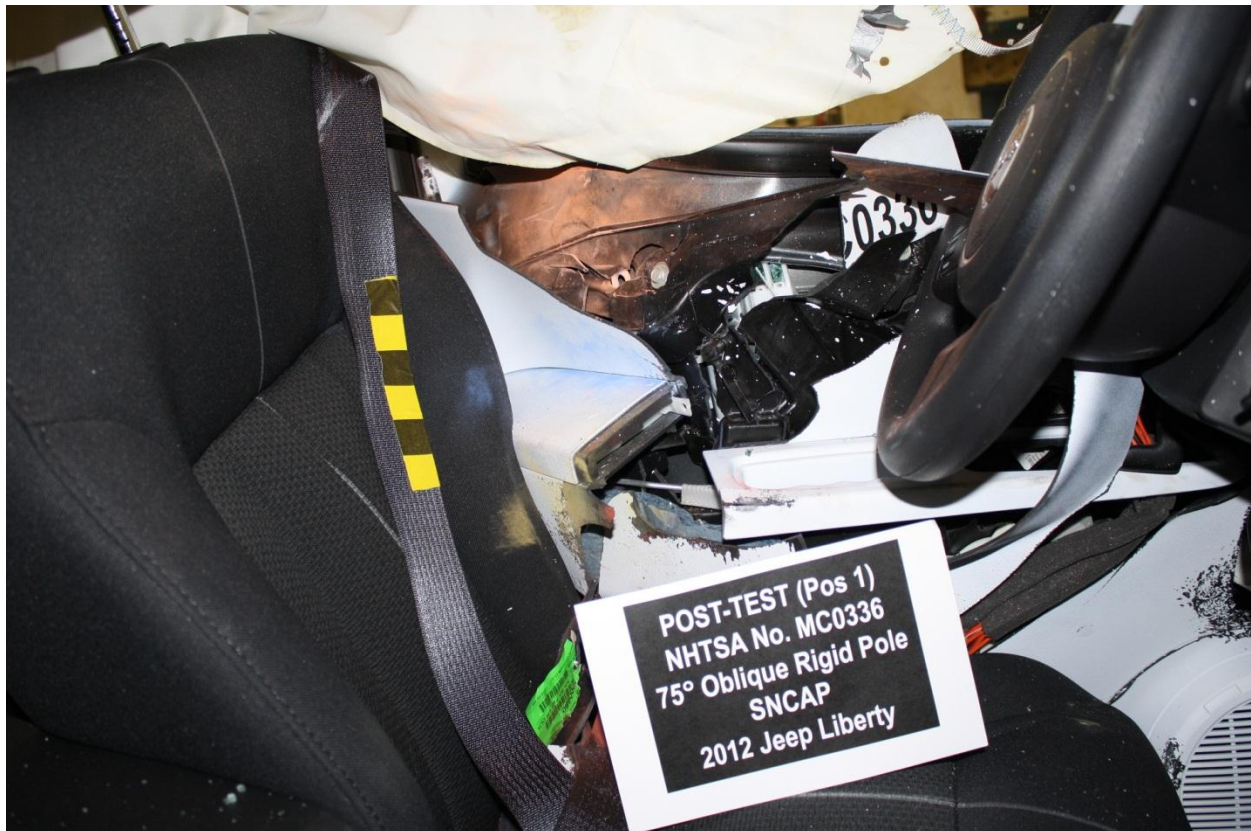
Figure A-48: Post-Test Dummy Close-Up Torso Contact with Vehicle Interior View

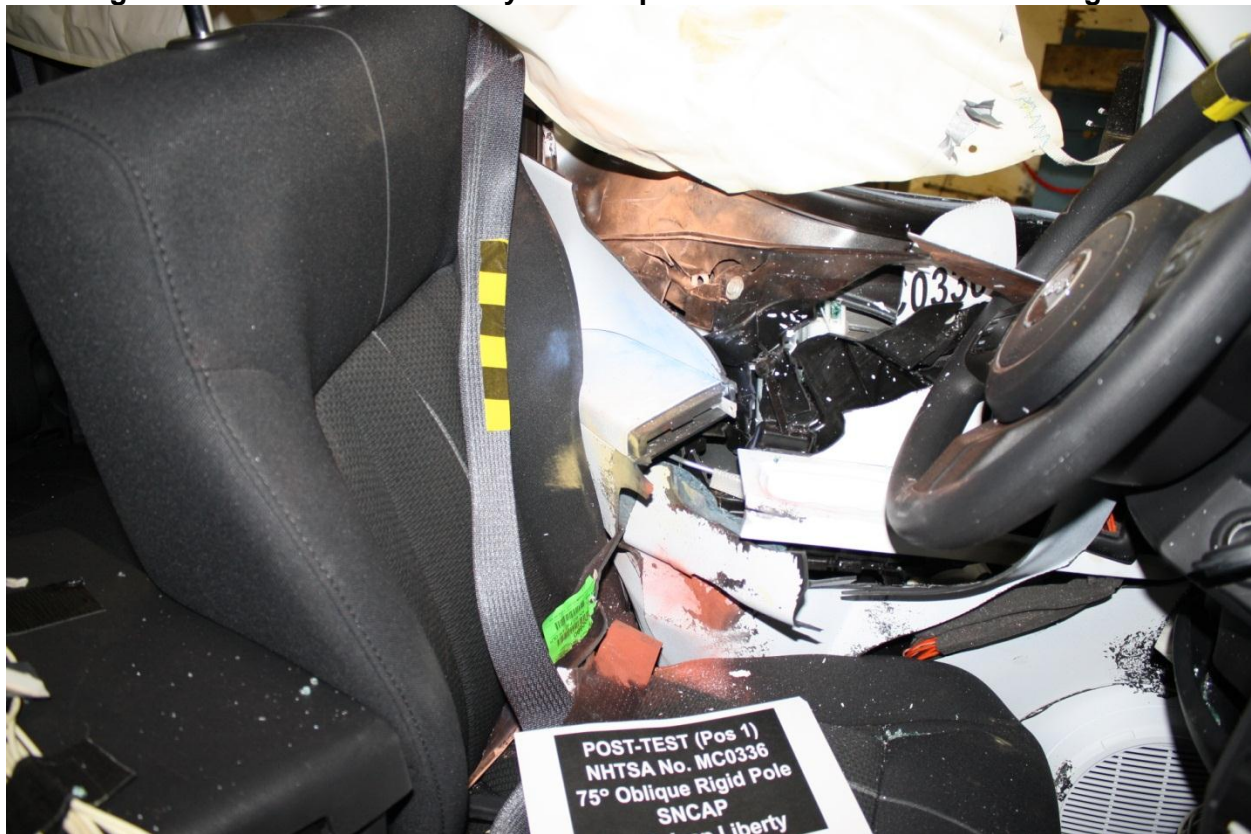
Figure A-50: Post-Test Dummy Close-Up Pelvis Contact with Vehicle Interior View

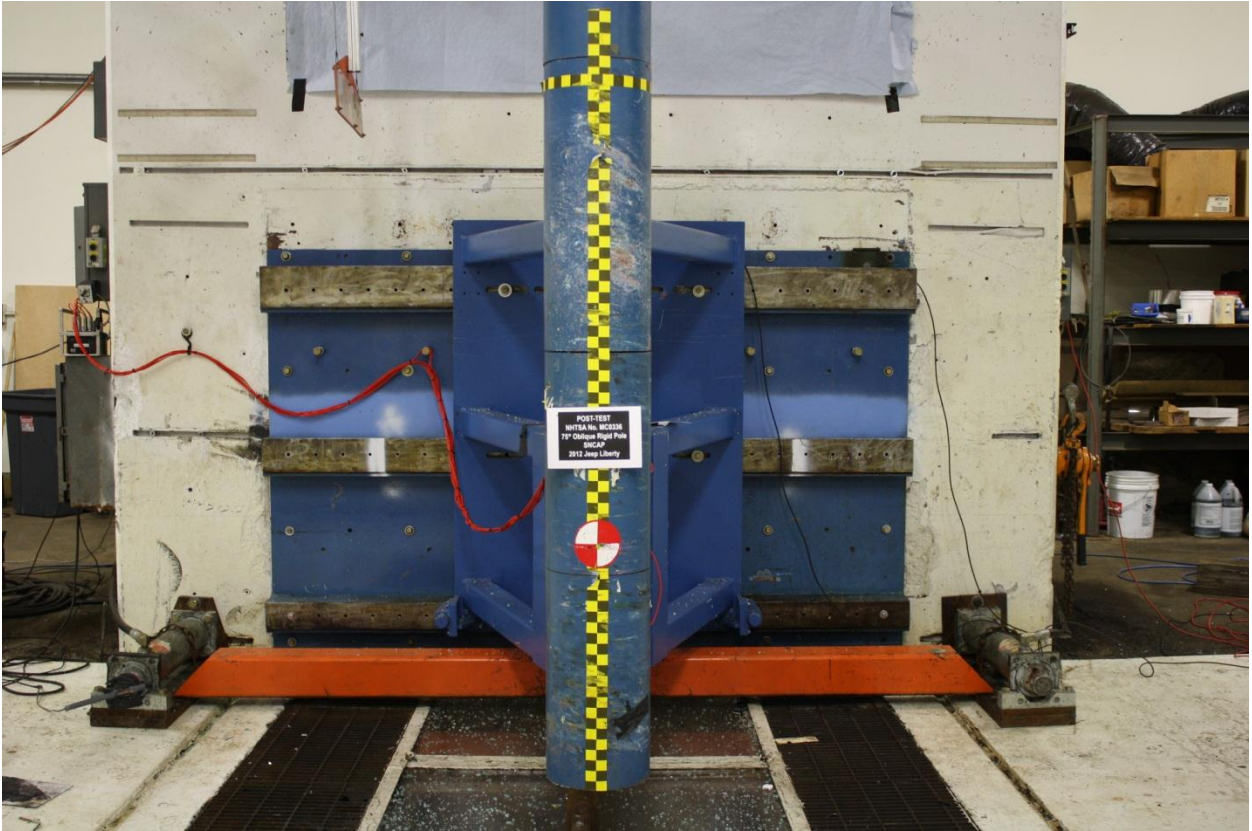
Figure A-57: Post-Test Pole Barrier Front View

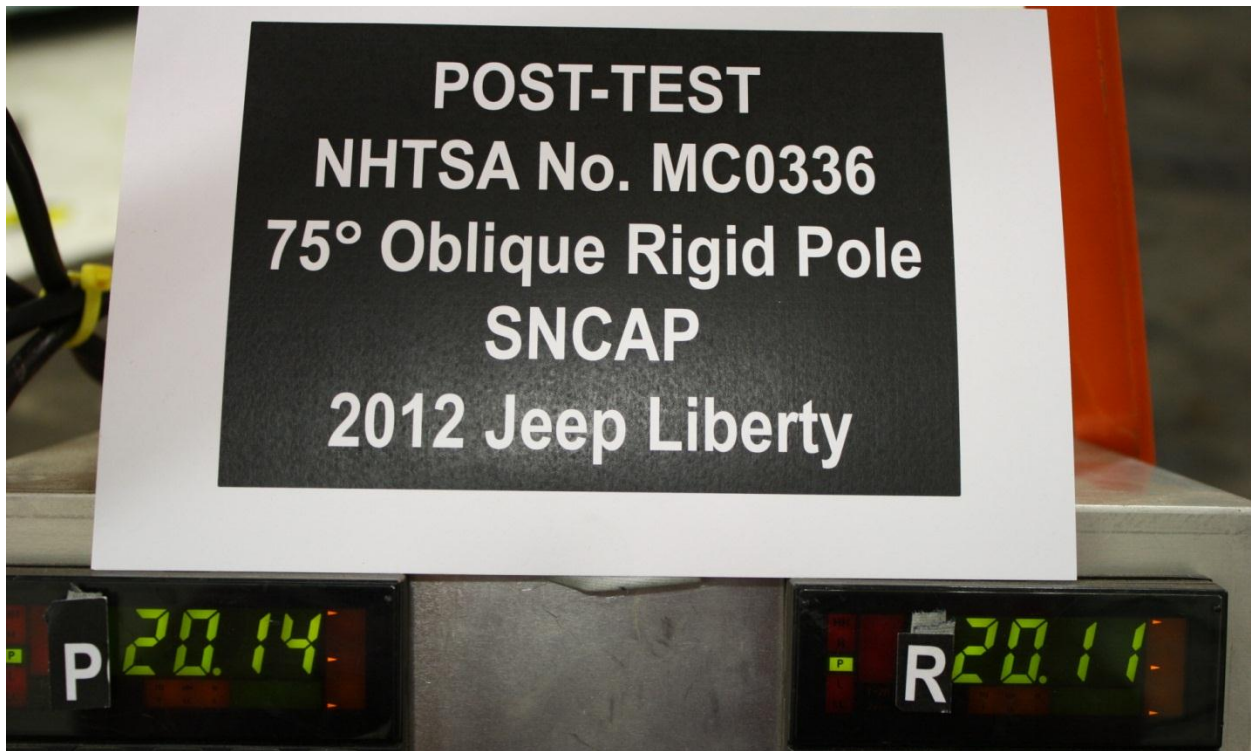
Figure A-61: Post-Test Primary and Redundant Speed Trap Read-Out

A rigid pole side test was conducted on a 2012 Jeep Liberty Sport 4x2 Utility Vehicle. The subject vehicle was towed into the rigid pole at an angle of 75° and a velocity of 32.41 km/h. The test was conducted by Calspan Corporation Transportation Research Group on 12/5/2011. Pre-test and post test photographs of the test vehicle and side impact dummy (SID-IIs) are included in Appendix A of this report.

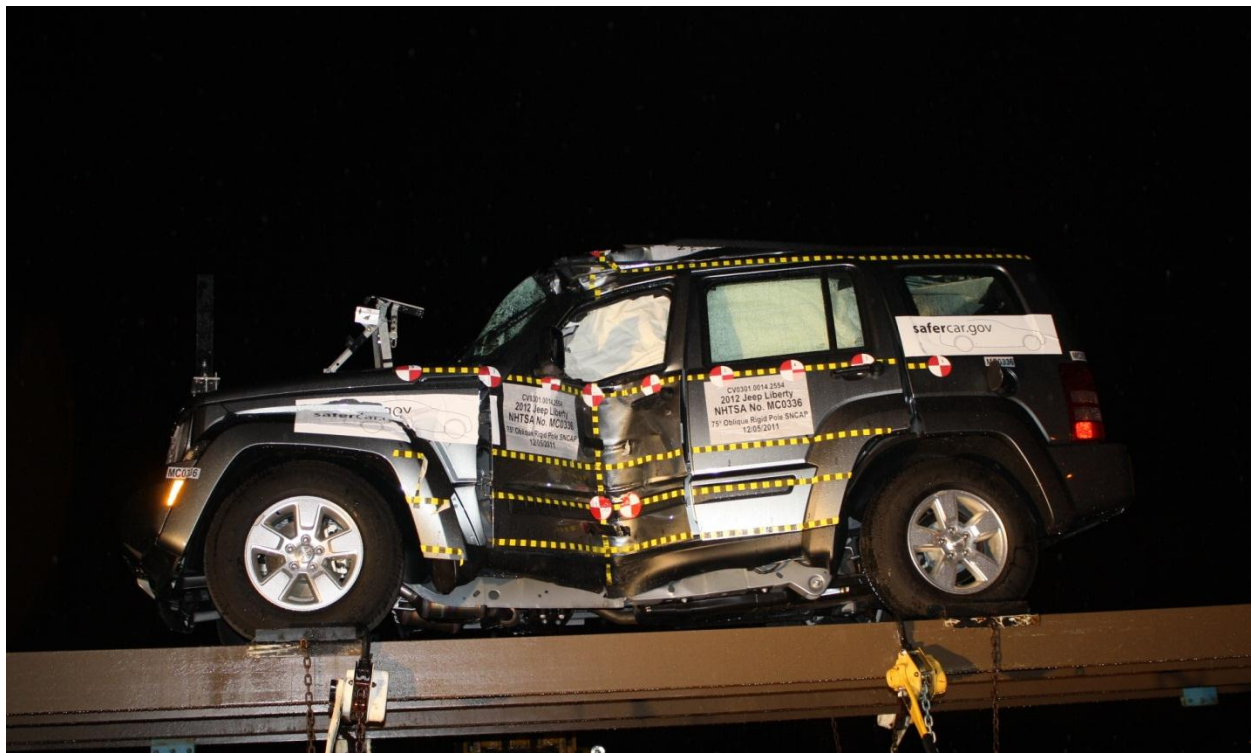
Figure A-62: FMVSS No. 301 Static Rollover 0 Degrees

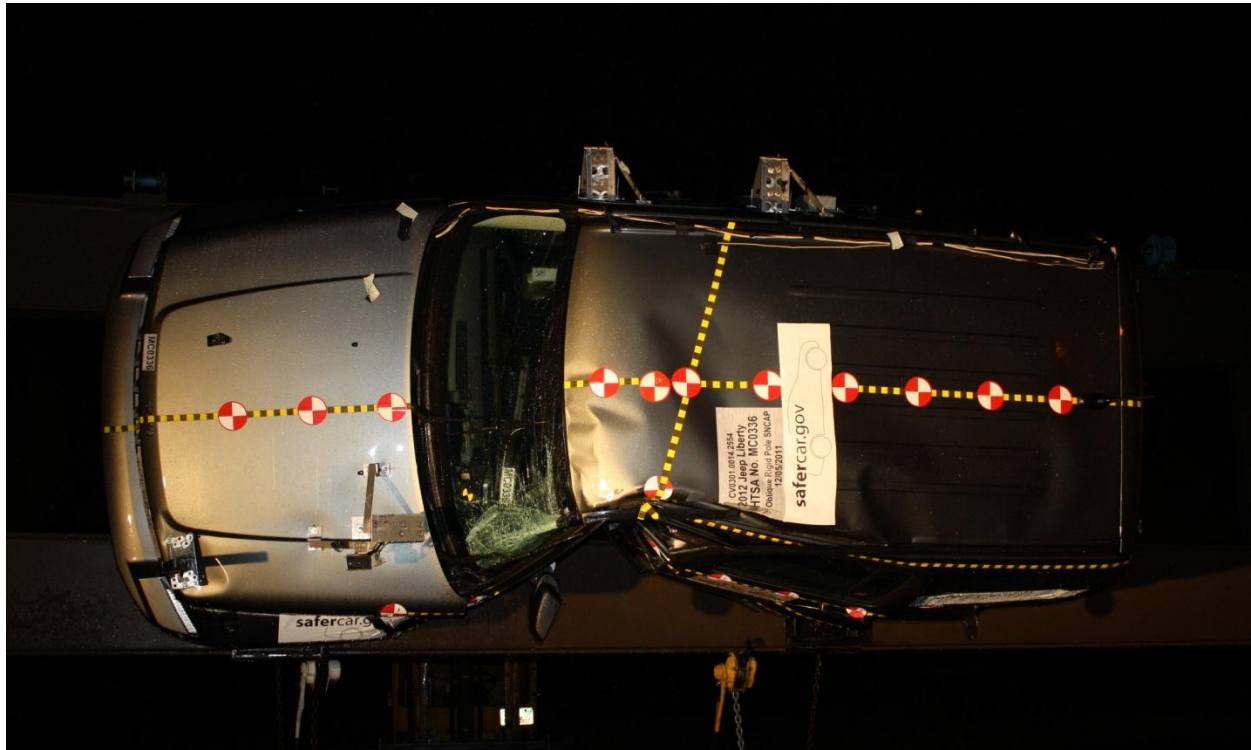
Figure A-63: FMVSS No. 301 Static Rollover 90 Degrees

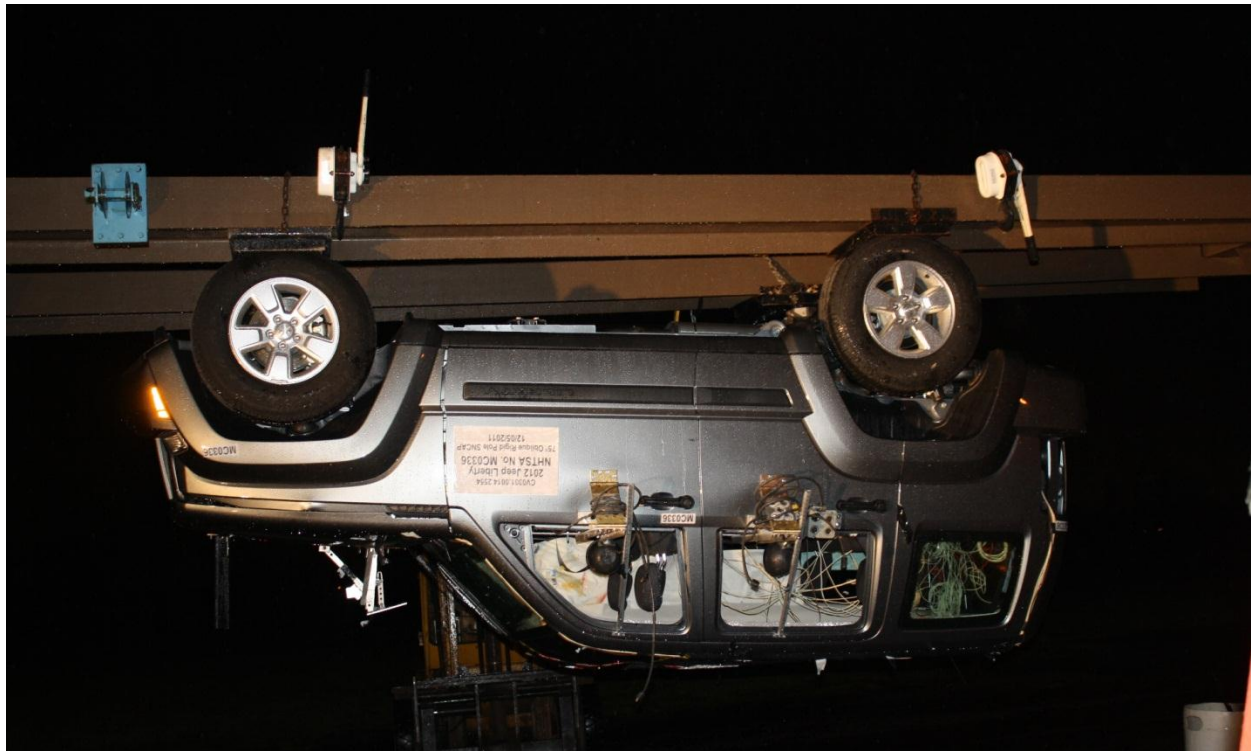
Figure A-64: FMVSS No. 301 Static Rollover 180 Degrees

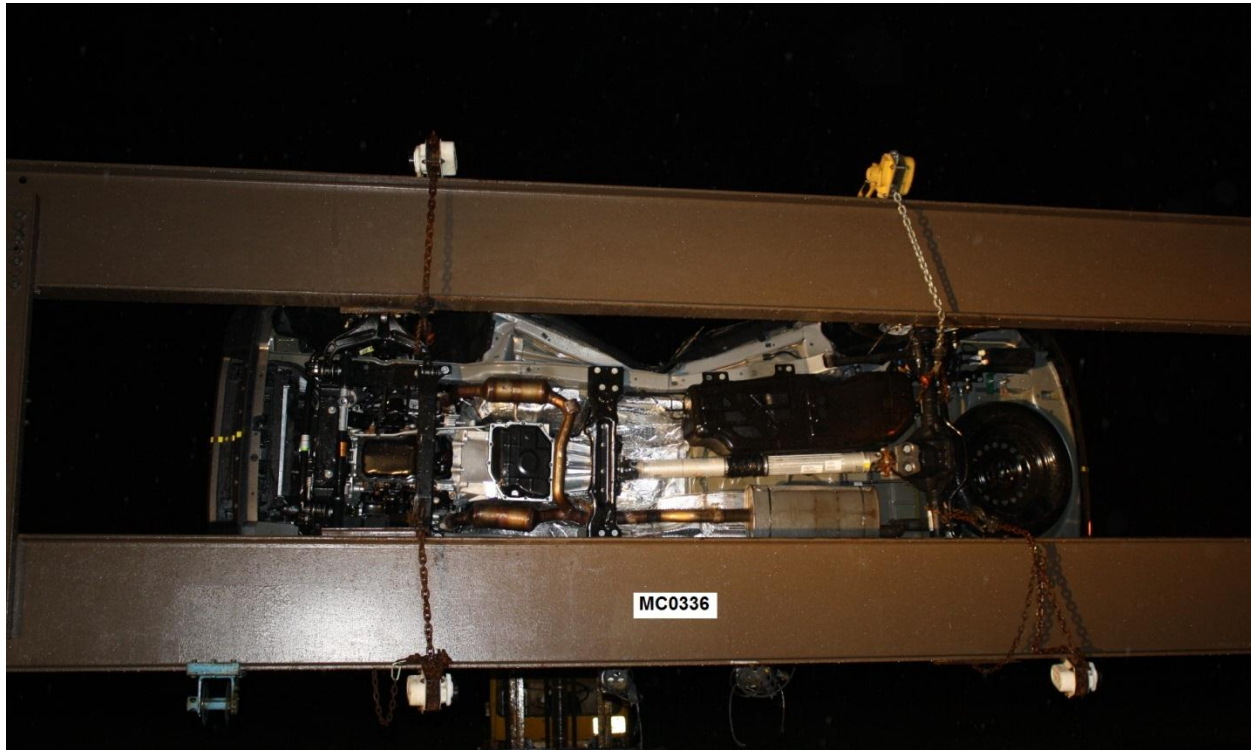
Figure A-65: FMVSS No. 301 Static Rollover 270 Degrees

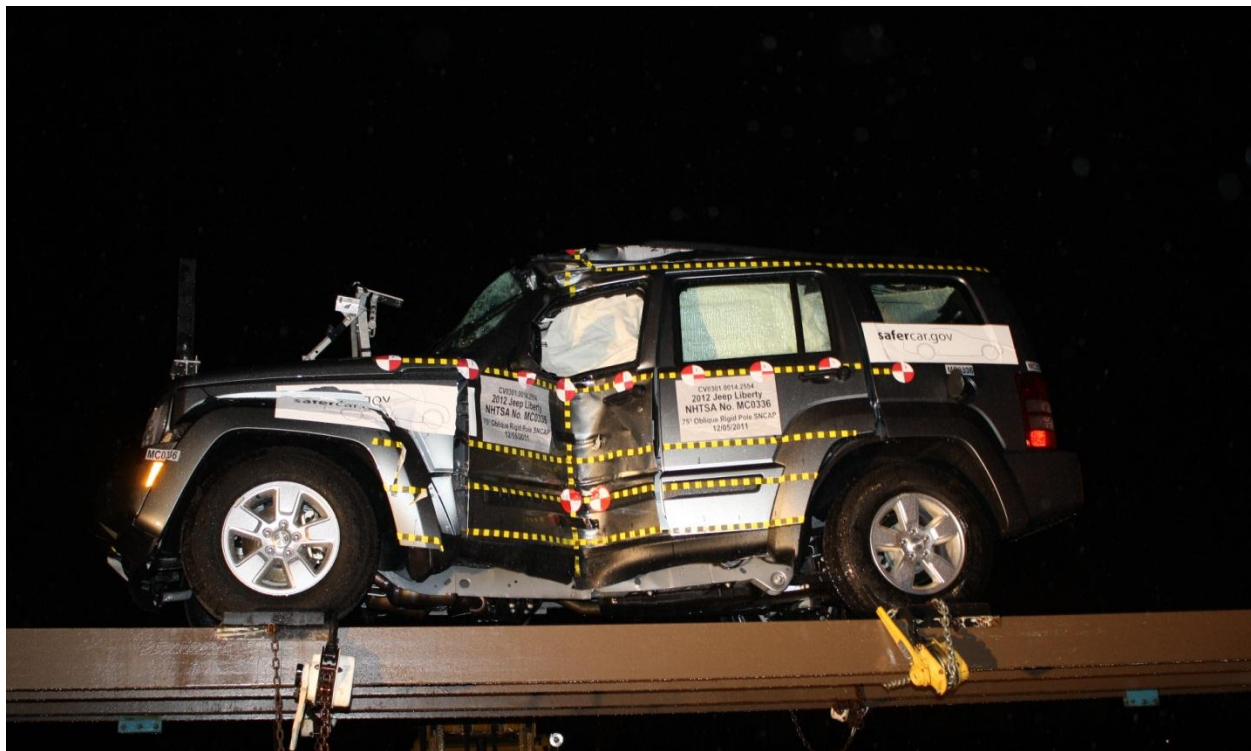
Figure A-66: FMVSS No. 301 Static Rollover 360 Degrees

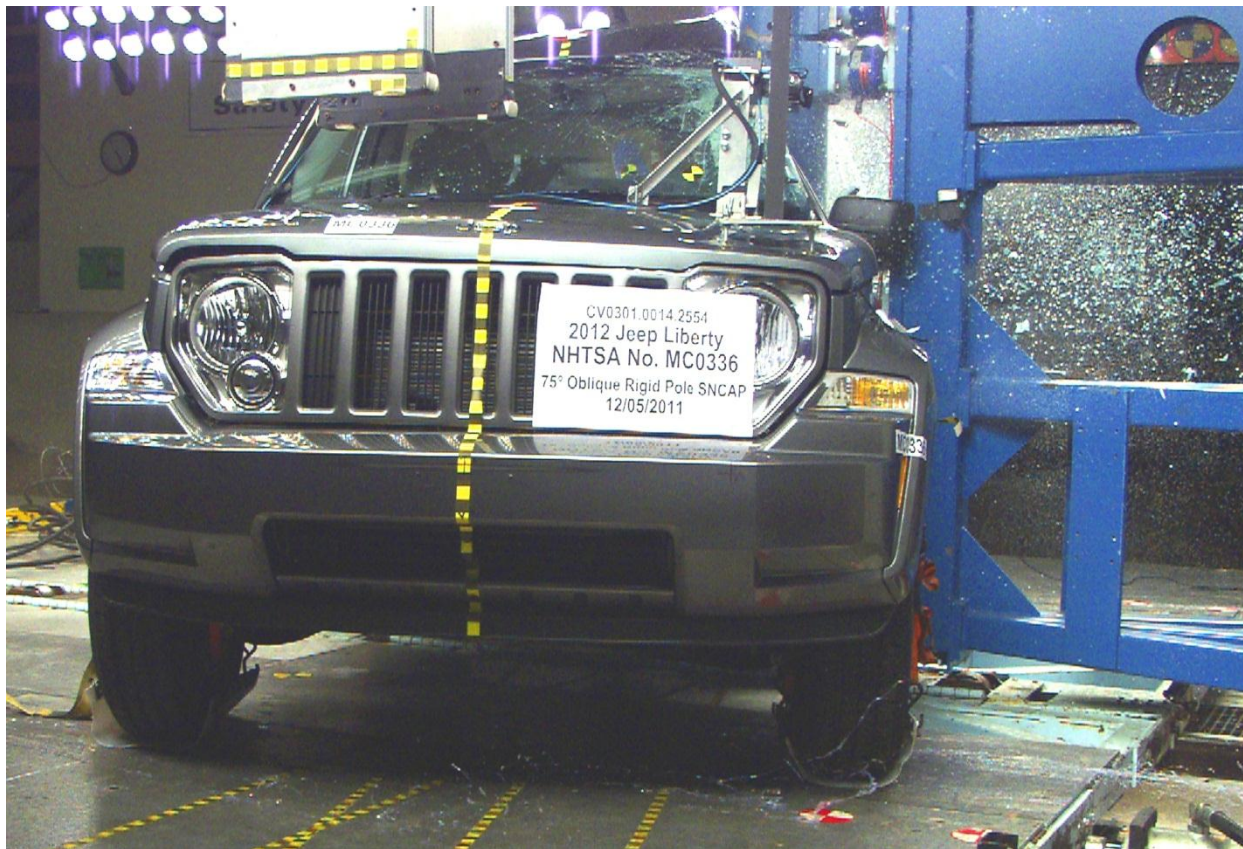
Figure A-67: Impact Event
