**REPORT NUMBER: SINCAP-MGA-2012-035**

**NEW CAR ASSESSMENT PROGRAM (NCAP)  
Moving Deformable Barrier Side Impact Test**

**GENERAL MOTORS LLC  
2012 Chevrolet Sonic LT 4-Dr Sedan  
NHTSA No.: MC0110**

**FINAL REPORT**

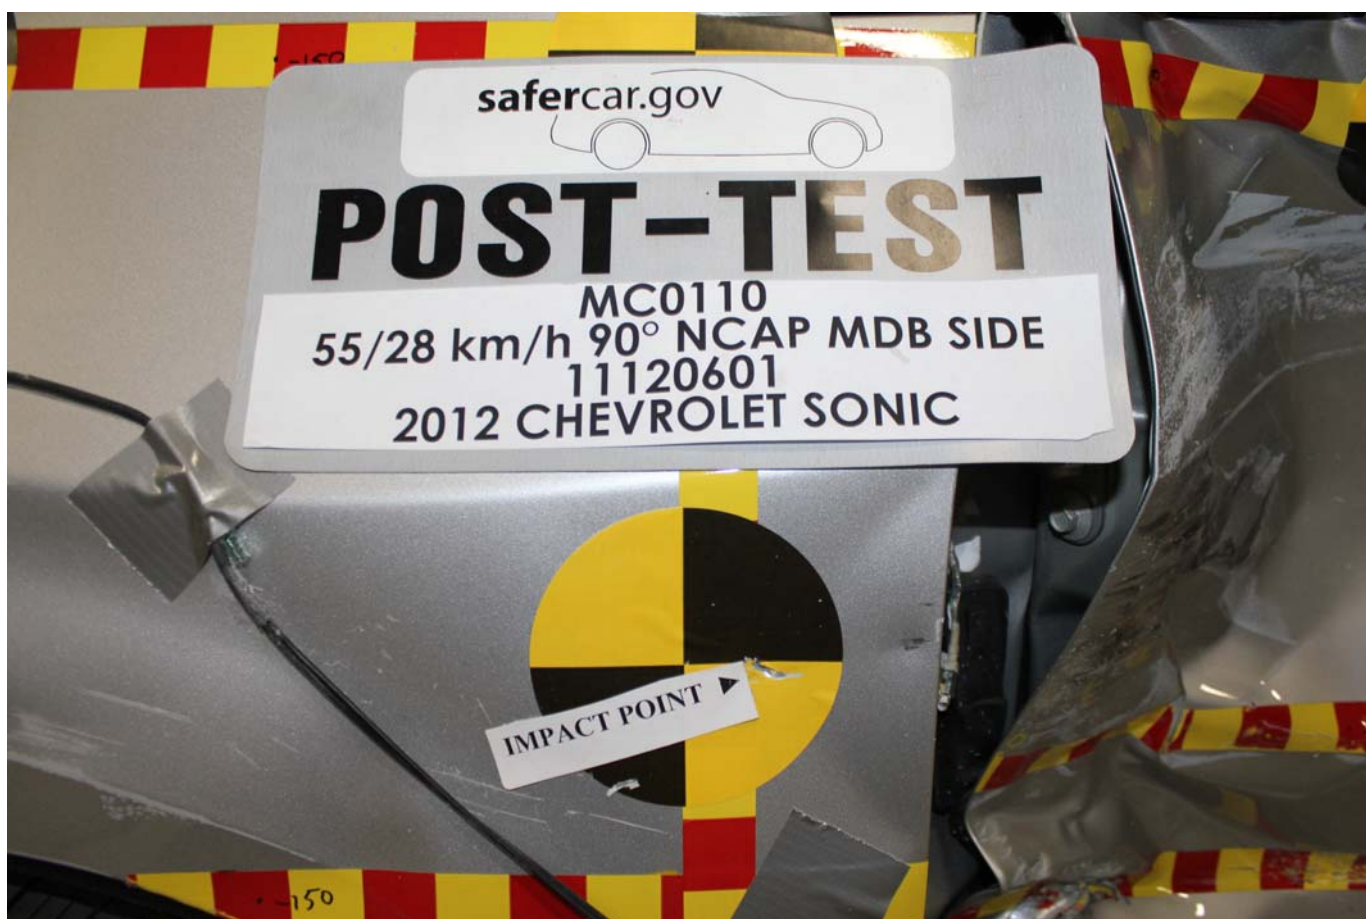
Post-Test Close-Up View of Impact Point Target

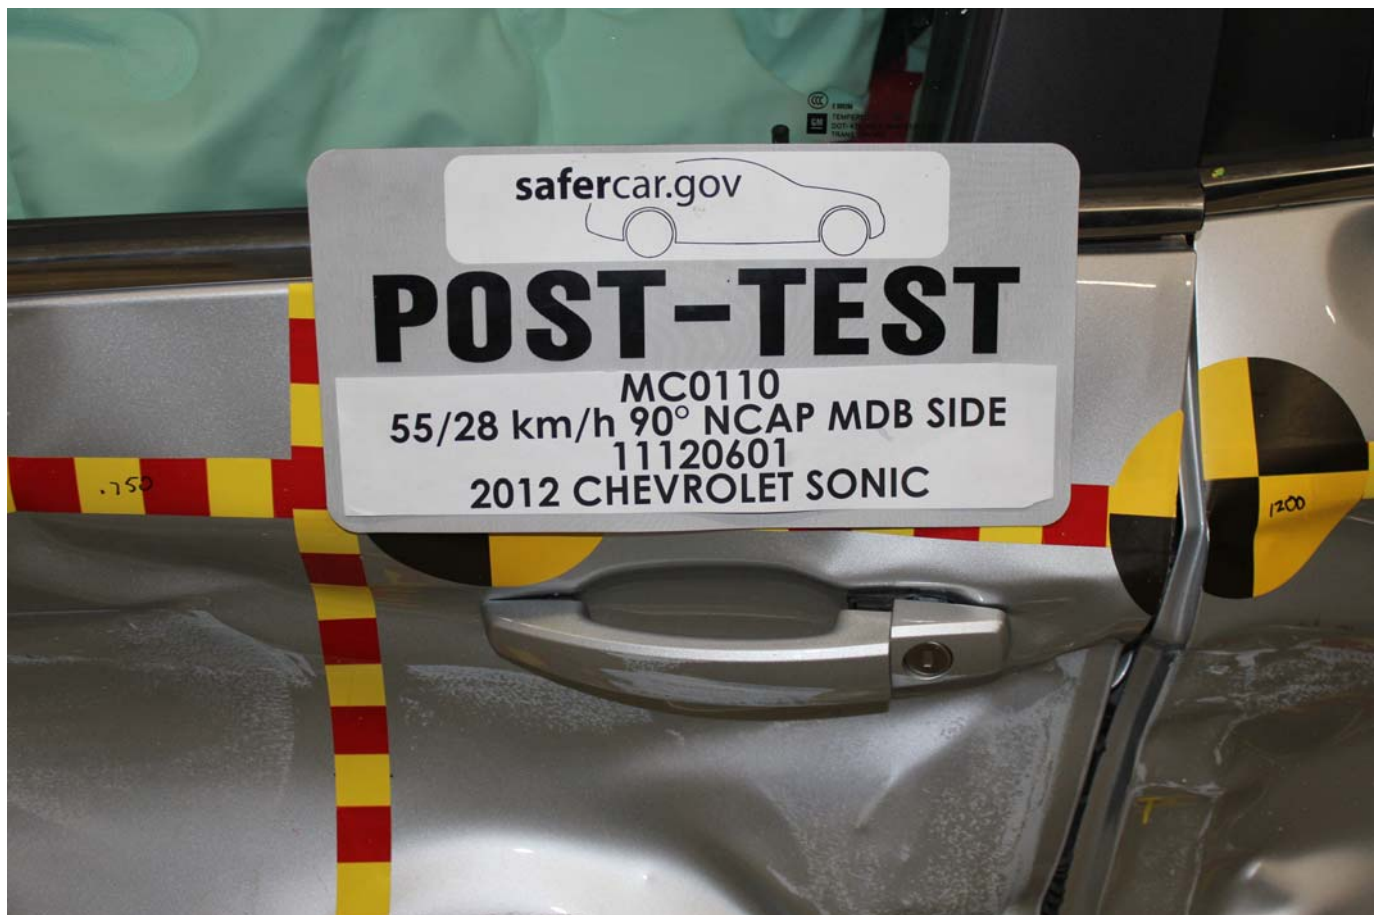
Post-Test Left Front Door Latch Close-Up

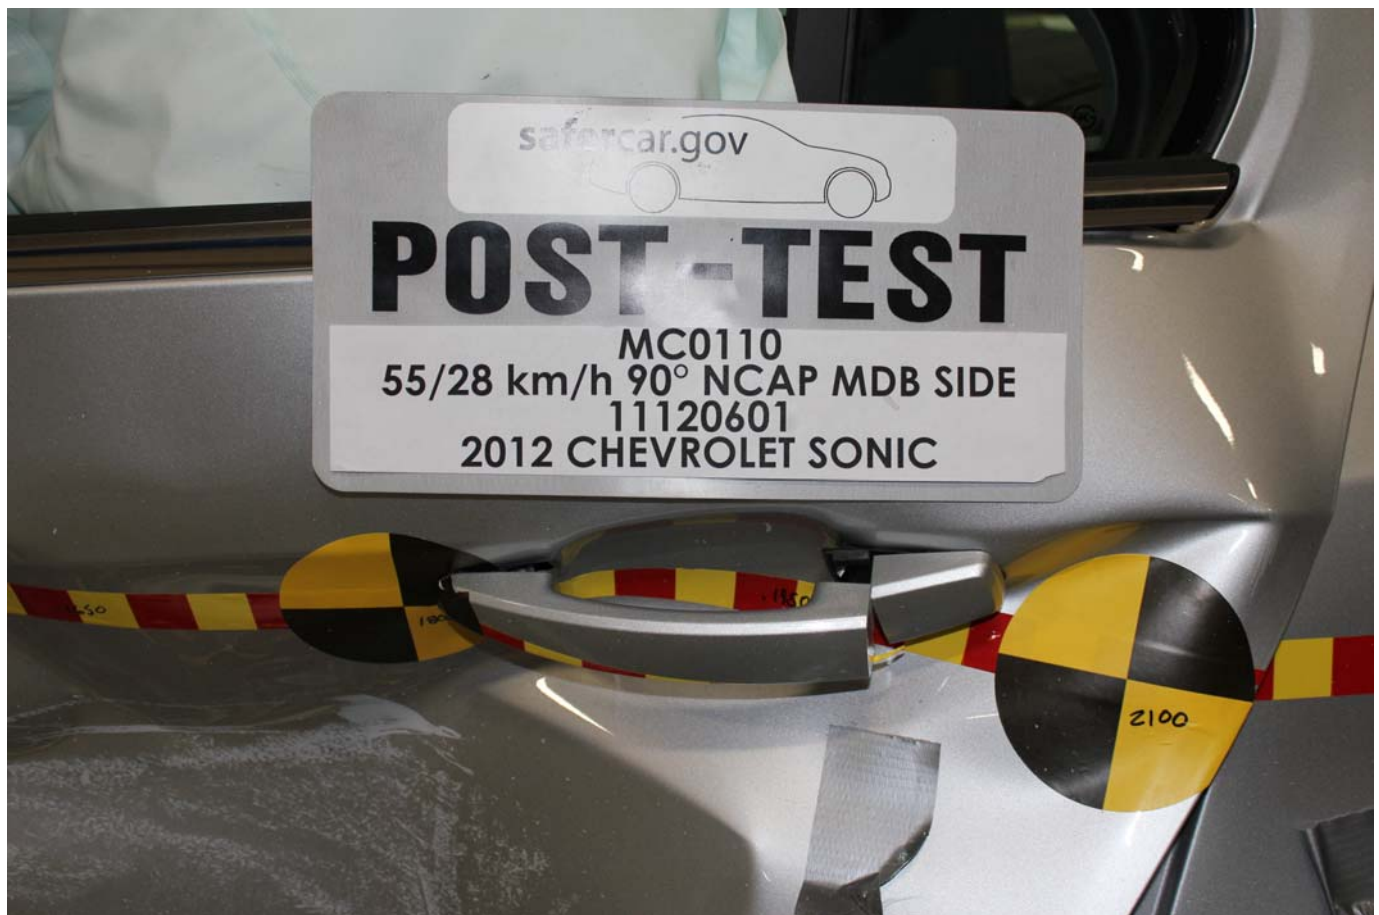
Post-Test Left Rear Door Latch Close-Up

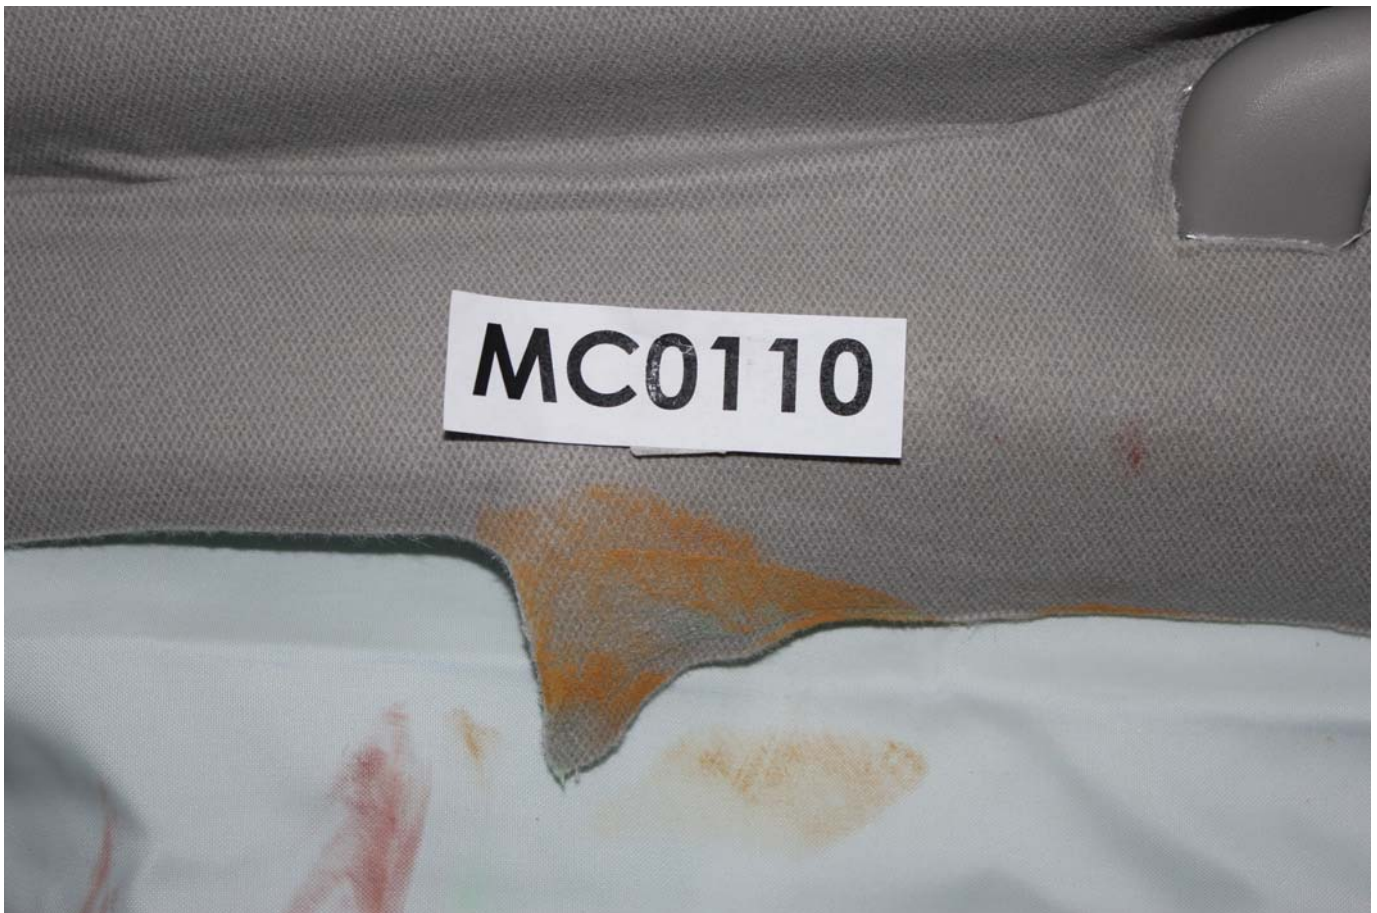
Post-Test Driver Inner Door Panel View

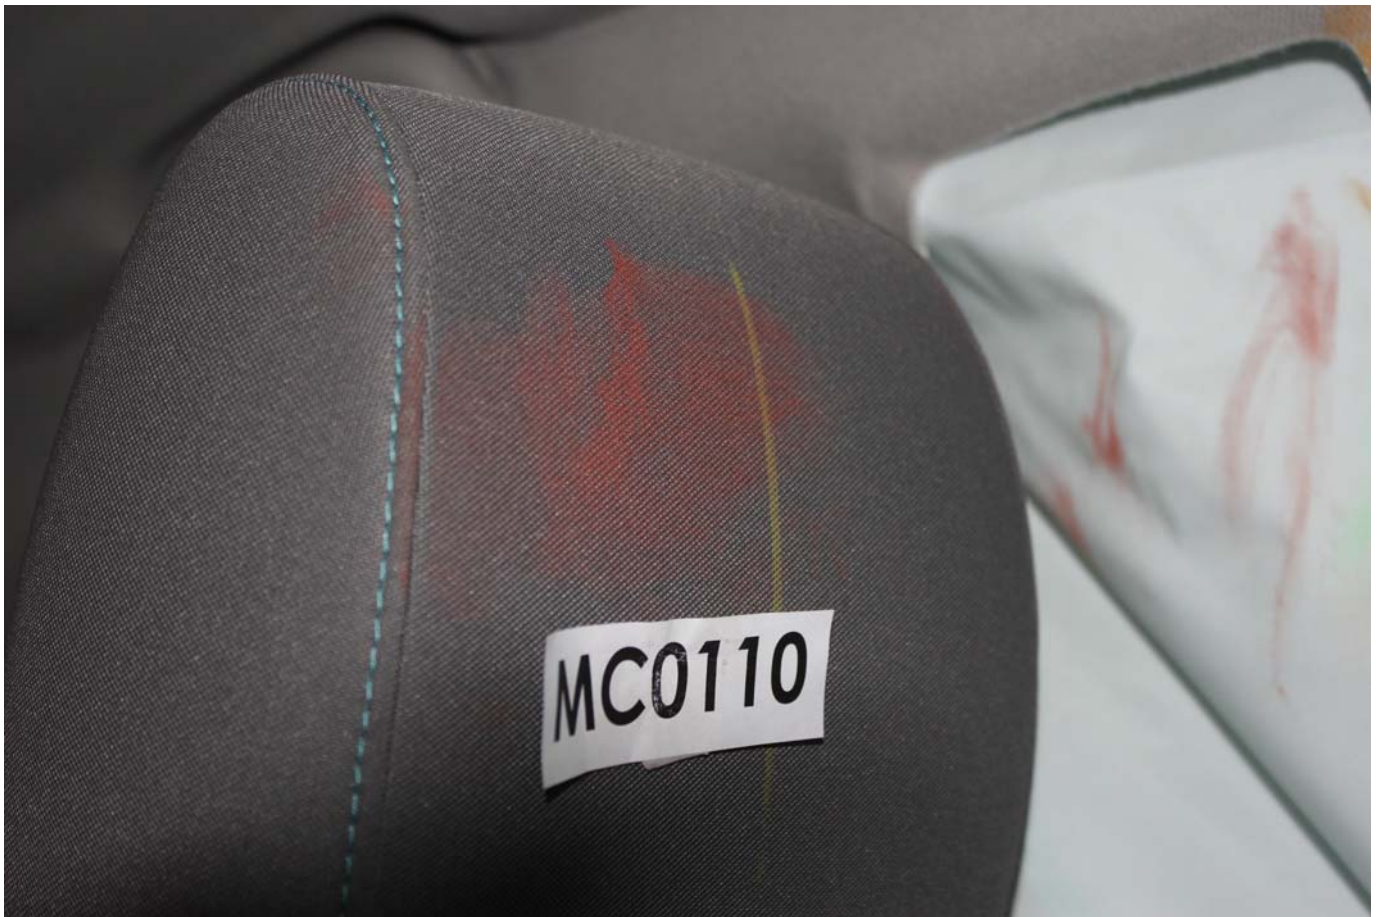
Post-Test Driver Dummy Close-up Head Contact with Vehicle Interior View

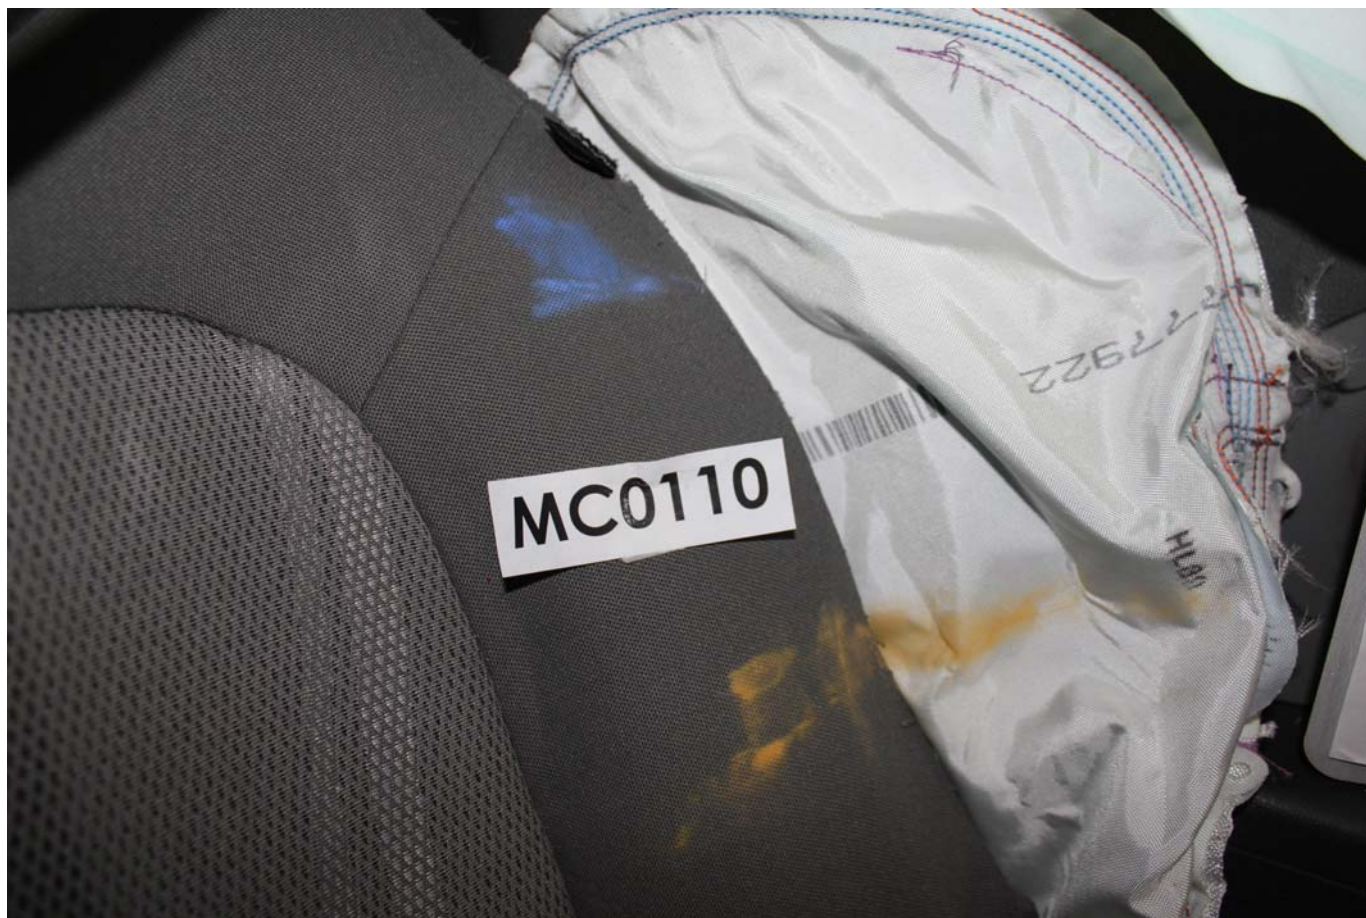
Post-Test Driver Dummy Close-up Head Contact with Side Airbag View

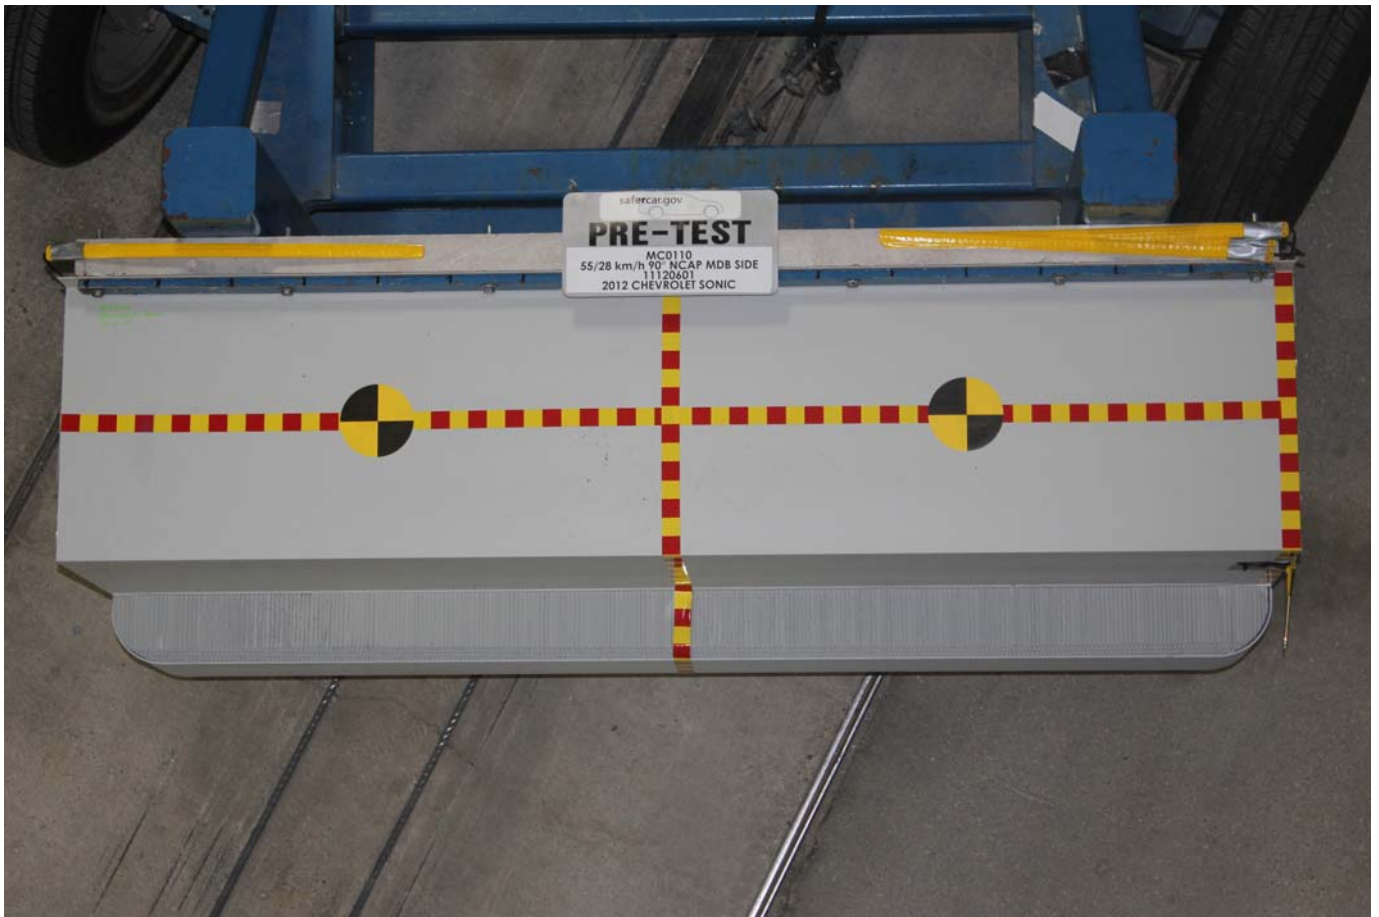
Post-Test Front View of MDB Impactor Face

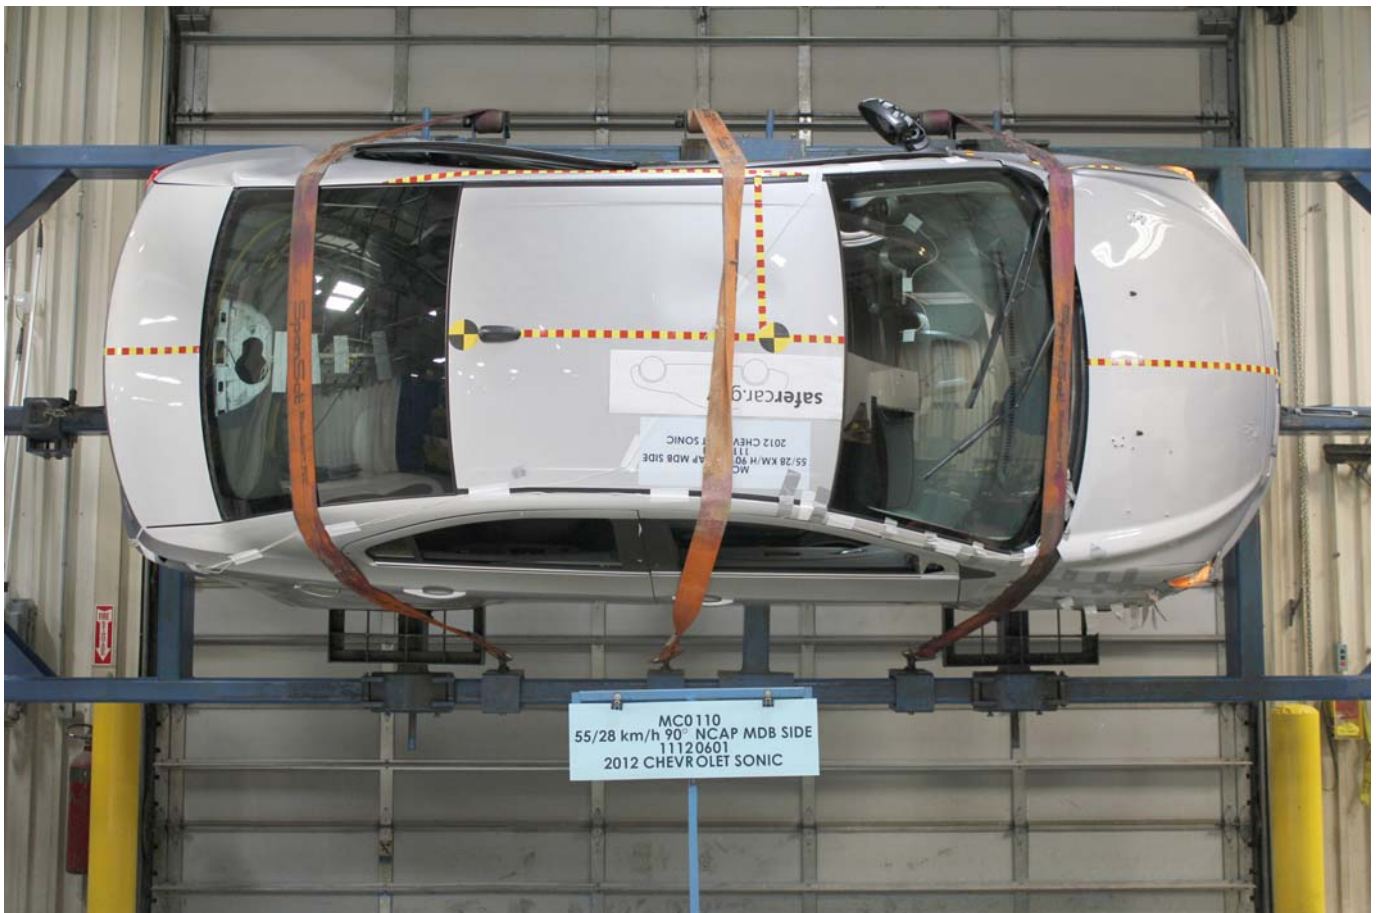
FMVSS No. 301 Static Rollover 90 Degrees

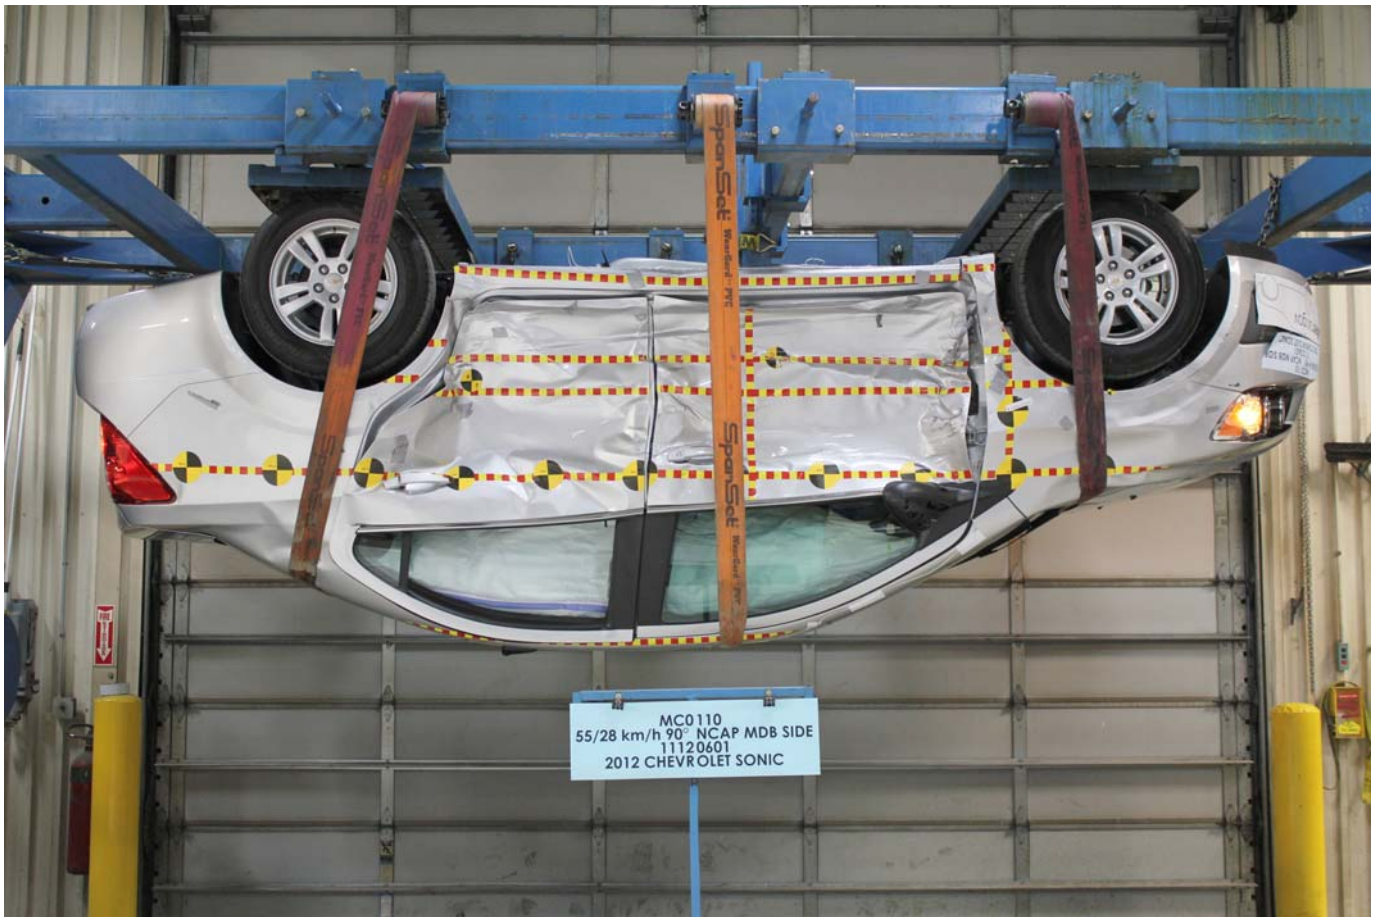
FMVSS No. 301 Static Rollover 180 Degrees

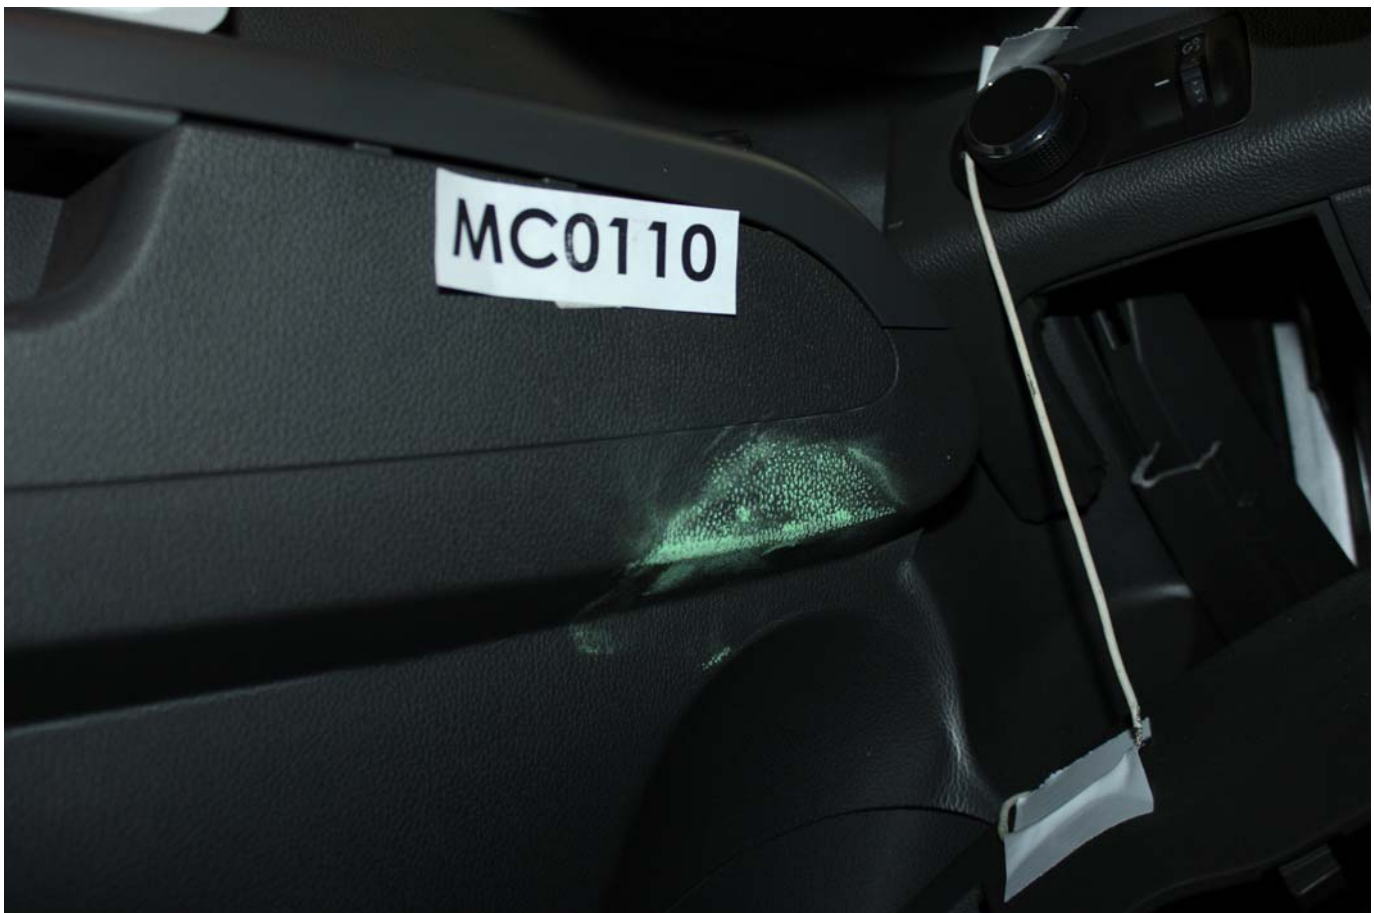
Post-Test Driver Dummy Knee Contact with Vehicle Interior View

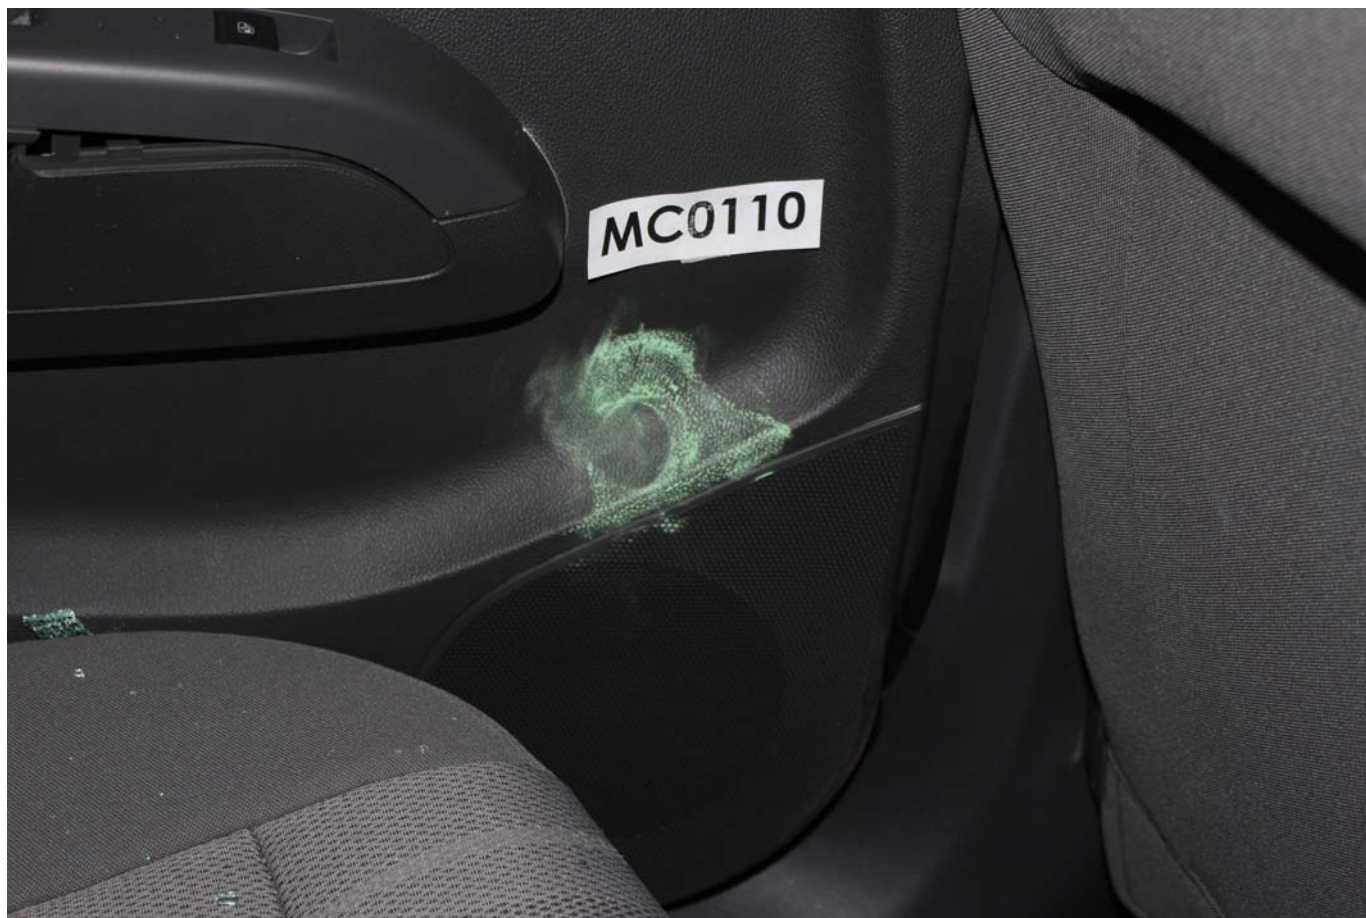
Post-Test Rear Passenger Dummy Knee Contact with Vehicle Interior View
