**REPORT NUMBER: NCAP-MGA-2012-036**

**NEW CAR ASSESSMENT PROGRAM (NCAP)  
Frontal Barrier Impact Test**

**GENERAL MOTORS LLC  
2012 Chevrolet Sonic 2LT 4-Dr Sedan  
NHTSA No.: MC0109**

**MGA RESEARCH CORPORATION  
5000 Warren Road  
Burlington, WI 53105**

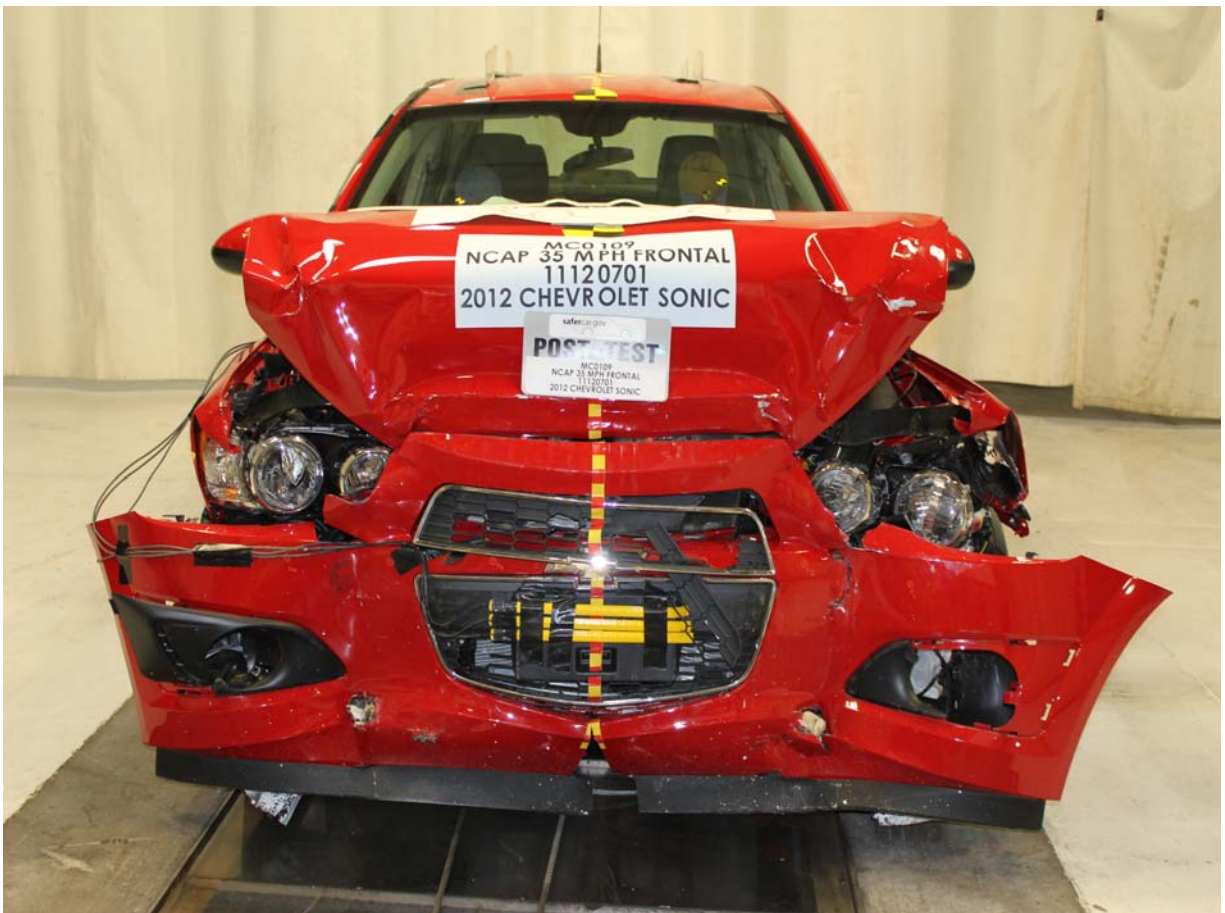
Post-Test Front View of Test Vehicle

The maximum static crush of the vehicle was 431 mm and both the driver and passenger side doors remained closed during the impact event and were operable after the impact.

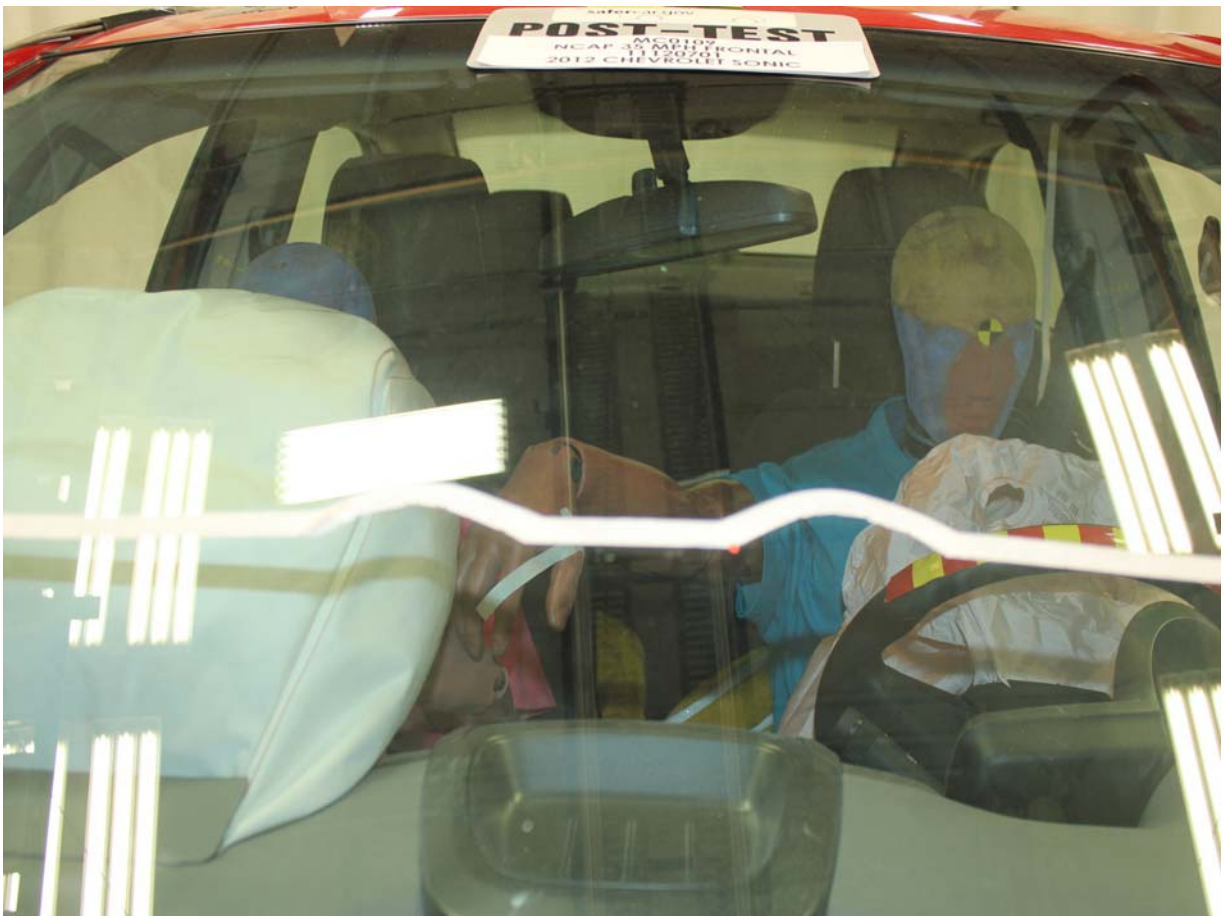
Post-Test Windshield View

There was 100 percent windshield retention and no intrusion into the protected zone of the windshield during the event. There was no Stoddard Solvent leakage after the event or during any phase of the static rollover.

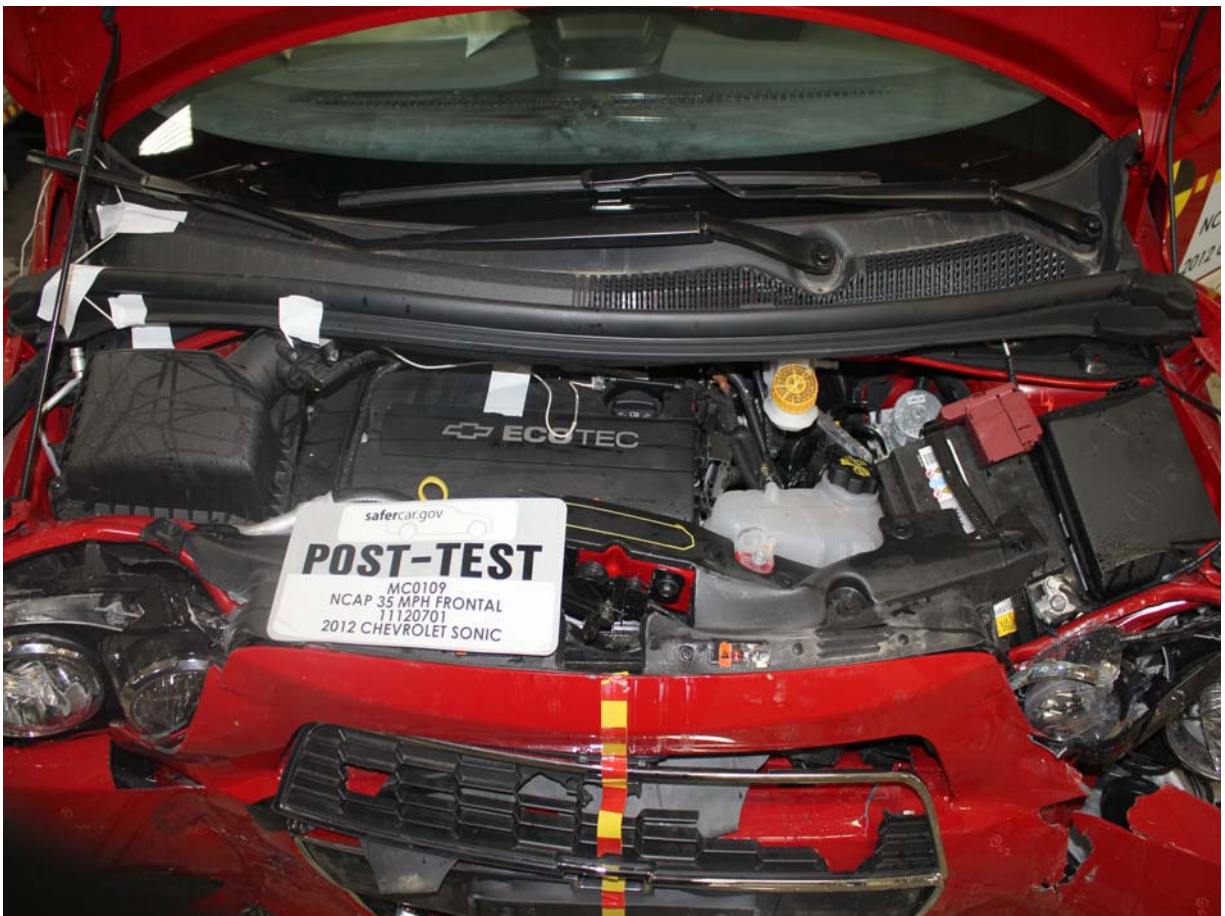
Post-Test Engine Compartment View

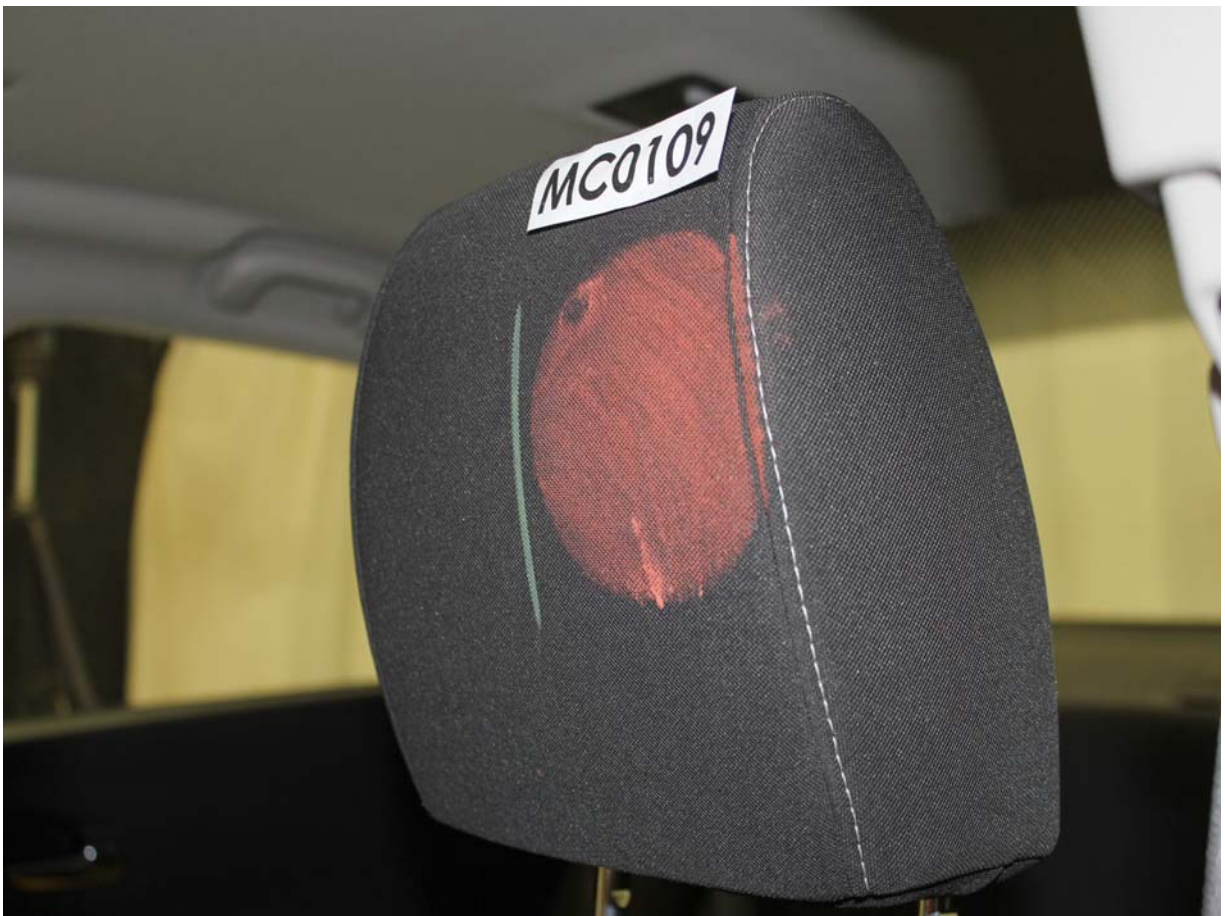
Post-Test Driver Dummy Contact with Headrest

The driver's visible contact points were as follows: The driver's head and chest contacted the airbag. The driver's head also contacted the headrest. The driver's knees contacted the knee airbag. The passenger's visible contact points were as follows: The passenger's head and chest contacted the airbag. The passenger's head also contacted the headrest. The passenger's knees contacted the knee airbag.

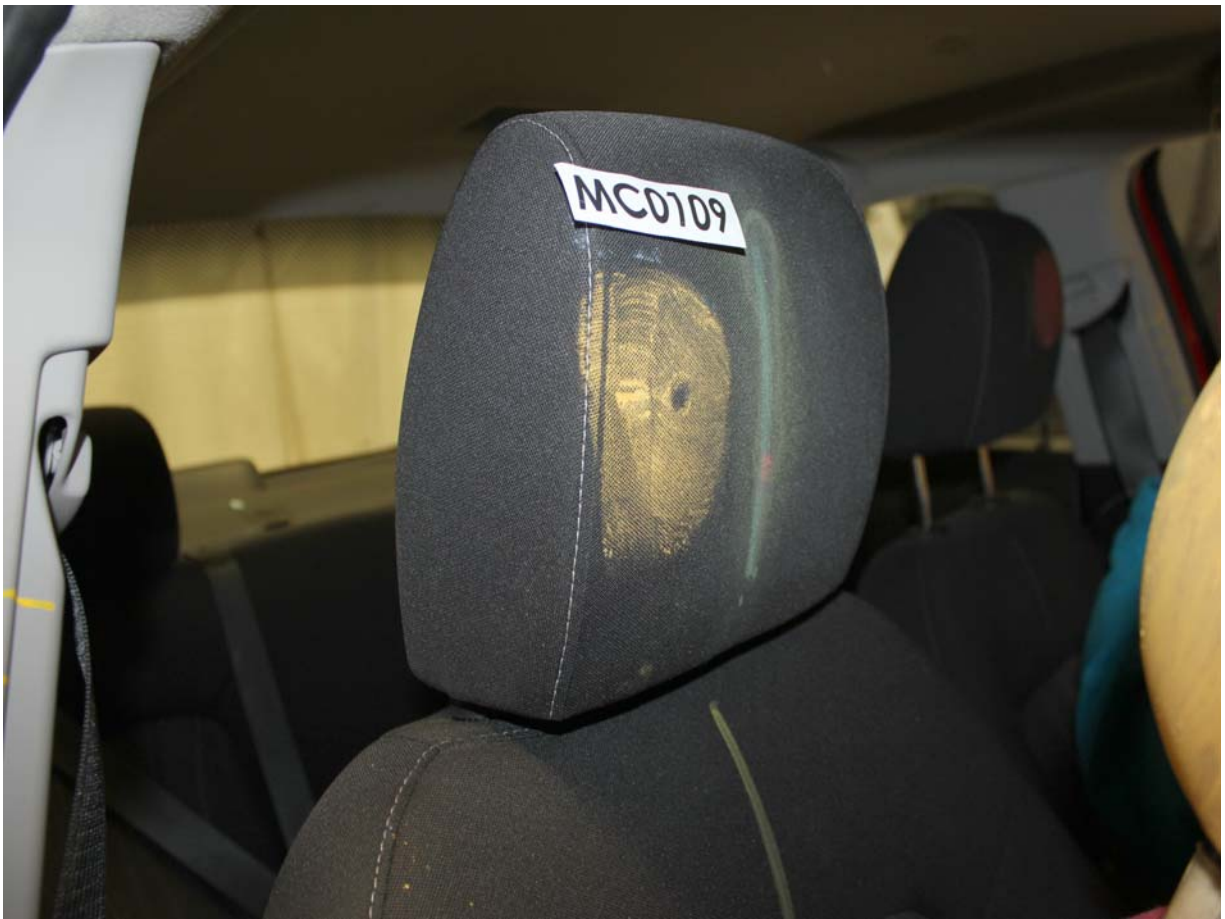
Post-Test Passenger Dummy Contact with Headrest

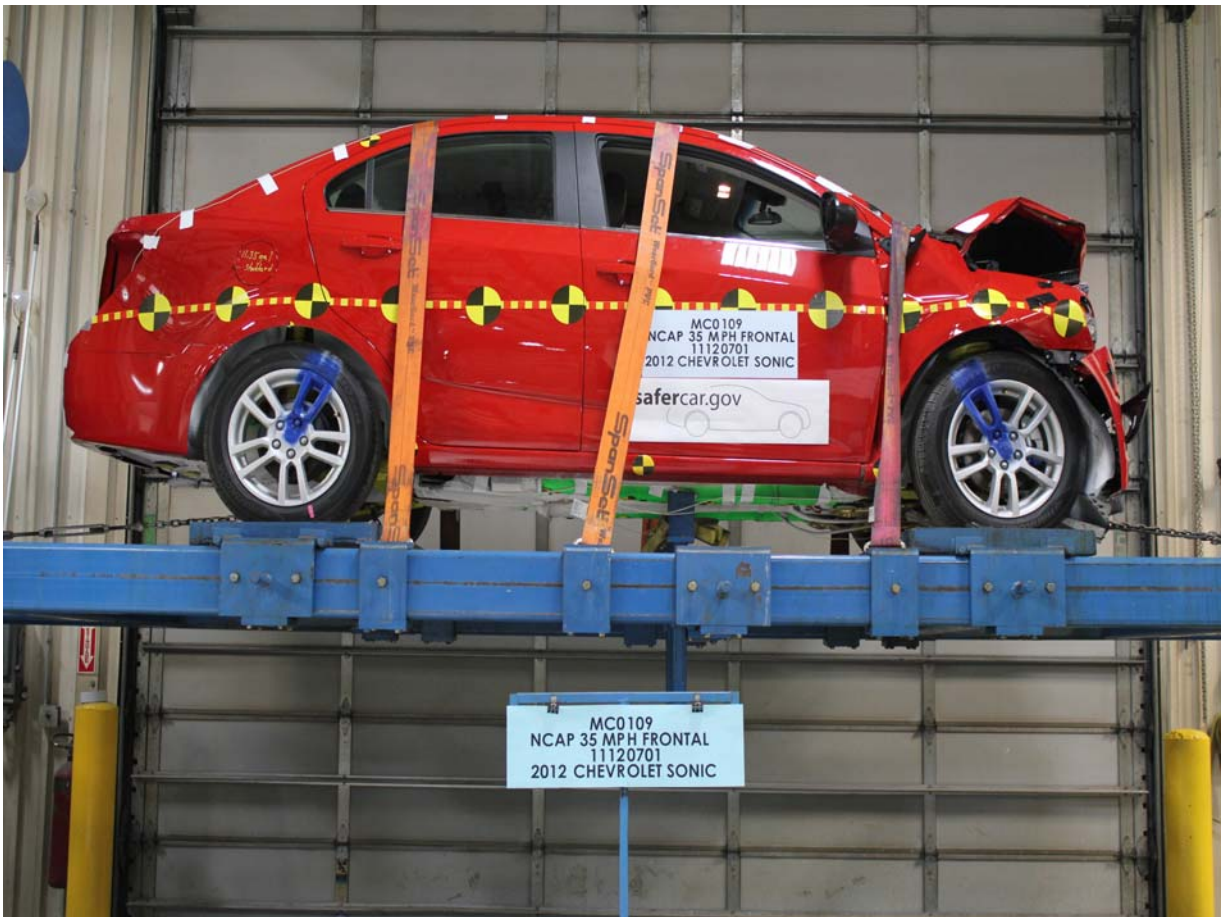
Vehicle at 0 Degrees on Static Rollover Device

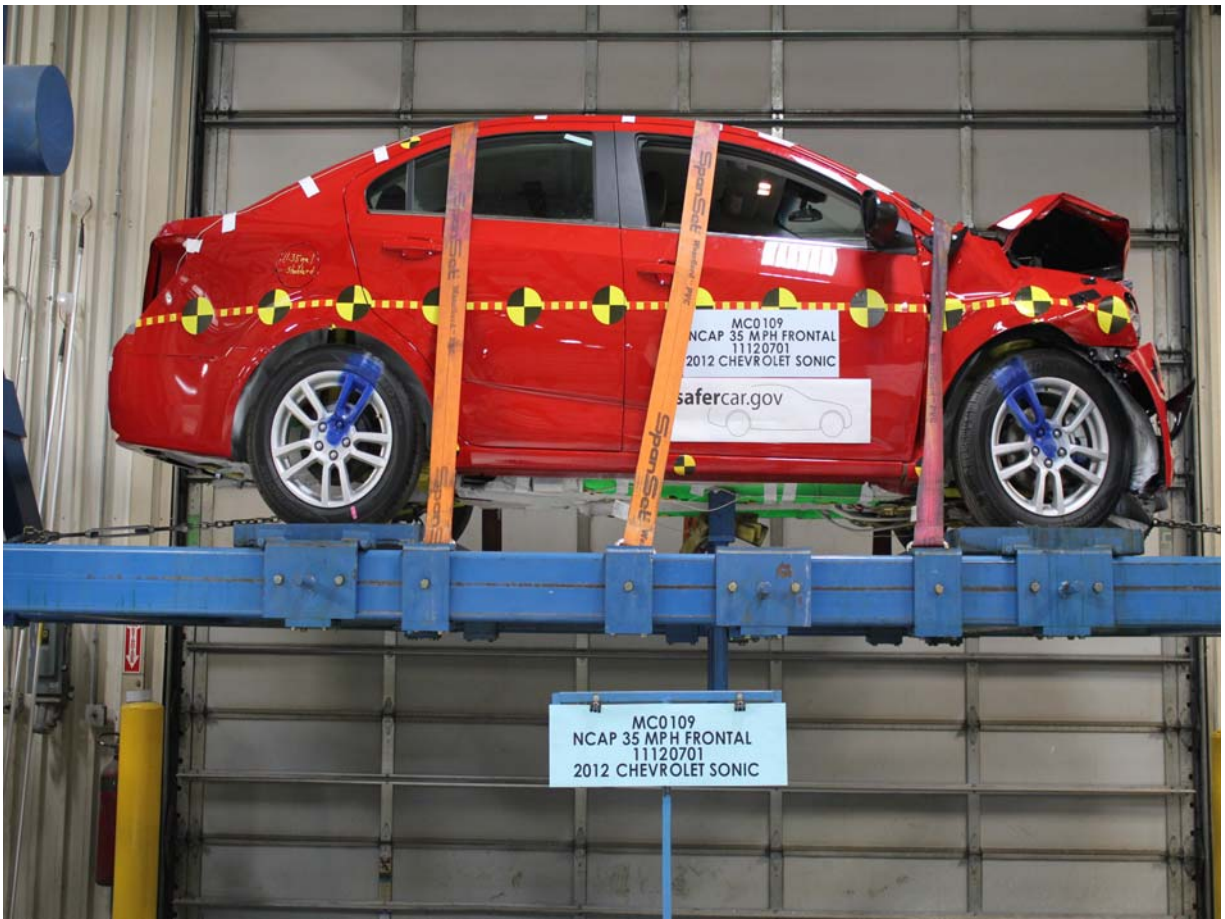
Vehicle at 360 Degrees on Static Rollover Device
