REPORT NUMBER: NCAP-CAL-12-013

**NEW CAR ASSESSMENT PROGRAM (NCAP)
FRONTAL BARRIER IMPACT TEST**

**AUTO ALLIANCE INTERNATIONAL, INC
2012 Mazda Mazda6 Sport
Four Door Sedan**

NHTSA No: MC5400

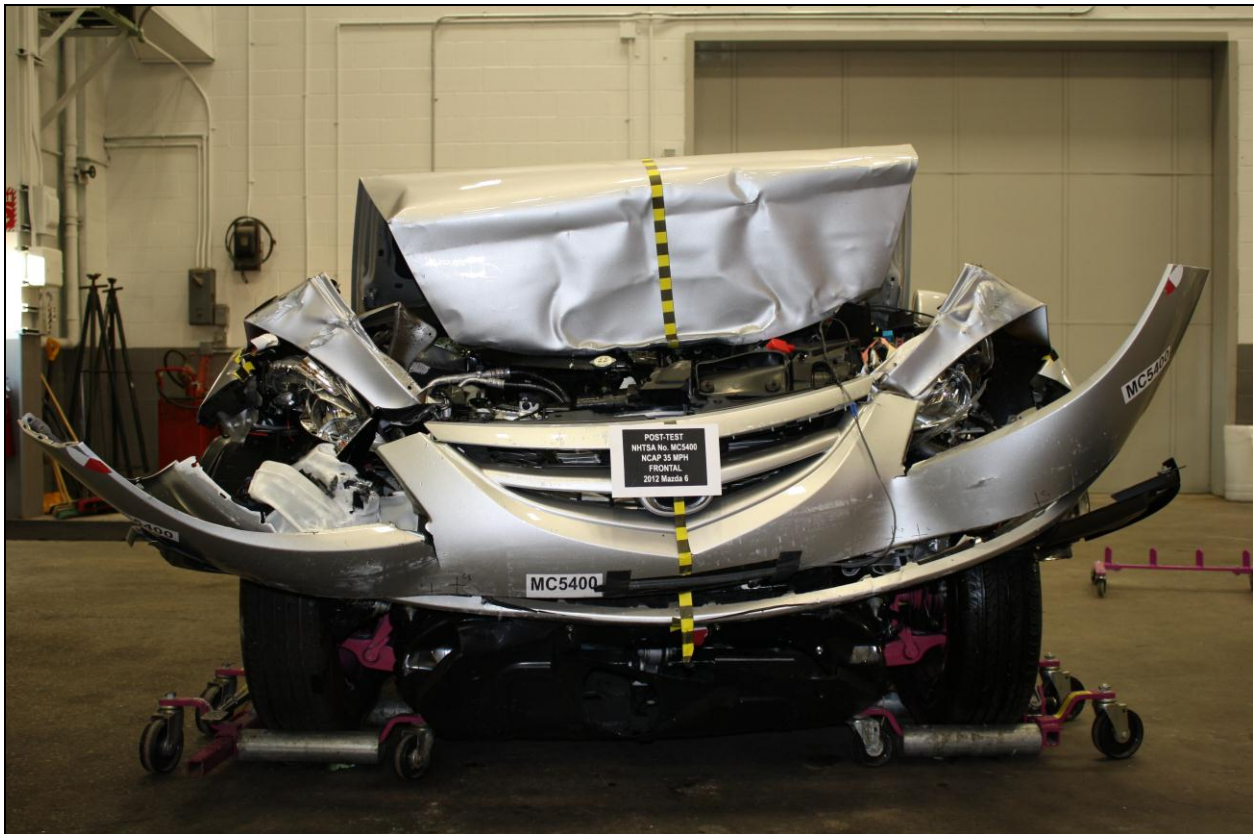
Figure A-8: Post-Test Front View of Test Vehicle

The maximum static crush of the vehicle was 454 mm and both the driver and passenger side doors remained closed during the impact event and were operable after the impact.

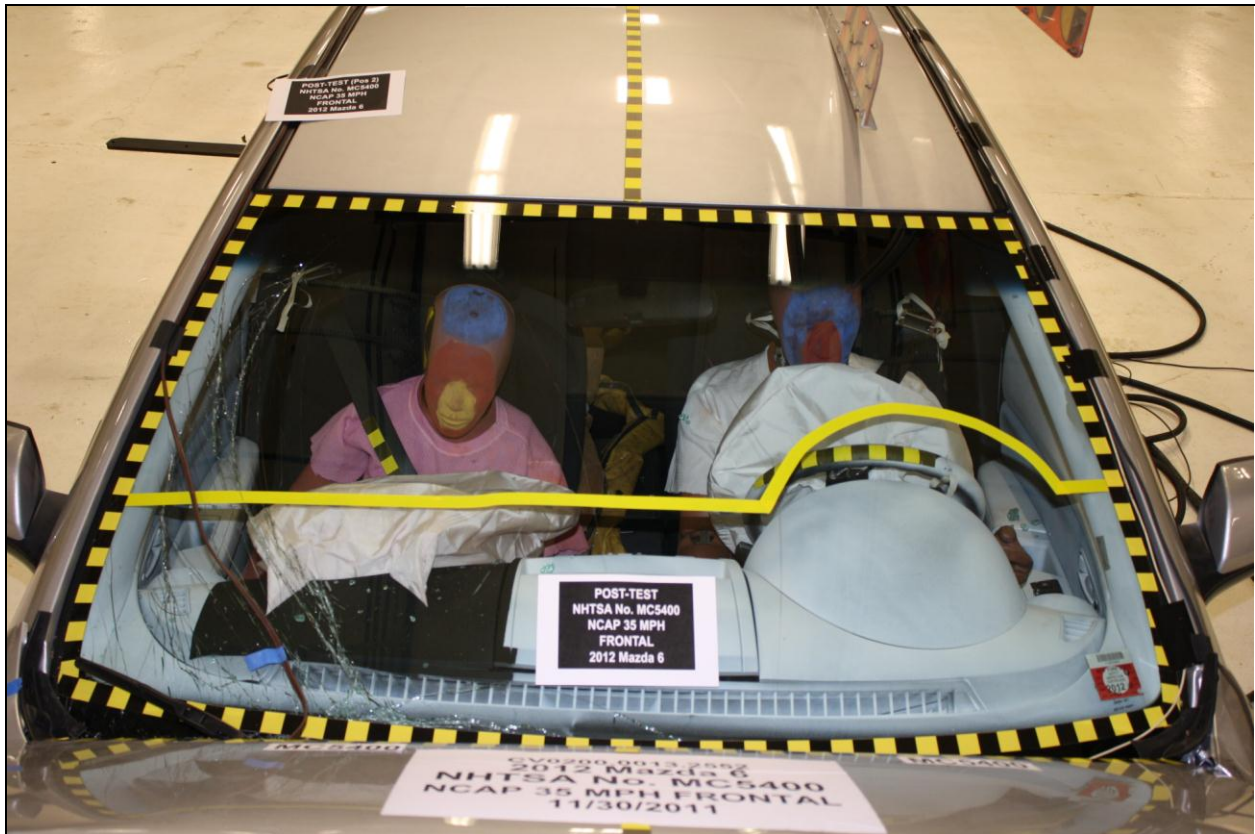
Figure A-18: Post-Test Windshield View

Critical Areas of Performance	Observations and Conclusions
Windshield Damage	Minor Cracks along Passenger's A-Pillar
Window Damage	Driver's side window shattered while in the door during impact.
Other Notable Effects	None

Measurement	Pre-Test (mm)	Post-Test (mm)	% Retention
Left Side	2,108	2108	100%
Right Side	2,108	2108	100%
Total	4,215	4215	100%

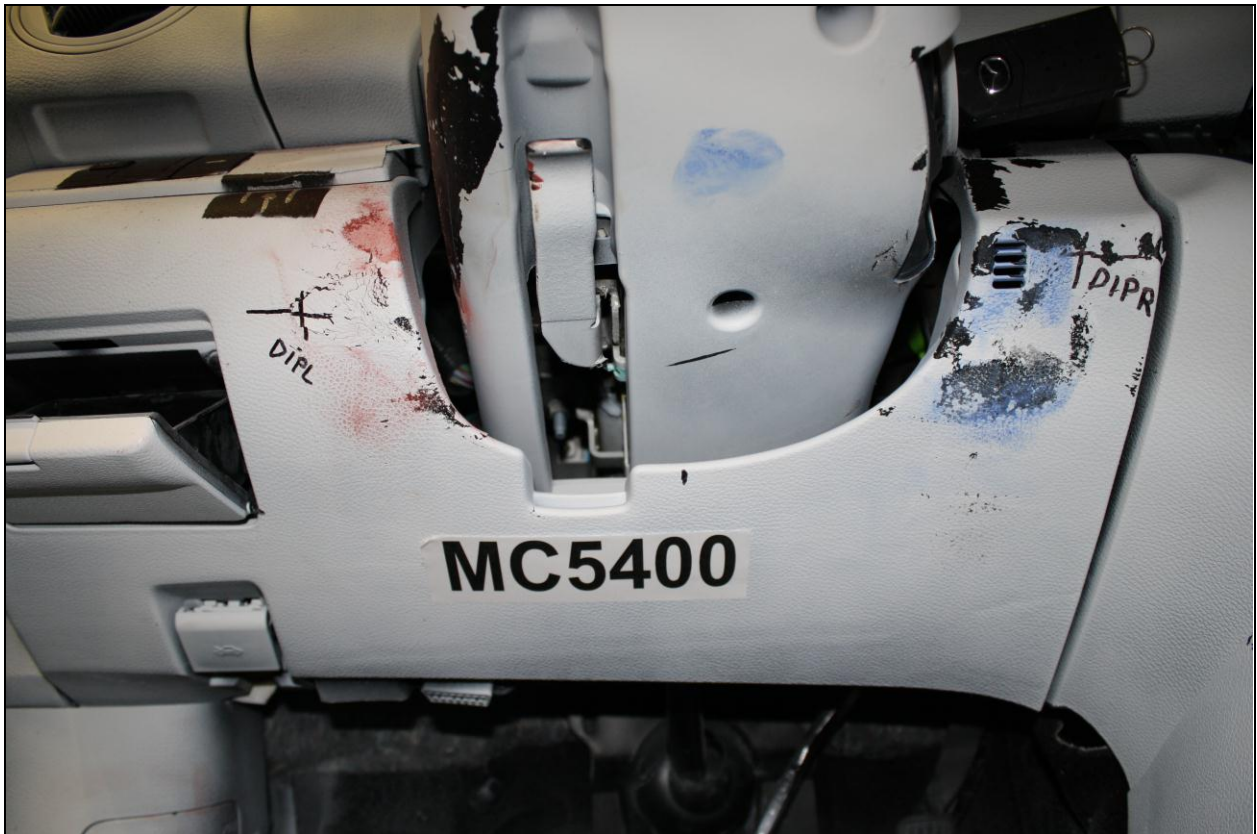
Figure A-40: Post-Test Driver's Side Knee Bolster

The driver's visible contact points were as follows: Face and Upper Torso with Frontal airbag with the back of head with the head restraint; both knees contacted the lower dash panel.

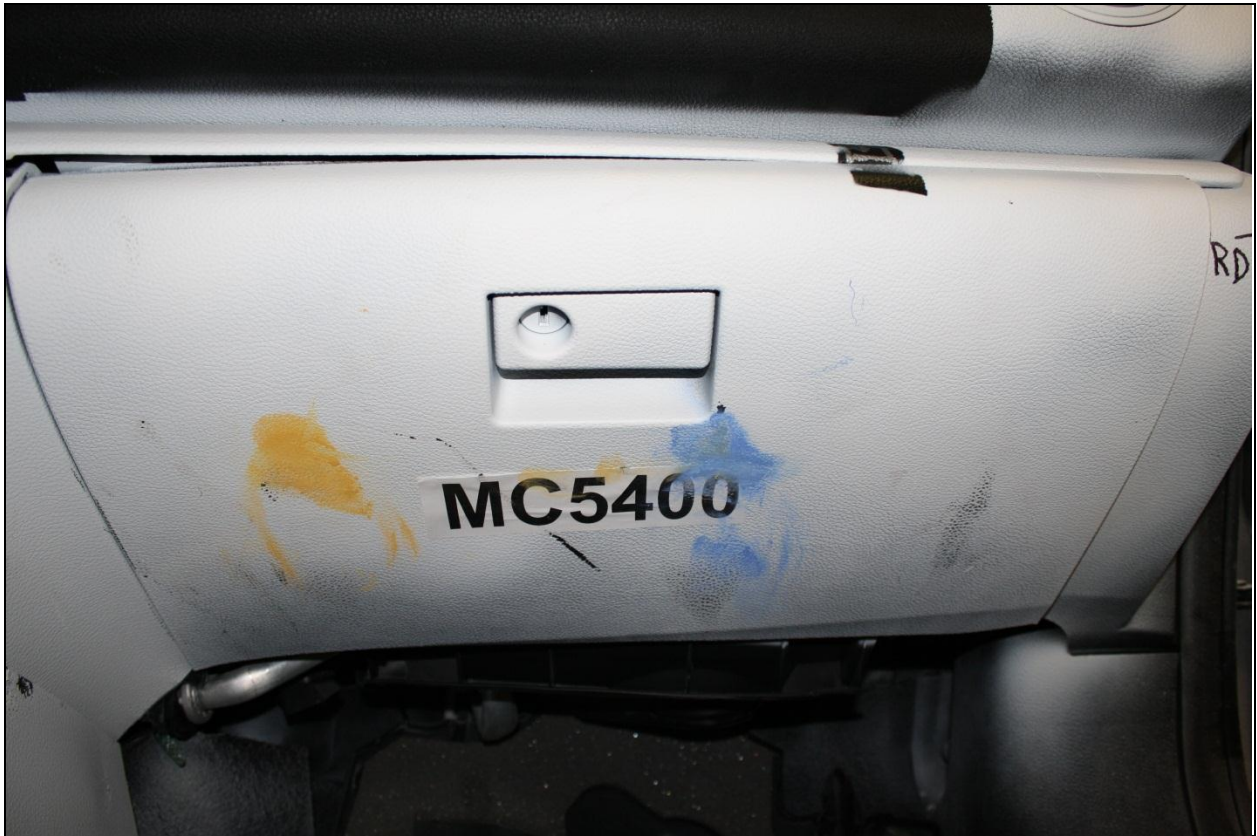
Figure A-59: Post-Test Passenger's Side Knee Bolster

The passenger's visible contact points were as follows: Face and Upper Torso with Frontal airbag with the back of head with the head restraint; both knees contacted the lower glovebox door.
