**REPORT NUMBER: SPNCAP-MGA-2012-037**

**NEW CAR ASSESSMENT PROGRAM (NCAP)  
Side Impact Pole Test**

**KIA MOTORS MANUFACTURING GEORGIA, INC. FOR HYUNDAI MOTOR COMPANY  
2012 Hyundai Santa Fe GLS FWD SUV  
NHTSA No.: MC0514**

**FINAL REPORT**

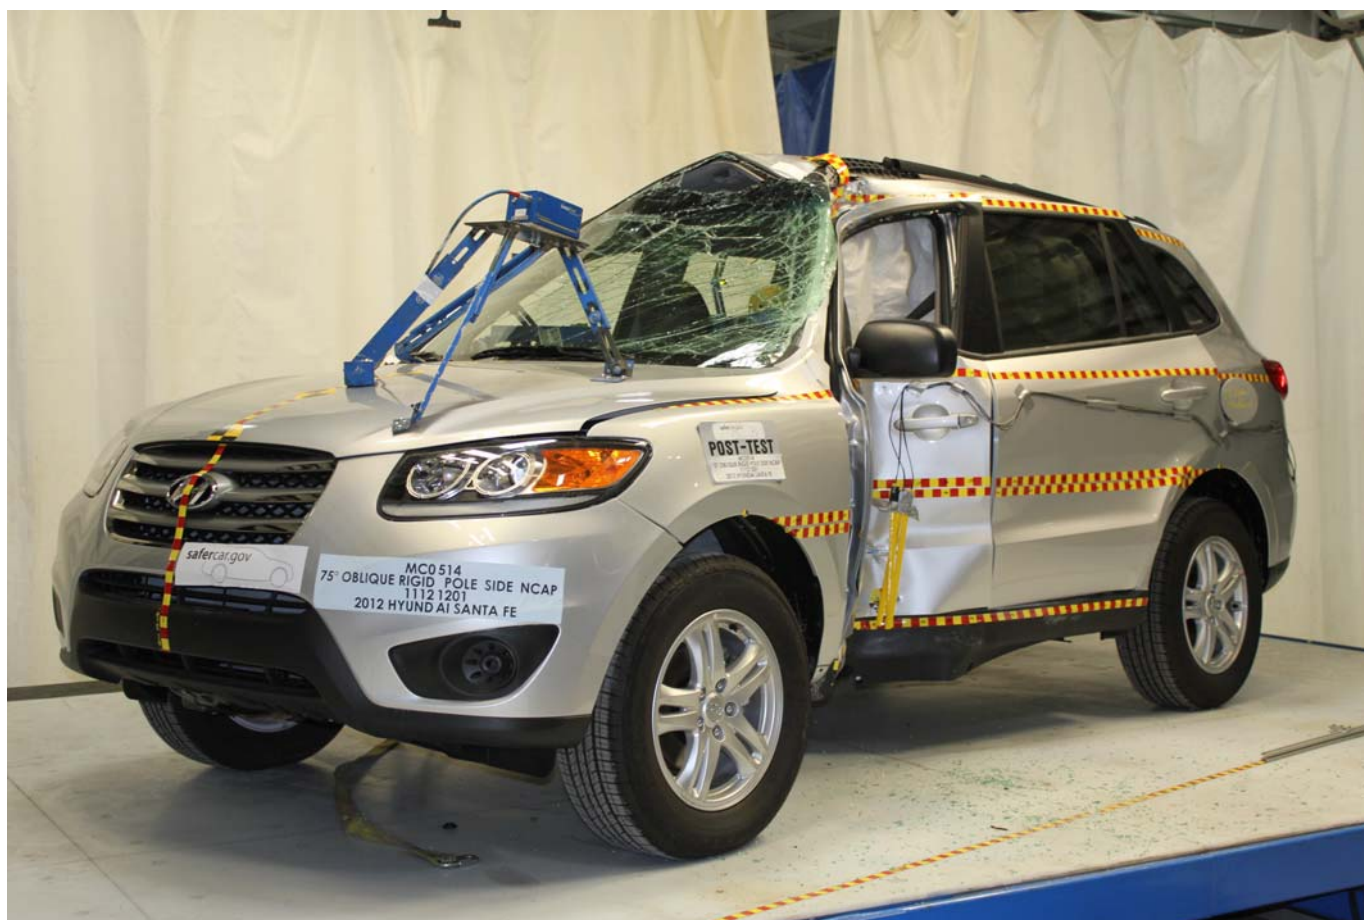
Post-Test Left Front  $\frac{3}{4}$  View of Test Vehicle

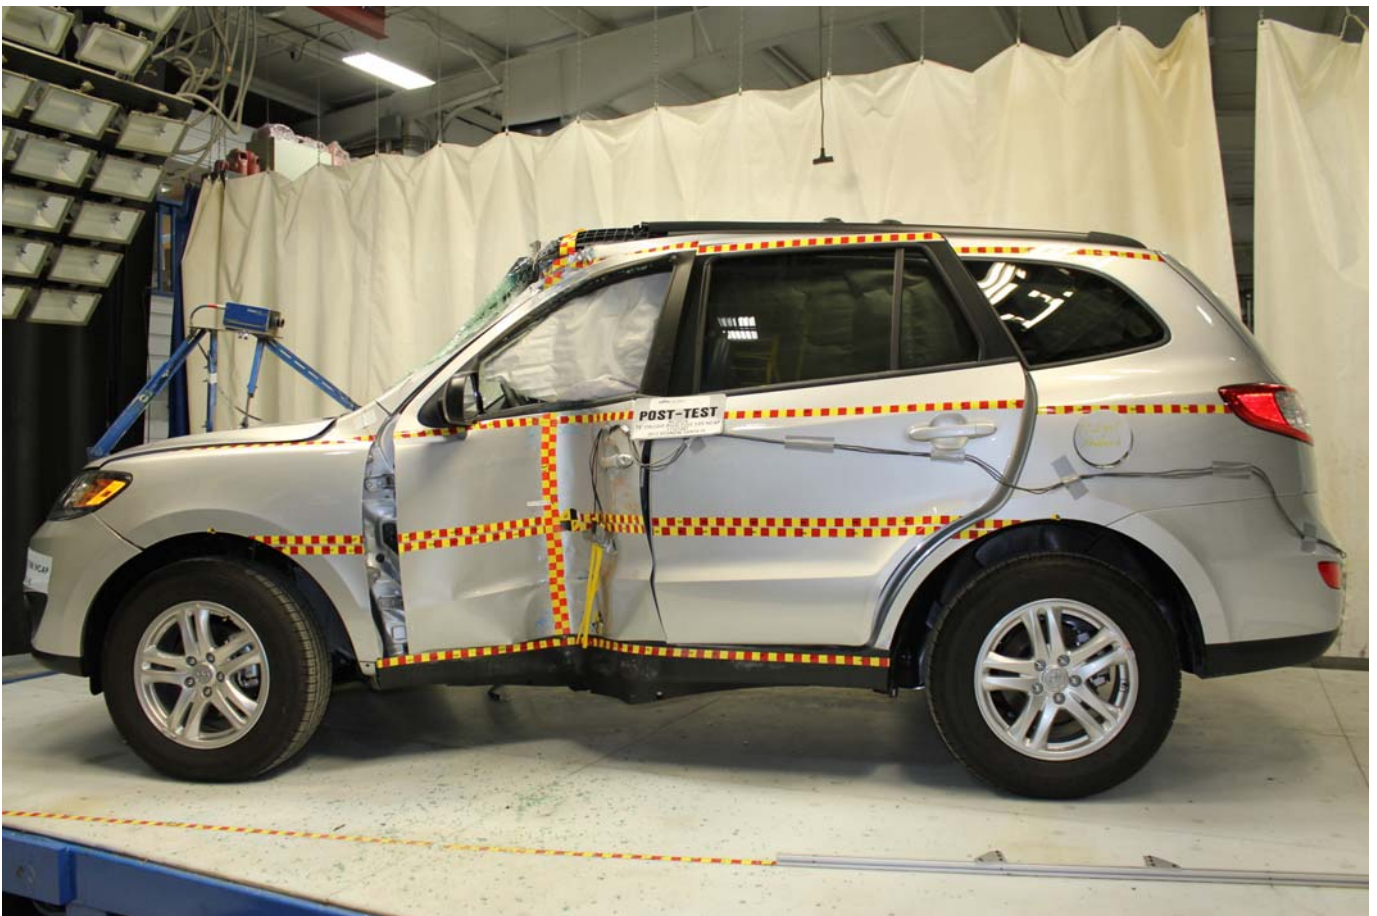
Post-Test Left Side View of Test Vehicle

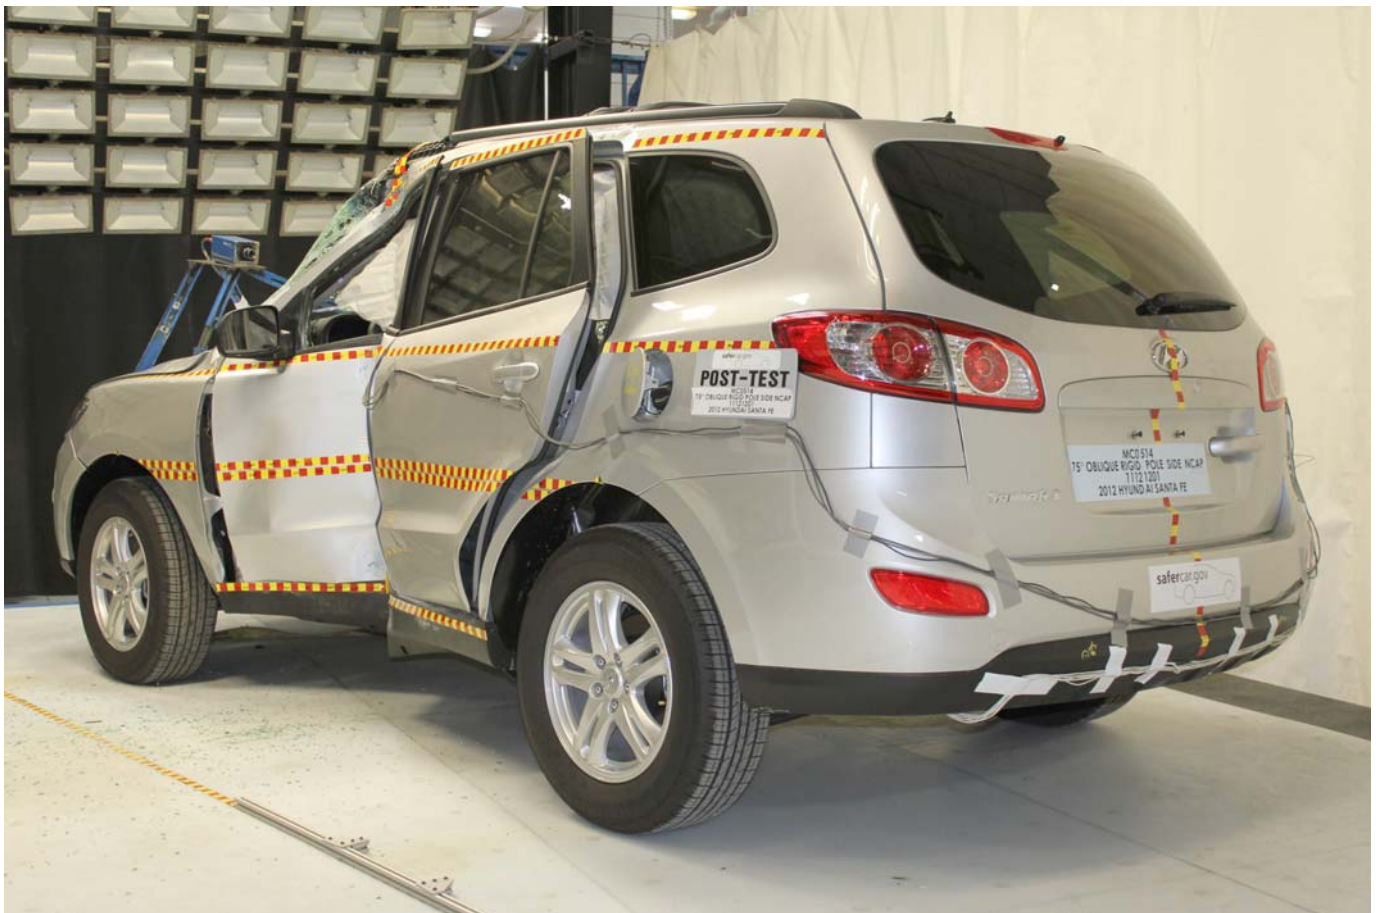
Post-Test Left Rear  $\frac{3}{4}$  View of Test Vehicle

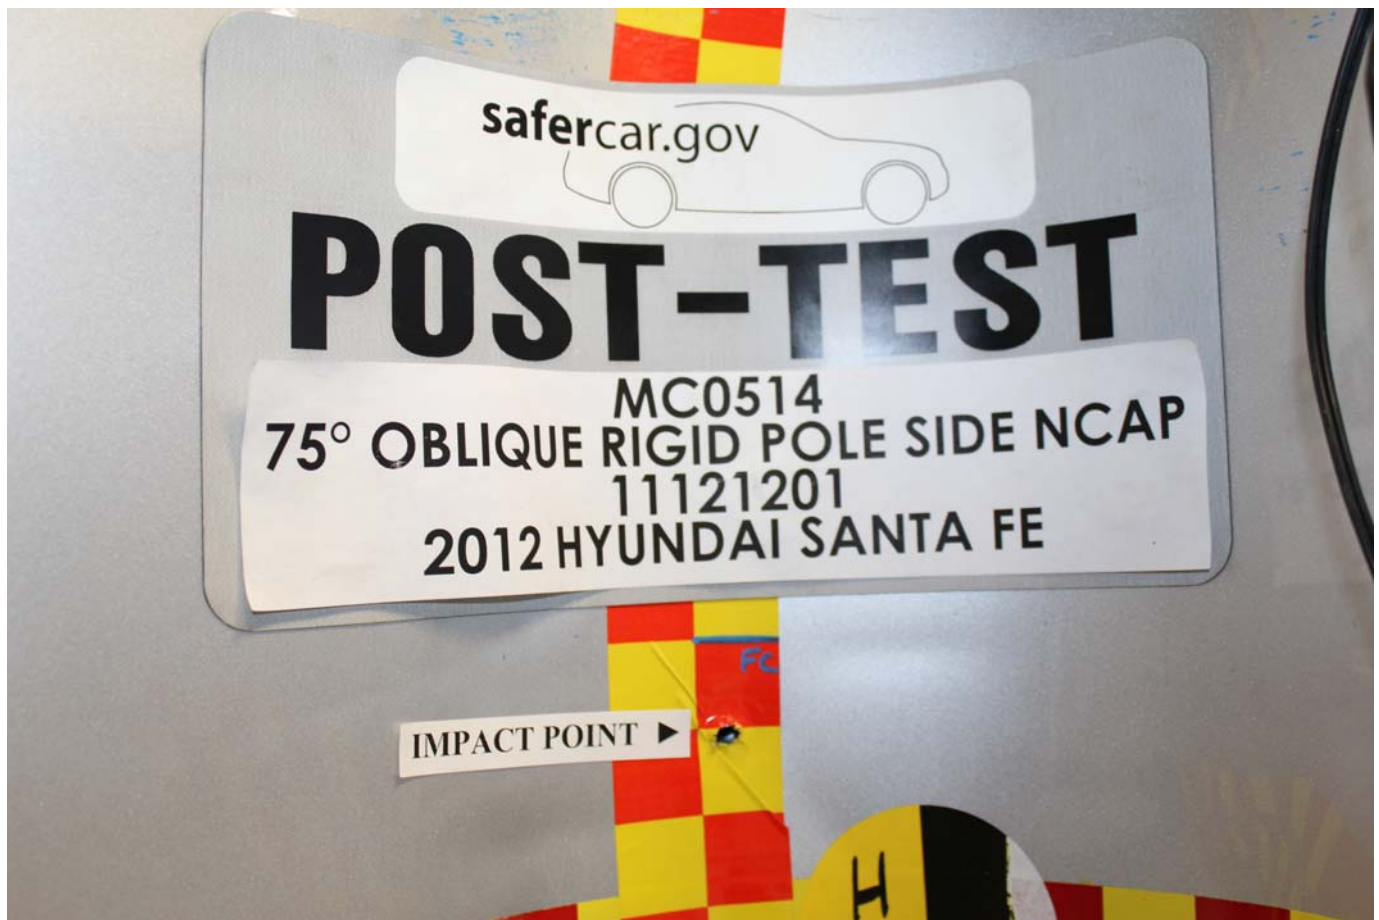
Post-Test Close-Up View of Impact Point Target Showing Impact Location

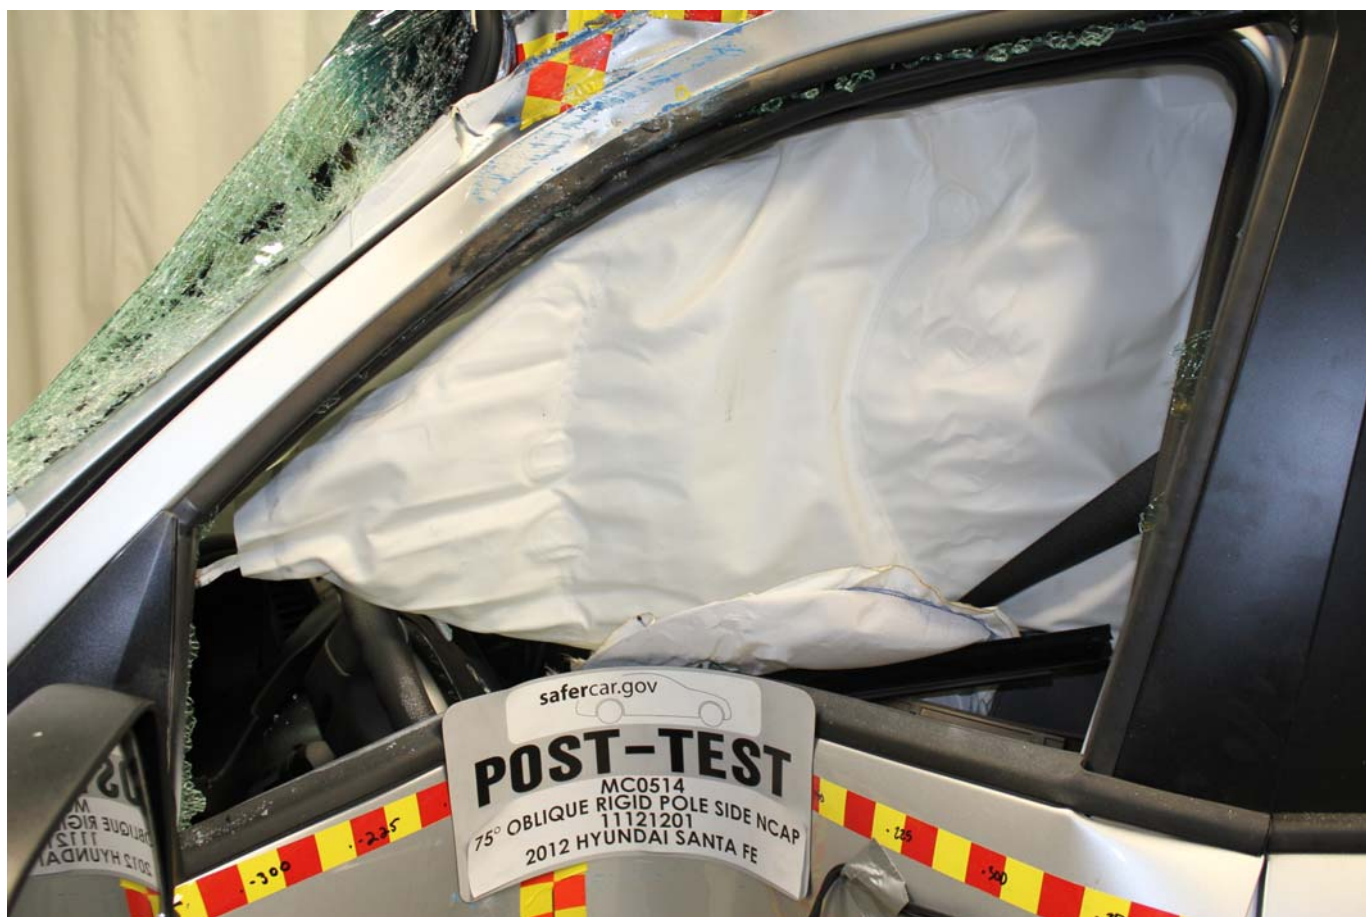
Post-Test Left Side View of Dummy Shoulder and Door Top View

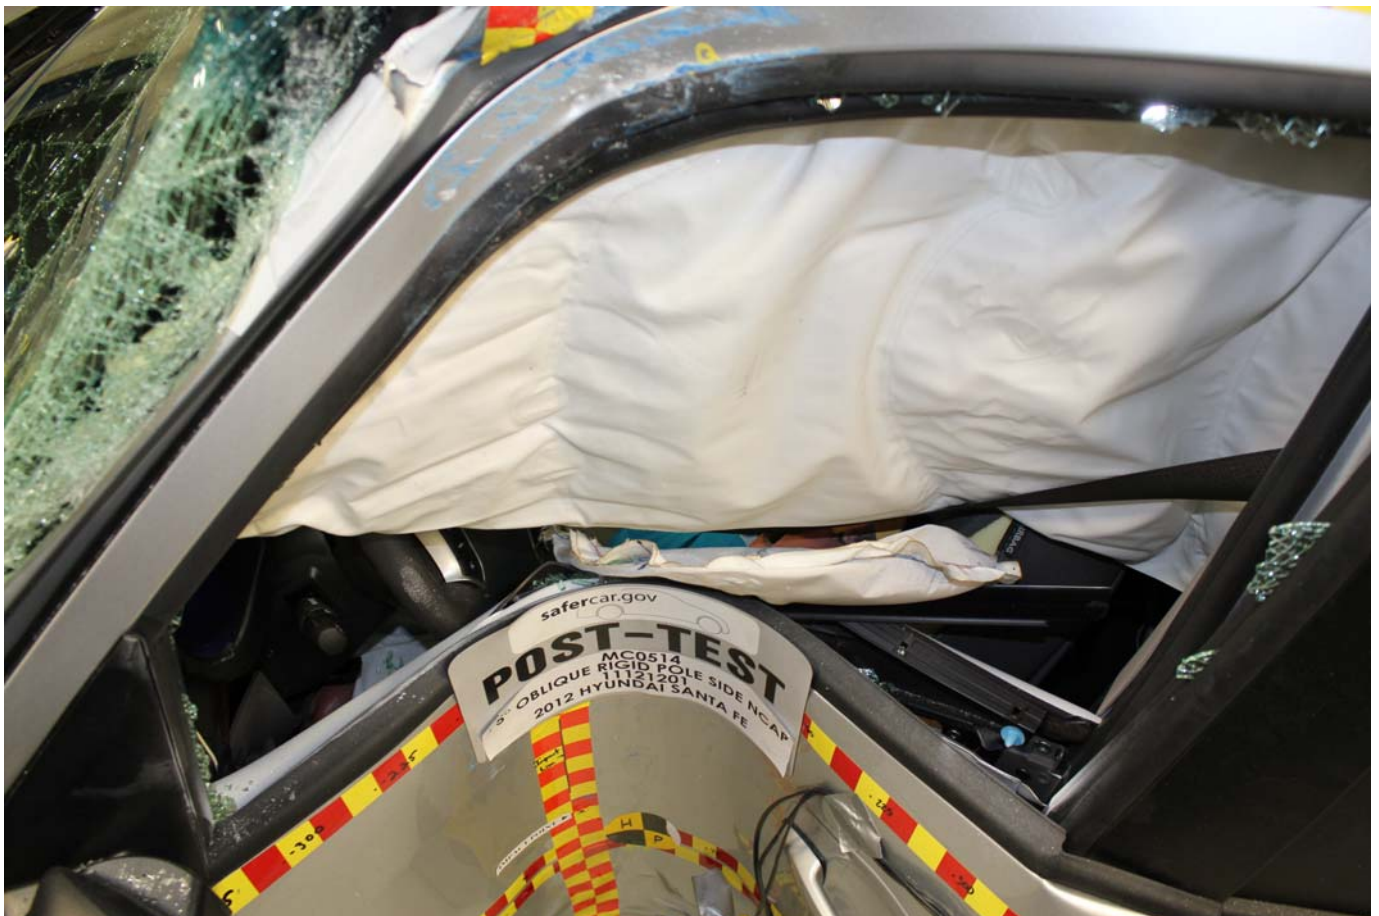
Post-Test Dummy and Door Clearance View

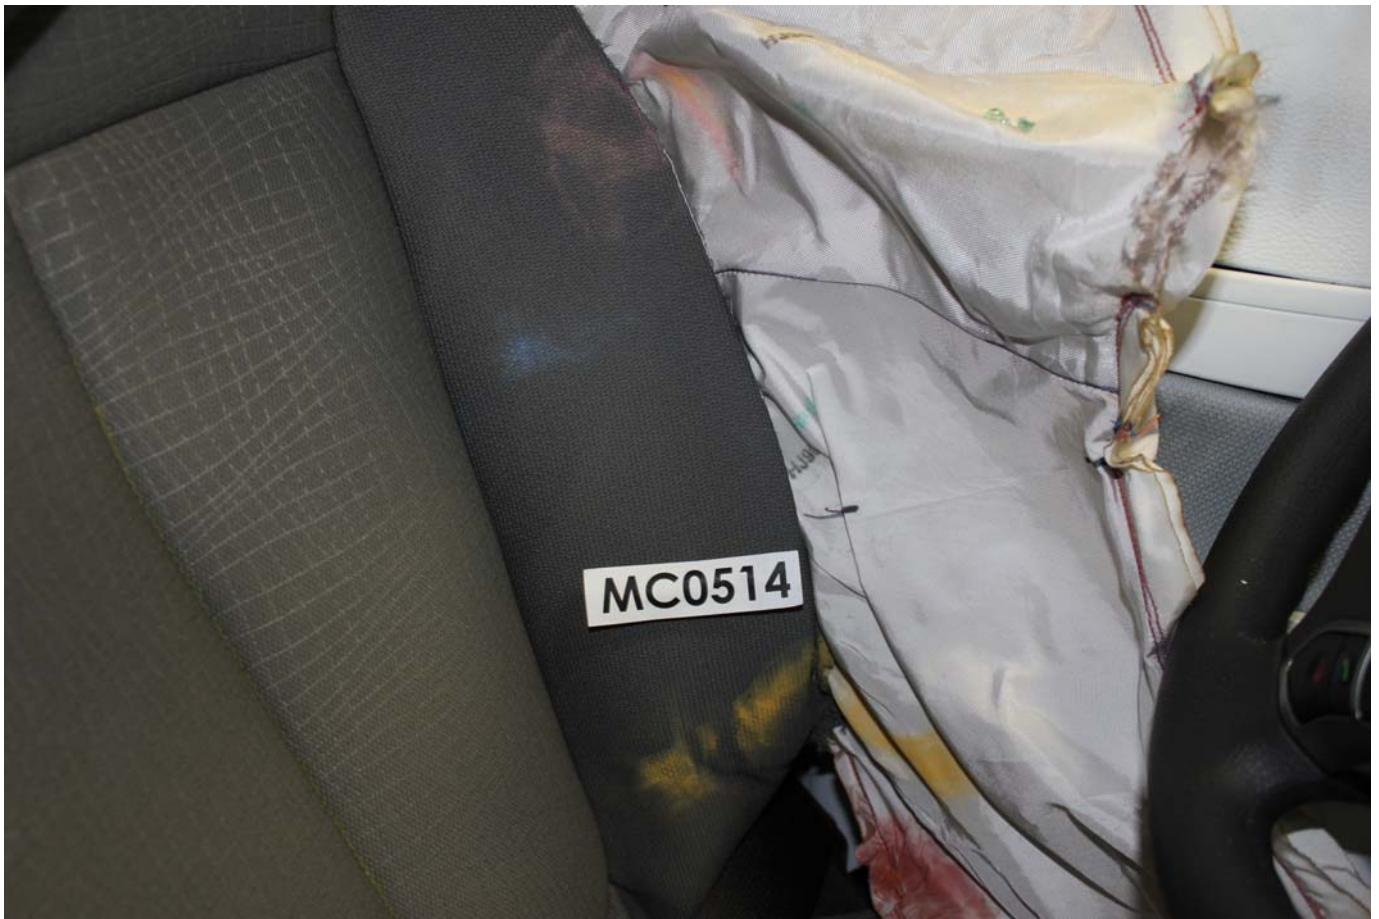
Post-Test Dummy Close-Up Torso Contact with Vehicle Interior View

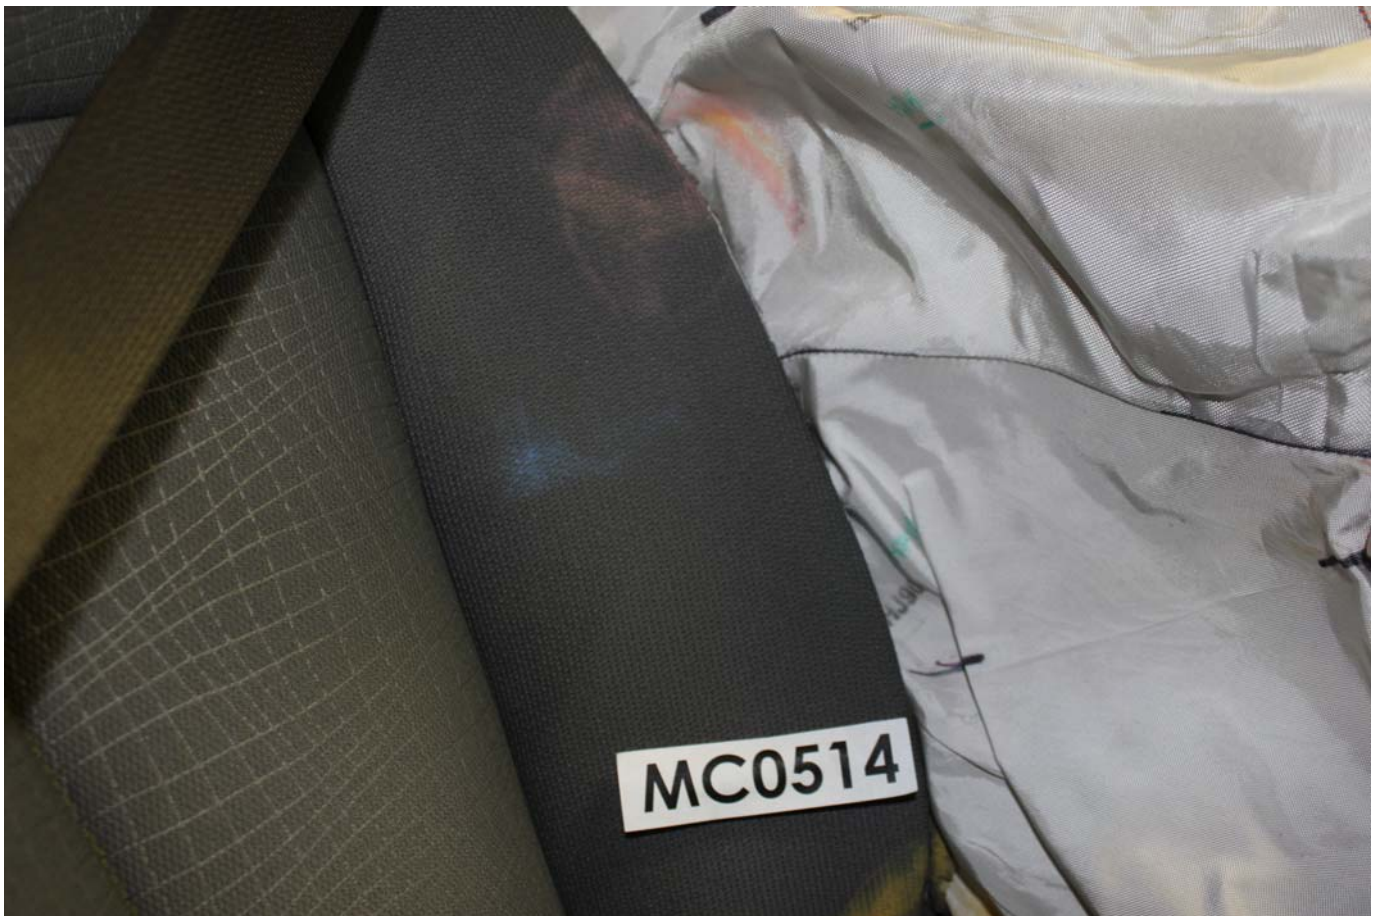
Post-Test Dummy Close-Up Torso Contact with Side Air Bag View

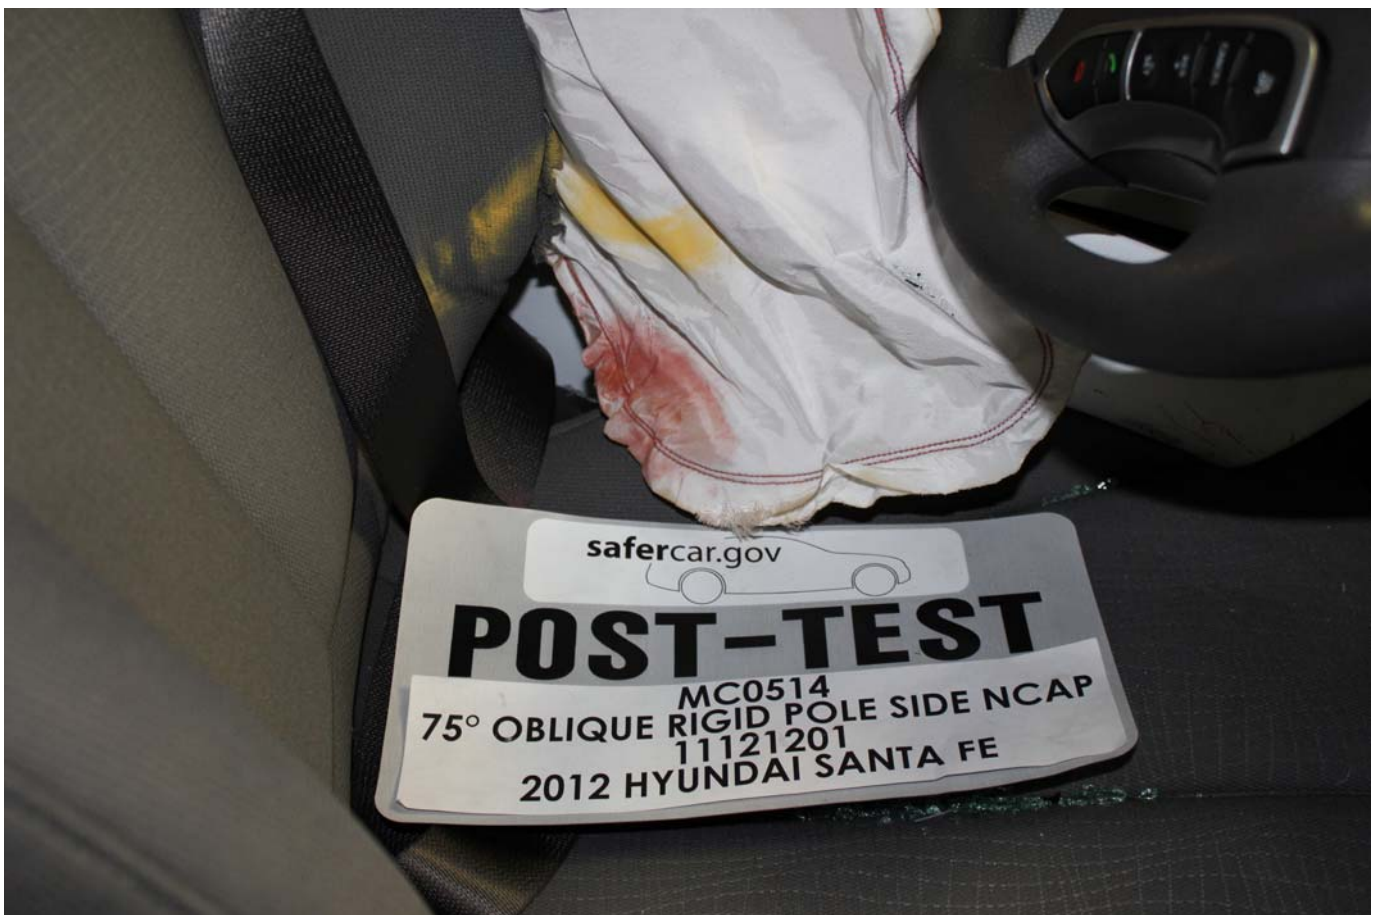
Post-Test Dummy Close-Up Pelvis Contact with Side Air Bag View

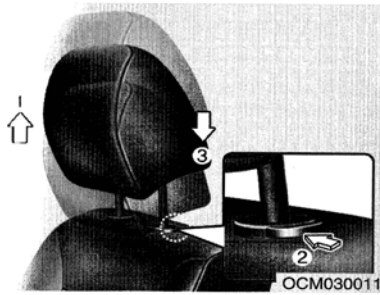
To raise the headrest, pull it up to the desired position (1). To lower the headrest, push and hold the release button (2) on the headrest support and lower the headrest to the desired position (3).

- For maximum effectiveness in case of an accident, the headrest should be adjusted so the middle of the headrest is at the same height as the center of gravity of an occupant's head. Generally, the center of gravity of most people's head is similar with the height of the top of their eyes. Also, adjust the headrest as close to your head as possible. For this reason, the use of a cushion that holds the body away from the seatback is not recommended.
- Do not operate the vehicle with the headrests removed as severe injury to the occupants may occur in the event of an accident. Headrests may provide protection against neck injuries when properly adjusted.
- Do not adjust the headrest position of the driver's seat while the vehicle is in motion.
