**REPORT NUMBER: NCAP-CAL-12-018**

**NEW CAR ASSESSMENT PROGRAM (NCAP)  
FRONTAL BARRIER IMPACT TEST**

**FUJI Heavy Industries LTD  
2012 Subaru Outback  
Utility Vehicle**

**FINAL REPORT**

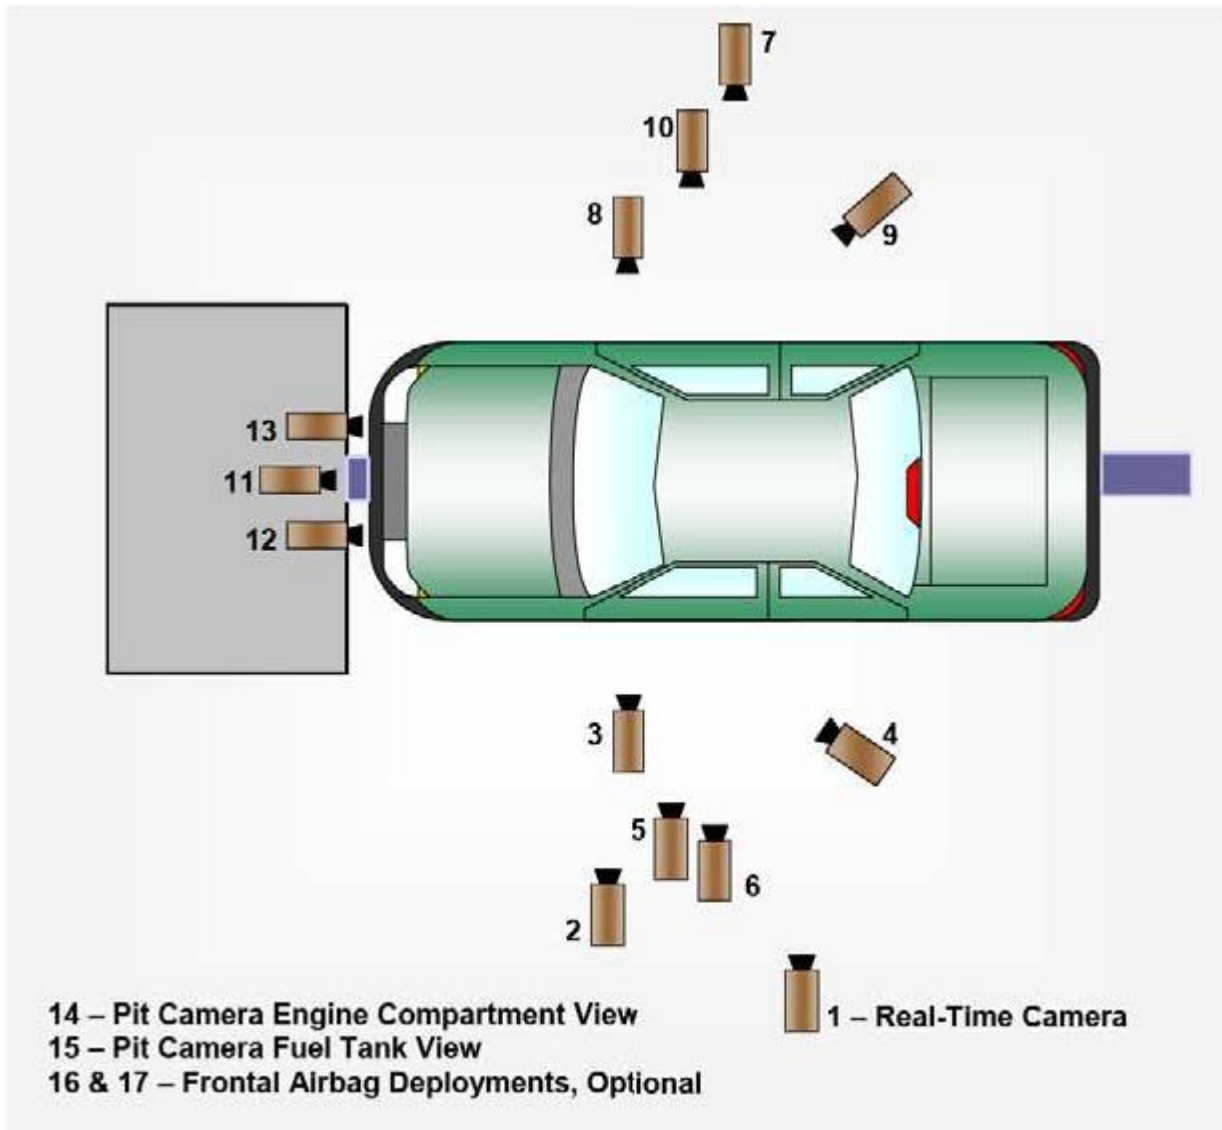
**CAMERA POSITIONS FOR FRONTAL IMPACTS**

One real-time camera and 14 high-speed cameras were used to document the frontal barrier impact event. Camera locations and other pertinent camera information can be found in this report.

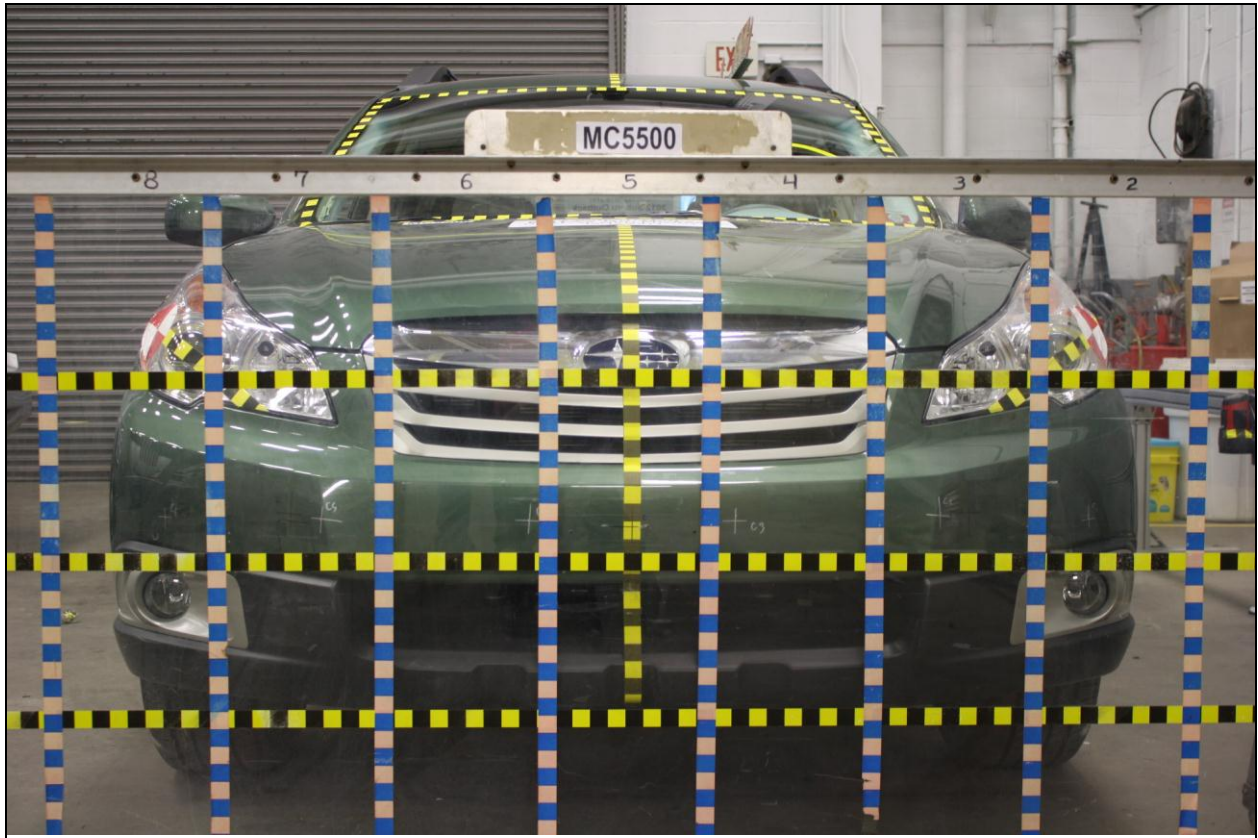
**Figure A-1: Load Cell Location**

A load cell barrier consisting of 36 load cells was impacted by a 2012 Subaru Outback Utility Vehicle at a velocity of 56.31 kph. The test was performed at Calspan on 12/13/2011. Pre- and post-test photographs of the vehicle and dummies can be found in Appendix A.

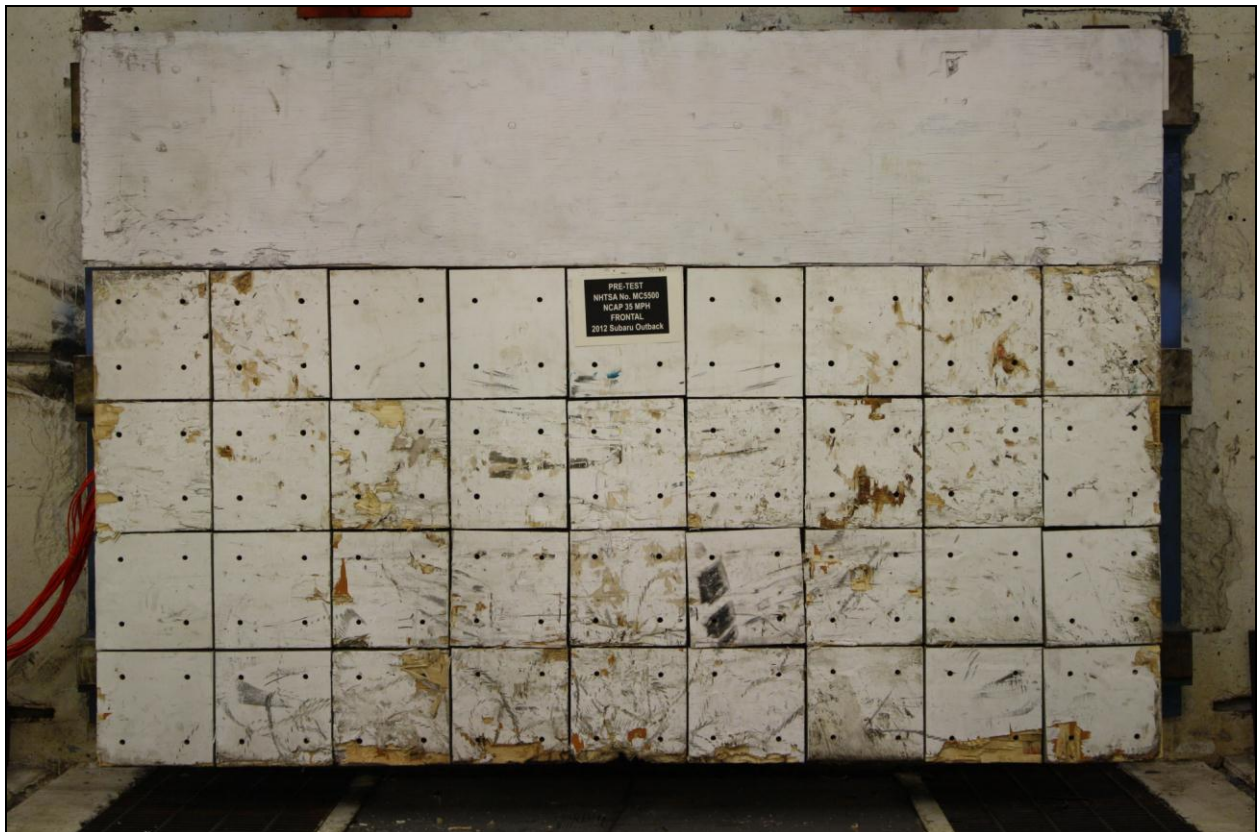
**Figure A-2: Load Cell Wall**

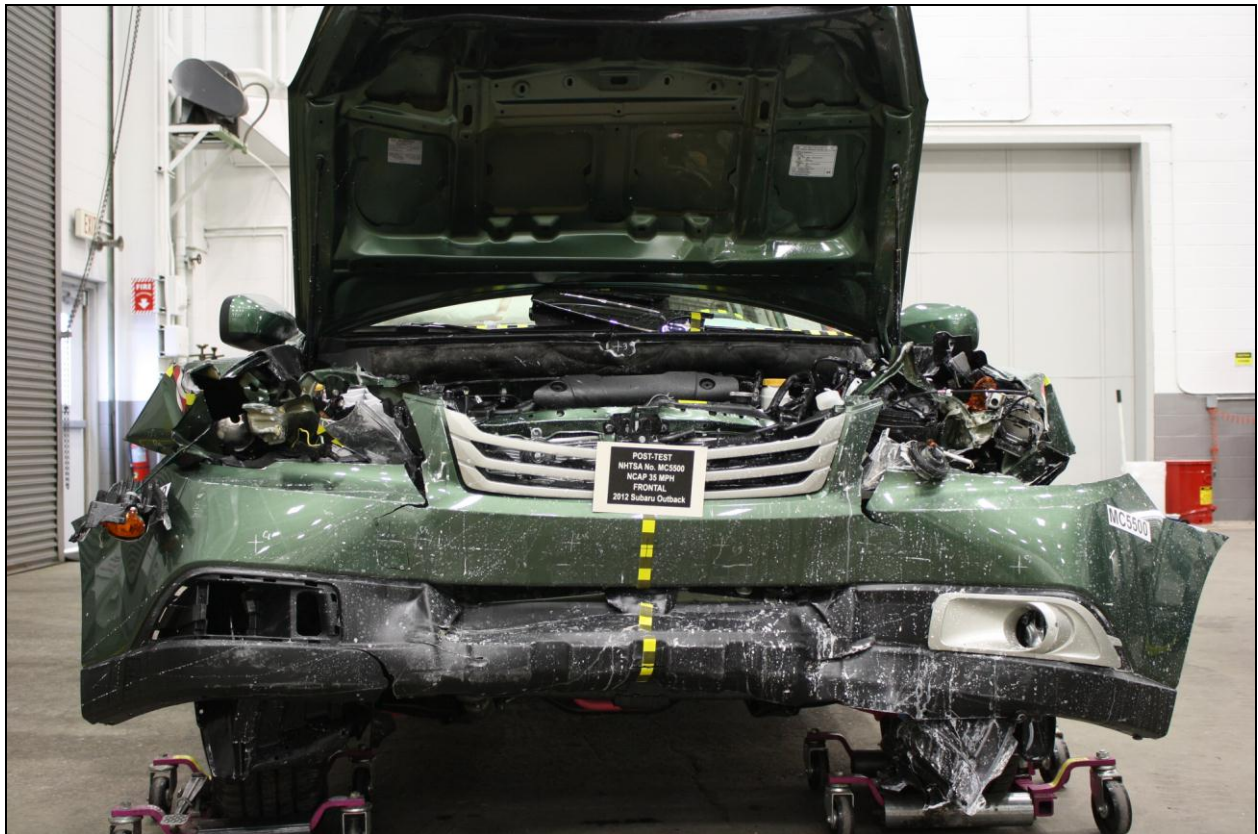
**Figure A-8: Post-Test Front View of Test Vehicle**

The maximum static crush of the vehicle was 544 mm and both the driver and passenger side doors remained closed during the impact event and were operable after the impact.

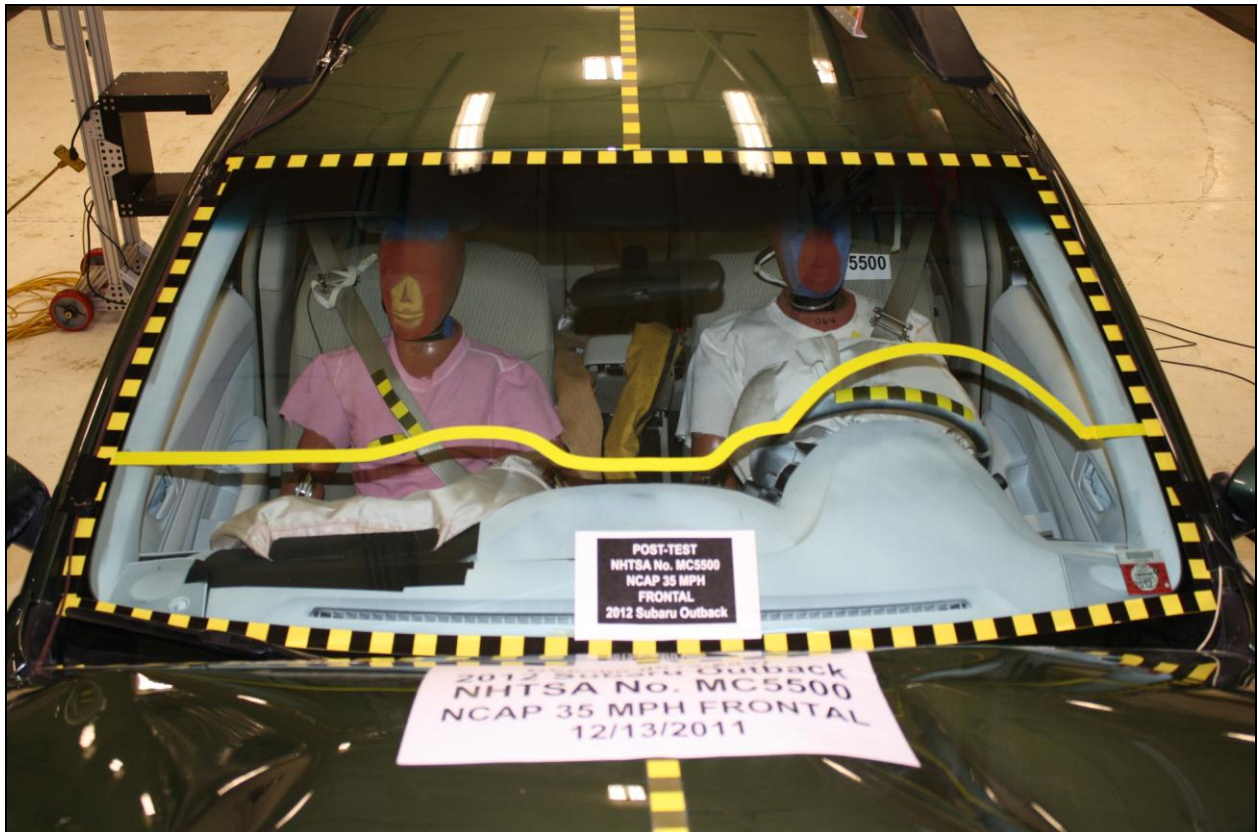
Figure A-18: Post-Test Windshield View

There was 100 percent windshield retention and no intrusion into the protected zone of the windshield during the event. There was no Stoddard solvent leakage after the event or during any phase of the static rollover.

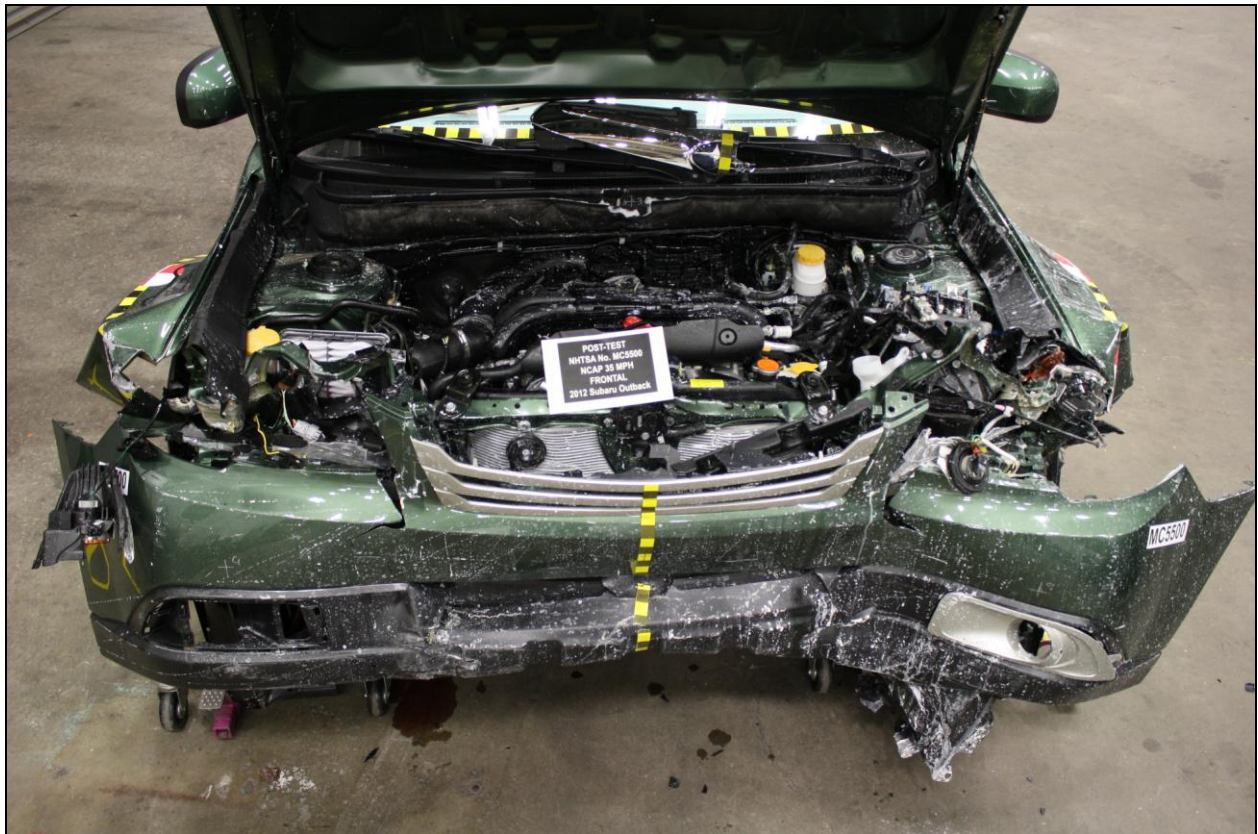
**Figure A-20: Post-Test Engine Compartment View**

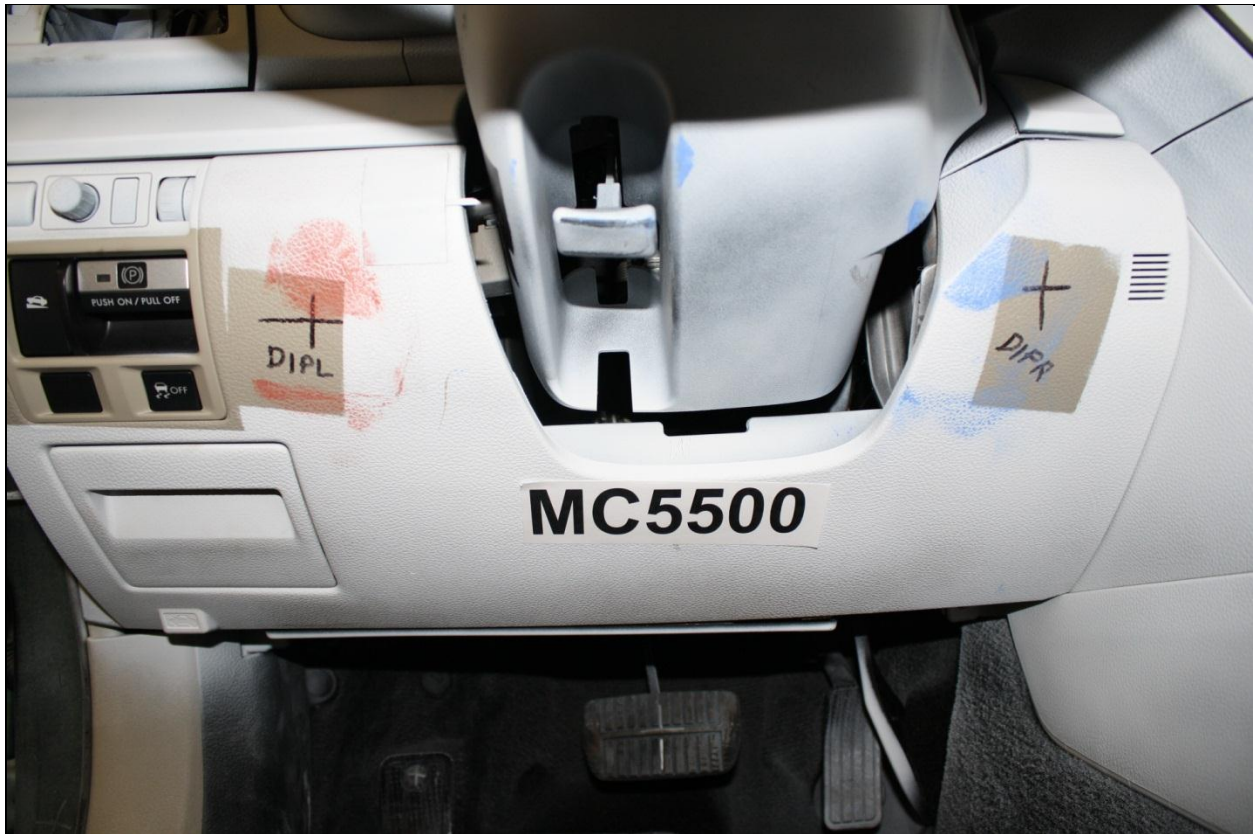
**Figure A-40: Post-Test Driver's Side Knee Bolster**

The driver's visible contact points were as follows: Face and Upper Torso with Frontal airbag with the back of head with the head restraint; both knees contacted the lower dash panel.

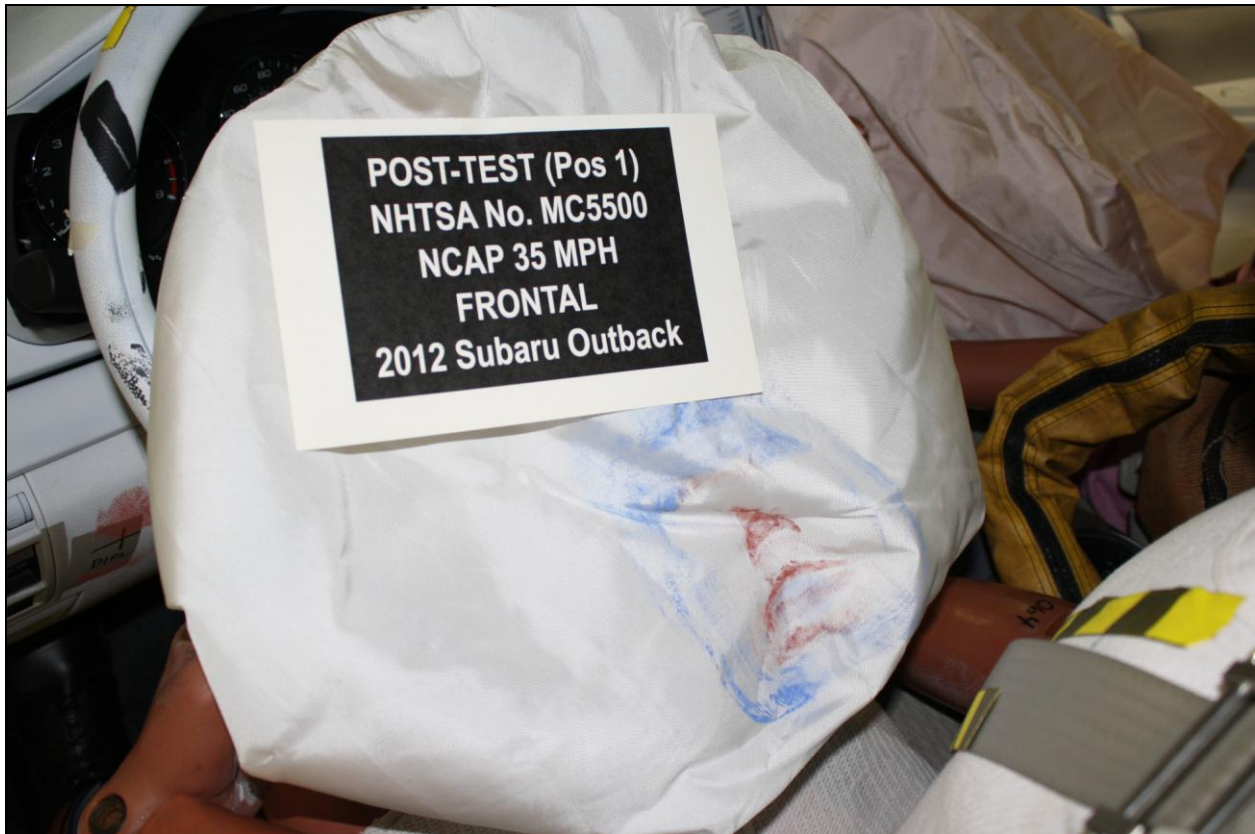
**Figure A-44: Post-Test Driver Dummy Contact With Airbag**

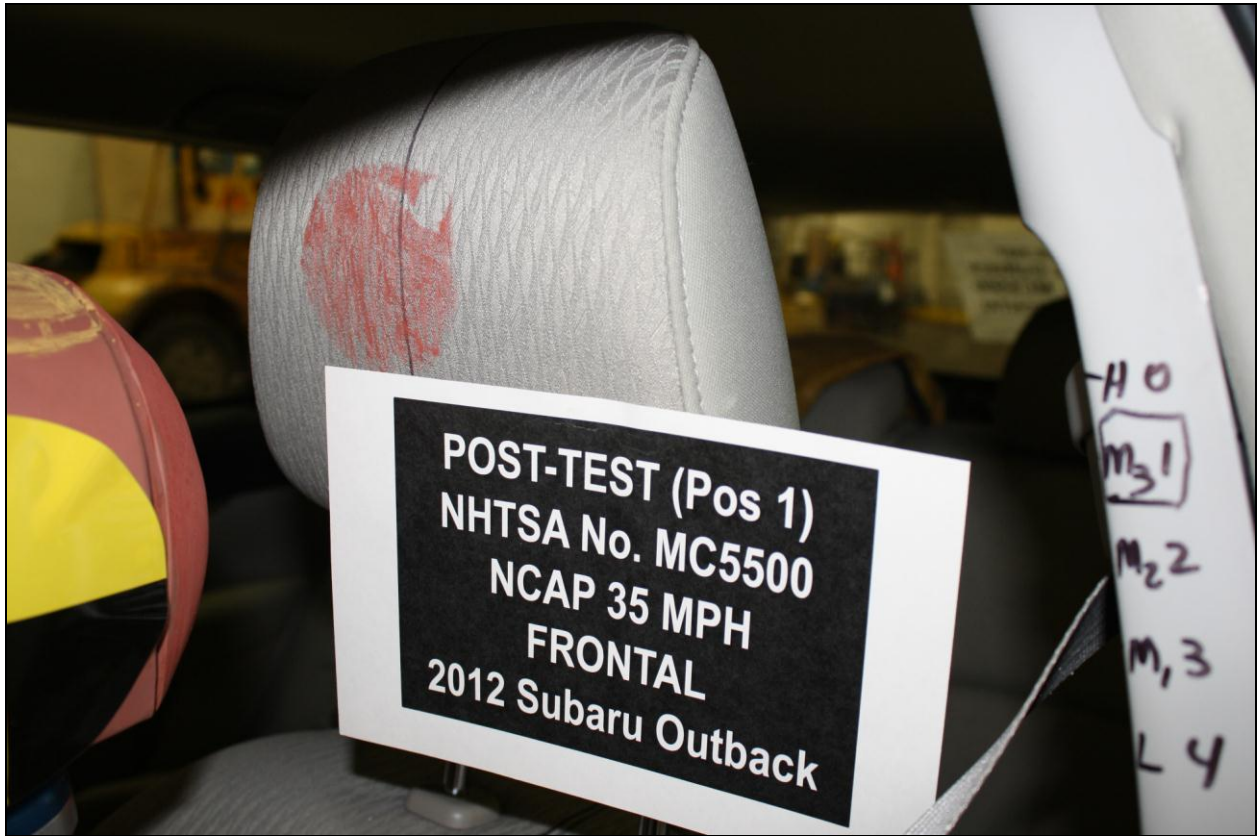
**Figure A-45: Post-Test Driver Dummy Contact with Headrest**

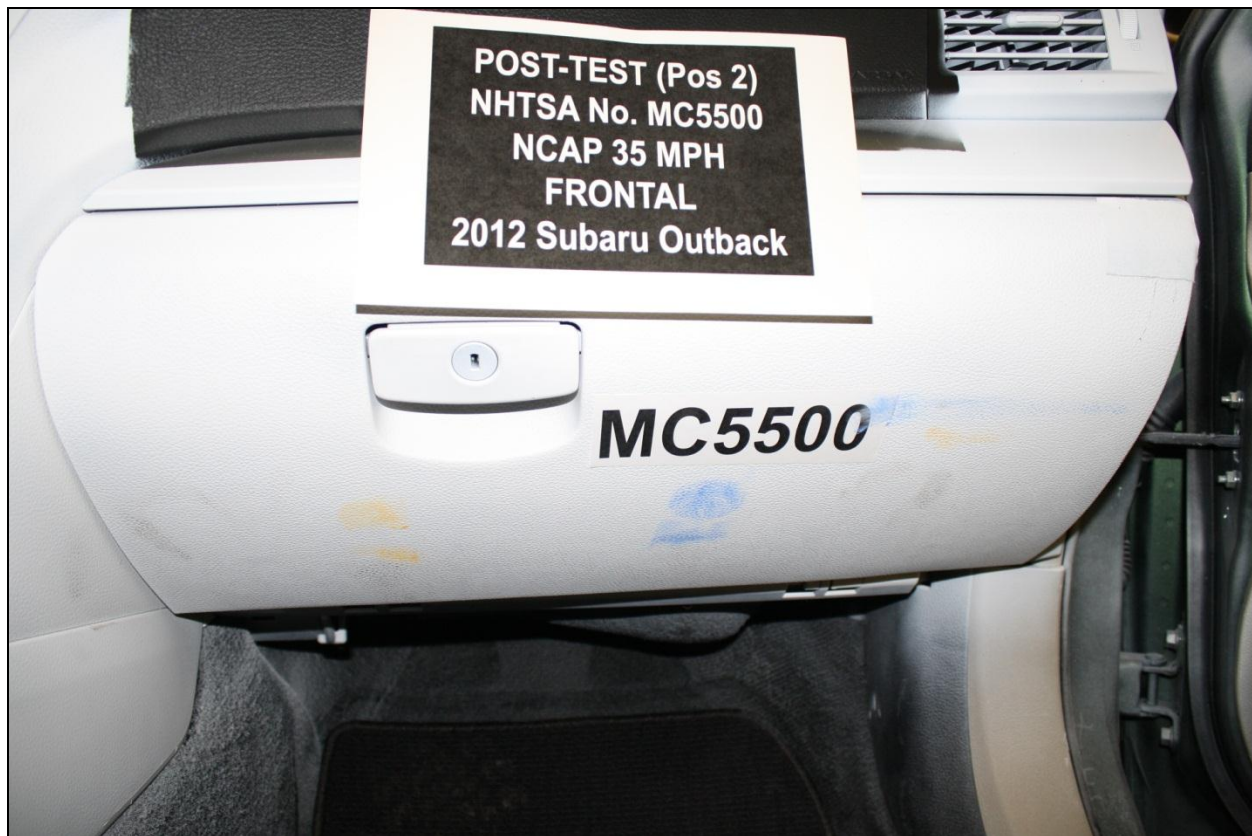
**Figure A-59: Post-Test Passenger's Side Knee Bolster**

The passenger's visible contact points were as follows: Face and Upper Torso with Frontal airbag with the back of head with the head restraint; both knees contacted the lower glovebox door.

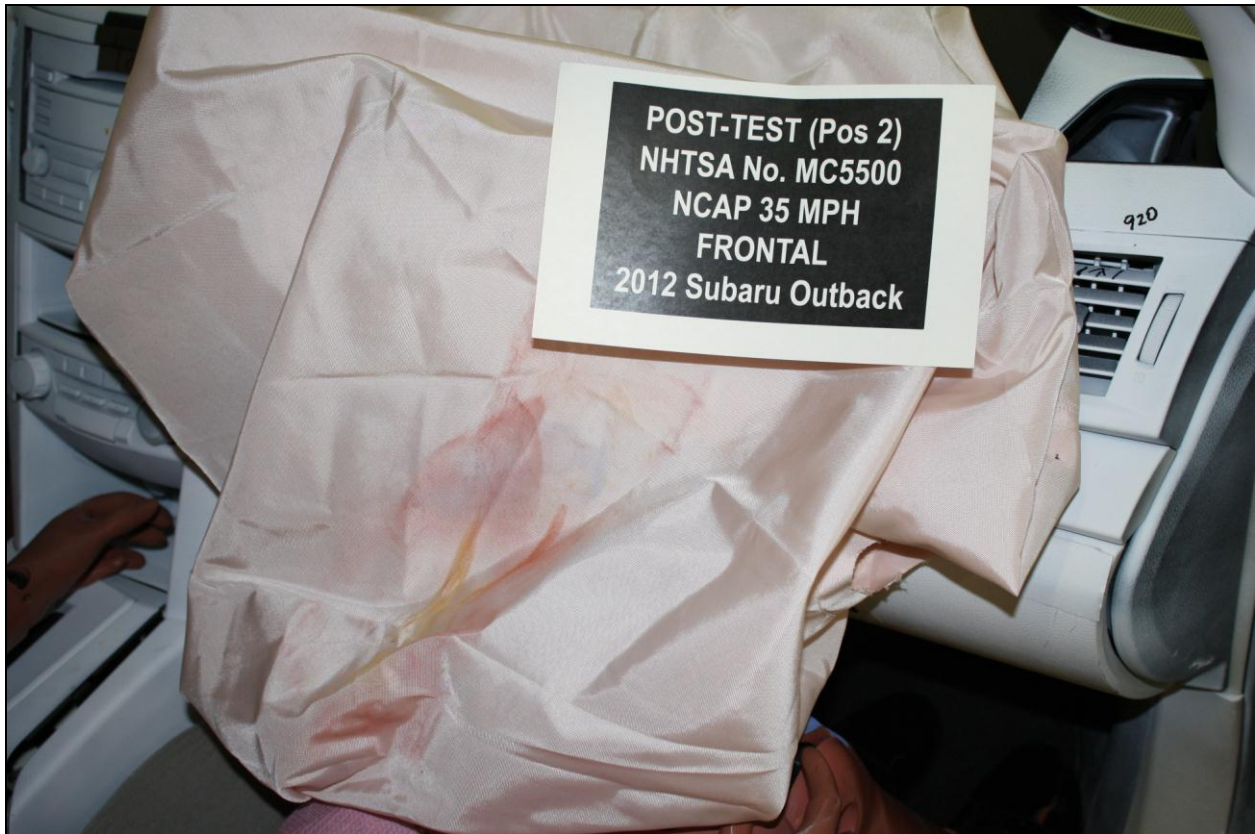
**Figure A-62: Post-Test Passenger Dummy Contact with Airbag**

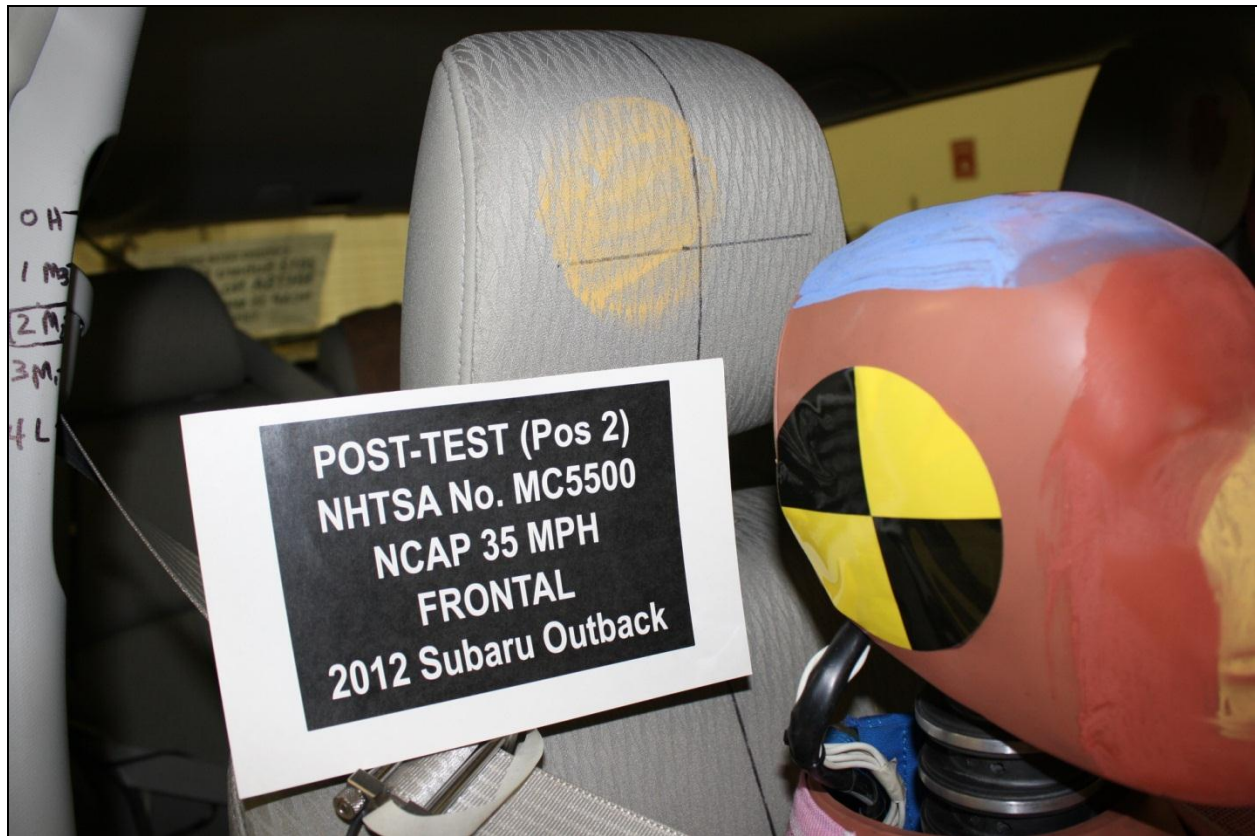
**Figure A-62a: Post-Test Passenger Dummy Contact with Headrest**

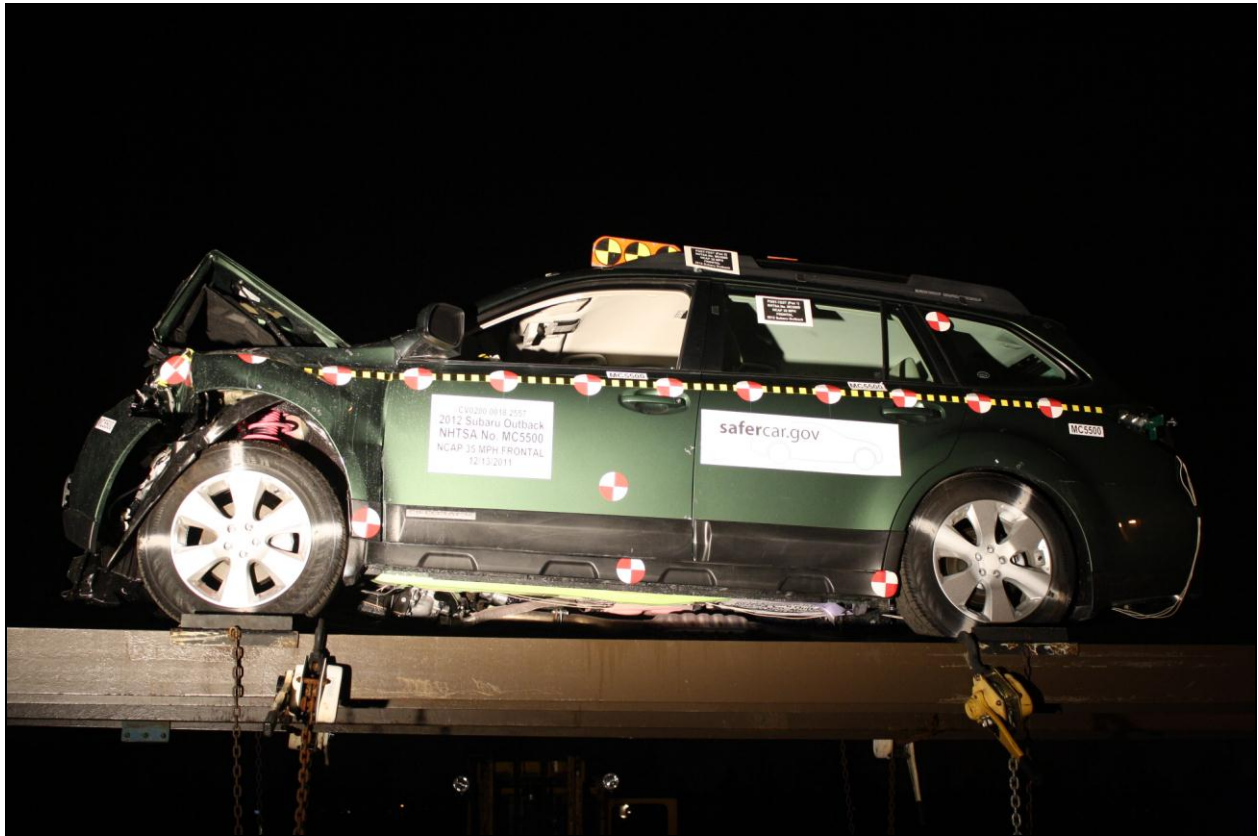
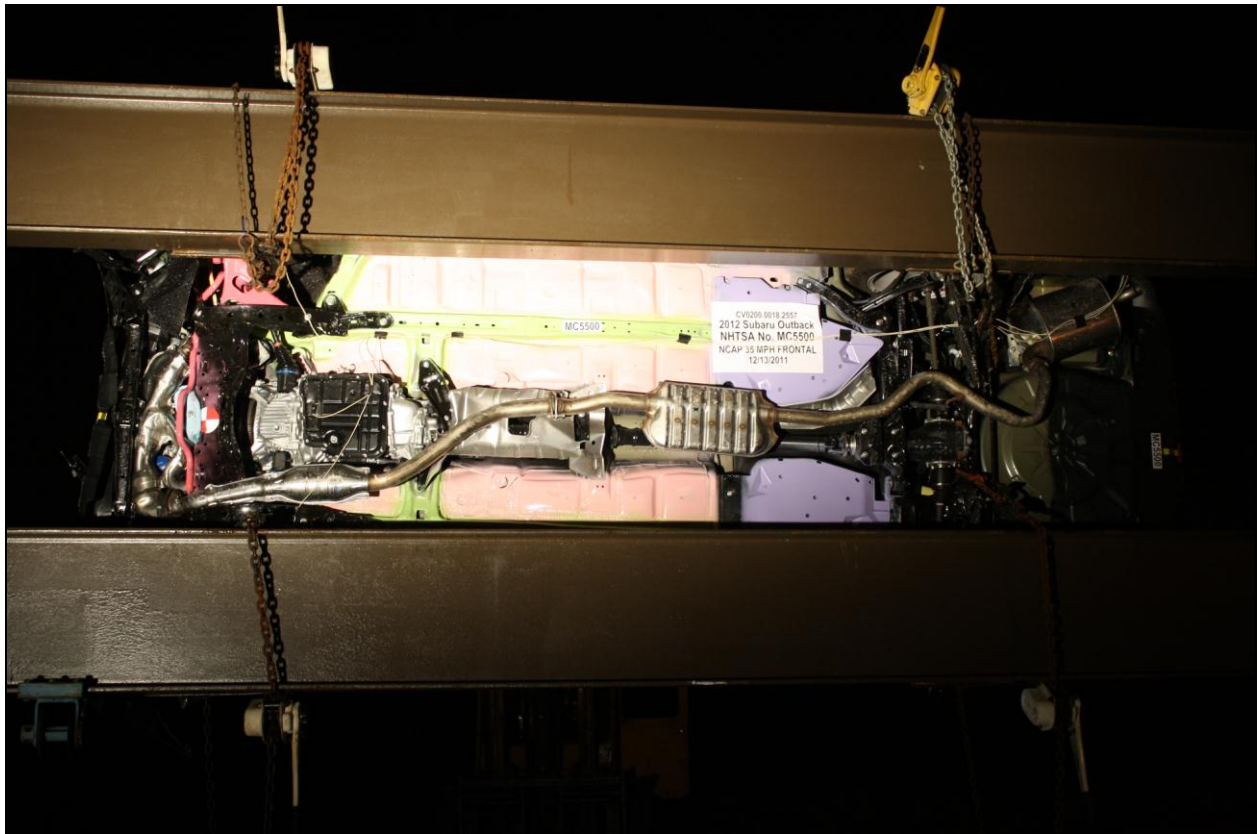
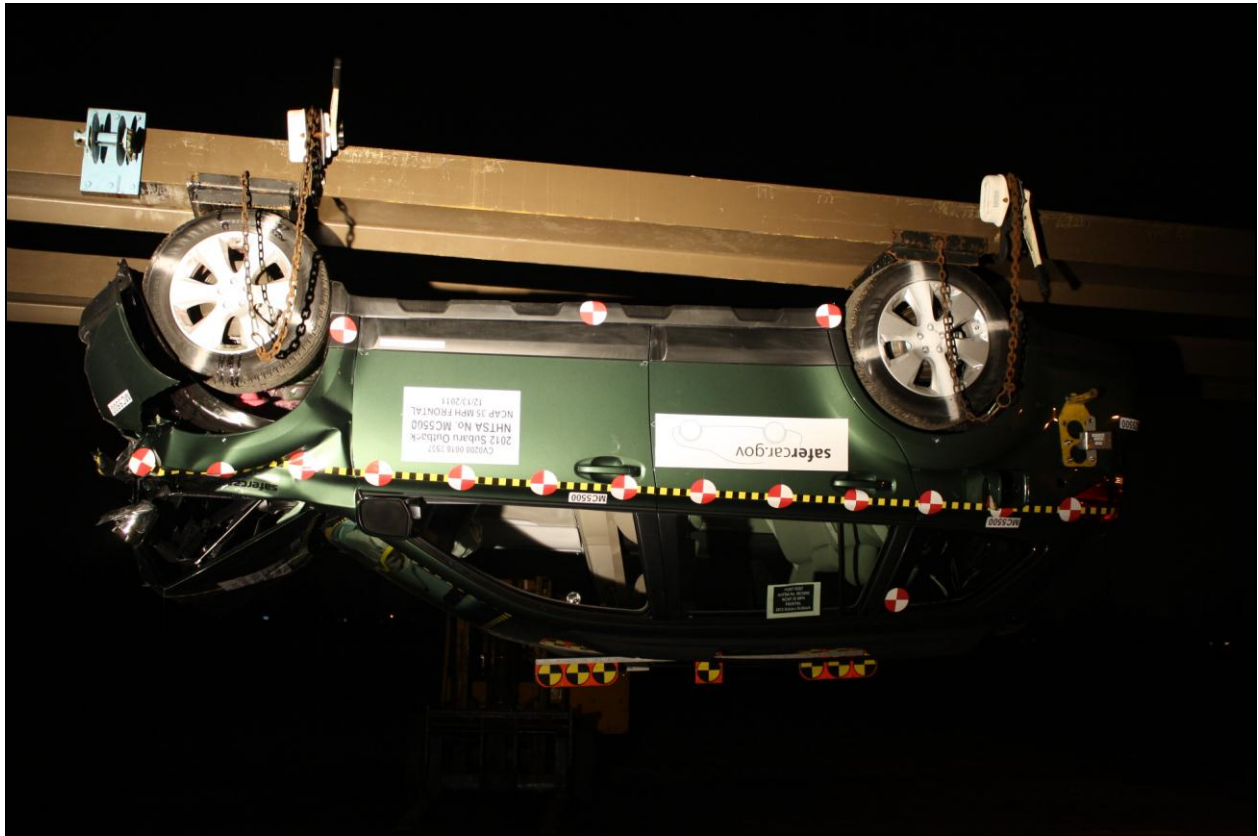
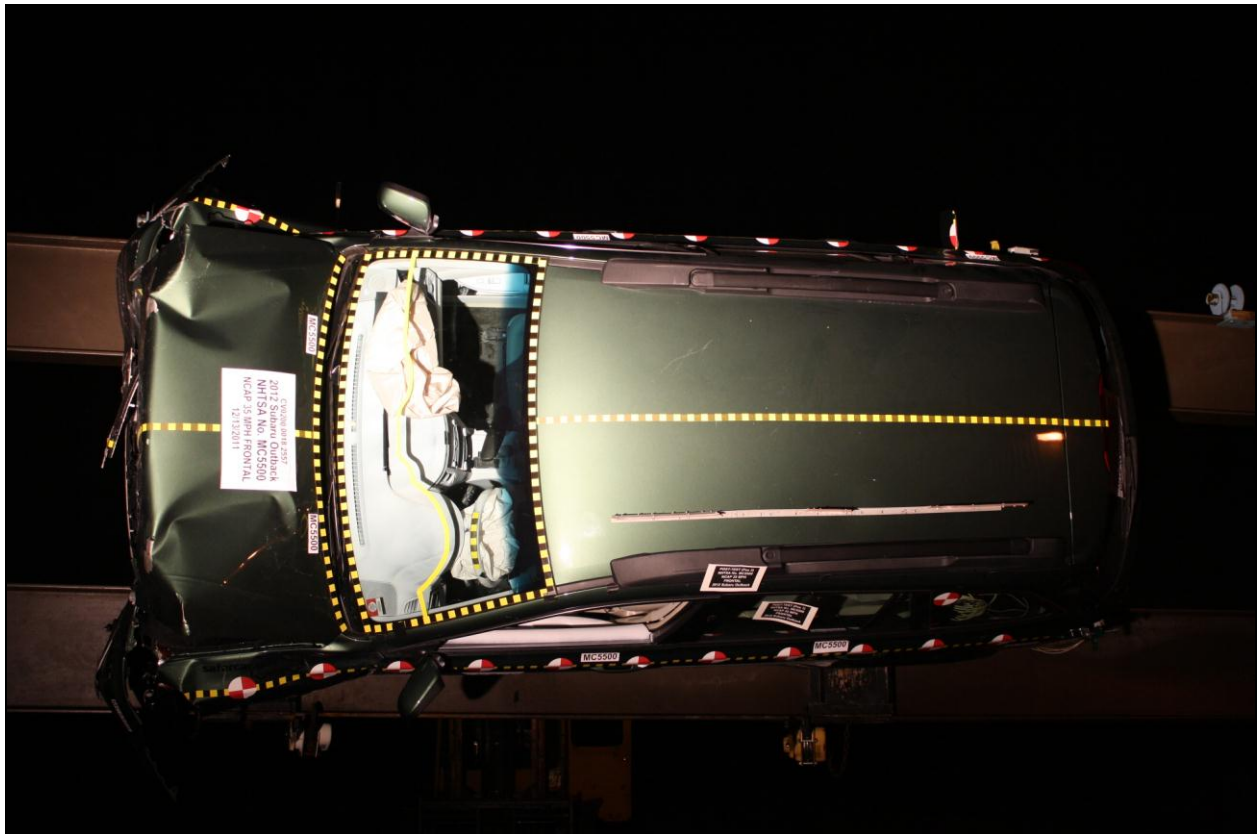
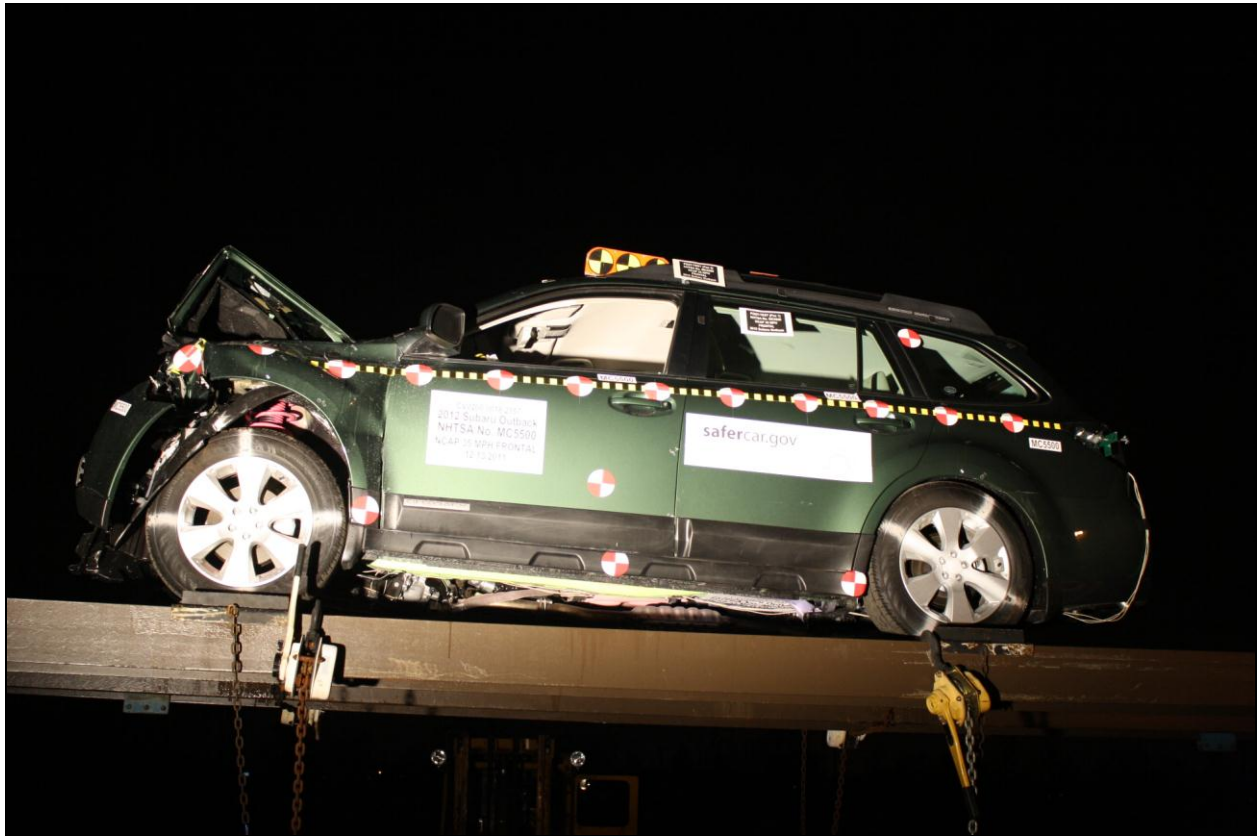
**Figure A-66: Vehicle at 0° on Static Rollover Device**

**Figure A-67: Vehicle at 90° on Static Rollover Device**

**Figure A-68: Vehicle at 180° on Static Rollover Device**

**Figure A-69: Vehicle at 270° on Static Rollover Device**

**Figure A-70: Vehicle at 360° on Static Rollover Device**

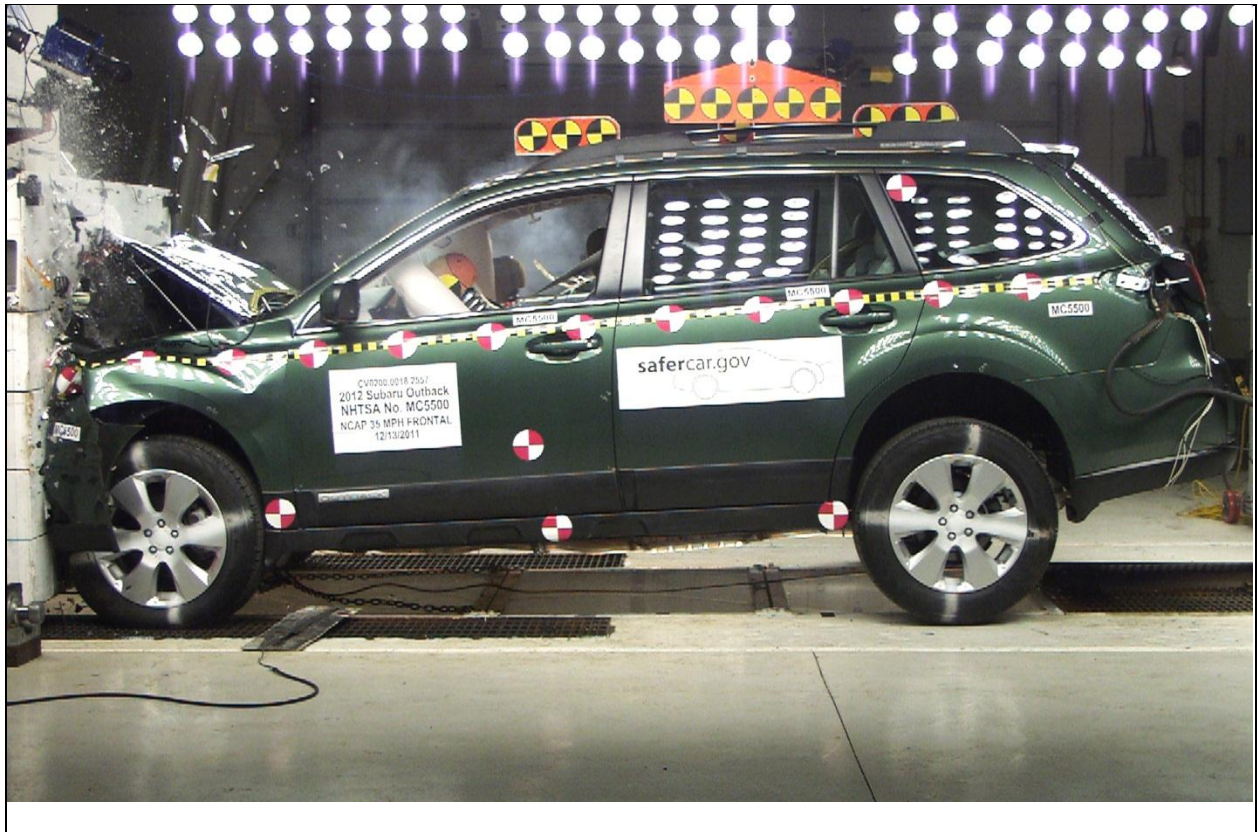
**Figure A-71: 2012 Subaru Outback Frontal Impact Event**
