**REPORT NUMBER: NCAP-MGA-2012-039**

**NEW CAR ASSESSMENT PROGRAM (NCAP)  
Frontal Barrier Impact Test**

**KIA MOTORS MANUFACTURING GEORGIA, INC. FOR HYUNDAI MOTOR COMPANY  
2012 Hyundai Santa Fe GLS AWD SUV  
NHTSA No.: MC0512**

**FINAL REPORT**

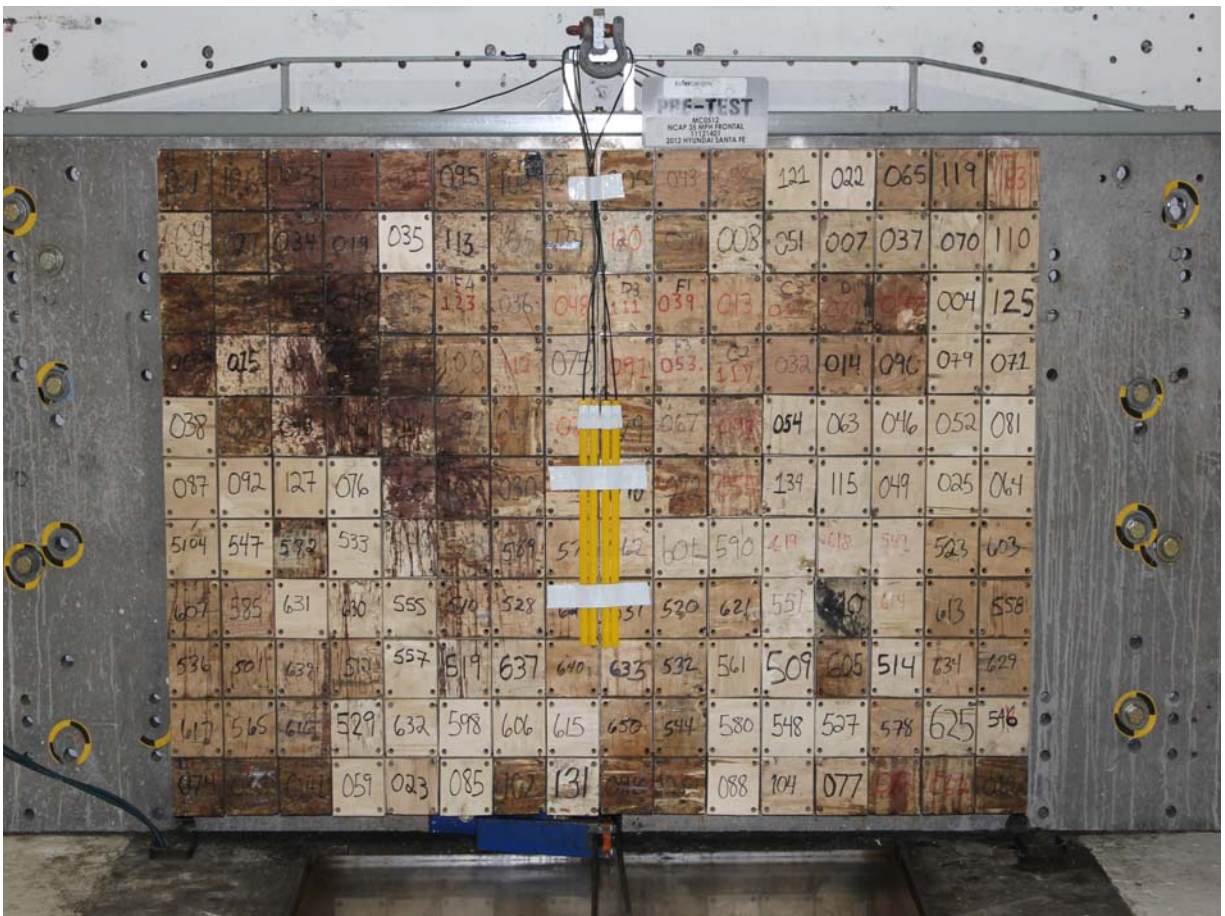
Load Cell Wall

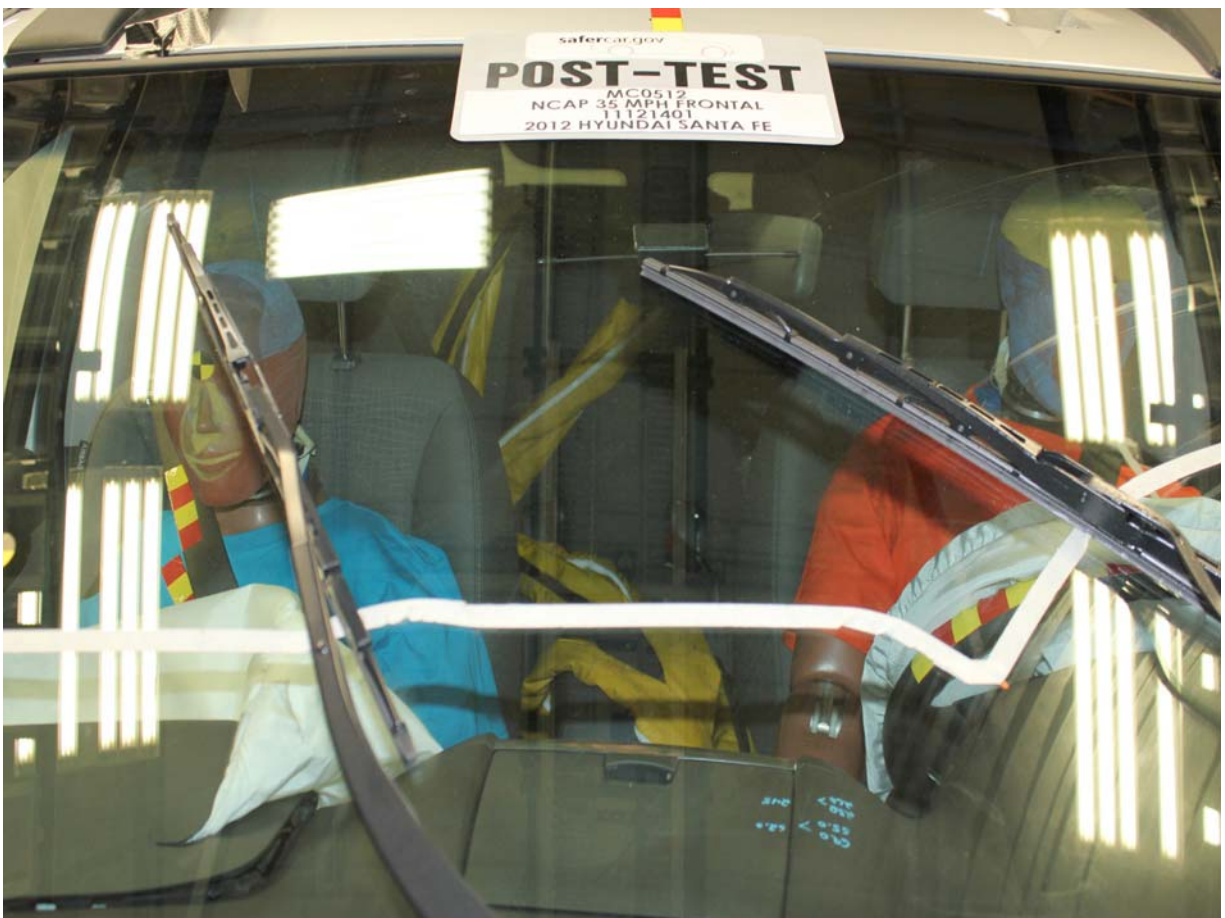
Post-Test Windshield View

There was 100 percent windshield retention and no intrusion into the protected zone of the windshield during the event. There was no Stoddard Solvent leakage after the event or during any phase of the static rollover.

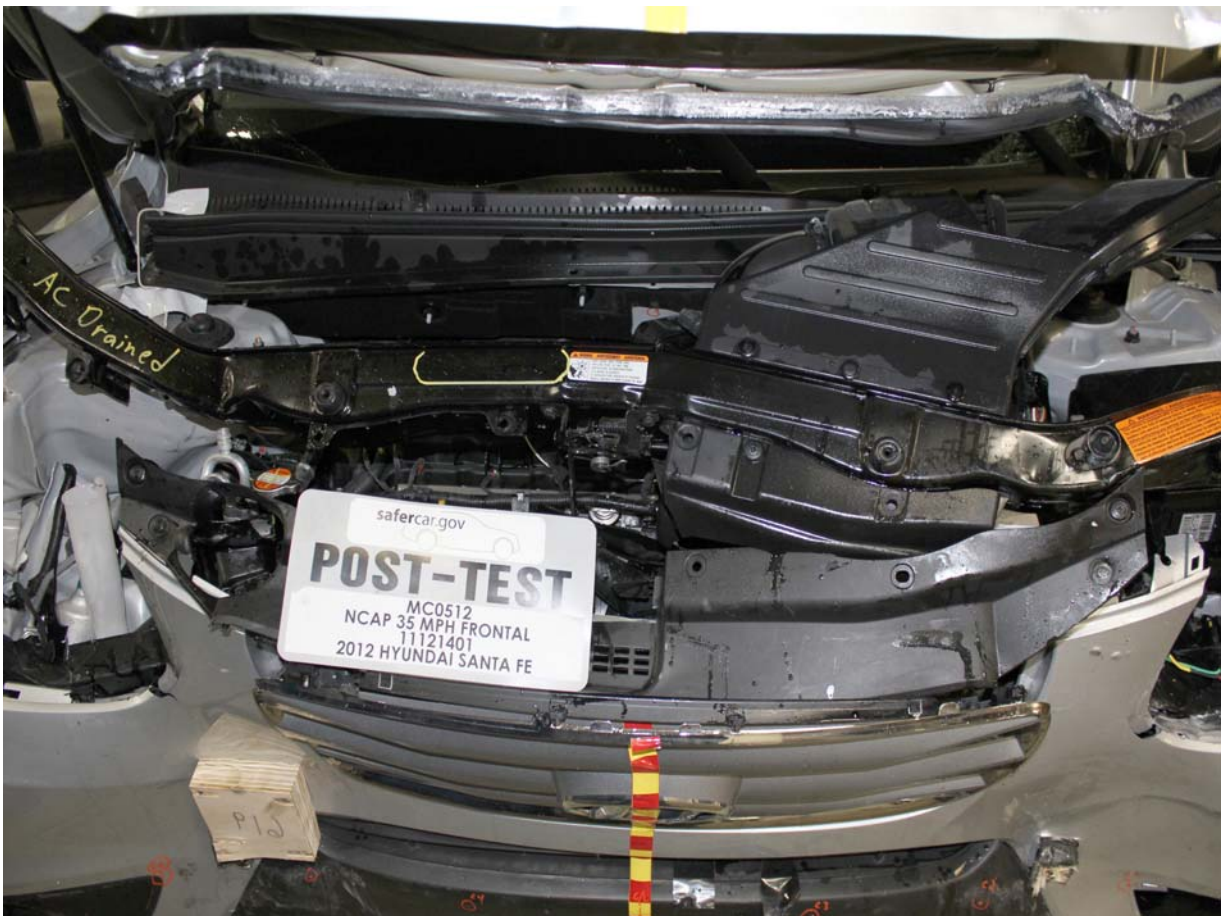
Post-Test Engine Compartment View

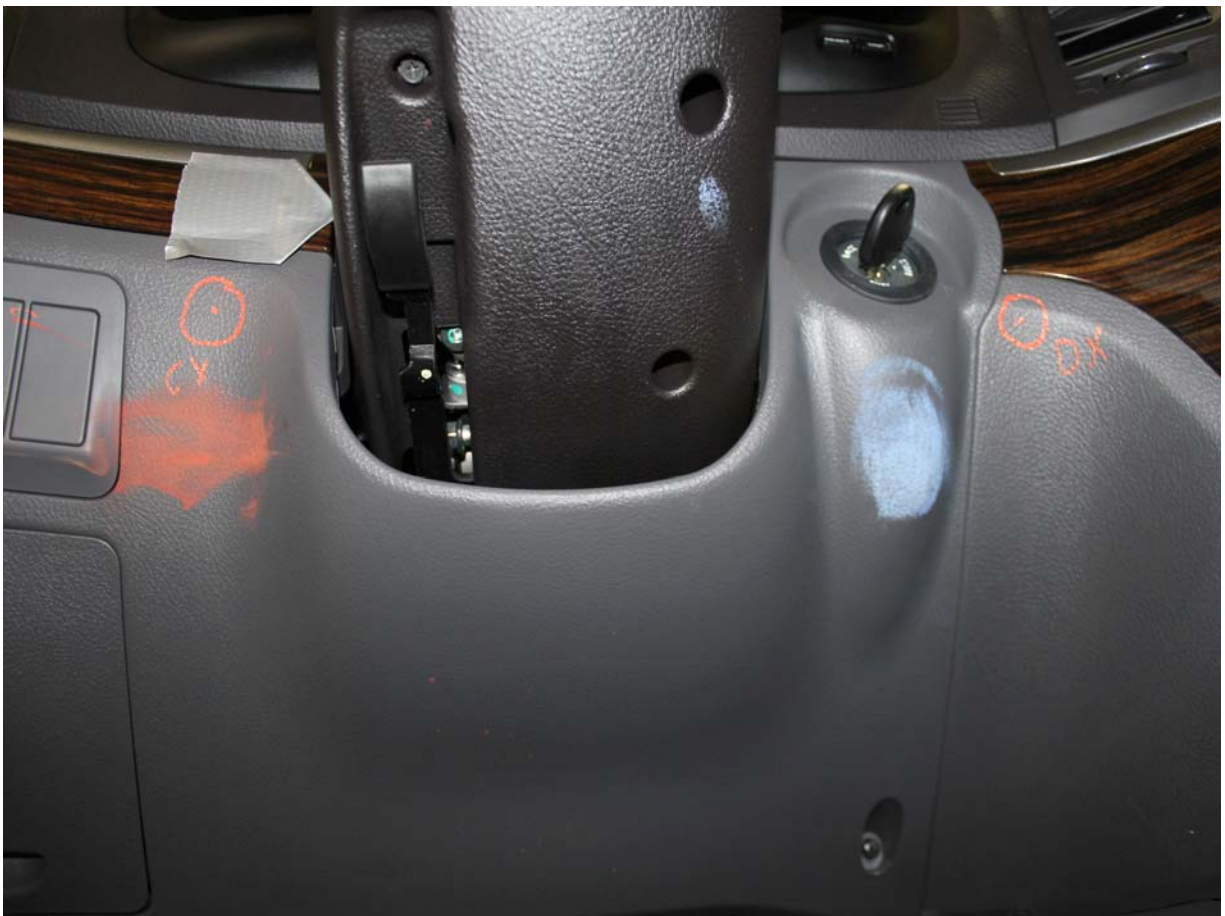
Post-Test Driver Dummy Contact with Knee Bolster

The driver's visible contact points were as follows: The driver's head and chest contacted the airbag. The driver's head also contacted the headrest. The driver's knees contacted the knee bolster. The passenger's visible contact points were as follows: The passenger's head and chest contacted the airbag. The passenger's head also contacted the headrest. The passenger's knees contacted the glovebox.
