REPORT NUMBER: SINCAP-MCW-12-06

NEW CAR ASSESSMENT PROGRAM (SINCAP)
MOVING DEFORMABLE BARRIER SIDE IMPACT TEST

HONDA OF AMERICA MFG., INC.
2012 HONDA FIT 5-DOOR HATCHBACK
NHTSA NUMBER: MC 5317

FINAL REPORT

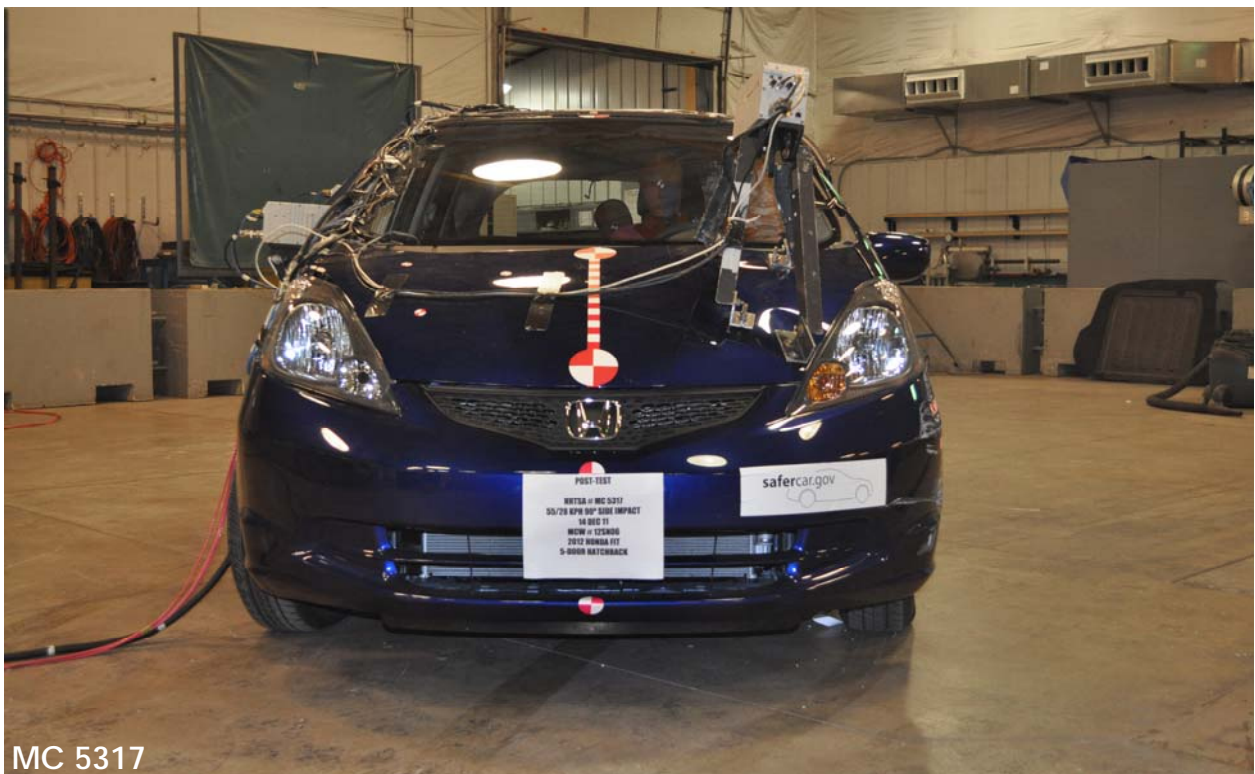
Figure A-4: Post-Test Frontal View of Test Vehicle

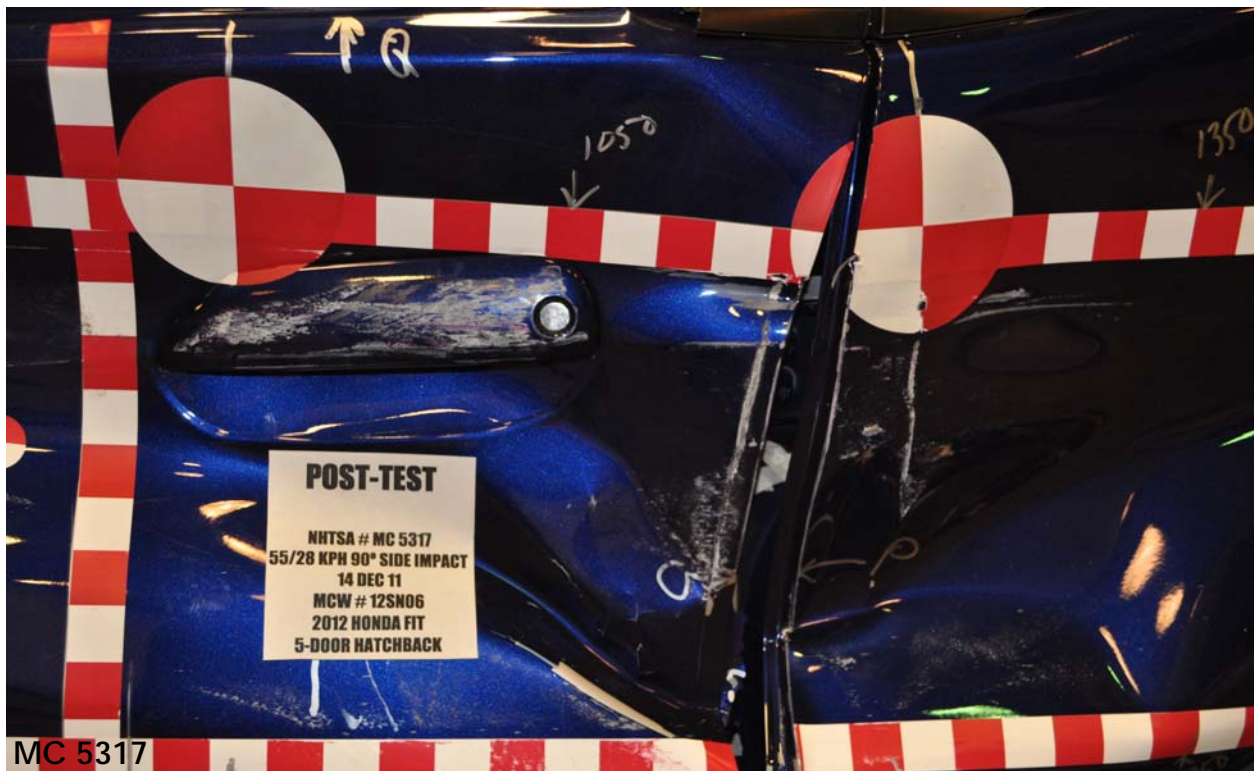
Figure A-22: Post-Test Left Front Door Latch Close-Up
