**REPORT NUMBER: NCAP-MGA-2012-040**

**NEW CAR ASSESSMENT PROGRAM (NCAP)  
Frontal Barrier Impact Test**

**HONDA MOTOR CO., LTD.  
2012 Honda Fit 5-Dr Hatchback  
NHTSA No.: MC5316**

**FINAL REPORT**

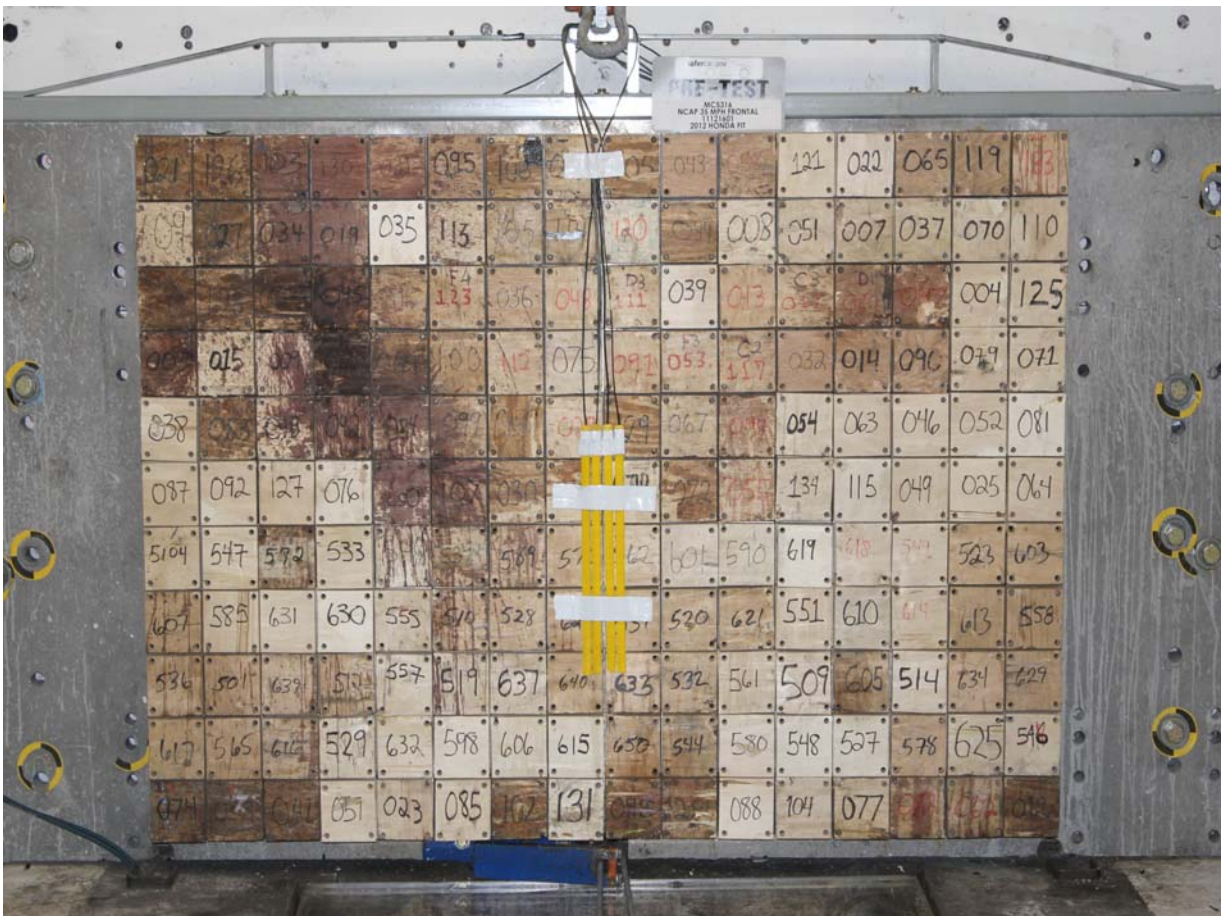
Load Cell Wall

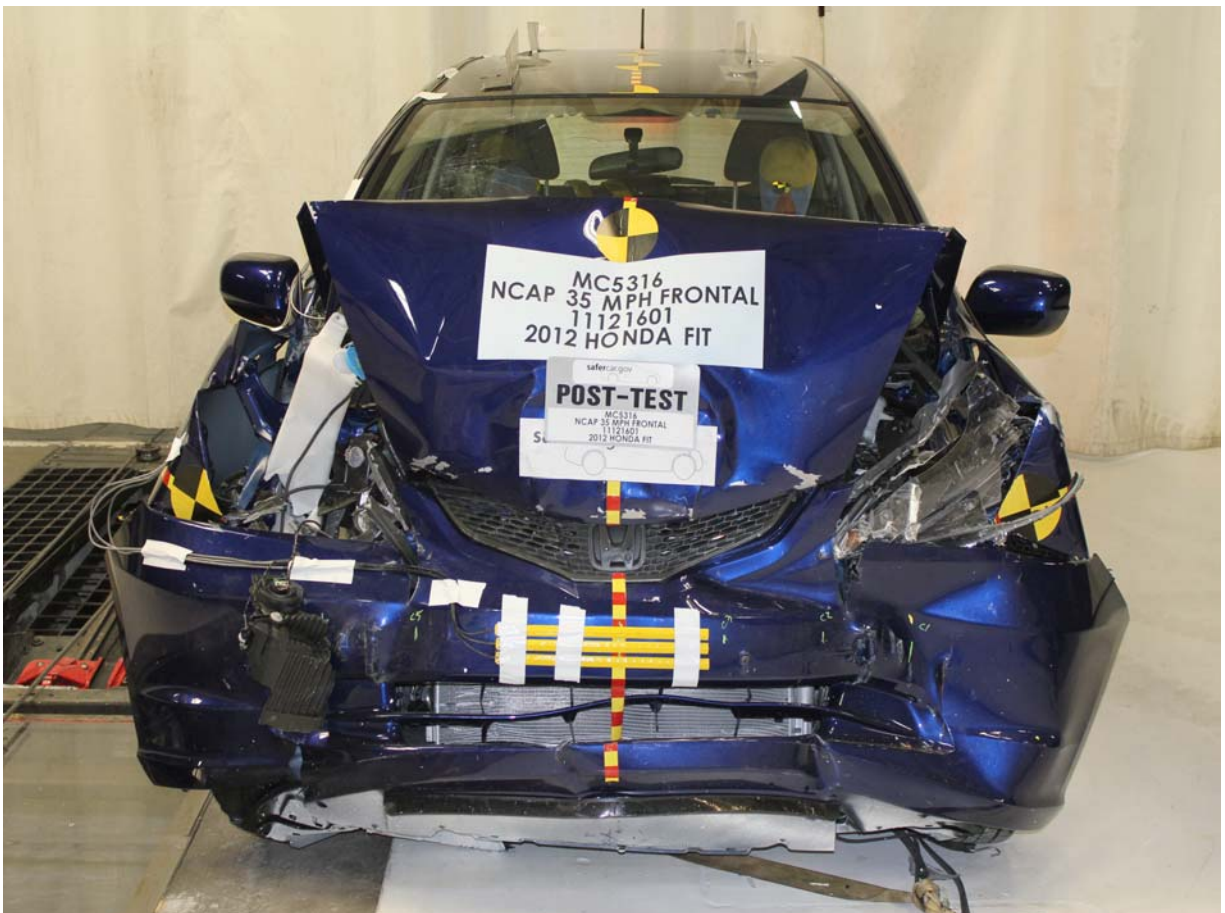
Post-Test Front View of Test Vehicle

The maximum static crush of the vehicle was 530 mm and both the driver and passenger side doors remained closed during the impact event and were operable after the impact.

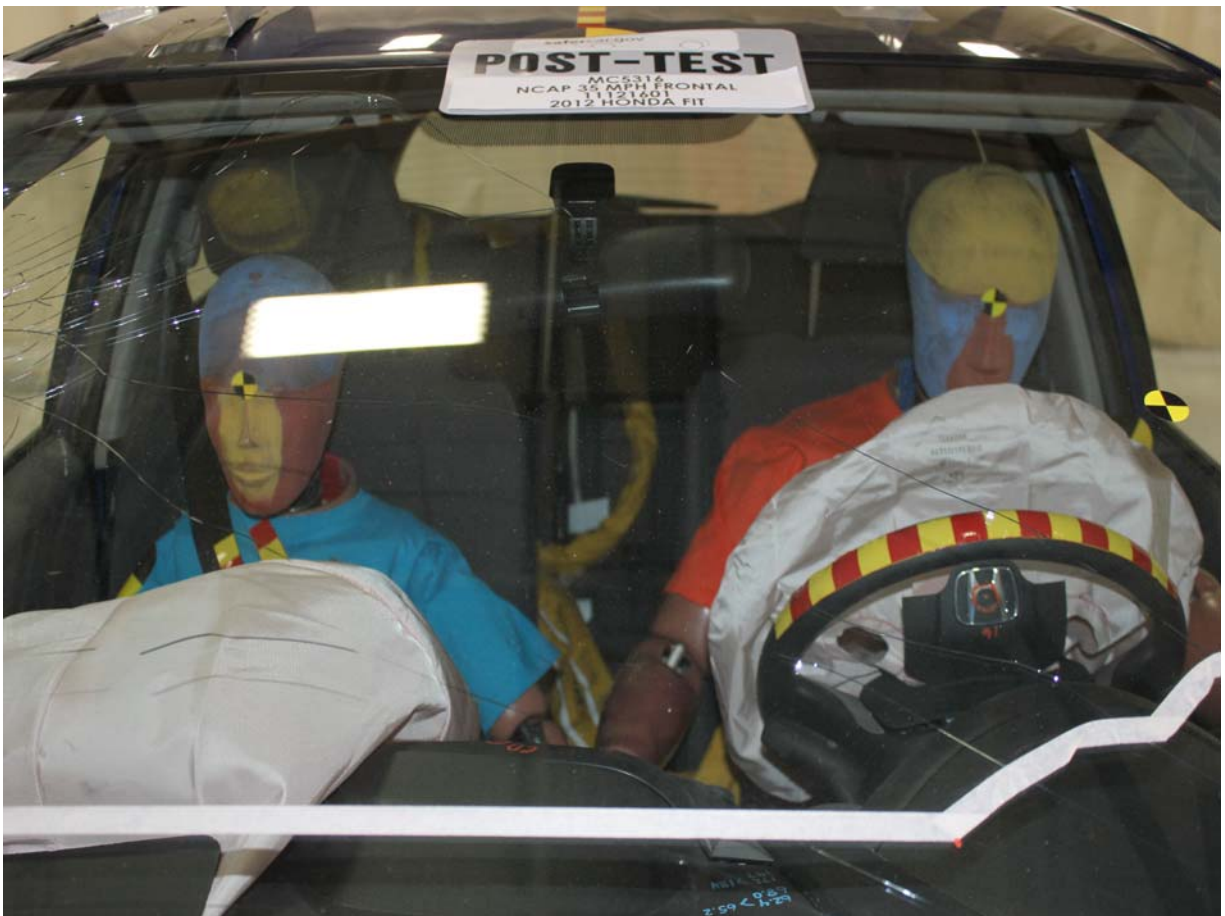
Post-Test Windshield View

There was 100 percent windshield retention and no intrusion into the protected zone of the windshield during the event. There was no Stoddard Solvent leakage after the event or during any phase of the static rollover.

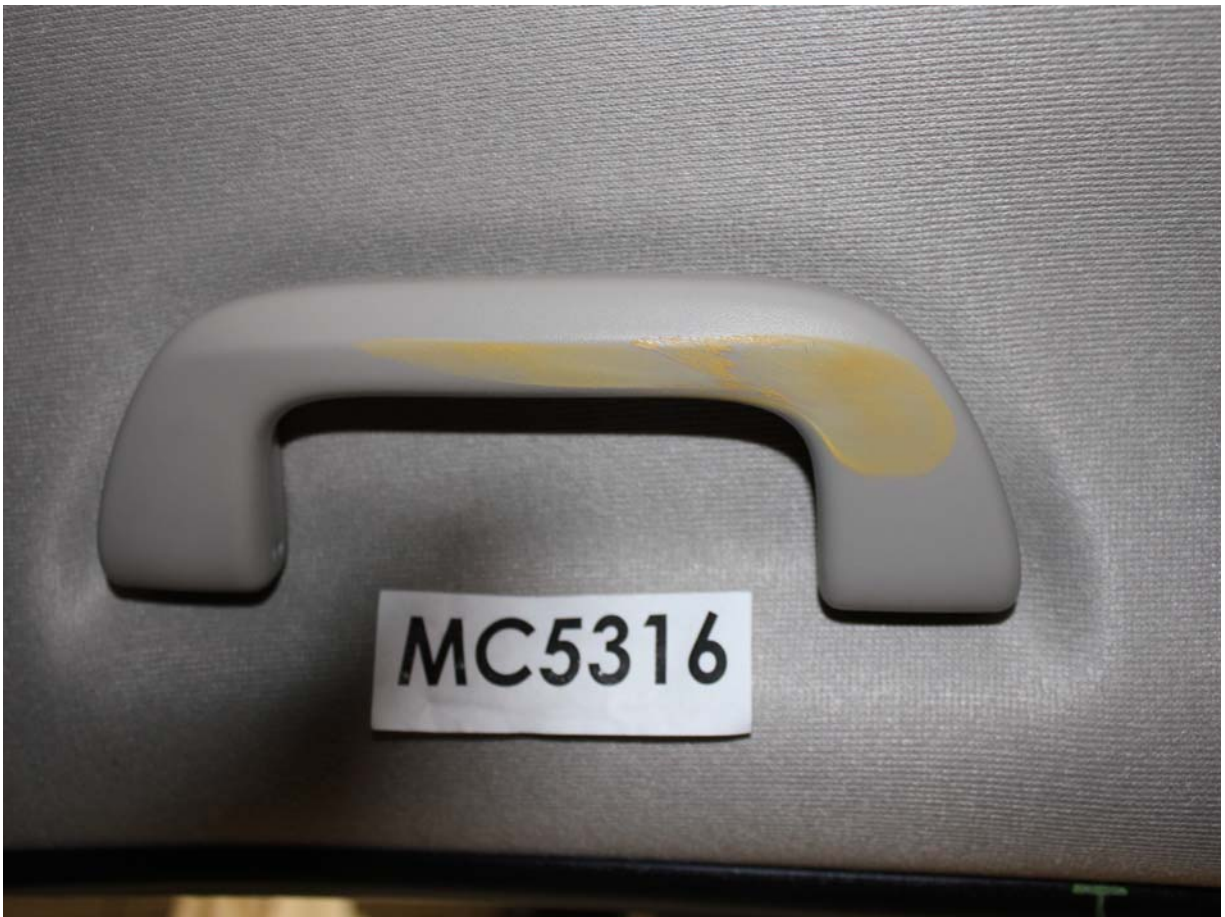
Post-Test Driver Dummy Contact with Handle on Ceiling

The driver's visible contact points were as follows: The driver's head and chest contacted the airbag. The driver's head also contacted the headrest and the handle on the ceiling. The driver's knees contacted the knee bolster. The passenger's visible contact points were as follows: The passenger's head and chest contacted the airbag. The passenger's head also contacted the headrest and seatback. The passenger's knees contacted the glovebox.
