**REPORT NUMBER: NCAP-MGA-2012-041**

**NEW CAR ASSESSMENT PROGRAM (NCAP)  
Frontal Barrier Impact Test**

**GENERAL MOTORS LLC  
2012 Chevrolet Silverado 2500 4WD Crew Cab  
NHTSA No.: MC0112**

**MGA RESEARCH CORPORATION  
5000 Warren Road  
Burlington, WI 53105**

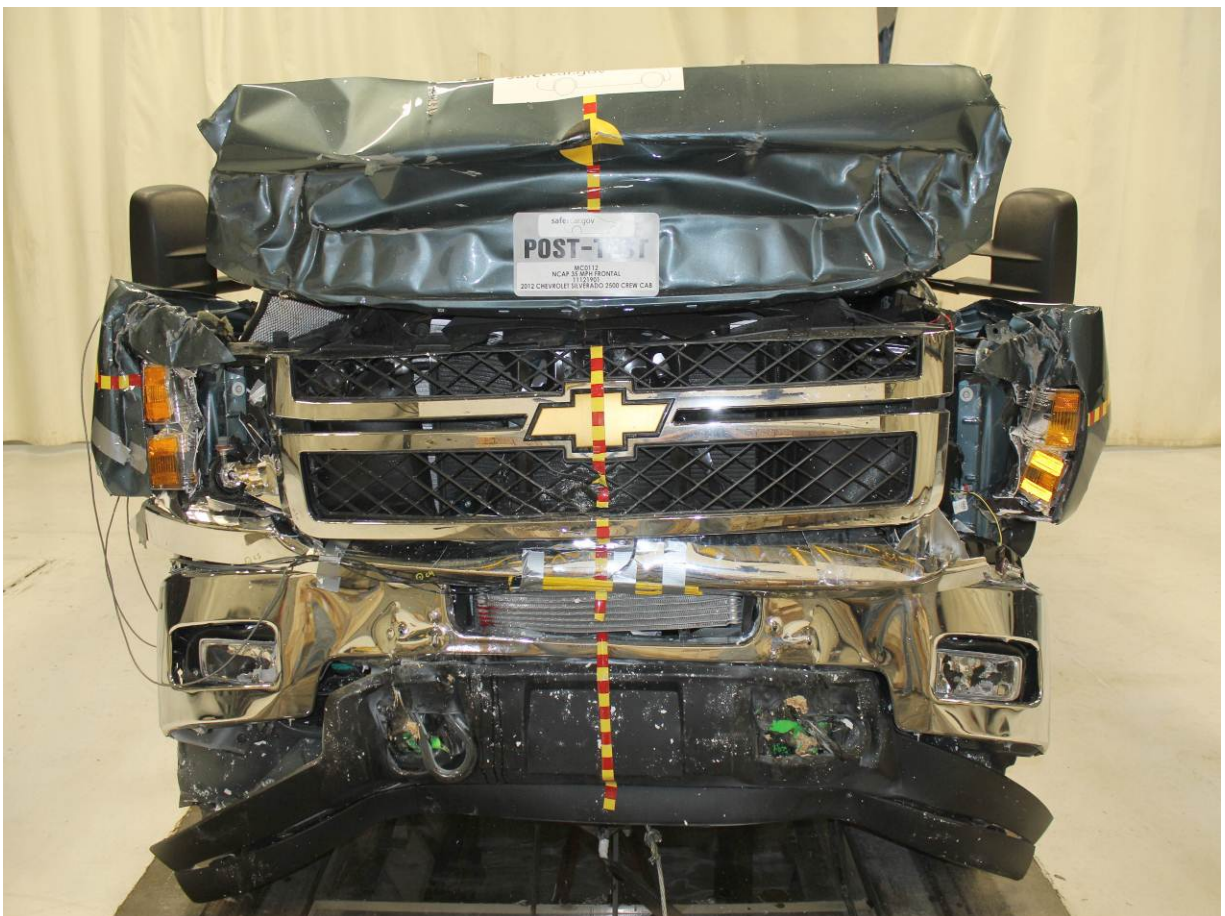
Post-Test Front View of Test Vehicle

The maximum static crush of the vehicle was 677 mm and both the driver and passenger side doors remained closed during the impact event and were operable after the impact.

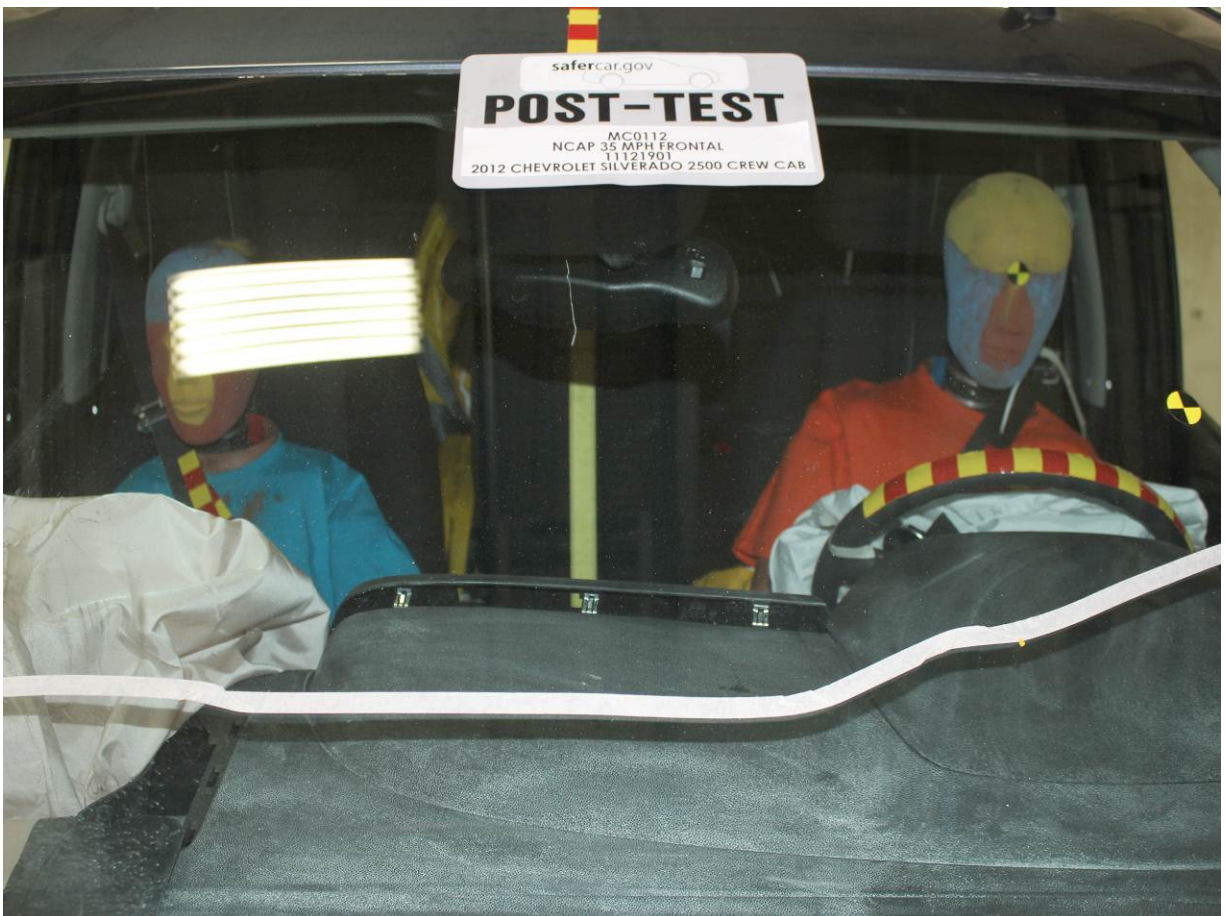
Post-Test Windshield View

There was 100 percent windshield retention and no intrusion into the protected zone of the windshield during the event. There was no Stoddard Solvent leakage after the event or during any phase of the static rollover.

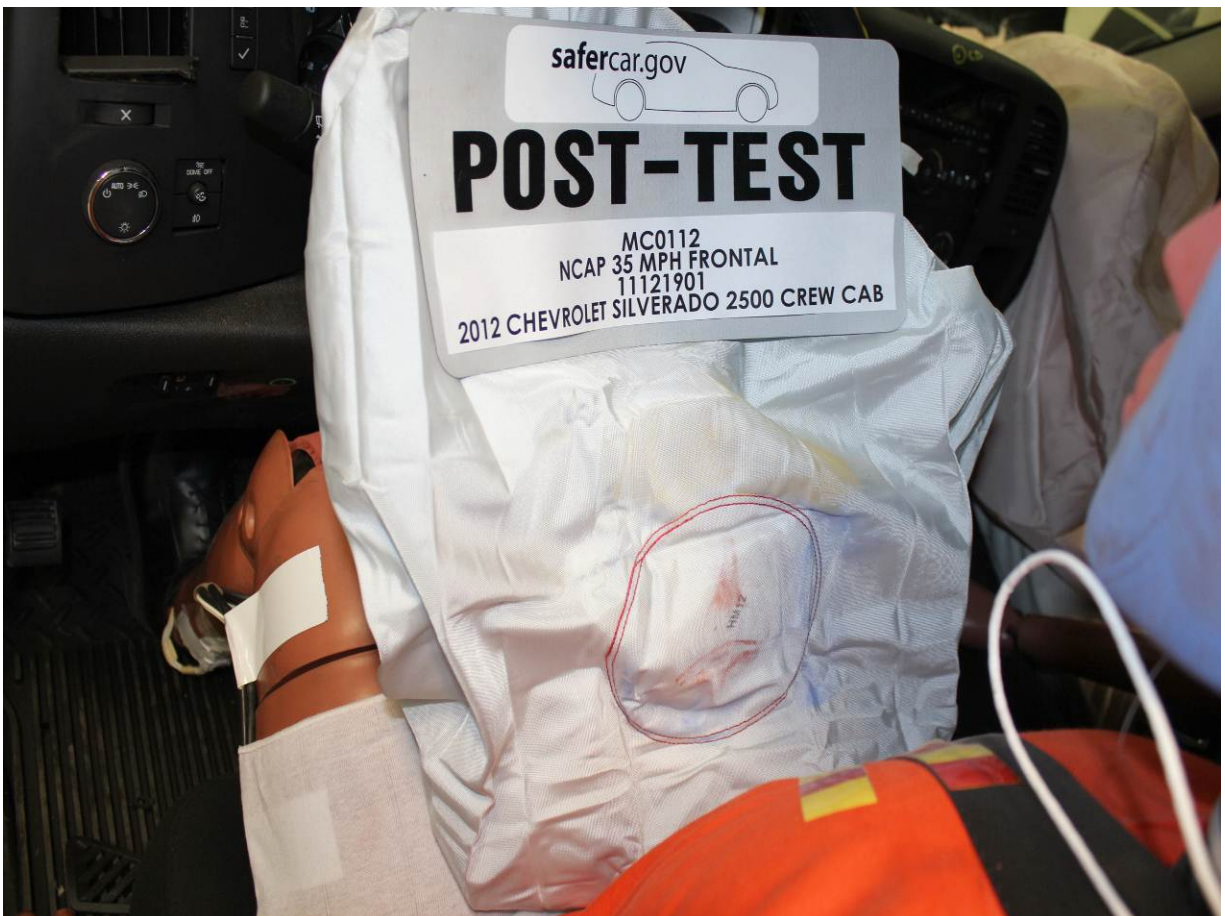
Post-Test Driver Dummy Contact with Airbag

The driver's visible contact points were as follows: The driver's head and chest contacted the airbag. The driver's head also contacted the headrest, seat back and seatbelt. The driver's knees contacted the knee bolster. The passenger's visible contact points were as follows: The passenger's head and chest contacted the airbag. The passenger's head also contacted the headrest and seat back. The passenger's knees contacted the glovebox.

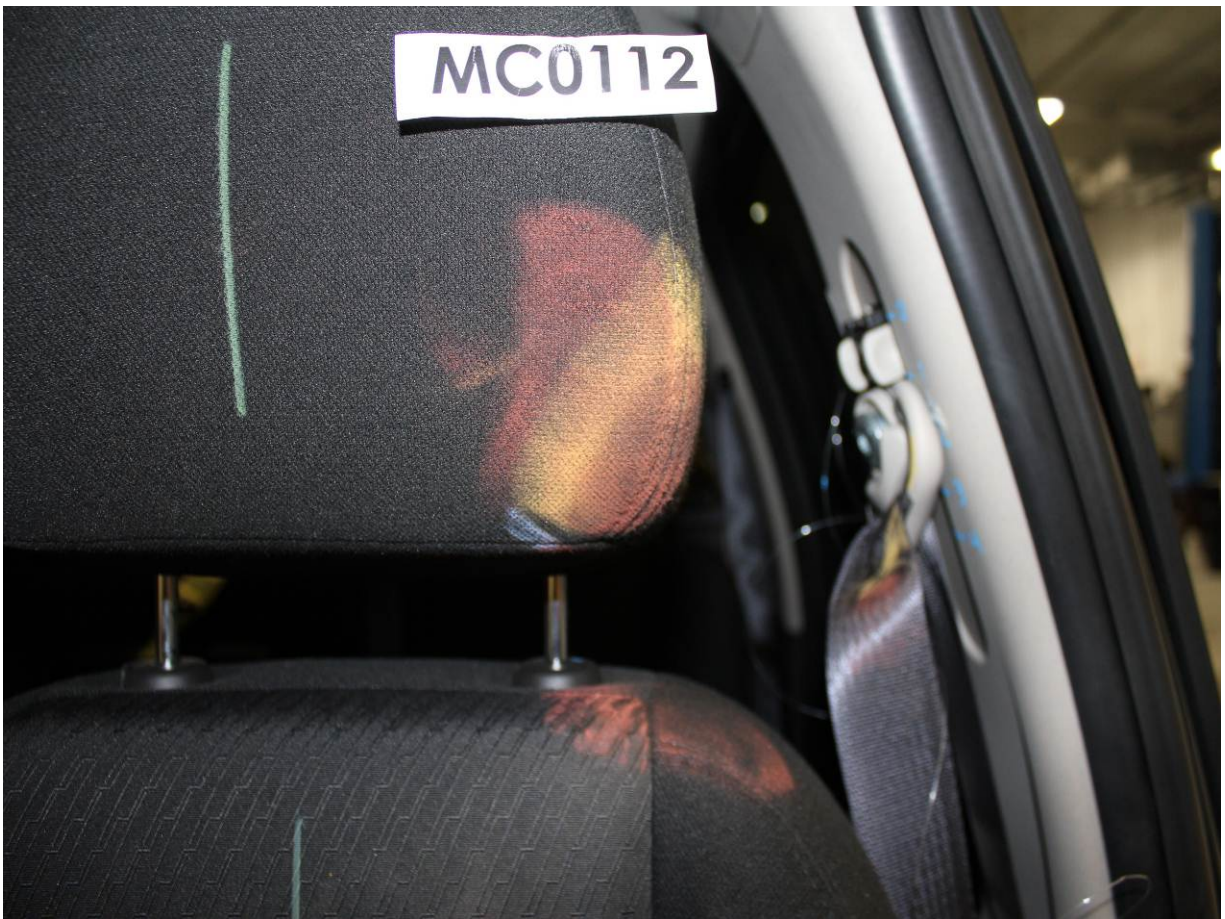
Post-Test Driver Dummy Contact with Headrest/Seat Back

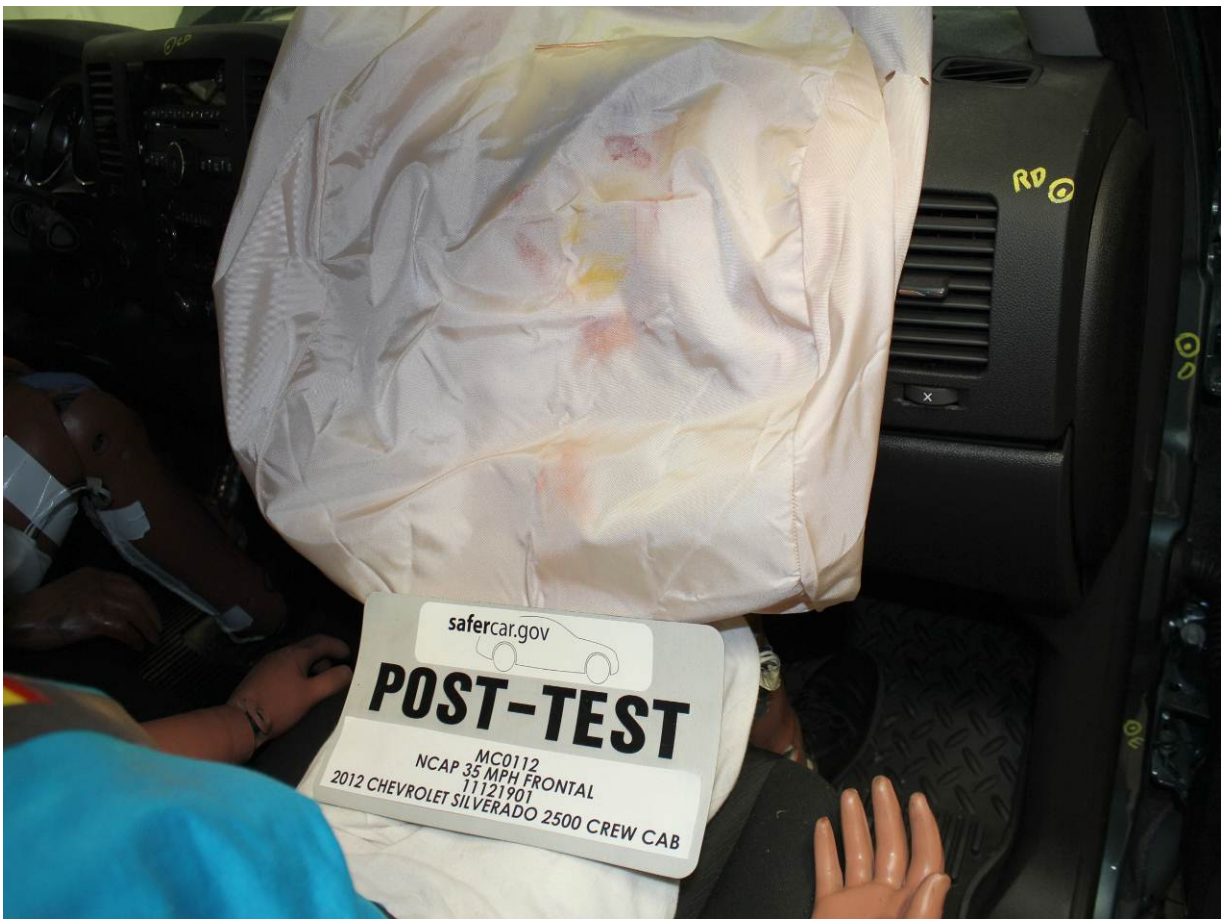
Post-Test Passenger Dummy Contact with Airbag

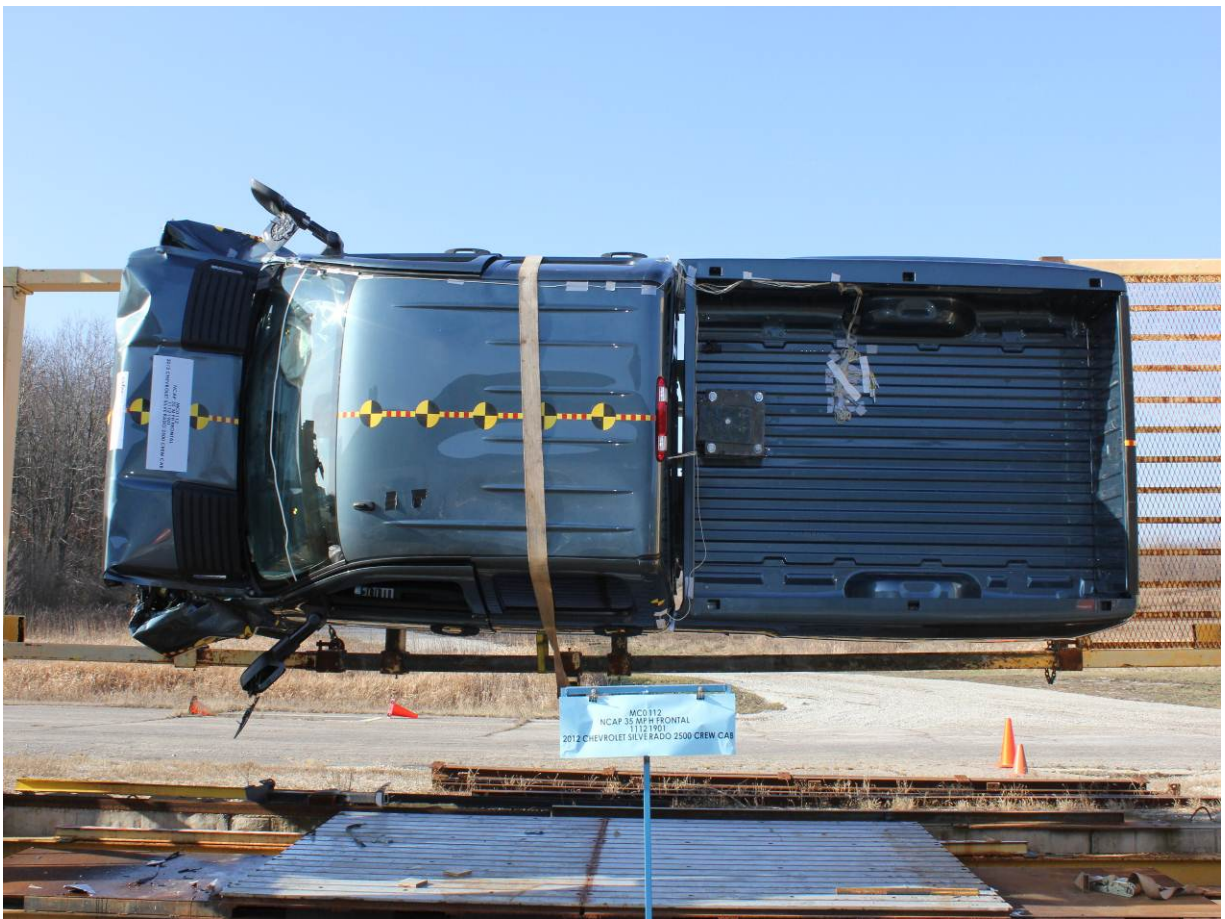
Vehicle at 90 Degrees on Static Rollover Device

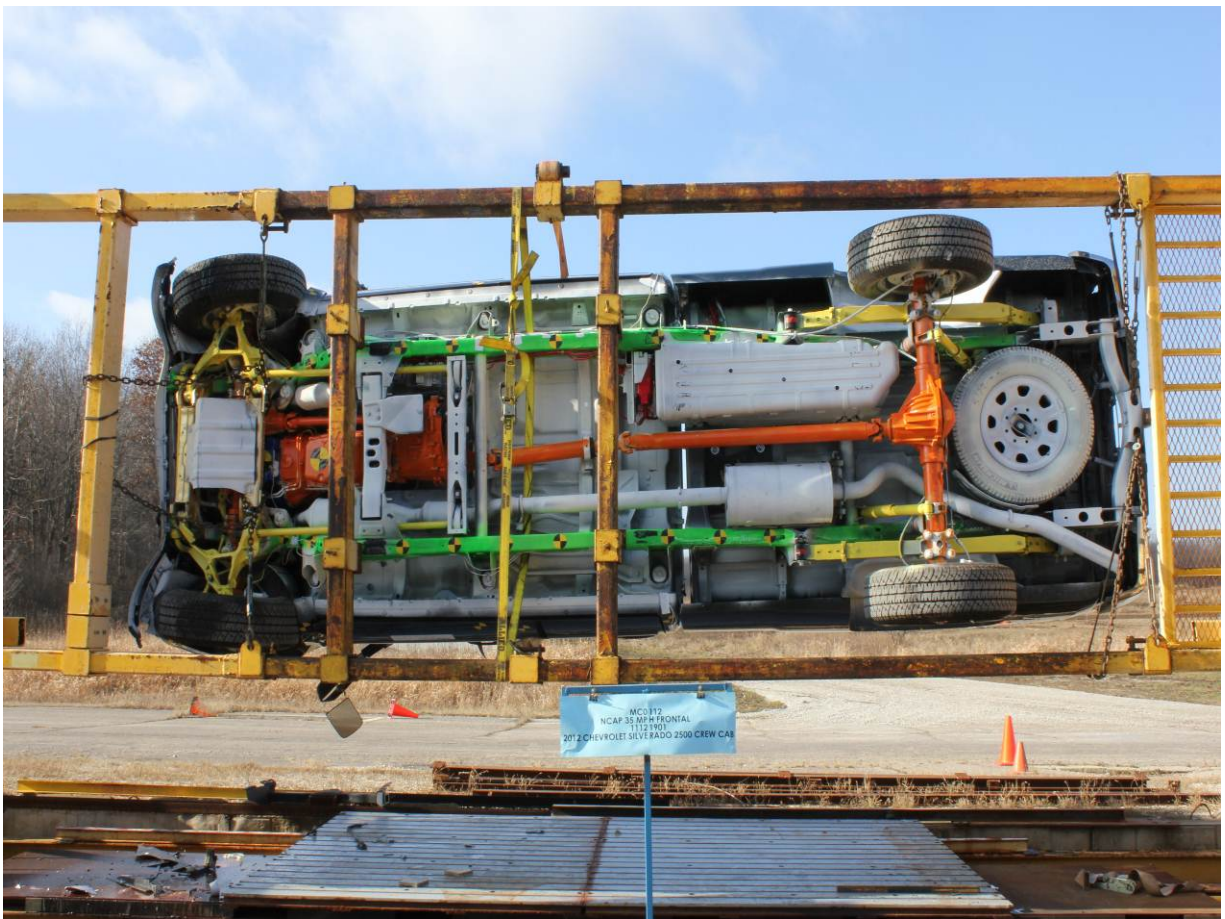
Vehicle at 270 Degrees on Static Rollover Device
