**REPORT NUMBER: SPNCAP-CAL-12-020**

**NEW CAR ASSESSMENT PROGRAM (NCAP)  
SIDE IMPACT POLE TEST**

**KIA Motor CO  
2012 Kia Sportage  
Utility Vehicle**

**FINAL REPORT**

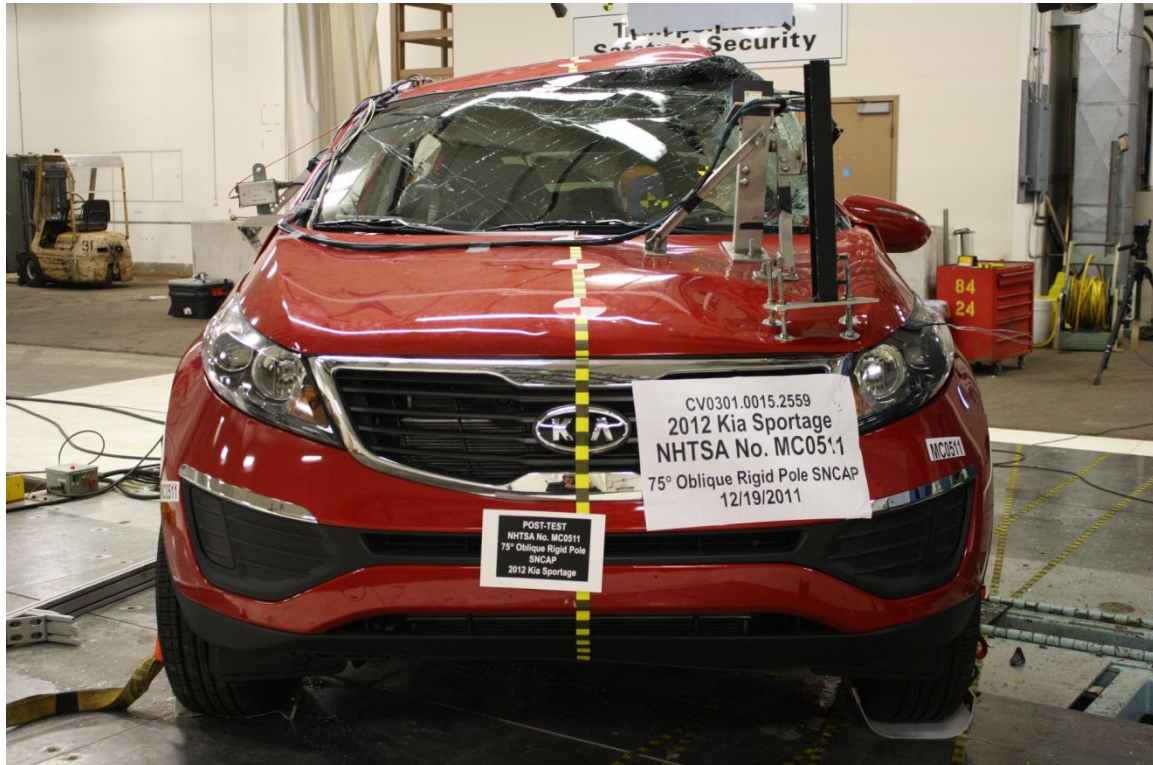
**Figure A-4: Post-Test Frontal View of Test Vehicle**

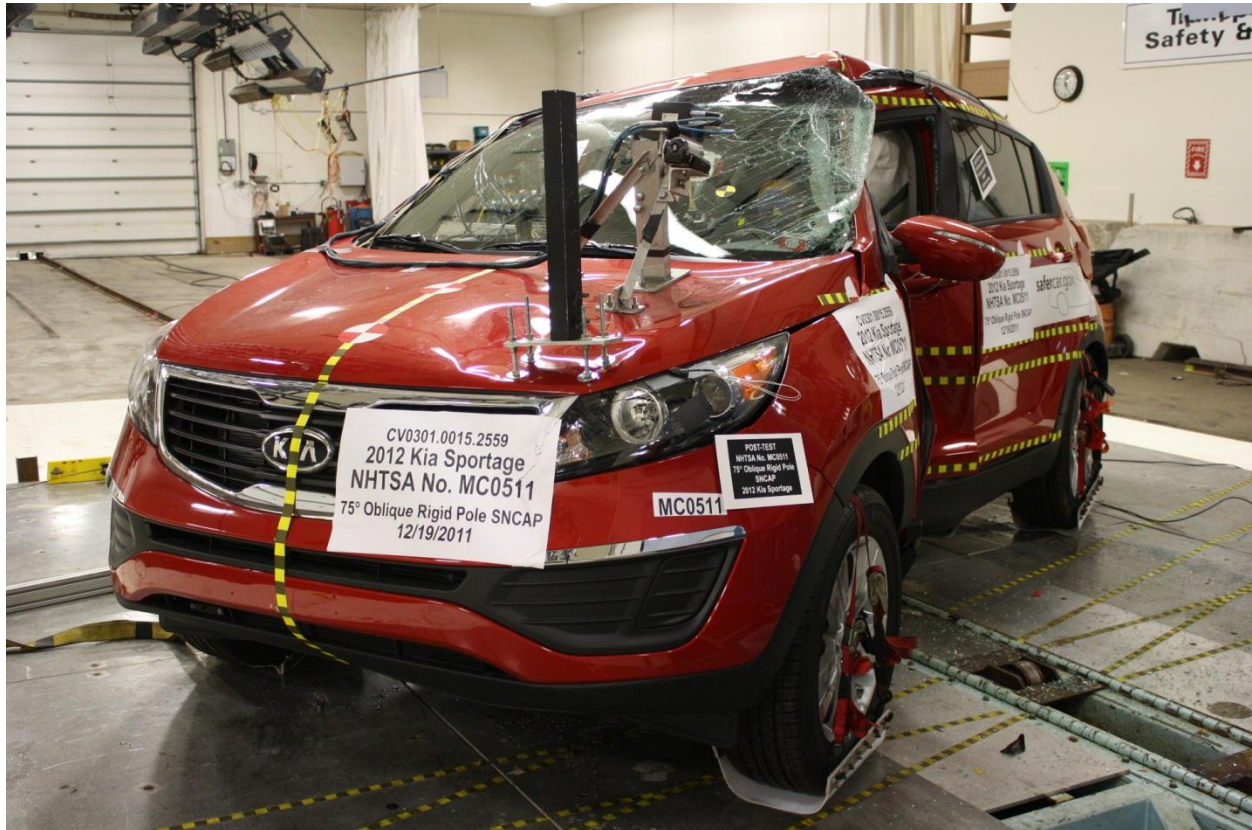
**Figure A-6: Post-Test Left Front  $\frac{3}{4}$  View Test Vehicle**

| Critical Areas of Performance | Observations and Conclusions |
|---|---|
| Windshield Damage | cracked and separated along the driver's side A-Pillar |
| Side Window Damage | Driver's window shattered during Impact |

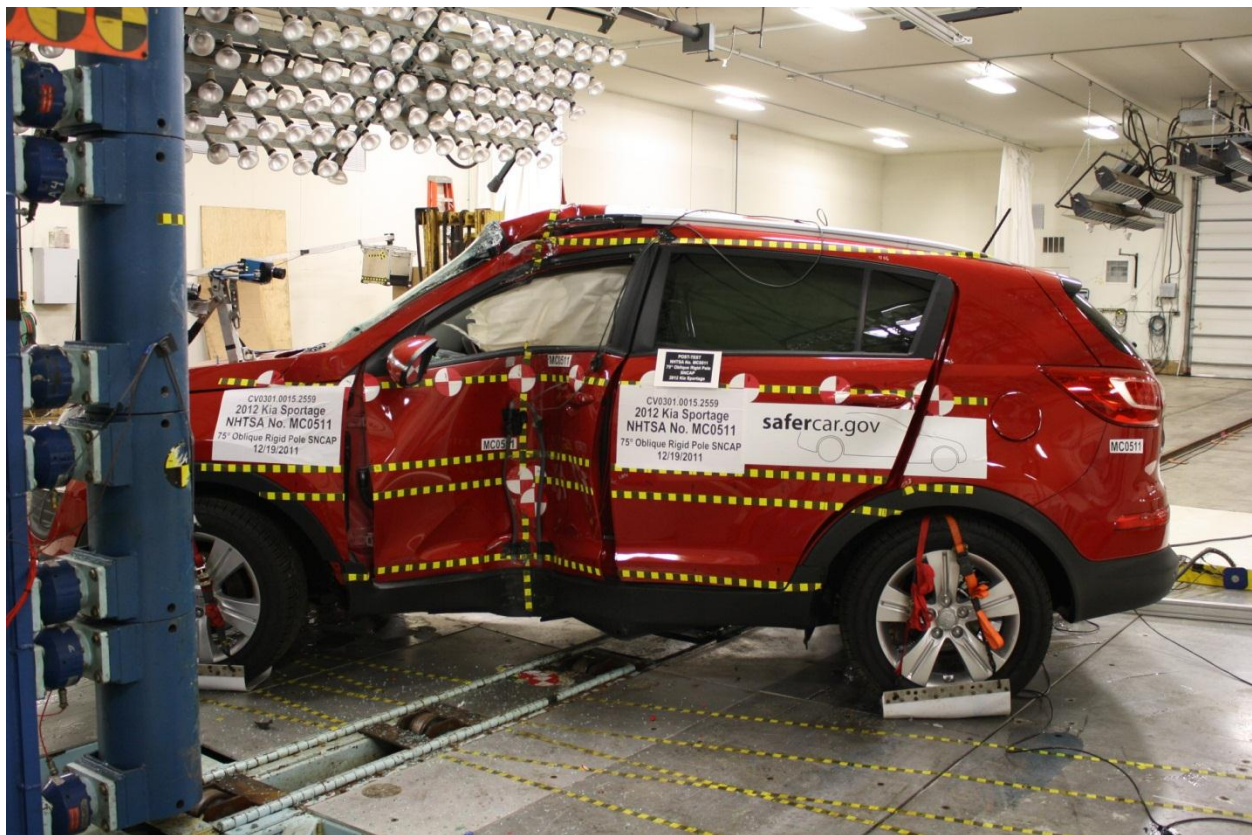
**Figure A-8: Post-Test Left Side View of Test Vehicle**

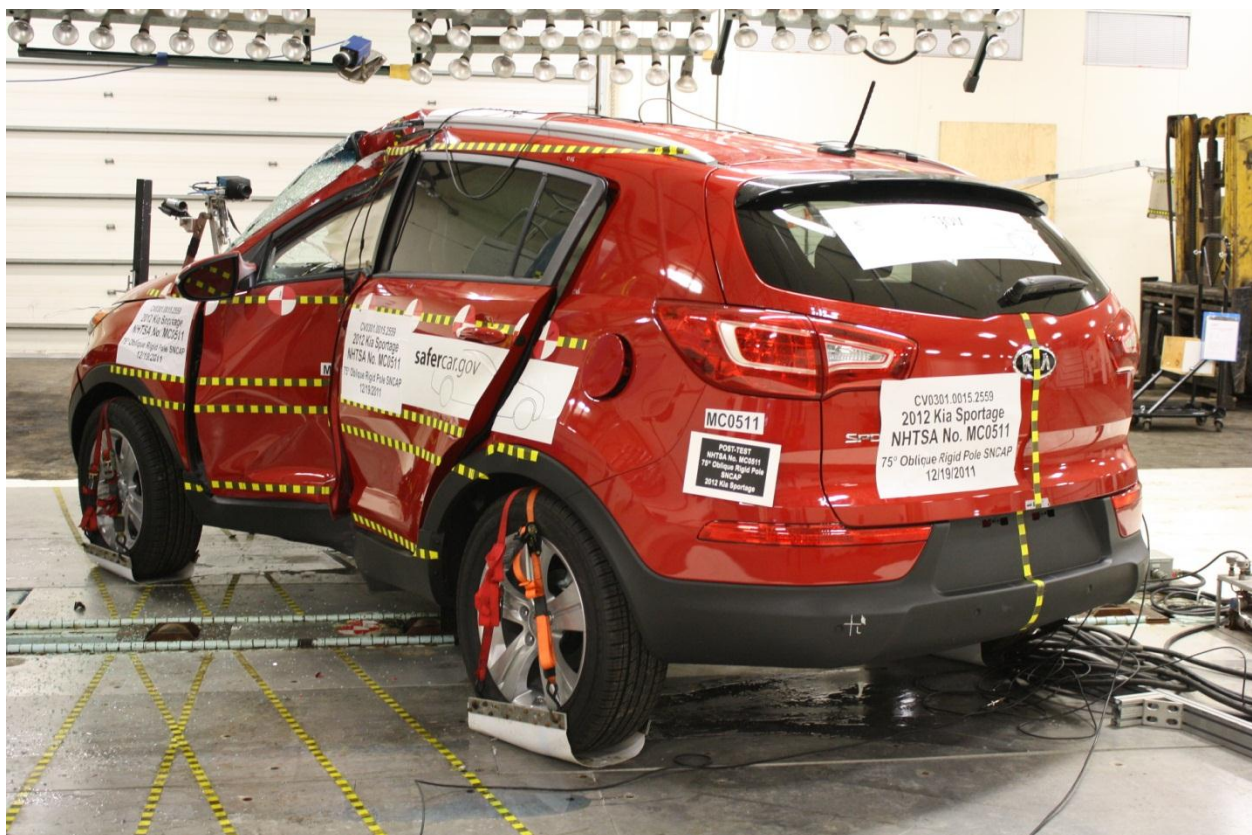
**Figure A-10: Post-Test Left Rear  $\frac{3}{4}$  View of Test Vehicle**

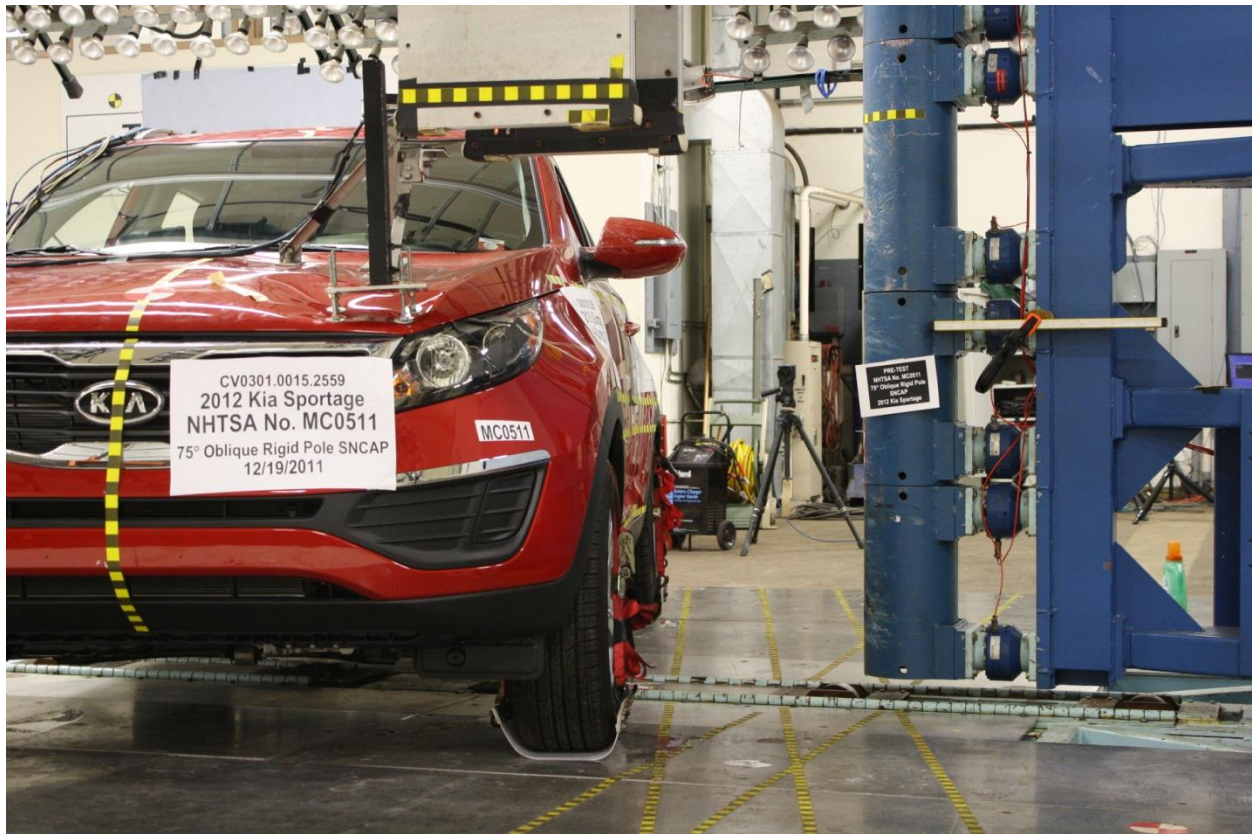
**Figure A-17: Pre-Test Left Side View of Pole Positioned Against Side of Vehicle**

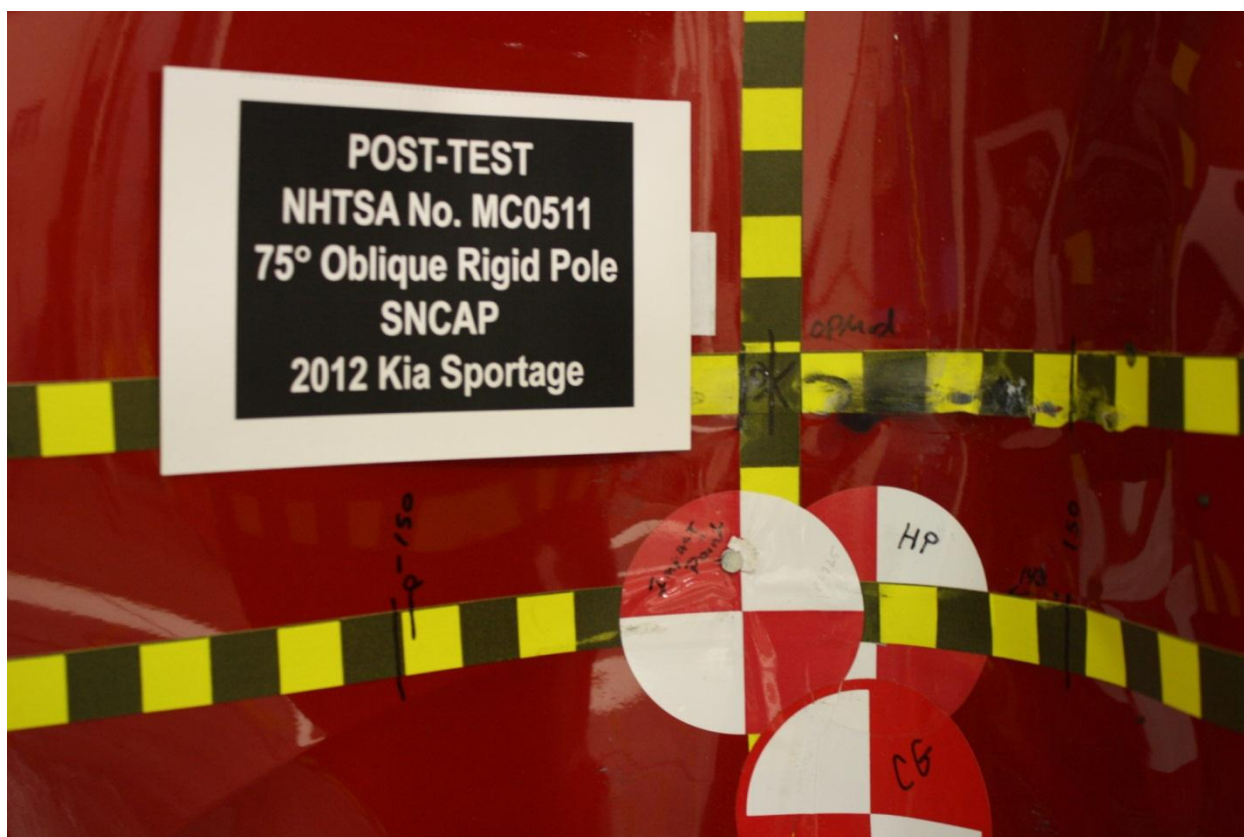
Figure A-20: Post-Test Close-Up View of Impact Point Target Showing Impact Location

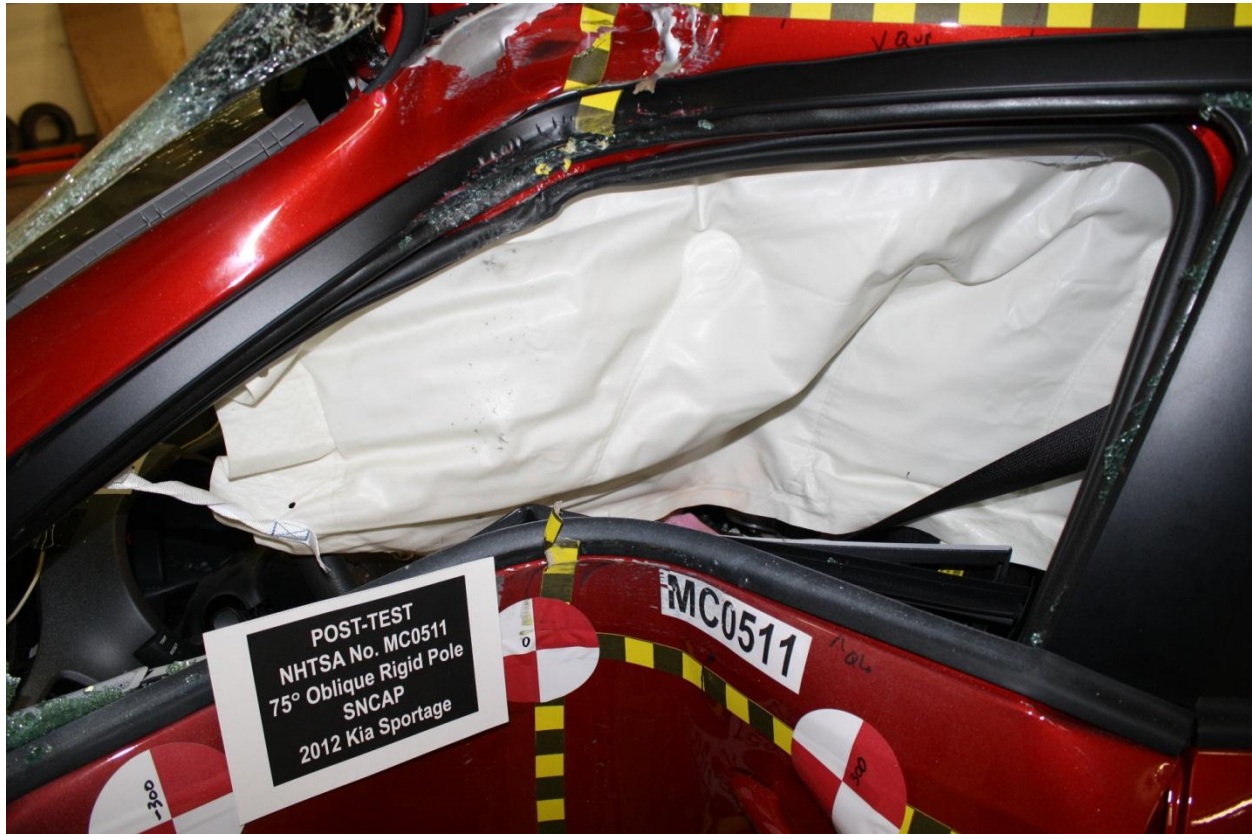
**Figure A-41: Post-Test Dummy and Door Clearance View**

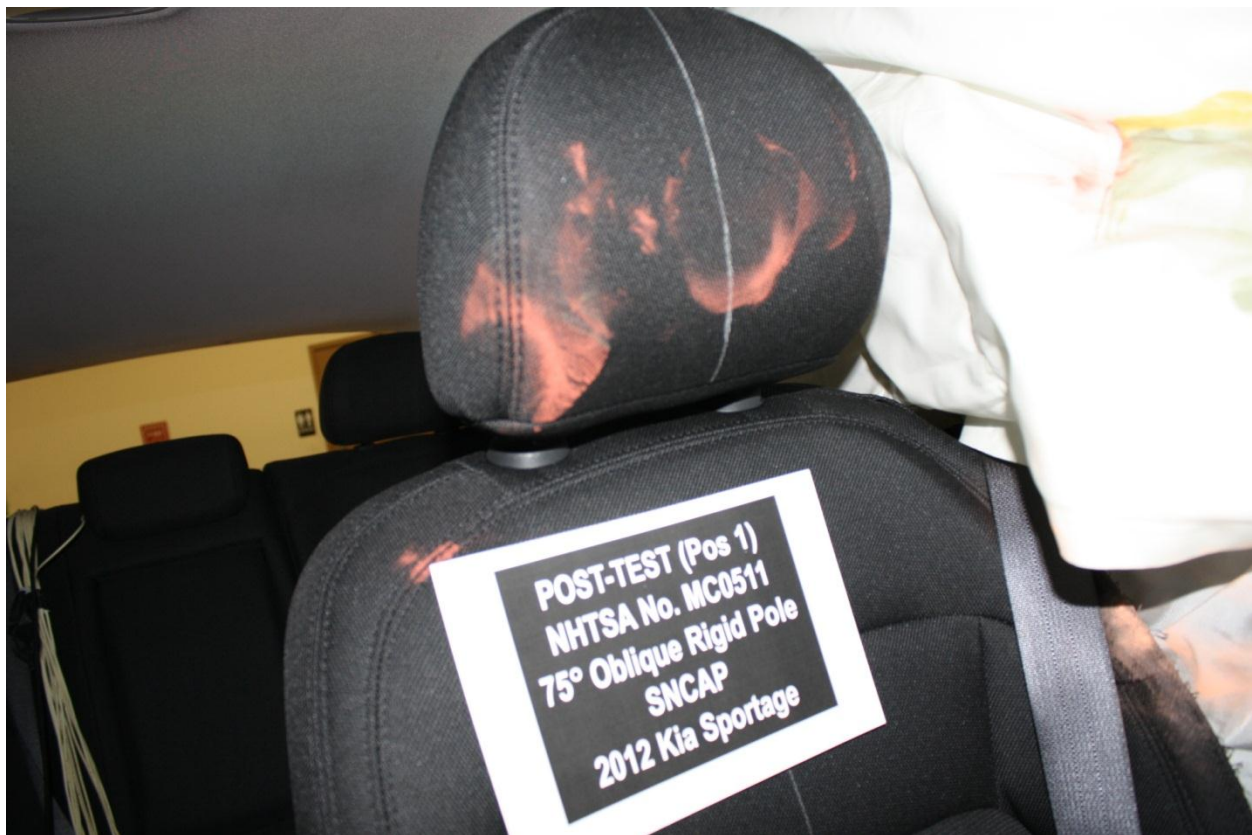
**Figure A-46: Post-Test Dummy Close-Up Head Contact with Vehicle Interior View**

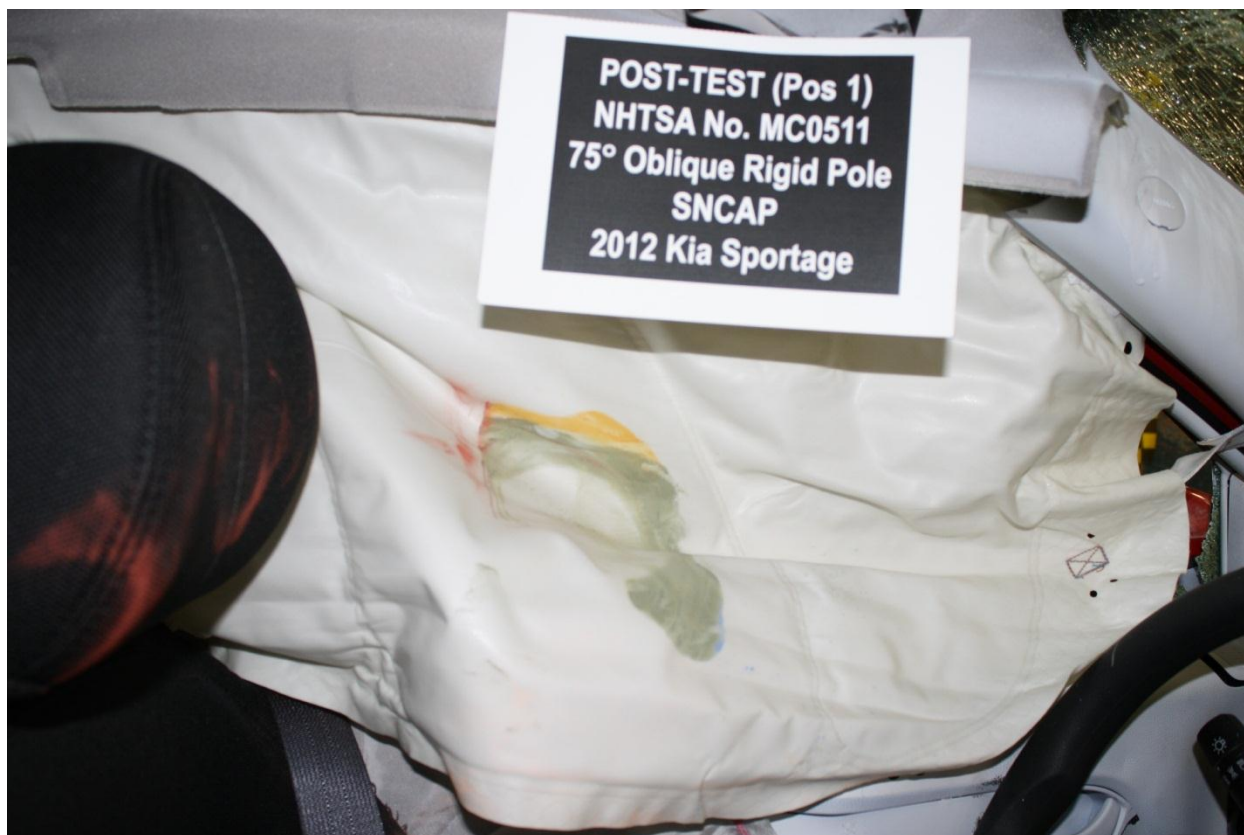
**Figure A-47: Post-Test Dummy Close-Up Head Contact with Side Airbag View**

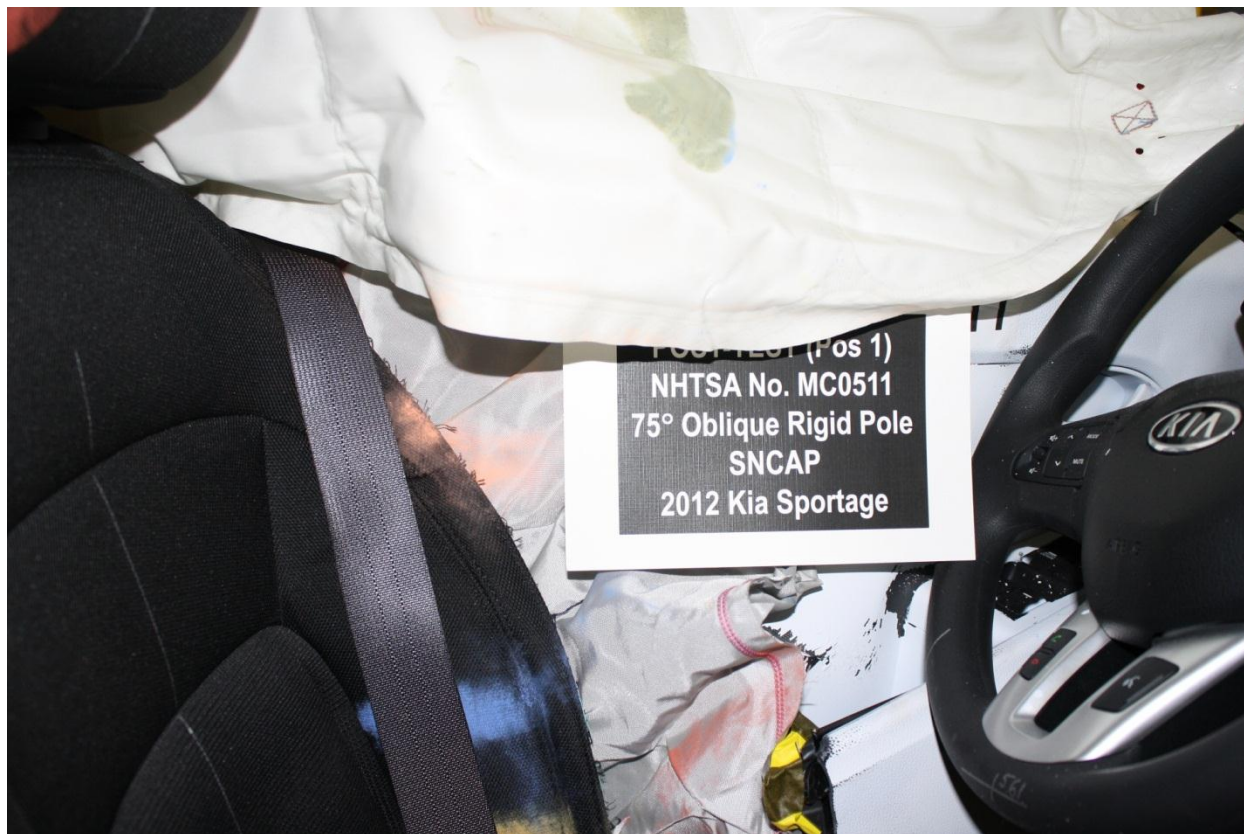
**Figure A-49: Post-Test Dummy Close-Up Torso Contact with Side Airbag View**

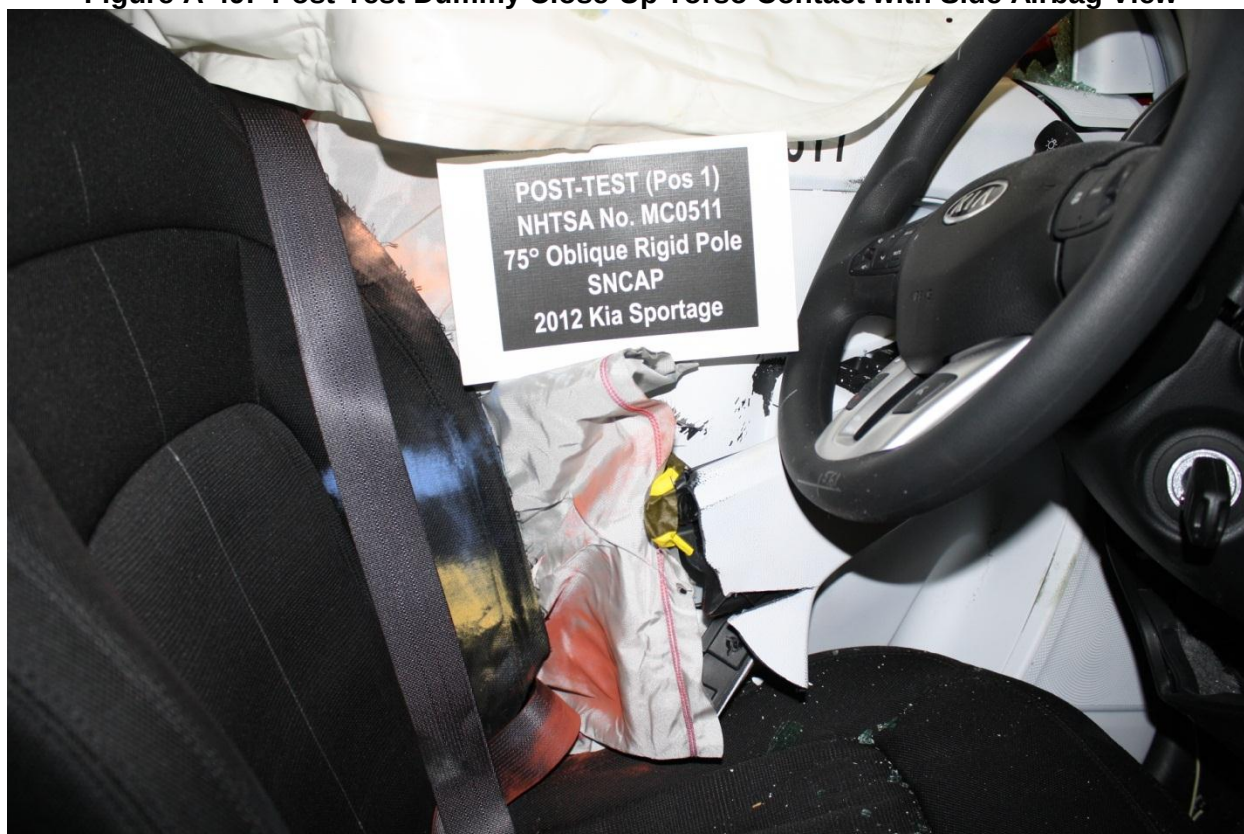
**Figure A-50: Post-Test Dummy Close-Up Pelvis Contact with Vehicle Interior View**

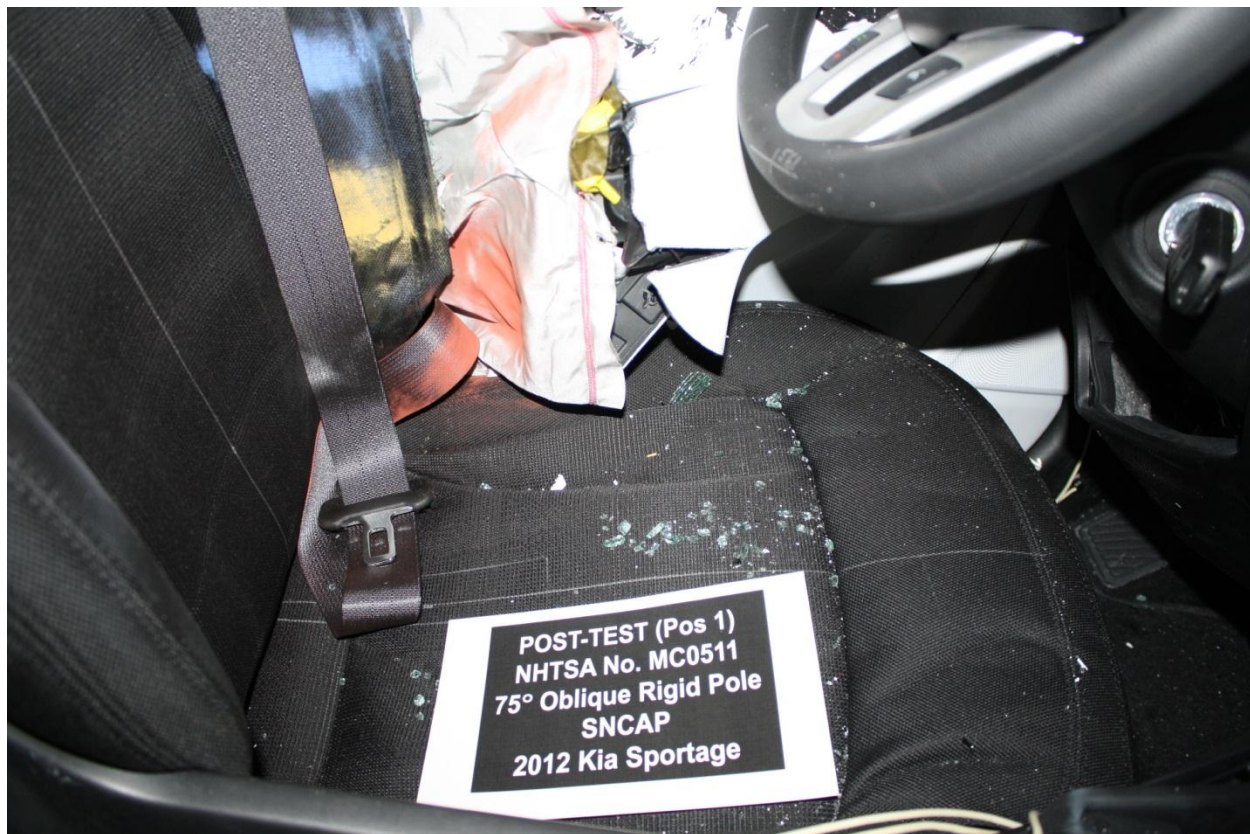
**Figure A-51: Post-Test Dummy Close-Up Pelvis Contact with Side Airbag View**

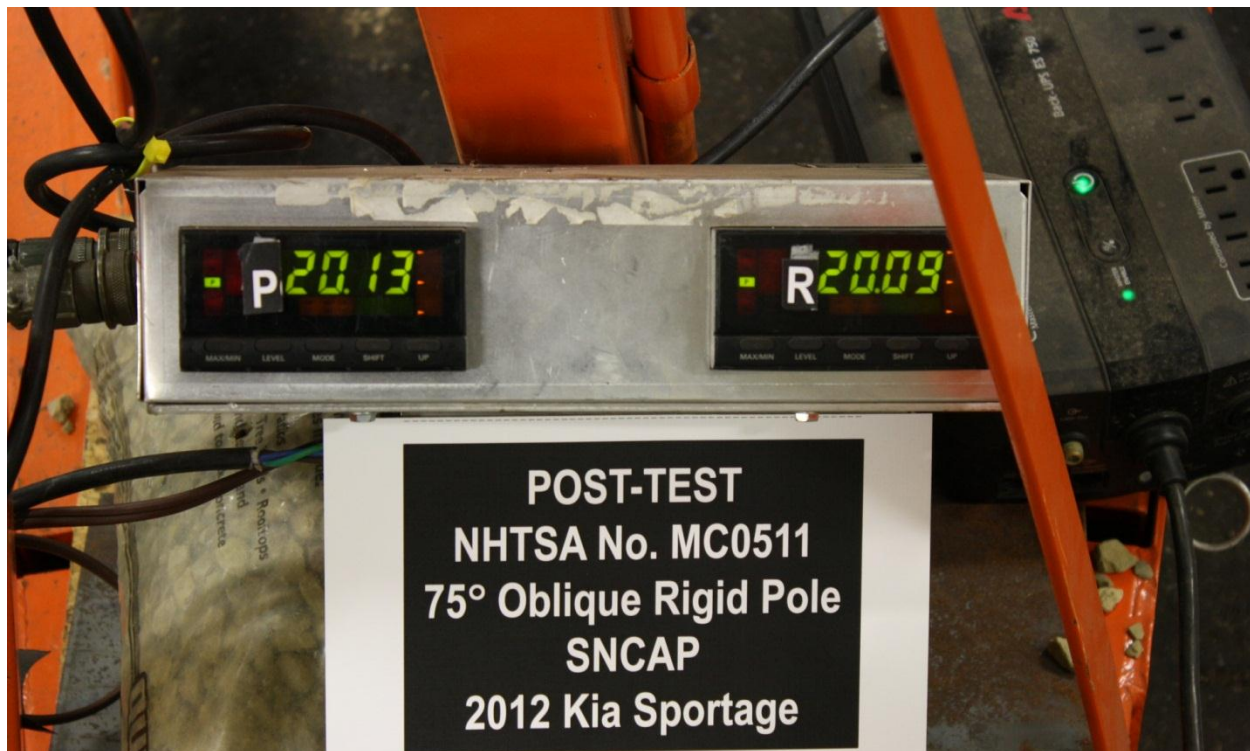
Figure A-61: Post-Test Primary and Redundant Speed Trap Read-Out

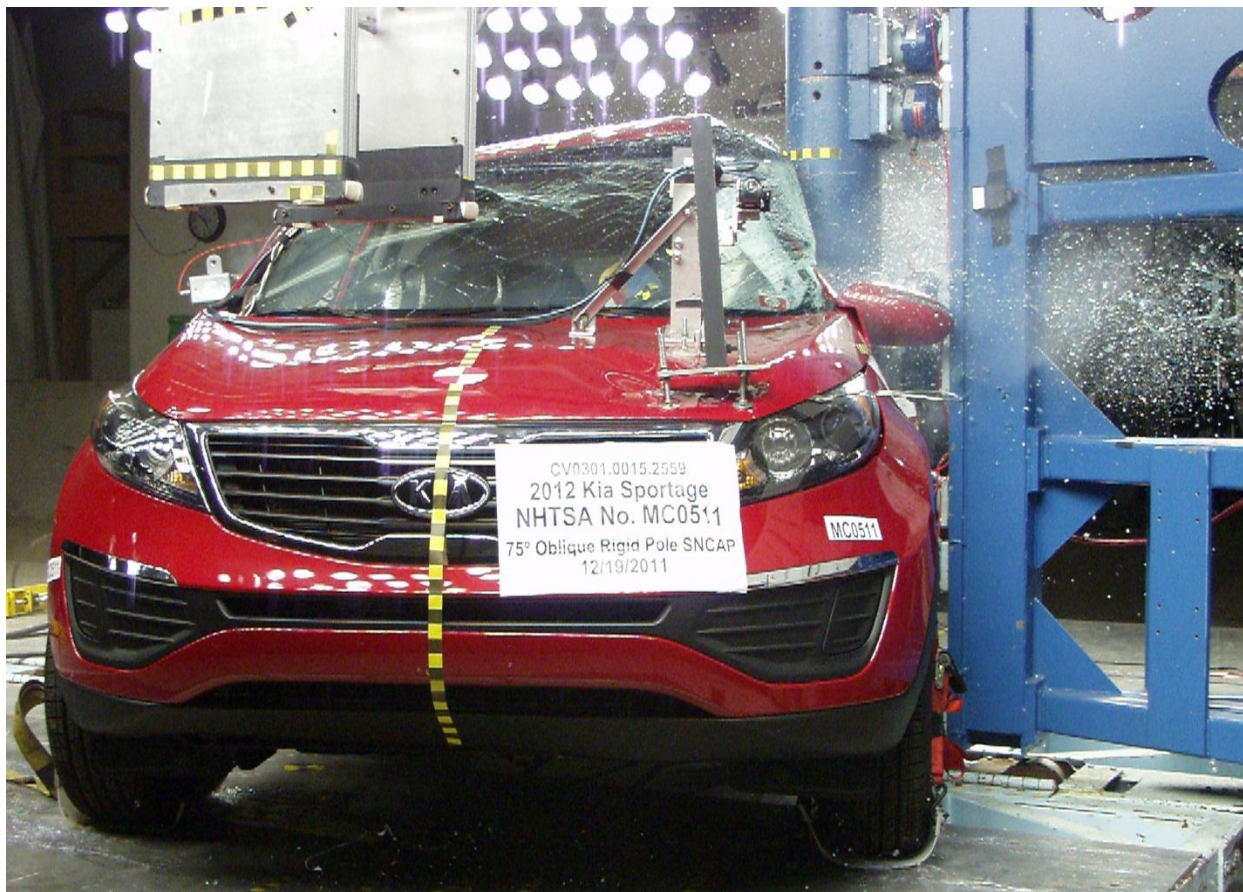
Figure A-67: Impact Event

A rigid pole side test was conducted on a 2012 Kia Sportage Utility Vehicle. The subject vehicle was towed into the rigid pole at an angle of 75° and a velocity of 32.40 km/h. The test was conducted by Calspan Corporation Transportation Research Group on 12/19/2011. Pre-test and post test photographs of the test vehicle and side impact dummy (SID-IIs) are included in Appendix A of this report.
