**REPORT NUMBER: SPNCAP-MGA-2012-042**

**NEW CAR ASSESSMENT PROGRAM (NCAP)  
Side Impact Pole Test**

**GENERAL MOTORS LLC  
2012 Chevrolet Silverado 2500 2WD Crew Cab  
NHTSA No.: MC0114**

**MGA RESEARCH CORPORATION  
5000 Warren Road  
Burlington, WI 53105**

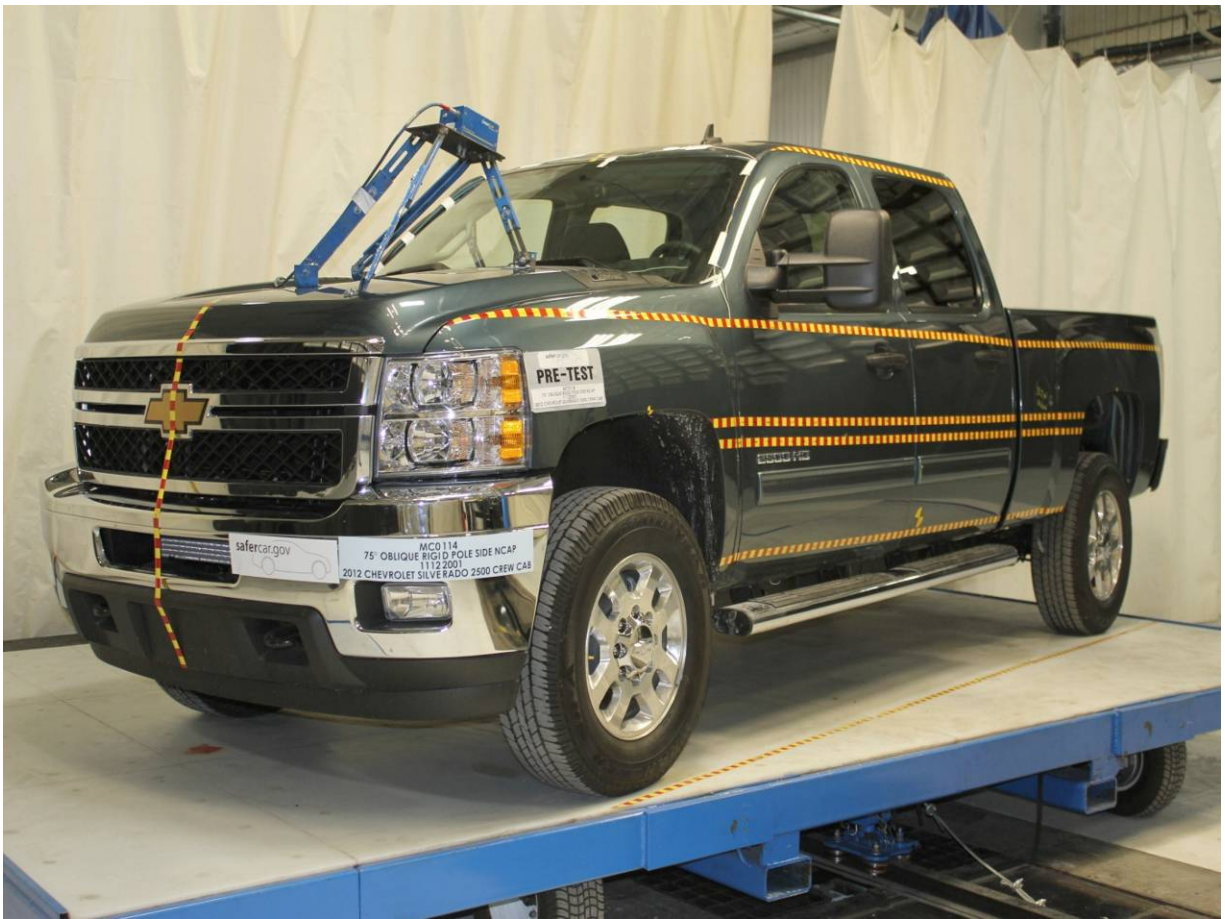
Post-Test Frontal View of Test Vehicle

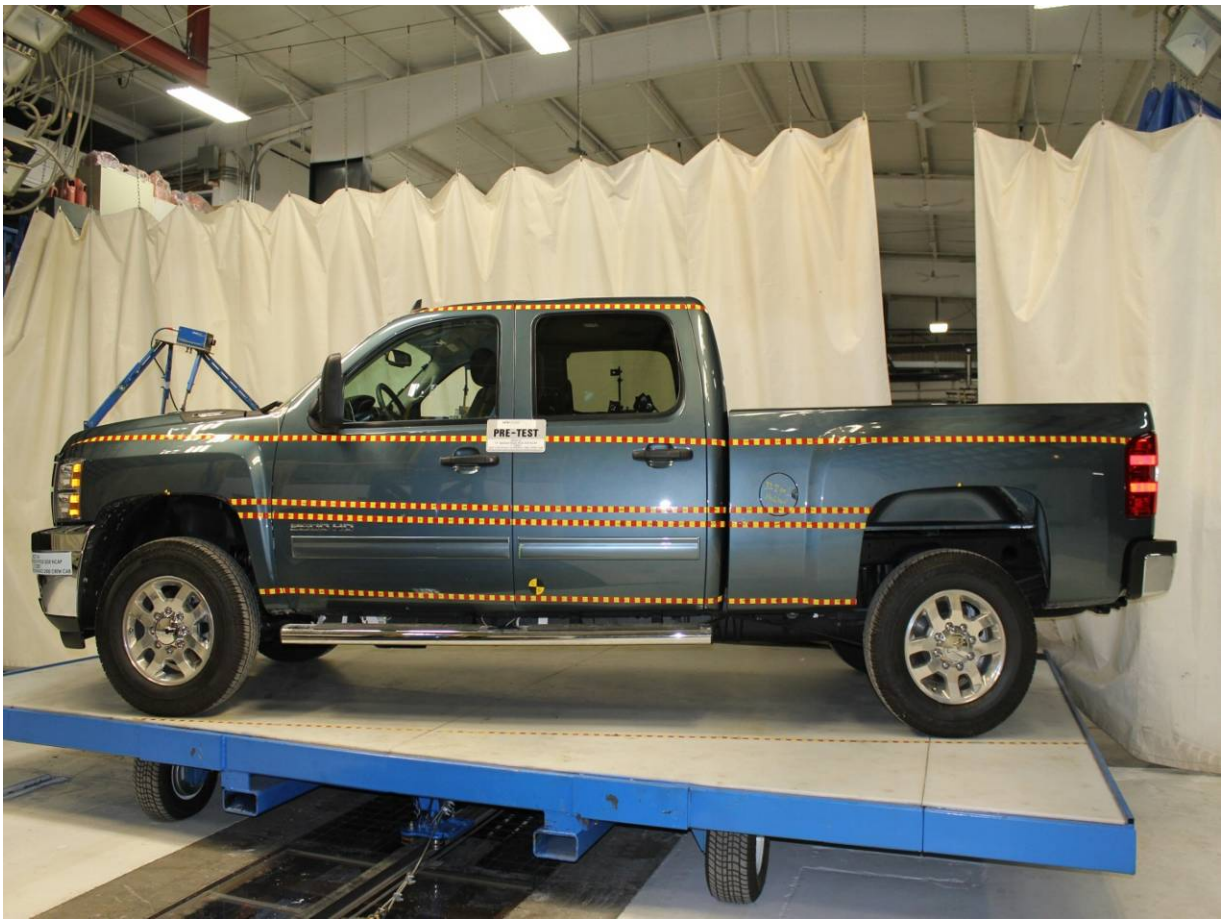
Post-Test Left Front  $\frac{3}{4}$  View of Test Vehicle

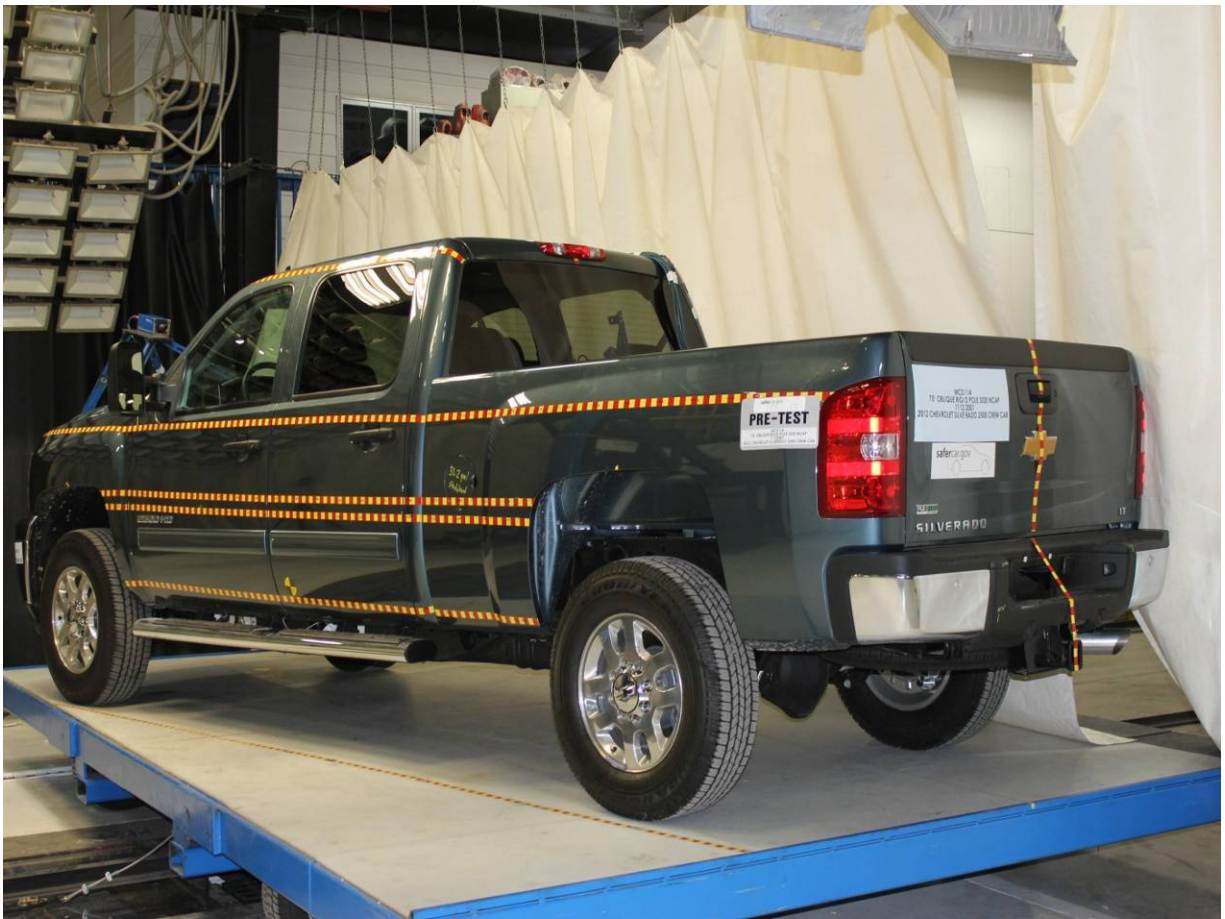
Post-Test Left Side View of Test Vehicle

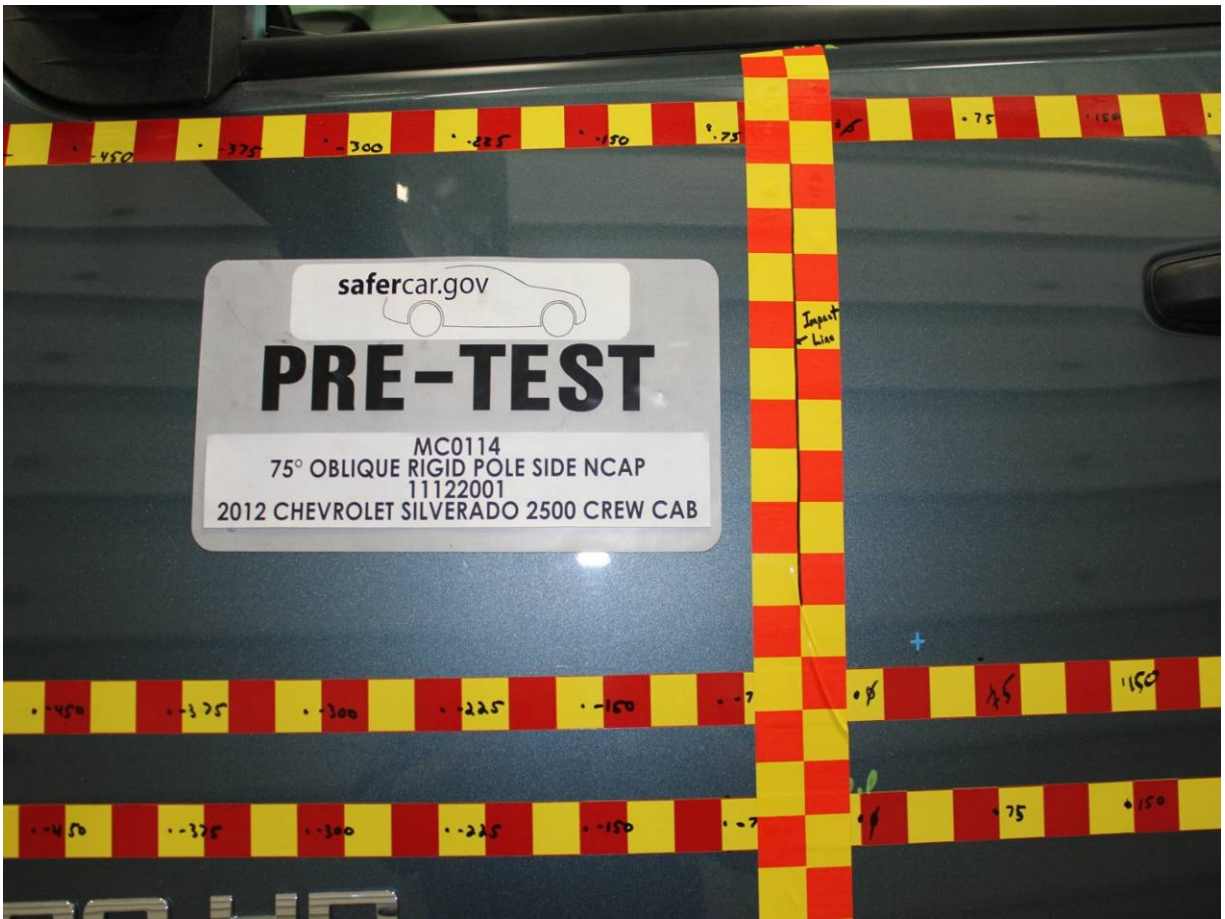
Pre-Test Left Side View of Pole Positioned Against Side of Vehicle

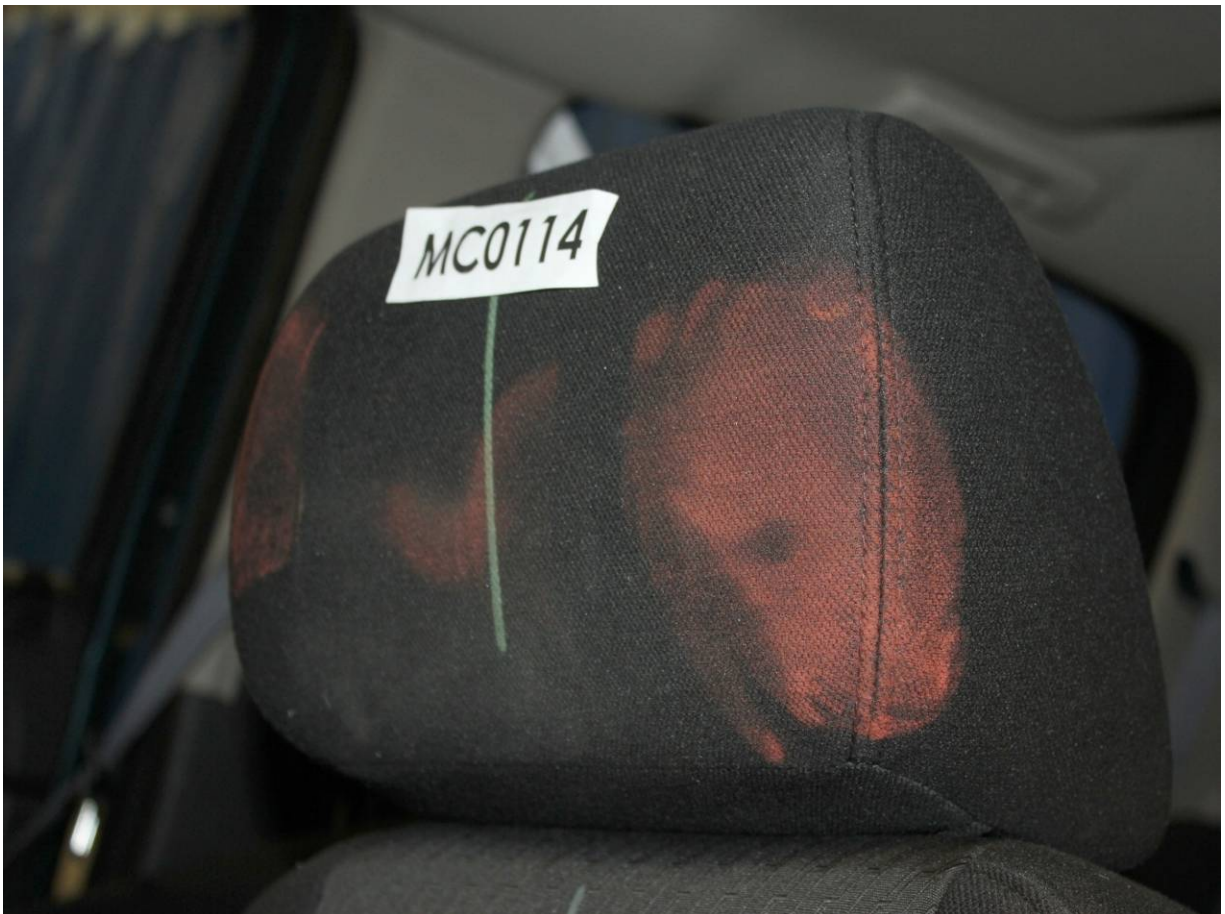
Post-Test Inner Door Panel View Showing Dummy Contact Location

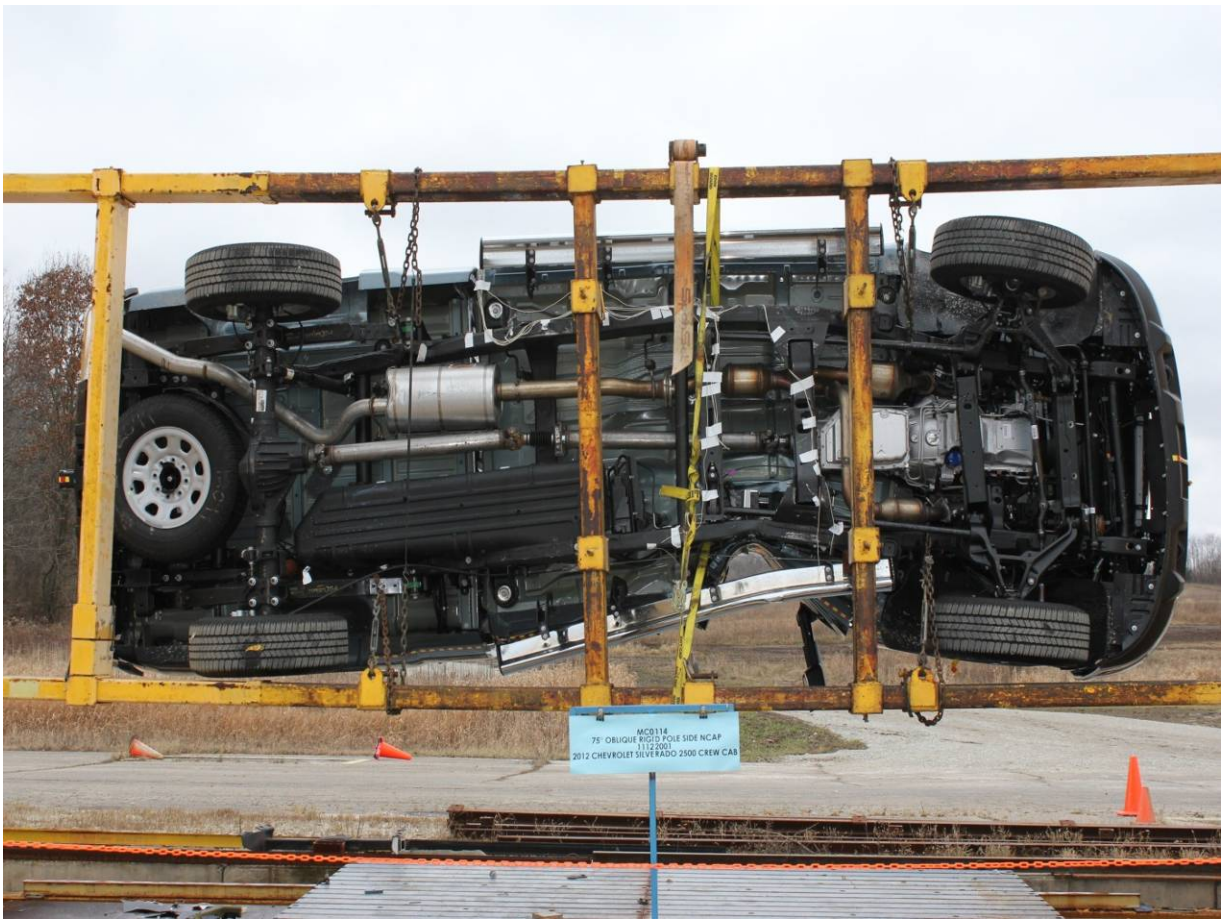
FMVSS No. 301 Static Rollover 0 Degrees

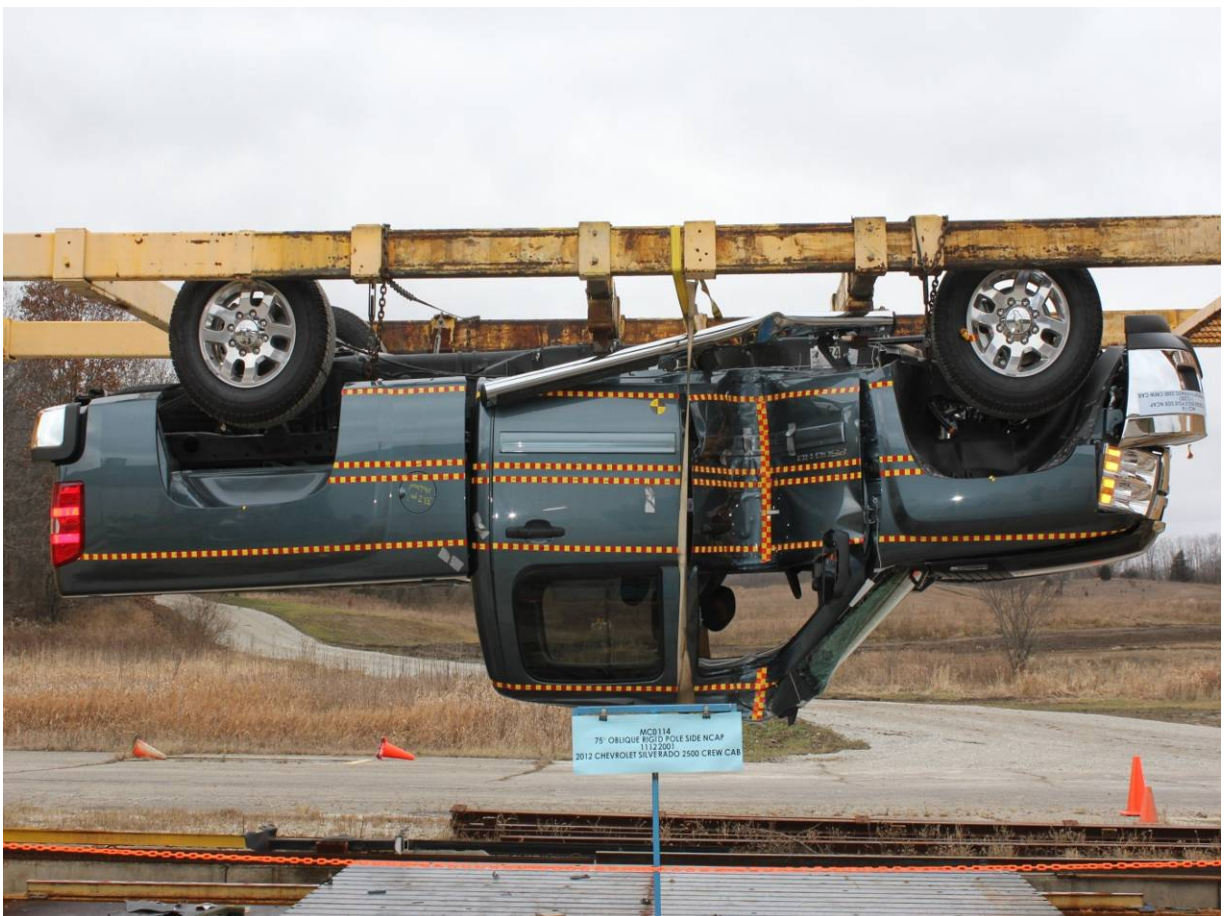
FMVSS No. 301 Static Rollover 90 Degrees

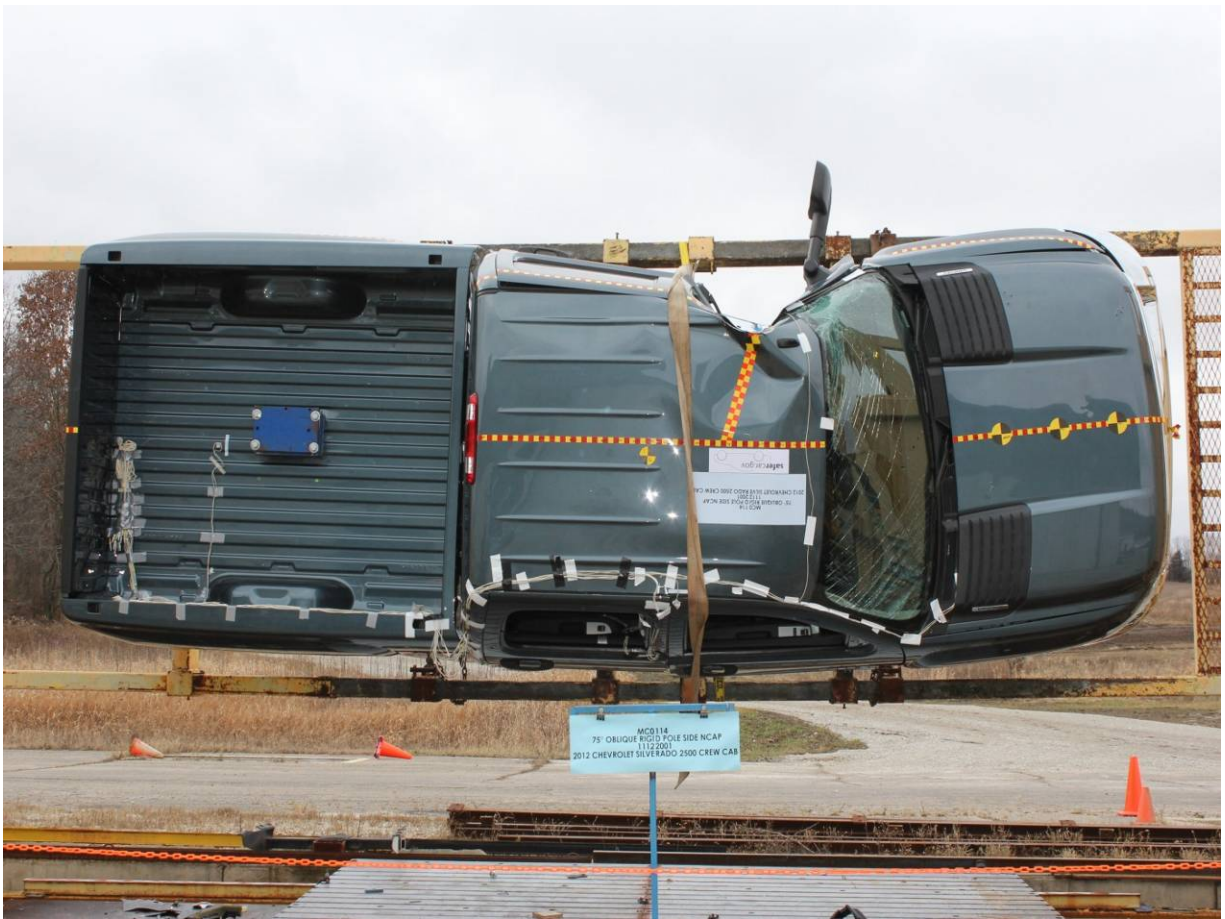
FMVSS No. 301 Static Rollover 180 Degrees
