**REPORT NUMBER: SINCAP-MGA-2012-043**

**NEW CAR ASSESSMENT PROGRAM (NCAP)  
Moving Deformable Barrier Side Impact Test**

**GENERAL MOTORS LLC  
2012 Chevrolet Silverado 2500 2WD Crew Cab  
NHTSA No.: MC0113**

**FINAL REPORT**

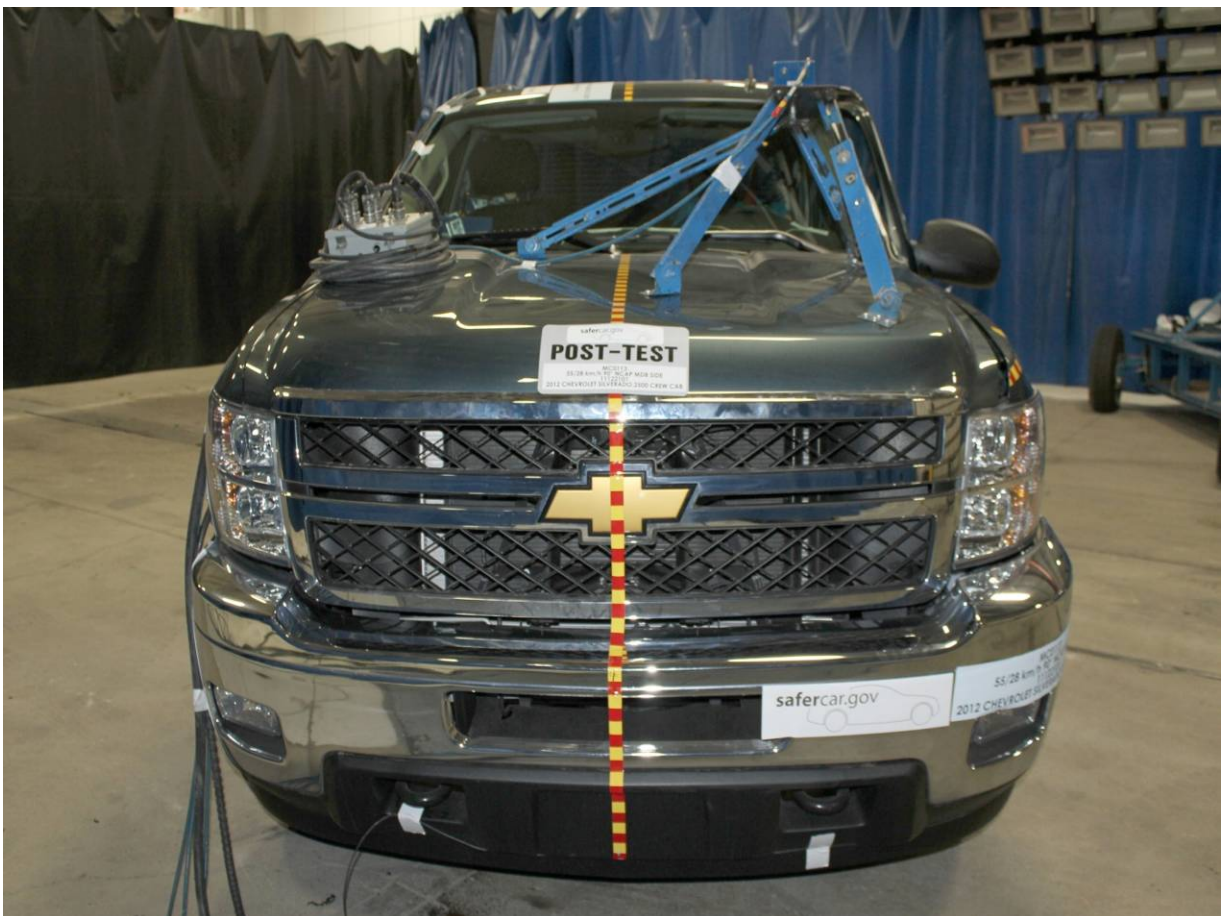
Post-Test Frontal View of Test Vehicle

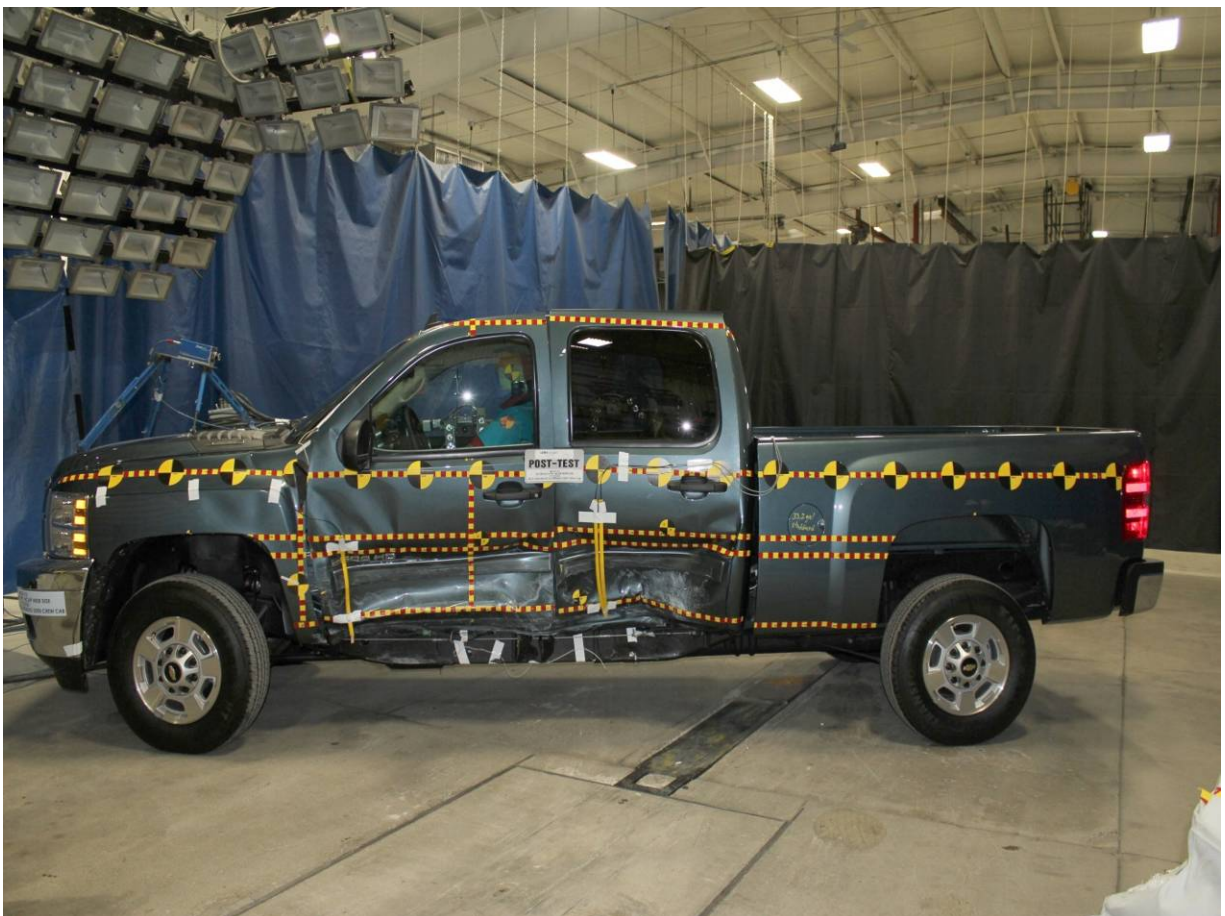
Post-Test Left Side View of Test Vehicle

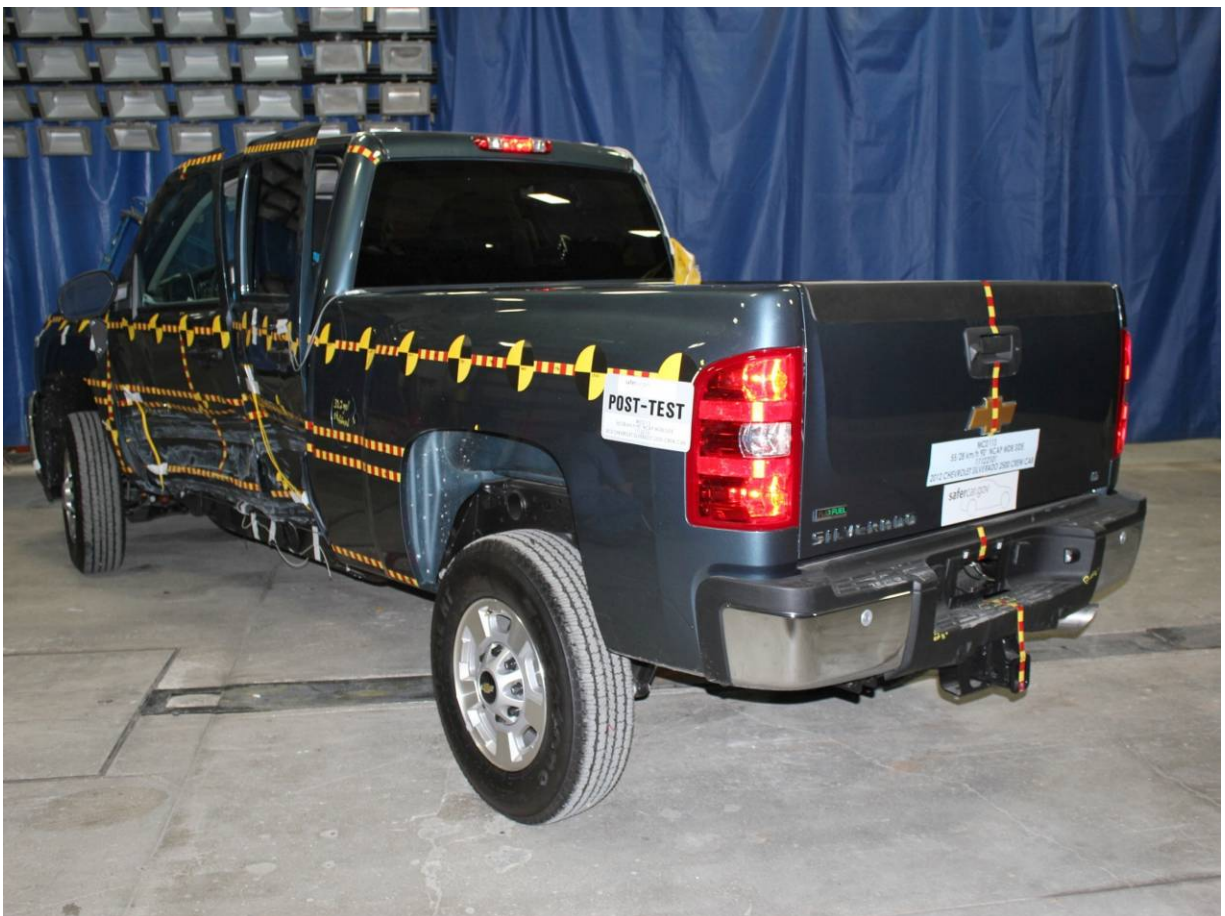
Post-Test Left Three-Quarter Rear View of Test Vehicle

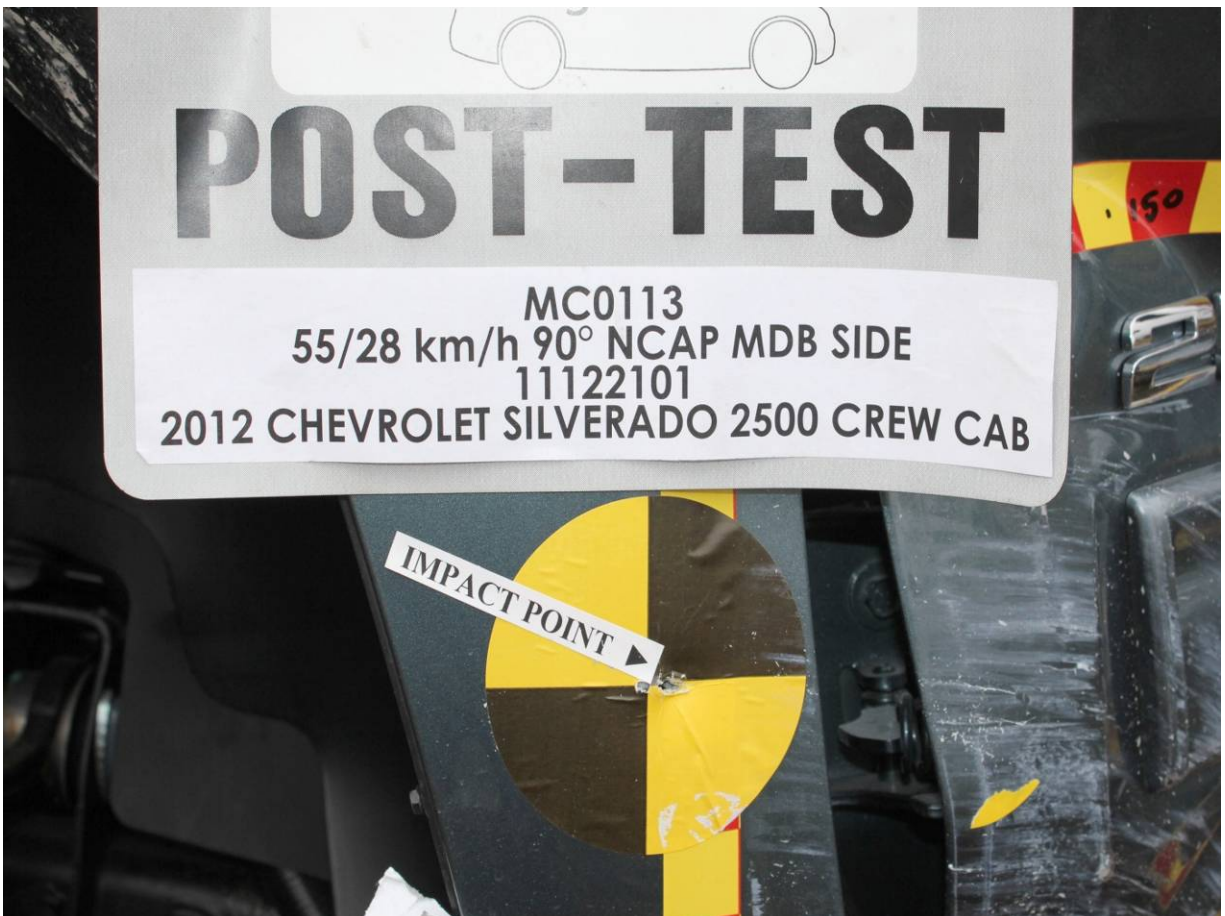
Post-Test Close-Up View of Impact Point Target

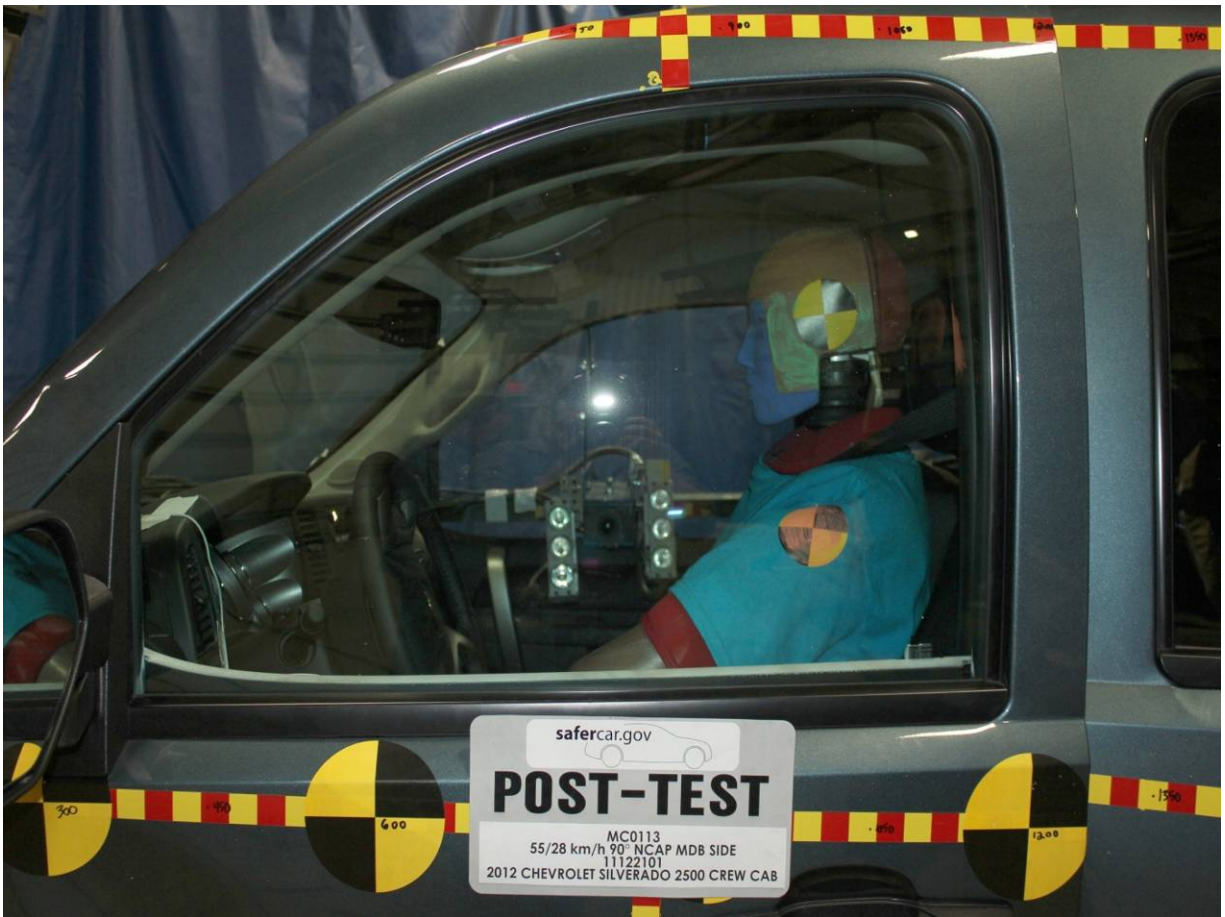
Post-Test Left Side View of Driver Dummy Shoulder and Door Top View

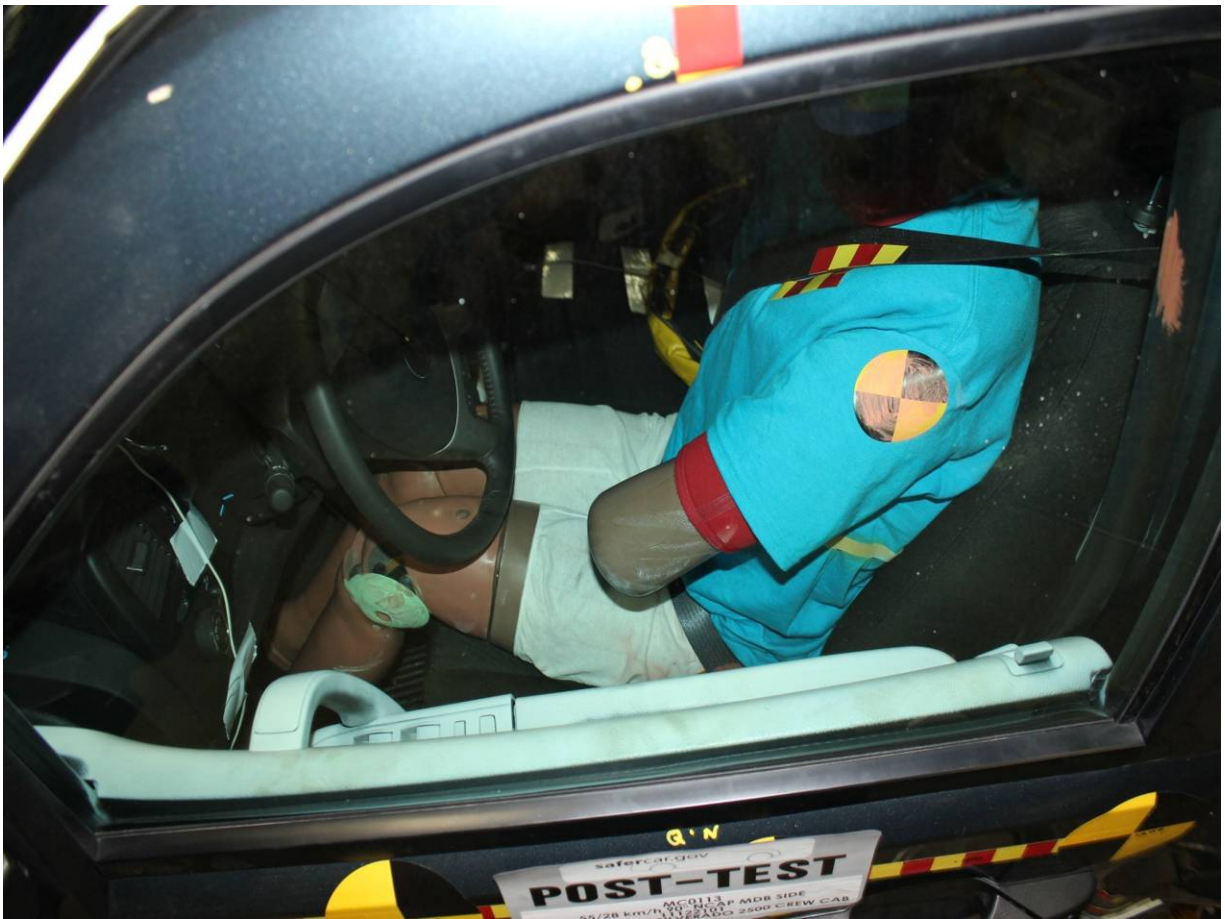
Post-Test Driver Dummy and Door Clearance View

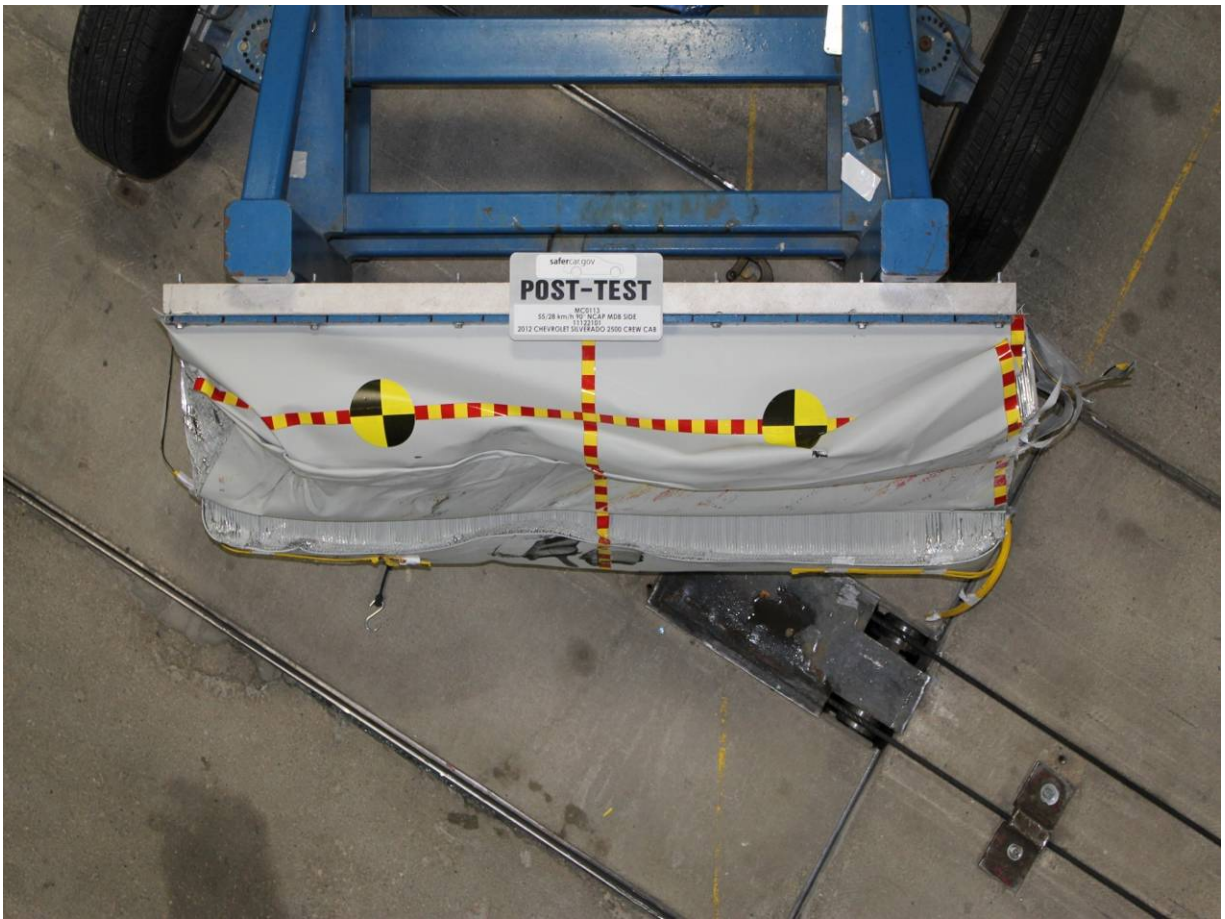
Post-Test Top View of MDB Impactor Face
