REPORT NUMBER: NCAP-MGA-2012-047

**NEW CAR ASSESSMENT PROGRAM (NCAP)
Frontal Barrier Impact Test**

**CHRYSLER GROUP LLC
2012 Ram 1500 SLT Crew Cab 4x4
NHTSA No.: MC0306**

**MGA RESEARCH CORPORATION
5000 Warren Road
Burlington, WI 53105**

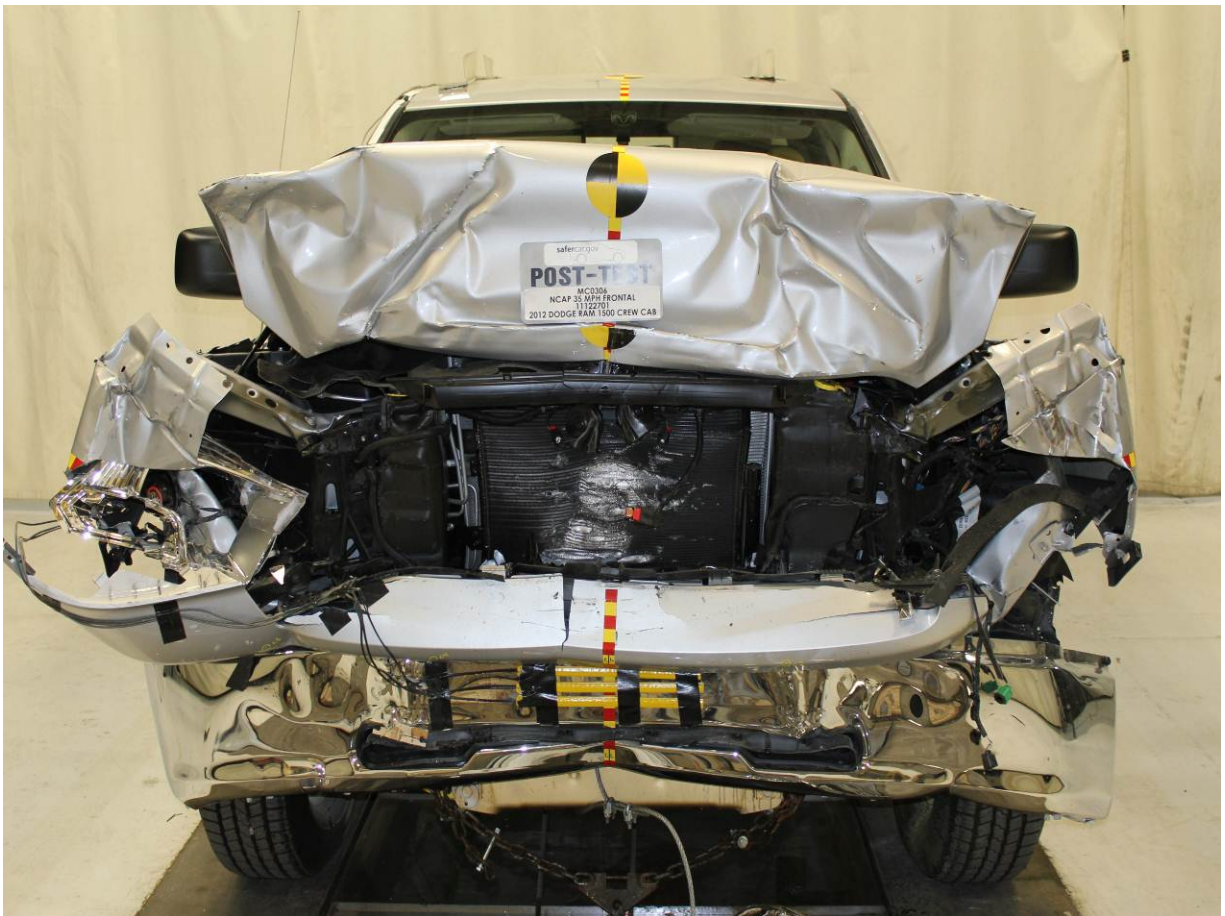
Post-Test Front View of Test Vehicle

The maximum static crush of the vehicle was 616 mm and both the driver and passenger side doors remained closed during the impact event and were operable after the impact.

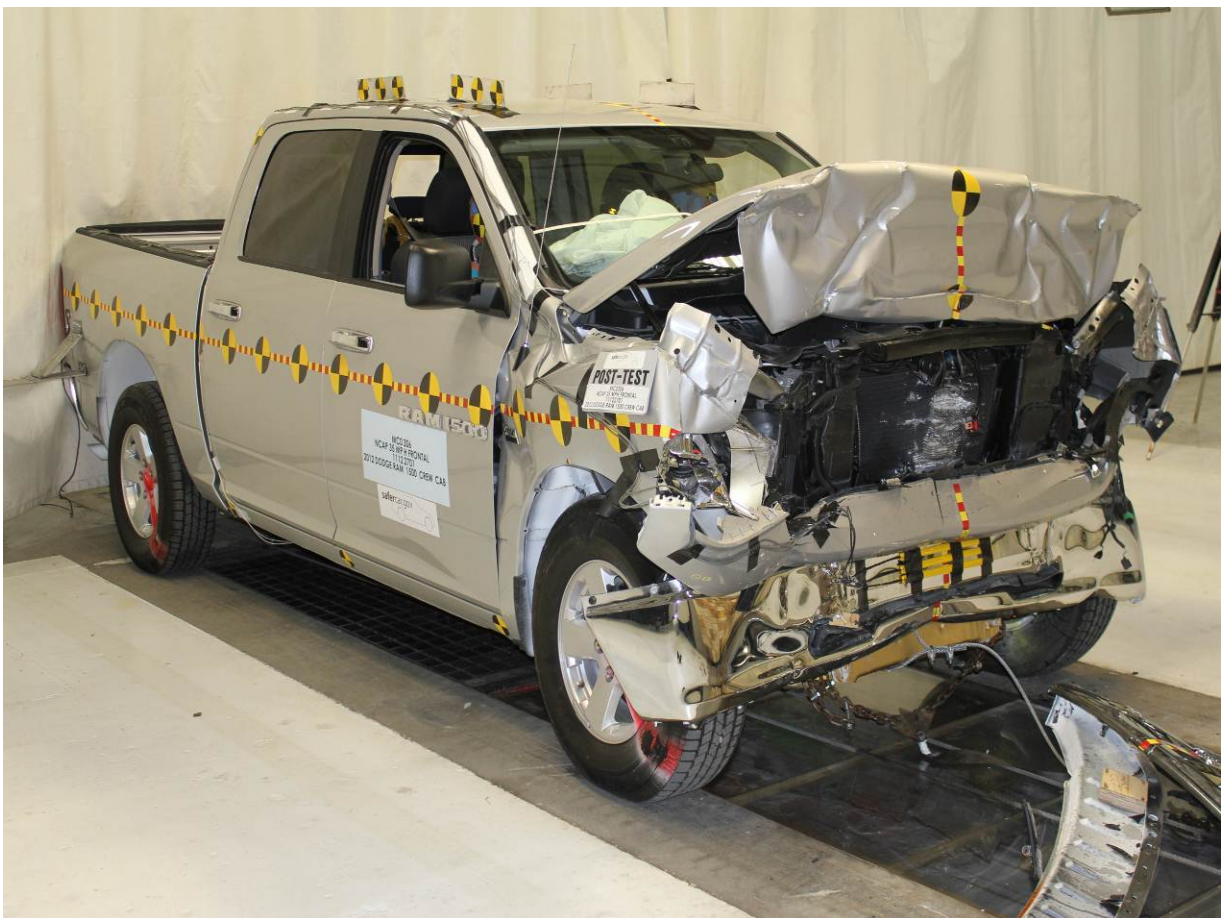
Post-Test Right Front Three-Quarter View

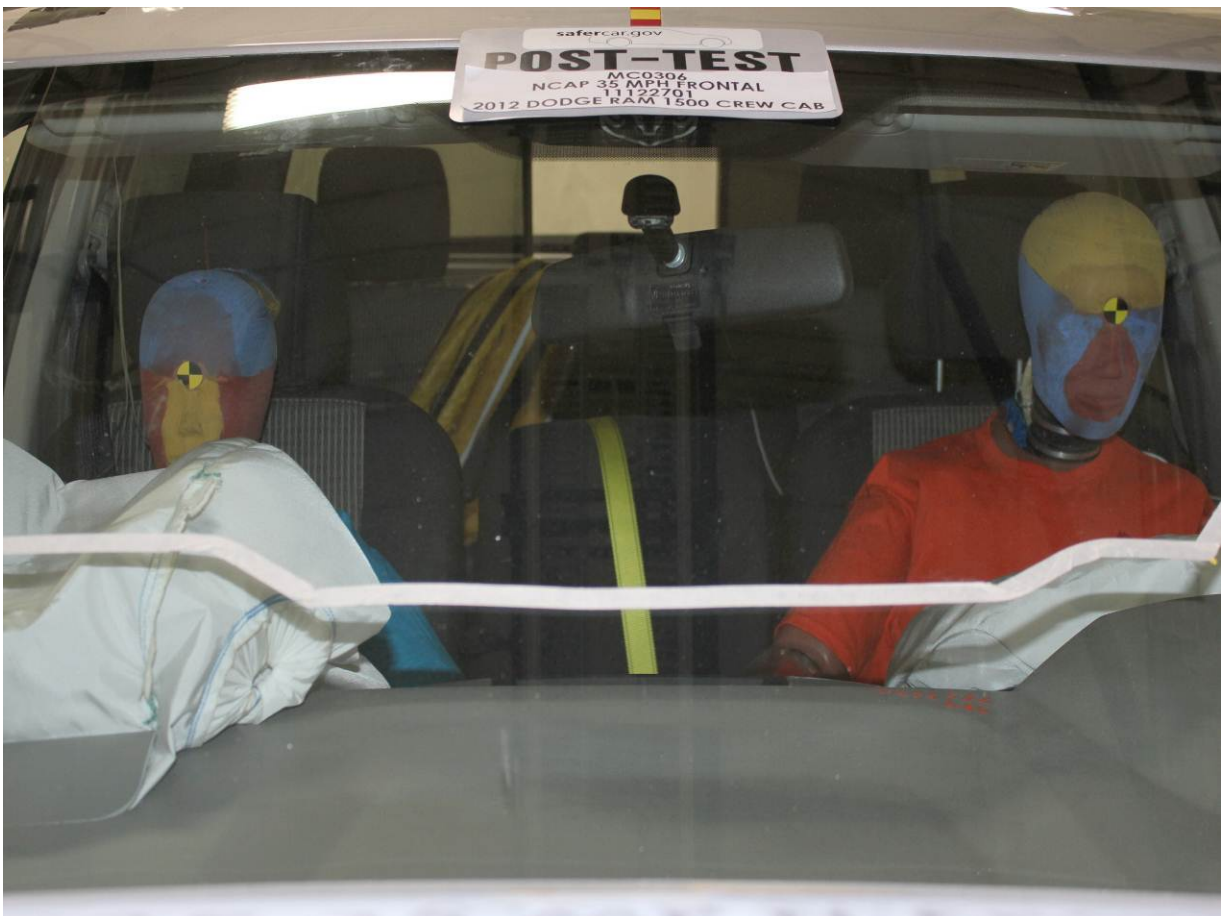
Post-Test Windshield View

There was 100 percent windshield retention and no intrusion into the protected zone of the windshield during the event. There was no Stoddard Solvent leakage after the event or during any phase of the static rollover.

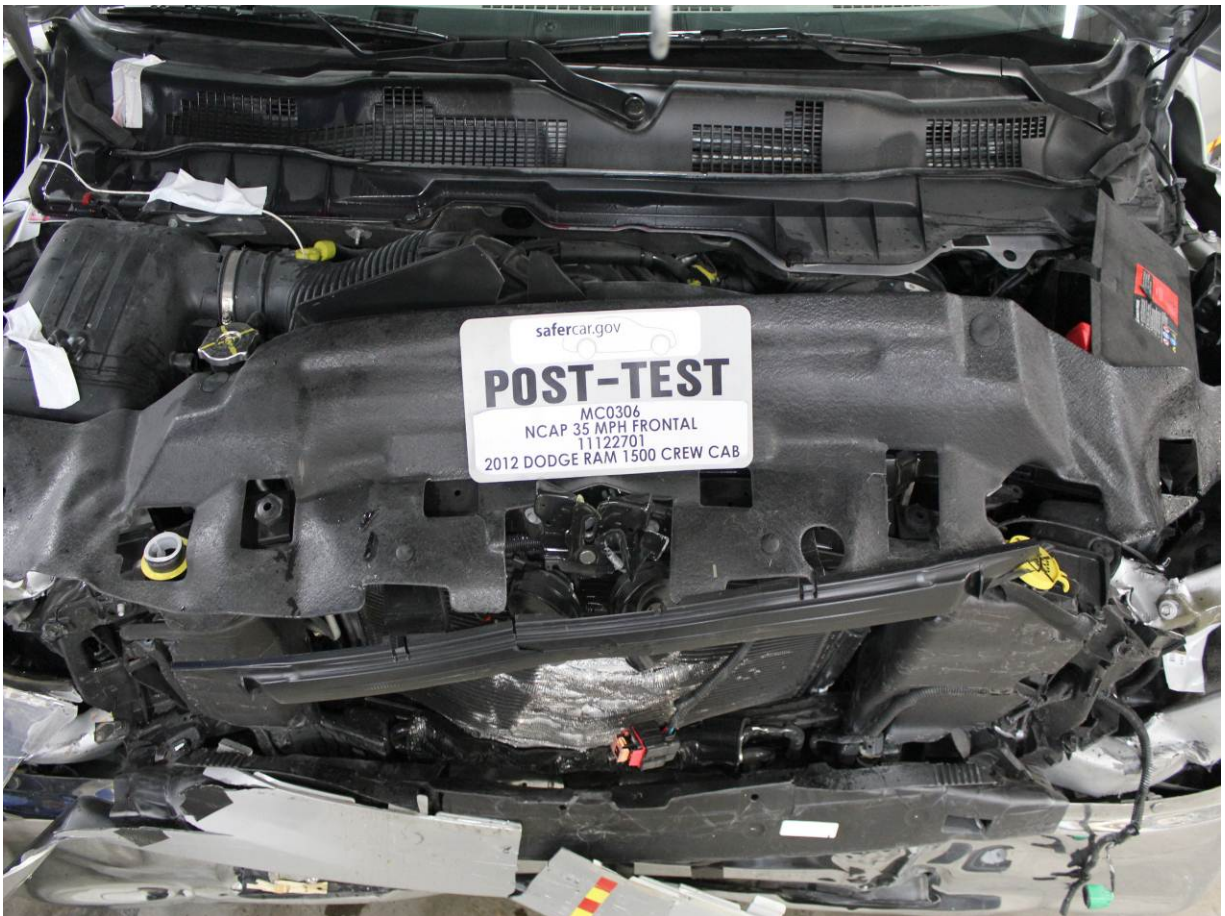
Post-Test Engine Compartment View

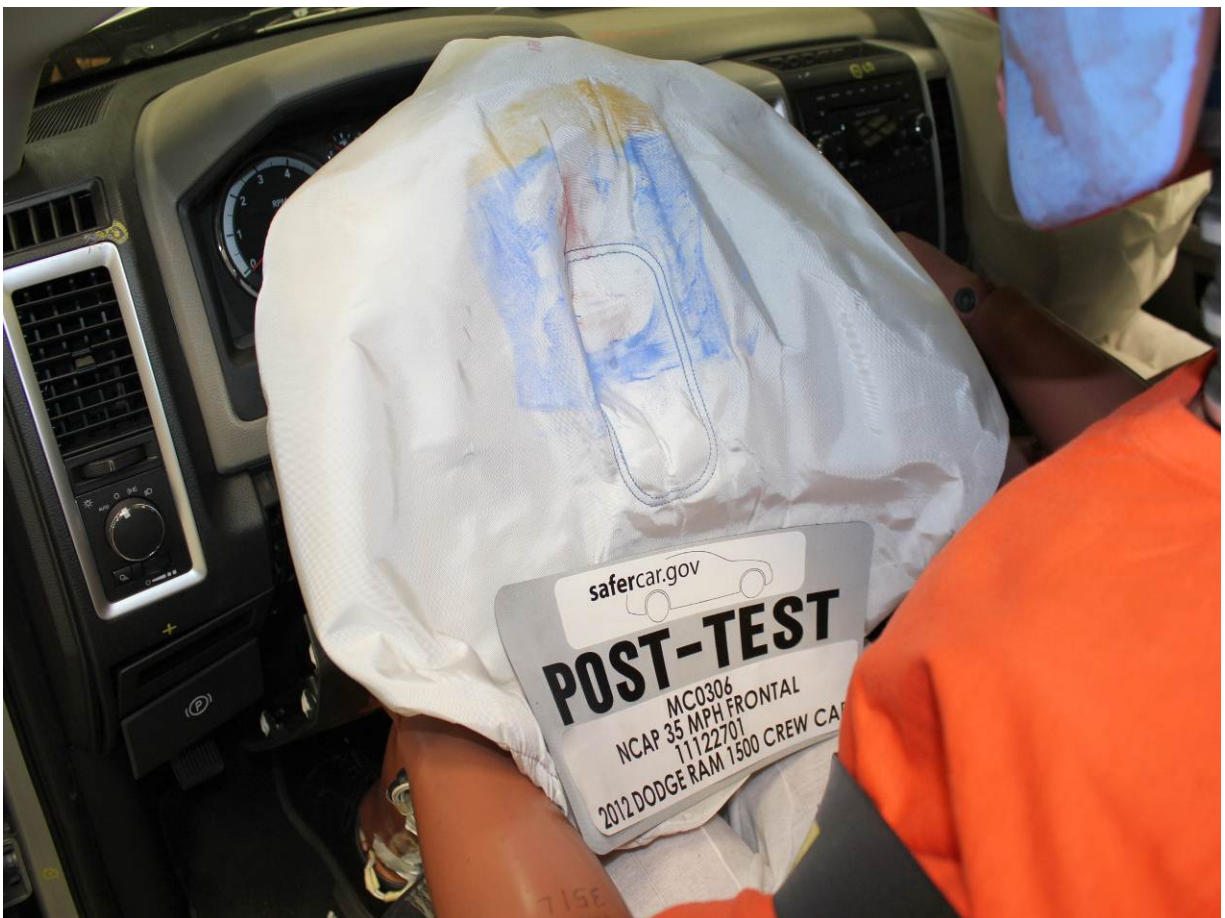
Post-Test Driver Dummy Contact with Airbag

The driver's visible contact points were as follows: The driver's head and chest contacted the airbag. The driver's head also contacted the headrest. The driver's knees contacted the knee bolster. The passenger's visible contact points were as follows: The passenger's head and chest contacted the airbag. The passenger's head also contacted the headrest. The passenger's knees contacted the glovebox.

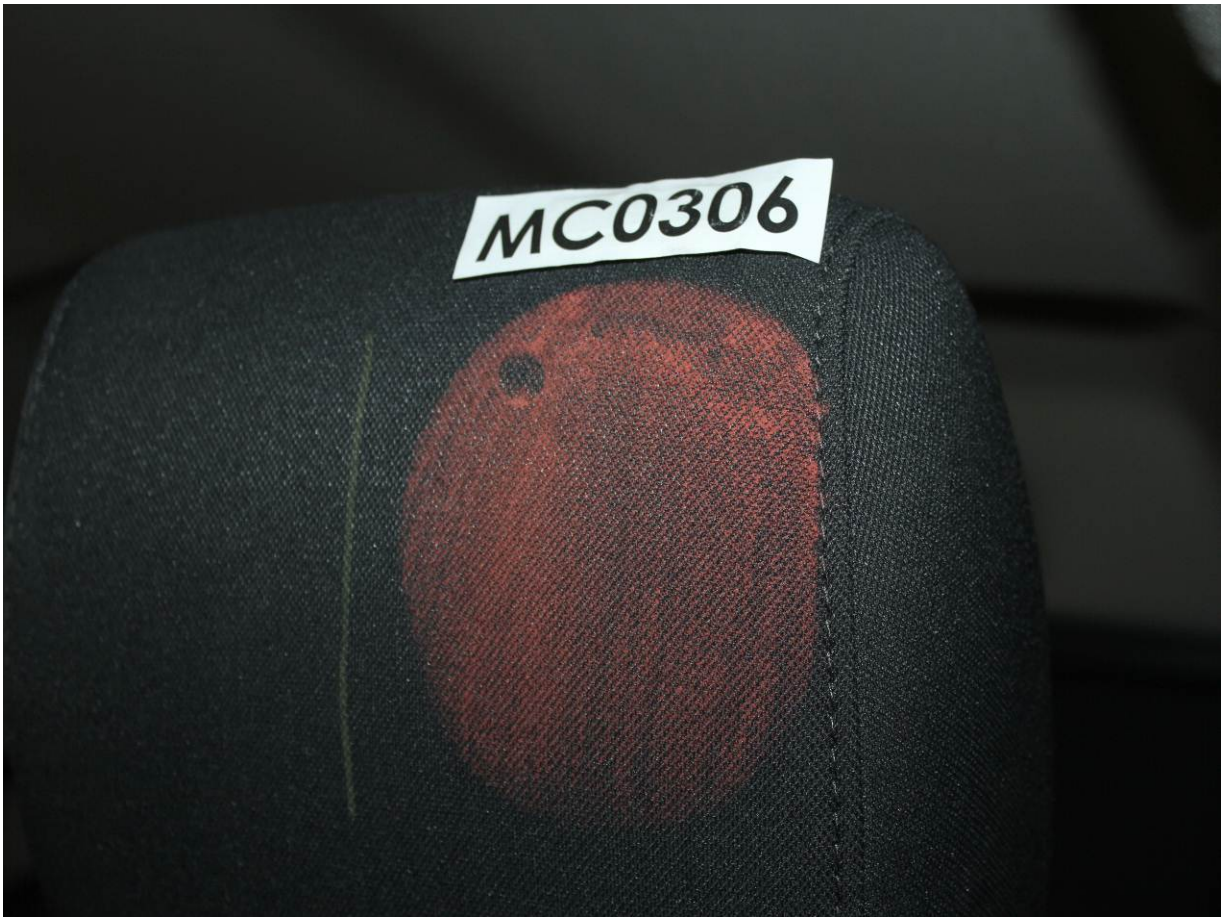
Post-Test Driver Dummy Contact with Headrest

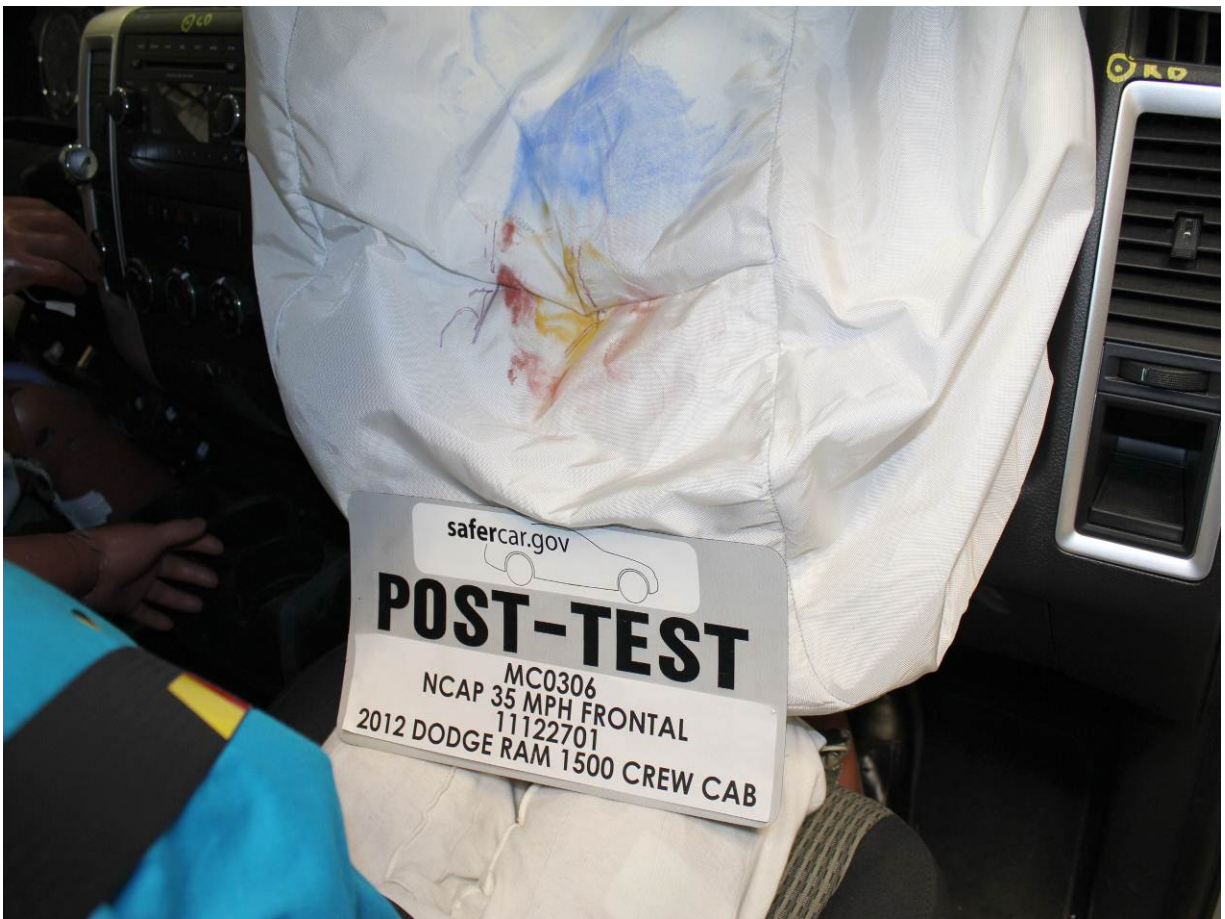
Post-Test Passenger Dummy Contact with Airbag

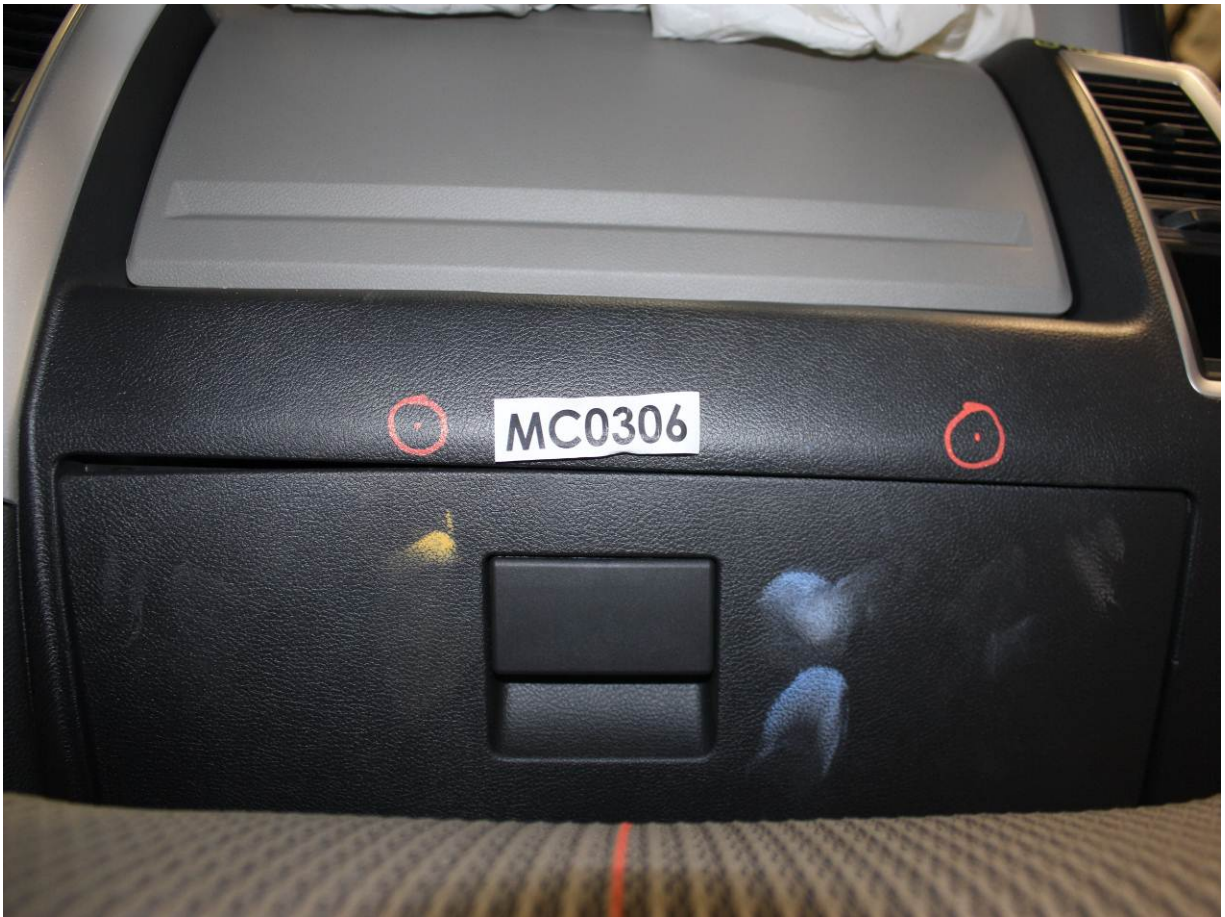
Post-Test Passenger Dummy Contact with Knee Bolster
