**REPORT NUMBER: SINCAP-MGA-2012-046**

**NEW CAR ASSESSMENT PROGRAM (NCAP)  
Moving Deformable Barrier Side Impact Test**

**CHRYSLER GROUP LLC  
2012 Chrysler 300 4-Dr Sedan  
NHTSA No.: MC0332**

**FINAL REPORT**

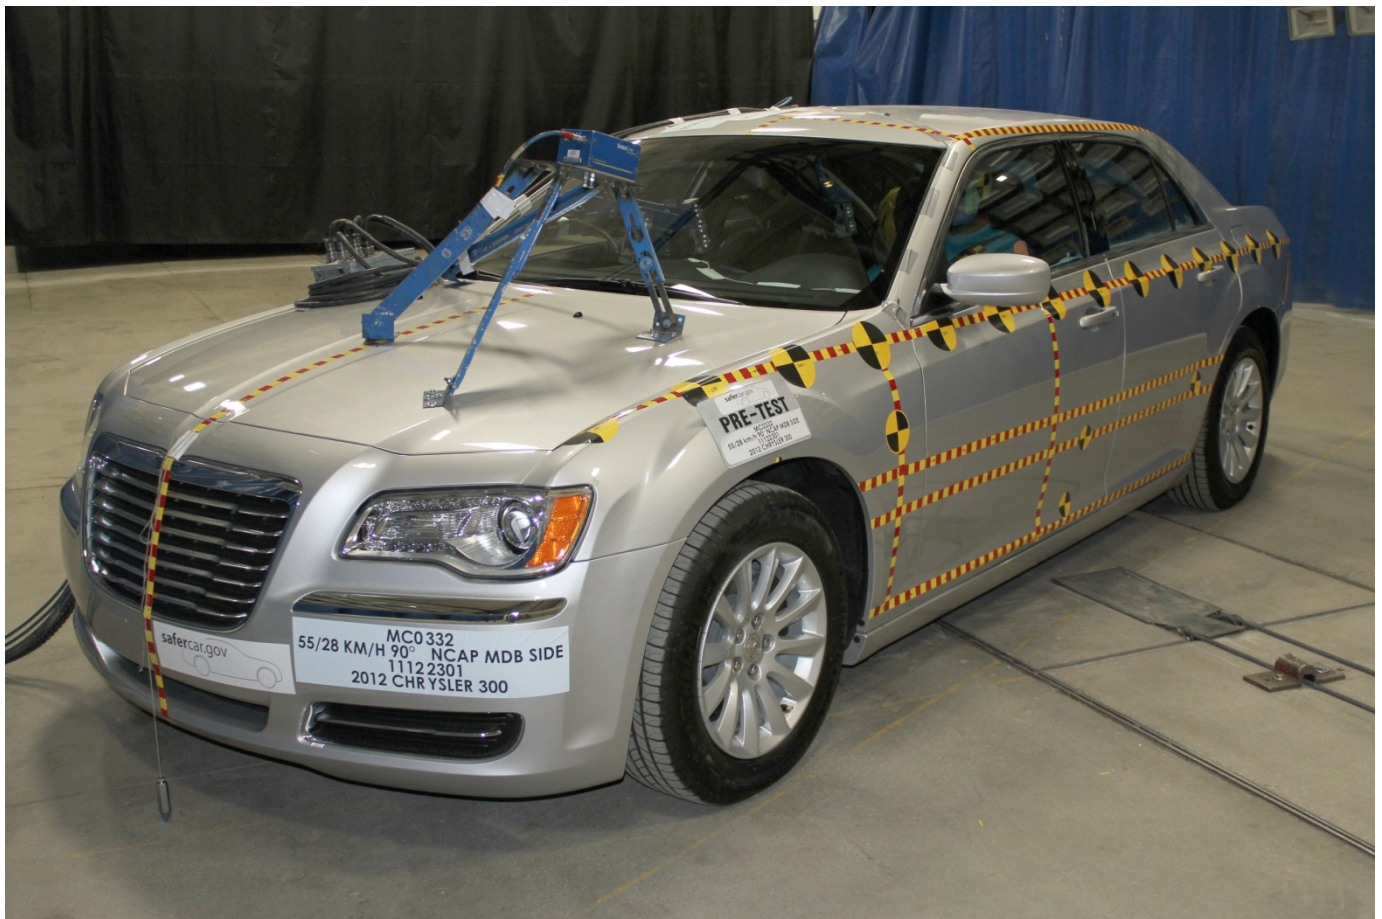
Post-Test Frontal View of Test Vehicle

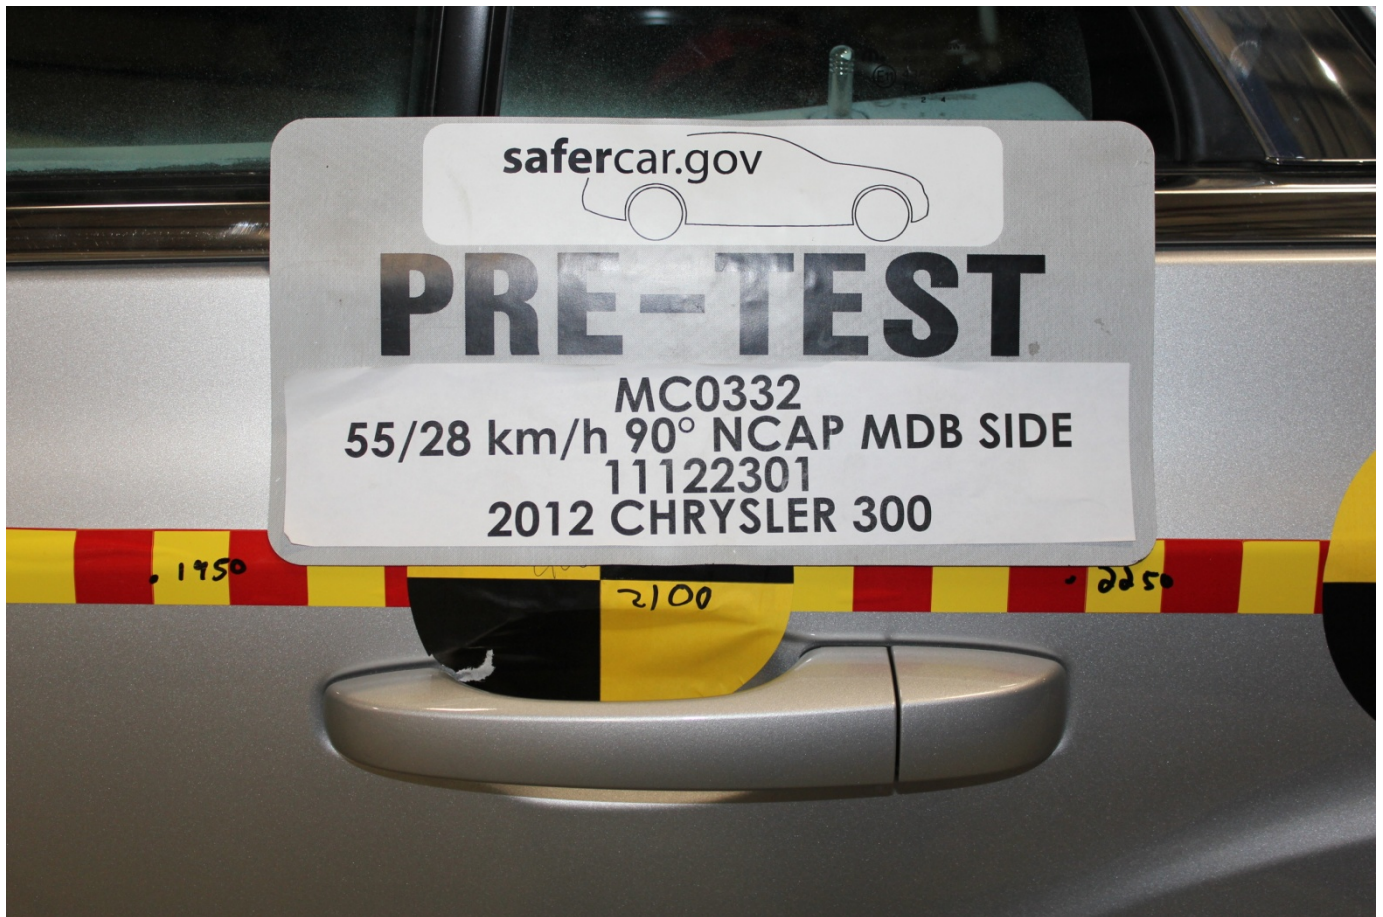
Post-Test Left Front Door Latch Close-Up

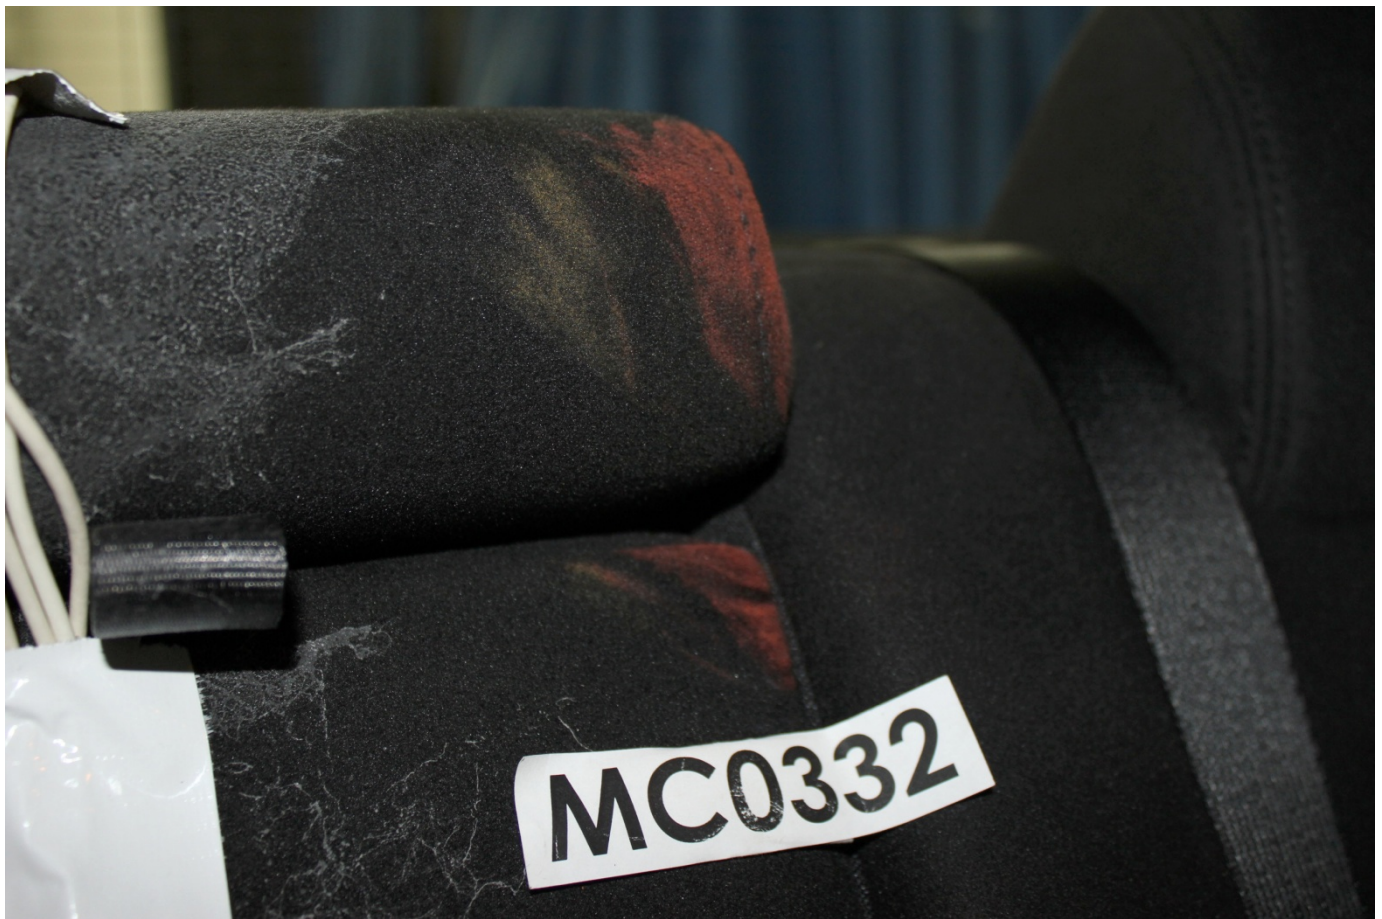
Post-Test Rear Passenger Inner Door Panel View

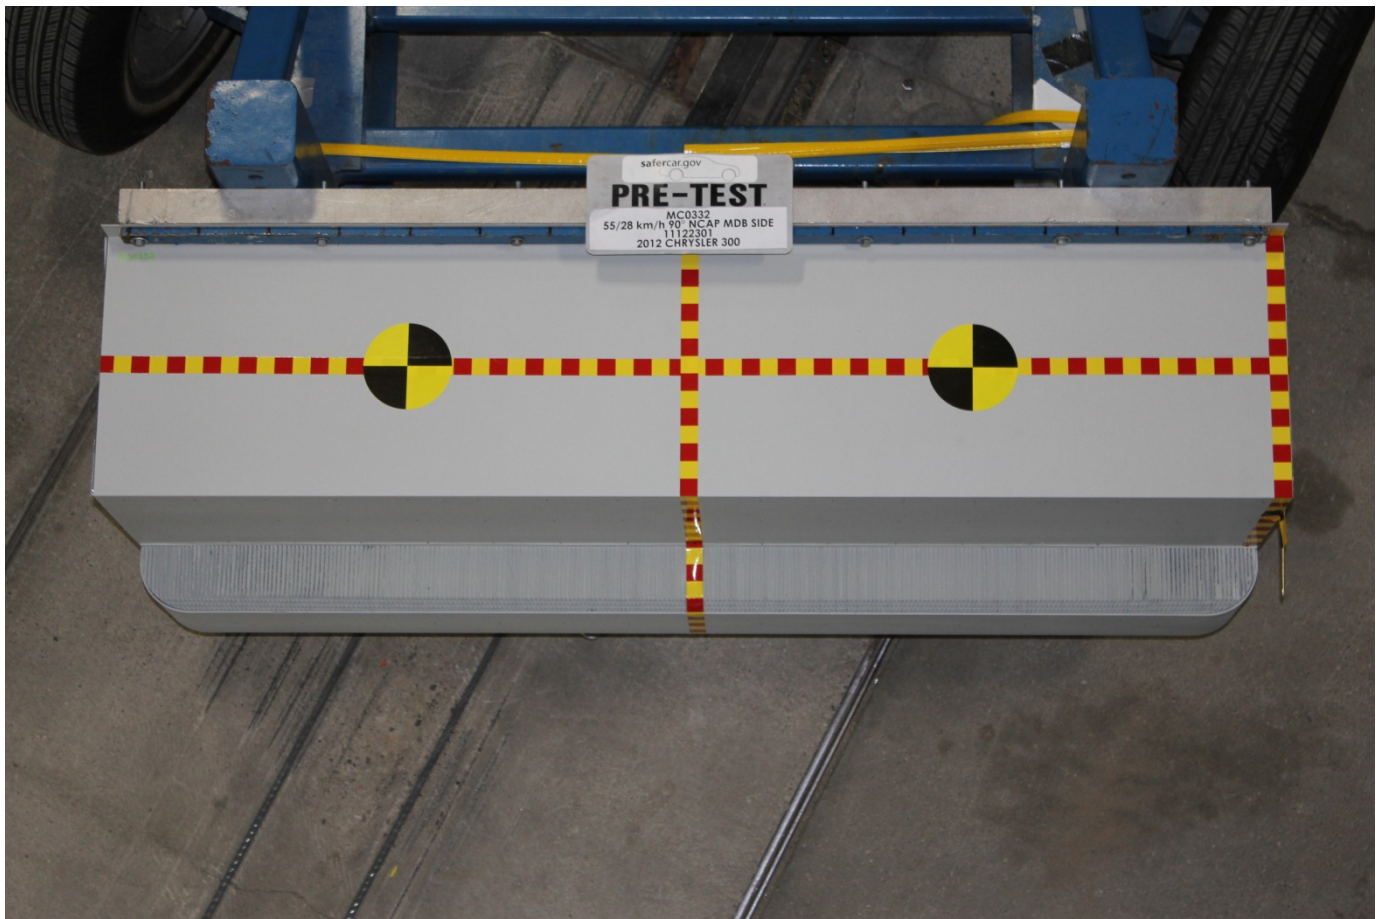
Post-Test Front View of MDB Impactor Face
