**REPORT NUMBER: TWG-MGA-2012-004**

**SIDE AIRBAG OUT-OF-POSITION INJURY  
TECHNICAL WORKING GROUP**

**CHRYSLER GROUP LLC  
2012 CHRYSLER TOWN & COUNTRY MINIVAN  
NHTSA NUMBER: MC0301TWG2**

**FINAL REPORT**

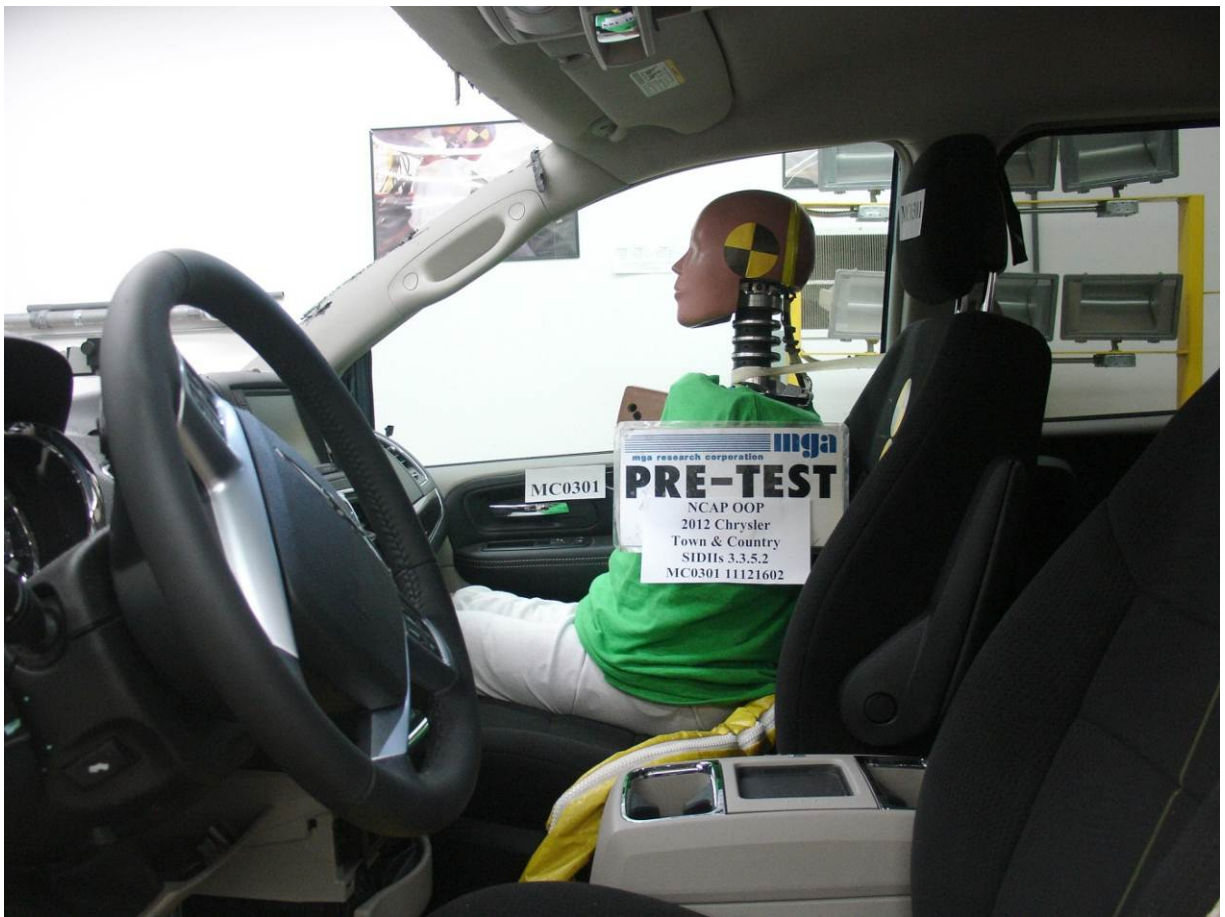
Pre-Test SID-IIs Dummy Left Side View

The SID-1Is dummy was placed in the right front passenger seat sitting upright in the center of the seat facing forward with its arm along the armrest. The arm was rotated horizontally in the forward direction with respect to the dummy. The seat track was adjusted forward. The dummy was slid outboard until the dummy's side contacted the door trim panel or armrest and the CG of the head was centered in the deployment trajectory of the airbag. Masking tape was wrapped around the dummy's neck bracket to hold the dummy in place.

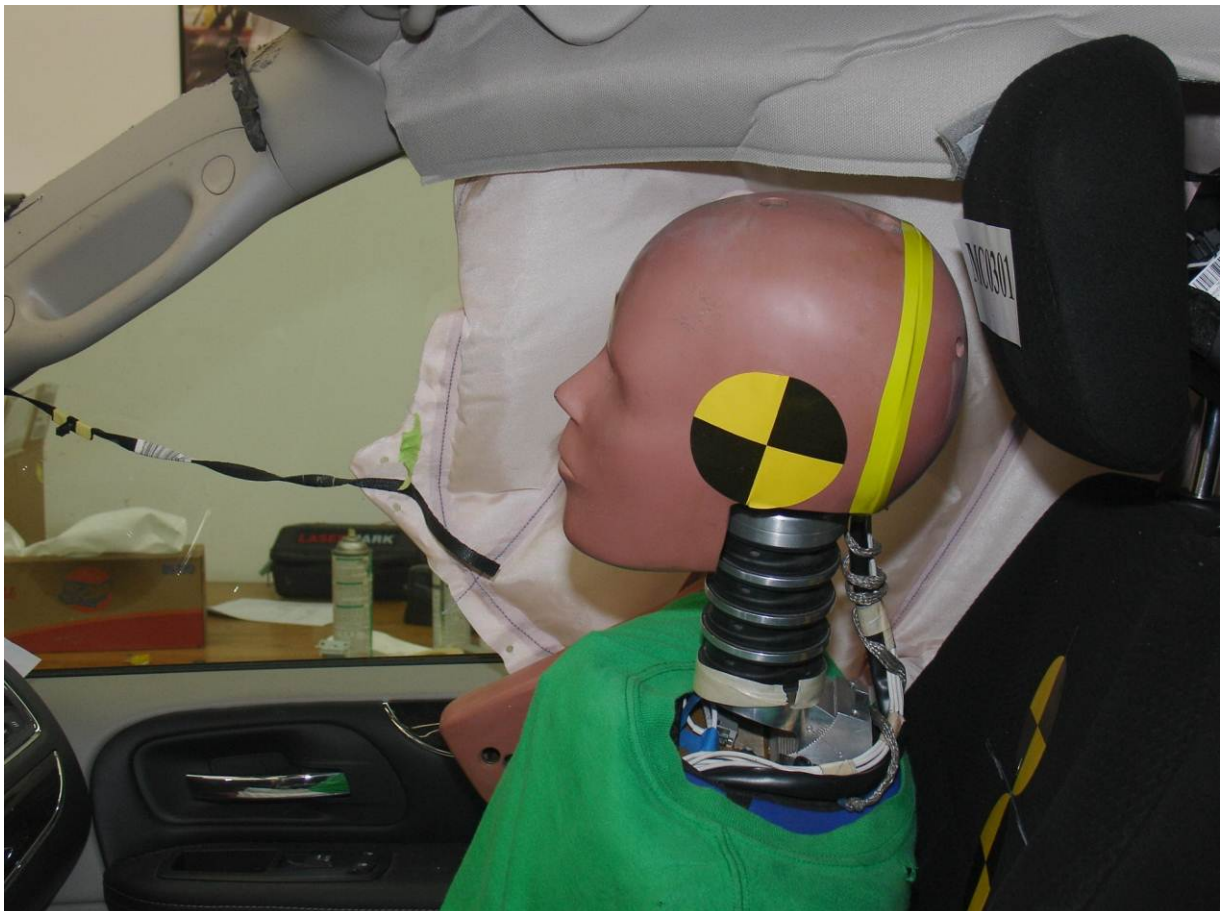
Post-Test SID-IIs Dummy Left Side Closeup View

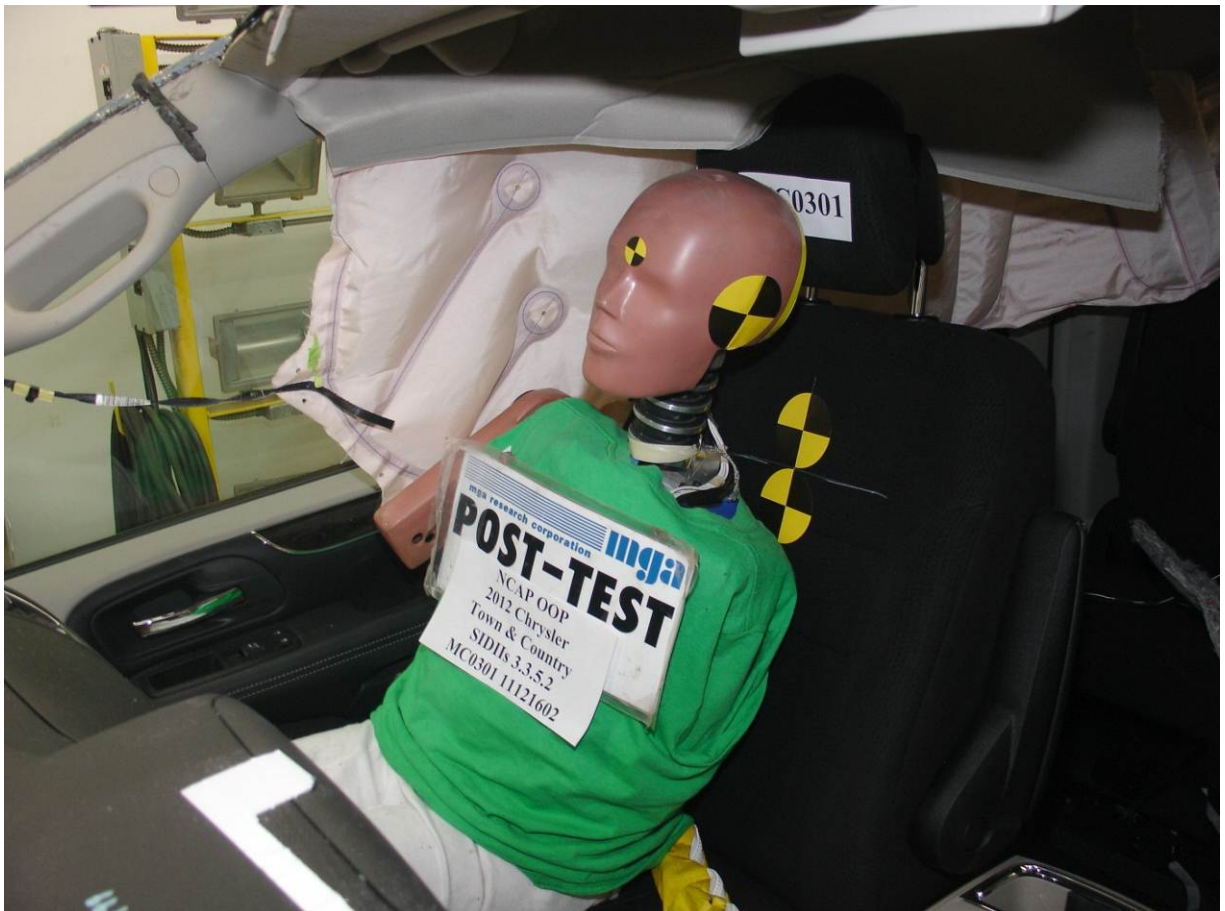
Post-Test SID-IIs Dummy Left ¾ Front View

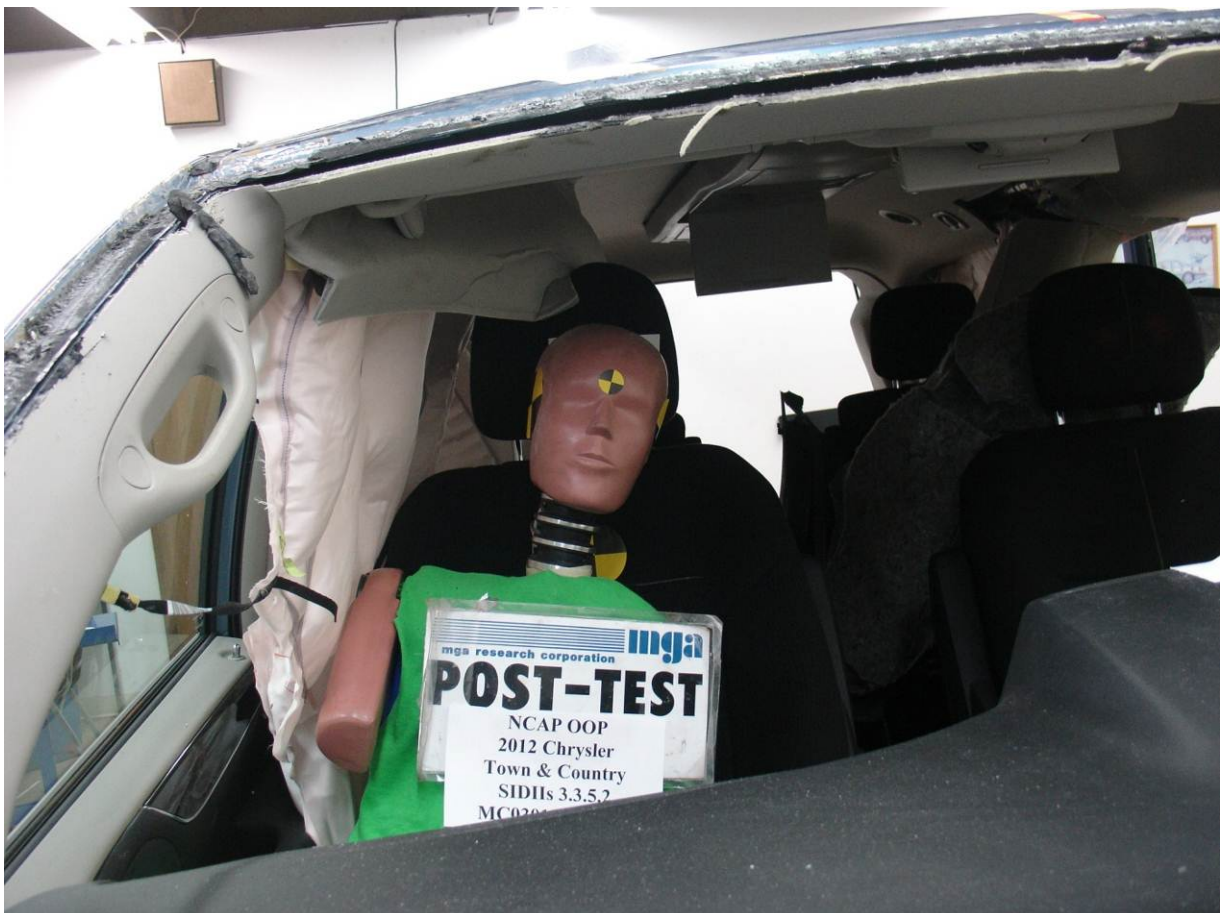
Post-Test SID-IIs Dummy Front View

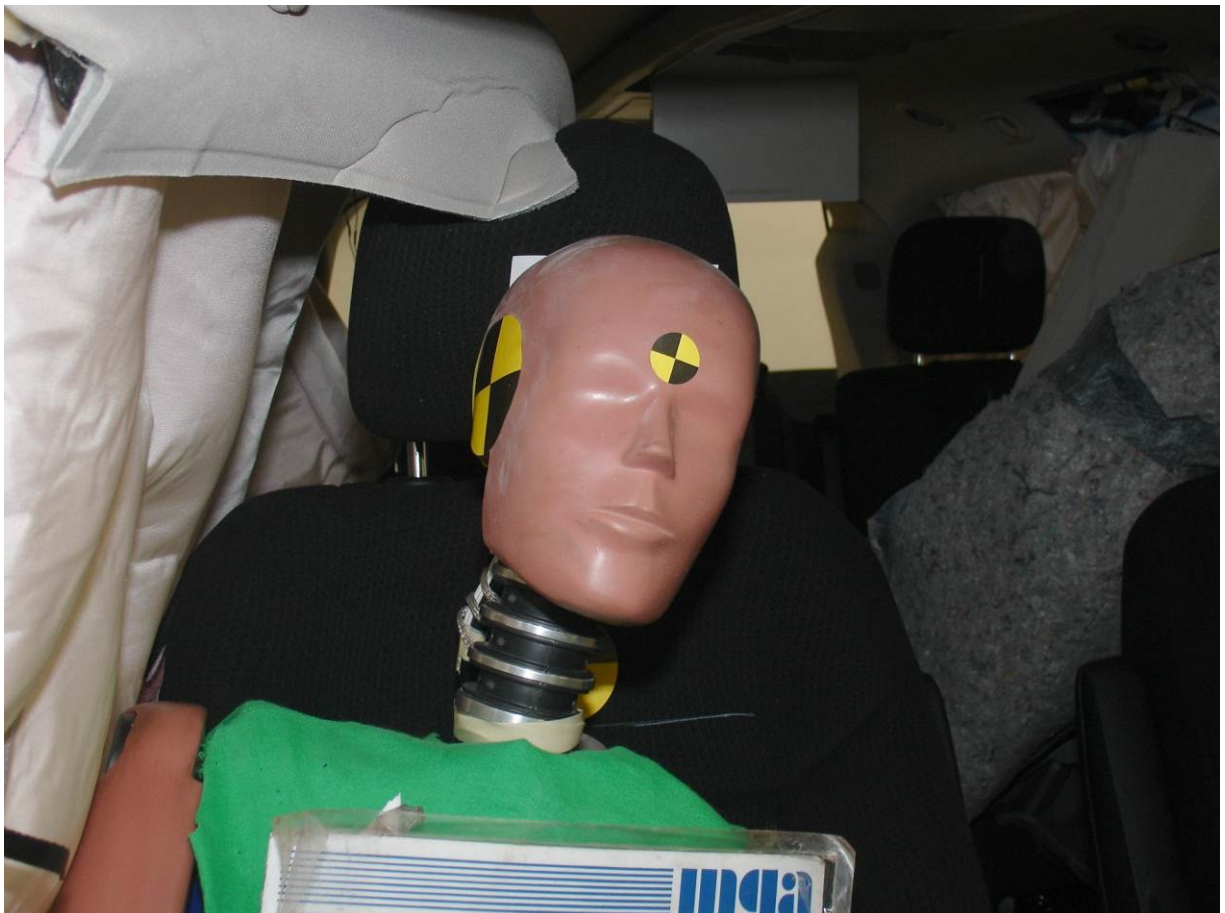
Post-Test SID-III Dummy Front Closeup View

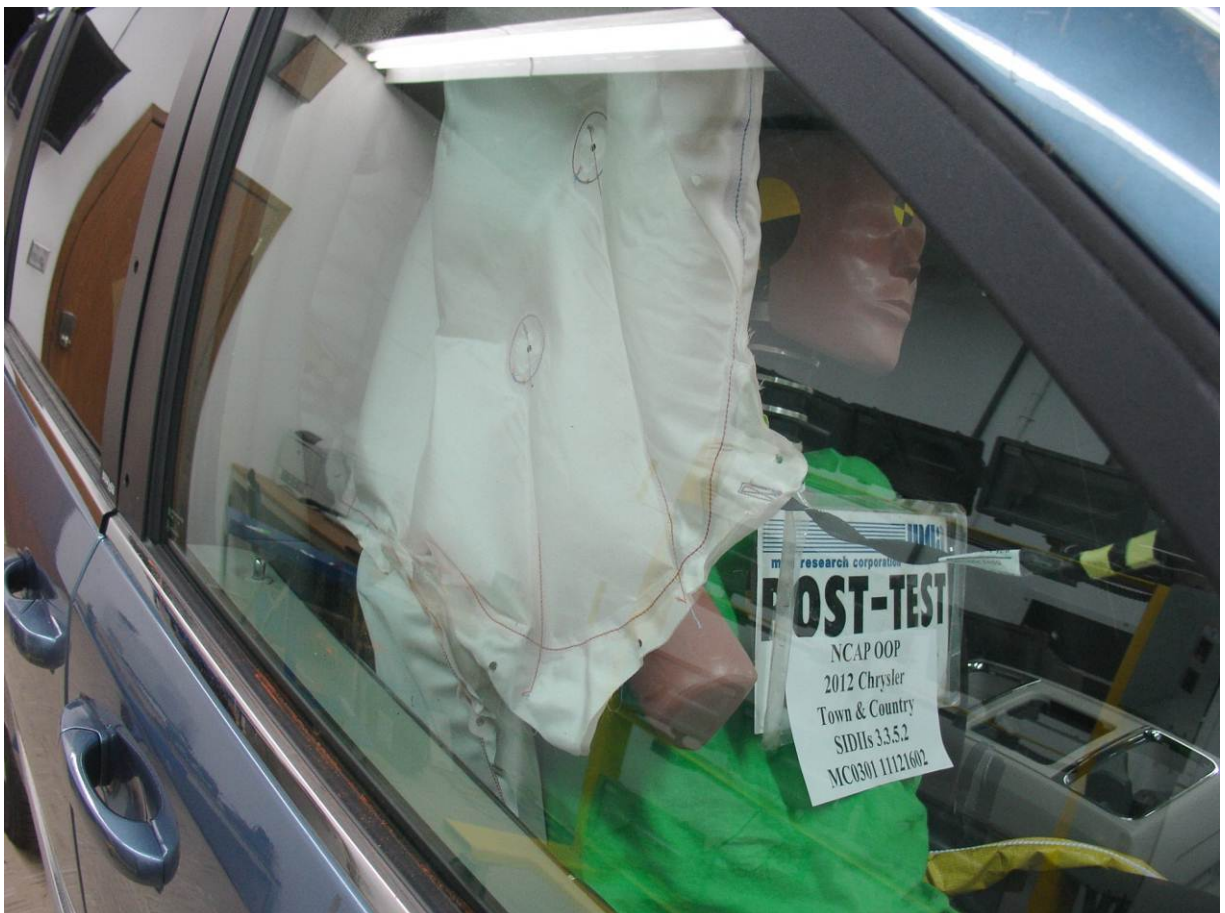
Post-Test SID-IIs Dummy Right ¾ Front View

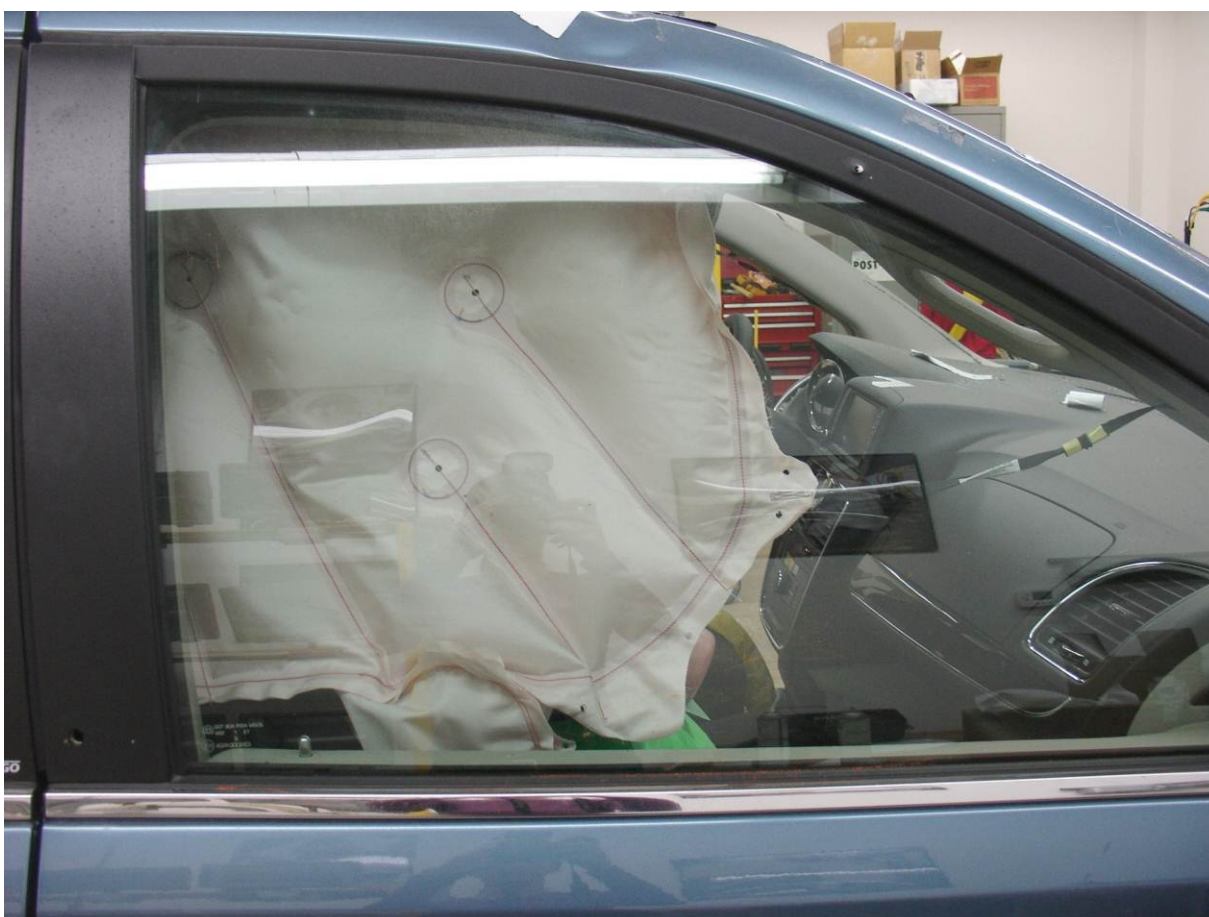
Post-Test SID-IIs Dummy Right Side View

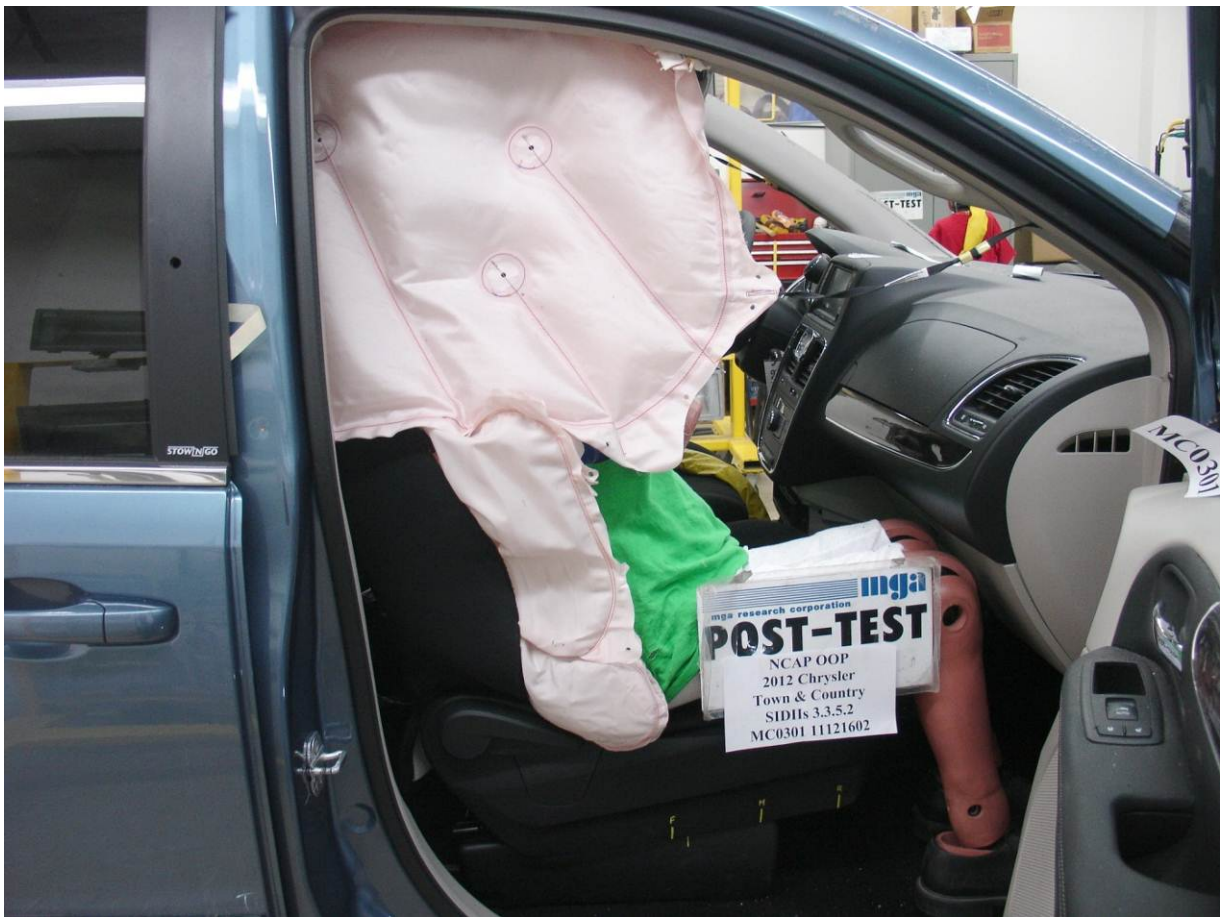
Post-Test SID-IIs Dummy Right Side View (Door Open)

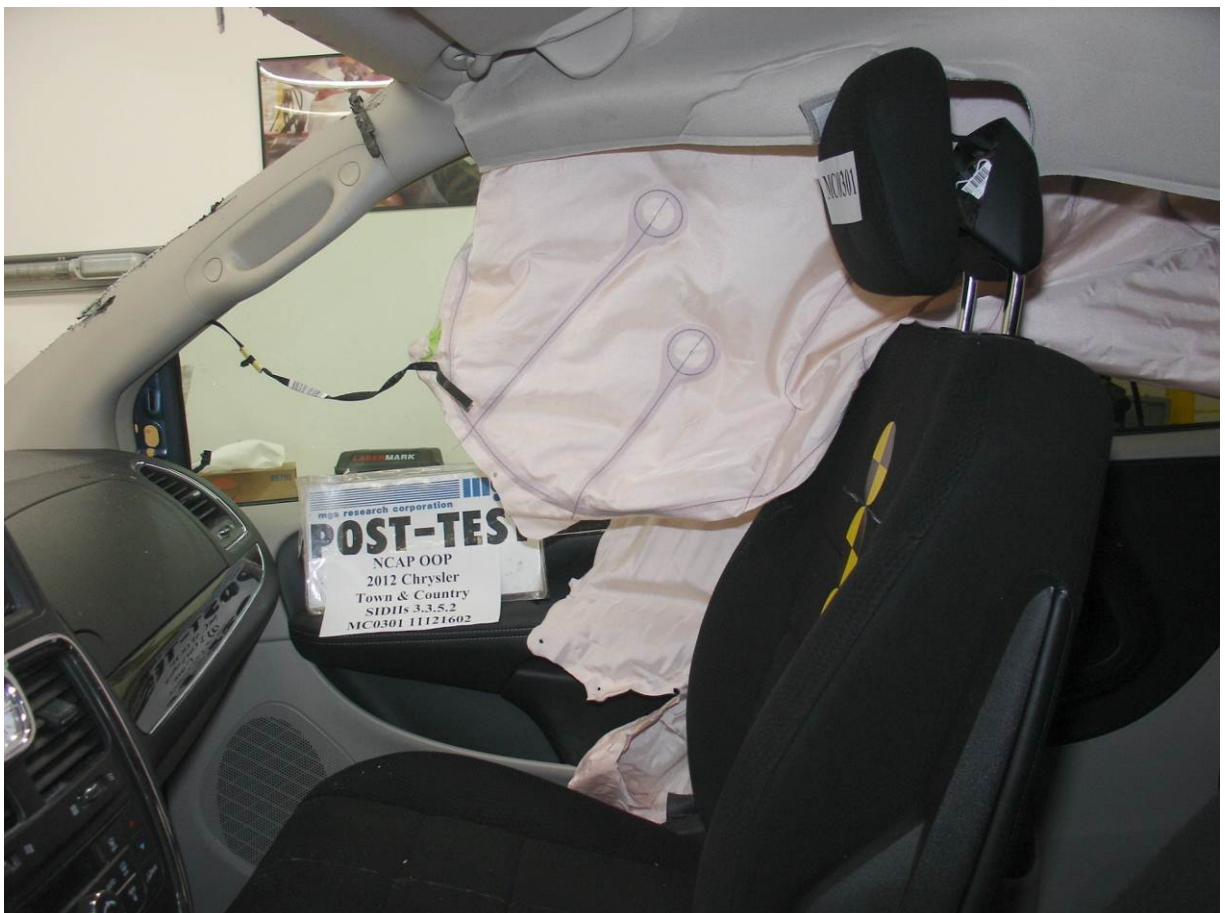
Post-Test Curtain Airbag Left View

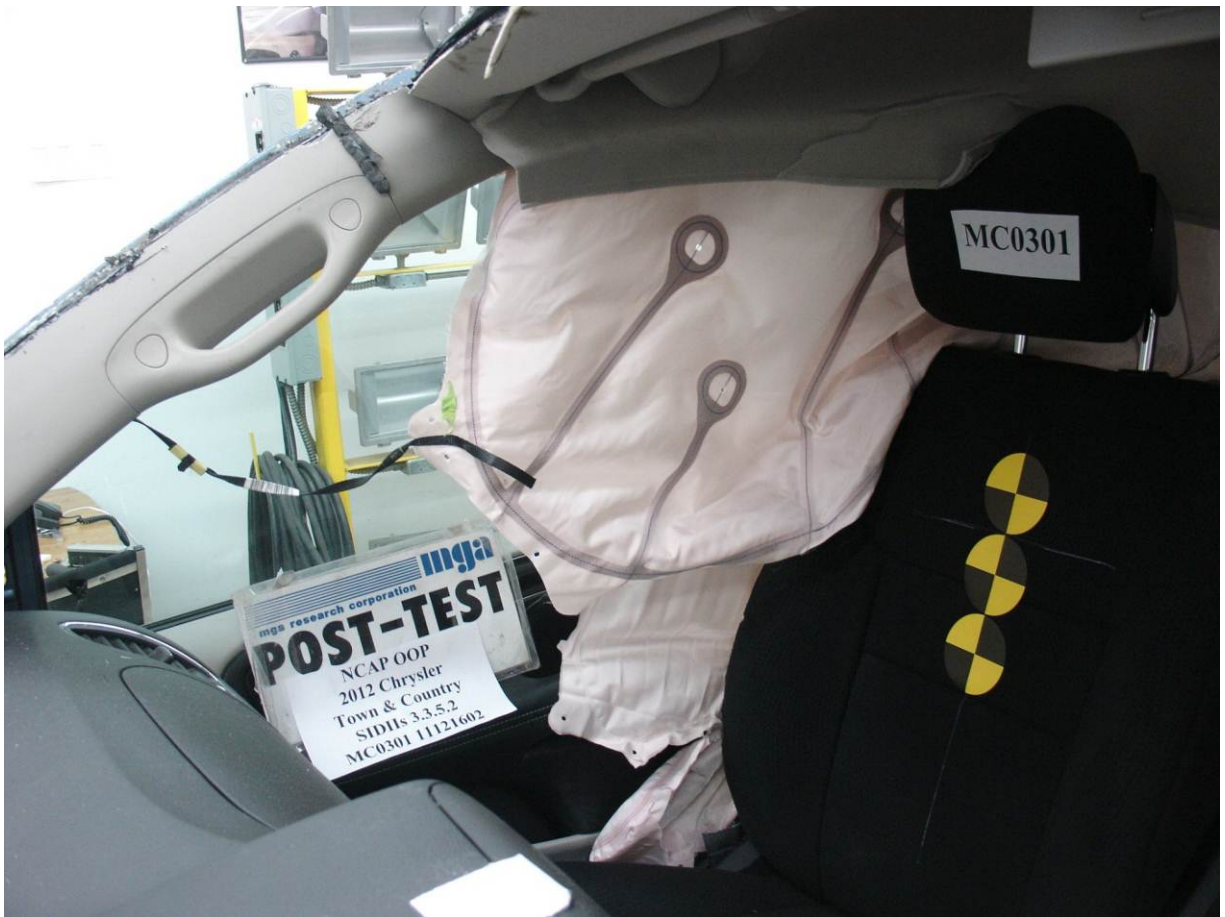
Post-Test Curtain Airbag Left ¾ Front View

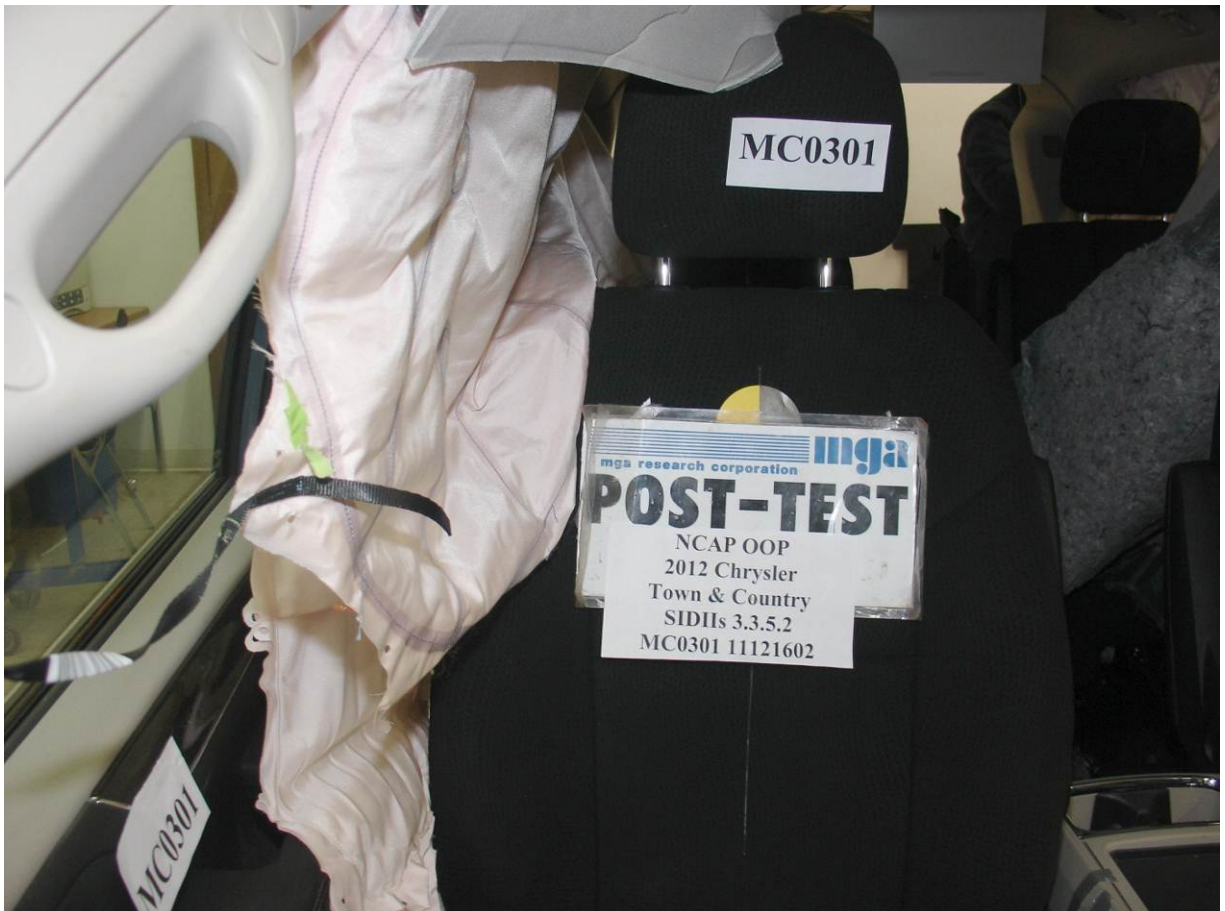
Post-Test Curtain Airbag Front View

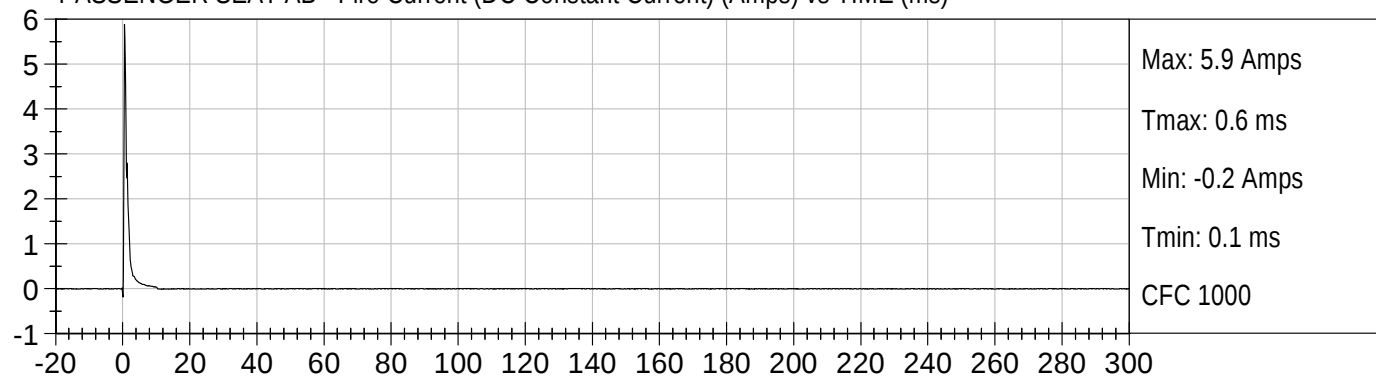
PASSENGER SEAT AB - Fire Current (DC Constant Current) (Amps) vs TIME (ms)
