**REPORT NUMBER: TWG-MGA-2012-002**

**SIDE AIRBAG OUT-OF-POSITION INJURY  
TECHNICAL WORKING GROUP**

**HYUNDAI MOTOR COMPANY  
2012 HYUNDAI ACCENT GLS 4-DR SEDAN  
NHTSA NO.: MC0504TWG2**

**FINAL REPORT**

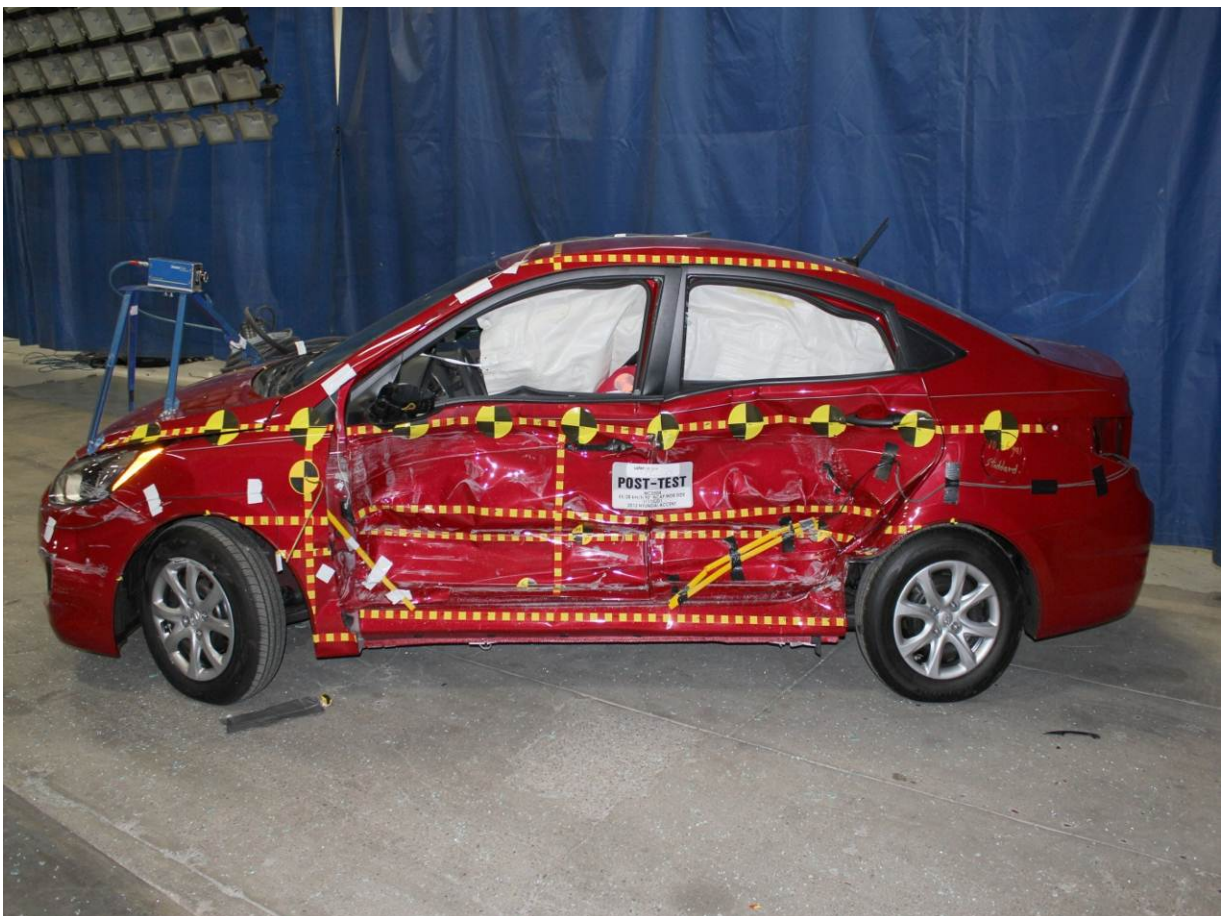
Post-Test Vehicle Left Side View

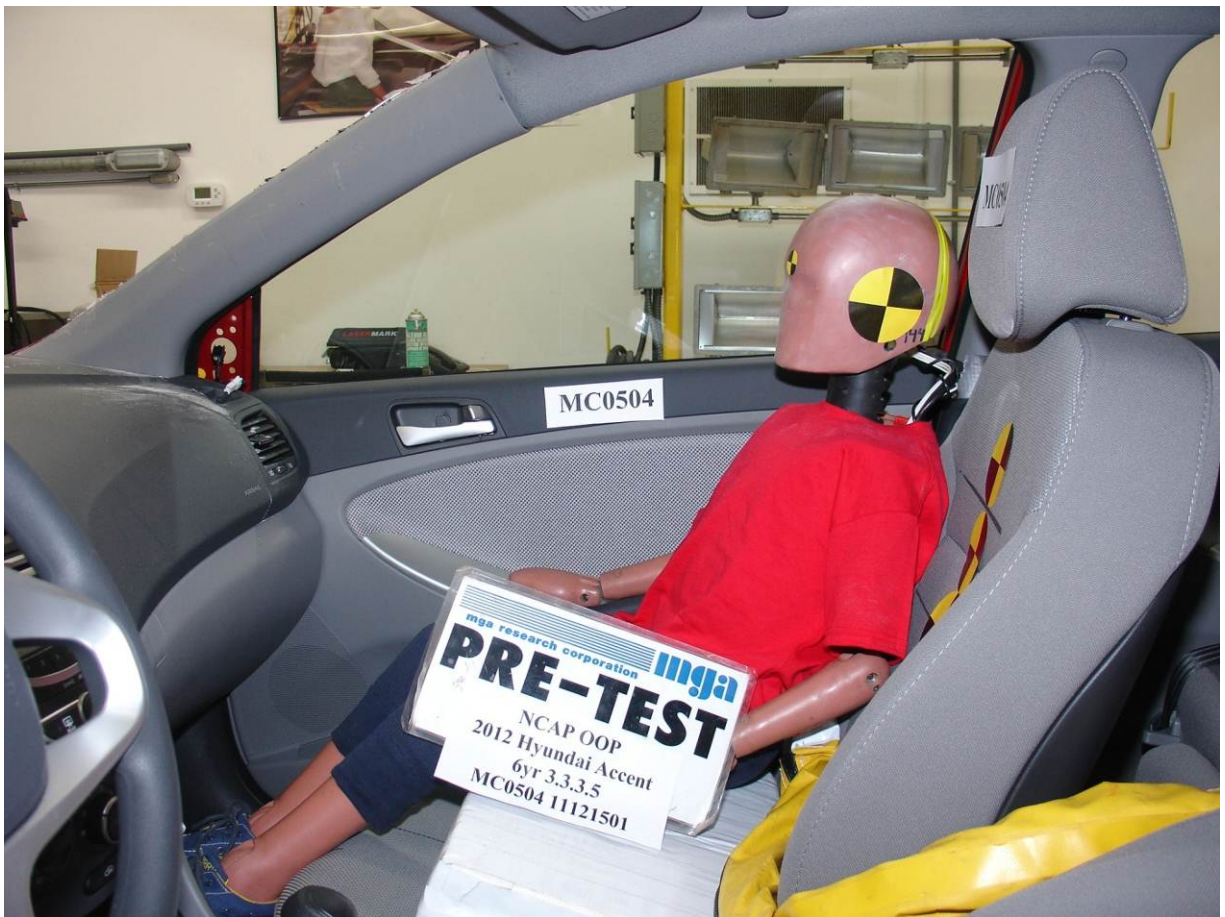
Pre-Test 6-Year-Old Child Dummy Left Side View

The Hybrid III 6-Year-Old child dummy was placed in the right front passenger seat along the outboard edge of the foam block, aligning the upper spine with the deployment trajectory of the airbag. The dummy's head was placed in between the seat bolster and pillar/side trim. The head remained in its neutral orientation. The legs were aligned so that they cross the heel placement points that were previously marked on the seat cushion. The feet were held in place and the pelvis slid forward and parallel to the centerline of the vehicle until the dummy's head/neck junction was aligned vertically with the top edge of the airbag module. The legs were then repositioned so that they cross the heel placement points. With the vehicle door closed, the dummy's outboard arm was raised to clear the armrest and the pelvis and upper torso was slid outboard until the pelvis or torso contacted the door. The outboard arm was placed on the armrest. The inboard arm was flexed so that the upper arm contacted the seat back and the fingertips contacted the foam block.

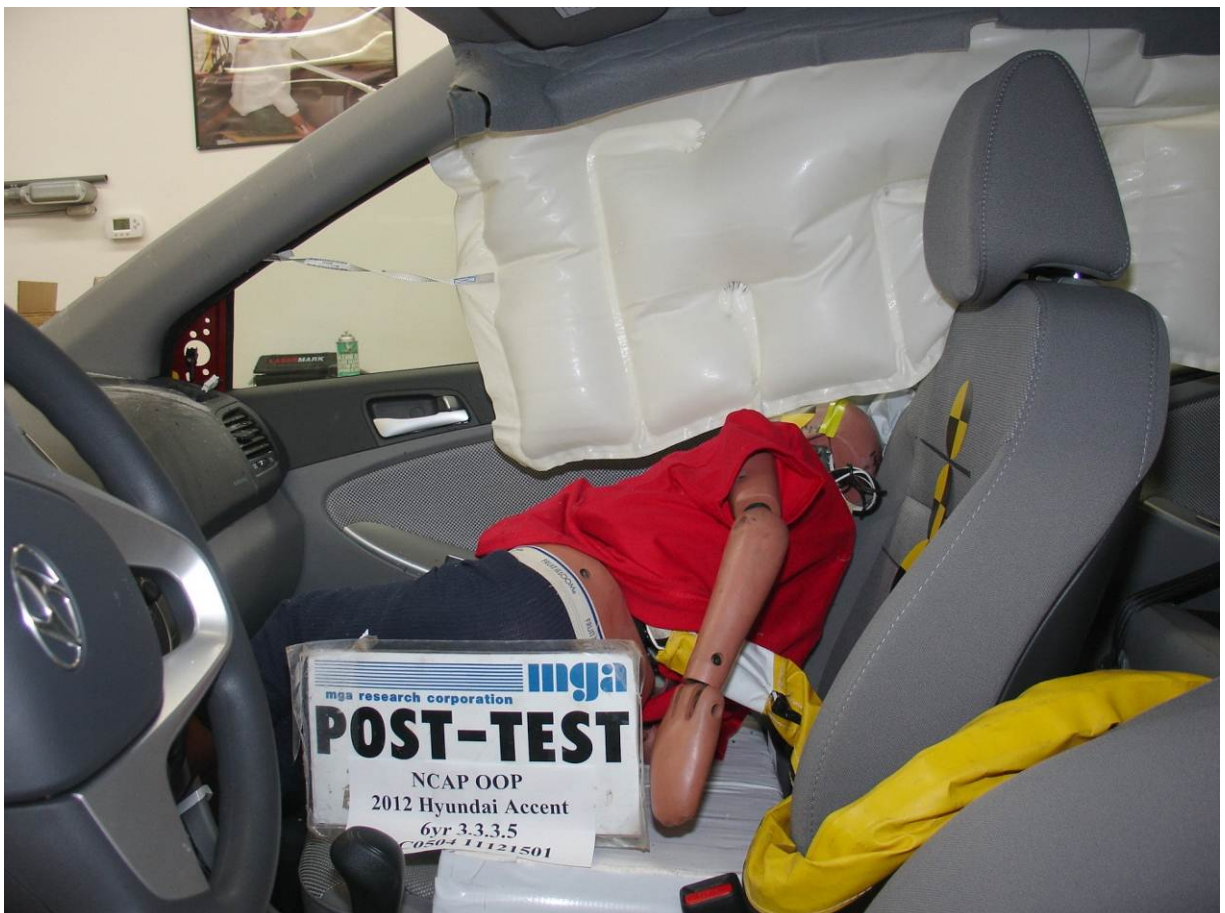
Post-Test 6-Year-Old Child Dummy Left Side View

- Curtain airbag to top and left side of head
- Torso/Pelvis bag to right shoulder and torso

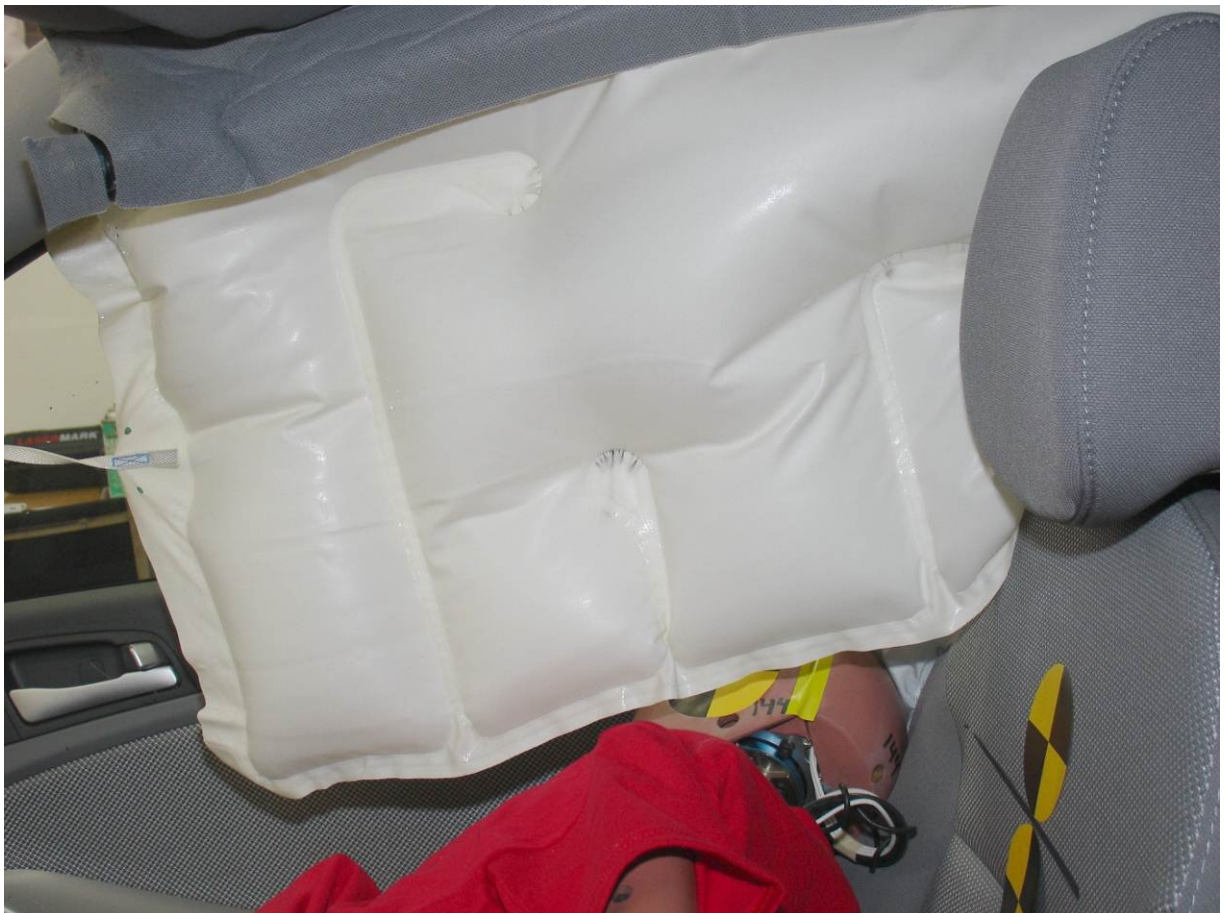
Post-Test 6-Year-Old Child Dummy Left Side Closeup View

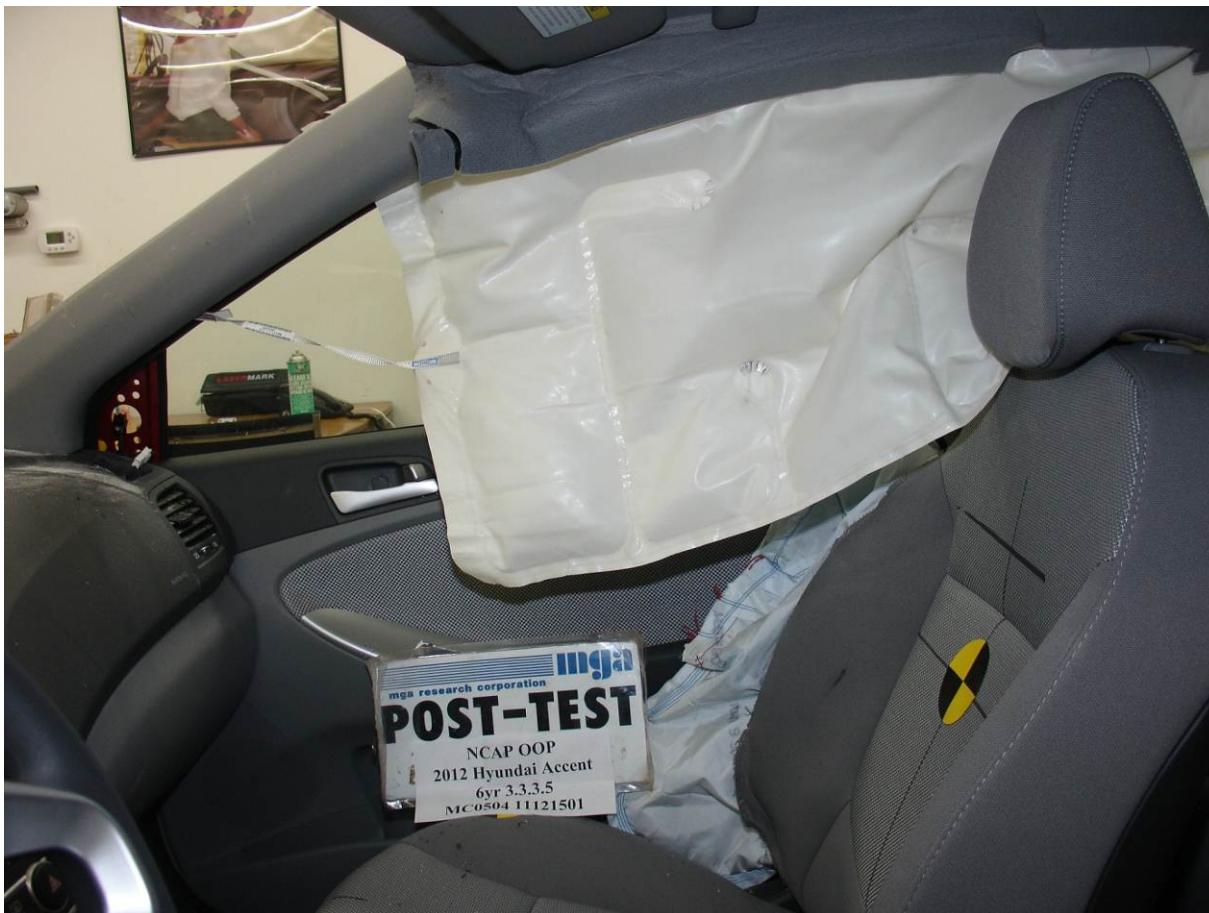
Post-Test Curtain Airbag Left Side View

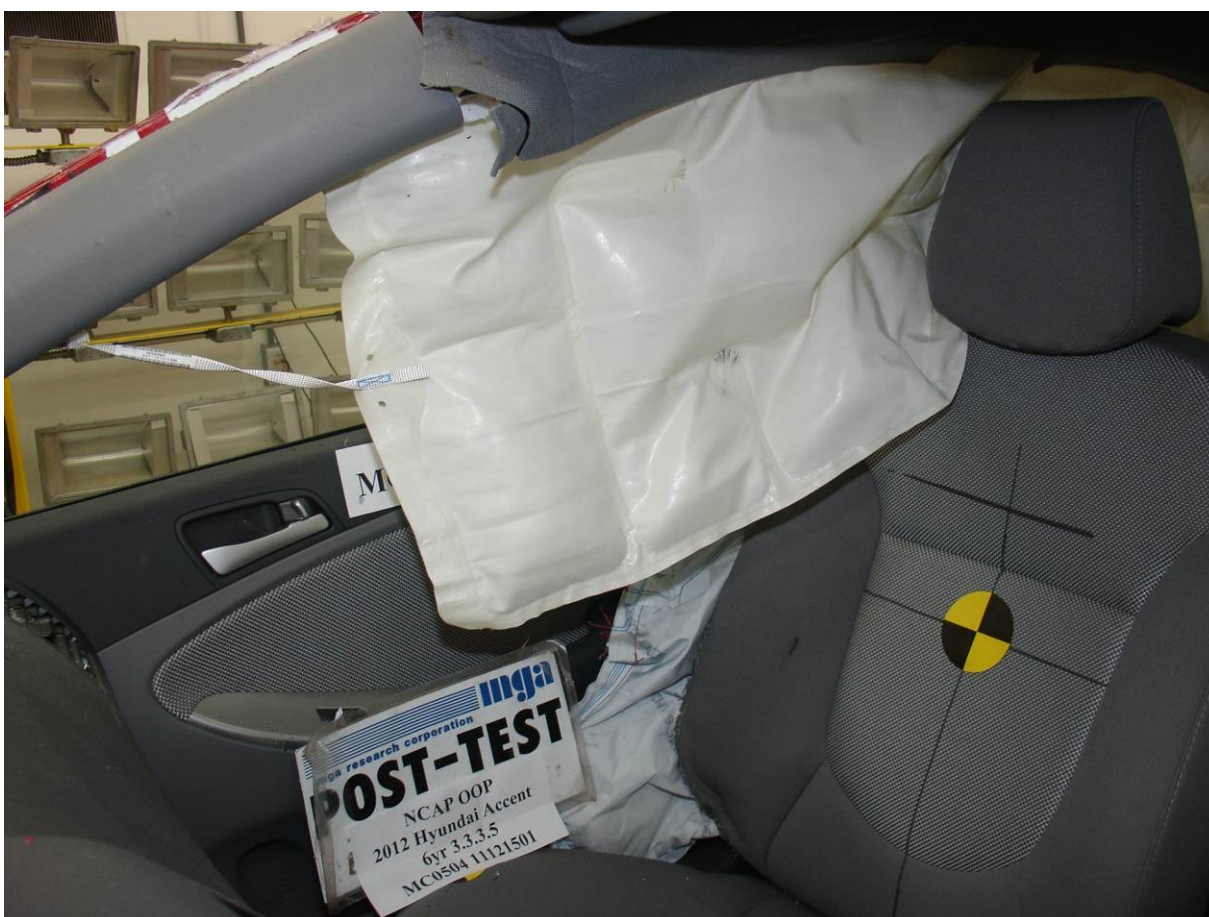
Post-Test Curtain Airbag Left 3/4 Front View

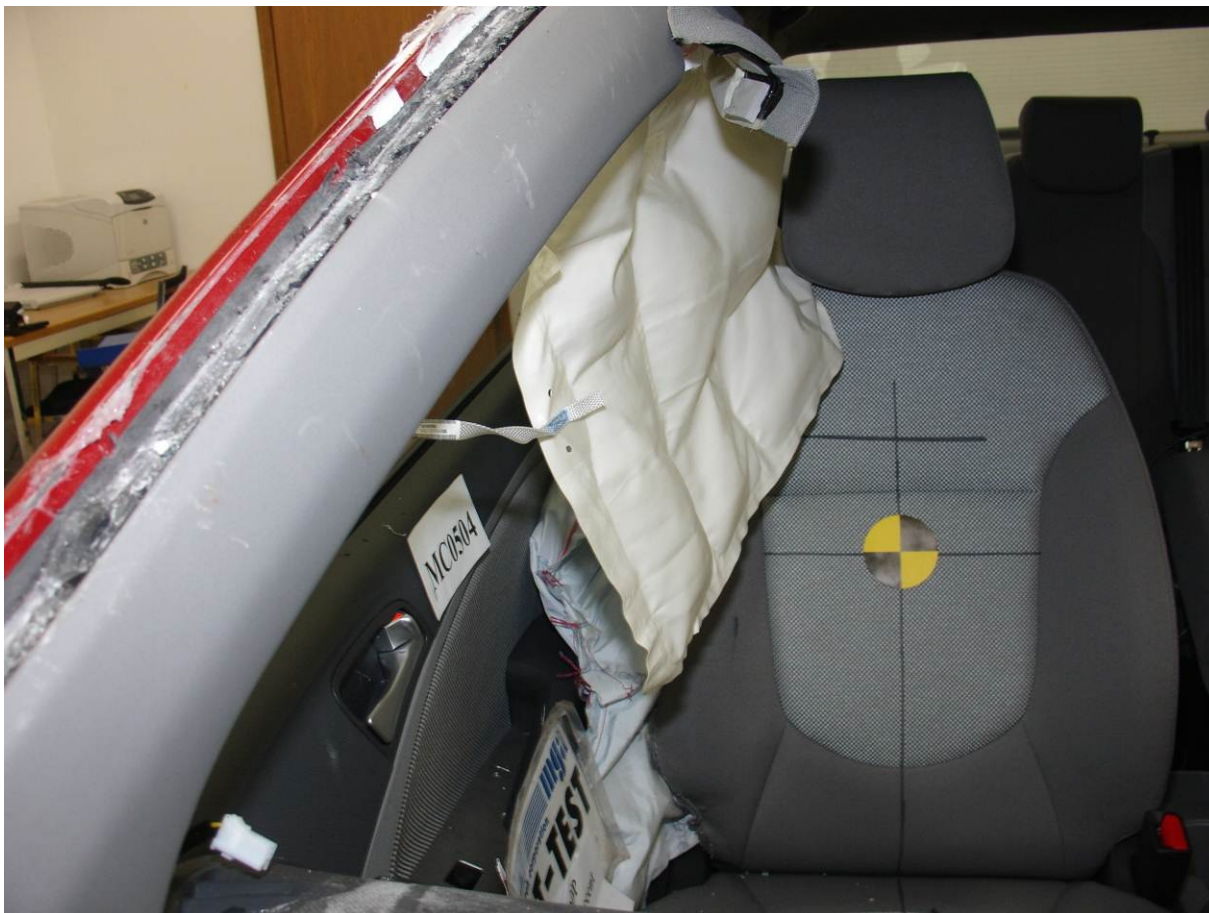
Post-Test Curtain Airbag Front View

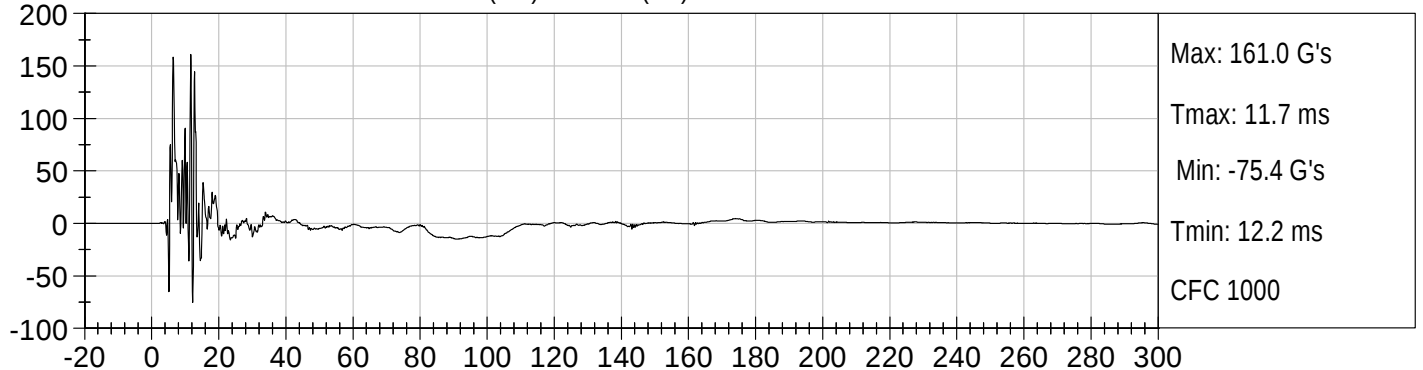
PASSENGER LOWER STERNUM X (G's) vs TIME (ms)

| | | MAXIMUM VALUE | | | |
|---|---|---|---|---|---|
| Lower Sternum X | G | 161.0 | 11.7 | -75.4 | 12.2 |
