**REPORT NUMBER: SPNCAP-KAR-12-030**

**NEW CAR ASSESSMENT PROGRAM (NCAP)  
SIDE IMPACT POLE TEST**

**TOYOTA MOTOR CORPORATION  
2012 TOYOTA YARIS LE 5-DOOR HATCHBACK**

**FINAL REPORT**

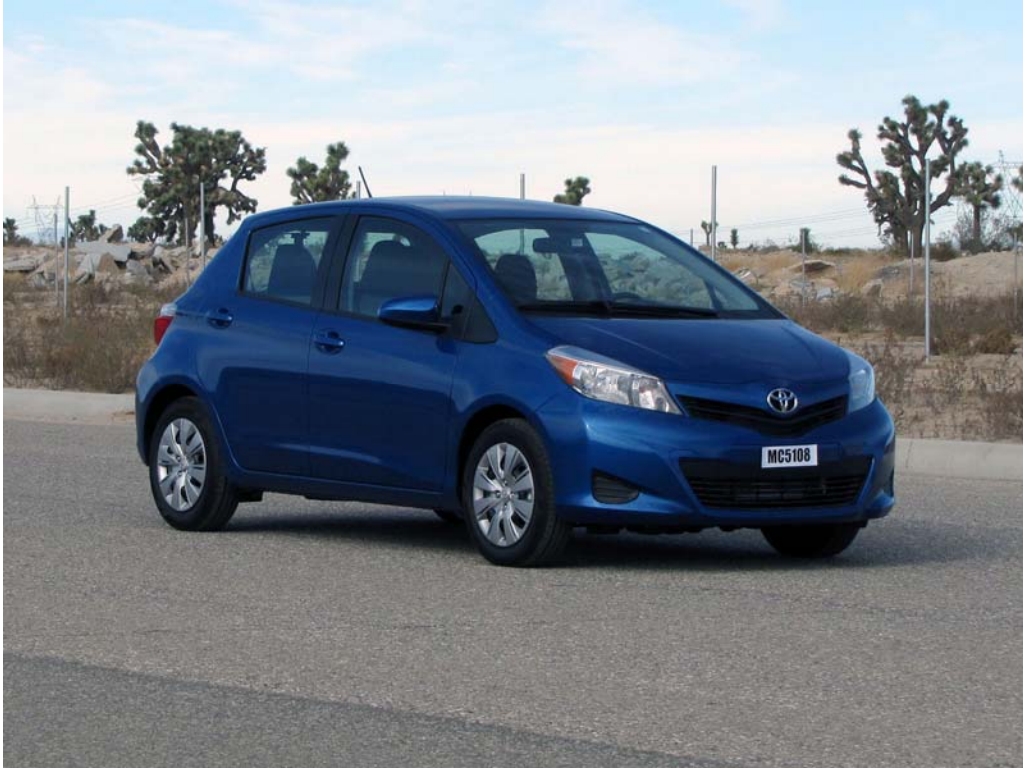
FIGURE 1. As-Delivered Right Front Three-Quarter View of Test Vehicle

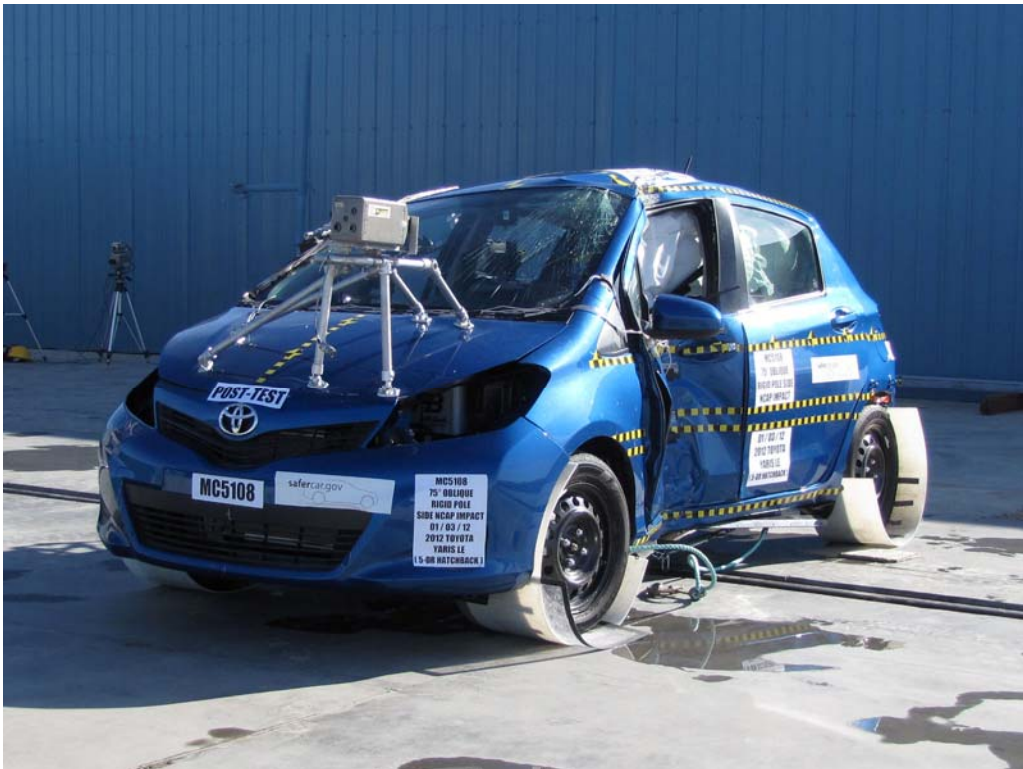
FIGURE 6. Post-Test Left Front Three-Quarter View of Test Vehicle

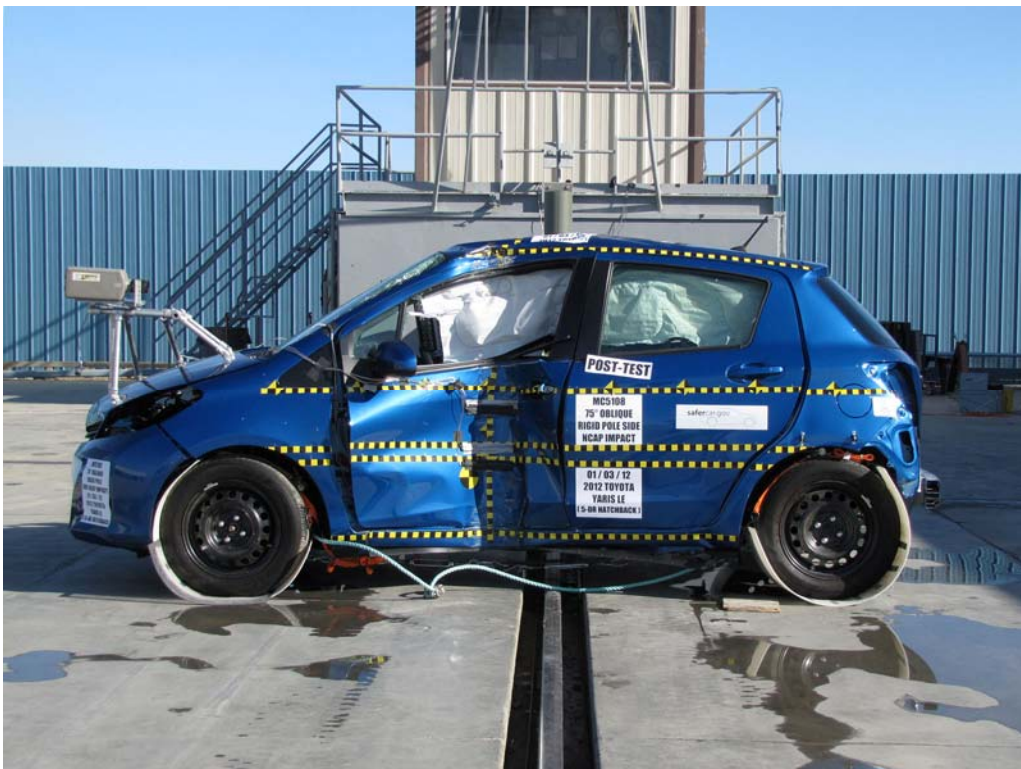
FIGURE 8. Post-Test Left Side View of Test Vehicle

Both the front and rear doors on the struck side of the vehicle remained closed and latched. There was no separation at the hinges or latches. Both doors on the non-struck side remained closed and latched. There were no ATD values that exceeded limits.

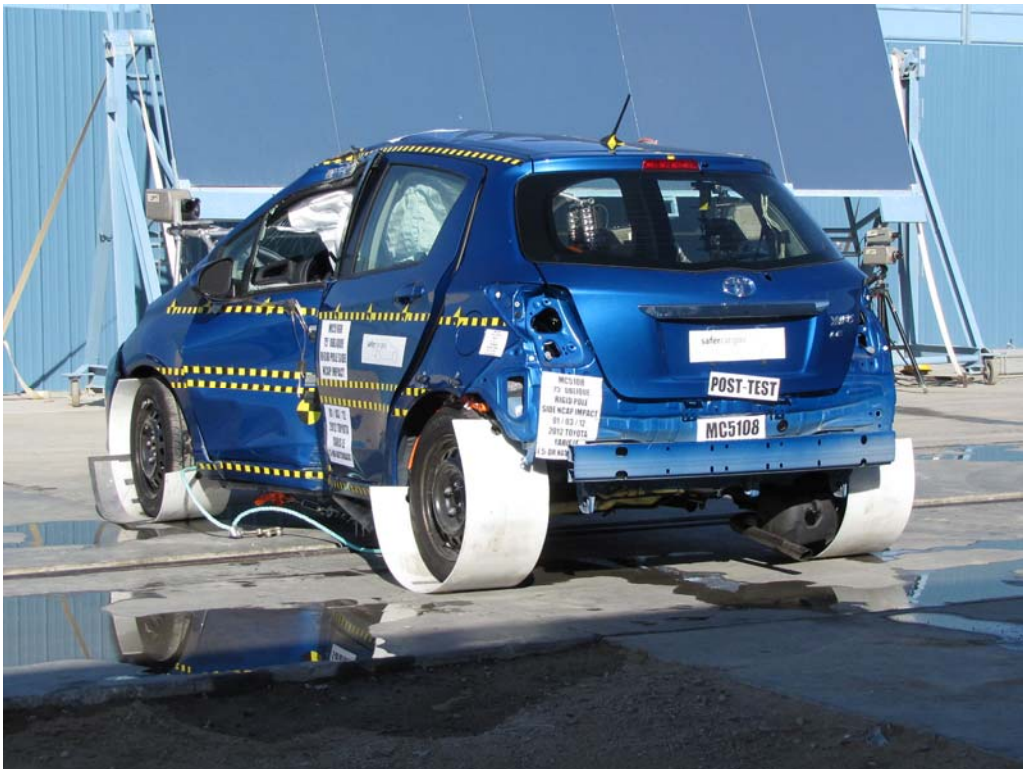
FIGURE 10. Post-Test Left Rear Three-Quarter View of Test Vehicle

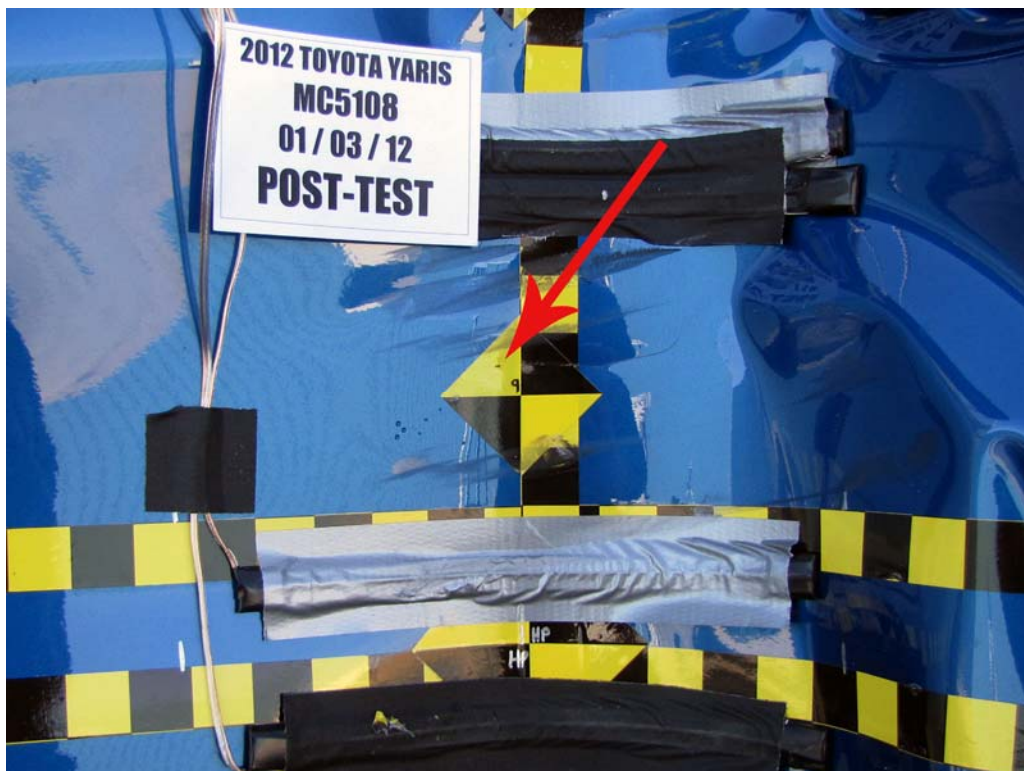
FIGURE 20. Post-Test Close-Up View of Impact Point Target Showing Impact Location

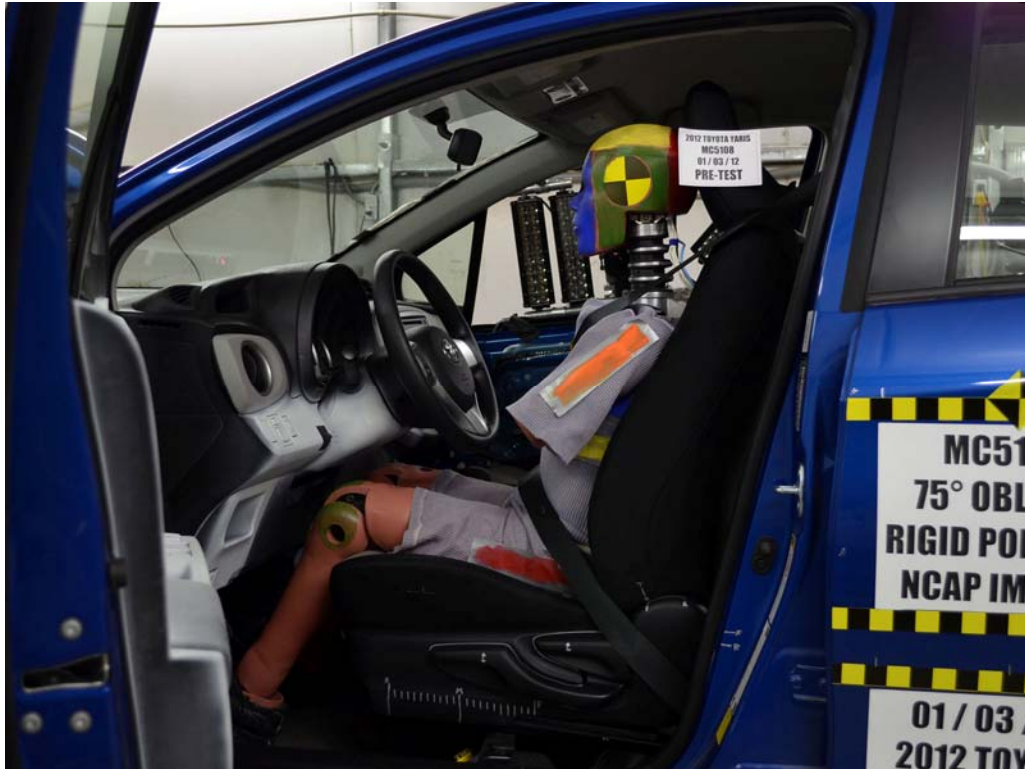
FIGURE 23. Pre-Test Left Side View of Dummy Showing Belt, Chalking, and Contact Switches

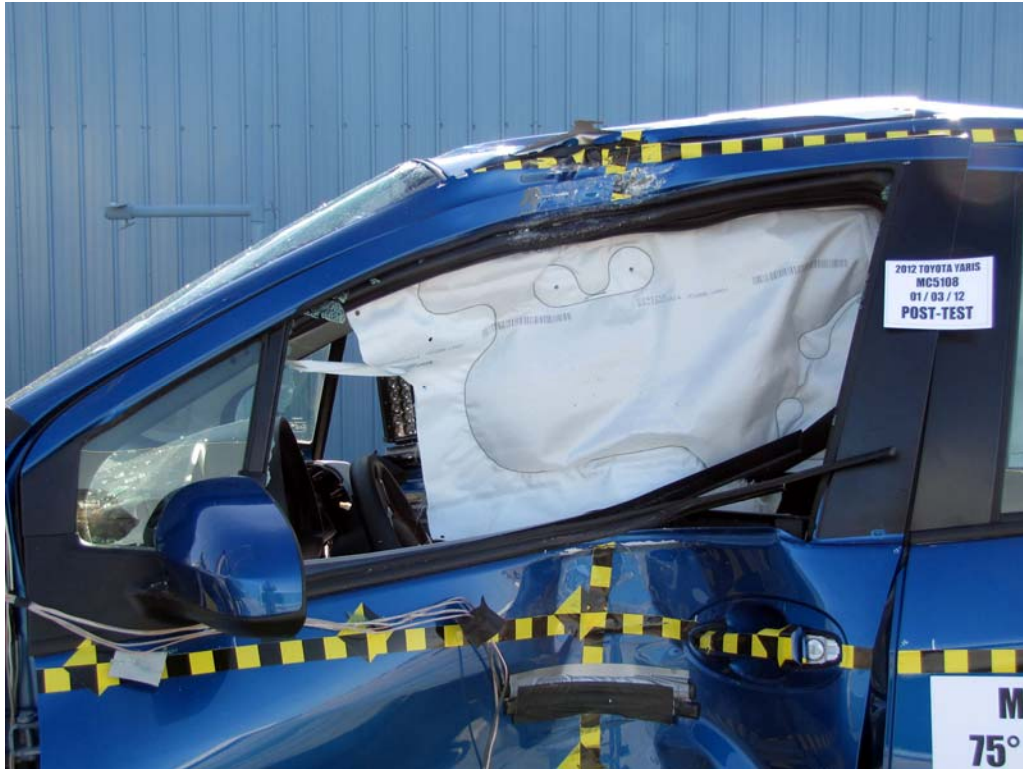
FIGURE 25. Post-Test Left Side View of Dummy Shoulder and Door Top View

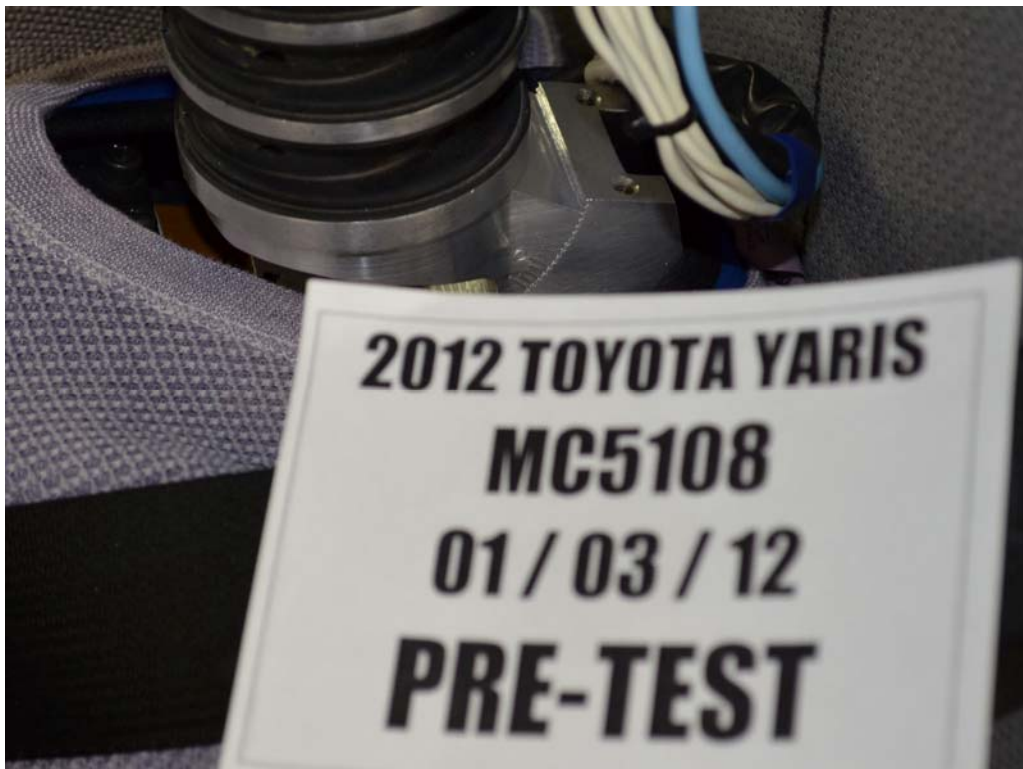
FIGURE 30. Pre-Test View of Dummy's Neck Showing Position of Adjustable Neck Bracket

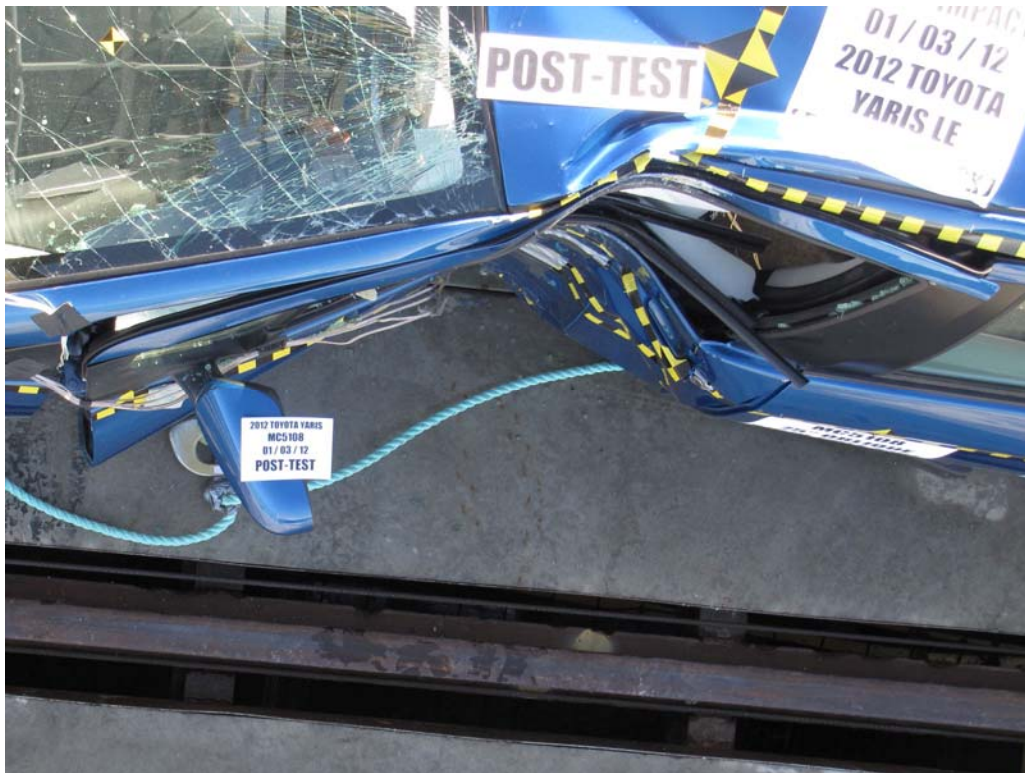
FIGURE 41. Post-Test Driver Dummy and Door Clearance

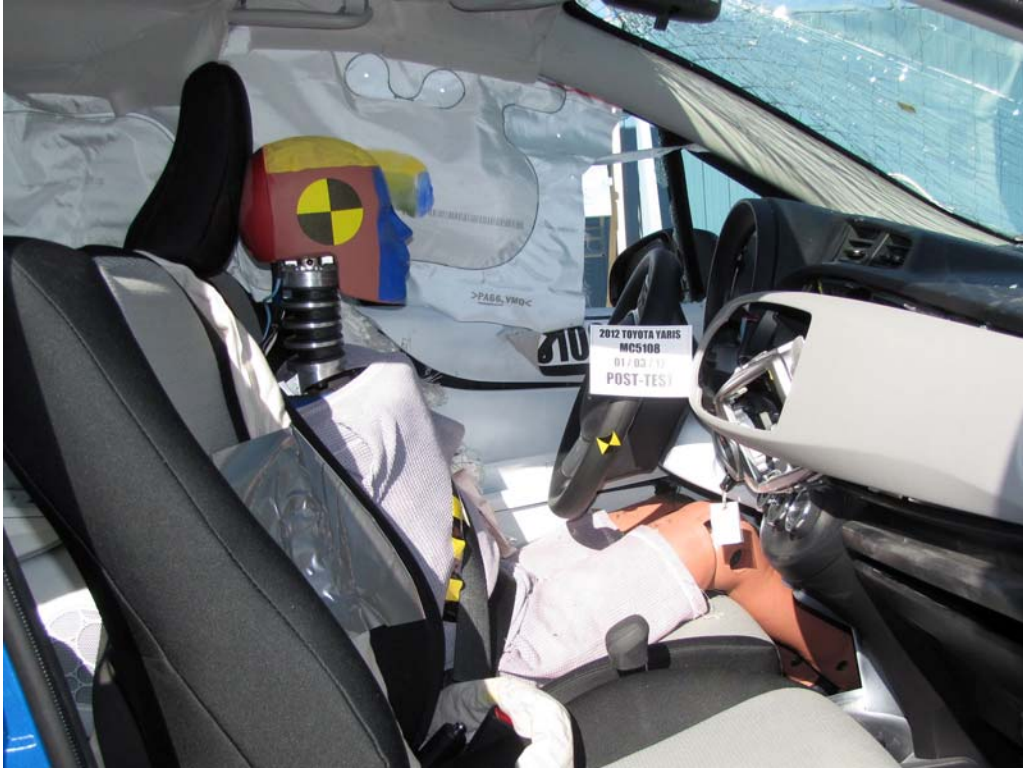
FIGURE 43. Post-Test Right Side View of Dummy and Front Seat Occupant Compartment

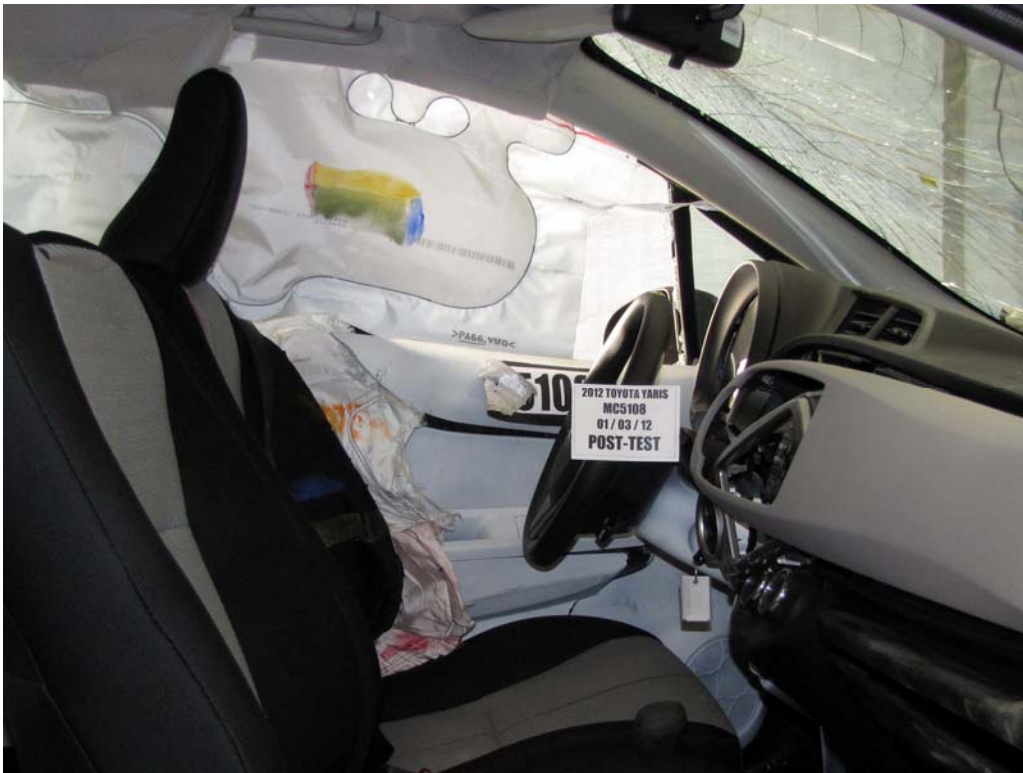
FIGURE 45. Post-Test Inner Driver Door Panel View  
Showing Dummy Contact Locations

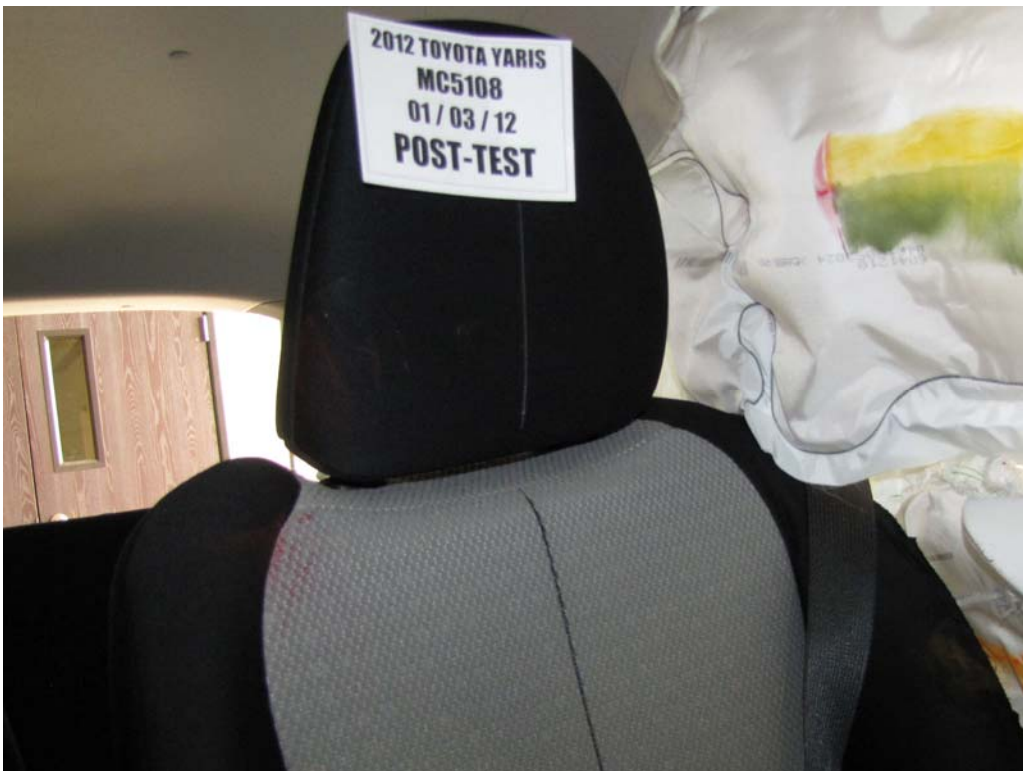
FIGURE 46. Post-Test Dummy Close-Up Head Contact with Vehicle Interior View

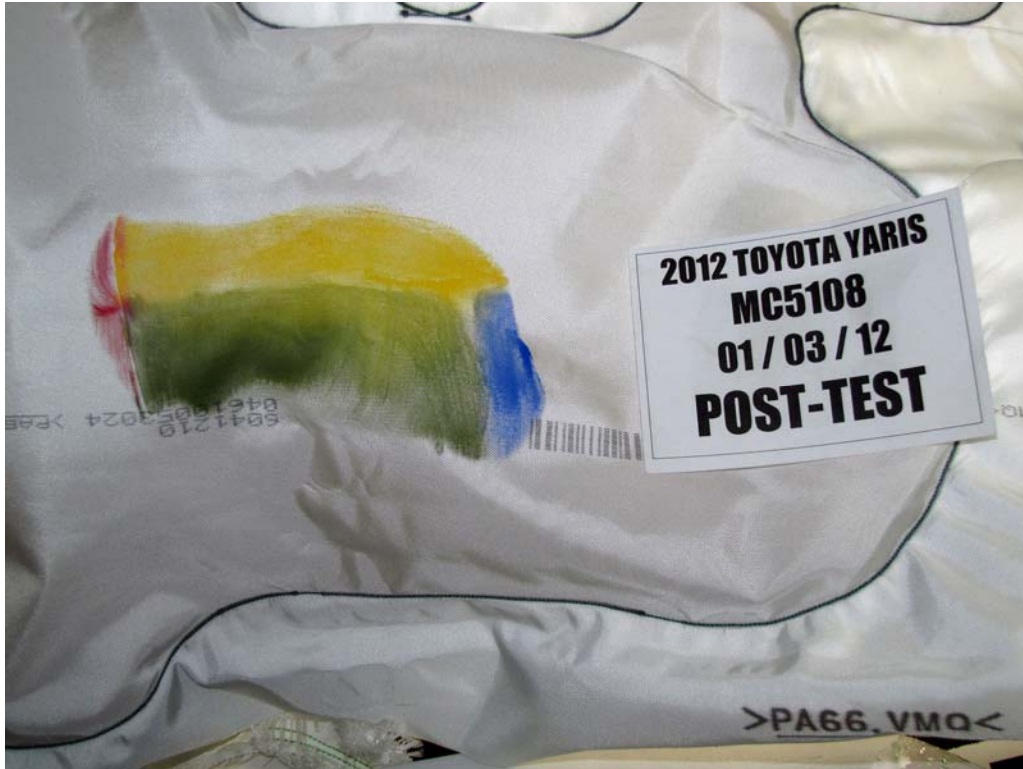
FIGURE 47. Post-Test Dummy Close-Up Head Contact with Side Airbag View

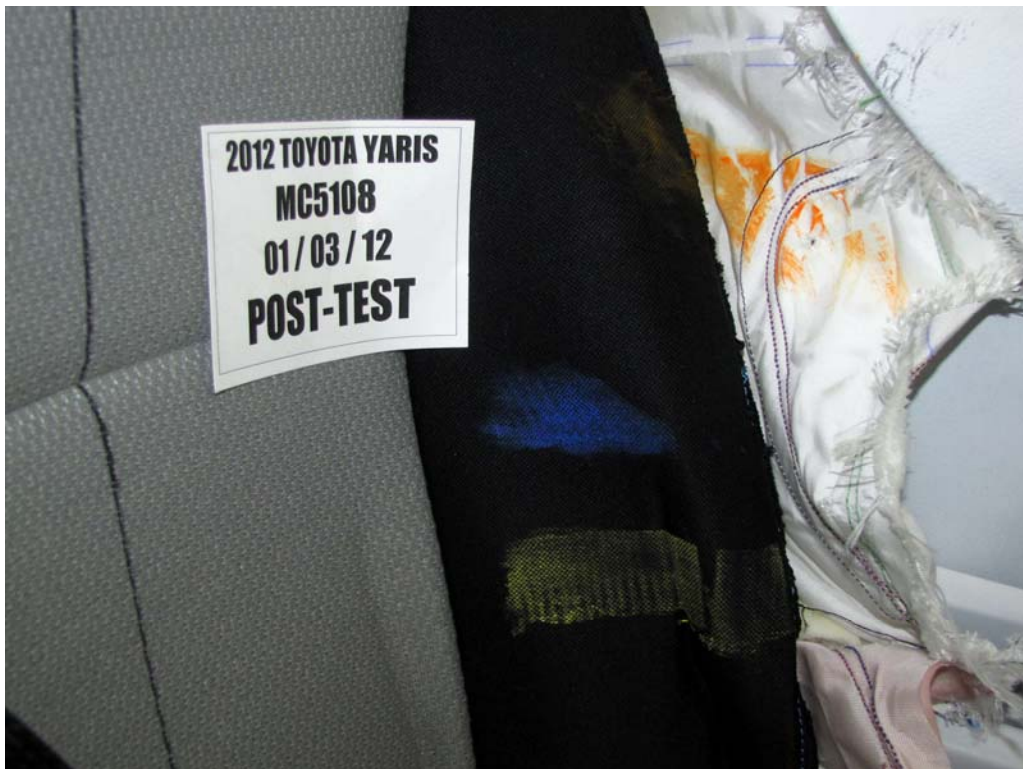
FIGURE 48. Post-Test Dummy Close-Up Torso Contact with Vehicle Interior View

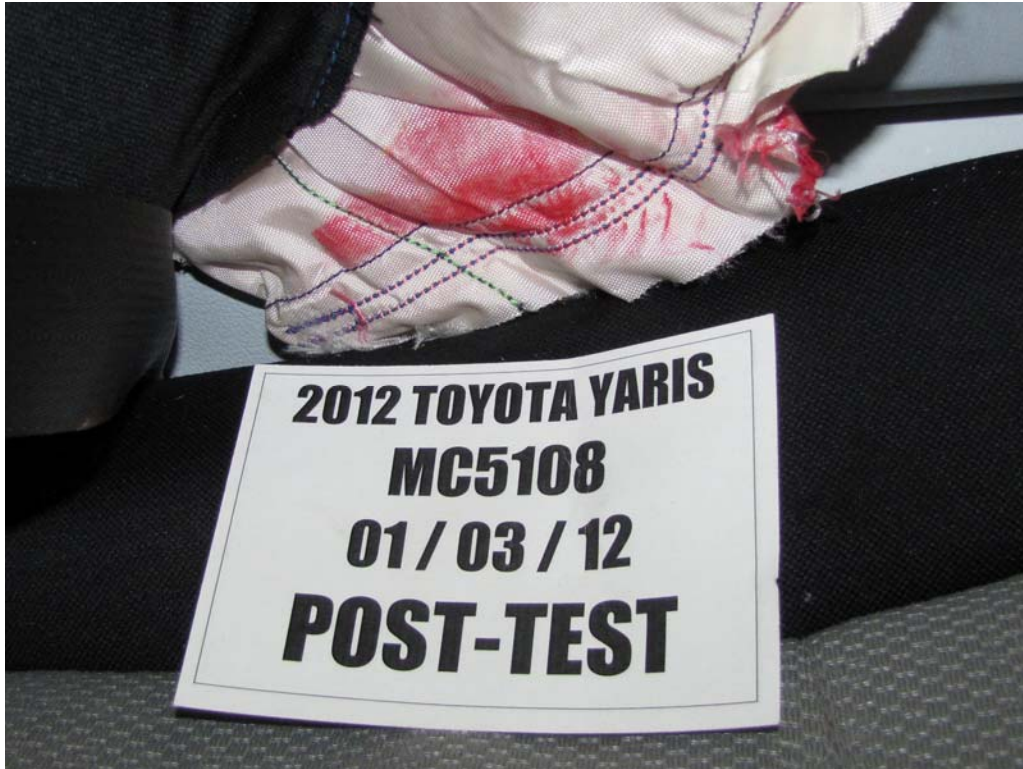
FIGURE 51. Post-Test Dummy Close-Up Pelvis Contact with Side Airbag View

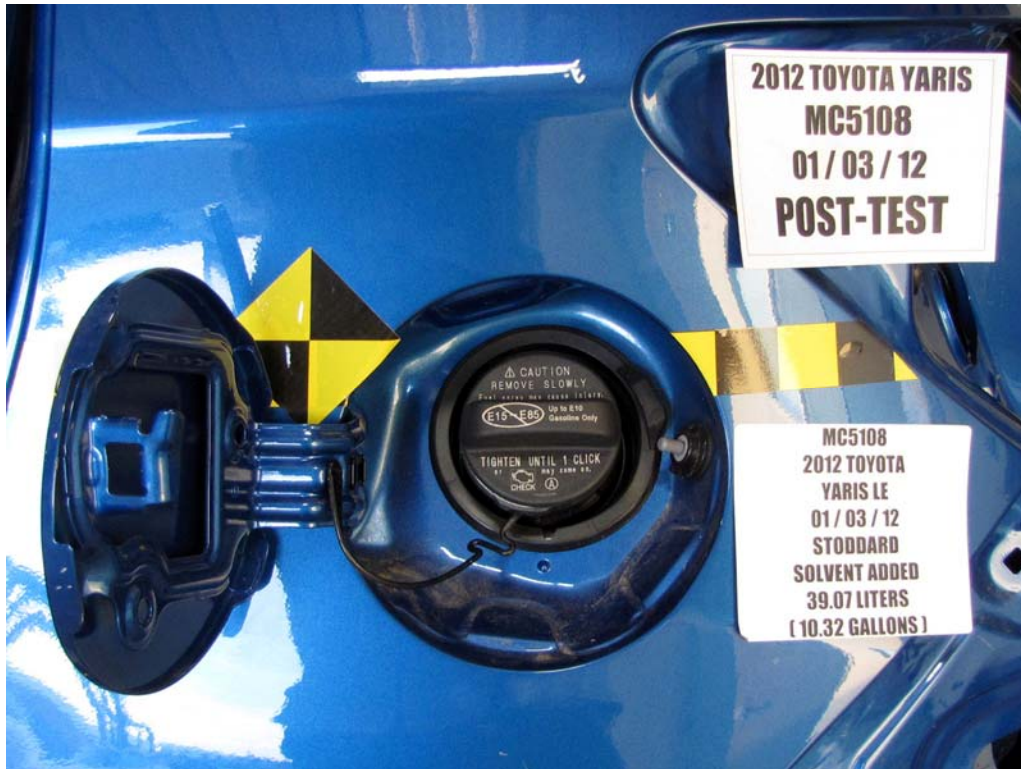
FIGURE 53. Post-Test View of Fuel Filler Cap or Fuel Filler Neck

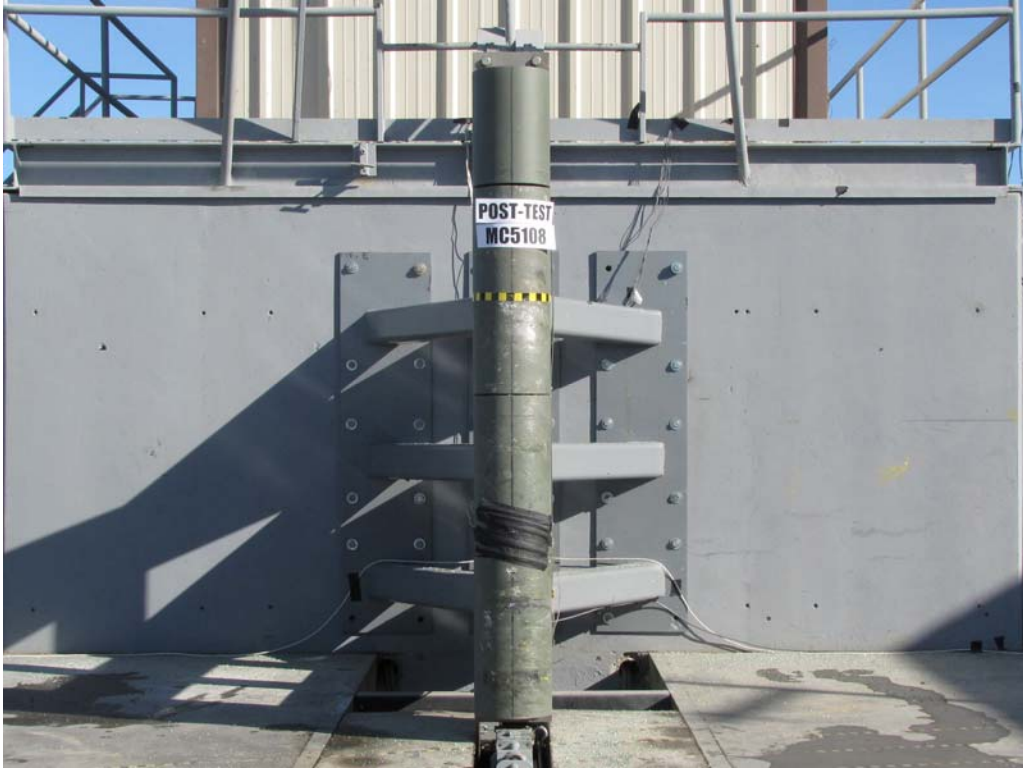
FIGURE 57. Post-Test Pole Barrier Front View

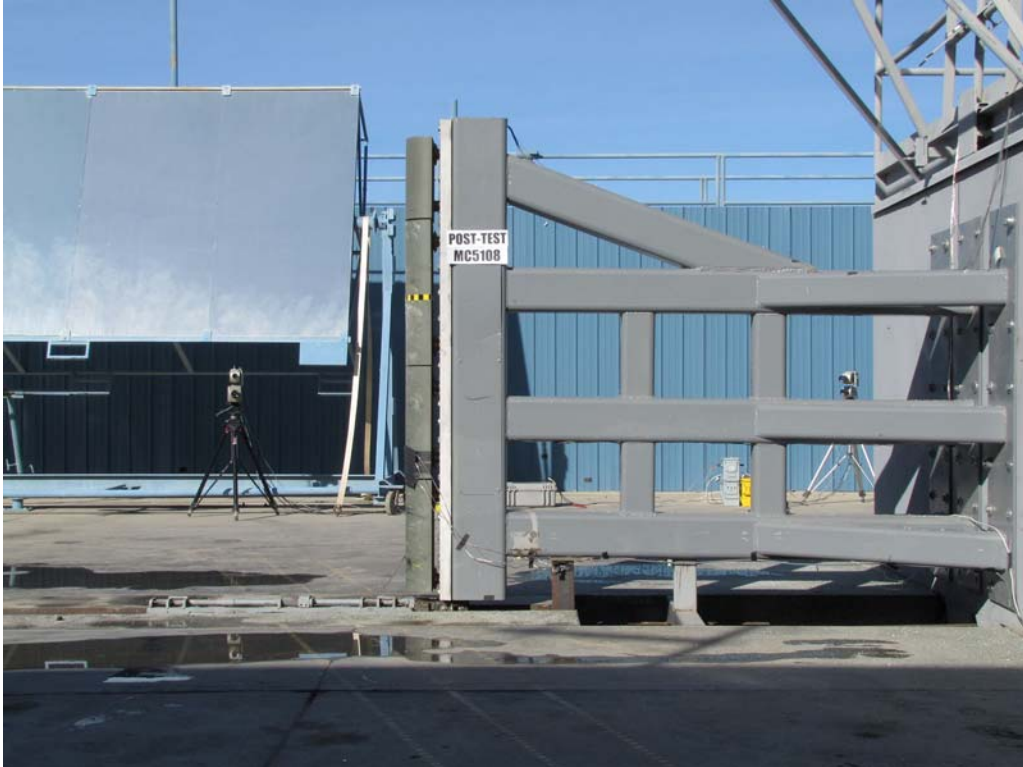
FIGURE 59. Post-Test Pole Barrier Side View

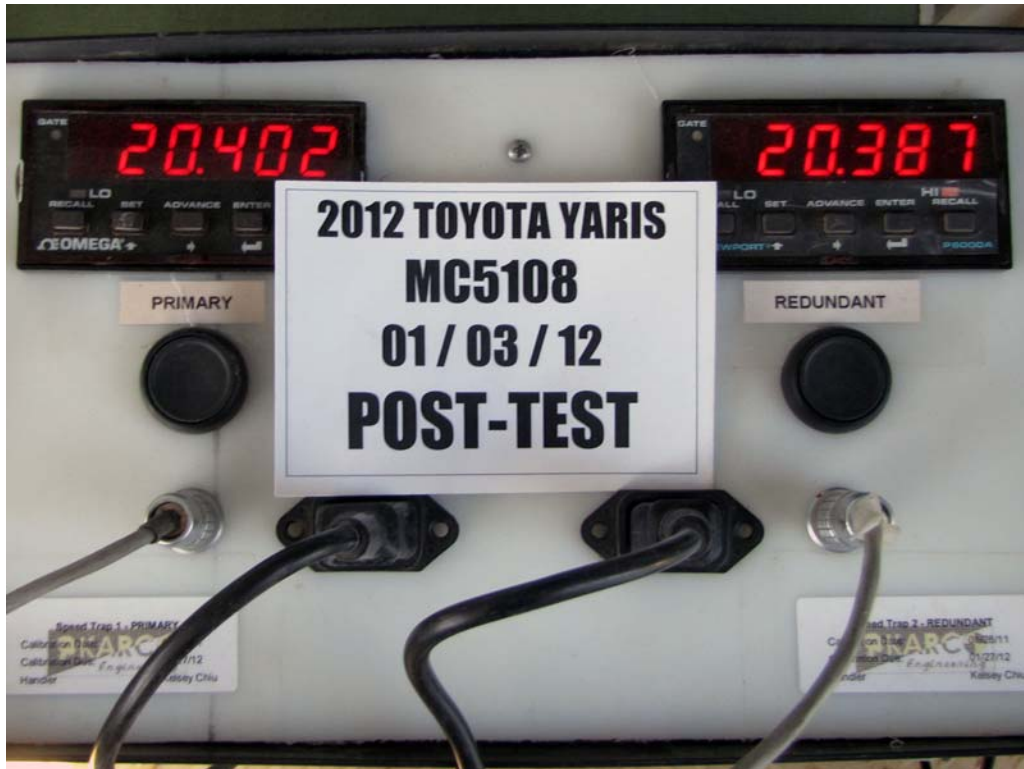
FIGURE 61. Post-Test Primary and Redundant Speed Trap Read-Out
