REPORT NUMBER: SPNCAP-MGA-2012-048

**NEW CAR ASSESSMENT PROGRAM (NCAP)
Side Impact Pole Test**

**CHRYSLER GROUP LLC
2012 Dodge Charger SE 4-Dr Sedan
NHTSA No.: MC0318**

**MGA RESEARCH CORPORATION
5000 Warren Road
Burlington, WI 53105**

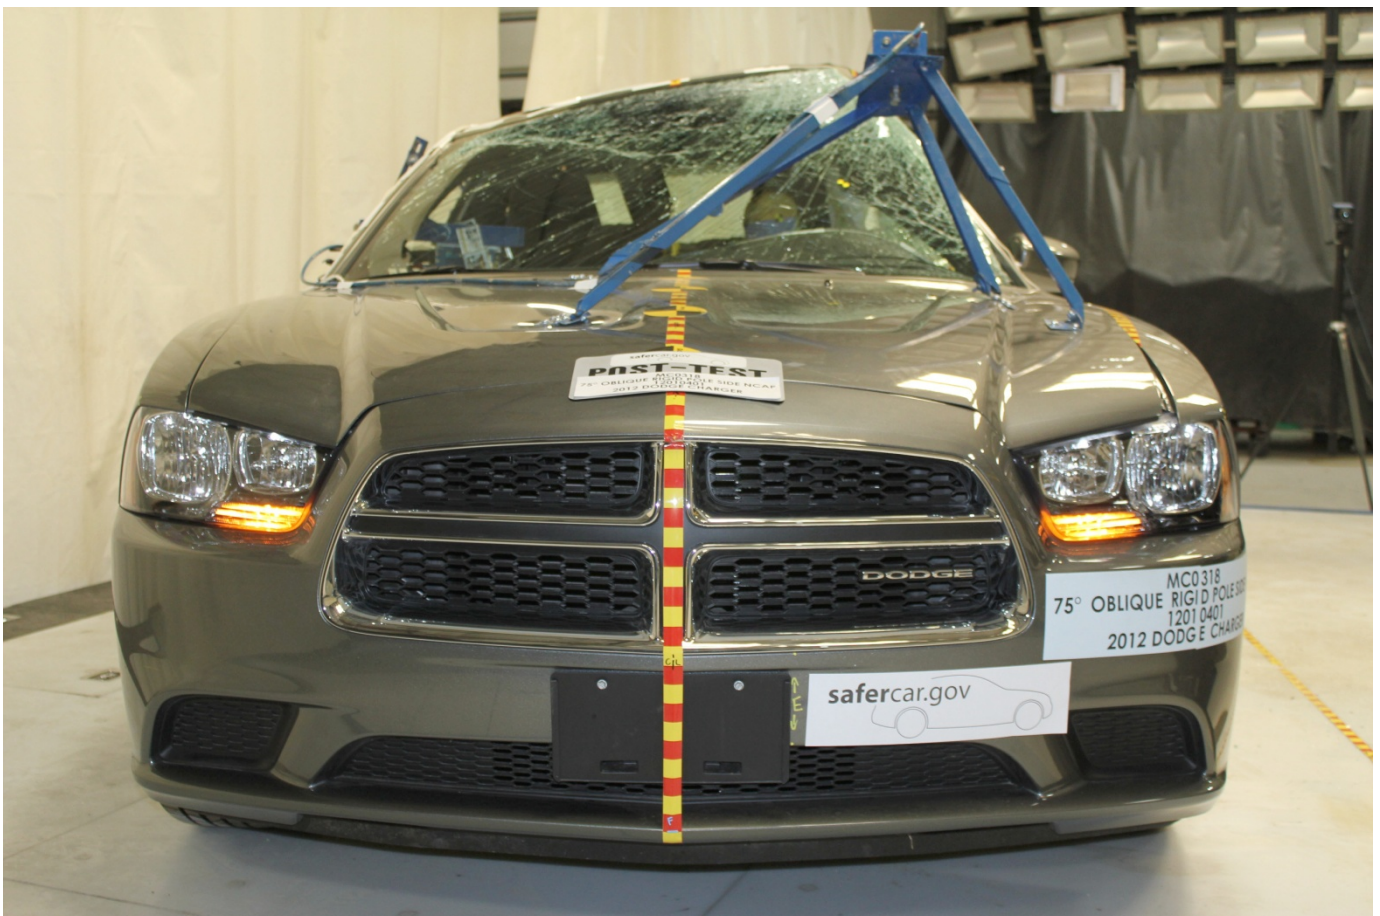
Post-Test Frontal View of Test Vehicle

Critical Areas of Performance	Observations and Conclusions
Pillar Performance	No Separation
Sill Separation	None
Windshield Damage	Cracked
Side Window Damage	Left Front Window Cracked
Other Notable Effects	None

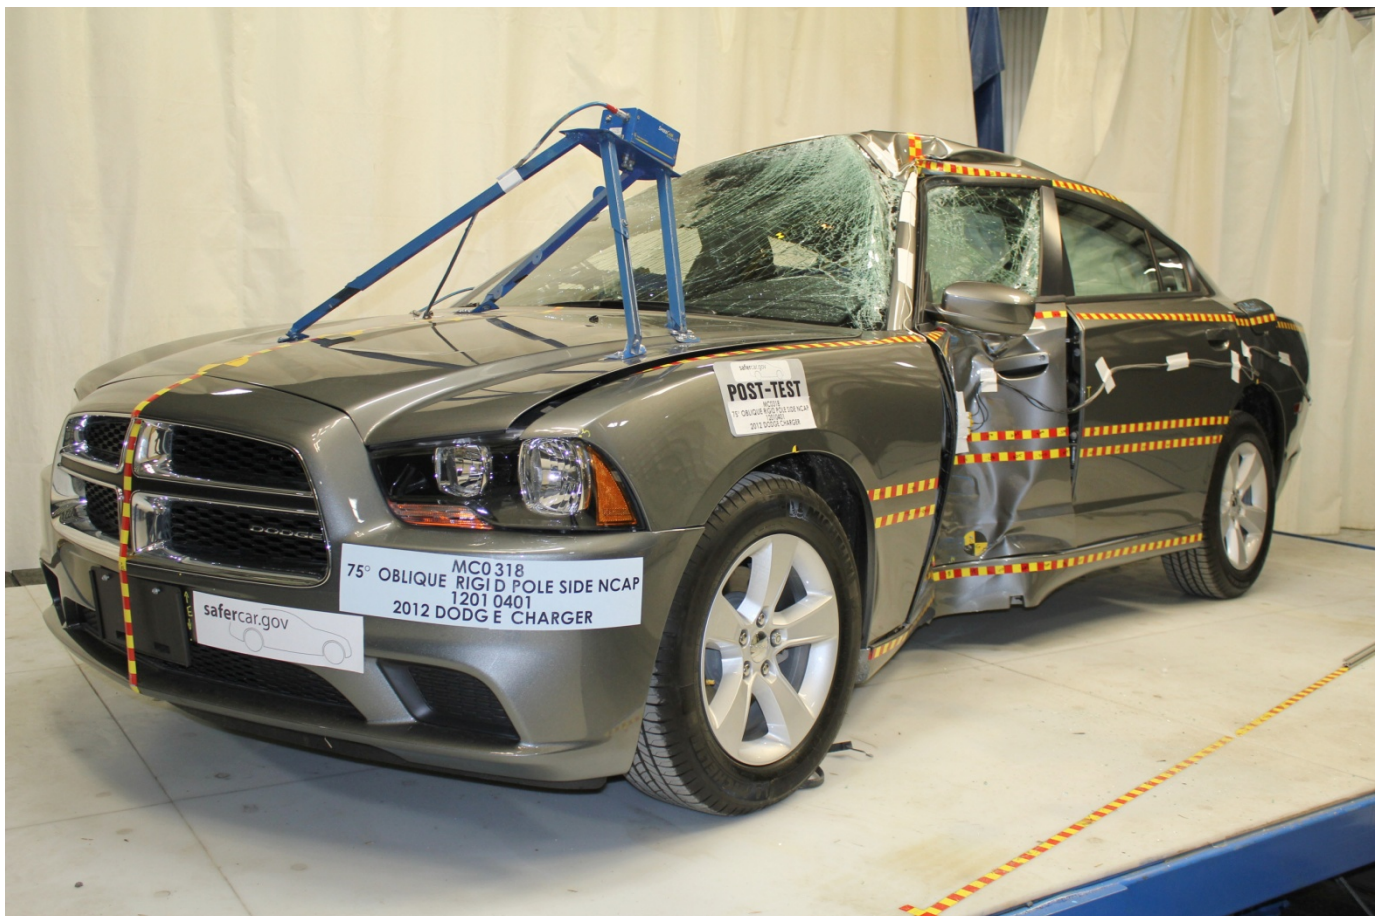
Post-Test Left Front ¾ View of Test Vehicle

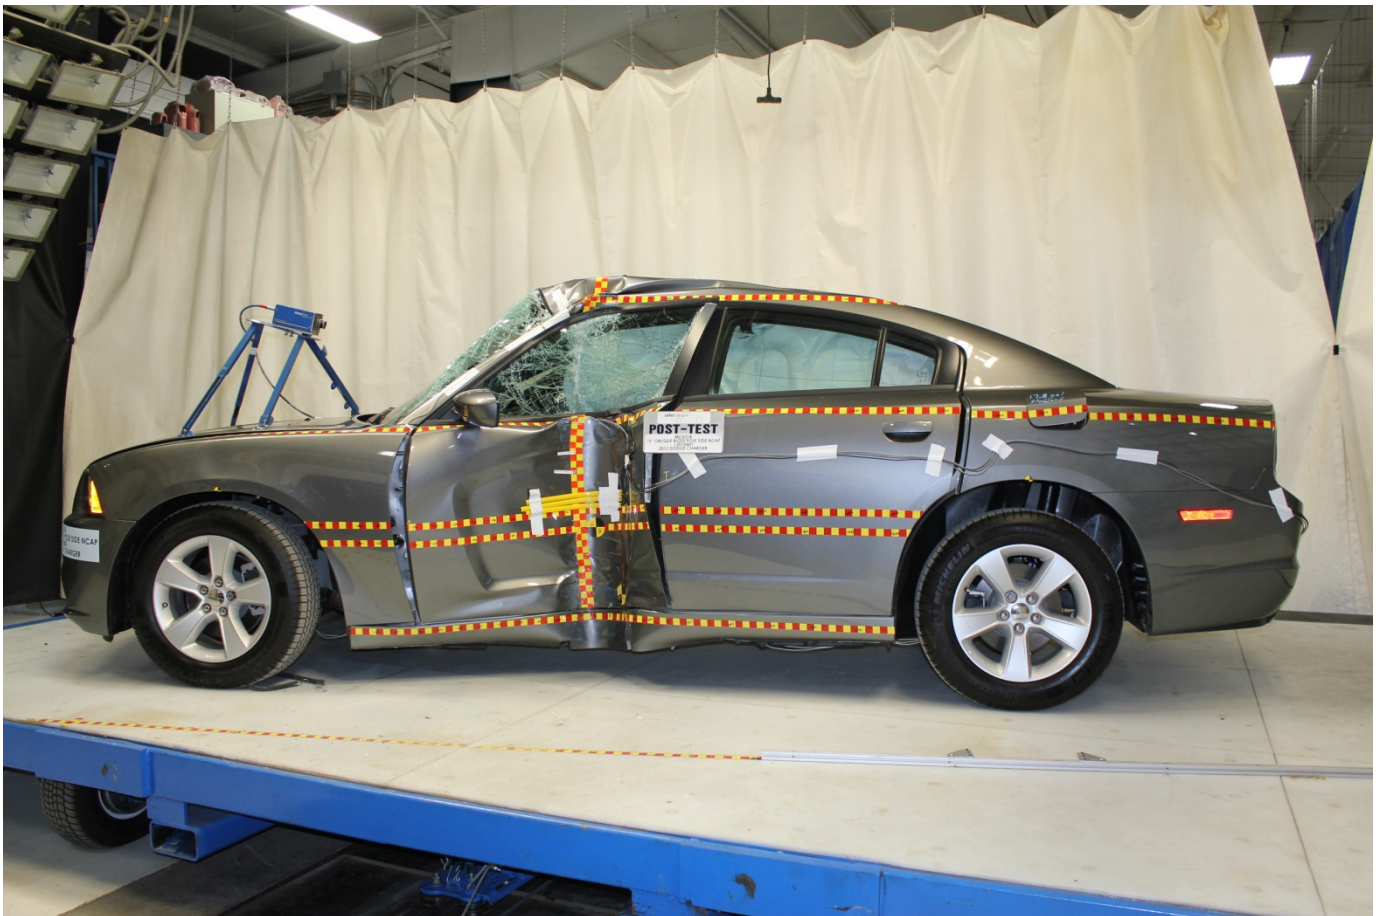
Post-Test Left Side View of Test Vehicle

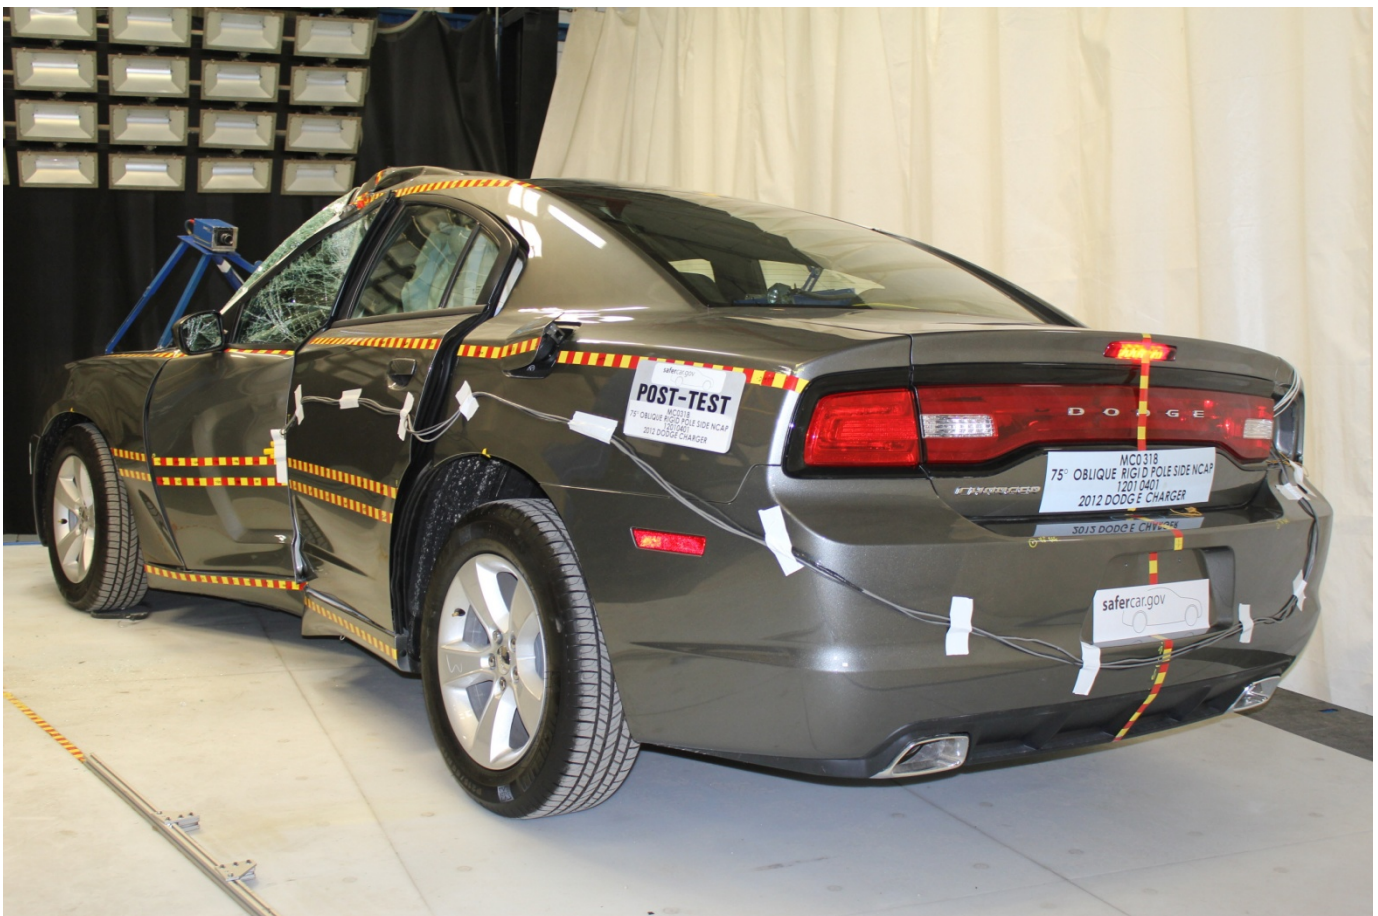
Post-Test Left Rear $\frac{3}{4}$ View of Test Vehicle

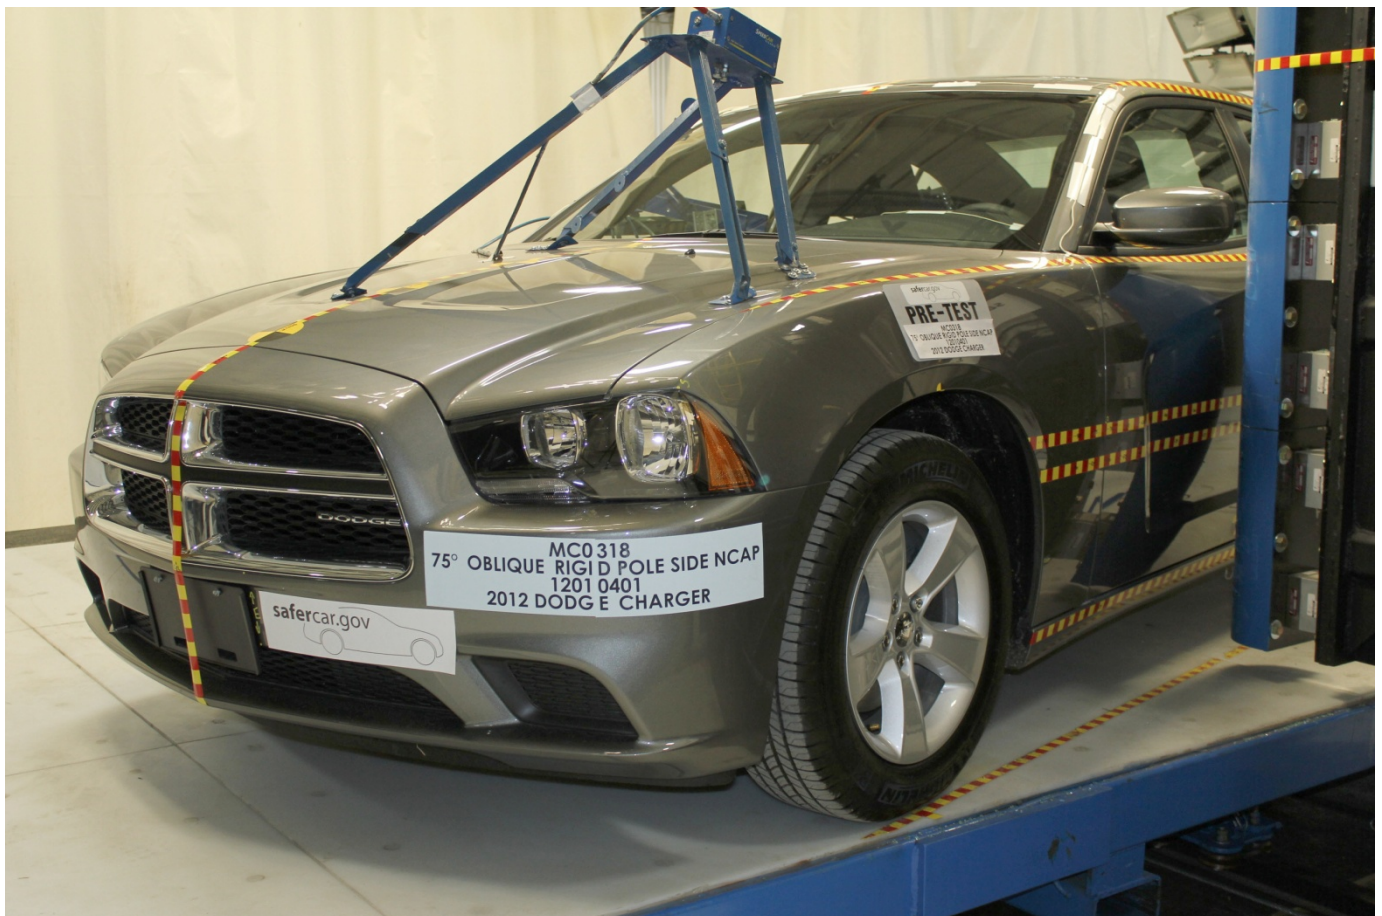
Pre-Test Left Side View of Pole Positioned Against Side of Vehicle

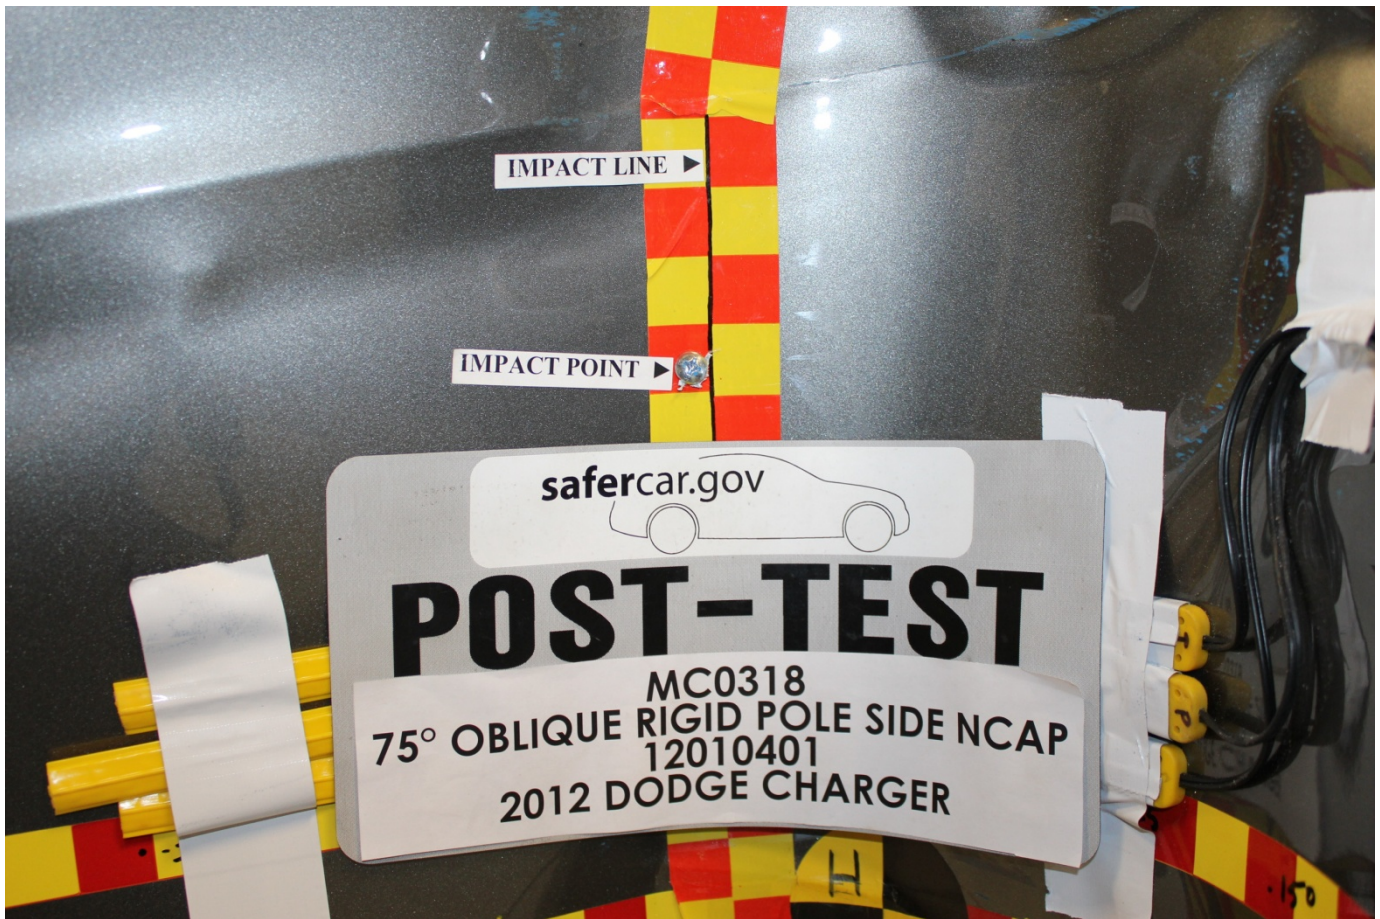
Post-Test Close-Up View of Impact Point Target Showing Impact Location

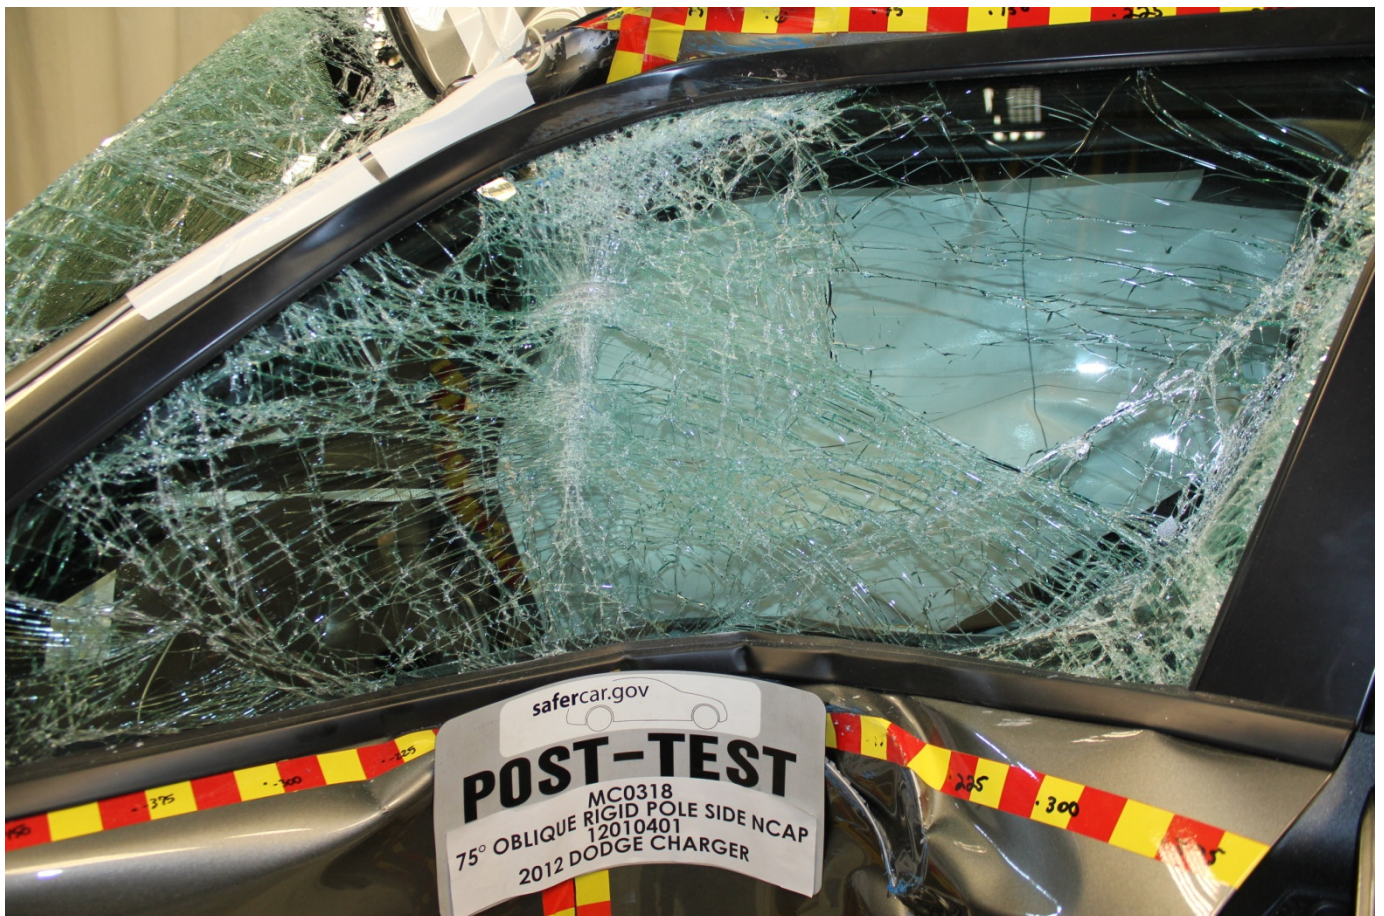
Post-Test Left Side View of Dummy Shoulder and Door Top View

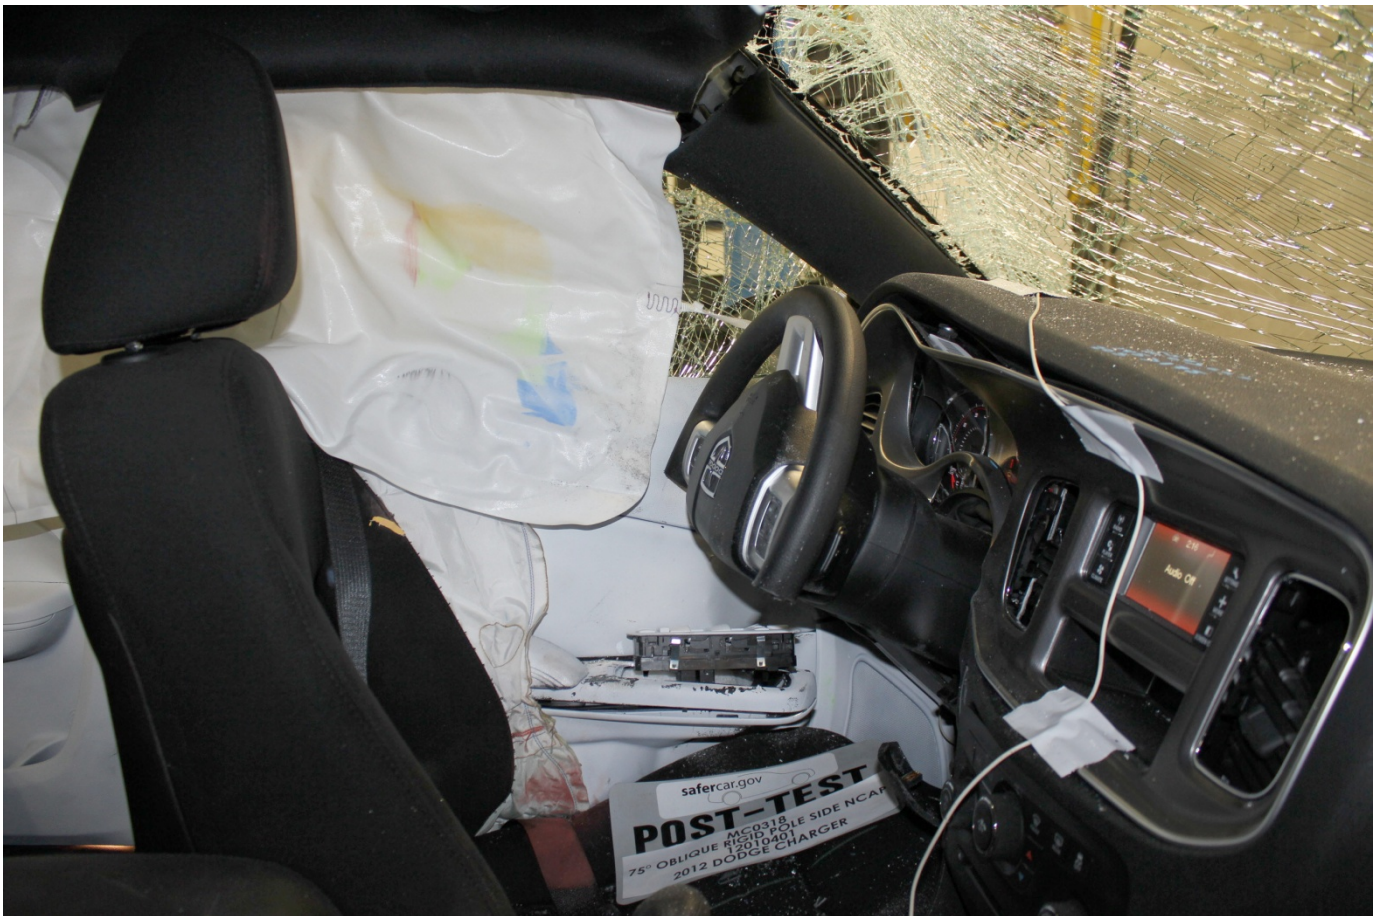
Post-Test Inner Door Panel View Showing Dummy Contact Location

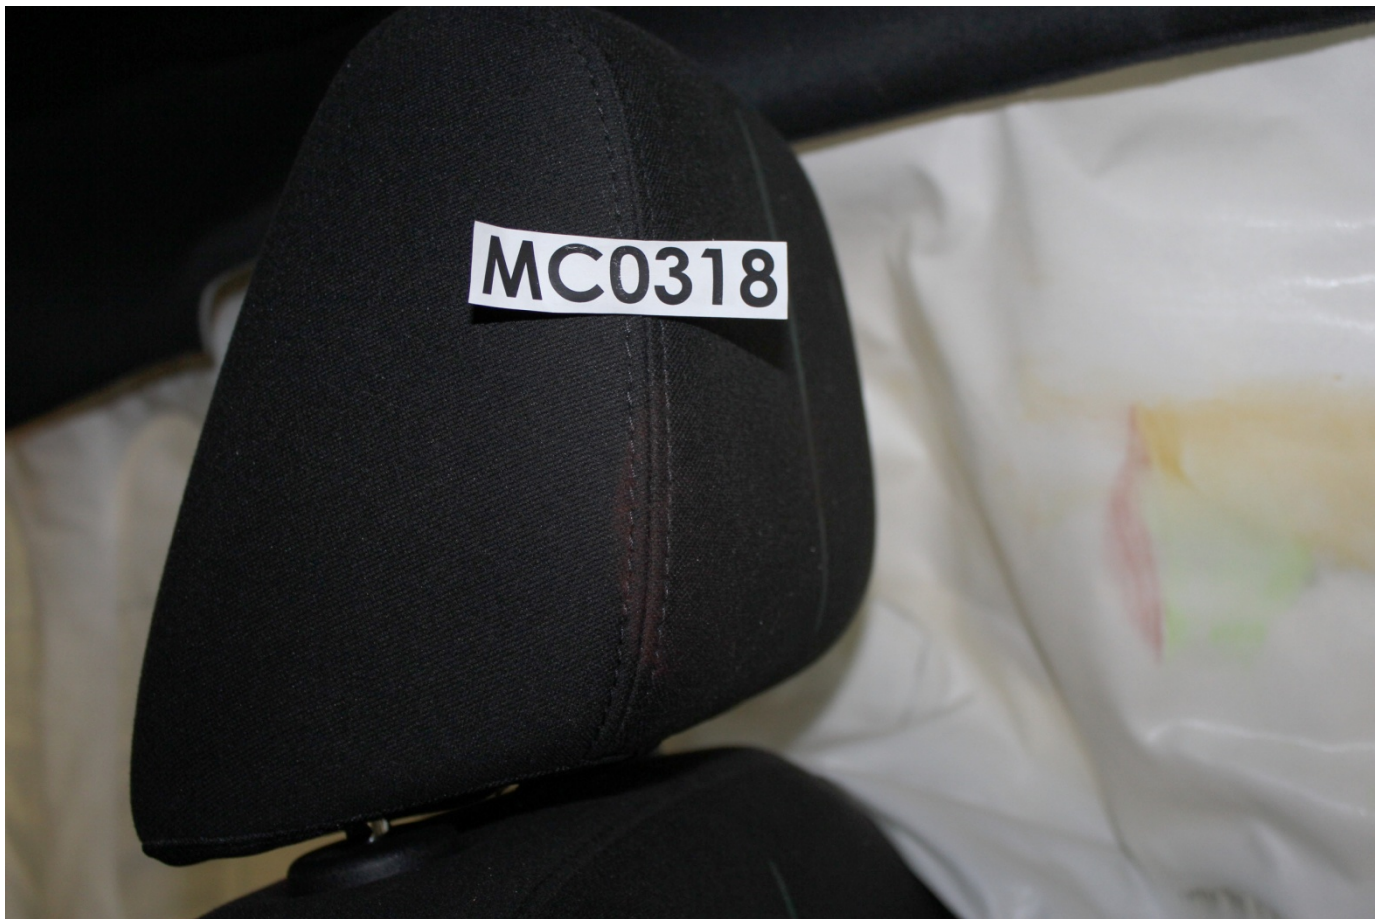
Post-Test Dummy Close-Up Head Contact with Vehicle Interior View

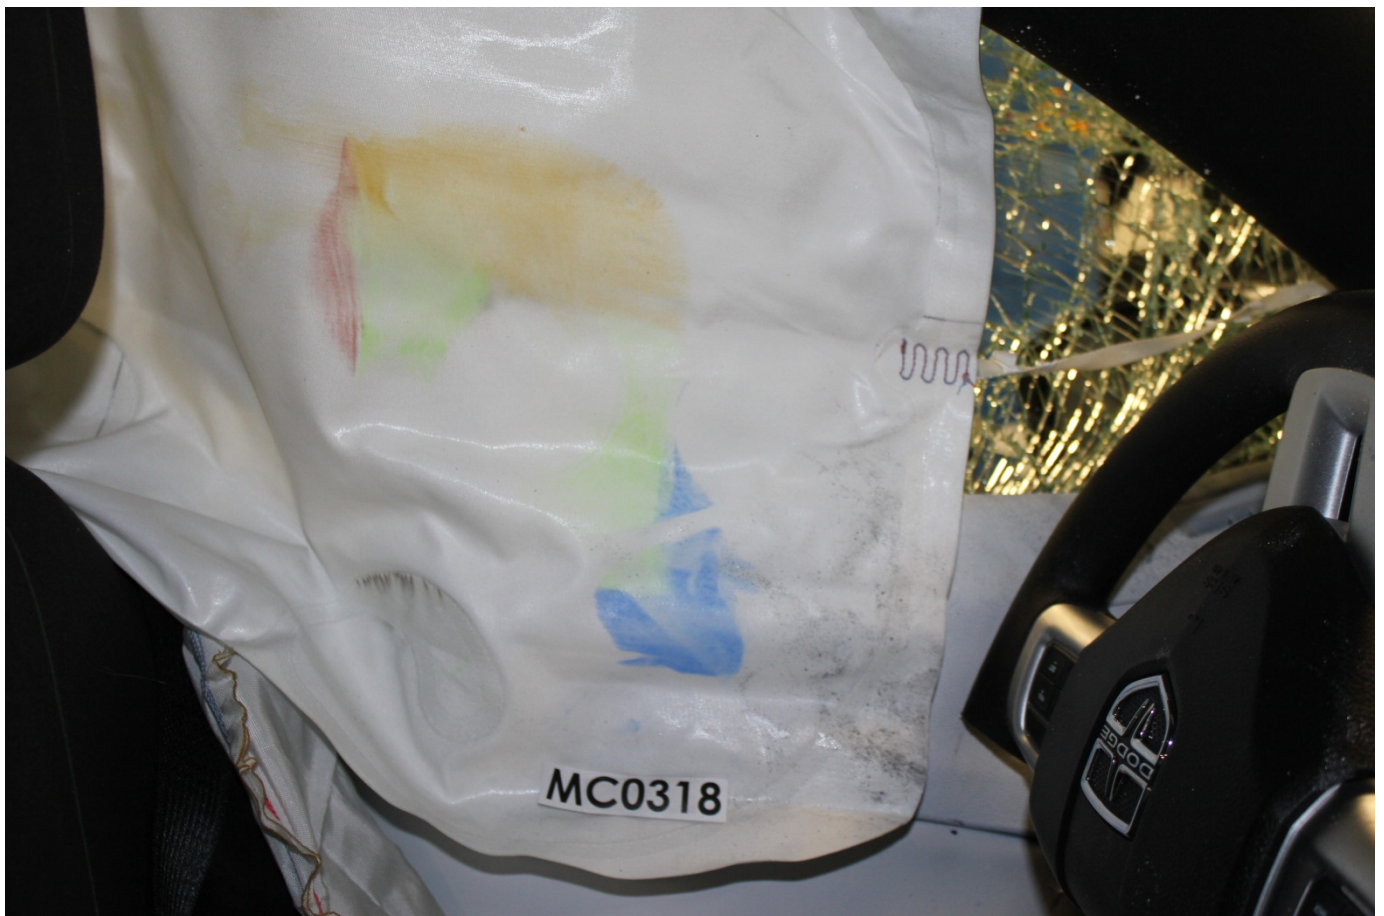
Post-Test Dummy Close-Up Head Contact with Side Air Bag View

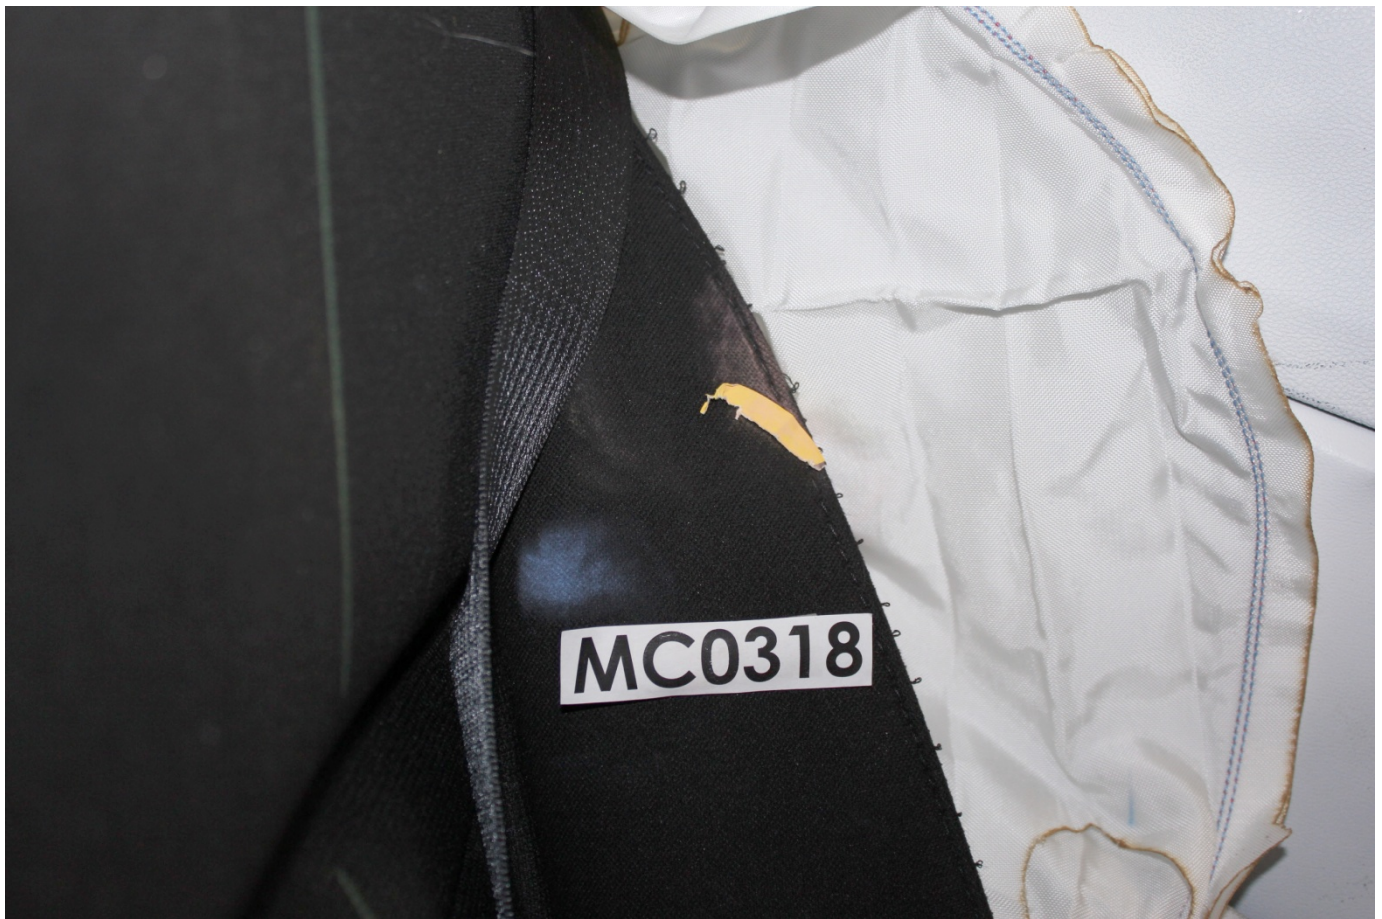
Post-Test Dummy Close-Up Torso Contact with Vehicle Interior View

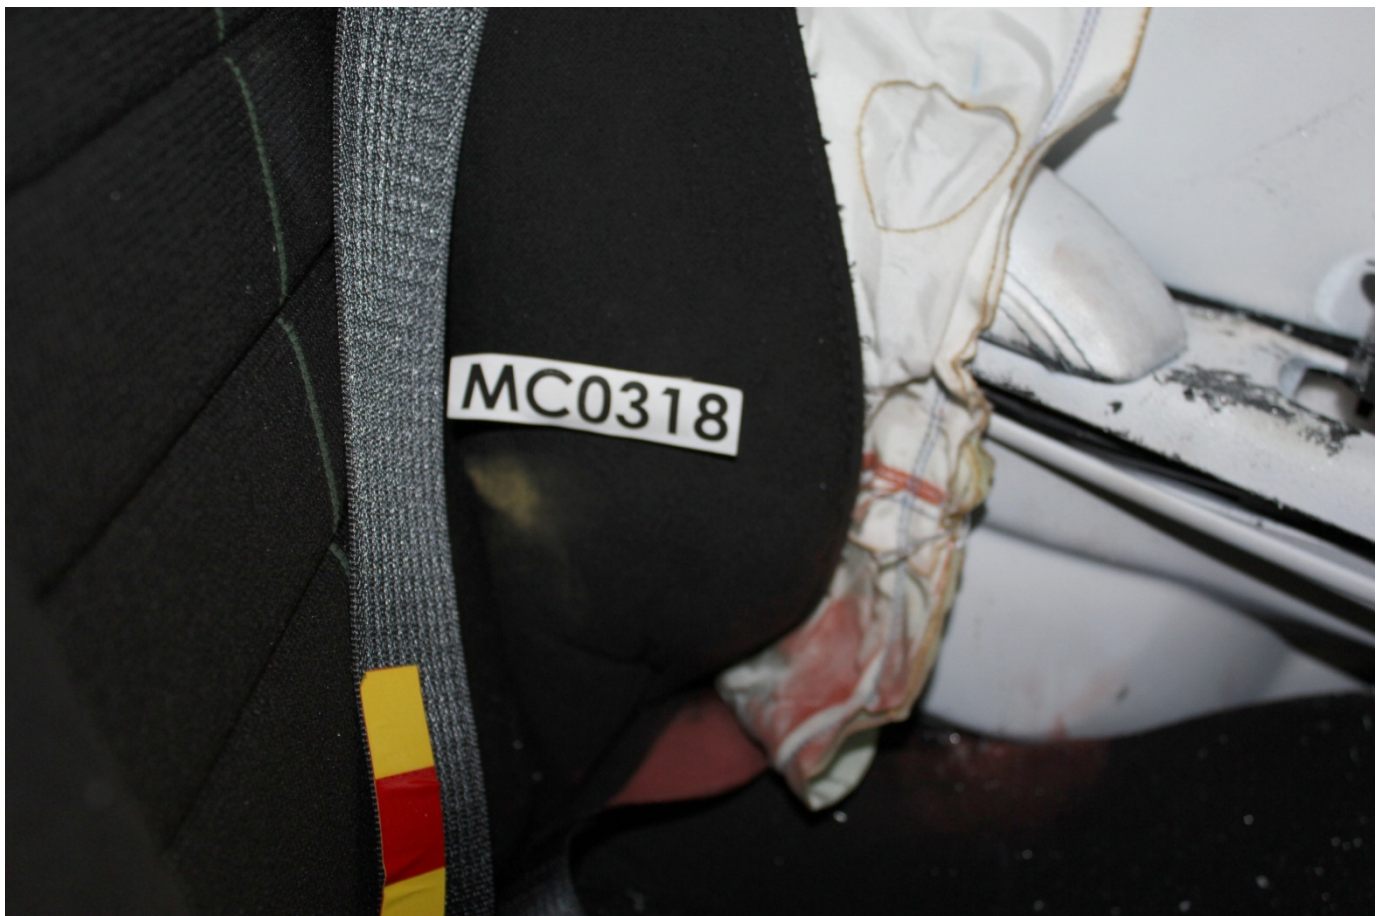
Post-Test Dummy Close-Up Torso Contact with Vehicle Interior View

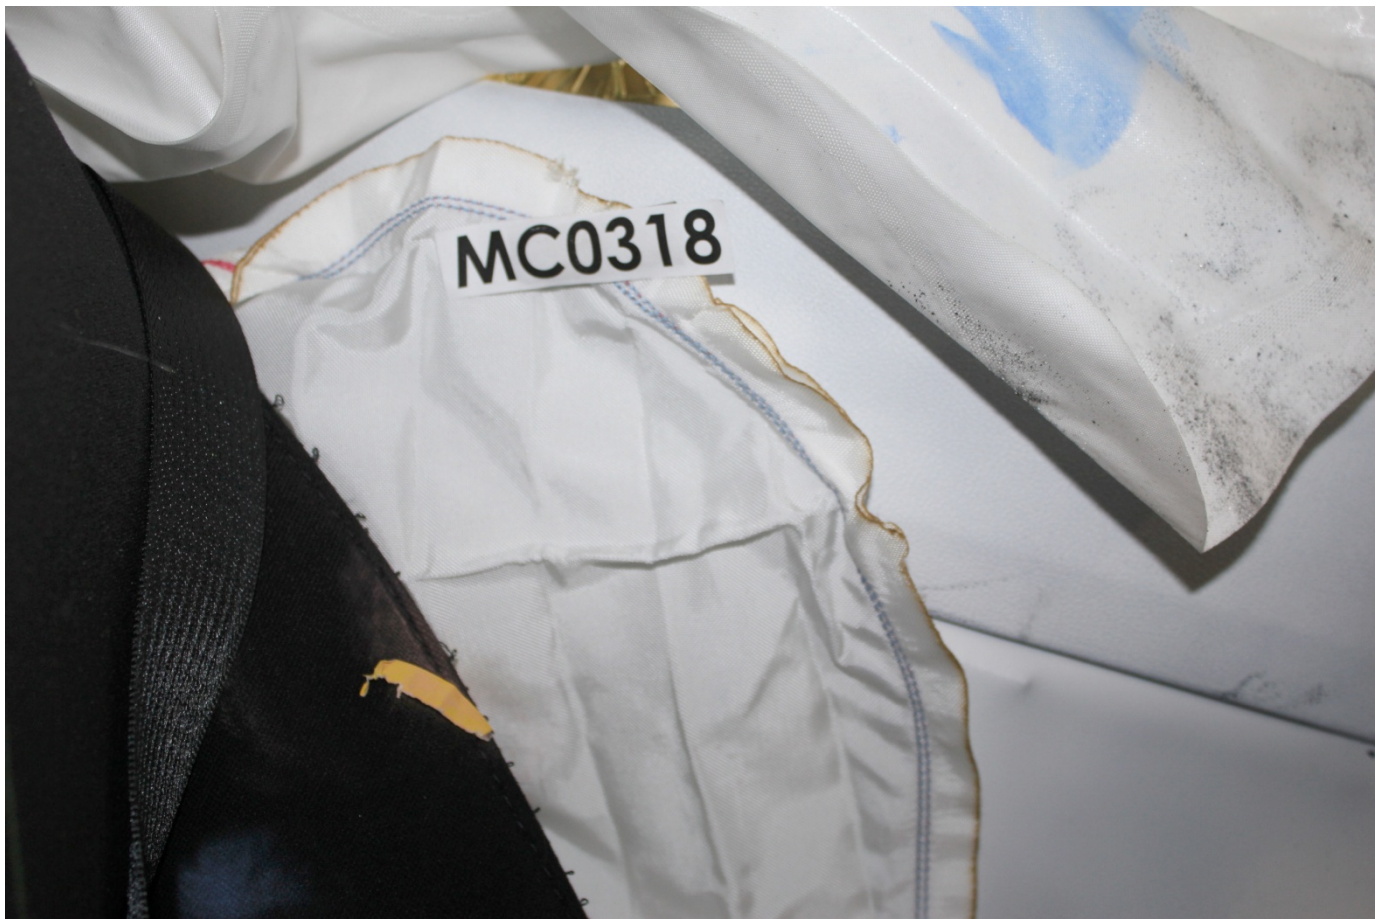
Post-Test Dummy Close-Up Torso Contact with Side Air Bag View

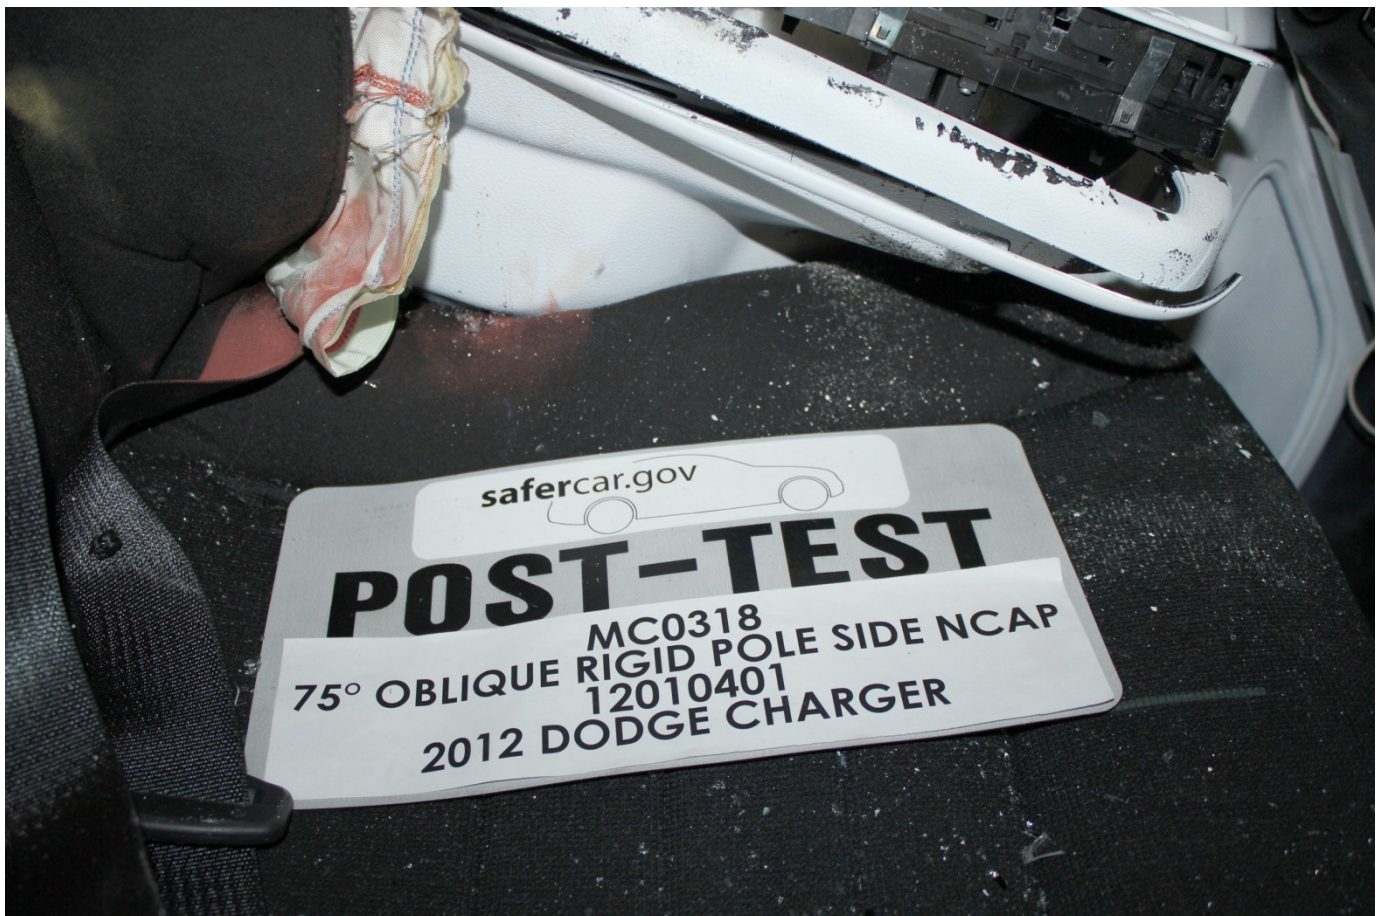
Post-Test Dummy Close-Up Pelvis Contact with Vehicle Interior View

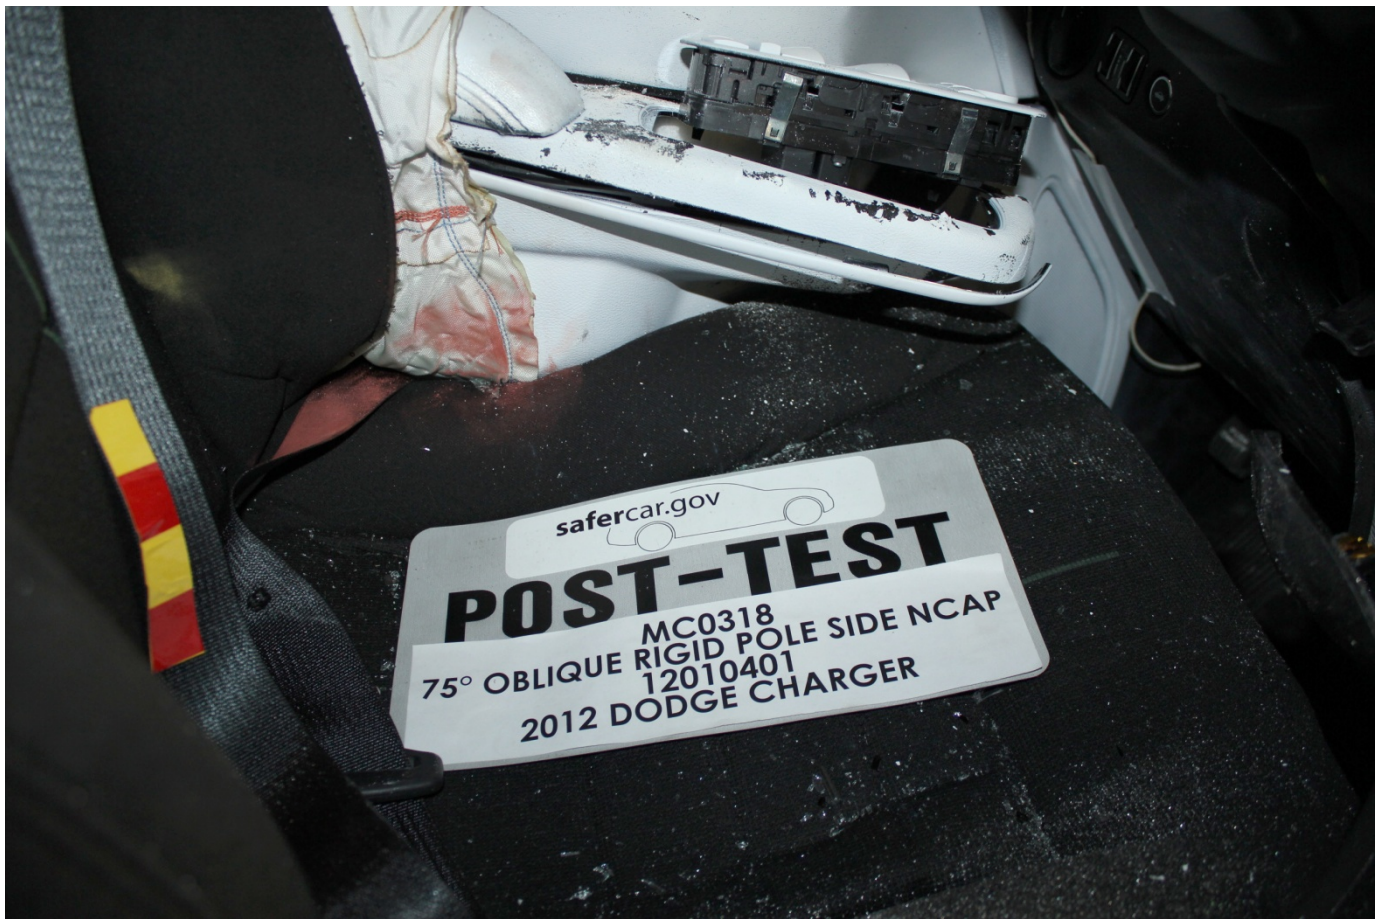
Post-Test Dummy Close-Up Pelvis Contact with Side Air Bag View

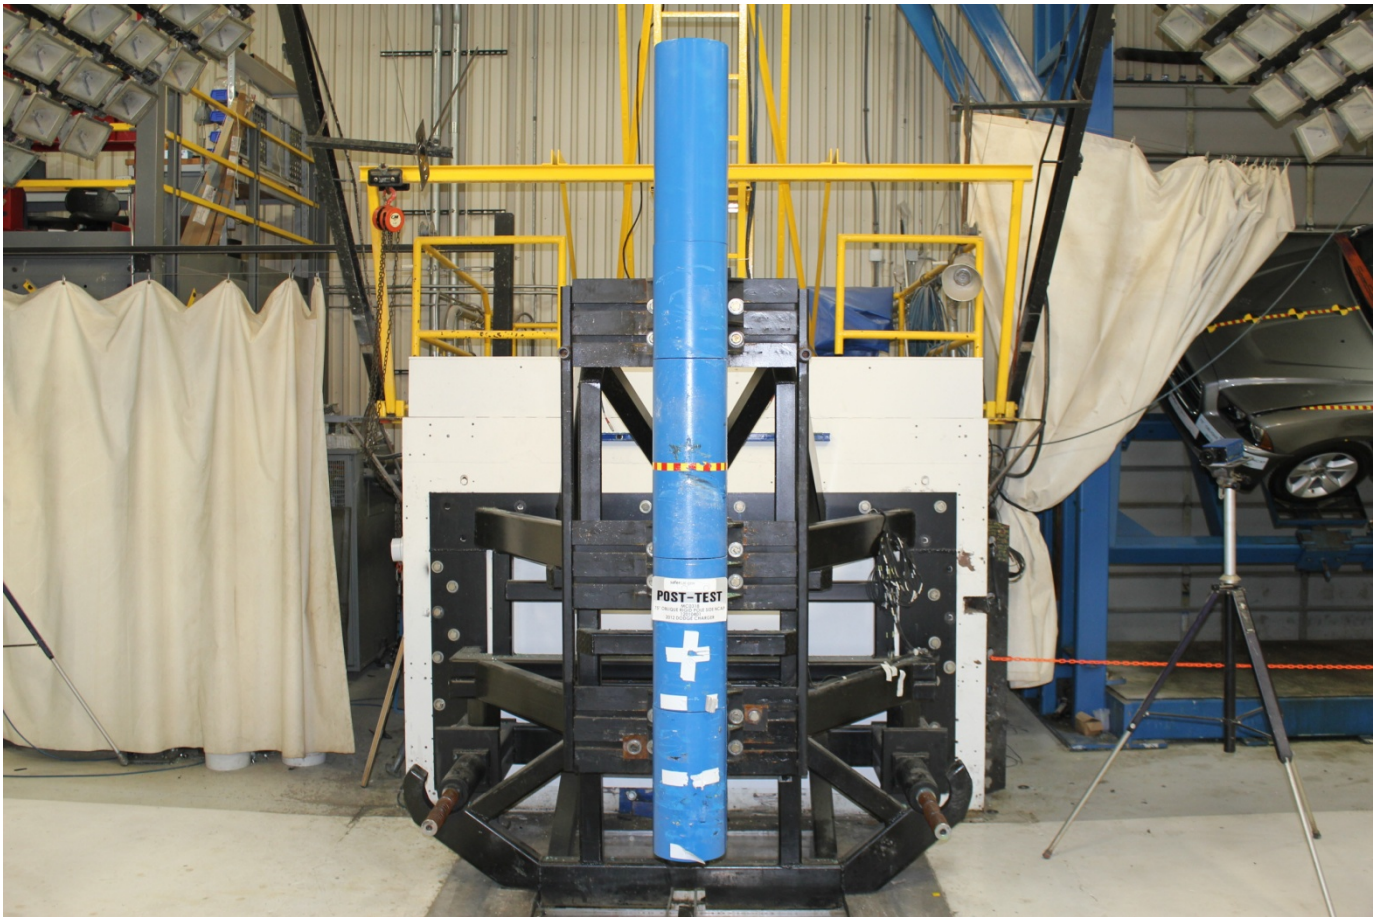
Post-Test Pole Barrier Front View

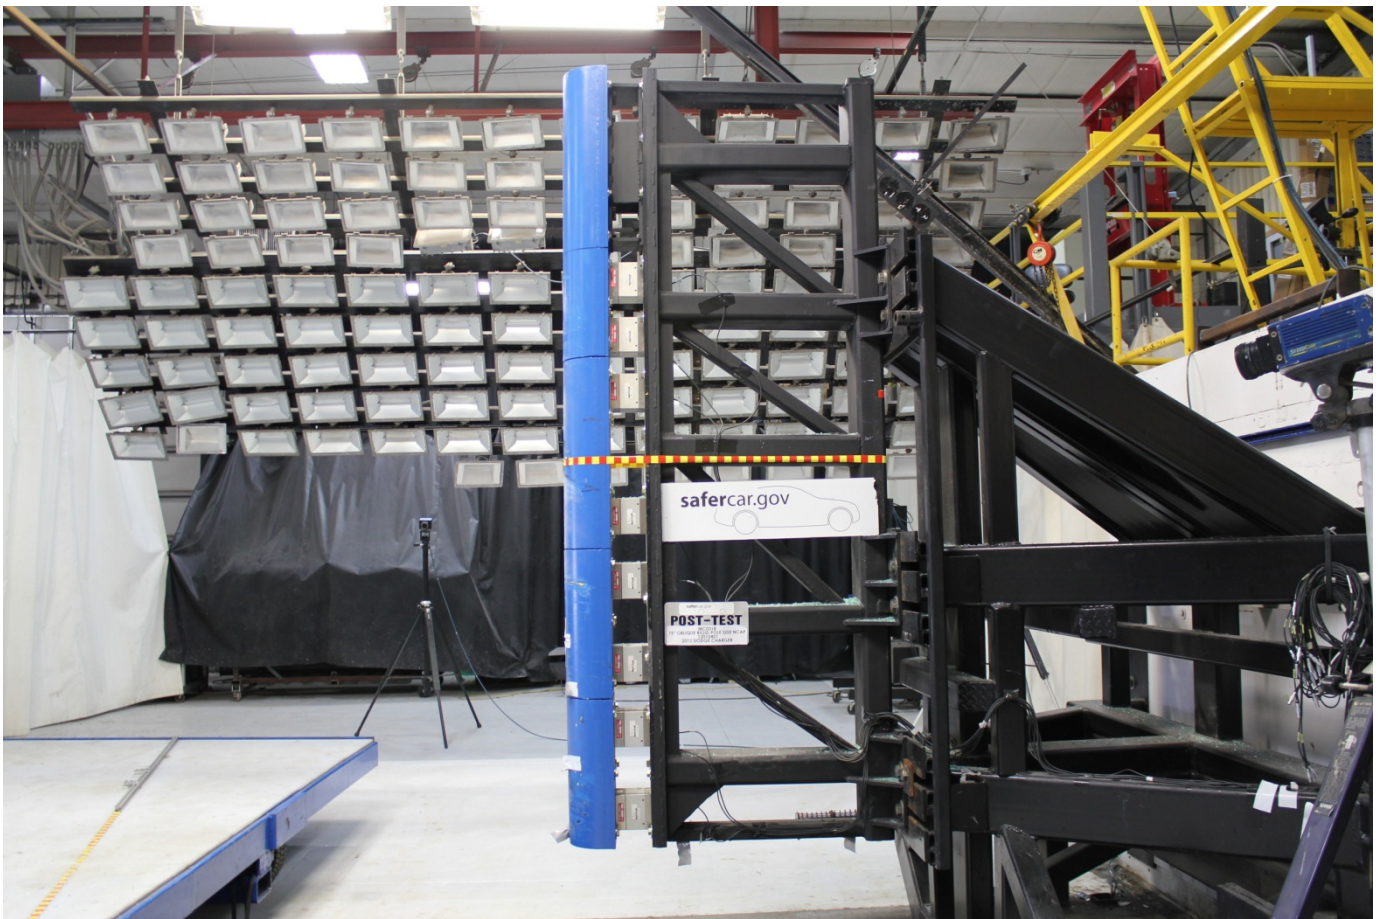
Post-Test Pole Barrier Side View

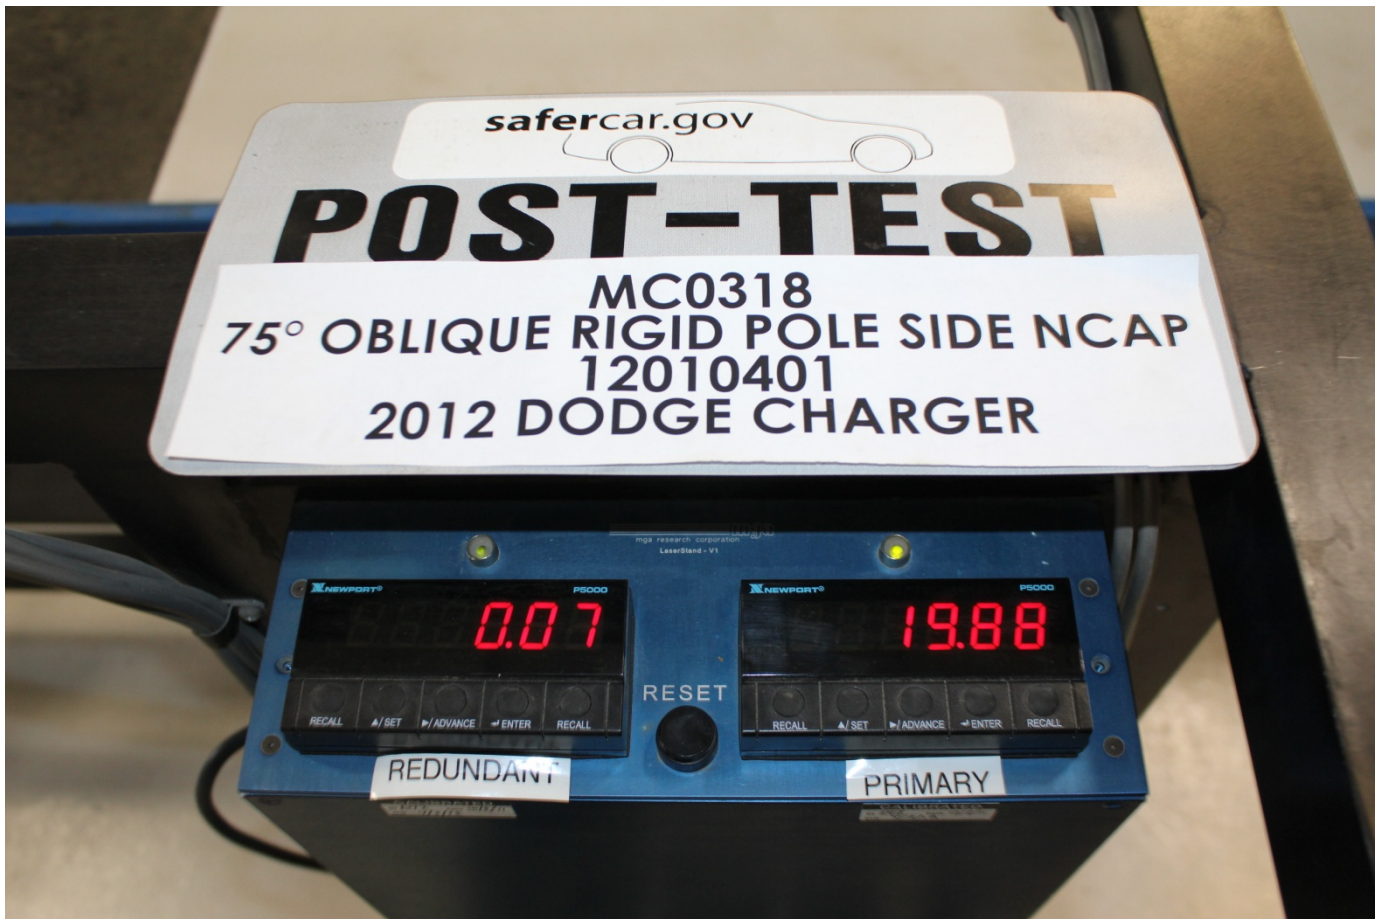
Post-Test Primary and Redundant Speed Trap Read-Out

A rigid pole side impact test was conducted on a 2012 Dodge Charger SE 4-Dr Sedan. The subject vehicle was towed into the rigid pole at an angle of 75° and a velocity of 32.0 km/h. The test was conducted by MGA Research Corporation in Burlington, Wisconsin, on January 4, 2012. Pre-test and post-test photographs of the test vehicle and side impact dummy (SID-IIs) are included in Appendix A of this report.
