REPORT NUMBER: SPNCAP-MGA-2012-048

**NEW CAR ASSESSMENT PROGRAM (NCAP)
Side Impact Pole Test**

**CHRYSLER GROUP LLC
2012 Dodge Charger SE 4-Dr Sedan
NHTSA No.: MC0318**

**MGA RESEARCH CORPORATION
5000 Warren Road
Burlington, WI 53105**

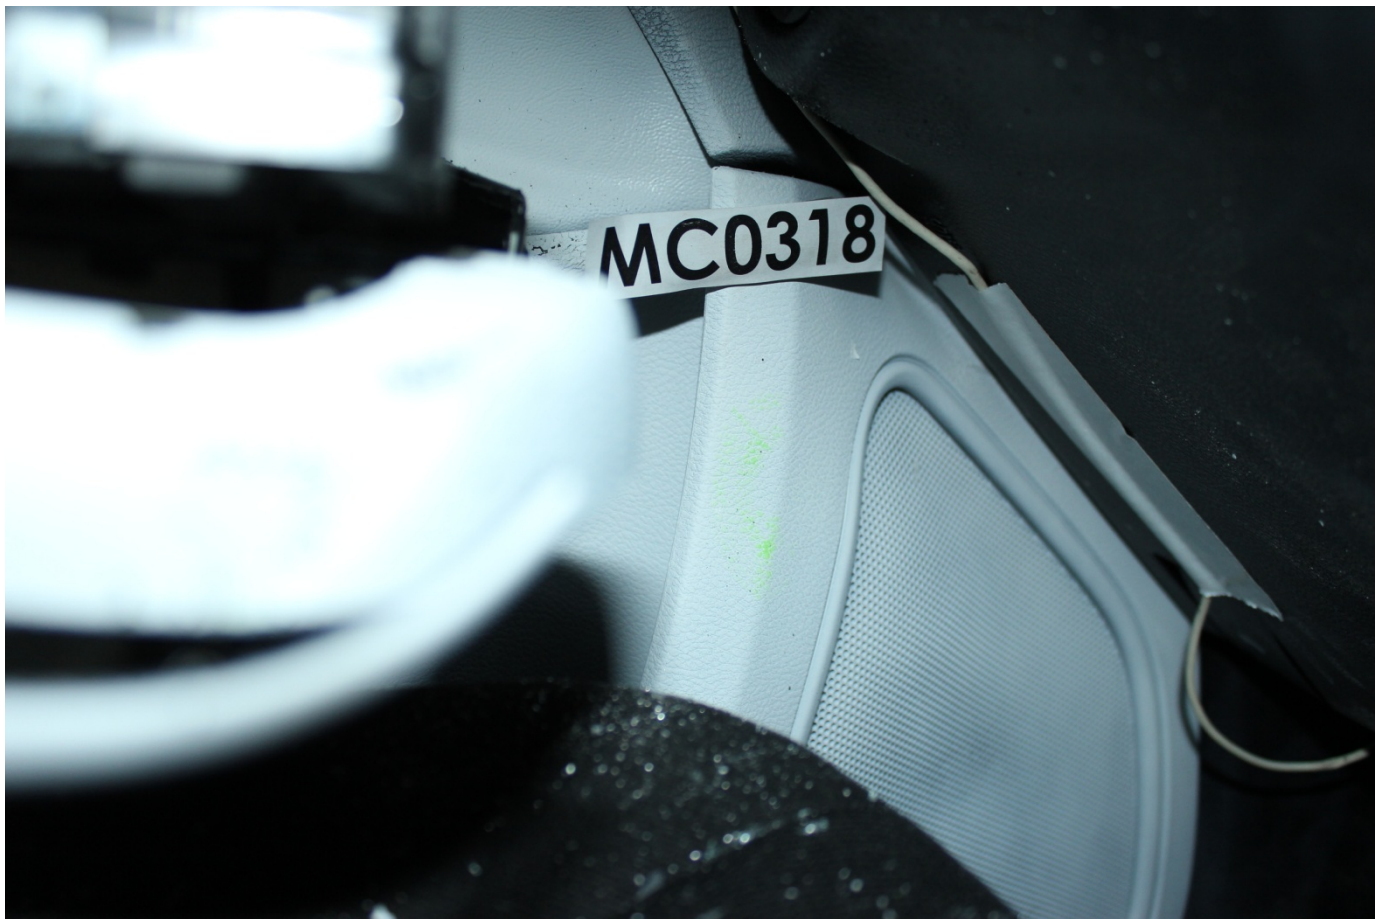
Post-Test Dummy Knee Contact with Vehicle Interior View
