**REPORT NUMBER: NCAP-MGA-2012-050**

**NEW CAR ASSESSMENT PROGRAM (NCAP)  
Frontal Barrier Impact Test**

**CHRYSLER GROUP LLC  
2012 Dodge Charger SXT AWD 4-Dr Sedan  
NHTSA No.: MC0316**

**FINAL REPORT**

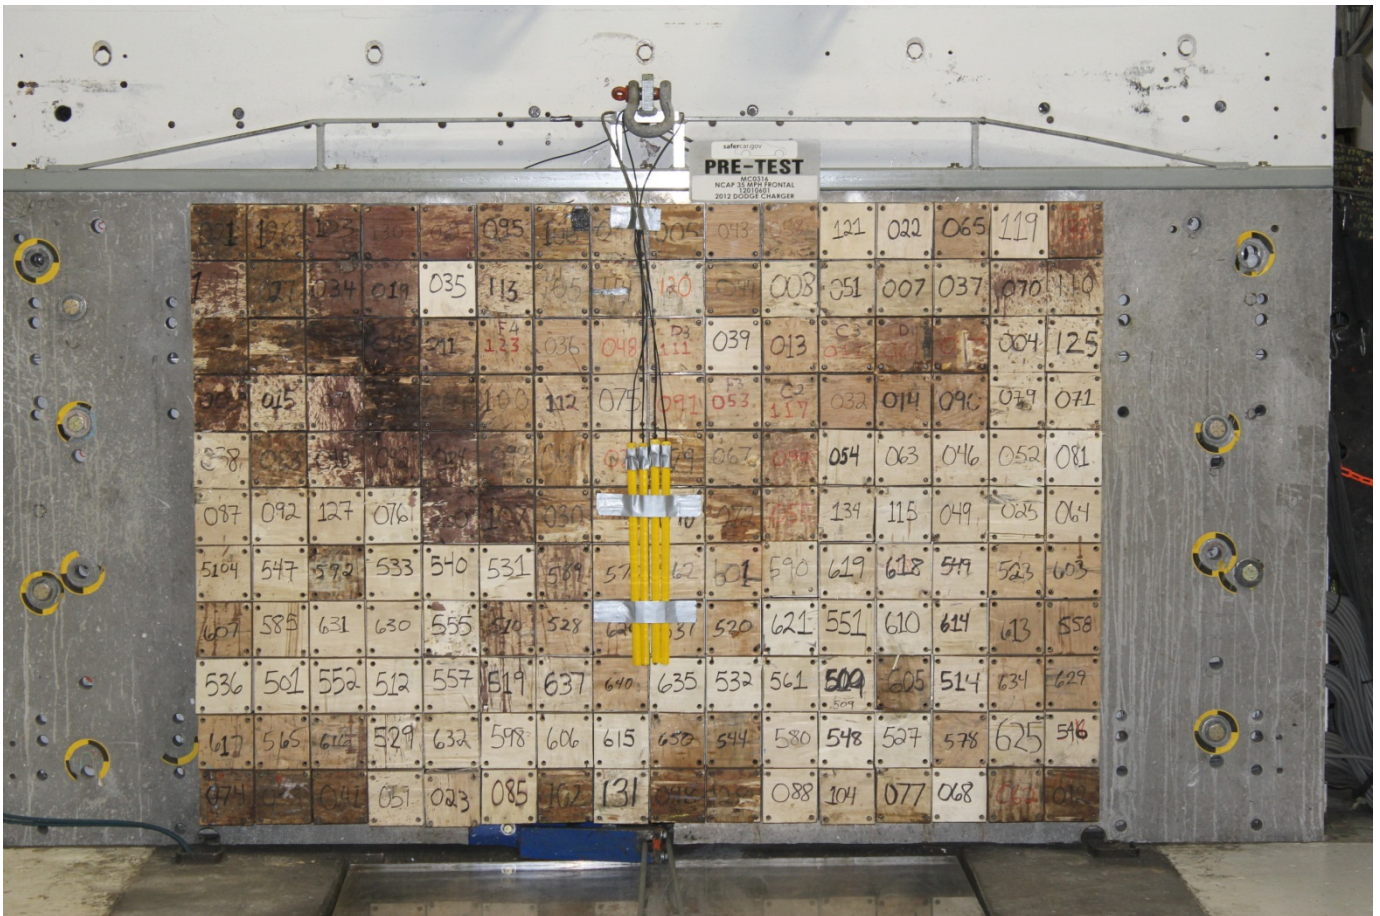
Load Cell Wall

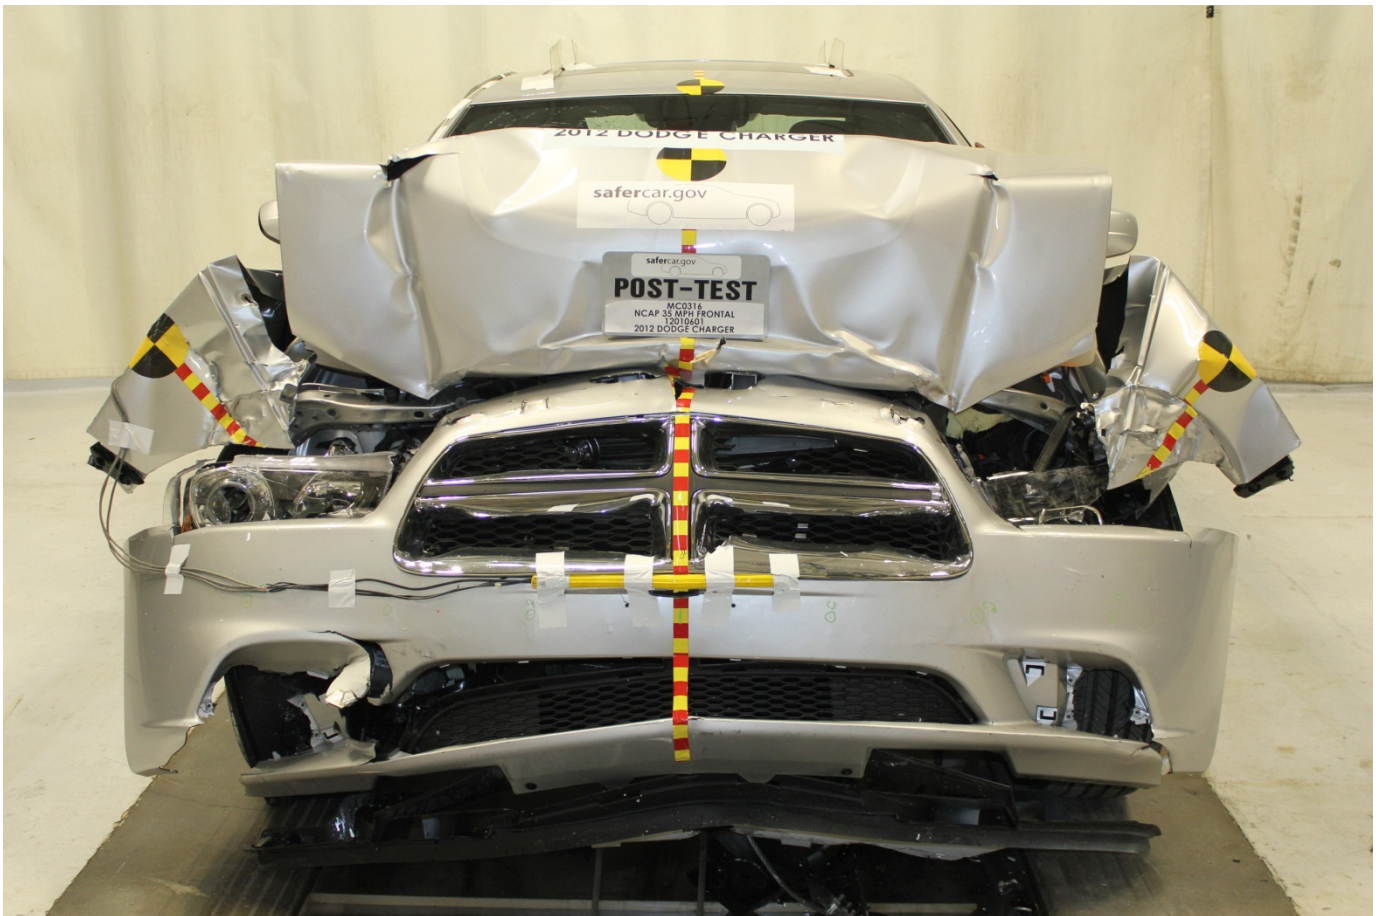
Post-Test Front View of Test Vehicle

The maximum static crush of the vehicle was 522 mm and both the driver and passenger side doors remained closed during the impact event and were operable after the impact.

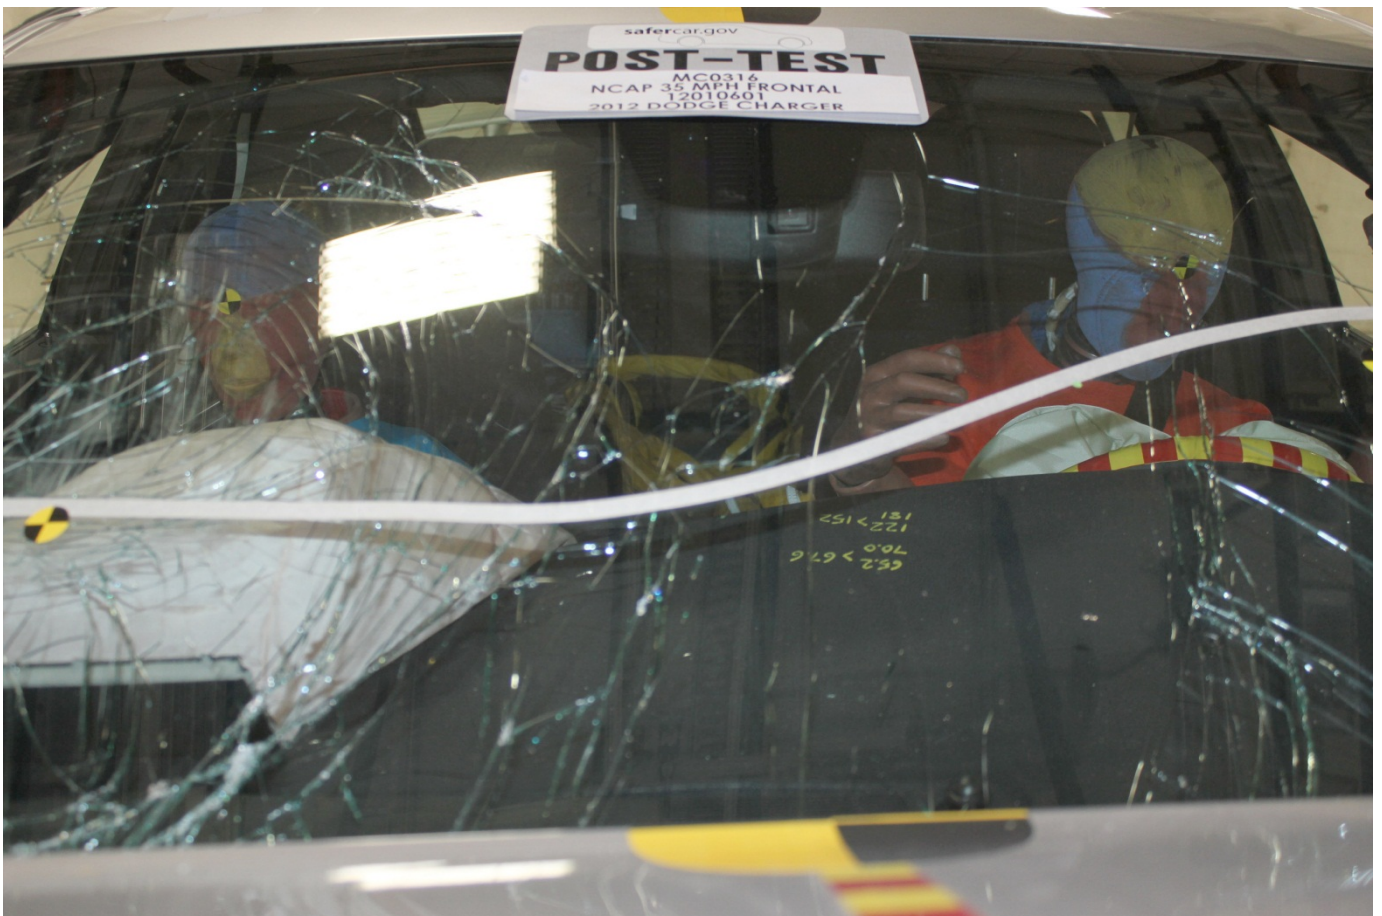
Post-Test Windshield View

There was 100 percent windshield retention and no intrusion into the protected zone of the windshield during the event. There was no Stoddard Solvent leakage after the event or during any phase of the static rollover.

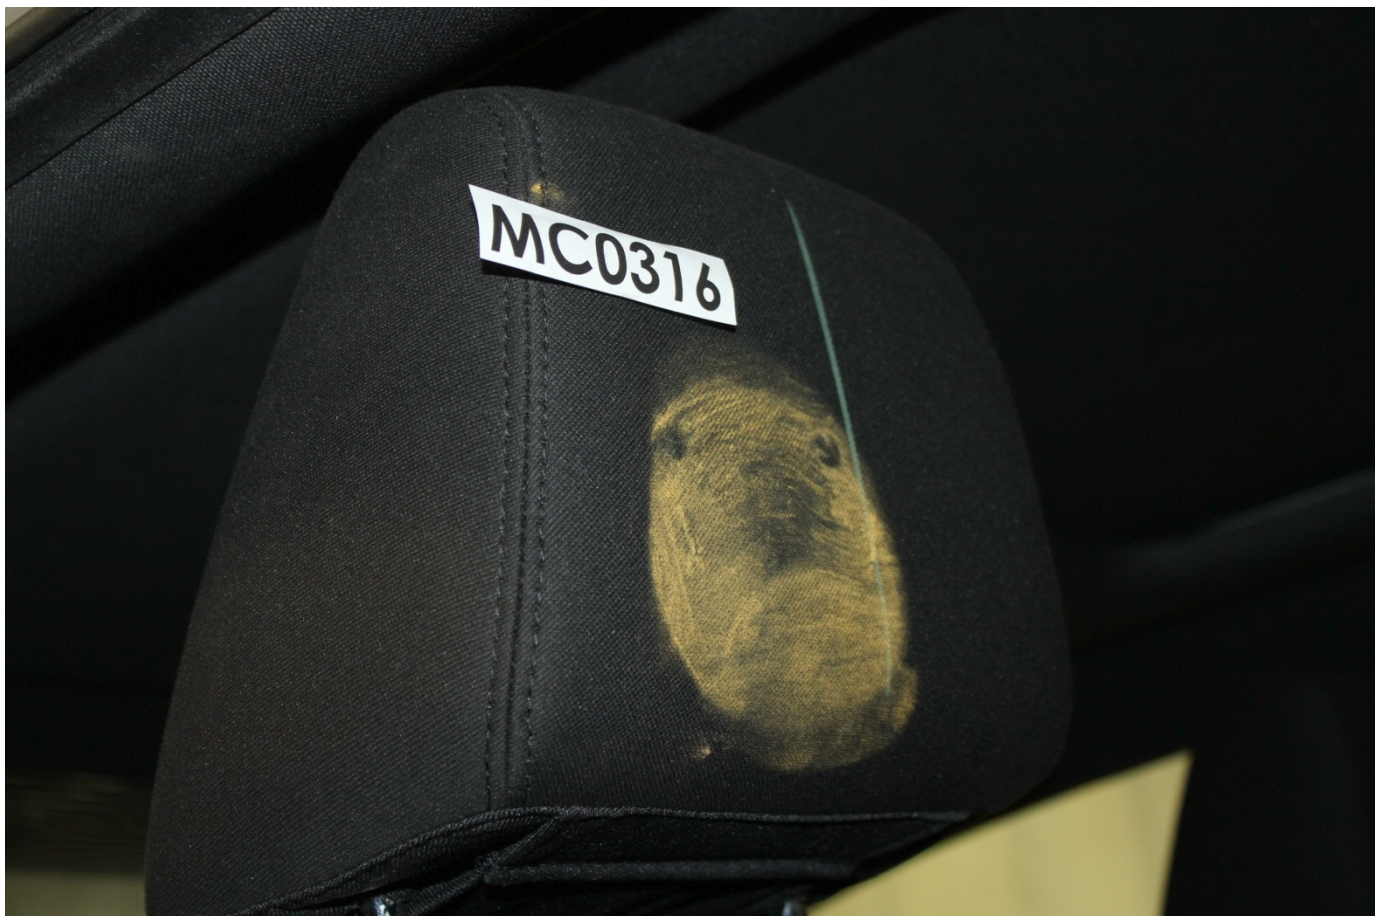
Post-Test Passenger Dummy Contact with Headrest

The driver's visible contact points were as follows: The driver's head and chest contacted the airbag. The driver's head also contacted the headrest. The driver's knees contacted the knee airbag. The passenger's visible contact points were as follows: The passenger's head contacted the airbag. The passenger's head also contacted the headrest. The passenger's knees contacted the glovebox.

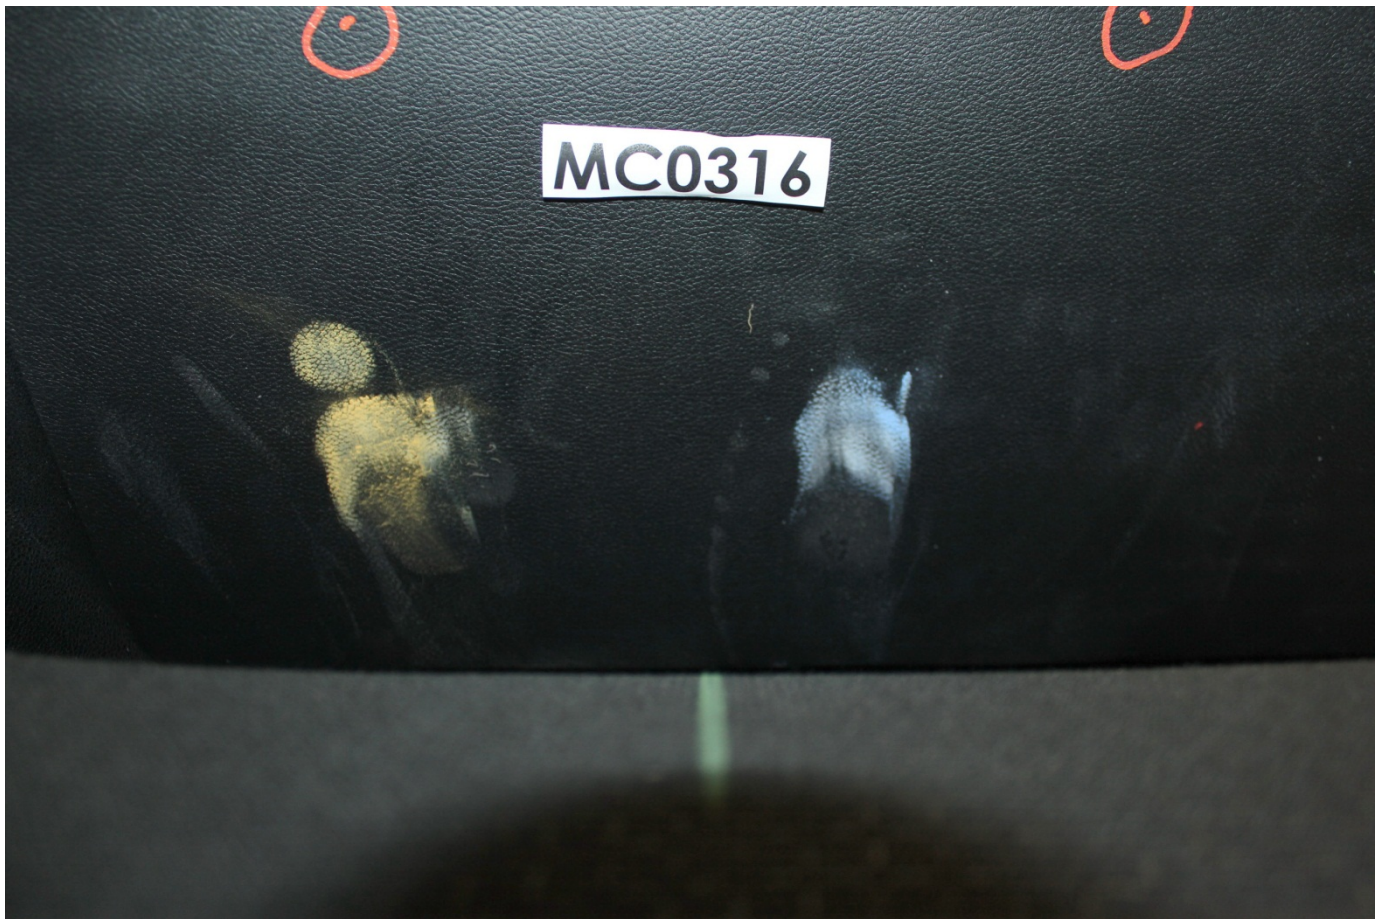
Post-Test Passenger Dummy Contact with Knee Bolster

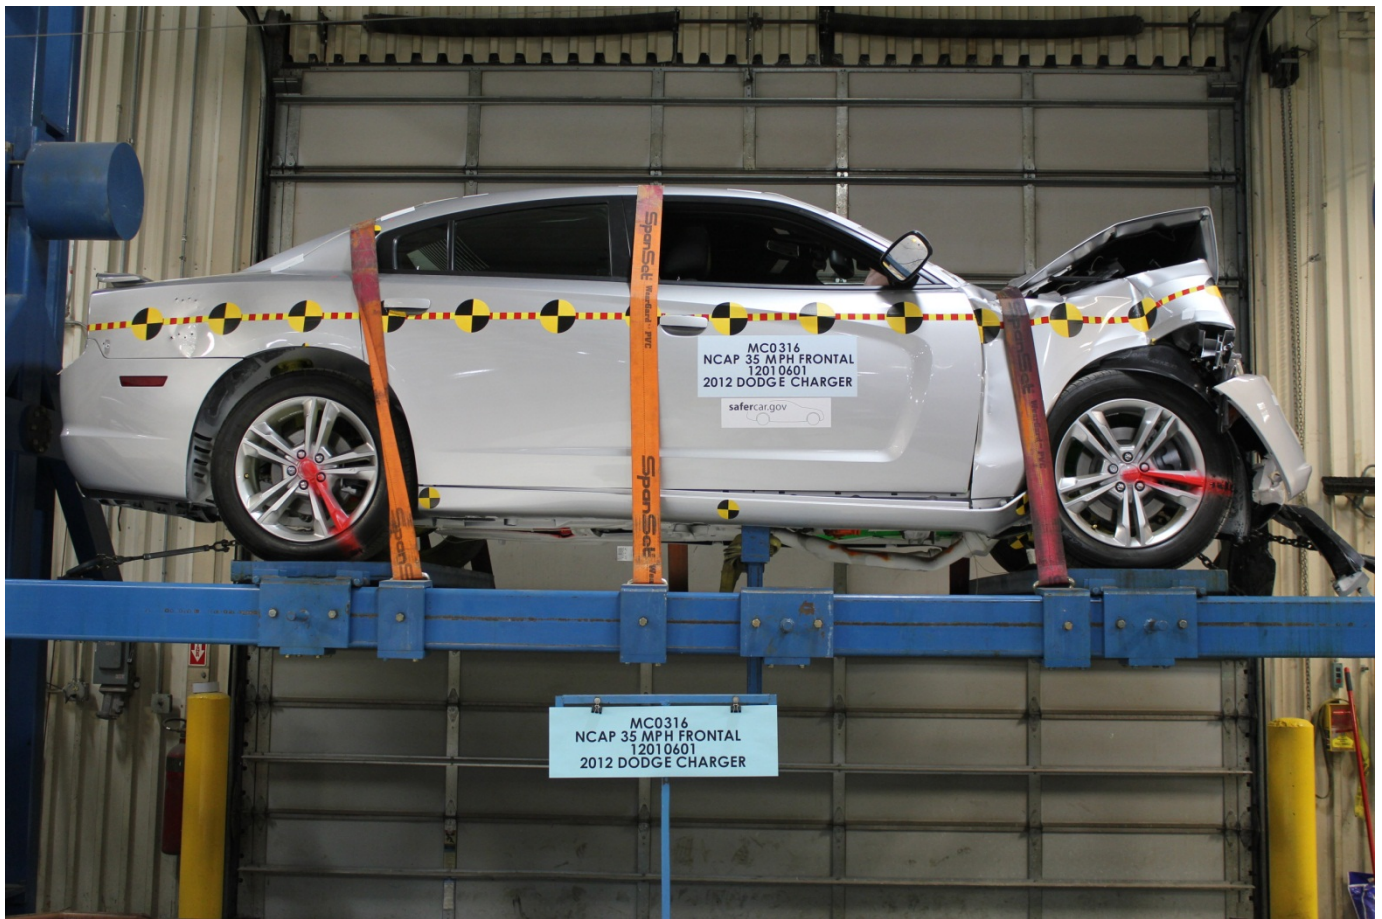
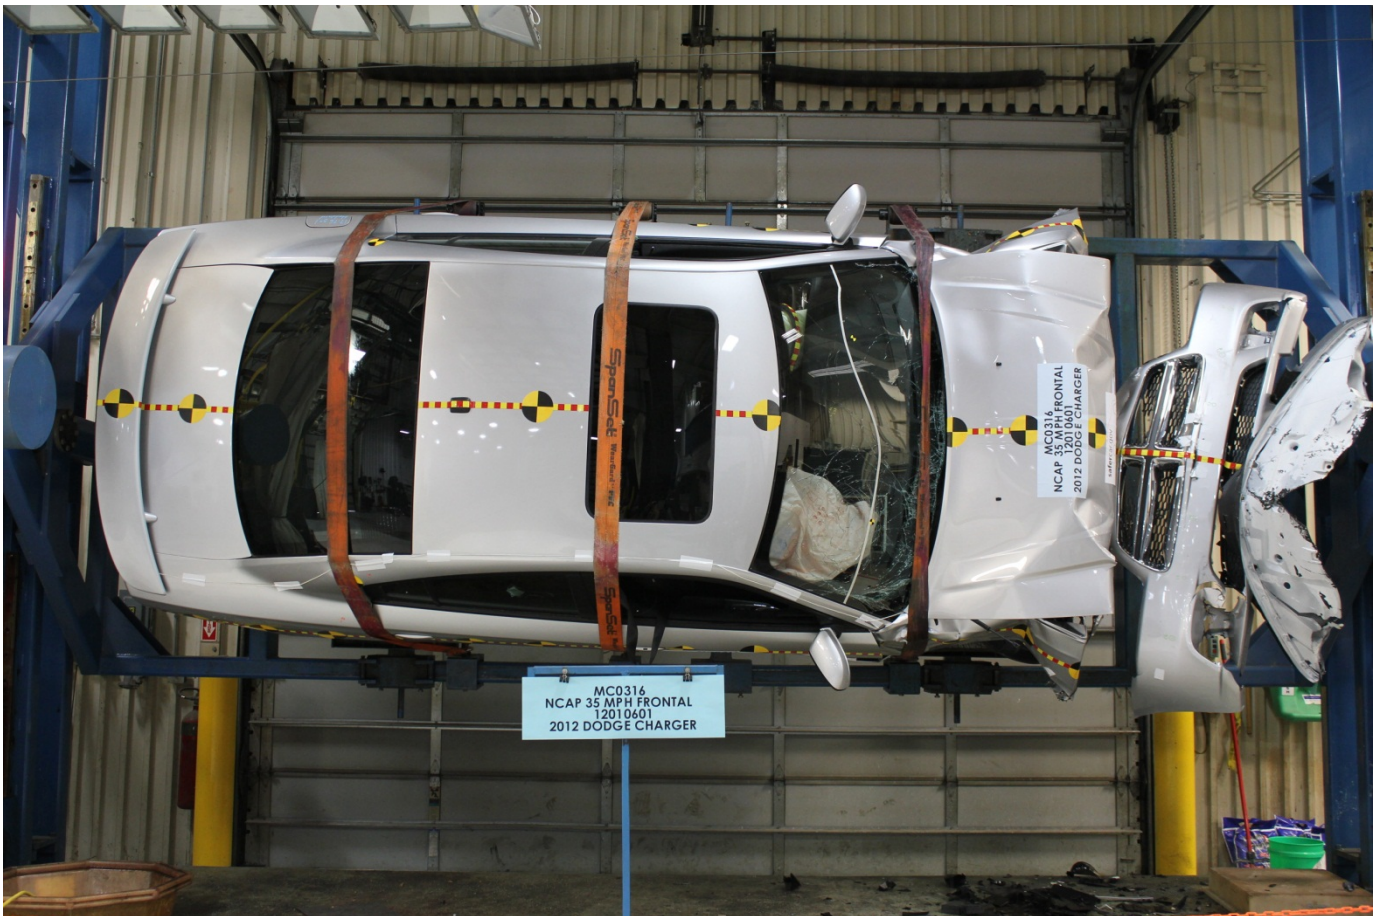
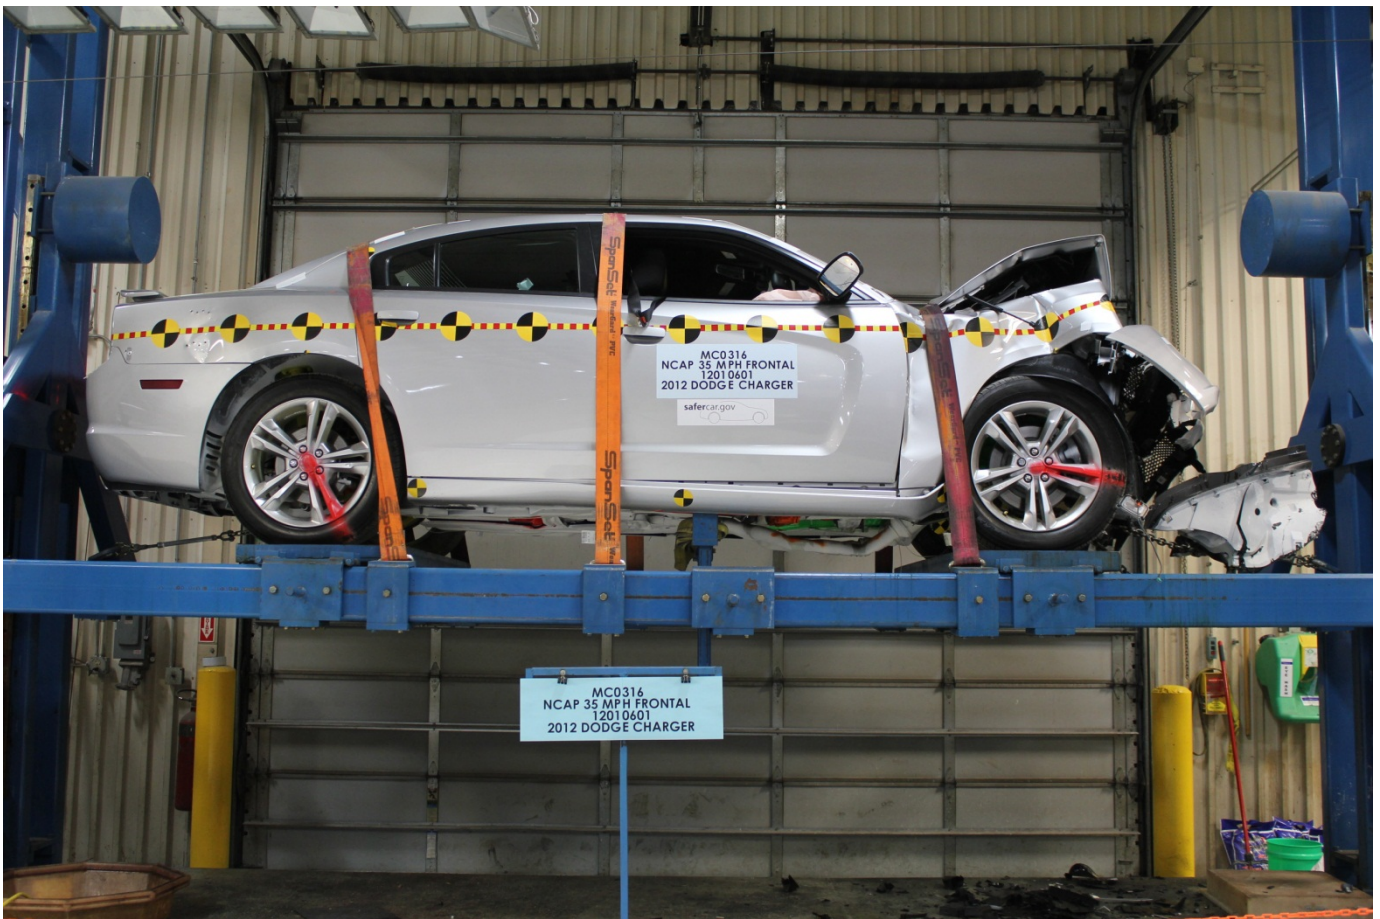
Vehicle at 0 Degrees on Static Rollover Device

Vehicle at 90 Degrees on Static Rollover Device

Vehicle at 180 Degrees on Static Rollover Device

Vehicle at 270 Degrees on Static Rollover Device

Vehicle at 360 Degrees on Static Rollover Device
