**REPORT NUMBER: 214P-MGA-2012-001**

**SAFETY COMPLIANCE TESTING FOR FMVSS 214  
DYNAMIC SIDE IMPACT PROTECTION  
RIGID POLE**

**GENERAL MOTORS LLC  
2012 CHEVROLET VOLT 5-DR HATCHBACK  
NHTSA NUMBER: CC0102**

**PREPARED BY:  
MGA RESEARCH CORPORATION  
5000 WARREN ROAD  
BURLINGTON, WI 53105**

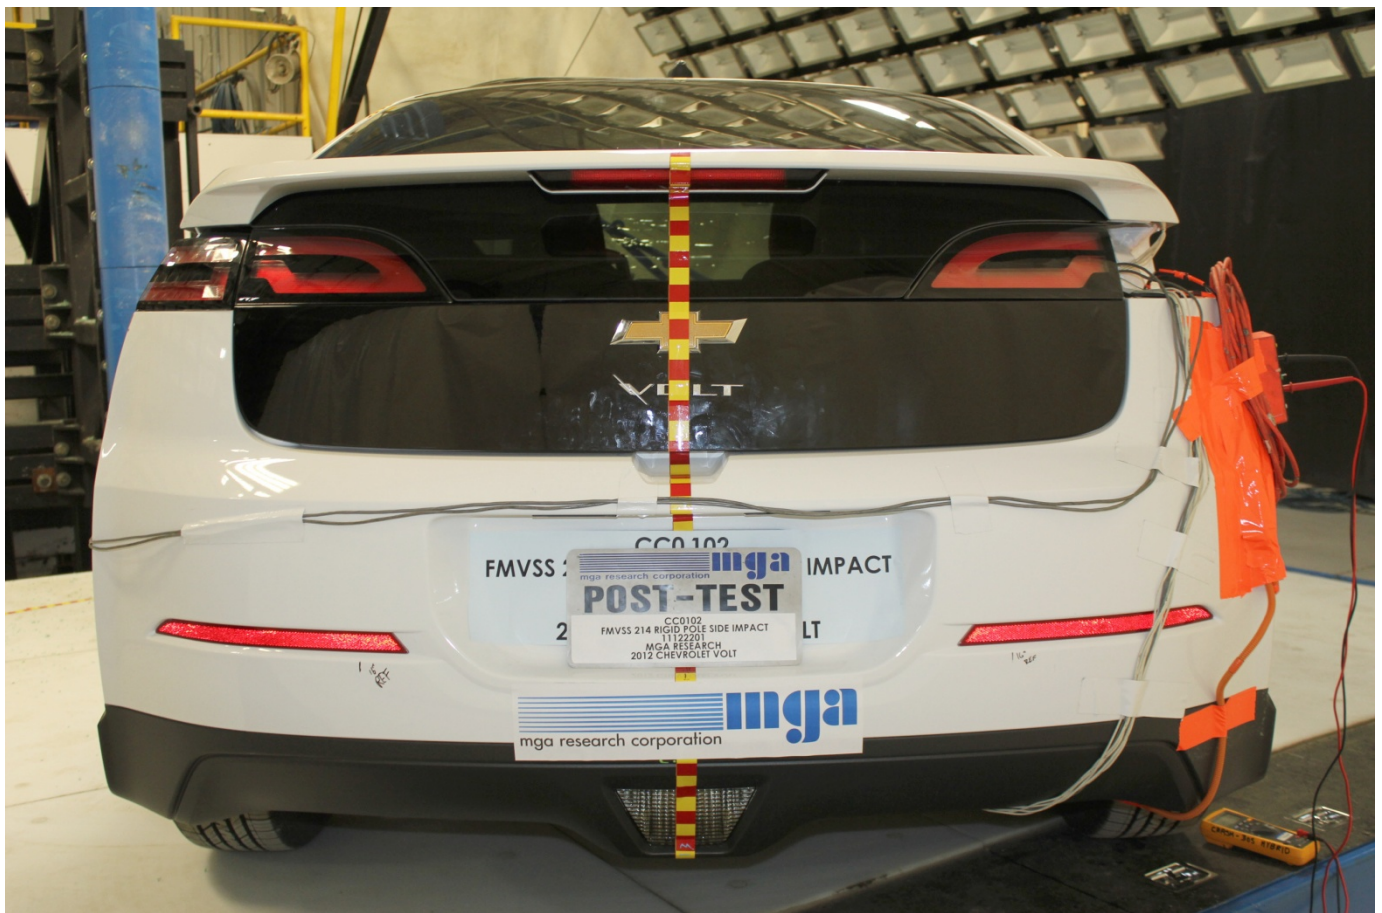
Post-Test Rear View of Test Vehicle

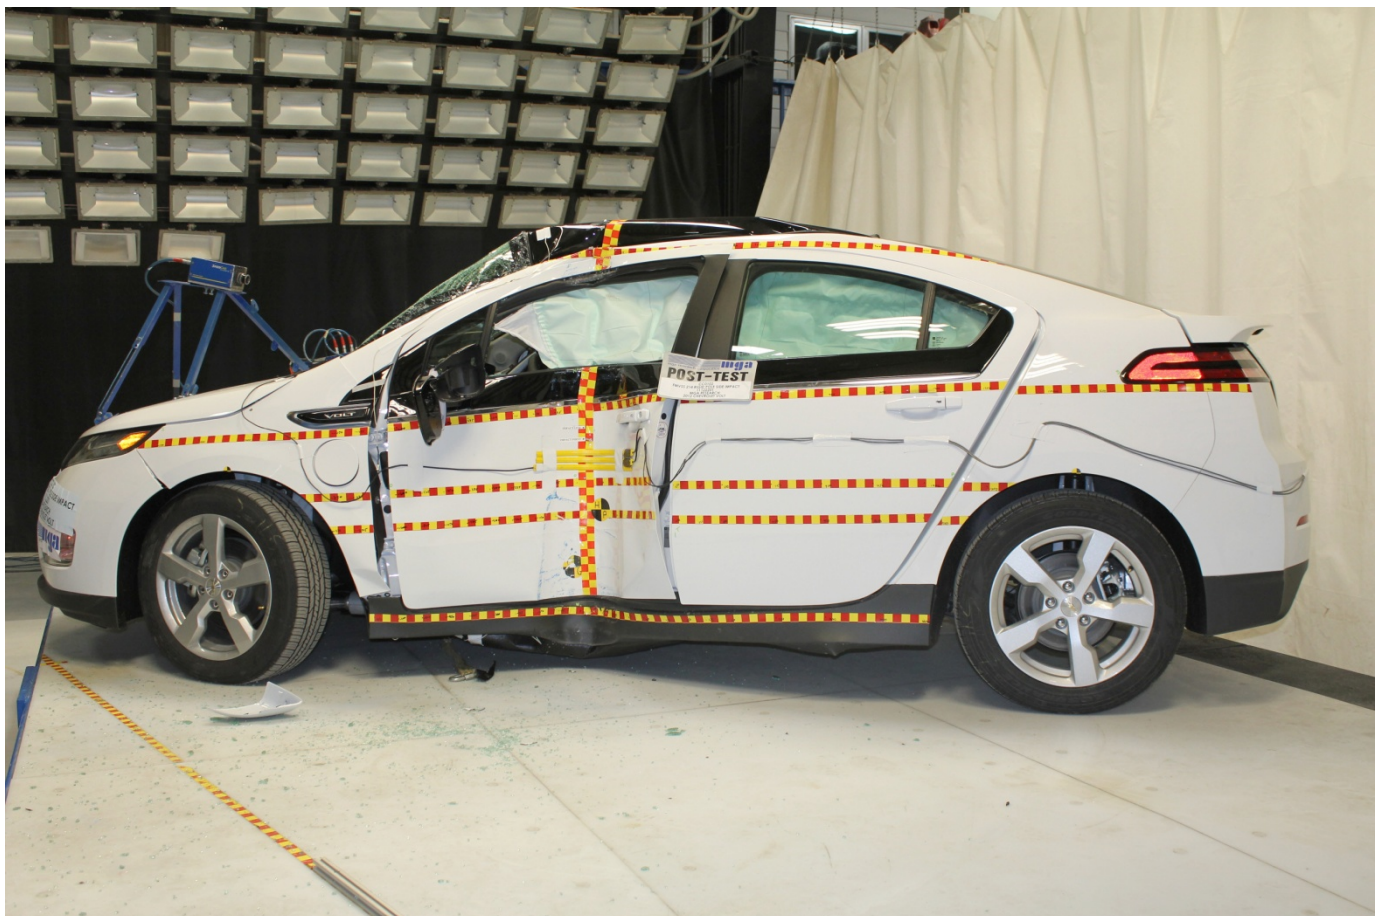
Post-Test Impacted Side View of Test Vehicle

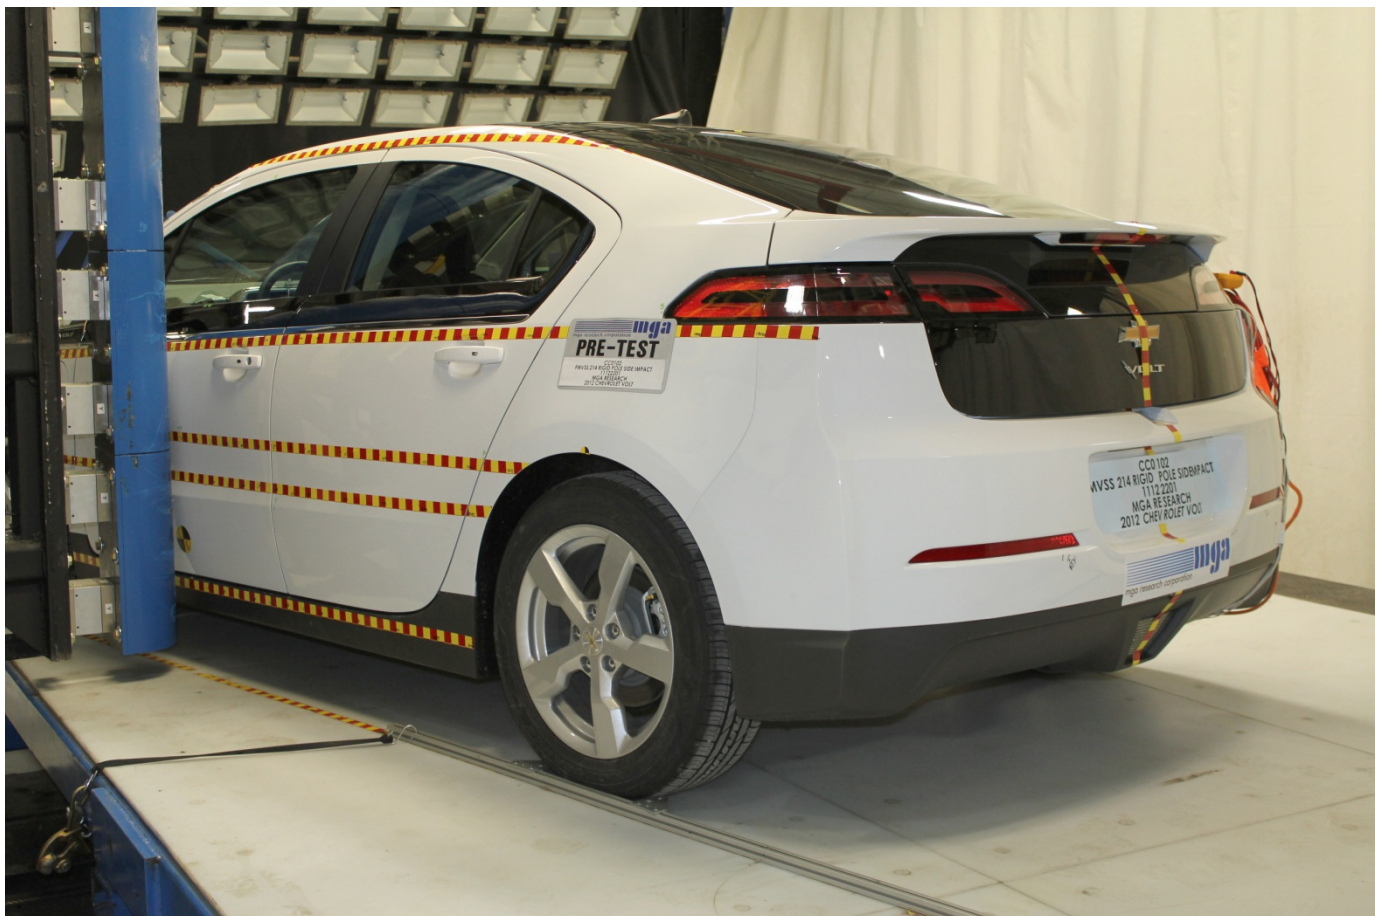
Pre-Test Left  $\frac{3}{4}$  Rear View of Vehicle and Pole

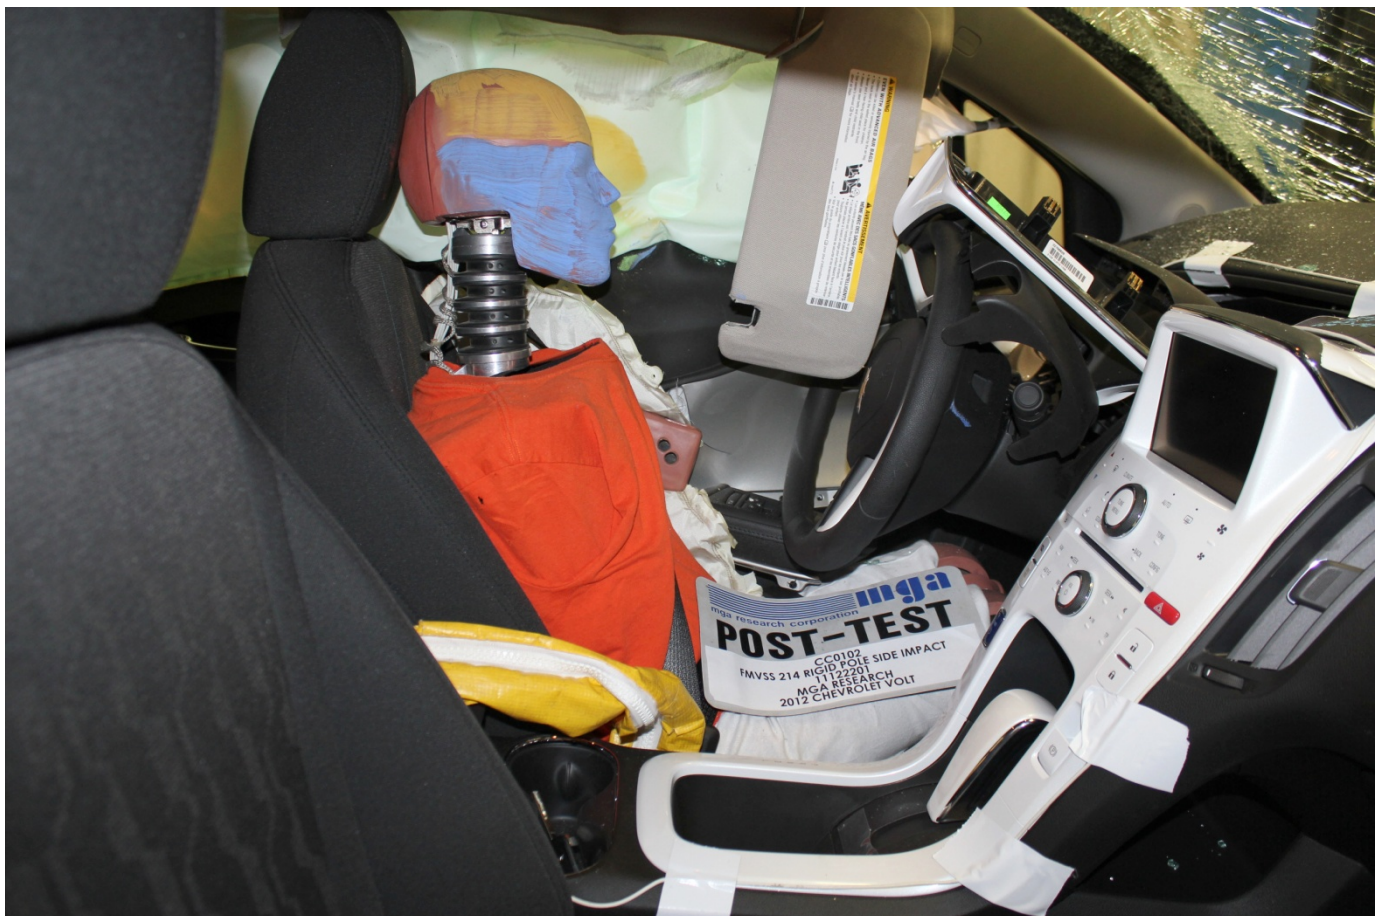
Post-Test Dummy Through Opposite Window

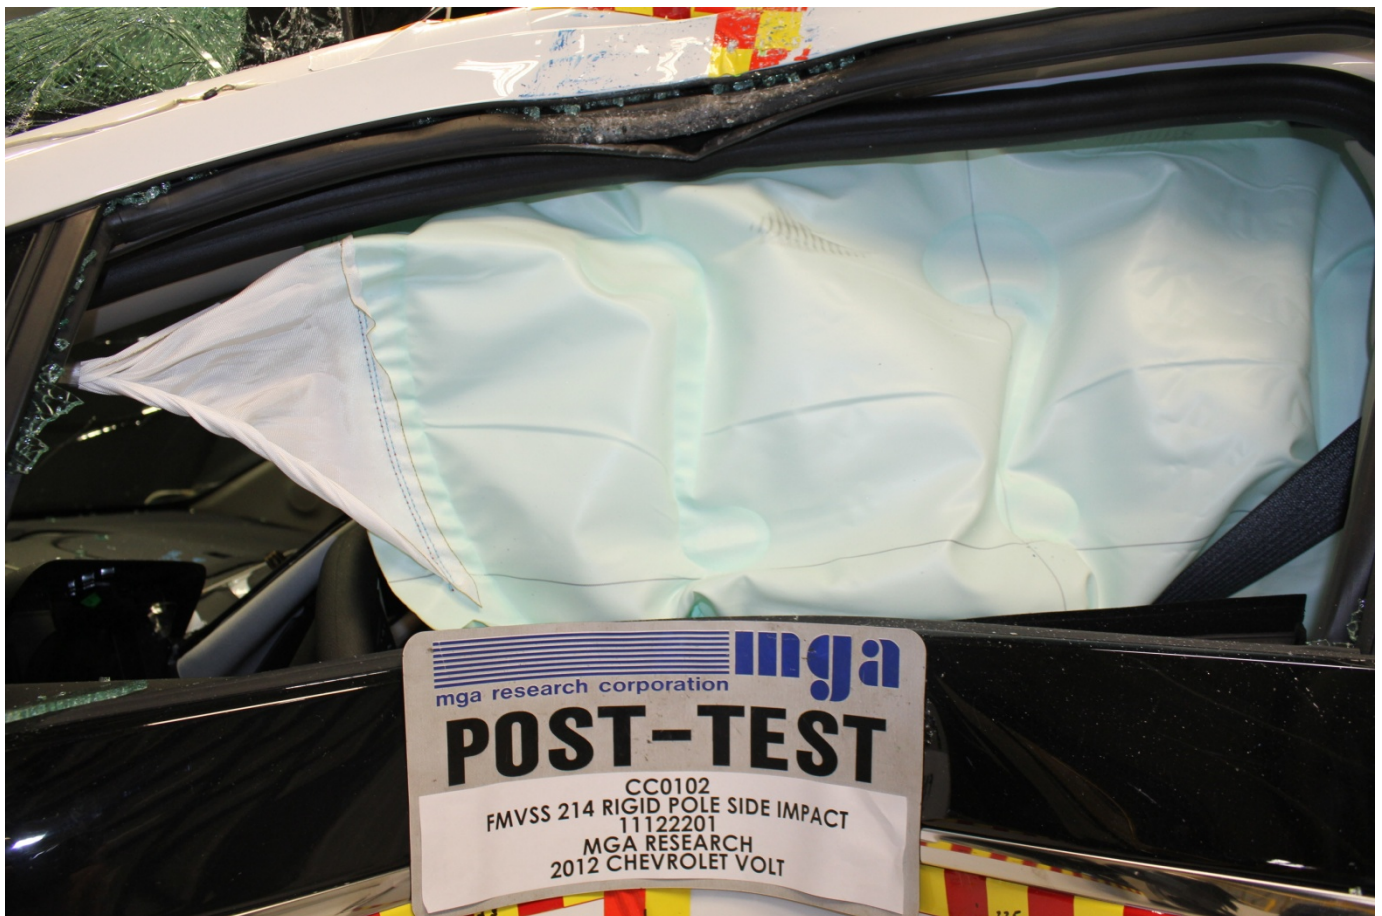
Post-Test Dummy with Door Closed (Impact Side)

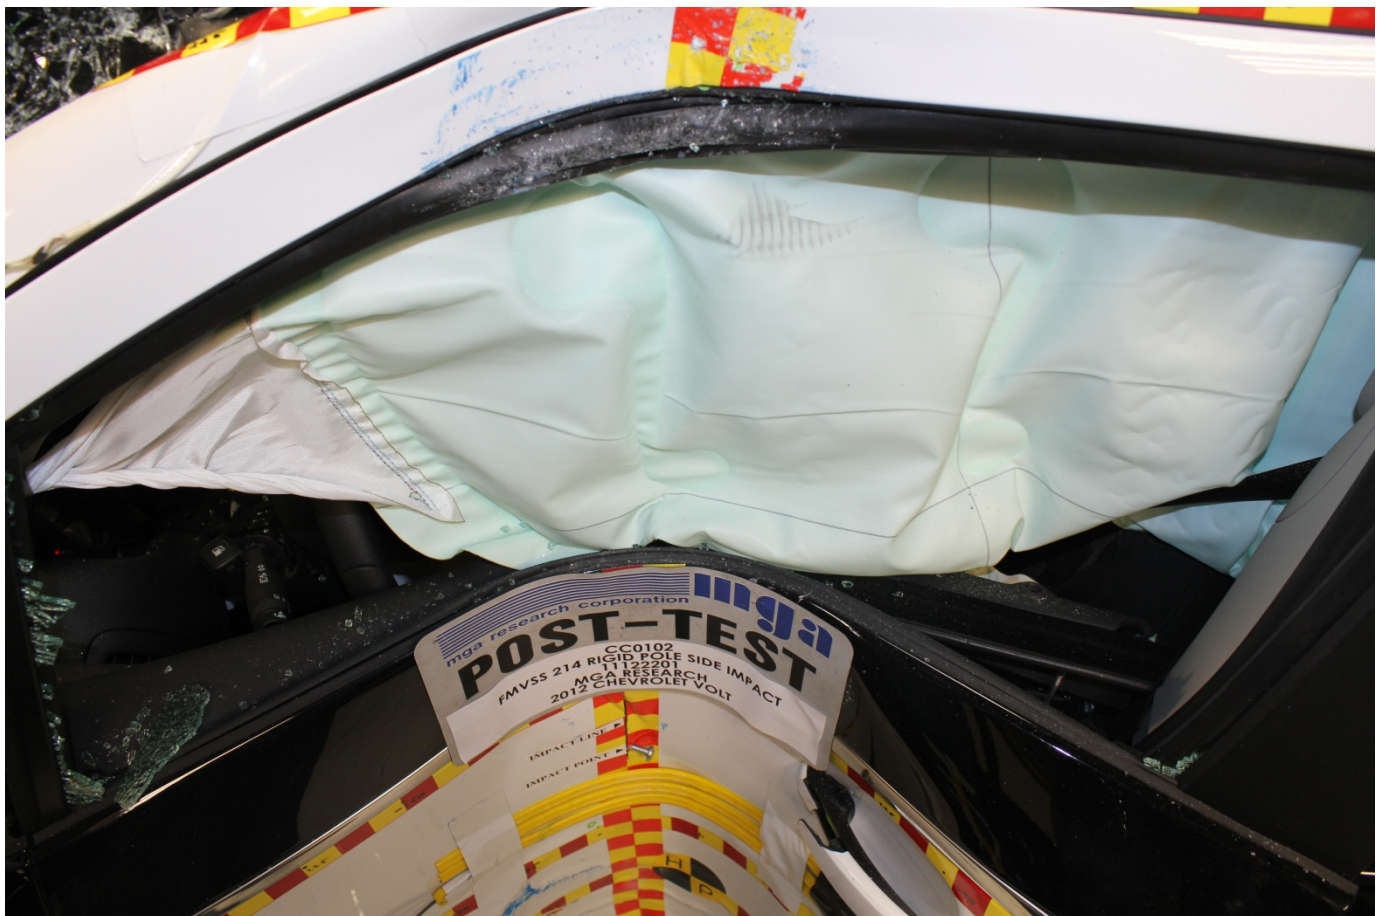
Post-Test Dummy Shoulder and Door Top View

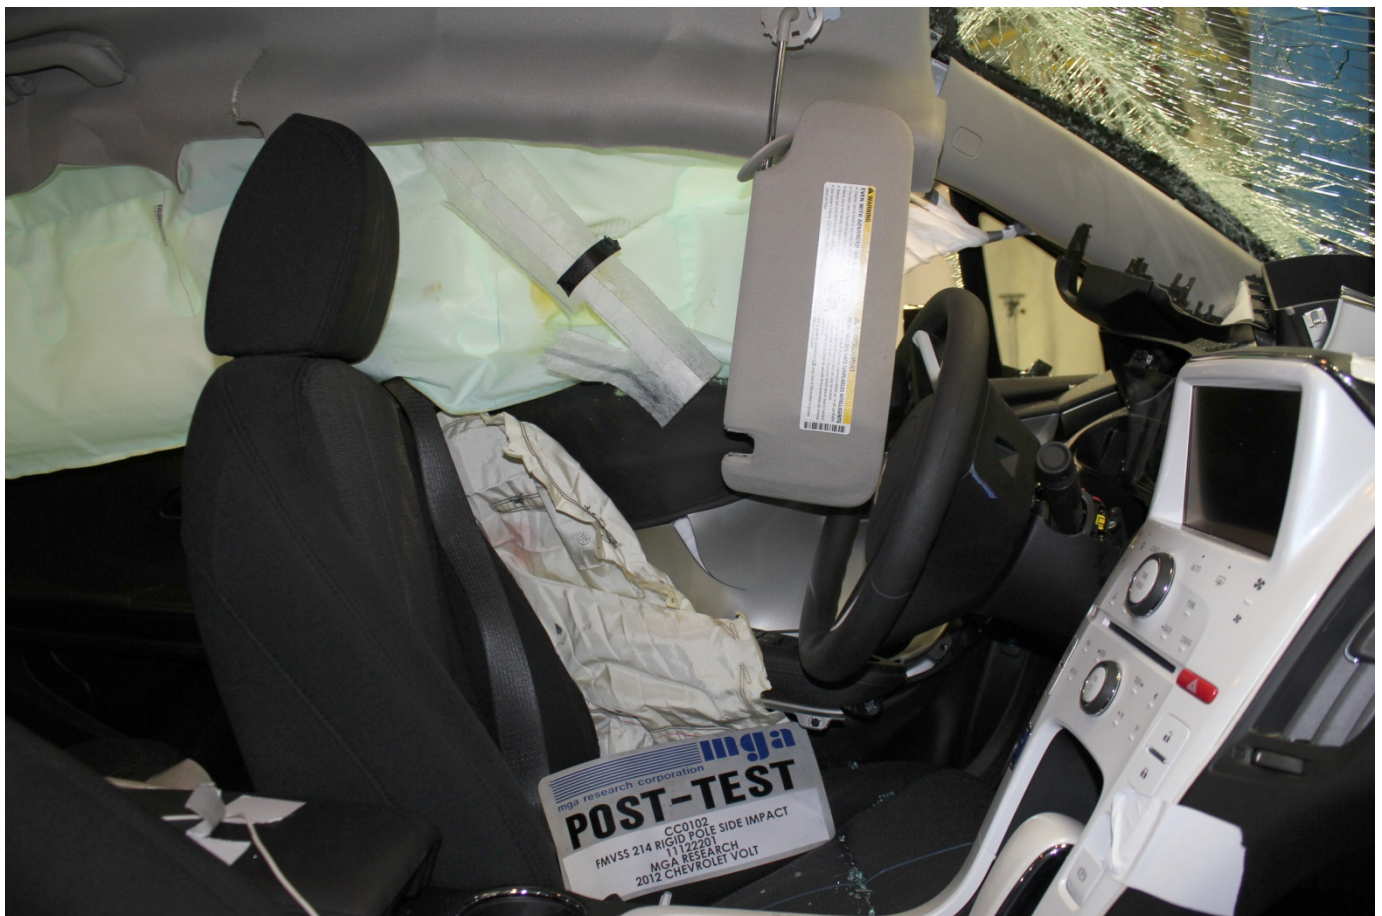
Post-Test Interior of Front Door Showing Dummy Impact Locations

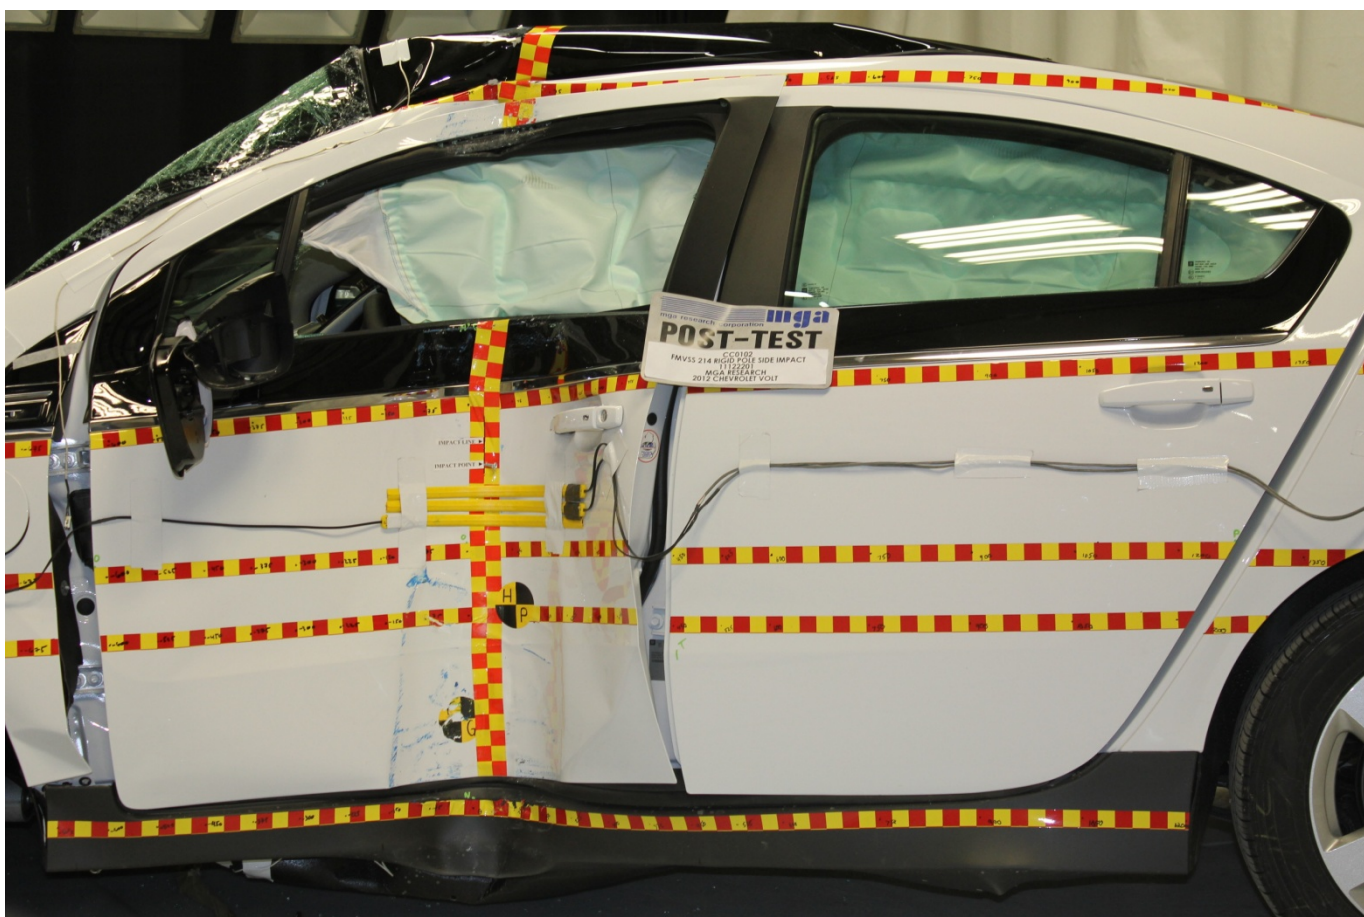
Post-Test Impact Zone Close-up View

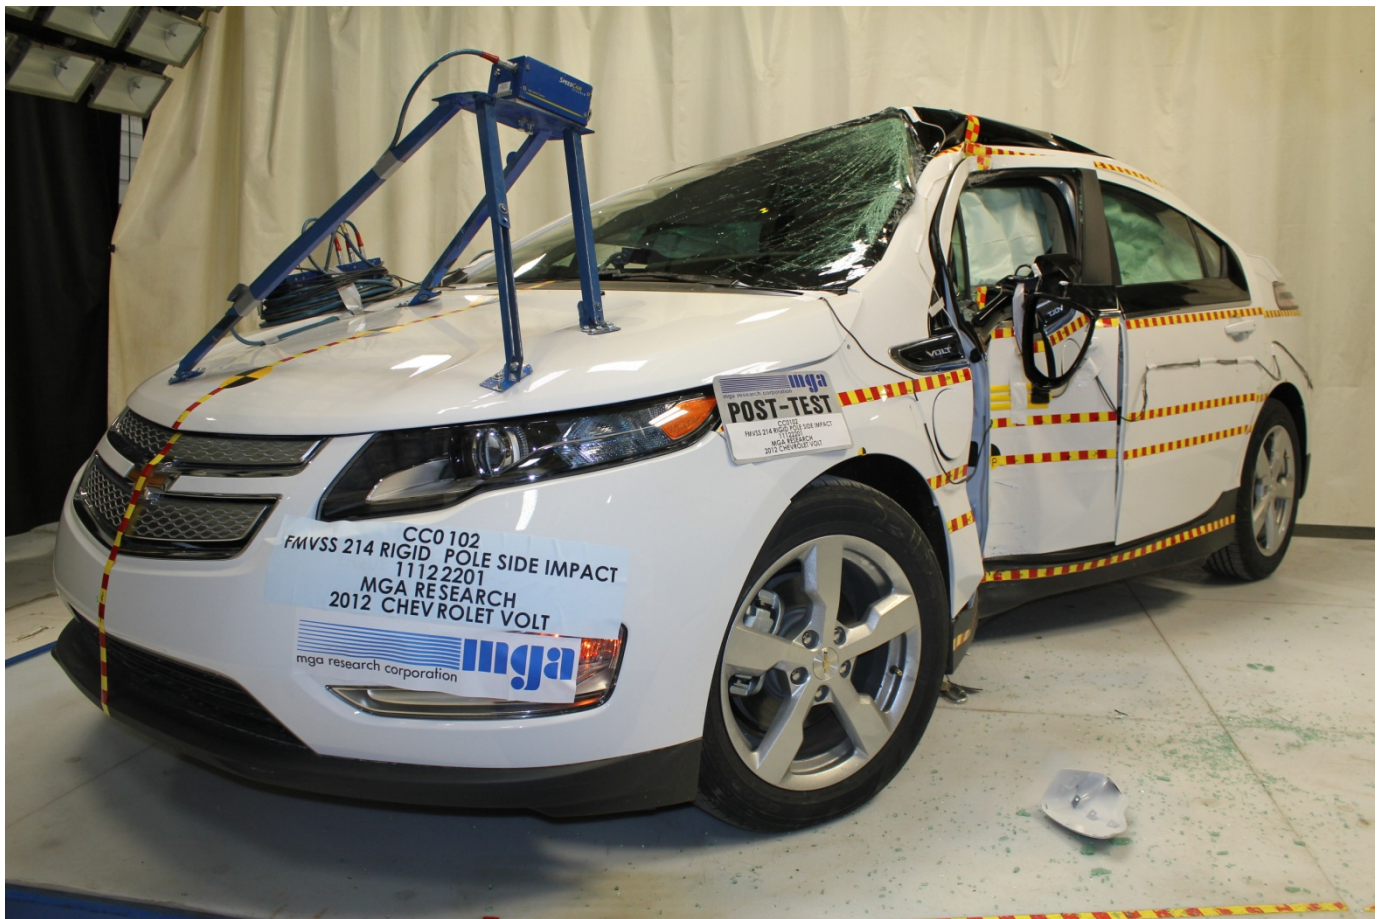
Post-Test  $\frac{3}{4}$  Front View of Impact Zone

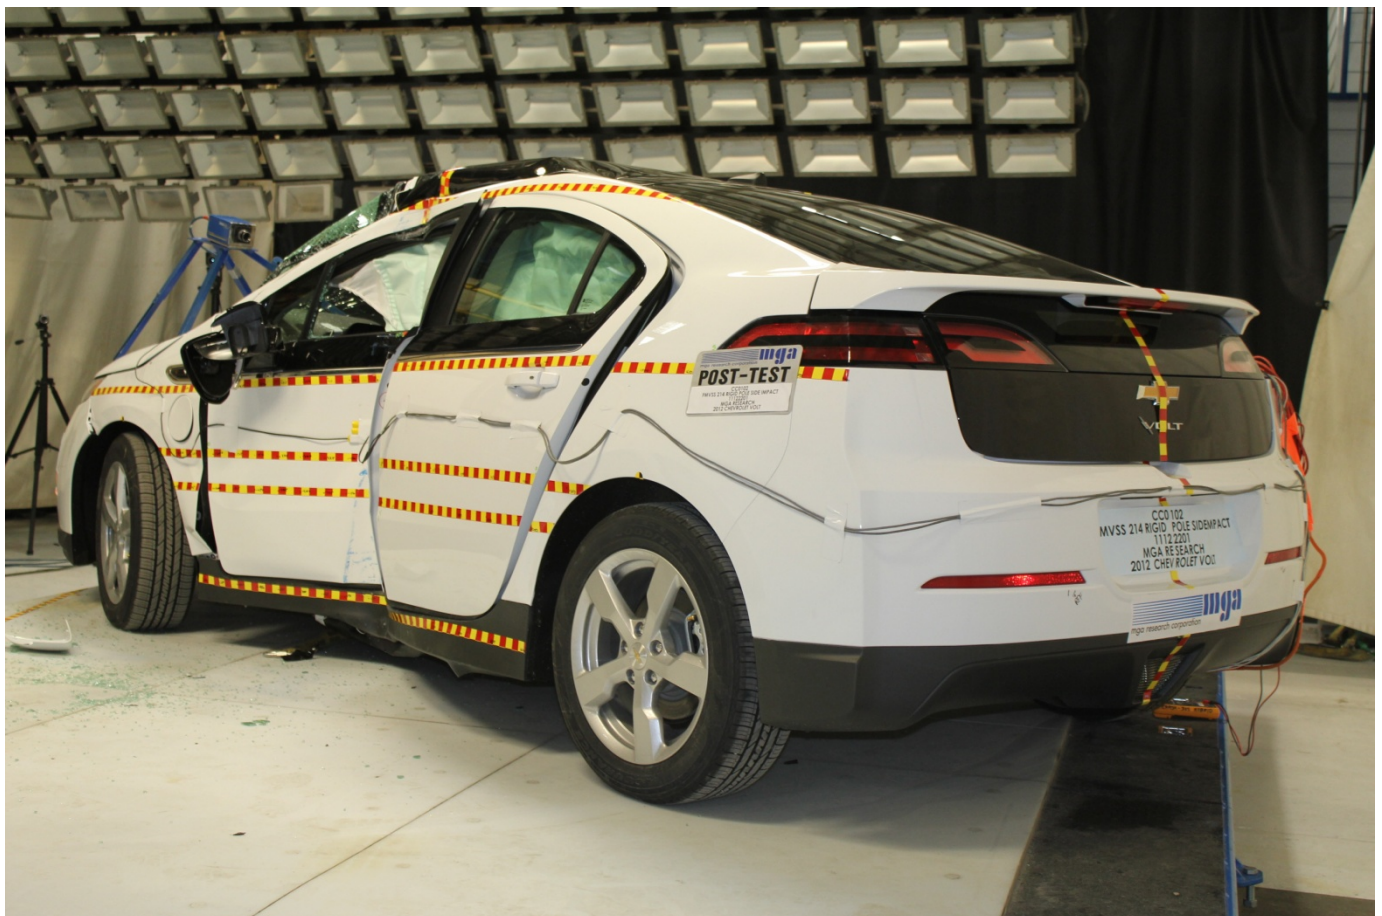
Post-Test  $\frac{3}{4}$  Rear View of Impact Zone

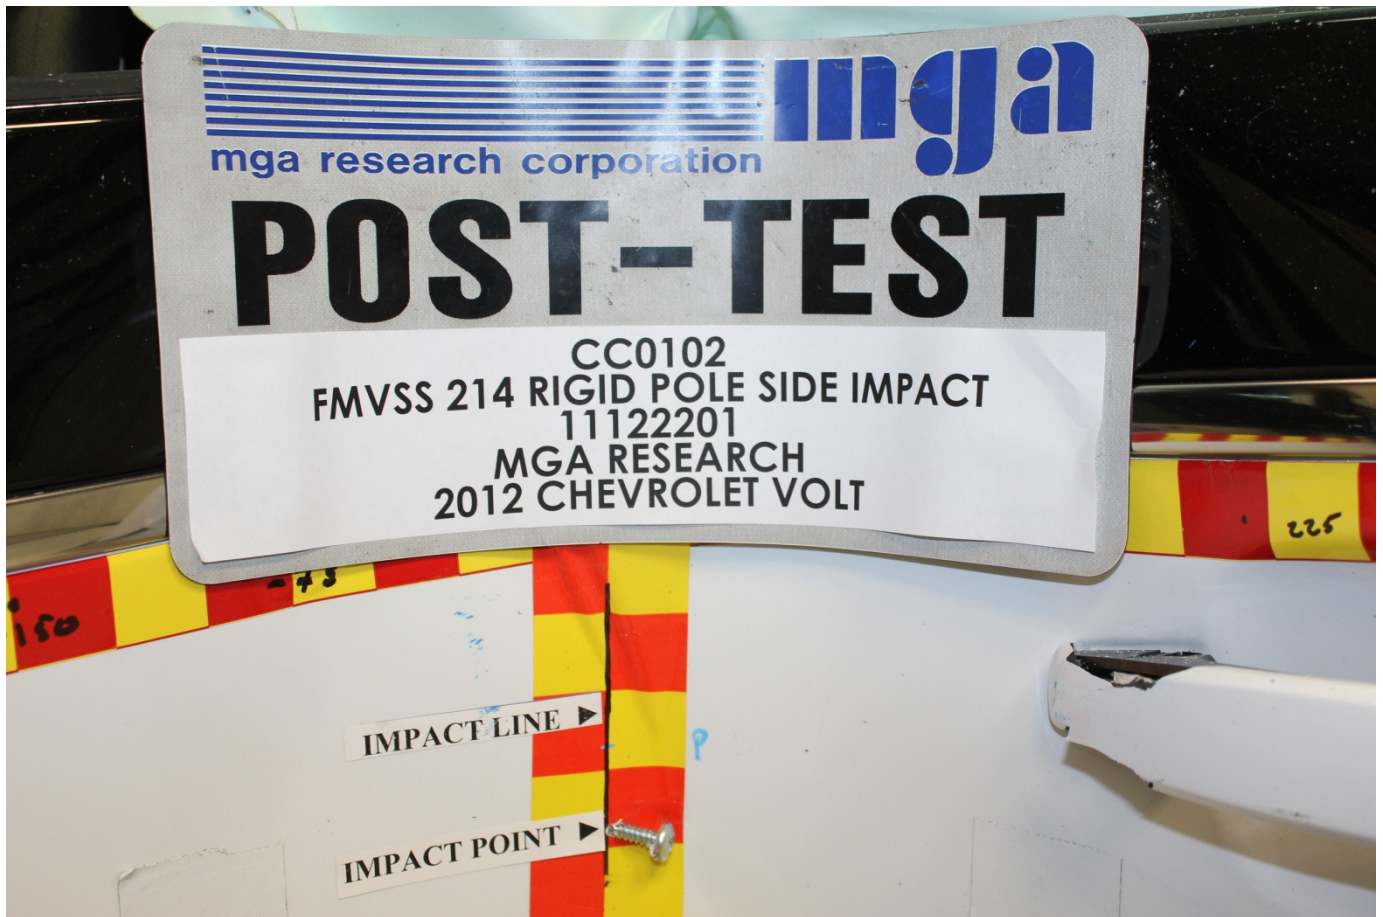
Post-Test Close-up View of Impact Point Target

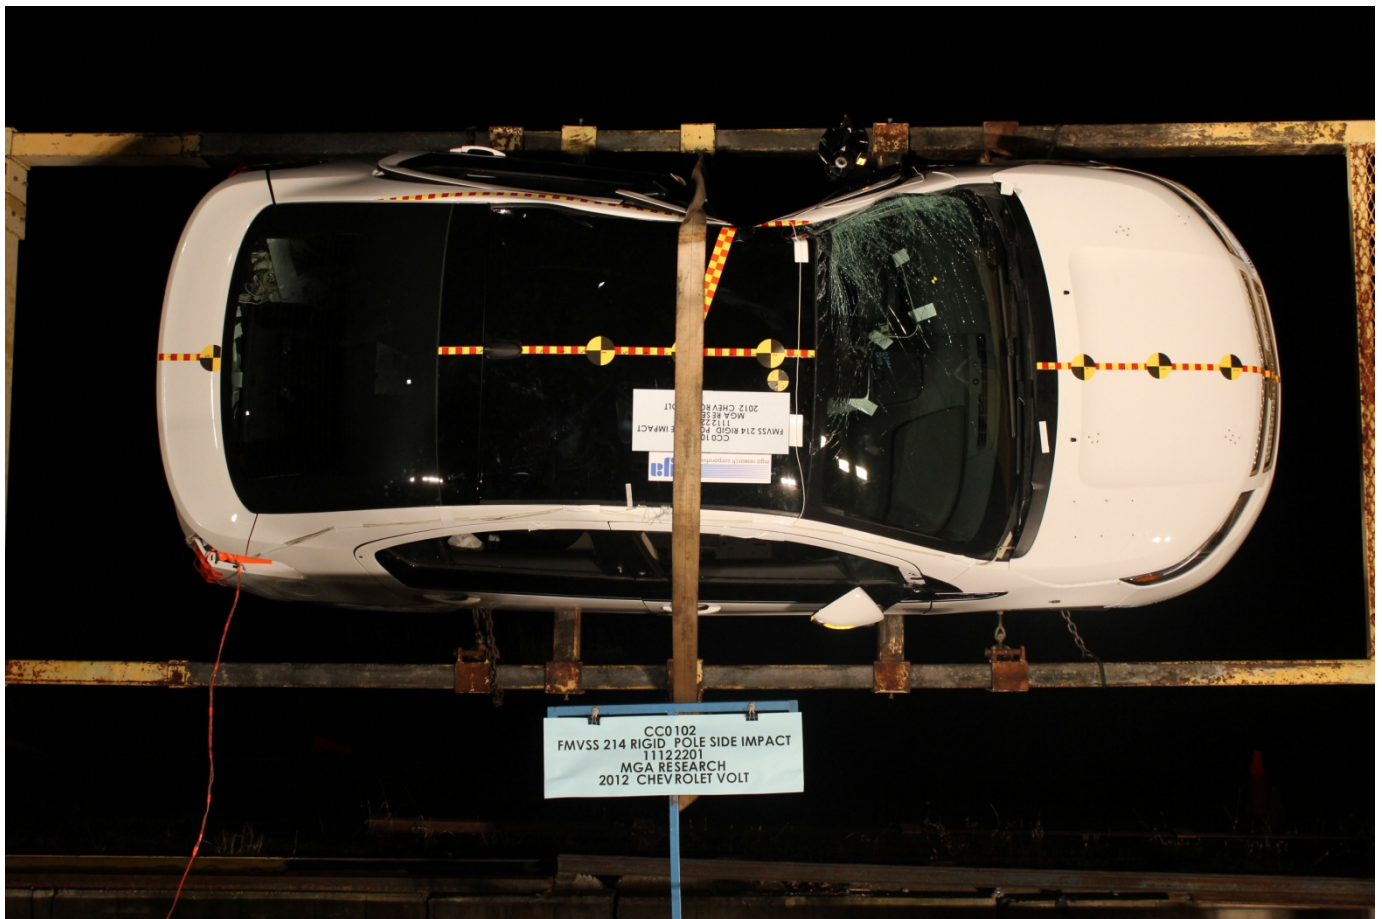
Post-Test Vehicle at 90 Degree Rollover

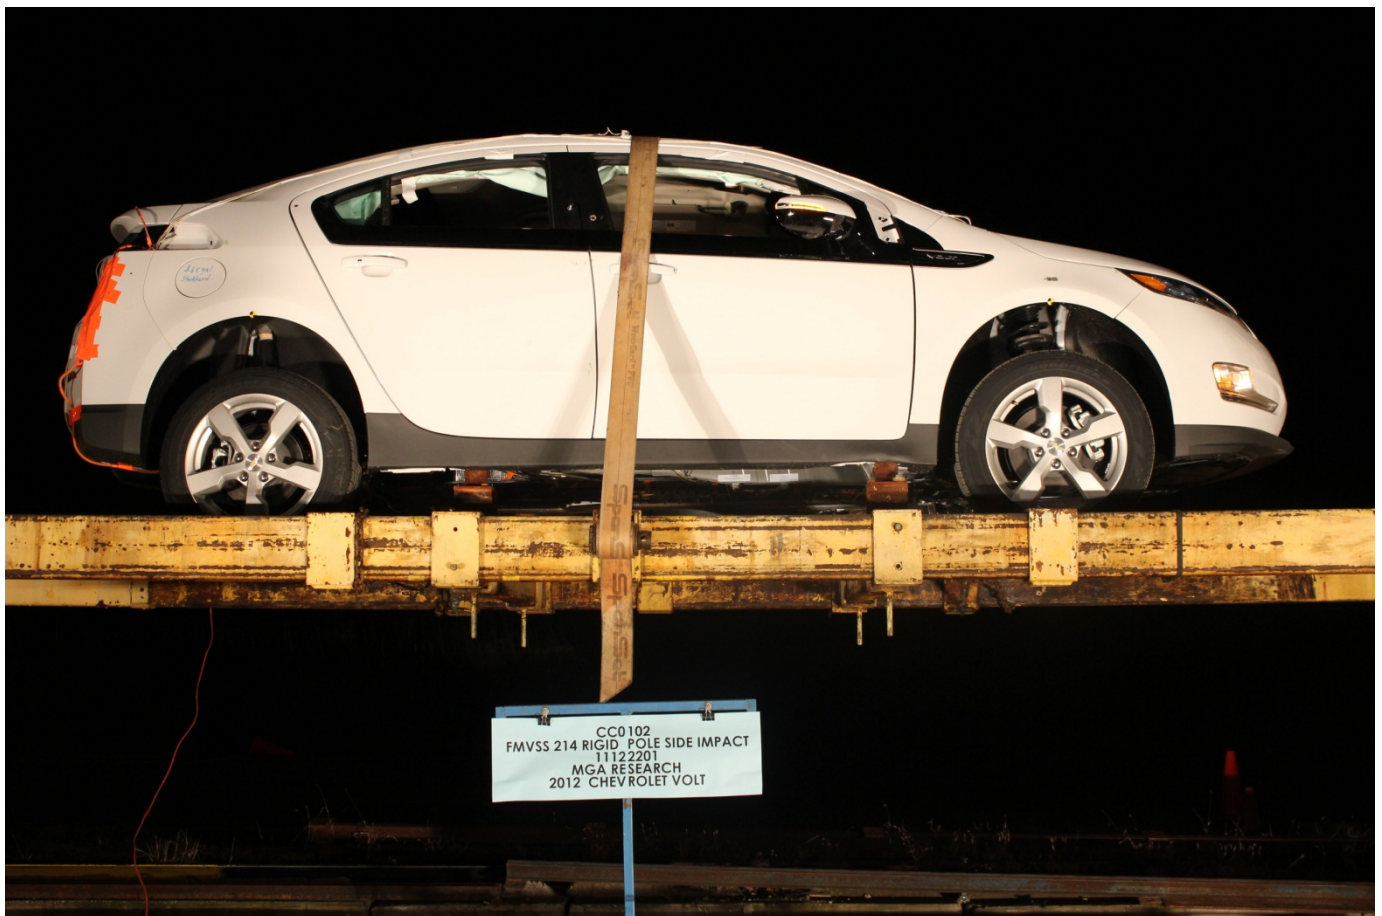
Post-Test Vehicle at 360 Degree Rollover
